# Premature Deterioration of Jointed Plain Concrete Pavements

FINAL REPORT

Date April 2011

By (PI) Dr. J. M. Vandenbossche, P.E.  
University of Pittsburgh

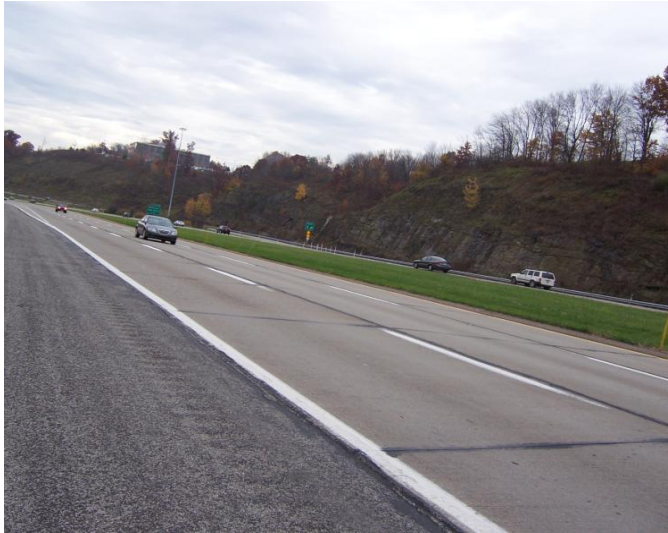
*Figure 5: Overall Condition of SR 60 Segment 303 Southbound (Control Section).*

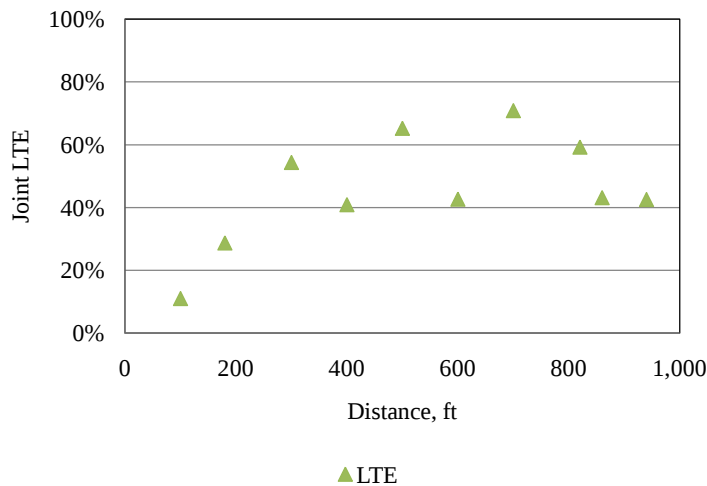
The joint load transfer efficiency values for the Distressed and Control sections are presented in Figure 14 and Figure 15, respectively. As observed in these figures, the LTE of the transverse joints for both sections is low considering that a good level of LTE is greater than 70 percent. This low LTE might be due to the incremental damage over time [4], given the age of the pavement. Comparing the two sections, the average LTE for the Distressed section was 46 percent, while the average LTE for the Control section was 58 percent. The higher average value obtained for the Control section is believed to be due to the contribution of the stabilized base to the load transfer. For the Distressed section, the base layer is granular. Comparatively, granular base layers contribute less to the transfer of load the base layer when compared with a stabilized base. Additionally, the differential deflections for the transverse joints are presented in Figure 16 and Figure 17, respectively.

Figure 14: Transverse Joint Load Transfer Efficiencies for SR 60 Segment 323 Southbound (Distressed Section).

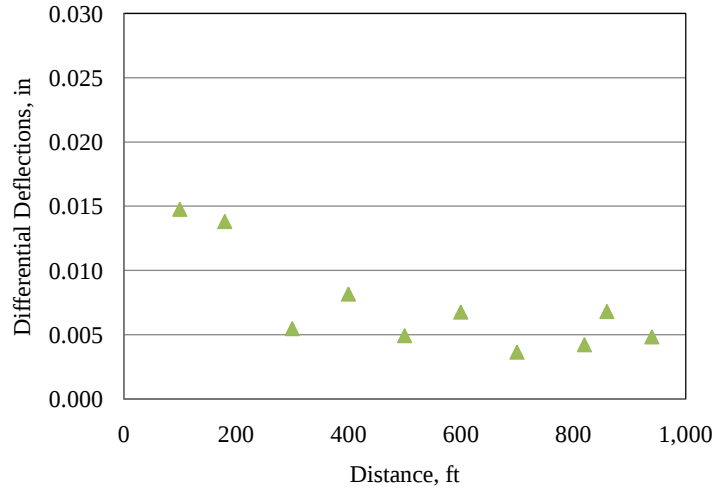
Figure 16: Differential Deflections at Transverse Joints for SR 60 Segment 323 Southbound (Distressed Section).

Differential deflections represent the difference between the deflections on the loaded side of the joint to the deflection on the unloaded side of the joint. If differential deflections are greater than 0.01 in, that indicates that there is a problem with load transfer at that location. For the Distressed section, only two of the transverse joints have differential deflections higher than the threshold value. These joints are also having the lowest LTE of the section. In the case of the Control section, none of the transverse joints have differential deflections higher than the threshold value, which agrees with the relatively better performance of the joints in this section.

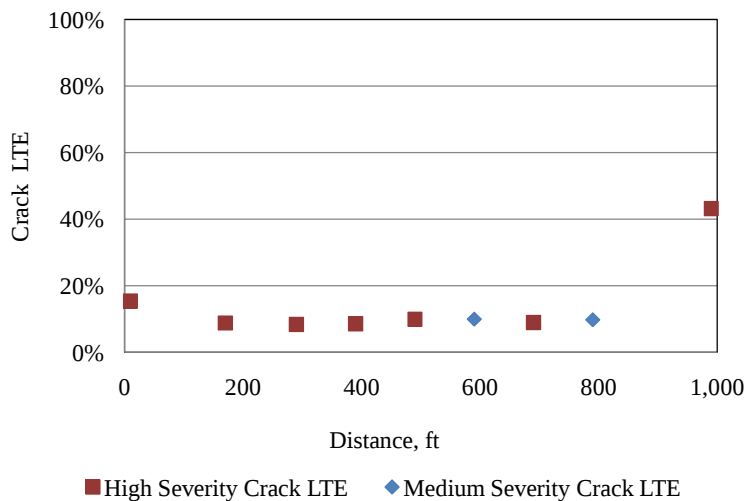
The crack load transfer efficiency for the Distressed and Control sections are presented in Figure 18 and Figure 19, respectively. The difference in the average LTE for the cracks in the Distressed and Control sections is quite significant. Crack LTE for the Distressed section is 14 percent while it is 40 percent for the Control section.

Figure 18: Transverse Crack LTE for SR 60 Segment 323 Southbound (Distressed Section).

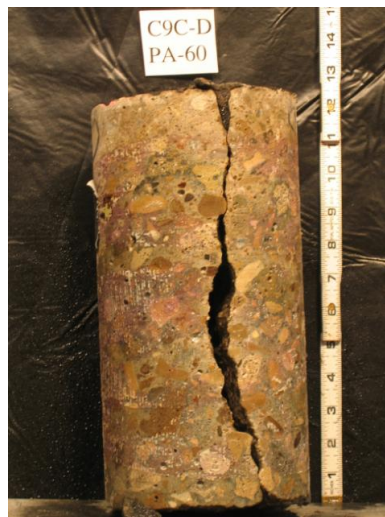
A core retrieved at a high severity crack location in the Distressed section is shown in Figure 20. It is observed in this figure that extensive abrasion has taken place at the lower portion of the core. This condition, which implies large differential movements between the crack faces, combined with a large crack width, is likely responsible for the low LTE observed for the cracks in the Distressed section. Figure 21 presents a core retrieved at a low severity crack located in the Control section. As observed in the figure, the PCC layer is completely bonded with the ATPB layer. This condition restrains the opening of the crack and enhances the effectiveness of the aggregate load transfer across the crack.

Figure 20: High Severity Transverse Crack Core of SR 60 Segment 323 Southbound Slab 9 (Distressed Section)

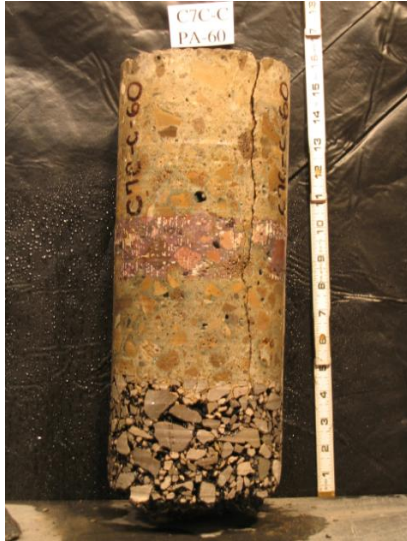
*Figure 21: Low Severity Transverse Crack Core of SR 60 Segment 303 Southbound Slab 7 (Control Section).*

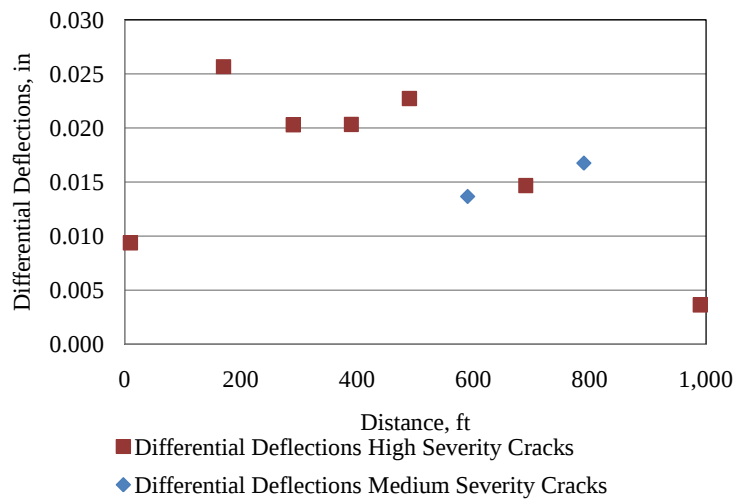
The differential deflections for transverse cracks are presented in Figure 22 and Figure 23 for the Distressed and Control sections, respectively. In the Distressed section, all but two values are above this threshold for differential deflection and only one value is significantly below the threshold. For the Control section, half of the differential deflection values for the Control section are below the threshold value and all of the differential deflections measured for the low severity cracks are well below the threshold values. The overall average differential deflection for the Distressed section is 0.016 in and the average differential deflections for the medium and high severity cracks are 0.015 in and 0.017 in, respectively. For the Control section, the overall average differential deflection is 0.010 in and is 0.001 in and 0.014 in for the low severity and medium severity cracks, respectively. The differential deflections for the Distressed and Control sections agree with the measured crack LTEs.

Figure 22: Differential Deflections at Transverse Cracks for SR 60 Segment 323 Southbound (Distressed Section).

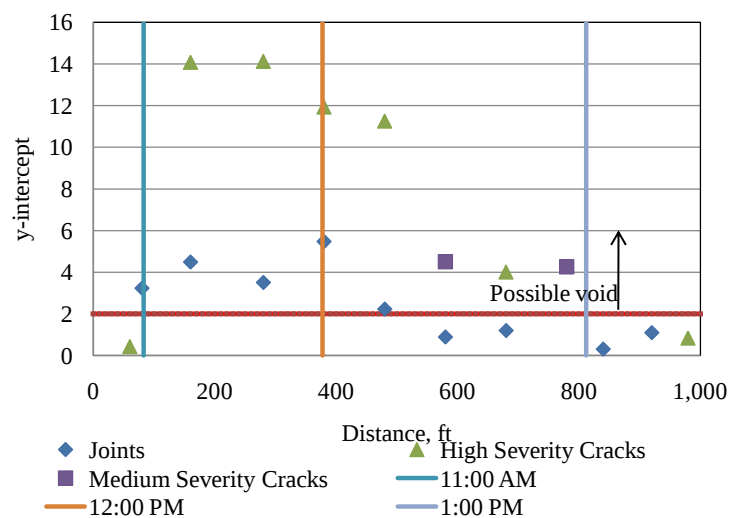
In the Distressed section, 45 percent of the joint tested have possible voids while 78 percent of the cracks potentially have voids. As observed in Figure 24, the transverse joints and cracks with potential voids tend to be located in the first half of the section. While conducting FWD testing in the Distressed section, the slab surface temperature increased 10 °F and the predicted (assumed linear) gradients increased from 0.65 °F/in to 1.25 °F. It is possible that this led to false negatives in the latter portion of the section since the presence of a large positive gradient causes downward curling of the slab, and hence diminishing the ability to detect a void.

Figure 24: Loss of Support of SR 60 Segment 323 Southbound (Distressed Section).

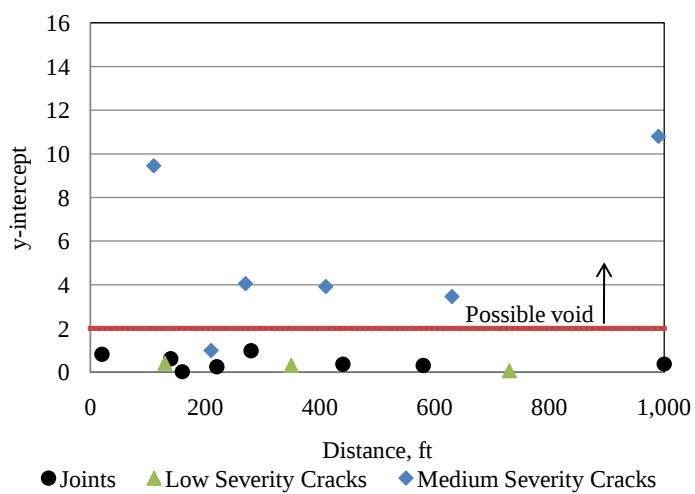
In the Control section, none of the joints or low severity cracks indicates the presence of a void. However, 44 percent of the medium severity cracks show the potential for voids beneath the slab. The identification of voids beneath slab at joints and cracks may be affected by the downward curling of the slab caused by the relatively high positive gradient during the testing (1.26 °F/in). The y-intercept value, which reflects the relative size of the void beneath the slab, could be higher for all of the joints and cracks. This condition suggests the likelihood of the existence of voids at the joints and cracks throughout the whole section.

Figure 25: Loss of Support of SR 60 Segment 303 Southbound (Control Section).

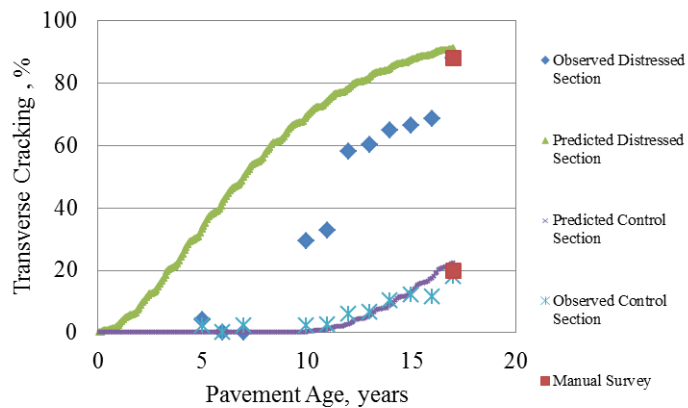
Figure 30 presents the MEPDG-predicted along with the observed transverse cracking for the Distressed section and Control section. The observed transverse cracking over time (from year 5 to year 16) is based on historic distress data provided by PennDOT, which has been collected using automated distress equipment. The data point for year 17 represents the percentage of transverse cracking of the Distressed section that was manually surveyed as part of the field data collection executed in the present study. Although there are some historic data points missing, it can be observed that transverse cracking began to be visible on the surface of the slabs between years 7 and 10. Additionally, it can be noticed in Figure 30 that, for the Distressed section, from year 11 to year 12, the percentage of cracking increases from 33 percent to 58 percent; and from year 16 to year 17 it increases from 69 to 88 percent.

Figure 30: Predicted and Observed Transverse Cracking for SR 60 Segment 323 and 303 Southbound (Distressed and Control Sections)

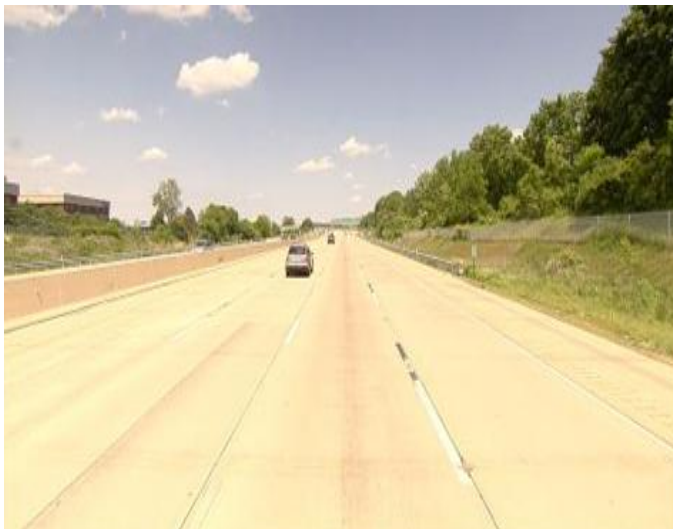
*Figure 35: Overall Condition of SR 202 Segment 440 Northbound.*

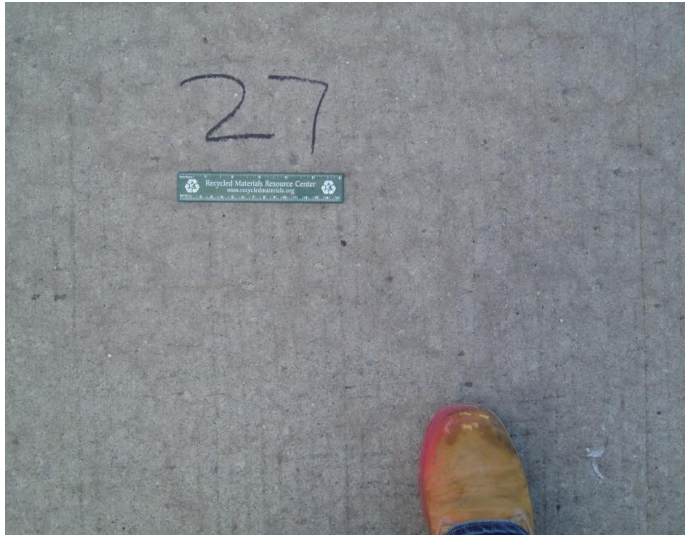
Map cracking was the other major distress observed in Segment 440. Map cracking over the entire surface of the slab was observed in 55 percent of the slabs. The microcracks within the map cracked areas are mainly oriented in the longitudinal direction of the slabs and are interconnected by finer cracks randomly distributed as shown in Figure 38 and Figure 39.

*Figure 39: Close-up of Microcracking of SR 202 Segment 440 Northbound, Slab 27.*

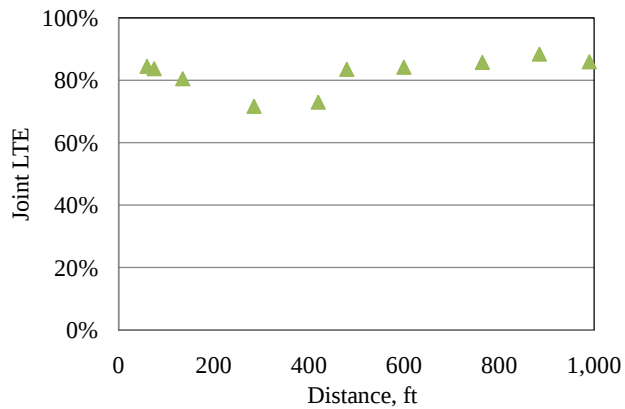
The joint load transfer efficiency values for the entire section are presented in Figure 44. As observed in the figure, the LTE is good (higher than 70 percent) for the majority of the transverse joints. This superior load transfer efficiency was expected considering the 1.5-in dowels used, the 13-in slab thickness, and the pavement is only 8-years old. As mentioned before, the effect of the temperature in the measured LTE values is negligible for this specific section due to the relatively low ambient temperature of 38 °F present when the FWD testing was performed.

Figure 44: Joint Load Transfer Efficiencies for SR 202 Segment 440 Northbound.

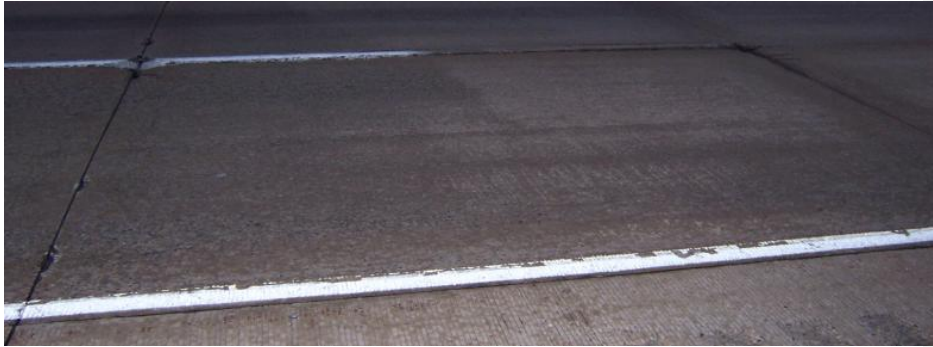
Figure 47: Overall View of Slab 5 SR 202 Segment 440 Northbound

Two cores from SR 202 were examined according to ASTM specification C856 “Petrographic Examination of Hardened Concrete” and ASTM specification C457 “Microscopical Determination of Air Void Content and Parameters of the Air Void System in Hardened Concrete.” These cores were from the mid-slab locations of Slab 5 and Slab 9. Slab 5 exhibited significant spalling along the centerline longitudinal joint between the driving lane and the adjacent lane as well as spalling along both transverse joints. The spalling along the transverse joints was closer to the longitudinal joint between the driving lane and the adjacent lane than it was to the lane/shoulder longitudinal joint. Typical locations of the spalled areas are

shown in Figure 47. Slab 9, the other slab from which a core was taken for petrographic analysis, did not exhibit any spalling.

Based on these conclusions, it seems apparent that the joint spalling can indeed be attributed an insufficient air void system. The influence of the traffic loads on spalling can be noticed particularly keenly in the wheelpath shown in Figure 47, as the spalled concrete tends to be dislodged in this area. It was also noted that this distress was observed at the pavement surface but none of the cores pulled exhibited deterioration at the bottom of the core. Generally, D-cracking is more extensive at the bottom since the bottom of the slab is typically saturated. This indicates that the entrained air void system might be better at the bottom of the slab than the top.

Typical repairs made to address spalling are a full-depth repair if the depth of spalling exceeds more than 1/3 the depth of the slab or a partial depth repair if the depth of the spalling is less than 1/3 the depth of the slab. For SR 202, the spalling developed as a result of D-cracking associated with the poor entrained air system. Since the bottom of the slab is always saturated, D-cracking tends to be more prevalent at the bottom of the slab when compared to that observed on the surface. Therefore, full-depth repairs are typically necessary. For SR 202, the distress does not generally develop at depths greater than 1/3 the depth of the slab since the entrained air void system at the bottom of the slab is better than at the top of the slab. It would be beneficial to pull a few more cores to verify this throughout the distress section. With the depth of the spalling being restricted to the upper portion of the slab, partial depth repairs might be effective. If regions are found where the deterioration runs throughout the depth of the slab then full depth repairs would be necessary. These repairs would help to extend the life of the pavement but it can be expected that the deterioration would eventually develop along the newly created joints in the original concrete adjacent to the repair area. It might be possible to further deter the continued deterioration by applying a sealant on the exposed portion of the existing slab prior to placing the repair material. Before this is attempted, one must insure that the sealant does not deter the bond between the existing slab and the repair material.

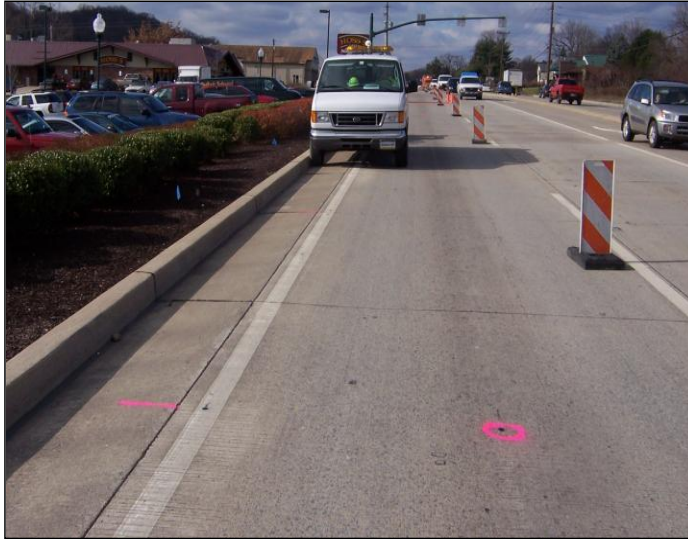
Figure 50: Overall Condition of US-22 Murrysville Segment 50 Eastbound.

During the site visit, it was found that full-depth repairs were performed within the section and that the stabilized base was removed in the area of the repairs and replaced with a granular base material. Based on the retrieved cores, full-depth repairs were performed on at least Slab 8 through Slab 12, since a granular base was found below the slab and not the ATPB present in the other portion of the roadway. According to information provided by PennDOT, these slab replacements were performed to repair corner breaks that developed prematurely in the pavement. The existing pavement cross section representing the average pavement layer thicknesses is shown in Figure 49 and overall condition of the pavement is presented in Figure 50.

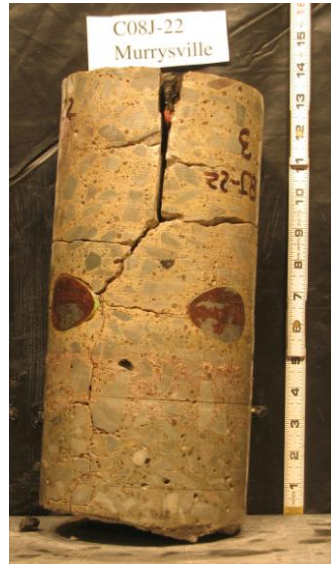
*Figure 55: PCC Core Retrieved at the Transverse Joint of Slab 8 of US-22 Murrysville Segment 50 Eastbound.*

Each core pulled at the transverse joints contained horizontal cracks running parallel to the plane of the slab surface, as shown in Figure 55. These horizontal cracks were observed not only in the four cores pulled from the joints of slabs in the distressed regions, but also the core (core C26J-22 in Table 24) pulled from a joint located approximately 400 feet into the section, a substantial distance away from the distressed areas. These horizontal cracks typically develop from internal stresses created when the joints lock-up. The expansion created as a result of ASR could be the cause of some of this cracking. The fact that the horizontal cracking is also present

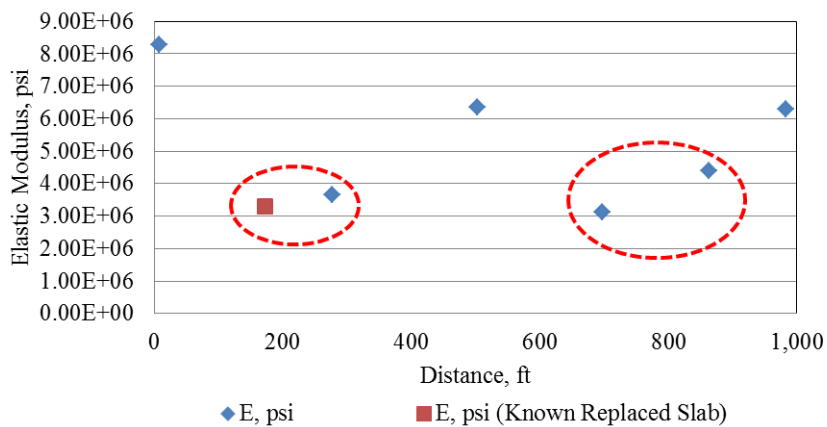
backcalculated static PCC elastic modulus along the section. As observed in the figure, there is a significant variation in the stiffness of the PCC layer along the section with a coefficient of variation of 38 percent. As mentioned previously, it appears that at least two separate concrete mixture designs were used in the construction of this section of roadway. This might be the result of paving the blockouts in front of the business access driveways with a separate mixture than the other throughway sections. One indicator of this is that the color of the paste in some of the cores was greyish, as is commonly found with concrete containing ground granulated blast furnace slag (GGBFS). The paste of the other cores was dark beige in color. The FWD locations in regions where the cores were beige are circled in red in Figure 57. Of the slabs for which coring was performed, the only slabs replaced, as evidenced by the granular base found to be present, were Slabs 8 through 12, beginning at a distance along the project of 178-ft. The average static elastic modulus for the cores taken in the sections without distress was 7.00 million psi with a COV of 16 percent. The average elastic modulus for the distressed slabs was 3.65 million psi with a COV of 16 percent.

Figure 57: PCC Elastic Modulus for US-22 Murrysville Segment 50 Eastbound.

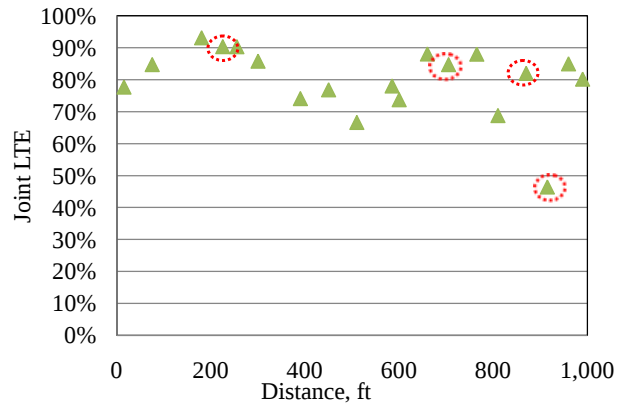
The joint load transfer efficiency along this section of roadway is shown in Figure 59. The average value is 81 percent and as observed in Figure 59, the LTE is good (higher than 70%) for the majority of the joints. Although, several of the joints have a LTE below 70%, considering the relatively young age of the pavement combined with the fact that 1.5-in dowels were used in constructing this section of roadway, it would be anticipated that the LTEs should not be below 80 percent.

The dashed circles in Figure 59 indicate joints in regions where the slabs are exhibiting the pattern of fine interconnected cracking. It should be noted that the joints in the distressed regions, as well as the joints directly adjacent to the distressed regions, tend to have higher levels of load transfer. The expansion resulting from ASR could result in narrower cracks widths and higher load transfer efficiencies.

Figure 59: Joint Load Transfer Efficiencies for US 22 Murrysville Segment 50 Eastbound.

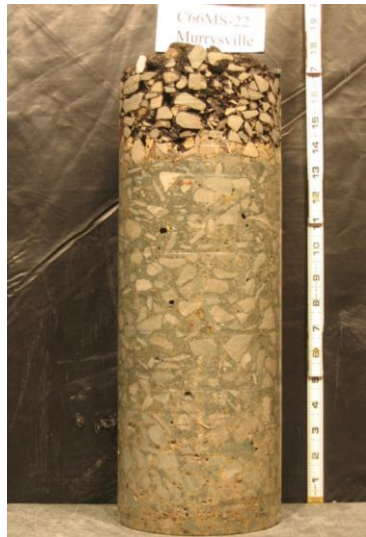
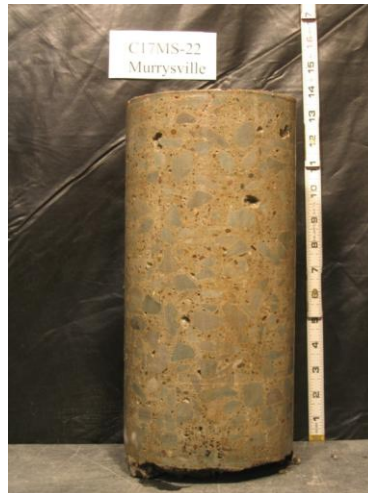
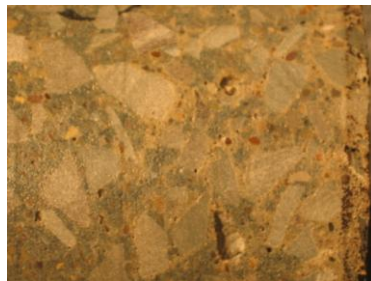
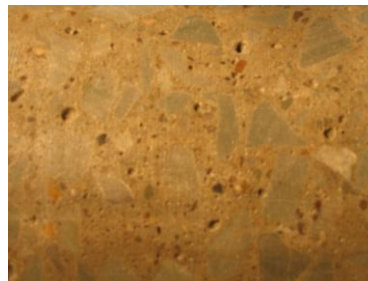
As mentioned previously, the color of the paste in the cores taken throughout the section also varied. The color of the paste for the cores pulled from areas not exhibiting distress was grey, especially in the lower portion of the core. This indicates that GGBFS was used. The color of the cores in the distressed sections were predominately dark beige, indicating that the proportion of GGBFS in this concrete might be lower than in the areas not exhibiting distress. This can be seen in Figure 62. Based on the cores pulled, the type of coarse aggregate used appears to be consistent throughout the section surveyed.

a.) Core from Slab without Distress

b.) Core from Distressed Slab

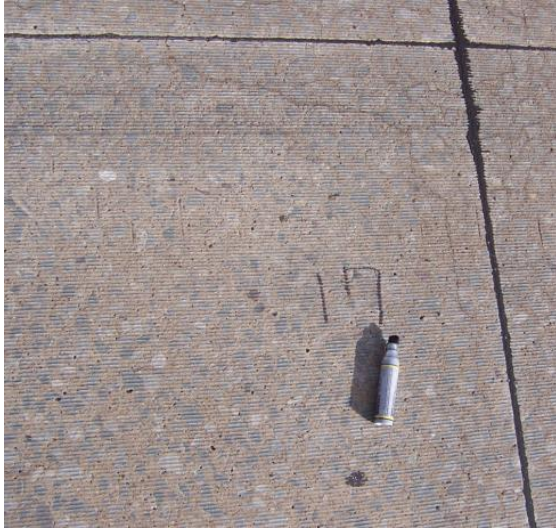
Two cores from SR 202 were examined according to ASTM specification C856 "Petrographic Examination of Hardened Concrete" and ASTM specification C457 "Microscopical Determination of Air Void Content and Parameters of the Air Void System in Hardened Concrete". These cores were from the mid-slab of Slab 17 and Slab 34. Slab 17 exhibited significant cracking. Slab 34, exhibited no distress. Figure 63 shows visible ASR cracking where the joints intersect at Slab 17. Figure 64 depicts the condition of the slab surface for Slab 34.

*Figure 63: Map Cracking Observed on Slab 17 US 22, Westmoreland County Segment 50 Eastbound*

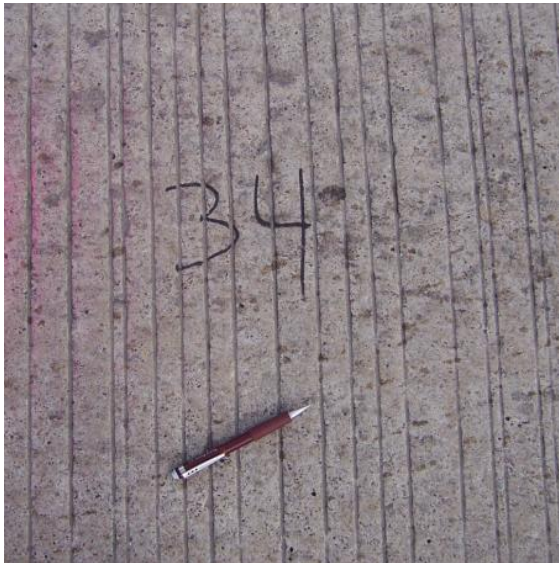
*Figure 64: Overall View of Slab 34 US-22, Westmoreland County Segment 50 Eastbound*

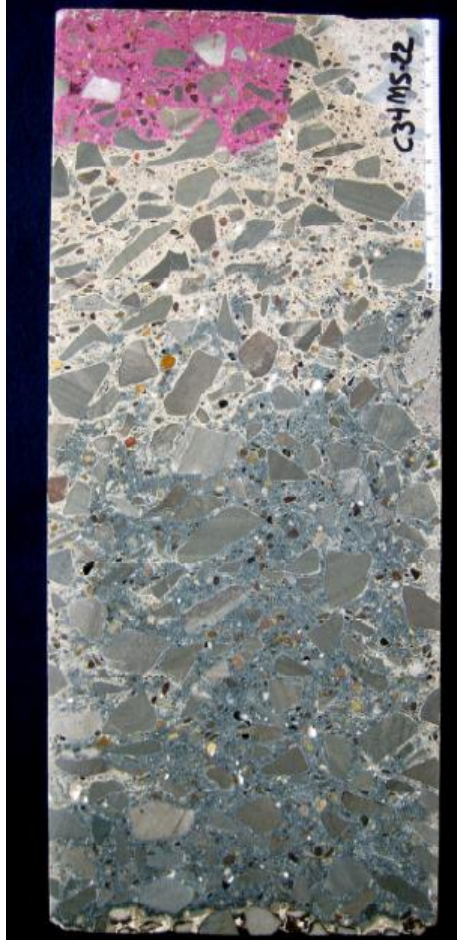
*Figure 67: Overall Condition of Core C34-MS22 of US-22 Murrys ville Westmoreland County Segment 50 Eastbound*

As was commented on in Section 4.7.4, and can be observed in Figure 66 and Figure 67, there is a significant difference in the coloration of the cement paste between the two cores examined by petrographic analysis. The blue coloration of the cement paste in the bottom portion of Figure 67 is the result of hydrated ground granulated blast furnace slag incorporated in the mix design as a supplementary cementitious material. The residual Portland cement in C17-MS22 is between 9 to 10 percent, while the residual slag is estimated to be between less than 1 percent. This level of GGBFS incorporated in the mix is representative of a level typical of a processing addition in the manufacturing of Portland cement. The residual Portland cement in C34-MS22 is between 5 to 7 percent while the residual slag is estimated to be between with 4 and 6 percent. This would represent a purposeful addition, represented by the mix design information summarized in Section 4.3. The incorporation of GGBFS mitigated the development of ASR Core C34-MS22 by reducing the effective alkali content of the cementitious material.

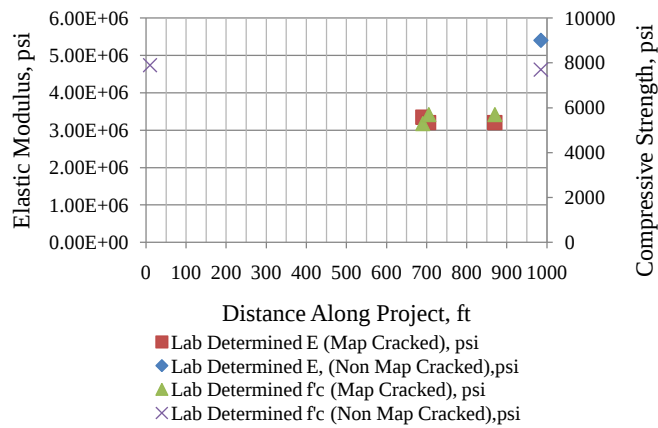
By incorporating the results of the petrographic analysis into the interpretation of the laboratory determined data it is clear that as stated in Section 4.11 the ASR is negatively influencing the structural properties of the concrete. Figure 70 shows the lab determined compressive strength and elastic modulus along the section with different series differentiating between data from map cracked and non-map cracked areas. Table 27 summarizes the statistics assuming that map cracked and non-map cracked areas are inherently different. From the results presented in Table 27 it can be seen that considering the map cracked and non-map cracked areas separately results in a decrease in the variation within each area. When comparing the differences in the statistics between the two areas it can be seen that there is a 29 percent

reduction in the compressive strength and a 40 percent reduction in the elastic modulus of the concrete due to the effects of ASR.

Figure 70: Influence of ASR on Concrete Structural Properties for US-22 Murrysville Segment 50 Eastbound

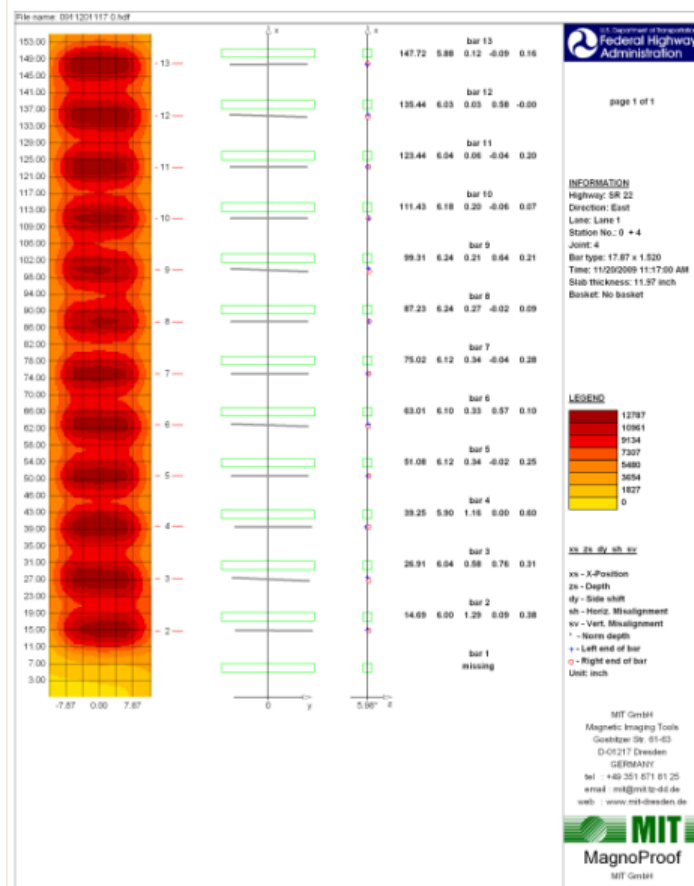
dowel bars are exposed to electromagnetic pulses generated by the scanner. These magnetic field strength images give the user a visual representation of the alignment of the dowels for a particular joint. An example image for Joint 4 of this project is shown in Figure 72.

Figure 72: Visual Representation of the Dowel Locations at Joint 4 for US-22 Murrys ville Segment 50 Eastbound.

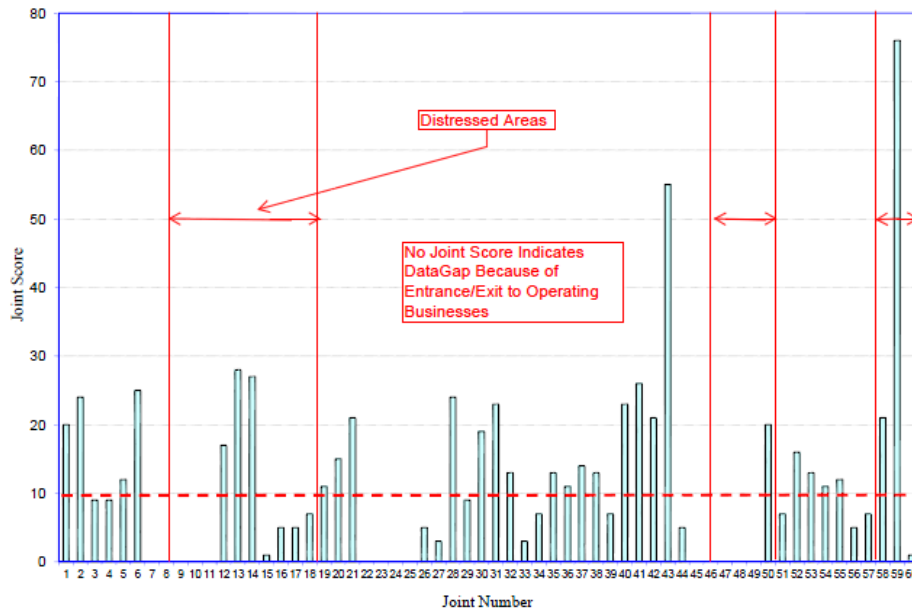
The joint score concept was developed by Yu and Khazanovich [12] and is a weighting system used to rate the potential of a given joint to lockup. According to Yu and Khazanovich, a joint score greater than ten indicates at least a moderate risk for joint lockup. Figure 73 shows the joint scores for the joints of this project. As can be seen in Figure 73, there is no clear relationship between the areas exhibiting the clearly defined crack parallel to the transverse joint and the joint score. In addition, some of the joints are missing scores. During the execution of the scans, these joints were skipped because they were located at entrances to businesses along Segment 50 and were not accessible for testing. It should also be noted that the last six joints in the section were also not evaluated.

Figure 73: Joint Scores along US-22 Murrysville for Segment 50 Eastbound.

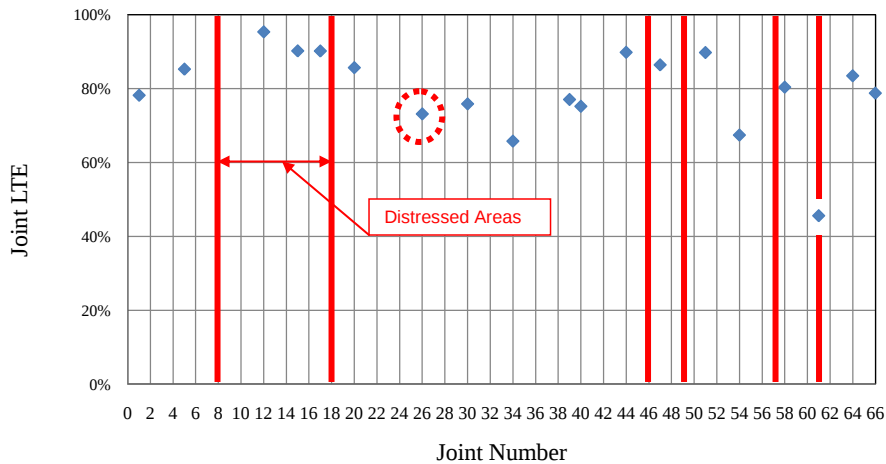
Load transfer efficiency data obtained from FWD testing was compared to the areas of the segment where ASR cracking was observed in attempt to correlate the LTE with this distress. The expansive nature of ASR should result in locked joints. Any high LTE outside of these areas could be the result of locked joints from dowel bar misalignment or inadequate lubrication of the dowel bars at the time of construction. Figure 74 shows that the LTE increases as joints become closer to the distressed areas with the LTE being quite high within the distressed areas. It should be pointed out that a core was pulled in a non-distressed area from joint 26 and the LTE at this joint is only 73%, indicating that the joint is not locked. The core did reveal a horizontal crack running parallel to the surface of the slab along mid-depth of the dowel. This joint is circled in Figure 74. This type of cracking could help explain the relatively low LTEs exhibited in the non-distressed sections. The cracking might be attributed to stress generated by the ASR in the distressed regions, insufficient lubrication of the dowel and/or dowel misalignment.

Figure 74: Comparison of Joint LTE with Known Distressed Areas of US-22 Murrysville for Segment 50 Eastbound

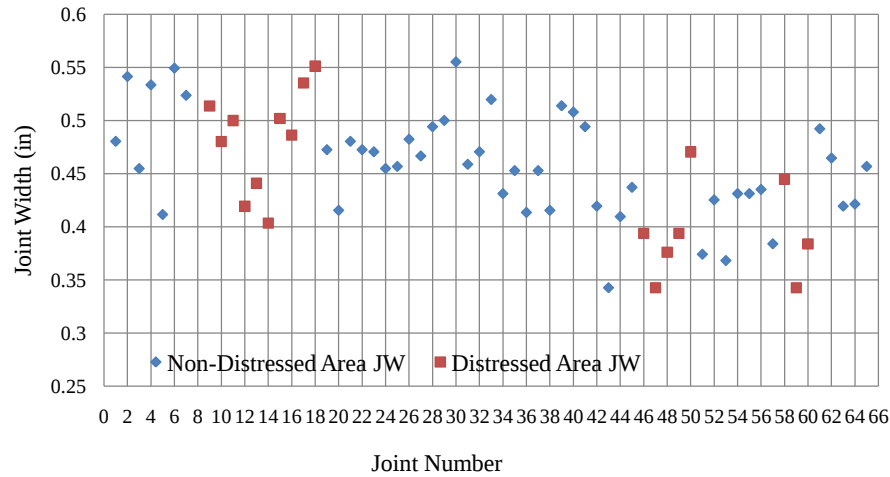
The measured joint widths at each joint, as well as the locations of the distressed areas, are shown in Figure 75. The purpose of this comparison was to determine if the distressed areas had smaller joint widths relative to the rest of the segment. If so, this could also indicate potential joint lockup. In order to draw some conclusions from this data, the magnitude of the joint width at known locations with locked joints was compared to other locations. Both Joints 12 and 58 were known to be locked since they contained embedded dowels that were immobile. The joint widths at Joints 12 and 58 are 0.42 and 0.48 in respectively. The average joint width for all the joints measured is 0.45 in and the standard deviation is 0.05 in. Therefore, it is concluded that the joint widths at Joints 12 and 58 are not significantly different from the other joints. As observed in Figure 75 the joint width exhibits a downward trend along the section, however, the cause for this is unknown.

Figure 75: Transverse Joint Width along US-22 Murrysville Segment 50 Eastbound.

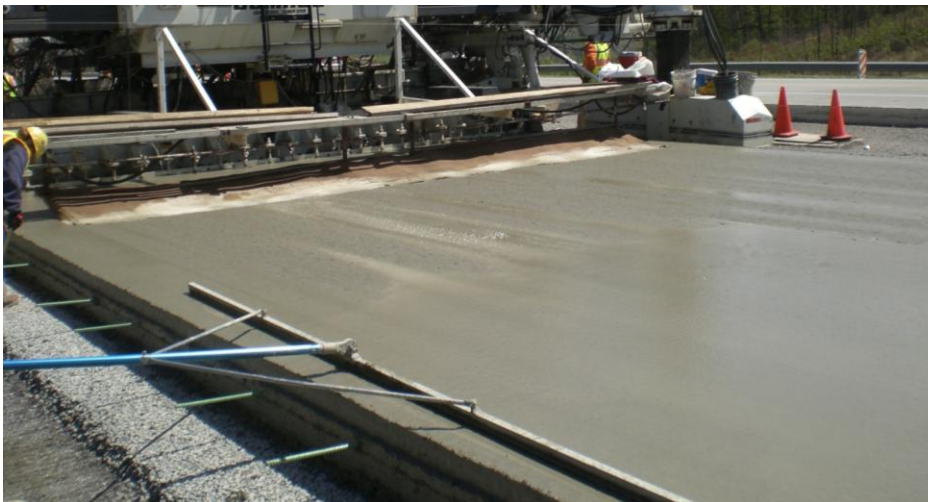
It is suggested that the curing specifications be changed, as previously described, to help address the drying shrinkage that was observed. It has been noticed that many of the pavers in the state drag wet burlap hung behind the paver along the surface of the pavement. This burlap is continually soaked, which results in an increase in the water to cement ratio on the pavement surface. This is then worked into the surface by about six to eight finishers following behind the paver. Figure 77 and Figure 78 below show the wet burlap drag and the resulting slurry

*Figure 77: Wet Burlap Drag and Finishing Behind the Paver*

These cracks can be prevented through the adoption of proper curing and finishing practices. The soaked burlap drag commonly drug behind the paver as shown in Figure 77 should be eliminated. This practice creates a high water to cement ratio at the surface and thereby increases the potential for drying shrinkage cracking and reducing the overall durability of the surface by increasing the porosity. Several of the projects also exhibited paste worn away at the surface, as seen in Figure 65. Eliminating this activity would help reduce the surface wear observed as well.

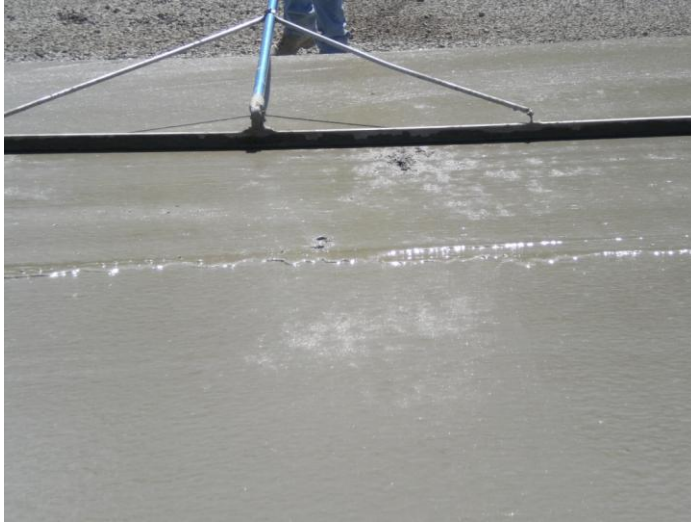
*Figure 78: Slurry Produced by the Wet Burlap Drag behind the Paver*

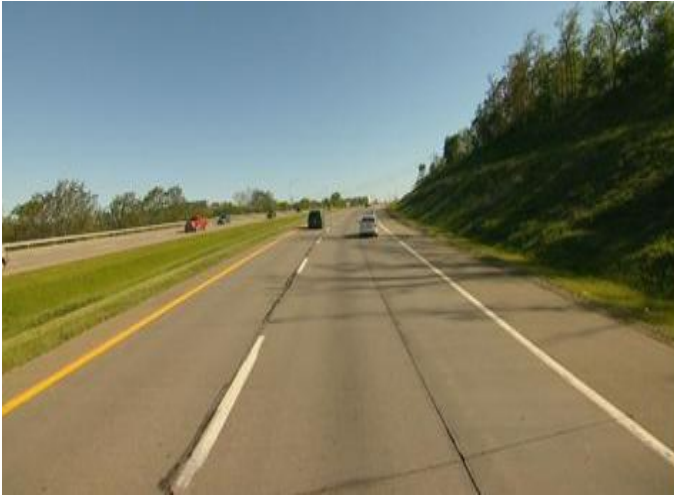
*Figure 83: Overall Condition of I 79 Segment 470 Northbound (Distressed Section)*

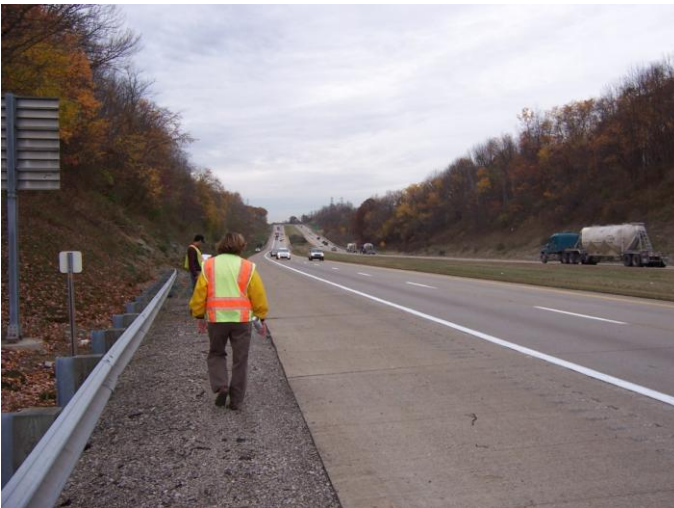
*Figure 84: Overall Condition of I 79 Segment 480 Northbound (Control Section)*

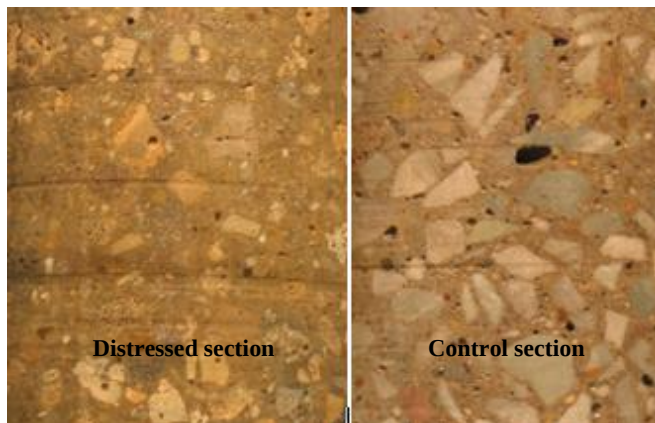
For I79 there is no available information regarding the concrete mixture design. Despite this missing information, based on the visual examination of the retrieved cores, it can be concluded that the concrete mixture designs used for the Distressed and Control sections are different. As observed in Figure 85, the coarse aggregate for the Distressed section is blast furnace slag whereas it is limestone for the Control section. The coarse aggregate gradation for the Control section also appears to be more uniform than that for the Distressed section. Additionally, the paste color for the specimens in the Control section was constant from top to bottom (brown). In the case of the Distressed section, a color variation from brown to grey was observed in the paste. The grey color was present around some coarse aggregate particles. This discoloration is a normal process in concrete containing blast furnace slag and it is not a detrimental characteristic.

*Figure 85: Concrete Core Surface Detail of I 79 Segments 470 and 480 Northbound (Distressed and Control Sections).*

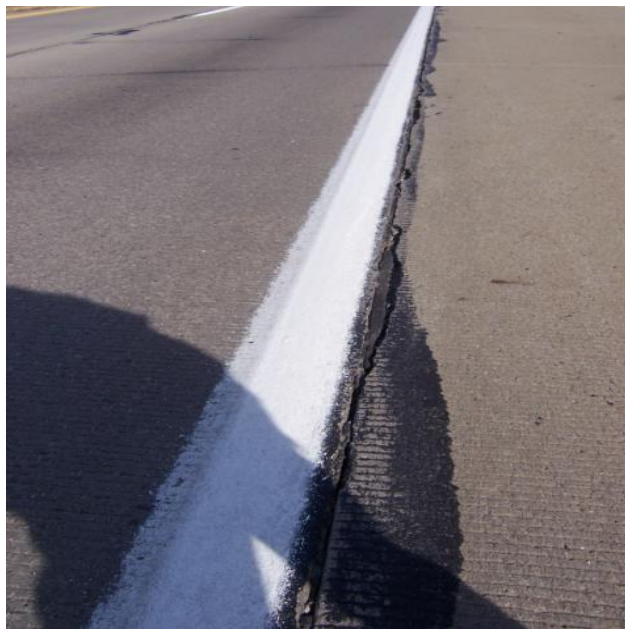
of the longitudinal joint between the lane and the shoulder in the Distressed section. An interesting observation in this figure is that, in addition to the difference in elevation between slab and shoulder, there is a horizontal separation between the driving lane and the shoulder. This separation suggests failure of the tie bars connecting these two elements.

*Figure 86: Lane-to-Shoulder Joint of I 79 Segment 470 Northbound (Distressed Section)*

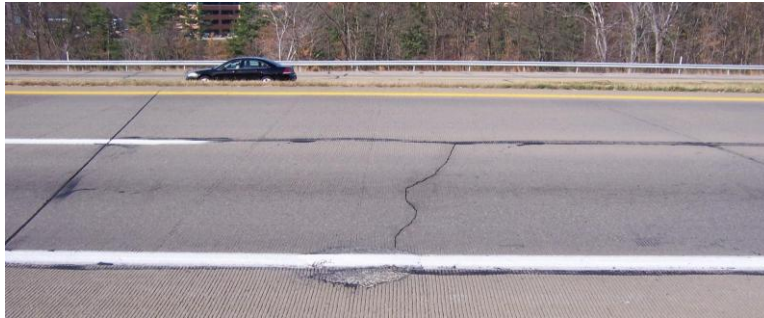
Figure 88 shows a low severity crack with an asphalt patch. Fourteen percent of the slabs in the Distressed section have an asphalt patch. The patches can be found at cracks, transverse joints, and longitudinal joints. The crack in this picture has been traced over with a marker to enhance its visibility.

*Figure 88: Digitally Enhanced Low Severity Transverse Crack and an Asphalt Patch of I 79 Segment 470 Northbound (Distressed Section)*

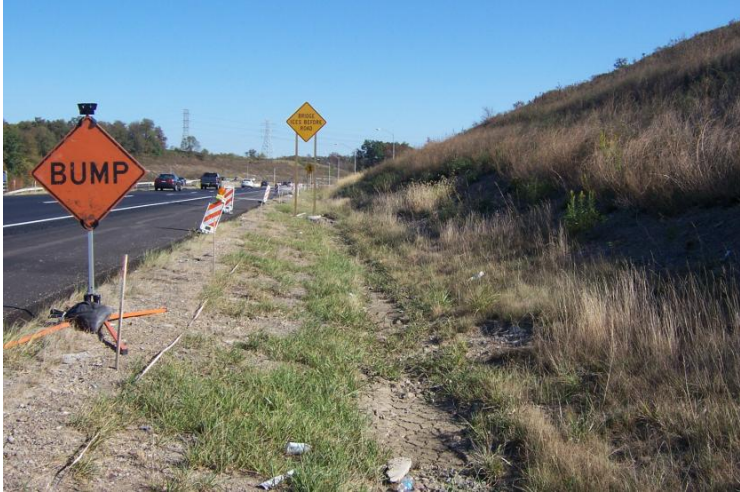
The Distressed and Control sections are located in cut areas as seen in Figure 89 and Figure 90 respectively. As observed in the figures, both sections are situated next to steep side slopes for which runoff water drains towards the pavement structure and is collected by a grass lined channel. The direction of the transverse slope of the pavement is different between the sections. The transverse slope in the Distressed section is directed such that all the water on the pavement surface drains towards the outside shoulder, while the transverse slope in the Control section is such that half the water drains towards the inner shoulder and half drains towards the outside shoulder. As a result, the ditch at the outside shoulder of the Distressed section collects more runoff water from the pavement than the ditch at the outside shoulder of the Control section. The side slope next to the Distressed section is also much larger and contributes a larger volume of water draining to the ditch than the corresponding side slope in the Control section. Another important difference in the overall drainage condition between the sections is that the longitudinal slope of the pavement for the Control section is considerably larger than that for the Distressed section.

*Figure 89: Side Slope of I 79 Segment 470 Northbound (Distressed Section) (photo taken after overlay placement)*

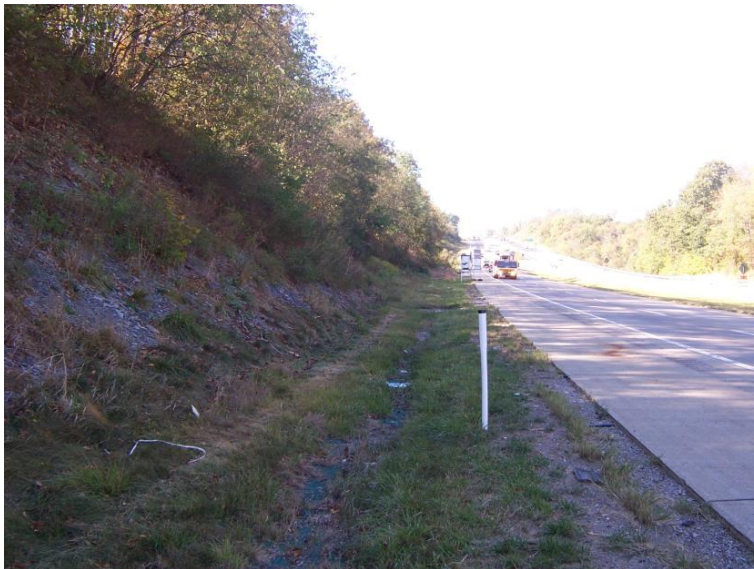
*Figure 90: Side Slope of I 79 Segment 480 Northbound (Control Section)*

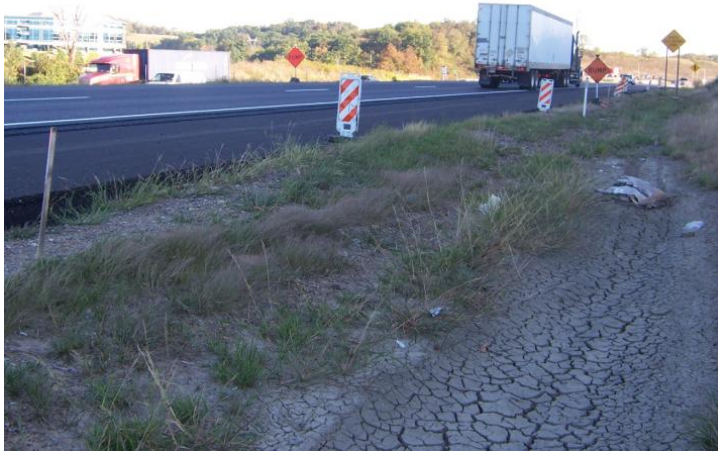
It was also noticed that several areas in the Distressed section exhibited drainage deficiencies. These areas were characterized by the absence of grass and dry natural soil with desiccation cracks on the surface as observed in Figure 91. The dimensions and severity of these areas varied along the section but were most pronounced in the areas adjacent to Panels 20 through 30. It is believed that the drainage deficiency is created by a combination of both poor grading of the ditch and lack of proper maintenance to guarantee positive flow towards a

drainage collector. Because of these deficiencies, ponding of water seems to have occurred resulting in a weakened structural capacity of the pavement. In the case of the Control section, no potential areas where ponded water gathered were observed.

*Figure 91: Typical Ponding Area of I 79 Segment 470 Northbound (Distressed Section) (photo taken after overlay placement)*

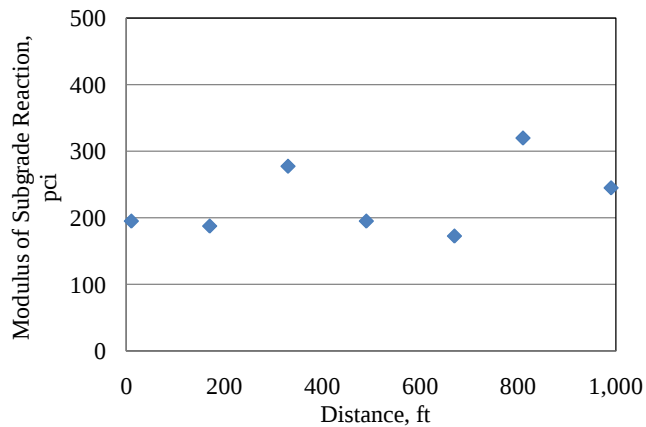
The modulus of subgrade reaction, k-value, was calculated using mid-slab deflections. Figure 96 and Figure 97 show the k-value along the Distressed and Control sections, respectively. The average static k-value for the Distressed section is 230 psi/in with a standard deviation of 55 psi/in and coefficient of variation of 24 percent. The average static k-value for the Control section is 280 psi/in with a standard deviation of 95 psi/in. The coefficient of variation is 34 percent. While the variability is considerably high for both sections, the average

k-values obtained are still typical for an unstabilized base. A higher average k-value was expected for the Distressed section considering that, as mentioned before, the subgrade in the Distressed section is mainly A-4 soil, whereas it is mainly A-6 soil in the Control section. During the field data collection, three panels (Slabs 27 to 29) were visually observed to be moving whenever traffic passed by suggesting significant support problems.

Figure 96: Modulus of Subgrade Reaction for I 79 Segment 470 Northbound (Distressed Section)

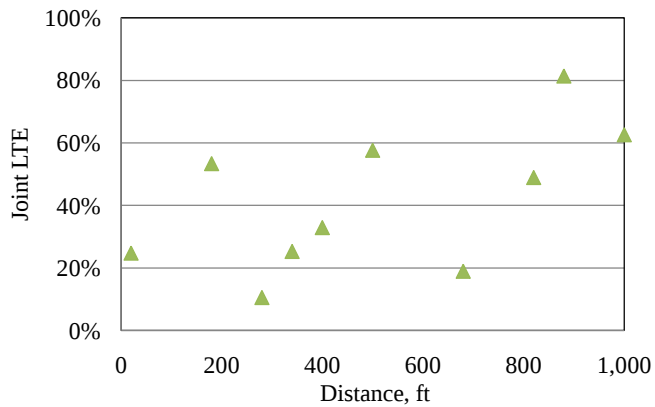
The joint load transfer for the Distressed and Control sections of I 79 are presented in Figure 98 and Figure 99. The relative performance between the Distressed and Control sections with respect to transverse joint load transfer was quite varied. The average LTE for the Distressed section was 42 percent and there was only one location for which the load transfer was above the recommended acceptable value of 70 percent. As one can surmise from the average value of 42 percent, many values were significantly lower than 70 percent indicating poor load transfer. The transverse joints in the Control section on the other hand had an average LTE of 93 percent. These high LTEs are indicative of consistently good load transfer performance in this segment. In the Distressed section, approximately half of the joints with poor load transfer have spalling.

Figure 98: Transverse Joint Load Transfer Efficiencies of I 79 Segment 470 Northbound (Distressed Section)
