# Premature Deterioration of Jointed Plain Concrete Pavements

FINAL REPORT

Date April 2011

By (PI) Dr. J. M. Vandenbossche, P.E.  
University of Pittsburgh

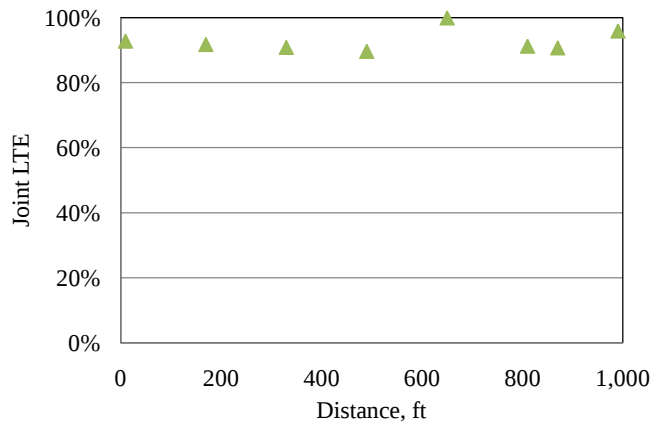
The joint load transfer for the Distressed and Control sections of I 79 are presented in Figure 98 and Figure 99. The relative performance between the Distressed and Control sections with respect to transverse joint load transfer was quite varied. The average LTE for the Distressed section was 42 percent and there was only one location for which the load transfer was above the recommended acceptable value of 70 percent. As one can surmise from the average value of 42 percent, many values were significantly lower than 70 percent indicating poor load transfer. The transverse joints in the Control section on the other hand had an average LTE of 93 percent. These high LTEs are indicative of consistently good load transfer performance in this segment. In the Distressed section, approximately half of the joints with poor load transfer have spalling.

*Figure 99: Transverse Joint Load Transfer Efficiencies of I 79 Segment 480 Northbound (Control Section)*

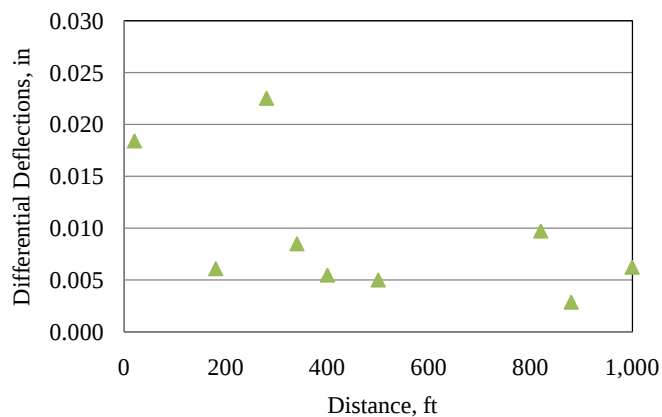
The differential deflections at joints for the Distressed and Control sections can be seen in Figure 100 and Figure 101, respectively. In the Distressed section, the differential deflections range from 2 to 23 mils. Low differential deflections correspond to high LTE and vice versa. A possible explanation for this is that there could be variability in the OGS base. While there are voids underneath all of the joints, some are larger than others. In general, the largest voids correspond to the locations where the LTE is the lowest.

Figure 100: Differential Deflections at Transverse Joints for I 79 Segment 470 northbound (Distressed section)

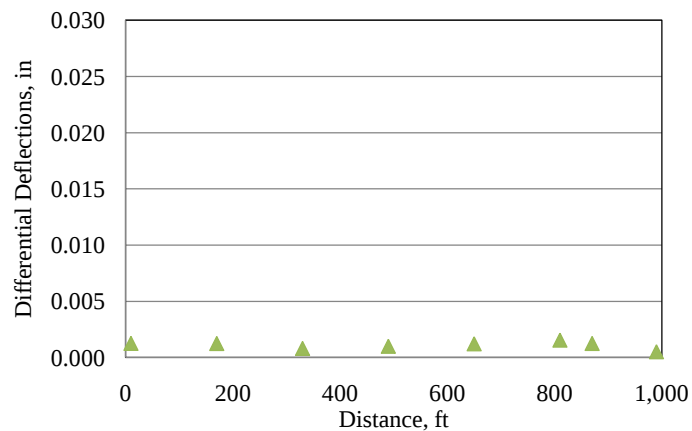
In the Control section, the LTE along the section is excellent and all of the differential deflections are less than 2 mils. However, analyzing the measured peak deflections revealed that these values are considerably high with an average value of 15 mils. This condition suggests a potential loss of support beneath the slabs.

Figure 101: Differential Deflections at Transverse Joints for I 79 Segment 480 northbound (Control section)

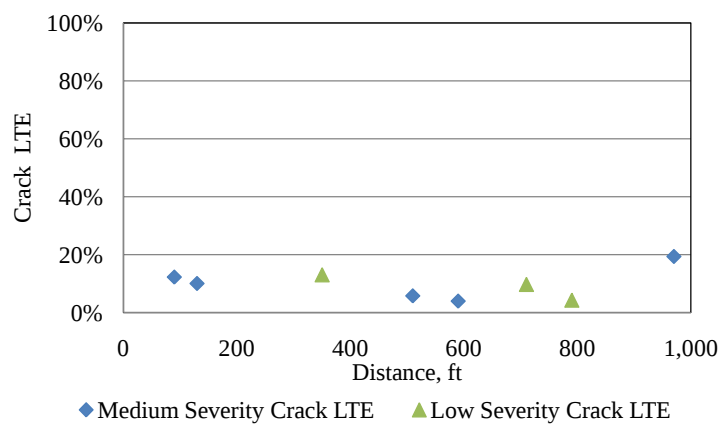
The crack load transfer efficiencies for the Distressed section of I 79 is shown in Figure 102. These crack load transfer efficiencies are considerably low throughout the section. The average crack load transfer efficiency is 10 percent. For a granular base, the base typically contributes approximately 30 percent in the load transfer. The very low crack LTEs for the Distressed

section is an indication of dowel looseness and a weakened base beneath the slab that is not providing complete support. The differential deflections, shown in Figure 103 are relatively high. The value is greater than 5 mils for every location with some locations exhibiting differential deflections more than 15 mils. The majority of the locations tested had medium severity cracks and at some locations, as previously mentioned, could be seen moving under traffic loads. This observation suggests serious support issues beneath the slab.

*Figure 102: Transverse Crack Load Transfer Efficiencies for I 79 Segment 470 Northbound (Distressed Section)*

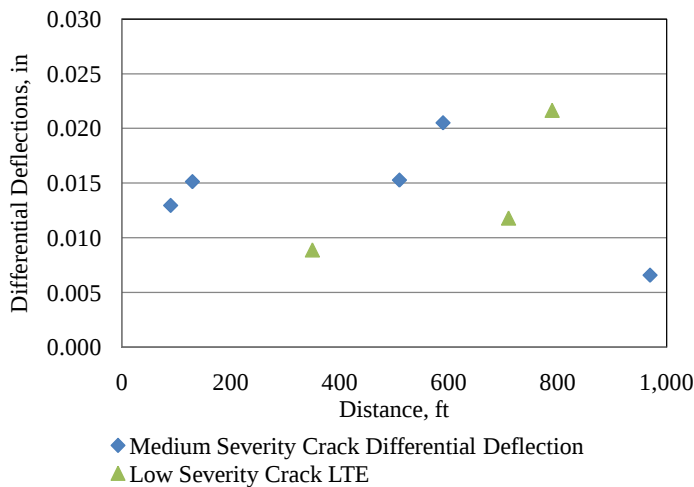
The differential deflections measured for the cracks in the Distressed section are presented in Figure 103. As stated previously, if differential deflections are greater than 10 mils, then there is a problem with load transfer. Almost all of the locations tested had differential deflections greater than 10 mils and the locations that did not exceed this threshold were close to 10 mils differential deflection. The values with larger differential deflections all have poorer load transfer efficiencies.

Figure 103: Differential Deflections at Transverse Cracks for I 79 Segment 470 Northbound (Distressed Section)

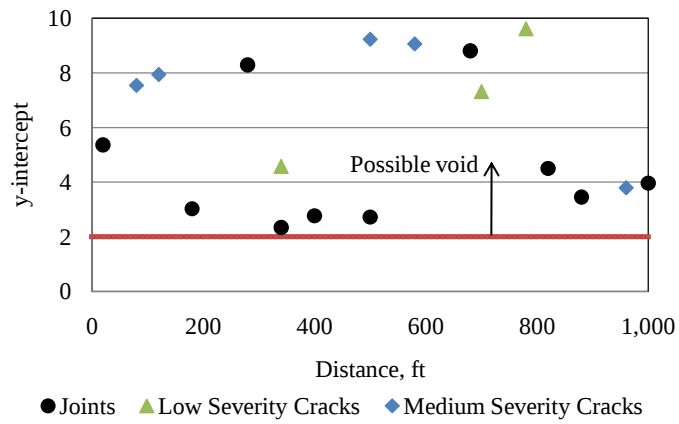
The Distressed section shows the potential for voids at every joint and crack. This agrees with the load transfer efficiencies and differential deflections calculated at these locations. It is suspected that the base beneath the slab has been eroded or experienced significant settlement.

Figure 104: Loss of Support for I 79 Segment 470 Northbound (Distressed Section)

Prior to the placement of the overlay, full-depth repairs should be performed on all medium and high severity transverse cracks. Load transfer restoration should also be performed at the joints exhibiting low load transfer. Full-depth repairs could be performed in lieu of load transfer restoration and slab stabilization at the joints indicating the presence of a void. It is also recommended that the drainage of the ditch between the hillside and the pavement for Segment 470 be improved. Care should be taken to ensure positive drainage in the longitudinal direction and subsequent proper maintenance of the ditch should be performed. In addition, a camera inspection of the existing drainage system should be performed to ensure that it is functioning properly. Ensuring proper drainage away from the Distressed area without ensuring proper subsurface drainage will likely not ameliorate the existing problem significantly.

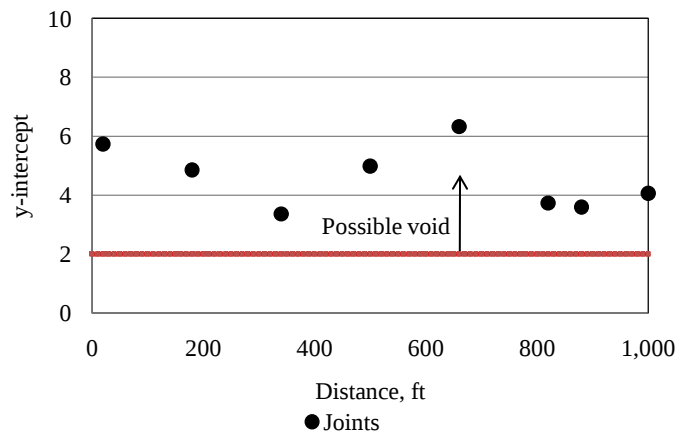
As mentioned previously, the load transfer efficiencies in the Control section are extraordinarily good with virtually no faulting, however, the section shows the potential for voids at every joint. This implies that even with a limited contribution of the base layer in load transfer, the dowels and aggregate interlock are working efficiently and are able to maintain a high level of load transfer. While no pumping or staining of fines near the longitudinal or

transverse joints was observed out in the field; there is a potential for a reduction in support through consolidation or aggregate degradation since an OGS was used.

Figure 105: Loss of Support for I 79 Segment 480 Northbound (Control Section)

As mentioned in the FWD analysis section, the only deficiency noticed in the Control section was the presence of voids beneath the slabs. As discussed previously, these voids could be the result of settlement or migration of the subbase or subgrade into the OGS layer. The LTE at the joints is still quite high so pumping is not providing a substantial contribution to the loss of support. Although the voids have not yet resulted in increased fatigue damage to the point where mid-slab cracking has developed, there exists the potential for these issues to arise. Slab

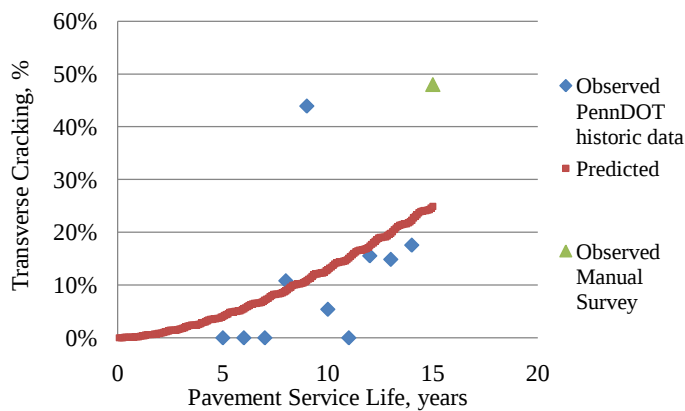
The slope of the predicted transverse cracking trend presented in Figure 113 implies that the fatigue damage the Distressed section is significant. For the Control section, the predicted and observed transverse cracking shown in Table 40 suggest that the Control section has not yet reached the critical zone of fatigue damage. The increase in slab thickness for the Control section was effective in decreasing the fatigue cracking, as predicted using the MEPDG.

periods of time. Exposure to moisture can also degrade the quality of the material. As mentioned in Section 5.7.5, several areas exhibiting drainage deficiencies were observed in the Distressed section. This condition explains the difference between the predicted and observed transverse cracking for year 15. Additionally, it is noteworthy that the MEPDG software does not consider such drainage deficiencies in its analysis and this consideration can also explain the difference between predicted and observed performance.

*Figure 113: Predicted and Observed Transverse Cracking for I 79 Segment 470 (Distressed section)*

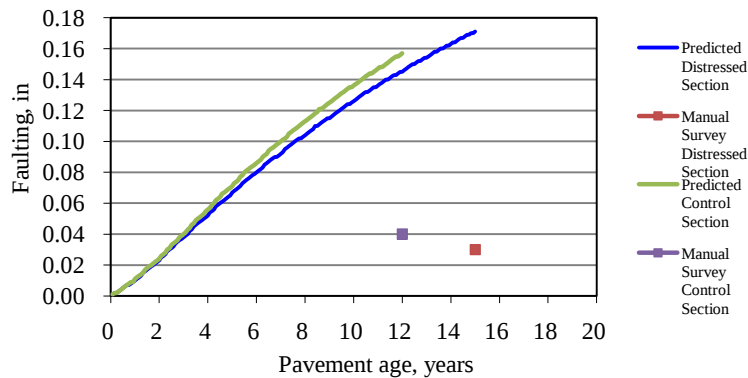
Figure 114 presents the predicted and observed faulting for both the Distressed and Control sections of I 79. The observed faulting corresponds to the data measured as part of the field data collection for the present study. Historic data for faulting was not available from PennDOT. As is evident in Figure 114, there is a large difference between the predicted and observed faulting in both the Distressed and Control sections. As discussed in Section 2.14.5, the high predicted faulting is principally caused by a high upward corner deflection calculated by the MEPDG.

Figure 114: Predicted vs. Observed Joint Faulting for I 79 Segments 470 and 480  
(Distressed and Control Sections)

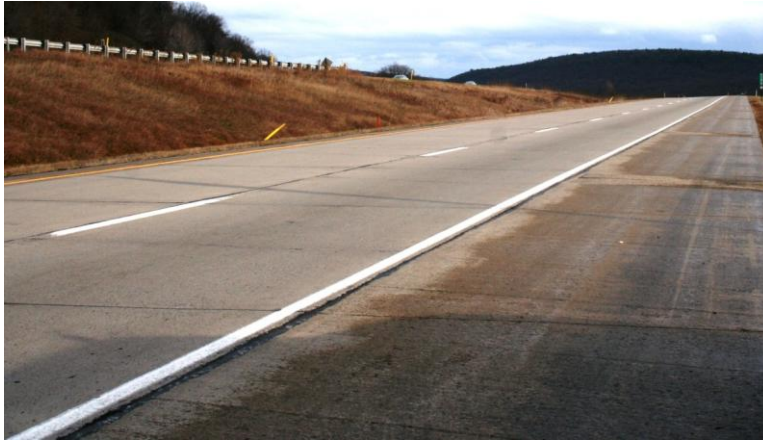
*Figure 119: Overall Condition of I 80 Segment 1914 (Portion of Distressed Section)*

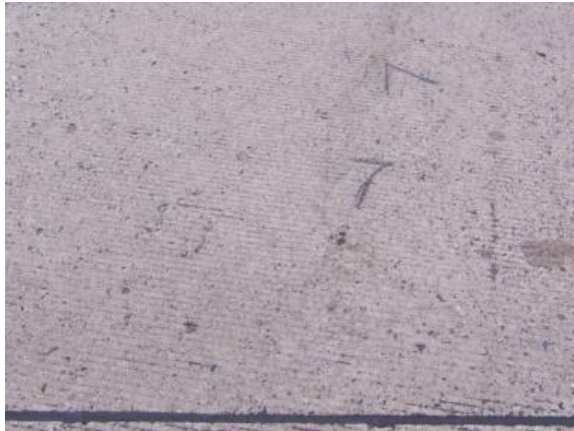
Low severity longitudinal cracking is present in 42 percent of the slabs in the Distressed section. There is no longitudinal cracking in the Control section Figure 124 shows a longitudinal crack in the Distressed section.

*Figure 124: Longitudinal Crack of I 80 Segment 1914 Eastbound (Distressed Section)*

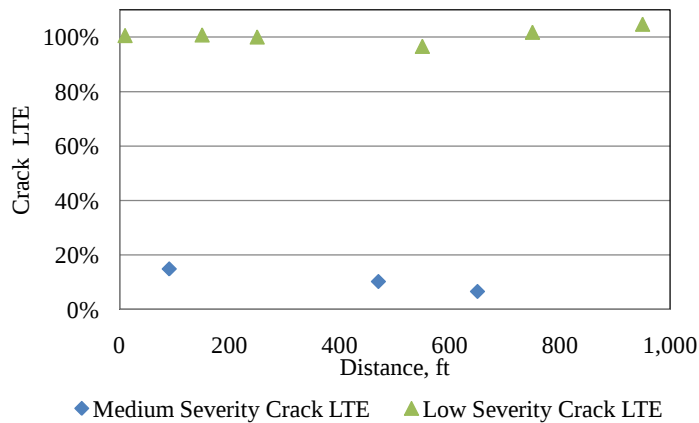
The crack load transfer efficiencies for the Distressed and Control sections of I 80 are shown in Figure 135 and Figure 136, respectively. The average crack load transfer efficiencies at the approach and leave sides of the cracks for the Distressed and section are 75 and 74 percent, respectively. As can be observed in Figure 135, there are three locations along the Distressed section for which the load transfer efficiency is significantly lower than the rest of the section.

The average LTE for only these three locations is only 11 percent while the average crack LTE for the other cracks is 100 percent. All three of the underperforming test locations are at cracks of medium-severity. Additionally, all three of those panels have longitudinal cracks. The rest of the locations have very high load transfer efficiencies with cracks that are of low-severity and crack widths that are too small to be measured.

Figure 135: Transverse Crack Load Transfer Efficiencies of I 80 Segments 1914 and 1920 Eastbound (Distressed Section)

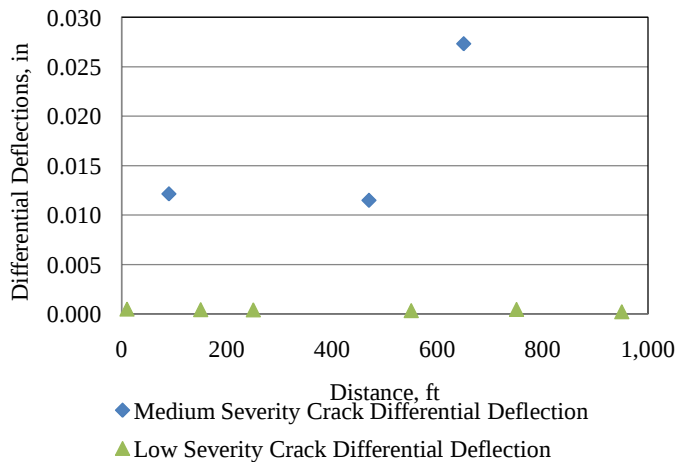
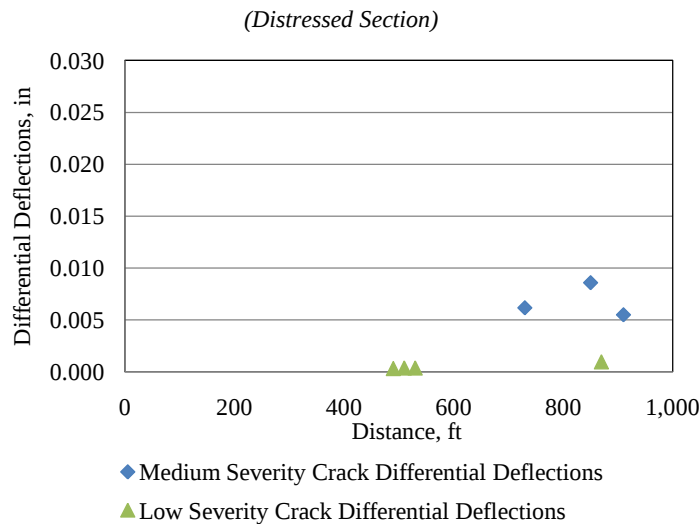
The differential deflections for transverse cracks are presented in Figure 137 and Figure 138 for the Distressed and Control sections respectively. In the Distressed section, the locations where the differential deflections are greater than 0.01-in are the same locations that have poor load transfer efficiency and medium severity cracks. The same is true for the Control section. These results agree with the load transfer efficiency values.

Figure 137: Differential Deflections at Cracks for I 80 Segments 1914 and 1920 Eastbound

Figure 138: Differential Deflections at Cracks for I 80 Segment 1930 Eastbound (Control Section)

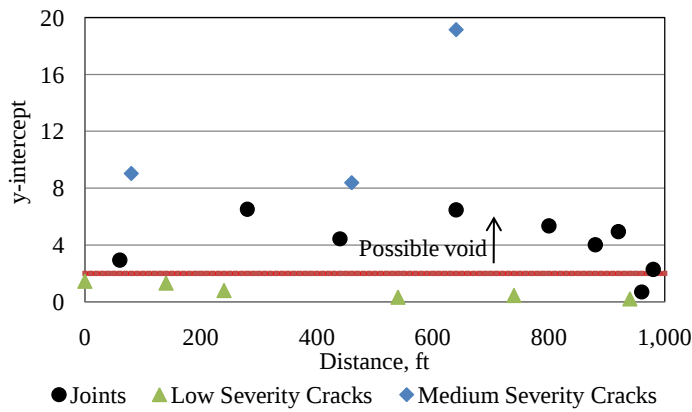
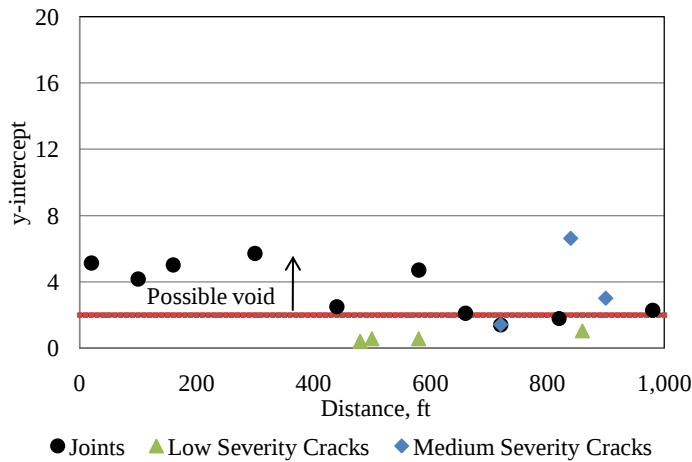
Figure 139: Loss of Support Results for I 80 Segments 1914 and 1920 Eastbound (Distressed Section)

To determine the presence of voids, the load vs. deflection response for each station was determined. As mentioned previously and explained in detail in Section 2.8.6, when the load vs. deflection relationship is plotted for the standard load levels and the deflection intercept value is greater than two mils, then the potential exists for the presence of voids beneath the slab. The load vs. deflection graphs for I 80 is presented in Figure 139 and Figure 140. These figures are for the Distressed and Control sections respectively. The Distressed section, shown in Figure 139, shows the potential for voids at eight joints and three medium severity cracks. The Control section, shown in Figure 140, shows the potential for voids at eight joints and two medium severity cracks. One contradiction to the generally observed trend for the Control section is that there is one crack of medium severity that does not show the potential for voids. Concerning this particular crack, the potential for voids, although not above the threshold value, is still higher than all of the low severity cracks. The loss of support for the cracks in both sections agrees with the load transfer efficiencies calculated above. Considering that the base is unstabilized, there is a potential for pumping. Despite the unstabilized base and the measured voids underneath the slab determined through FWD testing, no evidence of pumping was observed in the field. The

presence of voids at joints and crack locations is believed to be caused by consolidation of the OGS over time.

Another issue to address is that FWD testing revealed that voids are present at the corners of many of the slabs in both the Distressed and Control section. As mentioned previously, no pumping or staining of fines was observed in the field. In fact, because of the pavement structure including a rubblized pavement and an additional granular subbase, it is unlikely that migration of fines from the subgrade could be an issue for this pavement. However, voids could be possible due to the consolidation or breakdown of the OGS material or pumping due to fines in the OGS placed on top of the rubblized pavement after the rubblization process.

voids are due to settlement of the OGS layer from the many load applications over the years. However, because of the pavement age, it is doubtful that the voids will increase in size as most of the possible settlement has been realized already. In addition, there appears to have been no adverse effects to the pavement structure from the voids as load transfer efficiency is good at most of the joints in both the Distressed and Control section. A further breakdown of the LTEs at the transverse joints revealed that while some joints had LTEs less than the recommended value of 70 percent, these joints did not exhibit exceedingly poor load transfer. The lowest load transfer efficiency at the joints of I 80 was 54 percent at one of the joints in the Control section. This value, while not great, does not suggest complete failure of the dowels either. Therefore, performing slab stabilization as a means of addressing the voids underneath the slab might not be a rehabilitation procedure that provides good economic value for this section of I 80.

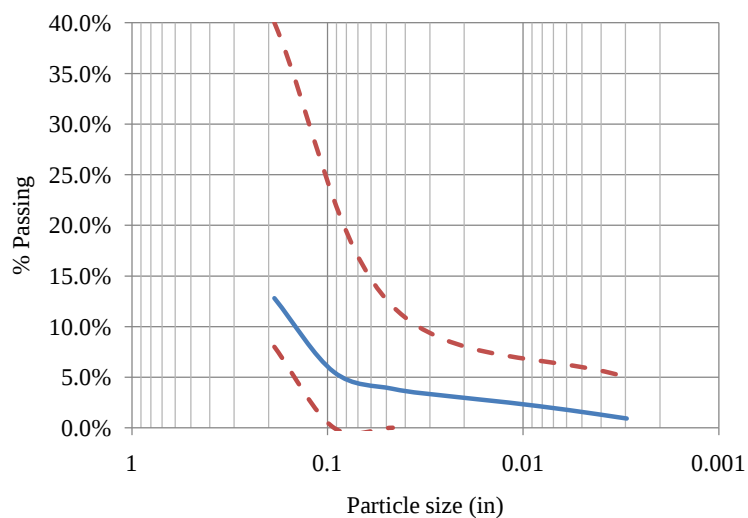
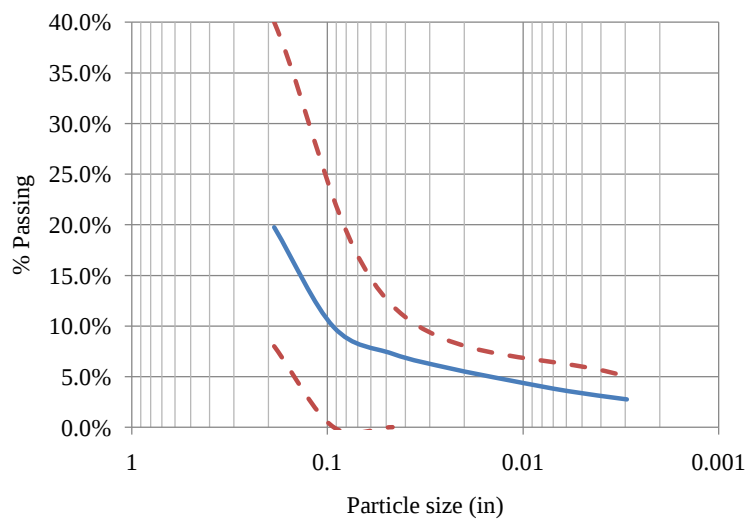
Figure 141: Particle Size Distribution Curve for the Portion Passing the No. 4 Sieve of the OGS Granular Base for I 80 Segment 1914 Eastbound Slab 33 (Distressed Section)

A granular base sample was obtained for the Distressed section from Slab 33. For the Control section a granular base sample was obtained from Slab 8. A sieve analysis using the portion of each sample passing the No. 4 sieve was performed. Figure 141 and Figure 142 present the gradation curve for each sample. As observed in the figures, the gradation of the samples agrees well with the specification and the percentage of fines (material finer than 30 mils) is within the range specified by Section 703 of PennDOT Specification 408 which calls for a maximum fines quantity of 5 percent

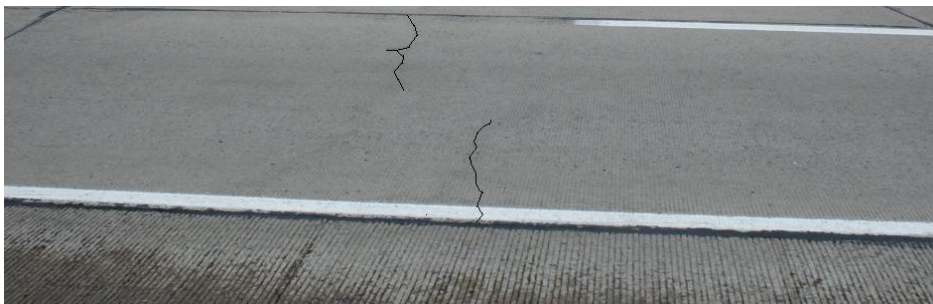
*Figure 143: Digitally Enhanced View of Slab 25 I 80 Segment 1914 Eastbound (Distressed Section)*

Determination of Air Void Content and Parameters of the Air Void System in Hardened Concrete”. The core was from a microcracked region of Slab 25 as shown in Figure 125. Slab 25, other than the microcracked region, exhibited cracks in the transverse direction as shown in Figure 143. These cracks, as highlighted in Figure 143, did not extend across the entire slab, but did happen to occur roughly at mid-slab.

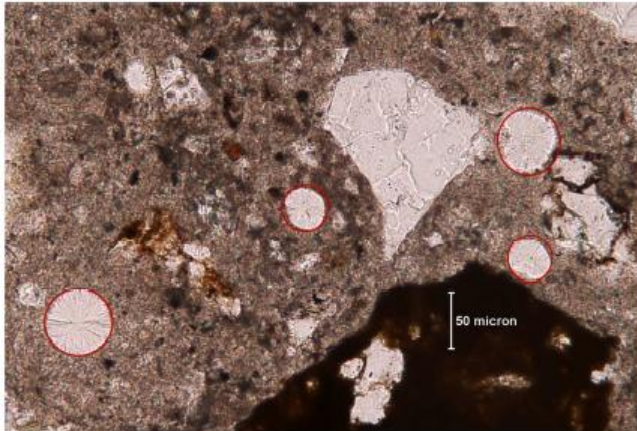
Table 46 presents the results from the petrographic and hardened air void analysis relevant to the determination of the cause of the distresses for I 80. the air void system in its present state is substandard for this pavement’s freeze thaw exposure conditions because it does not meet the requirements for spacing factor or specific surface area recommended by ACI to achieve good freeze thaw resistance. The recommended requirements set forth by ACI are a spacing factor  $<.008$ -in and a specific surface area  $>600\text{in}^2/\text{in}^3$ . Despite the current state of the air void system, it was also noted that secondary ettringite has partly or completely filled much of the finer air voids throughout the upper half of the core reducing the air void system in that region. This is illustrated in Figure 144. Despite these observations, the pavement has still functioned fairly well for almost 20 years without significant amounts of spalling or d-cracking near the joints.

Figure 144: Illustration of Ettringite Filled Air Voids (Circled in Red) in I 80 Core MC25-D. Magnification 200x

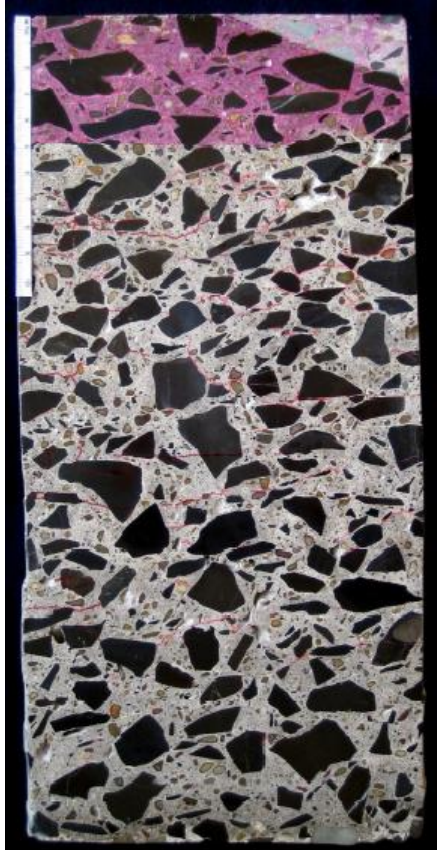
On a larger scale, the developing ASR is contributing to expansion throughout the depth of the core and causing internal cracking, it is noteworthy however that the microcracking caused by the ASR is only visible with magnification or the aid of a dye. This cracking takes the form of sub-horizontal microcracks at depth within the core as illustrated in Figure 146 by the red lines throughout the depth of the core and manifests itself as sub-vertical microcracks within the top 13-mm (.5-in) of the pavement, as shown in Figure 147. The large colored rectangular area in Figure 146 and Figure 147 represents the area tested for carbonation, while the slightly darker red lines represent ASR. Figure 147 was included to illustrate the sub-vertical microcracks in the region that were also tested for carbonation. Although it appears that minor amounts of ASR has developed, it does not appear that it has significantly affected the performance of the pavement to date.

*Figure 146: Illustration of the Extent of Microcracking Due to ASR within Core C25MC-D of I80.(ASR Illustrated by Red Lines)*

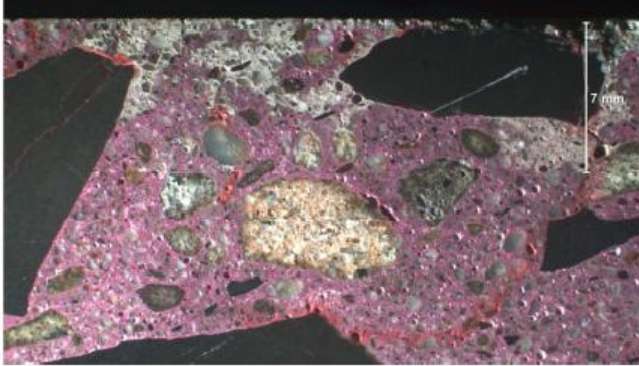
*Figure 147: Illustration of Sub-Vertical Microcracking due to ASR near C25MC-D Core Surface. Magnification 5x*

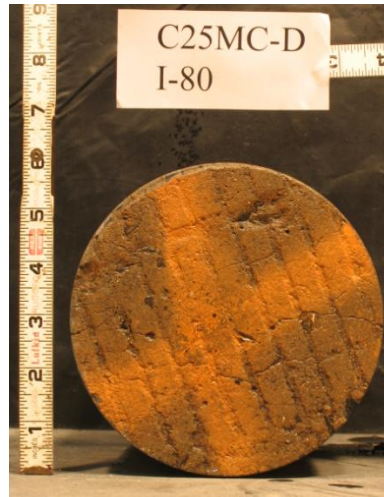
*Figure 148: Top View of PCC Core Retrieved at a Microcracked Location of I 80 Segment 1914 Eastbound, Slab 25,(Distressed Section)*

The map-cracking was found in a common and localized area adjacent to the outer lane-shoulder joint. Available moisture is required for ASR to occur. This can explain why the map cracking is primarily prevalent around the joints since these locations are a source of moisture infiltration into the pavement structure and are also prone to retaining moisture. The orientation and spacing of the cracks do not follow a noticeable trend; they are randomly oriented and distributed as seen in Figure 148. The depth of the microcracks shown in Figure 148 is approximately 0.7-in and the visual observation of the core revealed that at some points the crack goes through the coarse aggregate.

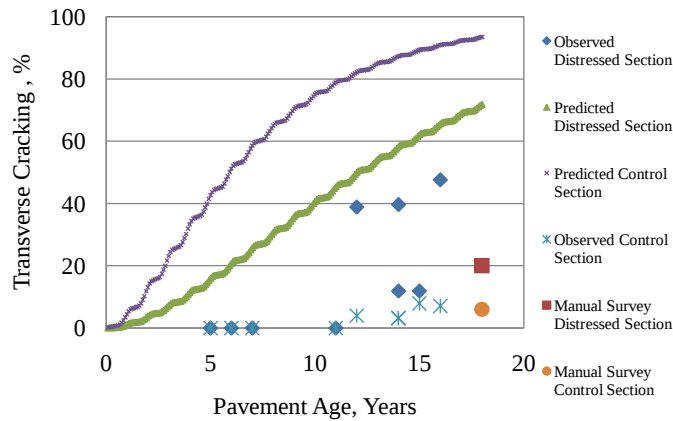
Figure 149: Predicted and Observed Transverse Cracking for I 80 Segments 1914 and 1920 and Segment 1930 Eastbound (Distressed and Control Sections Respectively)

Figure 149 presents the predicted and observed transverse cracking for both the Distressed and Control sections. The observed transverse cracking over time (from year 5 to year 17) is based on historic distress data provided by PennDOT. This data has been collected using automated distress equipment. The data points for year 18 represent the percentage of transverse cracking in the Distressed and Control sections that were manually surveyed as part of the present study. As observed in the plot, the historic distress data exhibited some anomalies that, according to PennDOT personnel, are typical for automated surveys. As observed in Figure 149, for the Distressed section, there is a remarkable difference between the percentage of cracking from the historic distress data and the percentage of cracking observed as a result of the manual distress survey carried out in this study. This difference might also be caused by deficiencies associated with the automated distress equipment. Comparing the observed and predicted cracking for year 18, it can be seen that the MEPDG is greatly over predicting the fatigue cracking for this pavement. This result is not surprising considering the complexity of the pavement structure for this specific project.

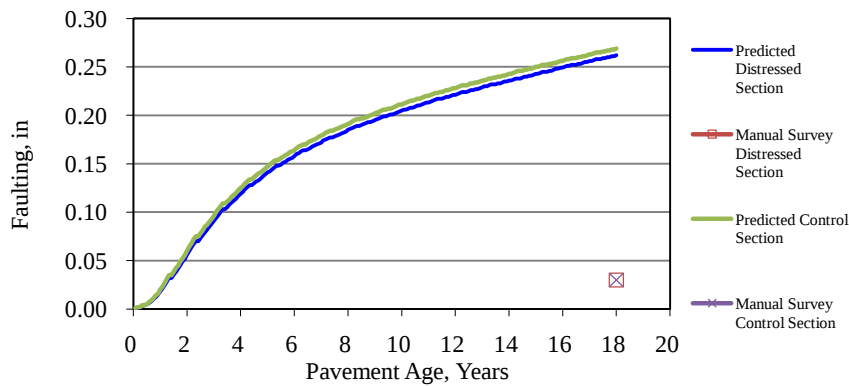
Figure 150: Predicted and Observed Faulting for I 80 Segments 1914 and 1920 and Segment 1930 Eastbound (Distressed and Control Sections Respectively)

Figure 150 presents the predicted and observed faulting for both the Distressed and Control sections. The observed faulting corresponds to the data measured as part of the field data collection for the present study. Historic data for faulting was not available. As noticed in the plot there is a large difference between the predicted and observed faulting. The high predicted faulting is most likely the result of the dowels being only 1-in in diameter.

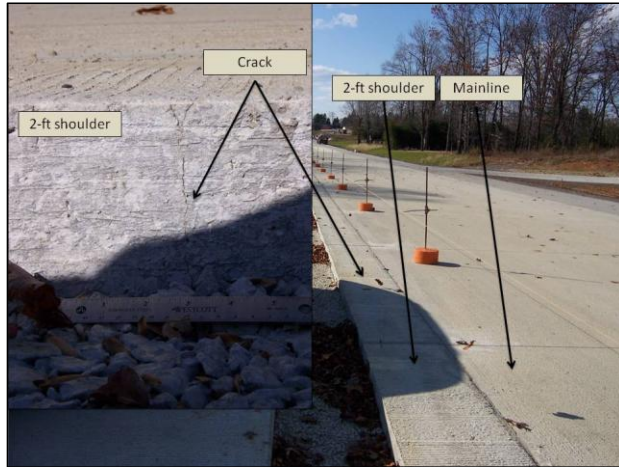
The mid-panel cracking in the shoulders was the only distress that the pavement exhibited. A typical crack can be seen in Figure 156 while a breakdown of the number of shoulder slabs cracked per section can be found in Table 61. The majority of the cracks propagated across the full width of the shoulder (full-length cracks); however, there were a few cracks that only partially traversed the width of the slab (partial-length cracks). The cracks were more open along the free edge and tight at the edge adjacent to the mainline. All of the cracks were wider at the top than at the bottom. This could be an indication of top-down cracking or just the result of the restraint provide by the base restricting further crack opening near the bottom of the slab. Based on these two observations, it seems possible that the cracks initiated at the upper outside edge away from the junction of the shoulder and the mainline.

Figure 156: Typical Crack Found in the 2-ft Shoulder of US 22, Indiana County

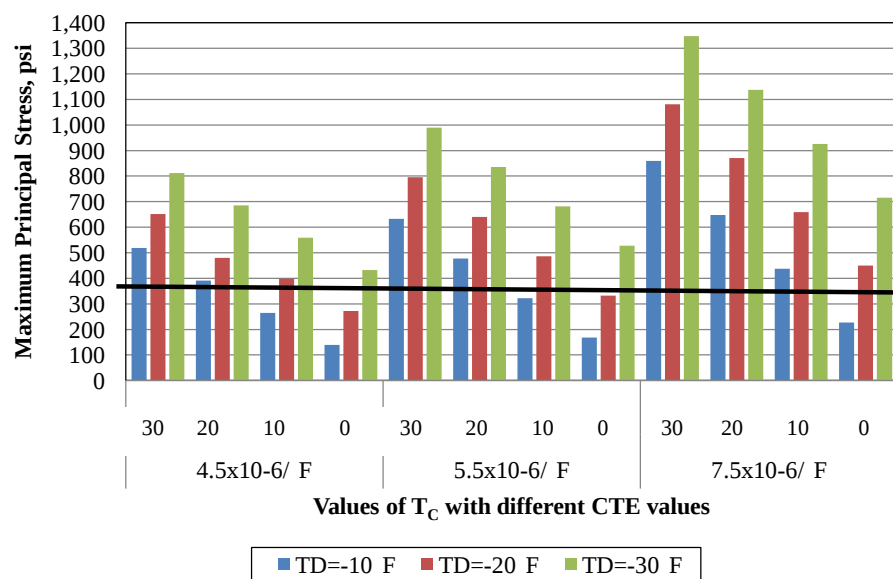
The following sections will discuss each parameter and the influence it has on the development of transverse cracking in the shoulder. Figure 166 shows a summary of the results for the stiffness of 3.3 million psi (corresponding to the seventh day). As shown in Figure 166, a crack is likely to occur for any stress larger than 405 psi.

From Figure 166 it seems that whether or not a crack will occur depends on the values of  $T_D$  and  $T_C$ . Assuming a CTE of  $5.5 \times 10^{-6}/^\circ\text{F}$  and 7-day strength/stiffness, a  $T_D$  of -10°F will not result in cracking unless the value of  $T_C$  is 20°F or higher. A  $T_D$  of -20°F will not produce cracking if  $T_C$  is lower than 10°F. A  $T_D$  of -30°F will result in cracking even if  $T_C$  is 0°F. The potential for a shoulder to develop transverse cracking based on the construction sequence and CTE can also be expressed as shown in Table 66.

Figure 166: Critical Value of  $T_c$  for Different CTE Values with a Tensile Strength of 405 psi.

Figure 166 shows the effect that CTE has on transverse cracking in the shoulder. As expected, a larger CTE results in a higher chance for crack to develop. A lower CTE reduces the chance for cracking. According to the LTPP database, the national average for CTE is approximately  $5 \text{ to } 5.5 \times 10^{-6} / ^\circ\text{F}$ .

Based on this result, the best way to avoid the shoulder transverse cracking seems to be constructing the shoulder and the mainline at similar temperatures. If it is unavoidable to construct the mainline and shoulder during the same season, Equation 5 can be used to determine the difference in zero-stress temperatures for the mainline and shoulder. The best months to construct pavements are the months when the pavement temperatures night are not too low. In Pennsylvania, these months seem to be from May to September. It is also possible to pave in April and October as long as the ambient temperature is relatively high.

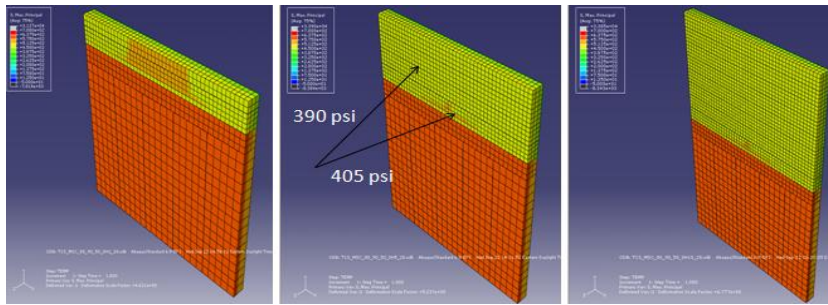
shoulder. This might be due to the fact that the thermal incompatibility ( $T_D=-10^\circ\text{F}$ ) for models in Figure 168 is smaller than that for models in Figure 167 ( $T_D=-20^\circ\text{F}$ ).

Figure 168: Influence of Shoulder Width When  $T_D=-10^\circ\text{F}$  and  $T_C=50^\circ\text{F}$  for the Shoulder Transverse Cracking Model.

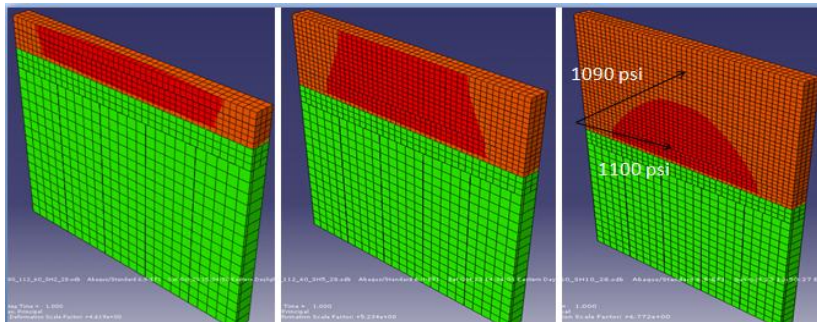
In Figure 169, the three models have a CTE of  $7.5 \times 10^{-6}/^\circ\text{F}$  and stiffness of 2.8 million psi. In all three of the models, the predicted stresses exceed the defined strength of the concrete indicating a crack occurring for all three models. In the 2-ft shoulder, there is an area of higher stress that is located in the center of the shoulder and extends across the entire shoulder width. In the 5-ft shoulder, the same area of higher stress still extends across the entire width of the shoulder; however, it begins to thin out as it reaches the outside edge. In the model with the 10-ft shoulder, the area of higher stress extends only a few feet across the shoulder. In all three of the models, the area of the shoulder that has a high stress concentration is the area around the tie bars.

Figure 169: Influence of Shoulder Width When  $T_D=-30^\circ\text{F}$  and  $T_C=70^\circ\text{F}$  for the Shoulder Transverse Cracking Model.

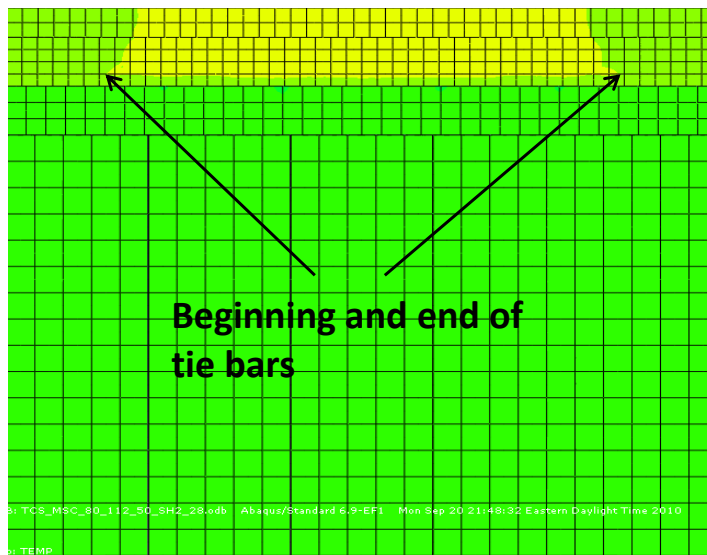
Figure 170 illustrates the concentration of stress surrounding the tie bars. This is a model

that is sliced in the z-direction so that the tie bars are visible. The larger stresses clearly begin to form around the tie bars. This holds true for all of the cases in the parametric study.

Figure 170: Illustration of the Stress Concentration Surrounding the Tie Bars in the Shoulder Transverse Cracking Model.

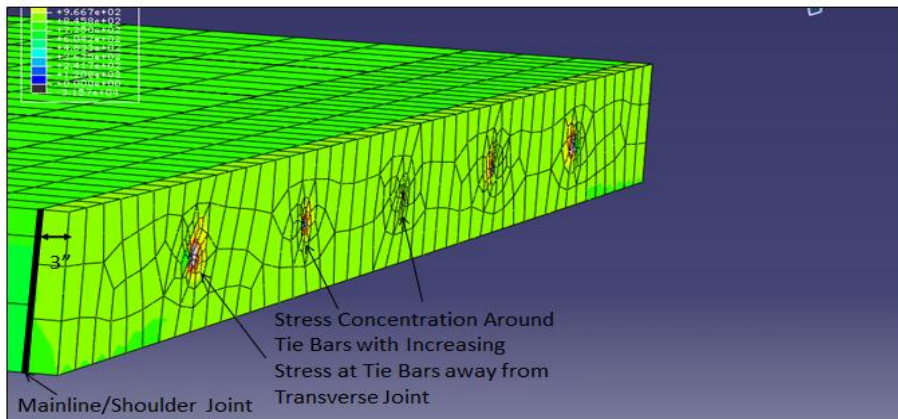
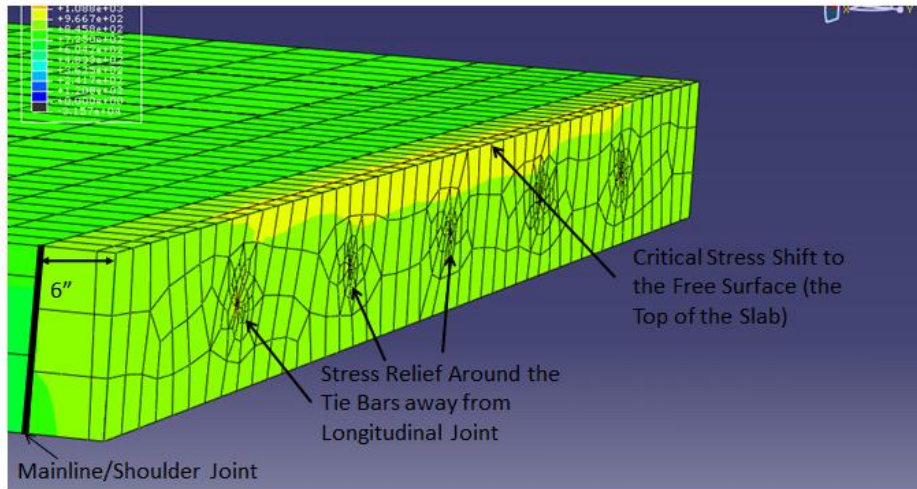
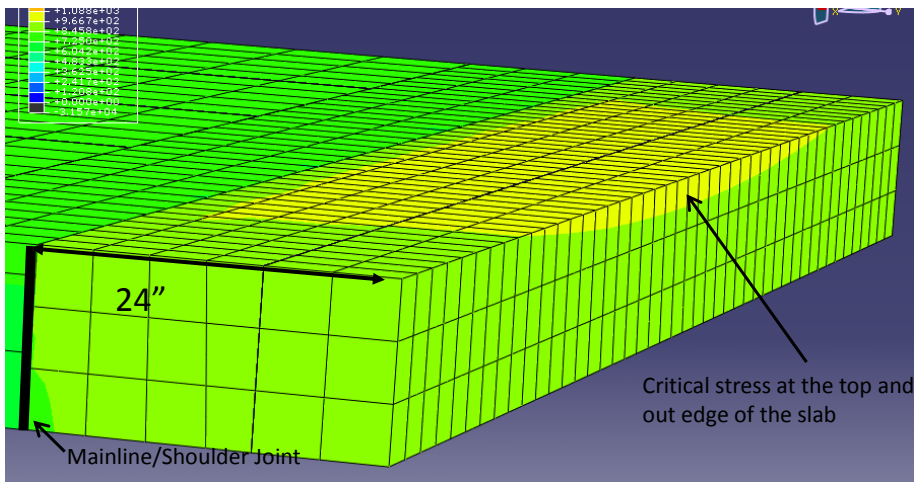
Figure 171: Illustration of the Shift of Stress Concentration from the Tie Bars to the Free Surfaces in the Shoulder Transverse Cracking Model.

Cross sections were cut as shown in Figure 146 to examine the details in the stress concentration around the tie bars. In Figure 171, three such cross sections that are 3 in, 6 in and

24 in away from the mainline/shoulder joint are shown. From Figure 171 (a), it is easy to observe that the stress concentration is more severe at the tie bars that are closer to the transverse joints. This observation results from the symmetry of the problem resulting in less constraint to relative displacement between the mainline and the shoulder at the transverse joint than at the mid-slab. More importantly, it is found through examination of Figure 171 (a, b, and c) that the stress concentration shifts away from the tie bars towards the free surfaces. Comparing Figure 171 (a, b, and c) it can be seen that trend becomes more pronounced as the cross section moves further away from the mainline/shoulder joint and starting with the cross section that is at 2 to 3-in from the mainline/shoulder joint.

This shift of stress concentration is highly oriented, as shown in Figure 171 (b) towards the free surfaces where the least constraint for displacements exists. Furthermore, in Figure 171 (b), it can be seen that the stress concentration zone reaches the top of the slab after 6-in from the mainline/shoulder joint. After a distance of 6 in from the mainline/shoulder joint, this zone remains constant and within the top 2 to 3 in of the shoulder as indicated by Figure 171 (c) that shows a cross section 24 in away from the lane-shoulder joint.

An additional conclusion based on Figure 171 (a) through (c) seems to be that the stress concentration occurs in the concrete surrounding the tie bars caused by the load transfer through the tie bars and the critical stress most likely lies at a zone that is around the top and outer edge of the shoulder. Although in Figure 171 (c), it appears that such a zone might cross the majority of the width of the shoulder, in actuality the zone will get narrower when the microcracks start to occur in the concrete around the tie bars due to the dramatic stress generated at these locations. Microcracking around the tie bars, starting with the tie bars towards the transverse joints will release some of stresses there and the stresses will be redistributed resulting in more stress at the middle of the shoulder. A cascading effect would likely result in this instance with each occurrence of microcracking at a tie bar resulting in the stress zone moving closer to the top and outer edge of the shoulder.

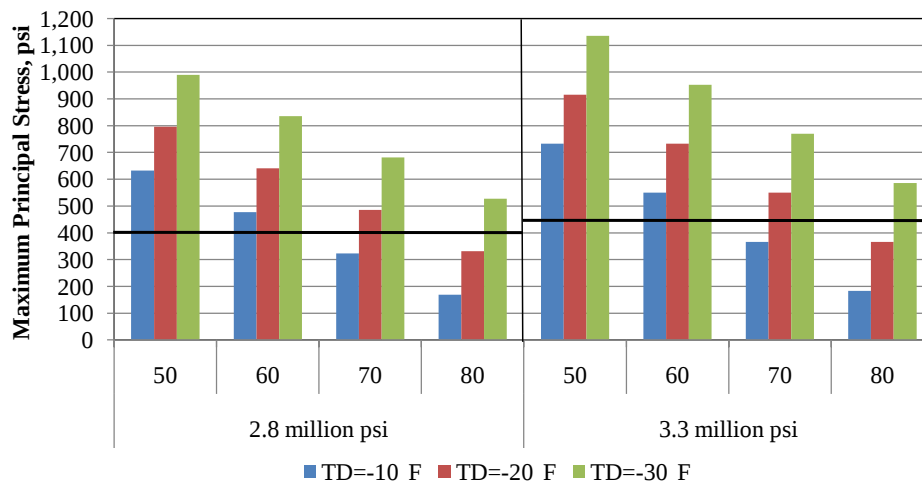
The stiffness of the concrete was only defined using the elastic modulus and Poisson's ratio. However, by increasing the stiffness, the trigger value for flexural strength also increases. Figure 172 shows 12 different scenarios with two different stiffnesses. The stiffness of 2.8 million psi corresponds to the 1-day strength and 3.3 million psi corresponds to the 7-day strength. The stresses seen with 3.3 million psi stiffness are larger than the stresses seen with 2.8 million psi stiffness; however, the strength for the stiffer concrete is also greater. Based on the results from Figure 172, it can be concluded that the transverse cracks in the shoulder could occur at any of the first few days.

Figure 172: Influence of Concrete Stiffness and Strength on the Shoulder Transverse Cracking.

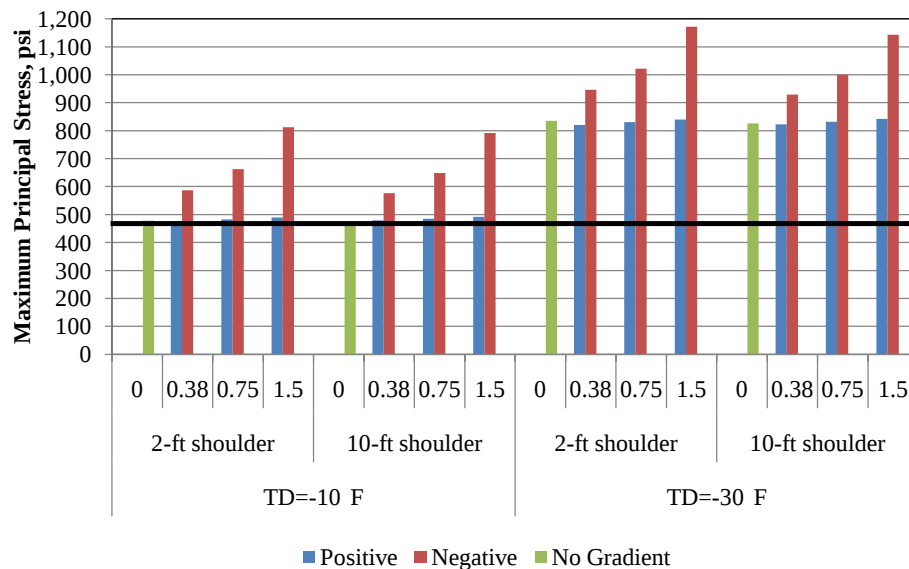
Figure 173 shows the effect of positive and negative gradients in comparison to a uniform temperature for a TD of -10°F and -30°F. In general, the critical tensile stress occurs at the bottom of the slab when a positive gradient is present and it occurs at the top of the slab when a negative gradient is present. Therefore, in Figure 173, the stresses with the negative gradients were recorded at the bottom of the slab and the stresses with the positive gradients were recorded at the top of the slab. When there is no gradient present, the critical stress location is at the top of the slab.

As shown in Figure 173, a positive gradient does not have an effect on the magnitude of stress when compared to a situation with no gradient. If there is a negative gradient present in the slab, the stresses at the top of the slab are magnified, even for the smallest gradient of -0.38 °F/in.

Figure 173: Effect of Gradients When  $T_s = 110^\circ\text{F}$  in the Shoulder Transverse Cracking Model
