# Forensic Investigation of AC and PCC Pavements with Extended Service Life

Volume 3: Petrographic Examination of Blast Furnace Slag Aggregate Concrete Cores taken from PCC Pavements in Cuyahoga County, Ohio

David Lankard, consultant

Report FHWA/OH-2010/004C

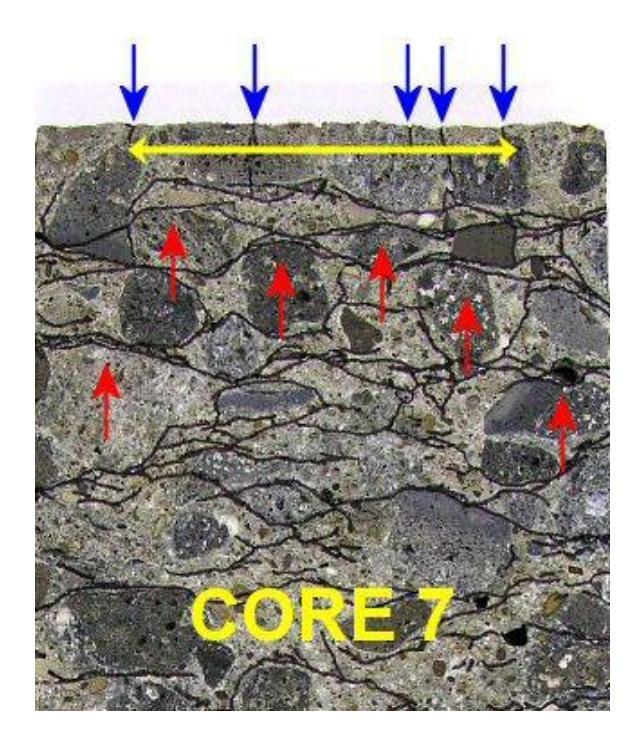
The nature and origin of the map-cracking form of distress in slag aggregate concretes are illustrated in Figure 16, and one of the photographs from this Figure is reproduced below. This is a section view (perpendicular to the plane of the wearing surface) of the top 3 in. (8 cm) of slag aggregate Core 7.

As viewed in two dimensions on a lapped surface of the concrete there are two forms of cracking that are diagnostic of the unique form of distress in slag aggregate concrete pavements. They include (1) shallow <u>vertical cracks</u>, which can be seen on the wearing surface of the pavement, and (2) <u>sub-surface horizontal cracks</u>. The internal sulfate attack reactions produce expansive stresses within the body of the pavement concrete. These expansive stresses create fractures in the concrete that are parallel to the plane of the wearing surface of the pavement slab. These fractures are referred to in our report as "sub-surface horizontal cracks" and in the above figure they have been marked with a black marking pen.

In service it is expected that the strains associated with these stresses will be greatest in the direction perpendicular to the nearest free surface (as shown by the red arrows in the figure). In this case the nearest free surface is the wearing surface of the pavement slab. This scenario results in the creation of tensile stresses in the immediate wearing surface layer as shown by the double yellow arrow in the figure. The result is the creation of shallow cracks, in which the fracture planes are oriented perpendicular to the plane of the wearing surface. These cracks are referred to in our report as "vertical cracks". Many of these cracks pass through near-surface slag aggregate particles.

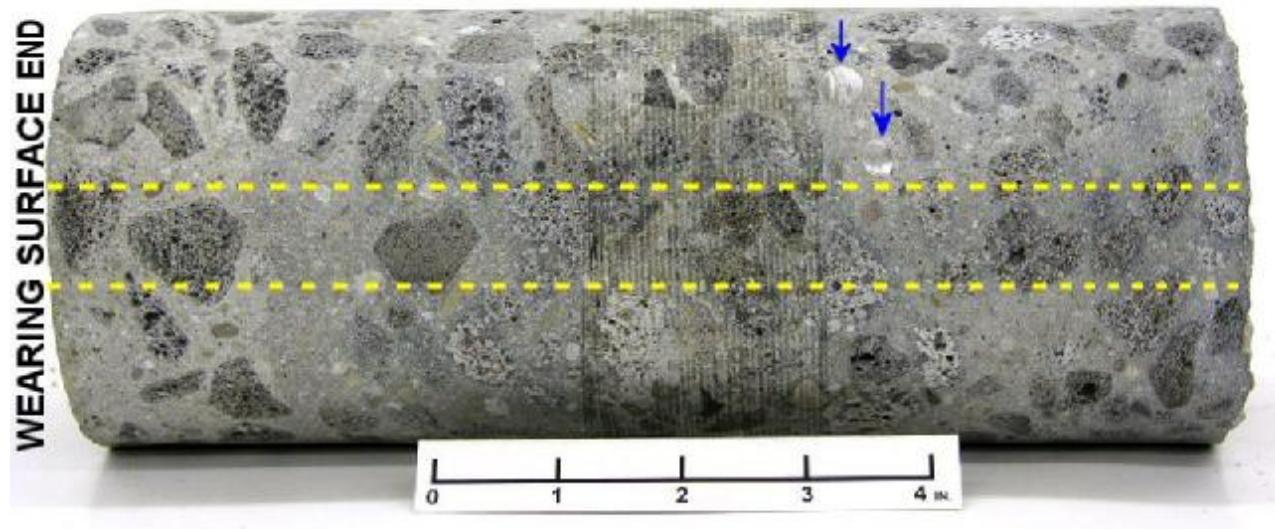
CORE 6

SR 175 @ CONCORD (NO DISTRESS)

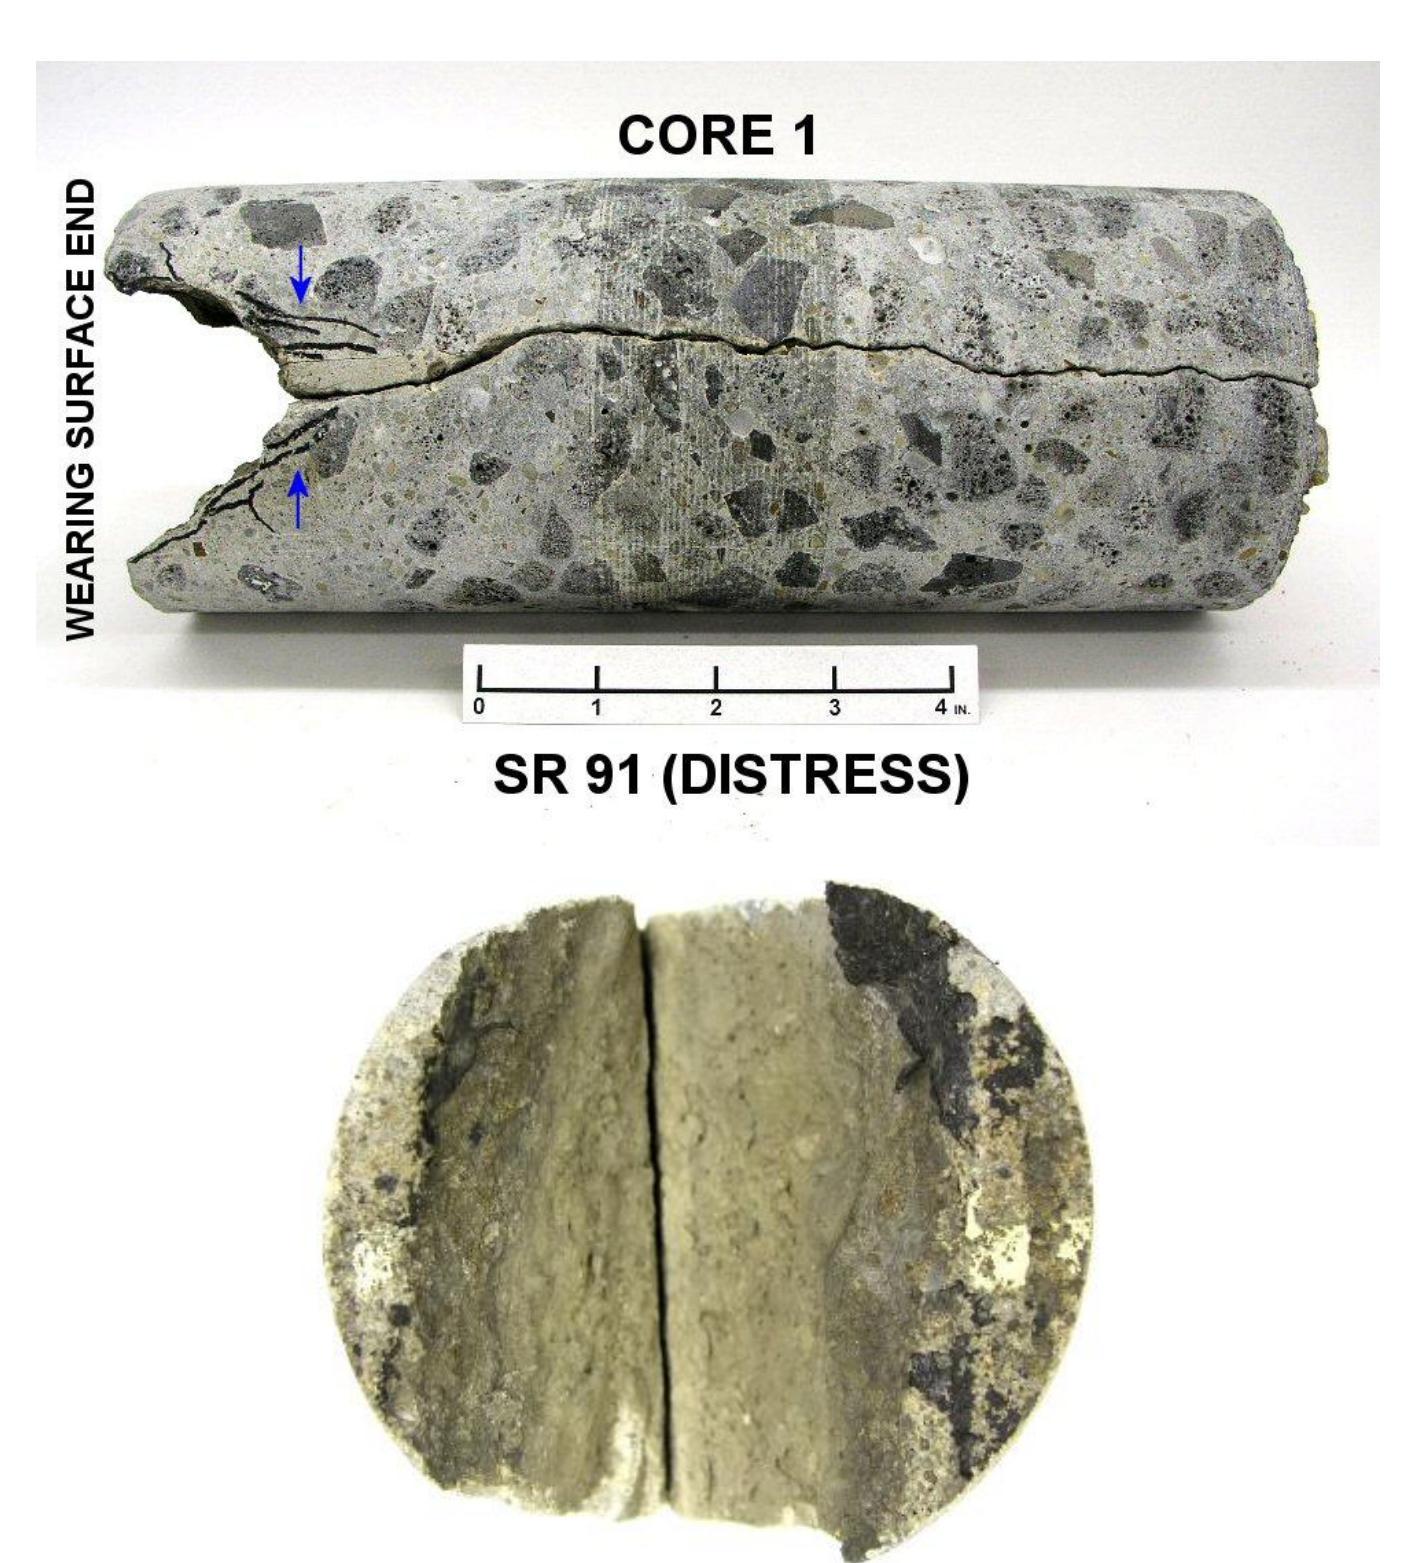
WEARING SURFACE OF CORE 1

Core 1 (Figure 4) was taken *through* a transverse control joint. The other three "Distress" cores were taken within 1 ft. to 4 ft. (0.3 m to 1.2 m) of a control joint and the following discussion focuses on the distress exhibited by these cores as revealed in their examination in the as-received condition. The features are similar in the cores and include,

Figure 4. Core 1 taken at a "Distress" location on State Route 91 in Cuyahoga County, Ohio as-received at Lankard Materials Lab on March 3, 2010. This core was taken through a control joint in the pavement, where some spalling has occurred. The arrows point to cracks in the core that have been marked with a black marking pen. There is a  $^{3}/_{16}$  in (5 mm) diameter mesh strand holding the two core pieces together.

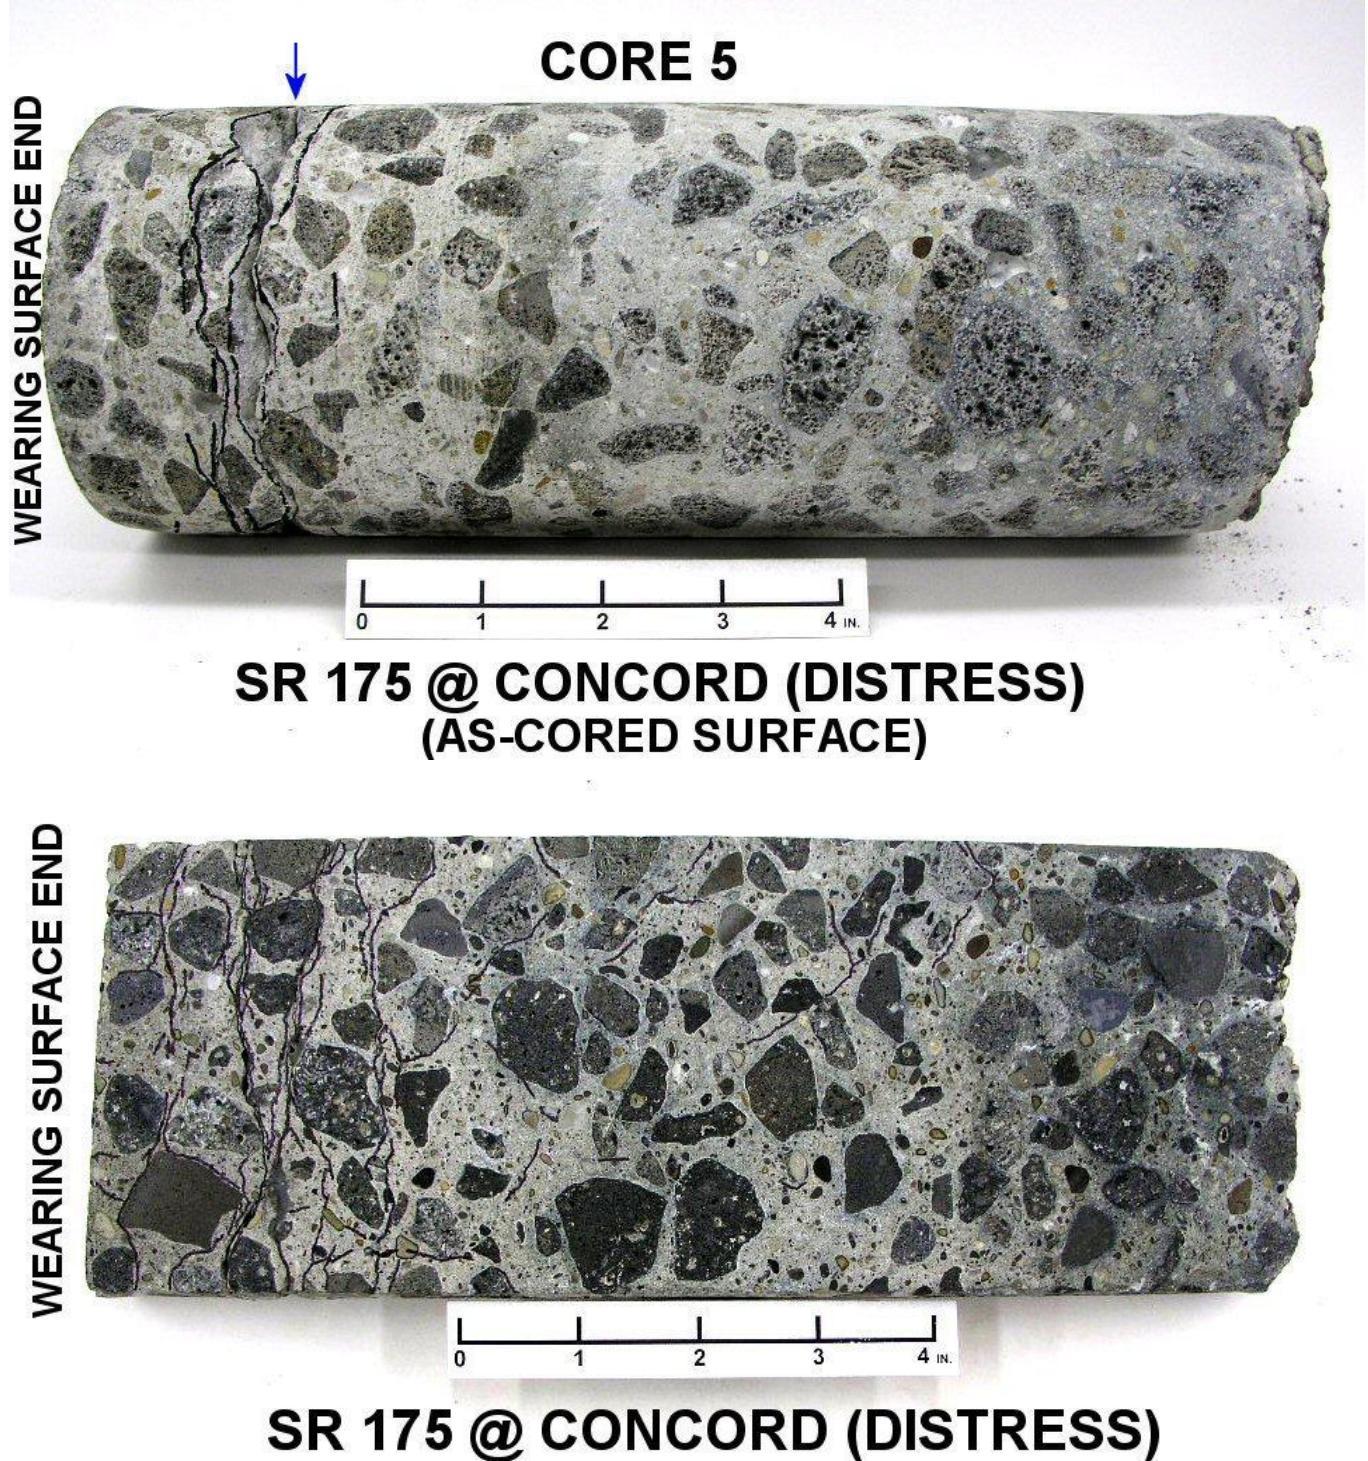
## SR 175 @ CONCORD (DISTRESS) (LAPPED SURFACE)

Figure 8. Two views (an as-cored surface and a lapped surface) of Core 5 taken from a "Distress" location on the SR 175 @ Concord pavement. The core was received in two pieces that were re-attached with an epoxy adhesive (at the site of the arrow). The lapping operation on the slab section of Core 5 (bottom photograph) revealed the presence of many more horizontal cracks in the core concrete than could be detected on the as-cored surfaces. Cracks that were detected in the microscopic examinations are marked with a black marking pen in both photographs.

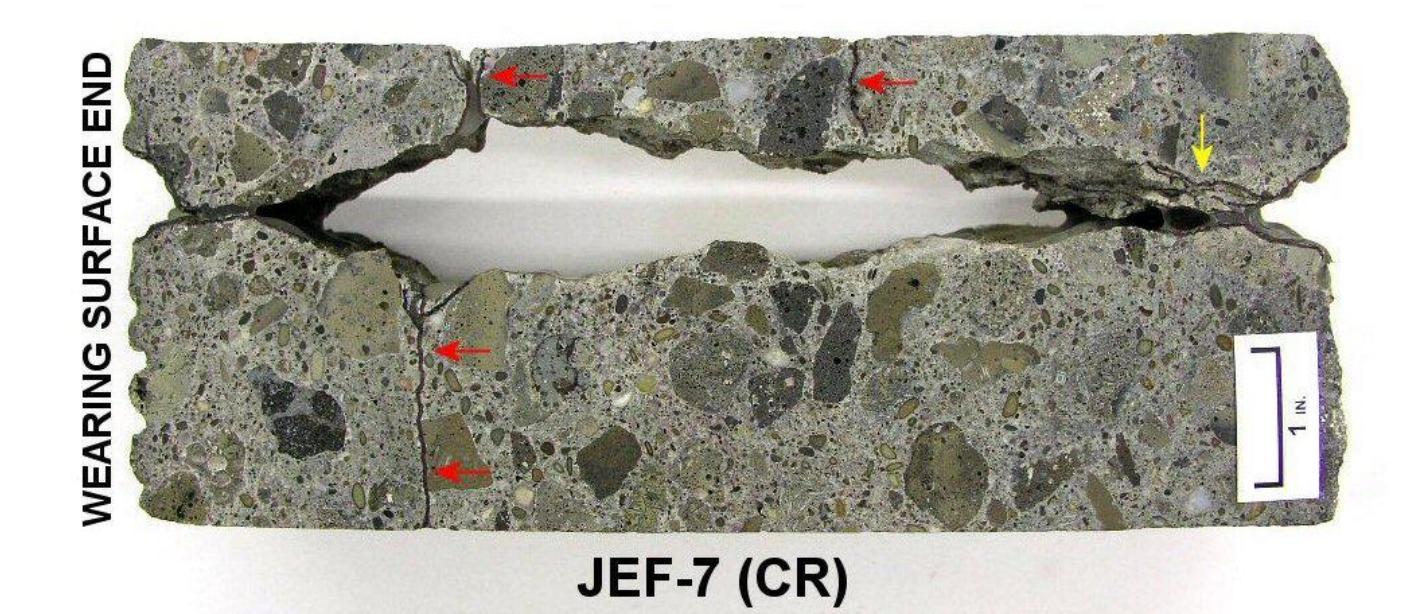
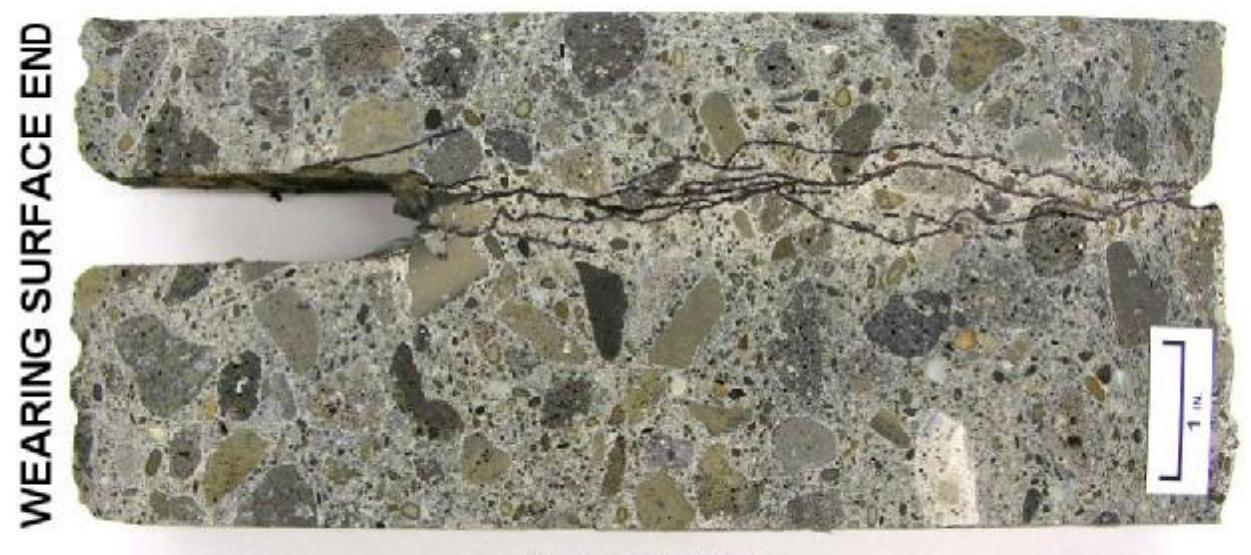
JEF-7 (JT)

Figure 47. Lapped surface views of a core taken through a transverse crack (CR) and a core taken through a transverse control joint (JT) on a slag aggregate pavement on State Route 7 in Jefferson County, Ohio. The pavement was 19 years old at the time of coring and had been given an "Excellent" performance rating. Cracks in the core concretes are marked with a black marking pen.

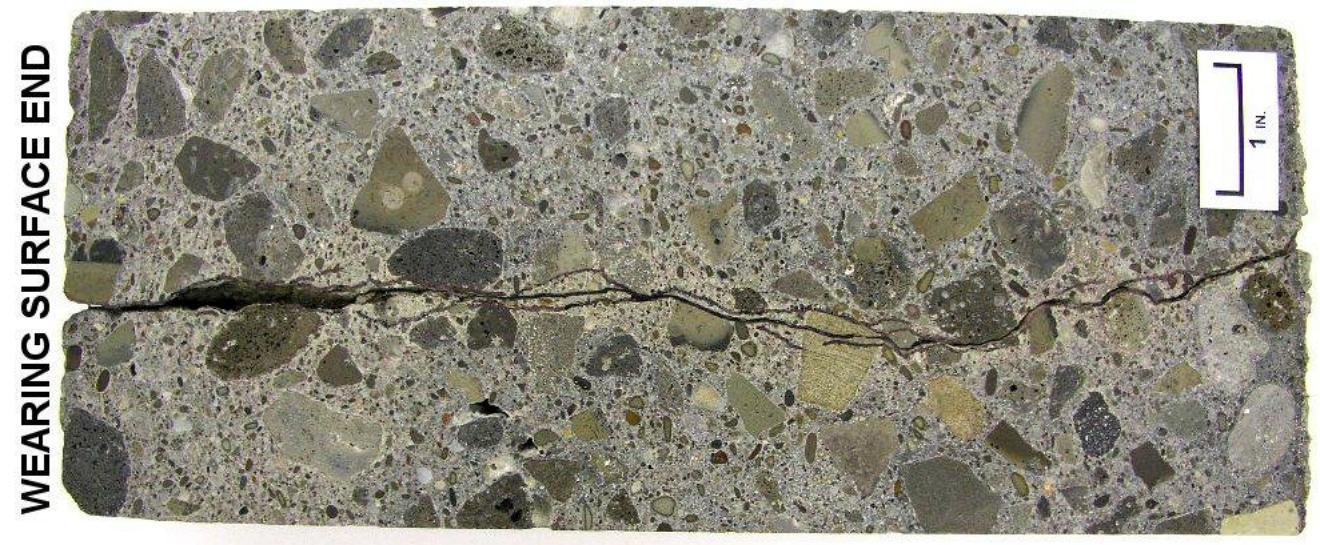
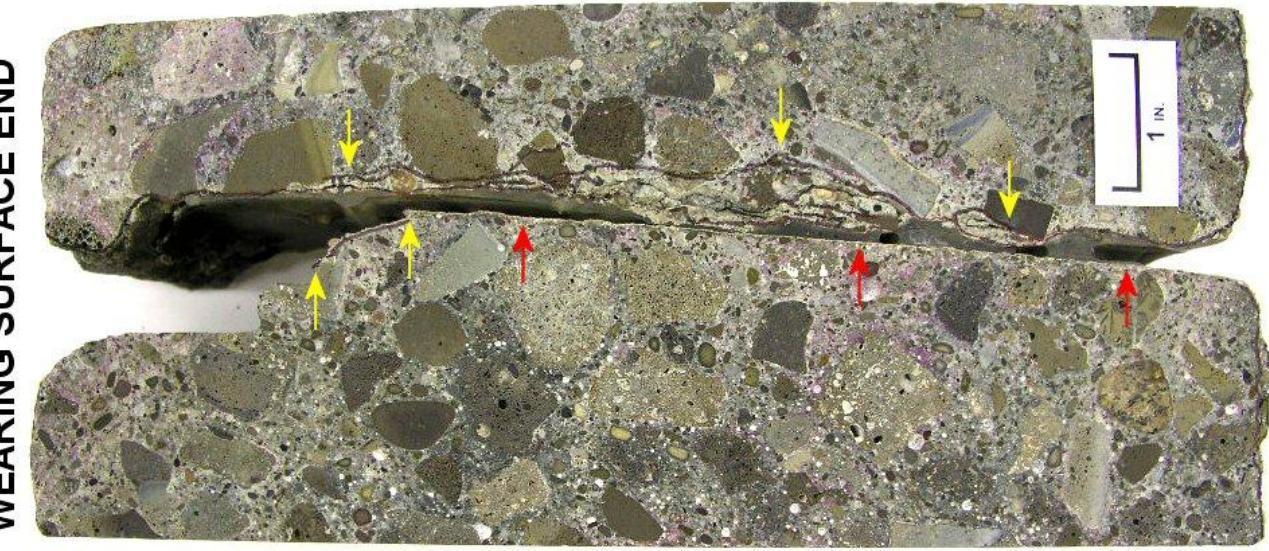
JEF-22 (JT)

Figure 48. Lapped surface views of a core taken through a transverse crack (CR) and a core taken through transverse control joint (JT) on a slag aggregate pavement on State Route 22 in Jefferson County, Ohio. The pavement was 19 years old at the time of coring and had been given an "Average" performance rating. Cracks in the core concretes are marked with a black marking pen

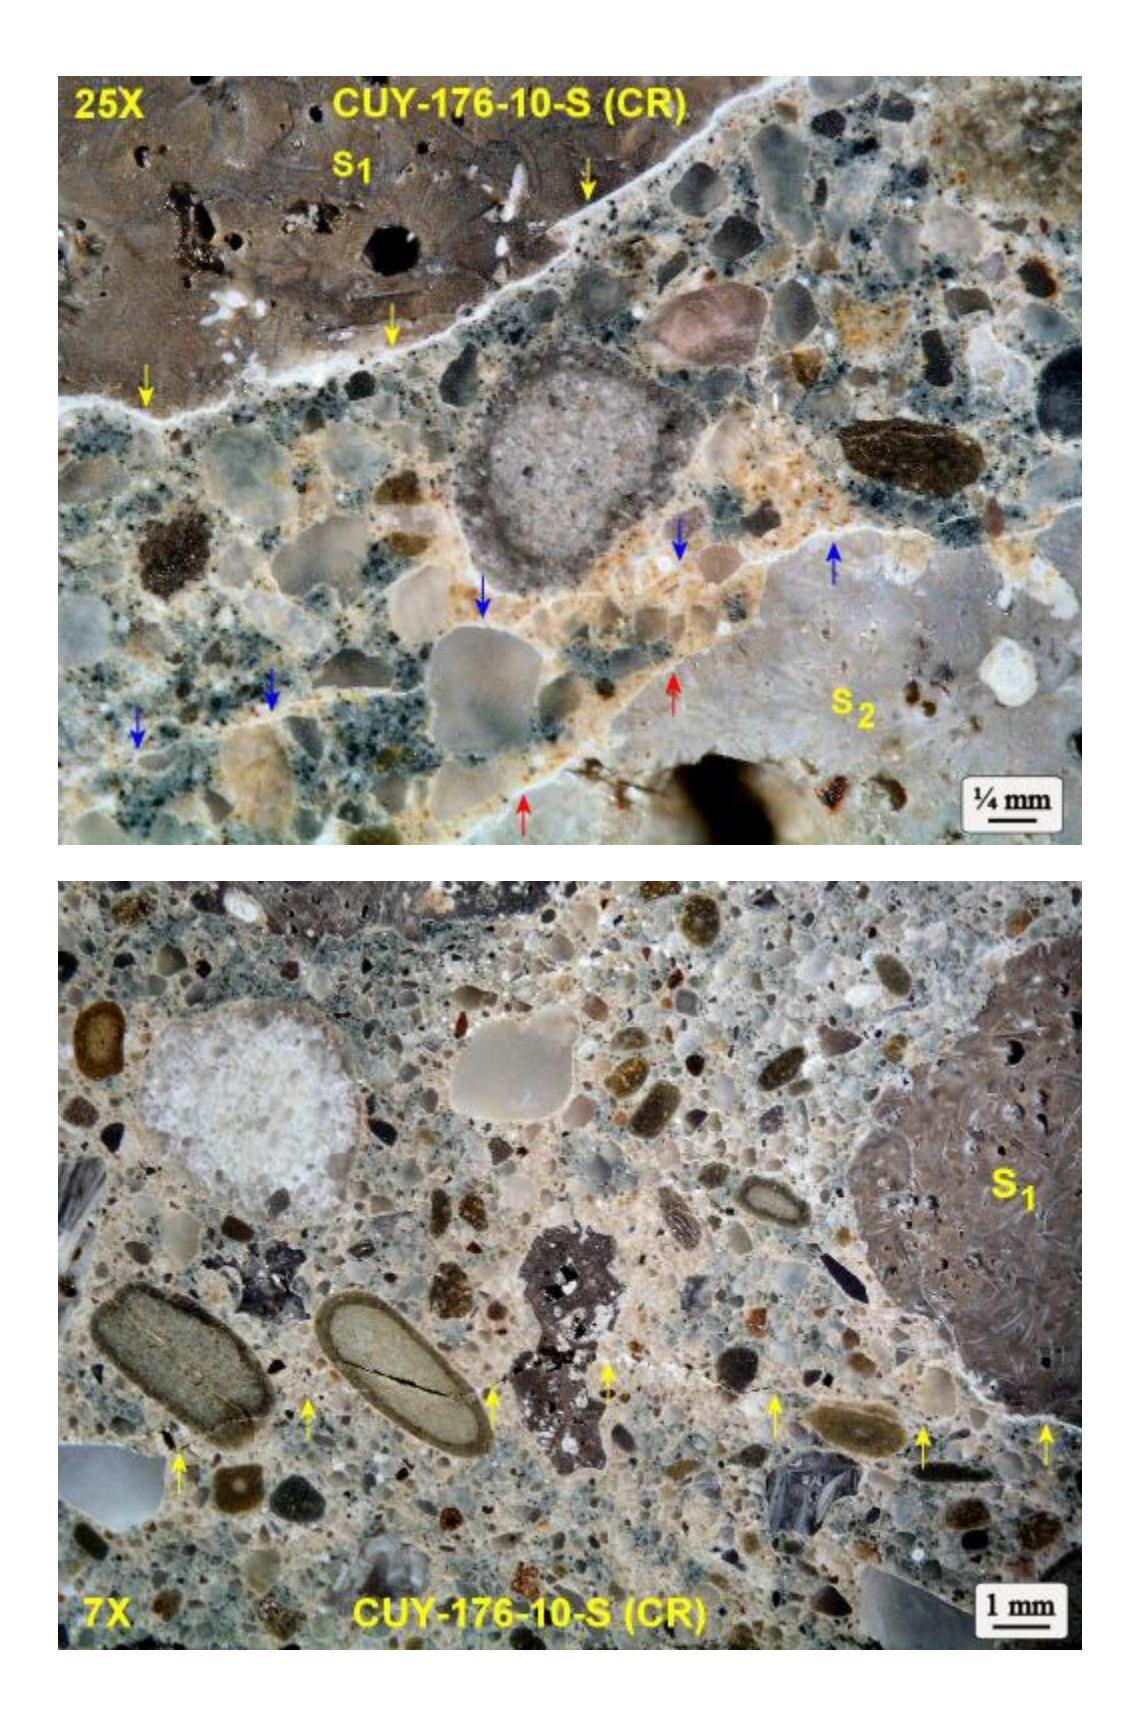
Figure 52. Lapped surface views (7X and 25X) of the Mid-Slab Crack Core taken from the southbound mainline pavement on SR 176 in Cuyahoga County, Ohio. The wearing surface is at the top in the photographs. The location is 5 in. below the wearing surface. The arrows point to the paths of very tight cracks that pass around slag aggregate particles (S1 and S2) and through a number of siltstone particles. The cracks are lined over much of their length with ettringite deposits.

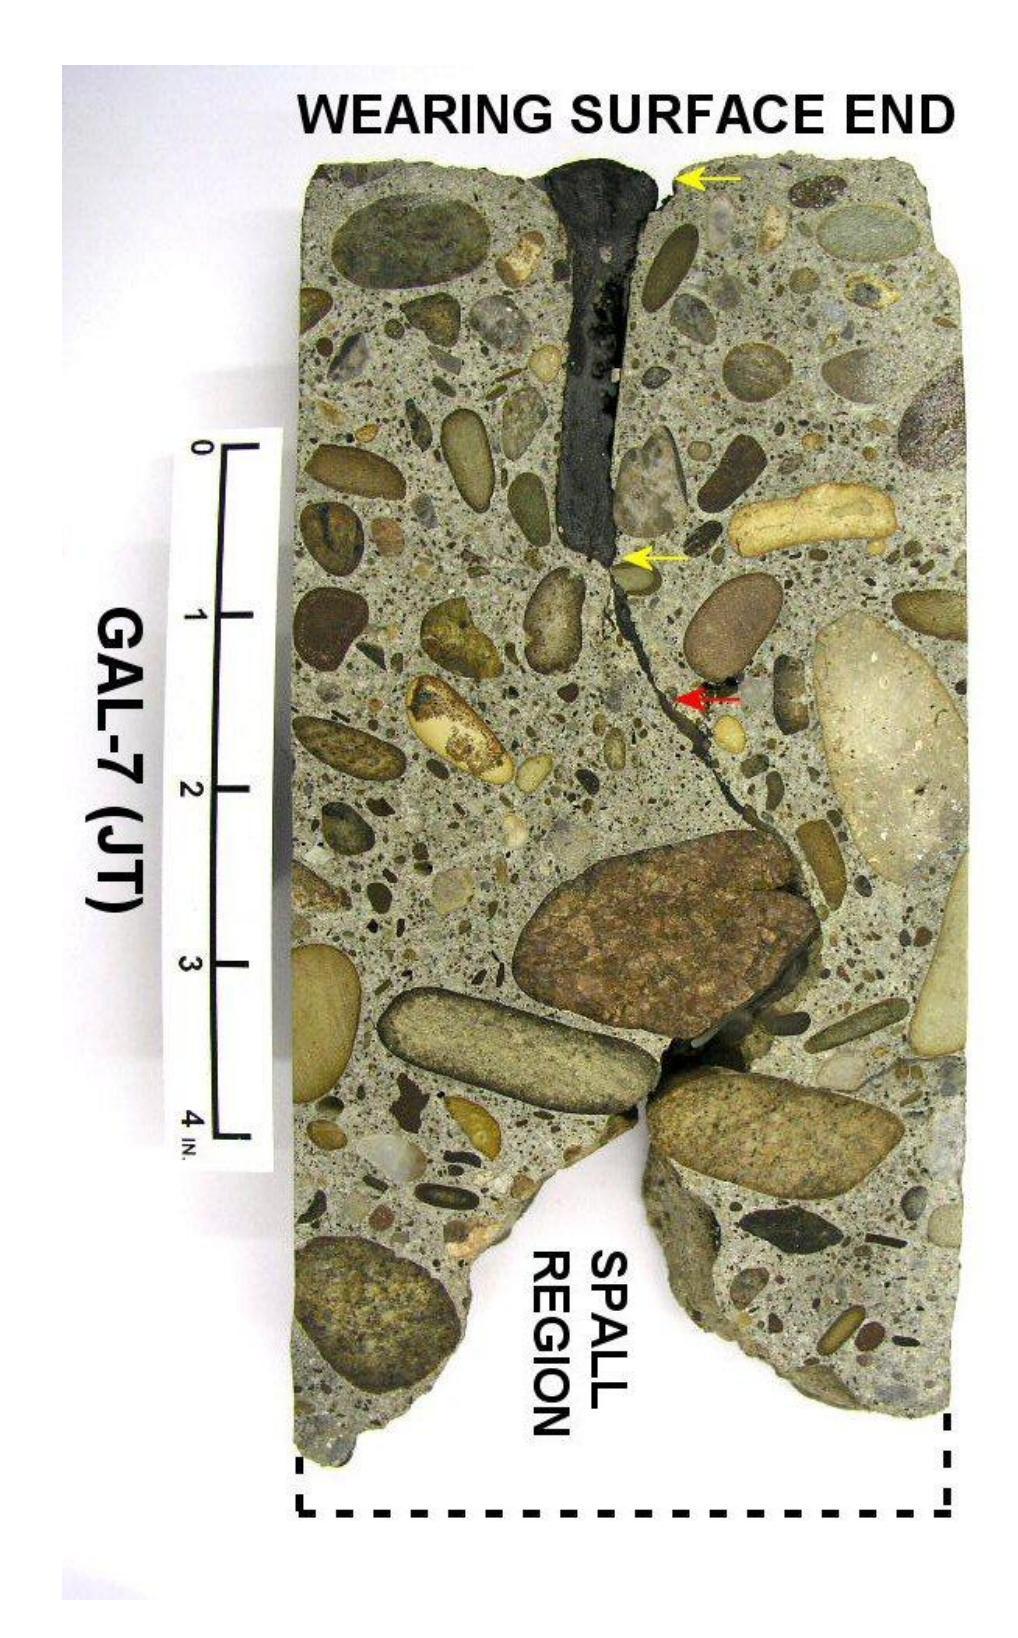
One such step is suggested by results obtained on a 64 year old ODOT pavement evaluated in our Forensic Study (Lankard, 2010). This pavement, constructed in 1946, is on State Route 7 in Gallia County, Ohio. The control joint spacing on the project is 40 ft. (12 m), and many of the joints are originals. Significantly, the control joint seal material in place on the core that we examined was also still in place after 64 years of surface. A lapped surface view of this joint core is shown in Figure 53.

The control joint seal is a sanded bituminous material that was poured into the joint void. The requirement at the time called for the material to meet the requirements of Section M-5.6 F-1 of the General Specifications. The joint seal material was placed (presumably a hot mix) after the joint crack had opened. The red arrow in Figure 53 shows the depth to which the sealant reached in the joint crack.

Figure 53. Lapped surface view of Core 2 taken through a transverse control joint on an ODOT PCC pavement on State Route 7 in Gallia County, Ohio. The pavement was constructed in 1946. This is an original joint, as is the joint sealant material, which is a sand-filled bituminous material.
