1. Report No. FHWA/TX-11/0-6120-1		2. Government Accession No.		3. Recipient's Catalog No.	
4. Title and Subtitle TREATMENTS TO REDUCE THE FREQUENCY OF FREEWAY EXIT SIGN HITS				5. Report Date January 2011 Published: June 2011

# **TREATMENTS TO REDUCE THE FREQUENCY OF FREEWAY EXIT SIGN HITS**

Report 0-6120-1

January 2011

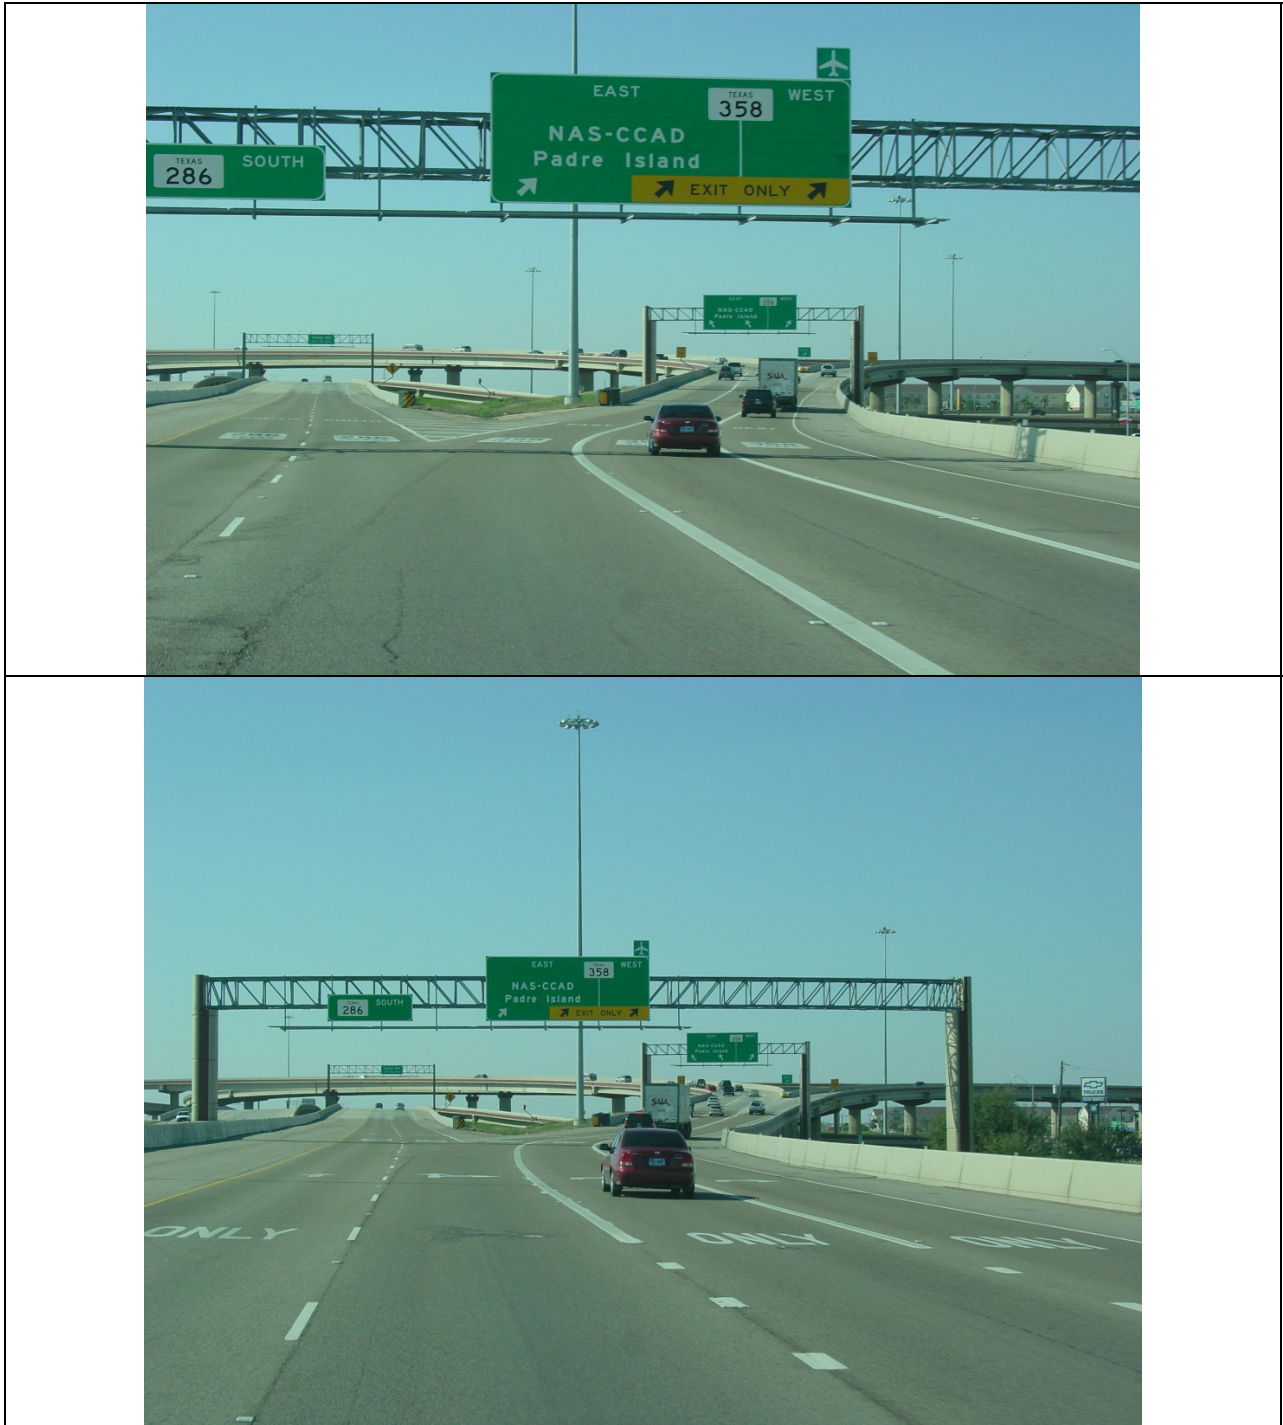
**Figure 40. Approach to Southbound SH 286 Exit to SH 358 East at Start of Gore Area.**

- This is a freeway to freeway direct connector ramp exit.
- There was no observed sight distance issue with this location.
- High operating speeds were observed on approach to the exit ramp.
- Very little visual clutter on approach.

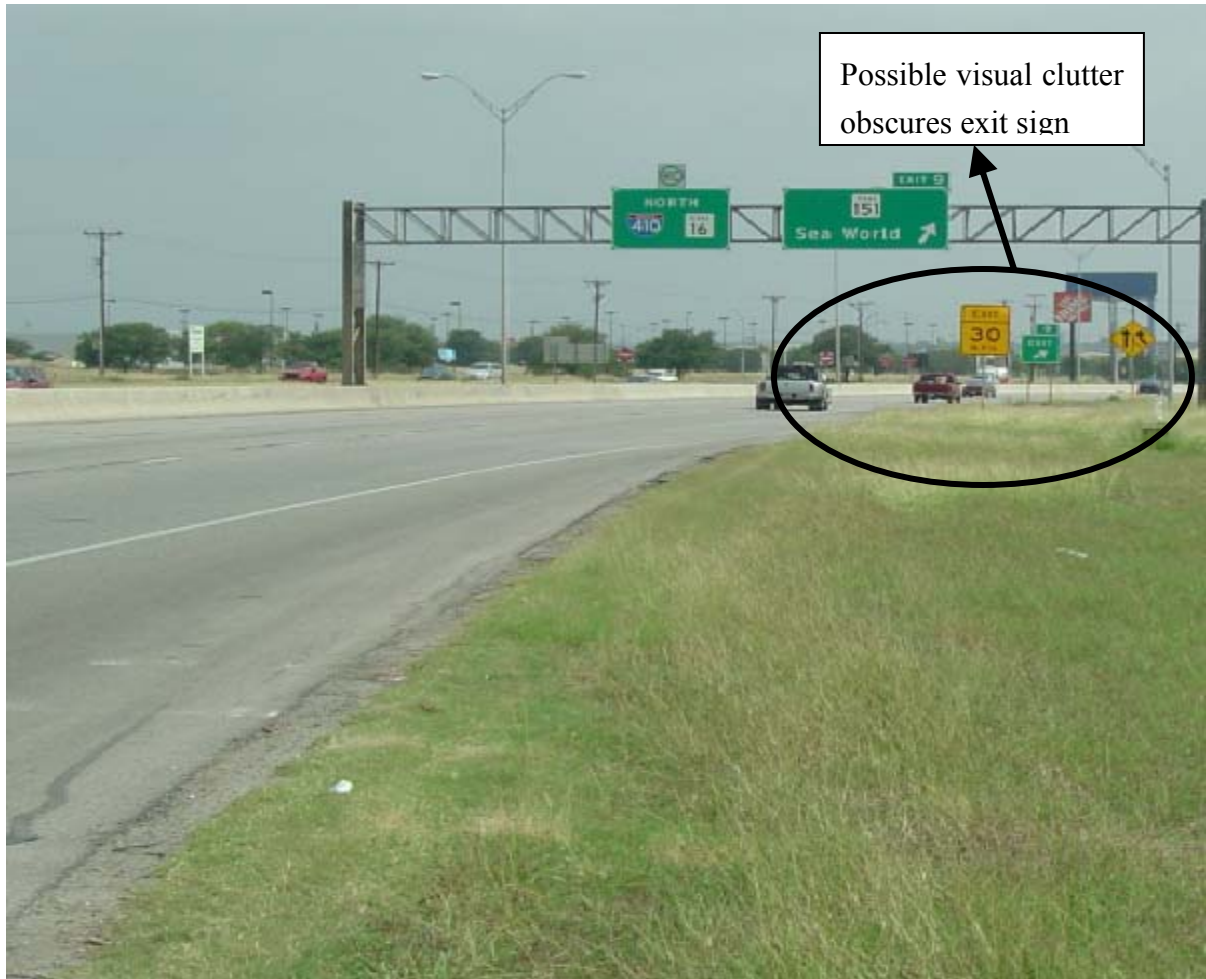
**Figure 45. Approach to SH 151 Exit on Northbound IH 410.**

- No obvious geometric deficiencies noted on site.
- High speeds were recorded for exiting traffic.
- Some visual clutter on approach to exit with numerous roadside signs (see Figure 45).
- Late maneuvering was a common observance.
