DEVELOPMENT OF A MASH TL-3 MEDIAN BARRIER GATE

Research/Test Report 9-1002-2

TEXAS TRANSPORTATION INSTITUTE THE TEXAS A&M UNIVERSITY SYSTEM COLLEGE STATION, TEXAS

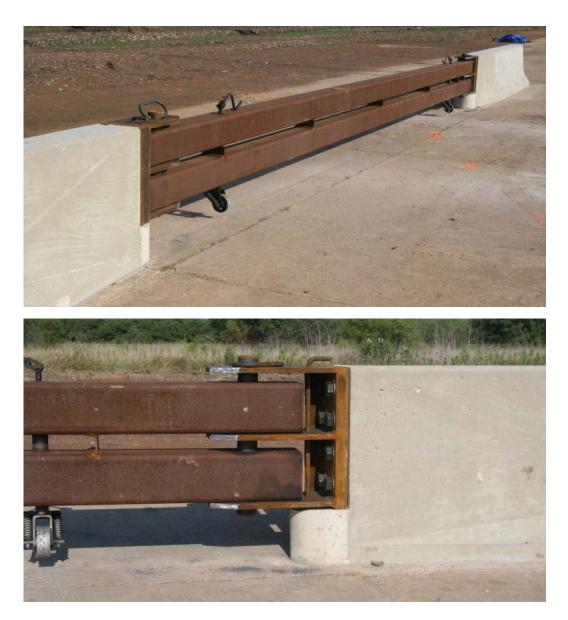
Figure 1.1. Emergency Opening System (EOS).

The 1100C test vehicle was contained and redirected. However, the gate failed to comply with *MASH* due to excessive occupant compartment deformation inside the vehicle (3).

Several modifications were made to the end of the EOS to help mitigate the severe vehicle snagging. These changes were developed with retrofit of the existing design as a goal. The horizontal steel plates on the end brackets were replaced with tapered sections of 2 inch \times ¹/₄-inch thick steel tubing. The ends of the tubular steel beams were cut off and tapered sections of tubing were added. These tubes tapered out 2 inches from the sides of the steel beams and then tapered back down to a width that was less than the width of the end of the concrete parapet to reduce snagging potential from a reverse direction impact. When assembled and installed, the tapered sections of tubing on the steel beams and end bracket overlapped each other to resemble

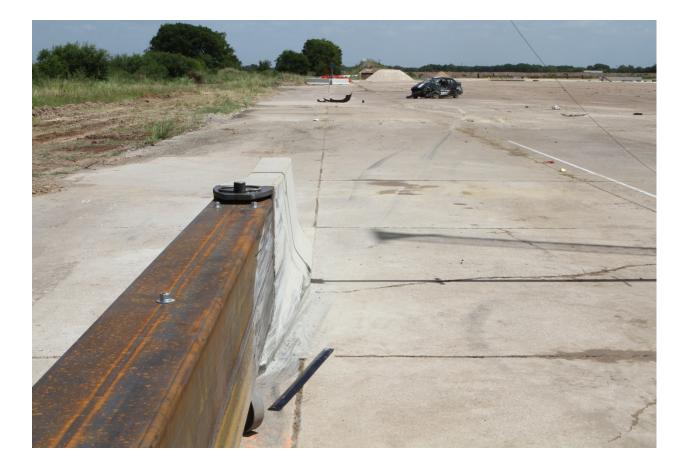
Figure 6.3. Vehicle/Barrier Positions after Test No. 420020-6.

Damage to the gate itself was only cosmetic and consisted of scuff marks as shown in Figures 6.3 and 6.4. The end of the upstream concrete parapet sustained two thin stress cracks on the field side. Minor concrete spalling was observed on the field side of the end of the downstream concrete parapet. No rebar was exposed and the spall was considered to be cosmetic in nature. The vehicle was in contact with the installation 10.2 ft. No measurable dynamic or permanent deflection was noted.

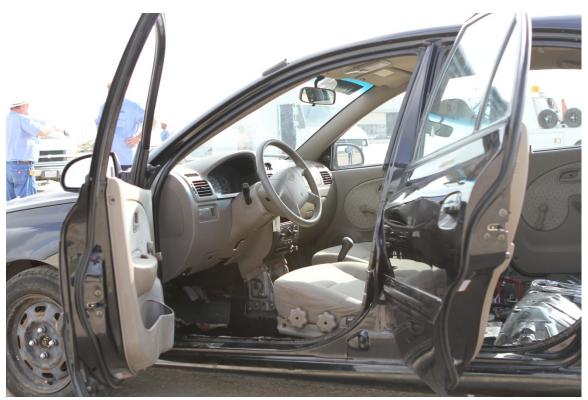
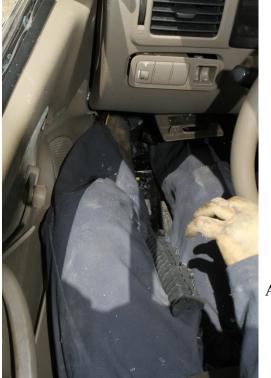
Figure 6.6. Interior of Vehicle for Test No. 420020-6.

As shown in Figure 6.5, the vehicle sustained damage to the front and left side. The left front strut, strut tower, and A-post were deformed. Also damaged were the front bumper, hood, grill, radiator and support, left front fender, left front tire and wheel rim, left front door and glass, the left rear door, and left rear quarter panel. The roof was deformed and the windshield sustained stress cracking. Maximum exterior crush to the vehicle was 12.0 inches in the side plane at the left front corner at bumper height. Maximum occupant compartment deformation was 3.0 inches in the firewall area near the toe pan on the driver side. Figure 6.6 shows photographs of the interior of the vehicle. Exterior crush and occupant compartment deformation measurements are provided in Appendix C, Tables C1 and C2.

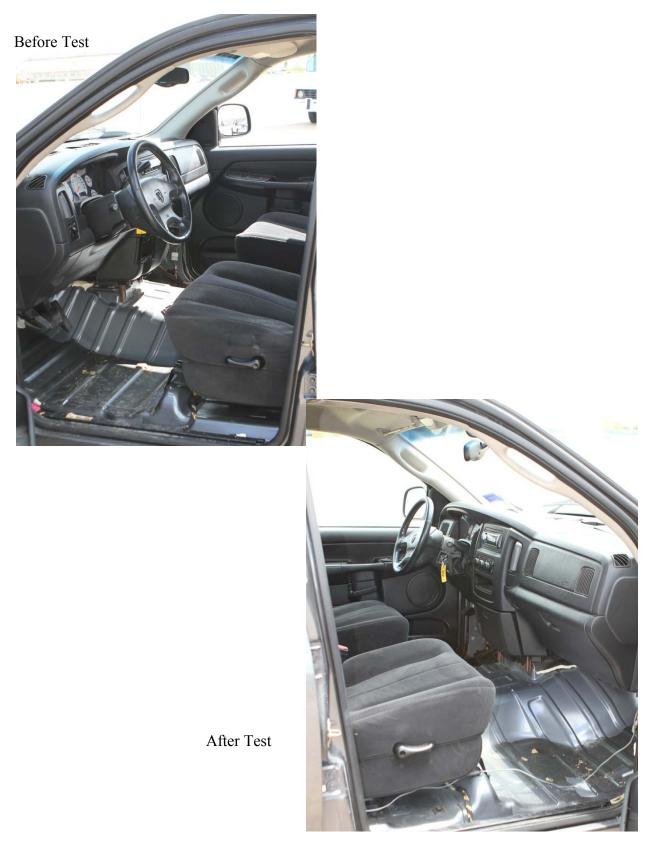
Figure 7.6. Interior of Vehicle for Test No. 420020-7.

As shown in Figure 7.5, the majority of the damage sustained by the 2270P vehicle was to the left front corner and above the top wheel line along the left side. The left upper A-arm was deformed. Also damaged were the front bumper, grill, left front fender, left front tire and wheel rim, left front and rear doors, rear of the cab, left exterior bed, left rear wheel rim (no loss of air in the tire), rear bumper, and tailgate. Maximum exterior crush to the vehicle was 12.0 inches in the side plane in the left front corner at bumper height. Maximum occupant compartment deformation was 0.5 inches across the cab at hip level on the driver side. Figure 7.6 shows photographs of the interior of the vehicle. Exterior crush measurements and occupant compartment deformation are provided in Appendix C, Tables C4 and C5.

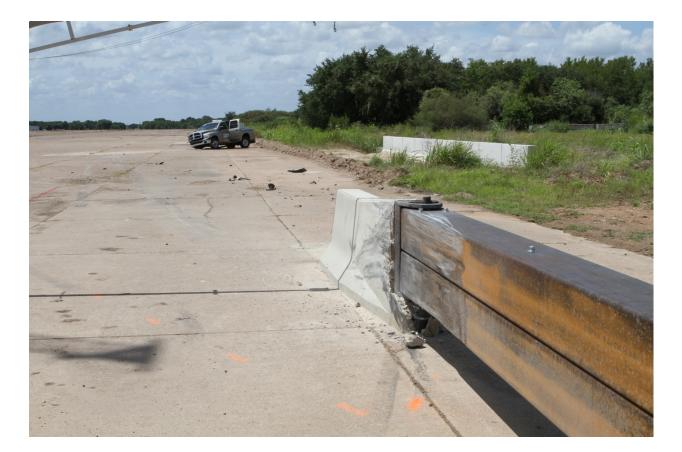
Figure 8.3. Position of Vehicle/Gate after Test No. 420020-8.

The lower toe and end of the concrete barrier sustained significant damage, as shown in Figures 8.3 and 8.4. The concrete was cracked and fell away from the reinforcement in the toe of the concrete barrier and also from the field side of the barrier. The concrete on the end of the traffic face of the barrier was cracked, but remained in place. The end bracket was pushed toward the field side 1.0 inch. Tire marks were present along the traffic face of the steel gate and traffic face of the concrete barrier for a distance of 11.75 ft. Working width, maximum dynamic deflection, and maximum permanent deformation were 1.25 inches.

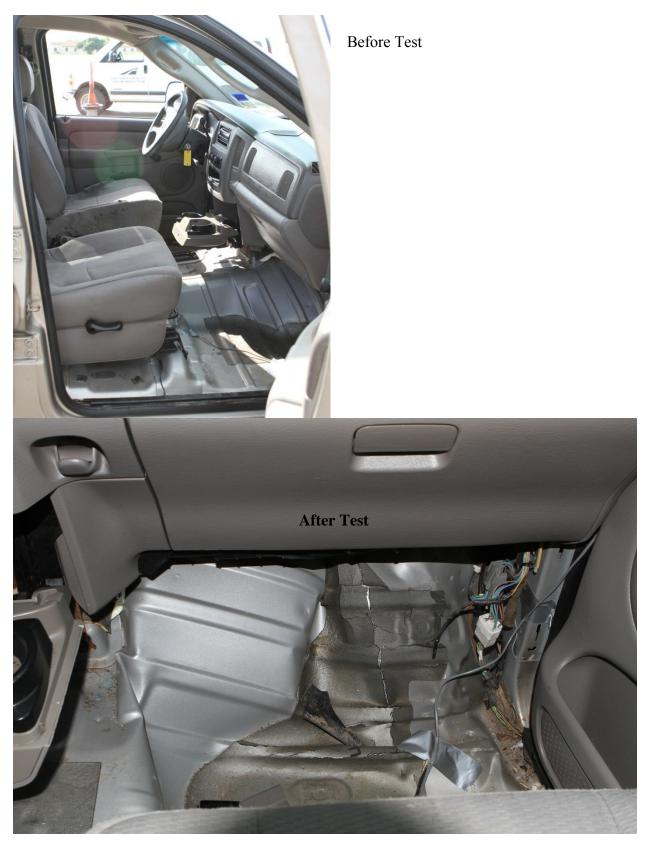
Figure 8.6. Interior of Vehicle for Test No. 420020-8.

Figure 8.5 shows the damage to the vehicle, which was mostly in the right front quarter in the side plane. The right upper and lower ball joint, right tie rod end, right frame rail, right front upper and lower A-arms, drive shaft, rear axle, and rear U-bolts and springs were damaged. Also damaged were the front bumper, hood, grill, right front fender, right front tire and wheel rim, right front and rear doors, right rear cab, right rear exterior bed, right rear tire and wheel rim, rear bumper, and tailgate. The windshield sustained stress cracks. Maximum exterior crush to the vehicle was 19 inches in the side plane at the right front corner at bumper height. Maximum occupant compartment deformation was 5.25 inches in the right firewall area near the toe pan on the front passenger side. Figure 8.6 shows photographs of the interior of the vehicle. Exterior crush and occupant compartment deformation are provided in Appendix C, Tables C7 and C8.
