1. Report No. FAA AM- 72-7		2. Government Accession No.		3. Recipient's Catalog No.	
4. Title and Subtitle EVALUATION OF A FIBERGLASS INSTRUMENT GLARE SHIELD FOR PROTECTION AGAINST HEAD INJURY				5. Report Date February 1972

6. Performing Organization Code	
7. Author(s) E. D. Langston John J. Swearingen, D. Av. T.				8. Performing Organization Report No.	
9. Performing Organization Name and Address FAA Civil Aeromedical Institute P. O. Box 25082 Oklahoma City, Oklahoma 73125				10. Work Unit No.

# EVALUATION OF A FIBERGLASS INSTRUMENT GLARE SHIELD FOR PROTECTION AGAINST HEAD INJURY

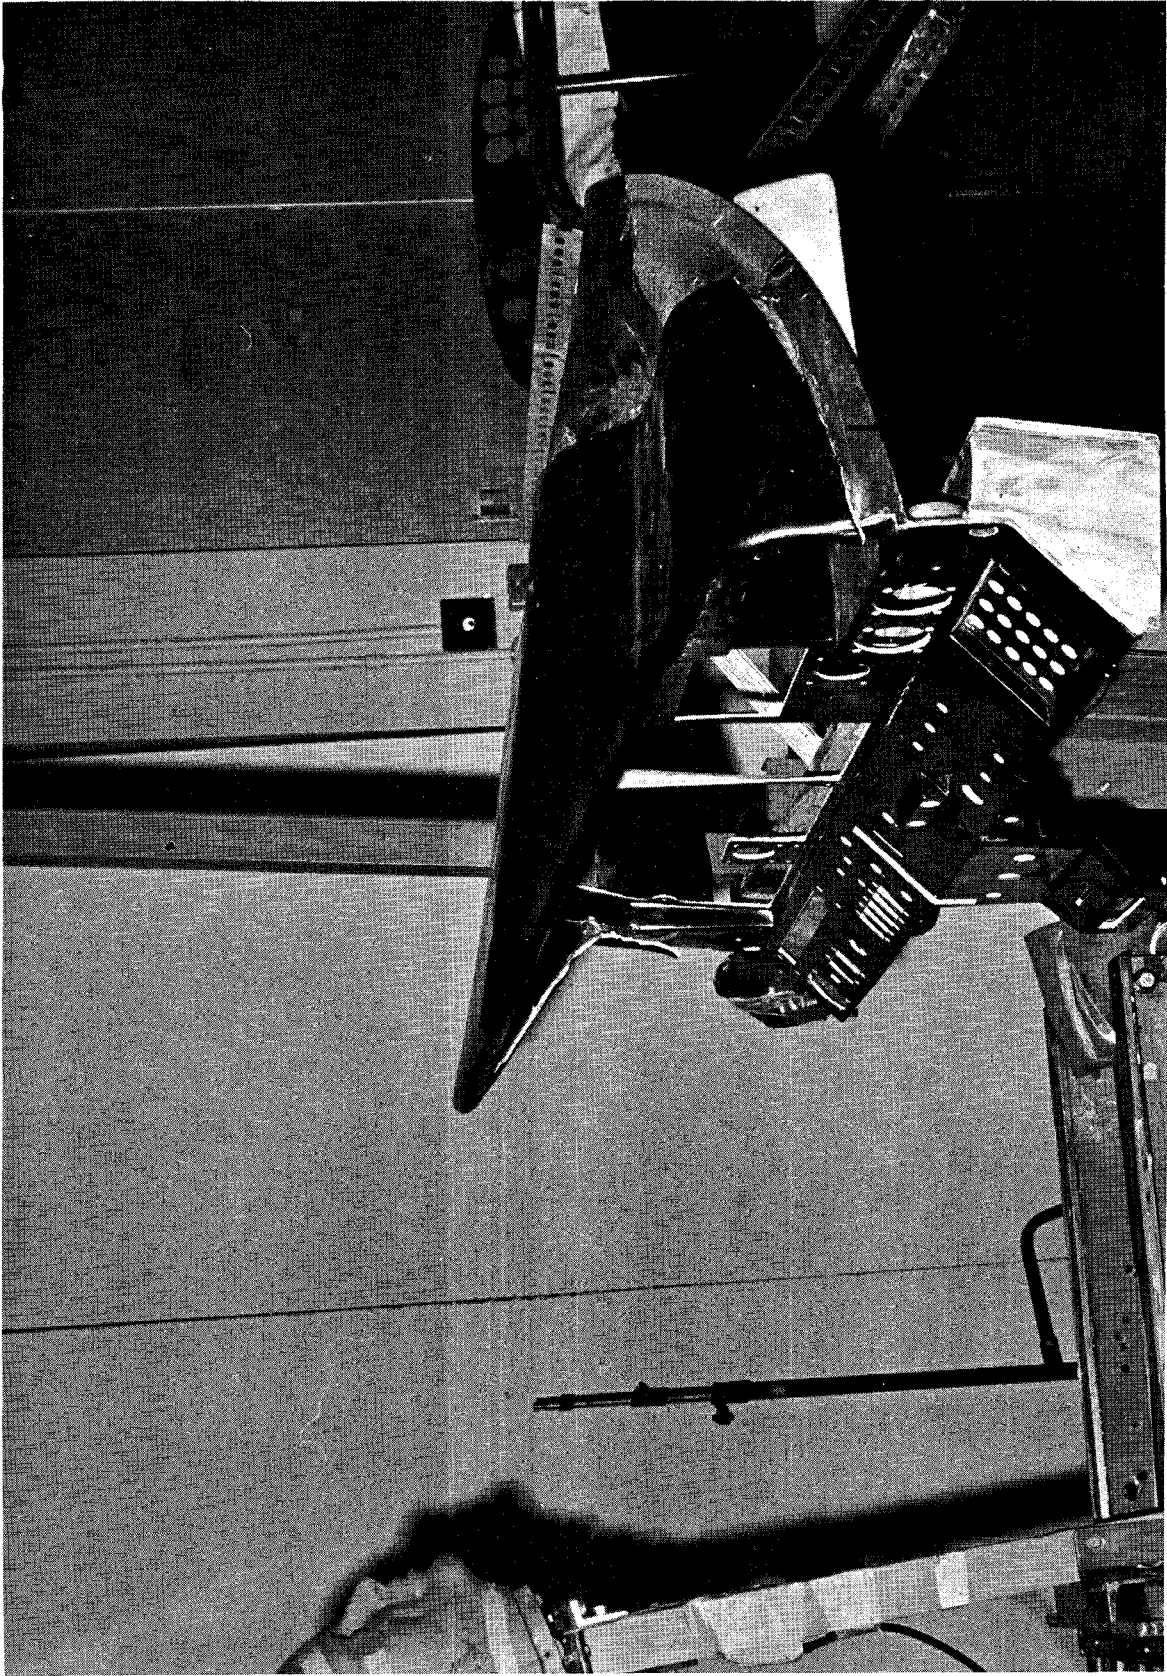
It should be noted at this point that the glare shield protruded only in front of the left pilot and that the right side dropped back such that the head impact area for the right seat occupant consisted of a layer of the thin padding over a rigid structure at the top of the instrument panel (Figure 1).

FIGURE 1. Fiberglass instrument panel and glare shield mounted at the end of the crash sled.

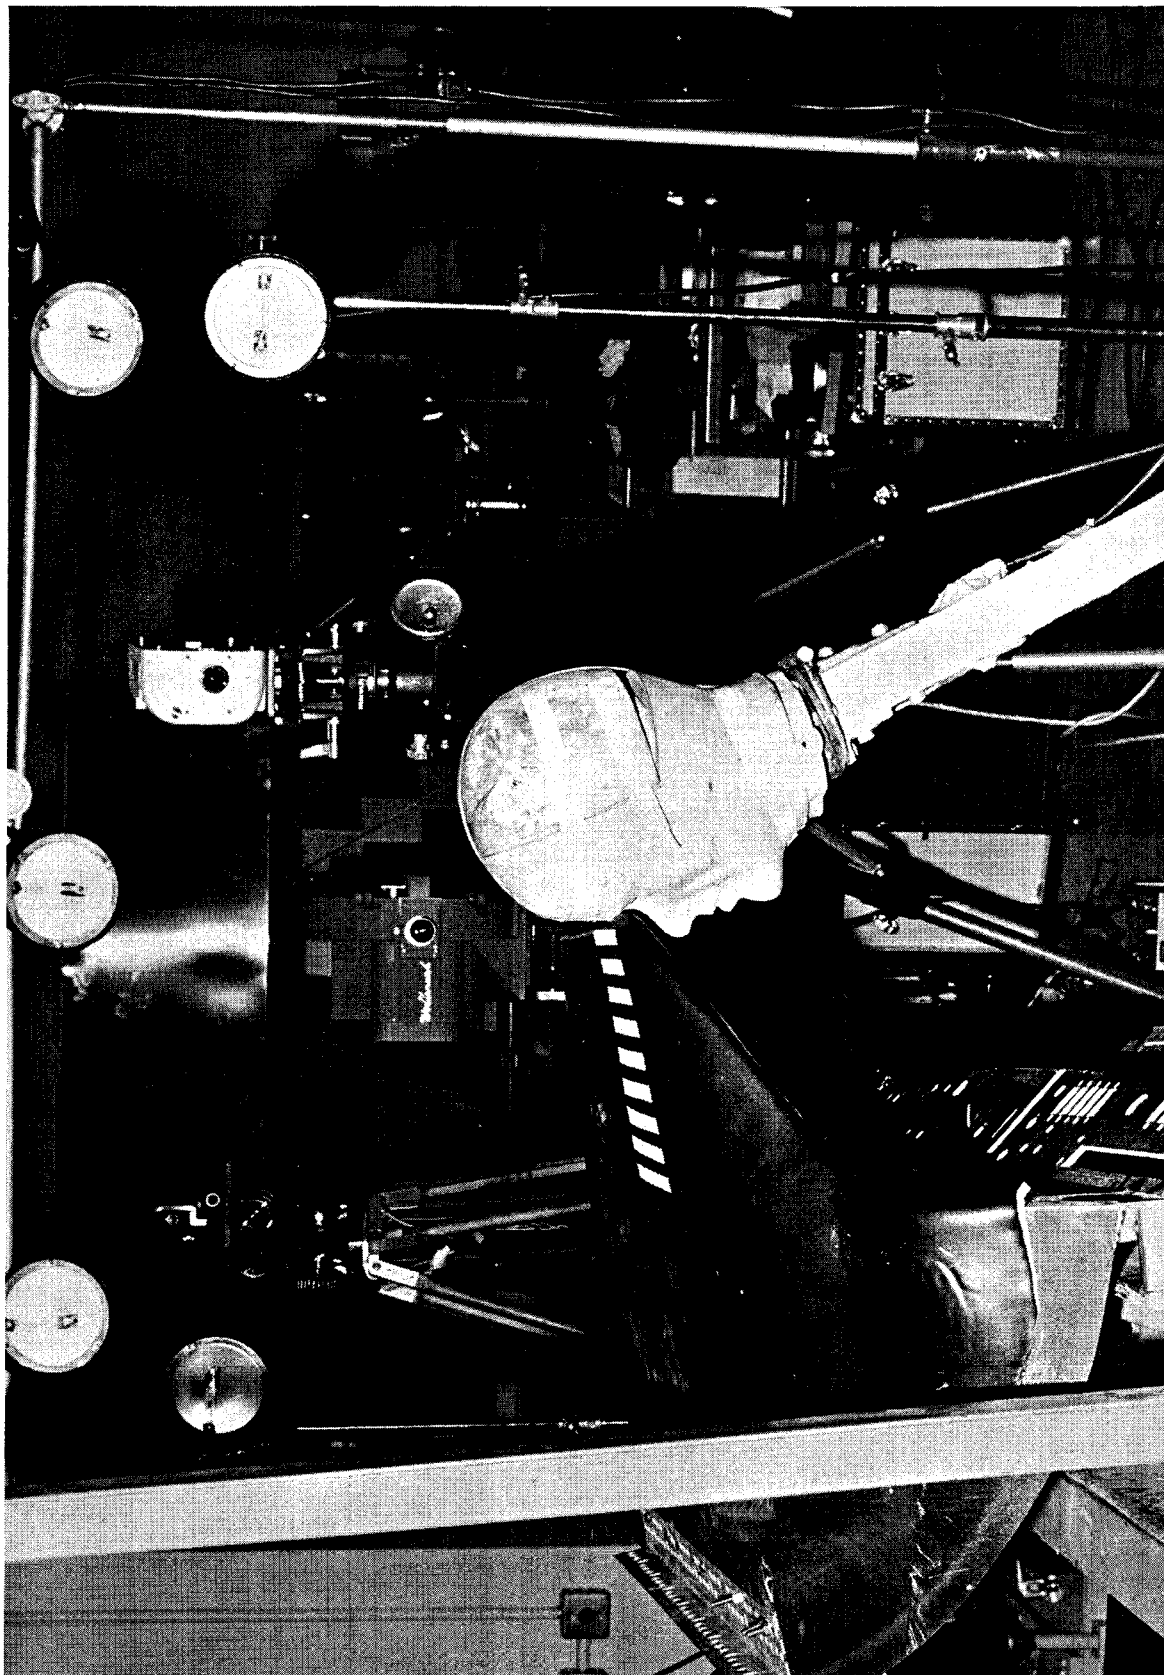
FIGURE 2. Strips of adhesive tape were added to show depth of head penetration.
