1. Report No. FAA-AM-73-1		2. Government Accession No.		3. Recipient's Catalog No.	
4. Title and Subtitle APPLICATION OF COMMERCIAL AIRCRAFT ACCIDENT INVESTIGATION TECHNIQUES TO A RAILROAD DERAILMENT.			5. Report Date January 1973		6. Performing Organization Code

APPLICATION OF COMMERCIAL AIRCRAFT ACCIDENT INVESTIGATION TECHNIQUES TO A RAILROAD DERAILMENT

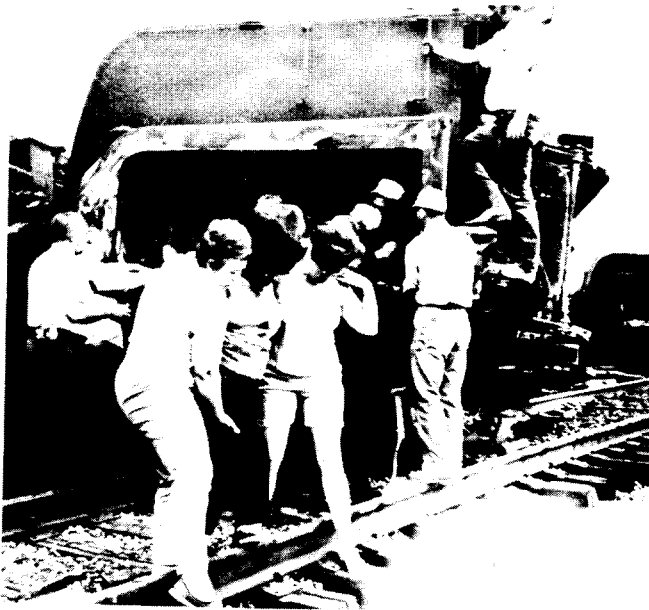
a. Injured passengers being helped out the end of the car and down to the ground after having climbed over partitions and through the 2-foot high tunnels over or under the rest rooms as shown in Figure 25.

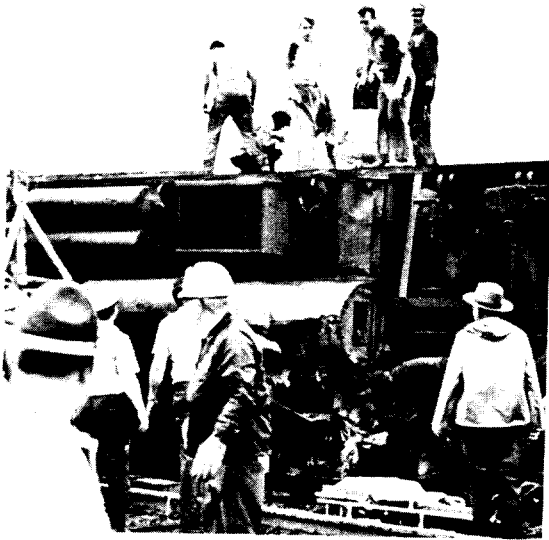
b. Some were rescued by being lifted up through windows by means of ropes.

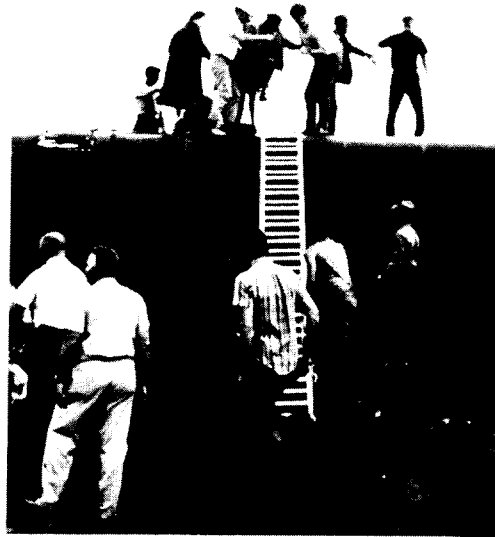
c. Other rescue workers brought ladders to assist passengers to the ground after they climbed up the seats and out the windows.

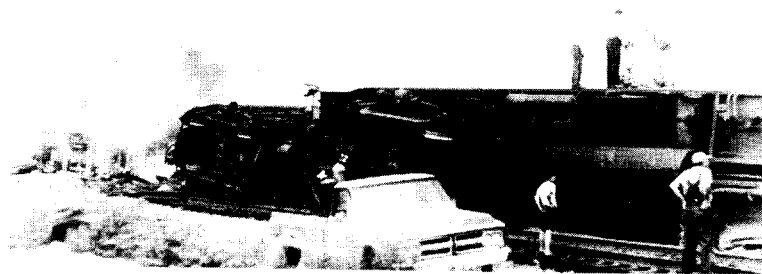
FIGURE 22. Photographs of passenger escape taken soon after the crash.

E. Escape. There are no emergency escape hatches or doors leading directly to the outside of a passenger car. As long as the car remains upright on its wheels, able-bodied passengers can wind their way through the narrow doors and passageway (slightly over 2 feet wide) around the restroom at either end of the car and go out the end of the car. It was impossible for rescue workers to move a seriously injured passenger on a 6-foot stretcher through the narrow, crooked passageway. Those that had broken arms or legs, or fractures of the vertebrae, could not escape on their own and had to wait to be lifted up through windows or carried up and down ladders. While five passengers were ejected through windows and fatally injured, at least three others were ejected through windows and survived with minor to serious injuries, and one was thrown from the end of the car (she was going from one car to another at the time of the derailment) into a field and survived with severe injuries. Figure 22 shows rescue workers helping passengers to escape from the overturned passenger cars.

d. View of rescue workers lowering a ladder through a window they have knocked out to rescue passengers.
