**CONSTRUCTION MONITORING AND PROCEDURES FOR I-275  
“WARRANTY PROJECT”  
KENTON/BOONE COUNTIES**

**KTC-01-29/FR107-01-1I**

December 2001

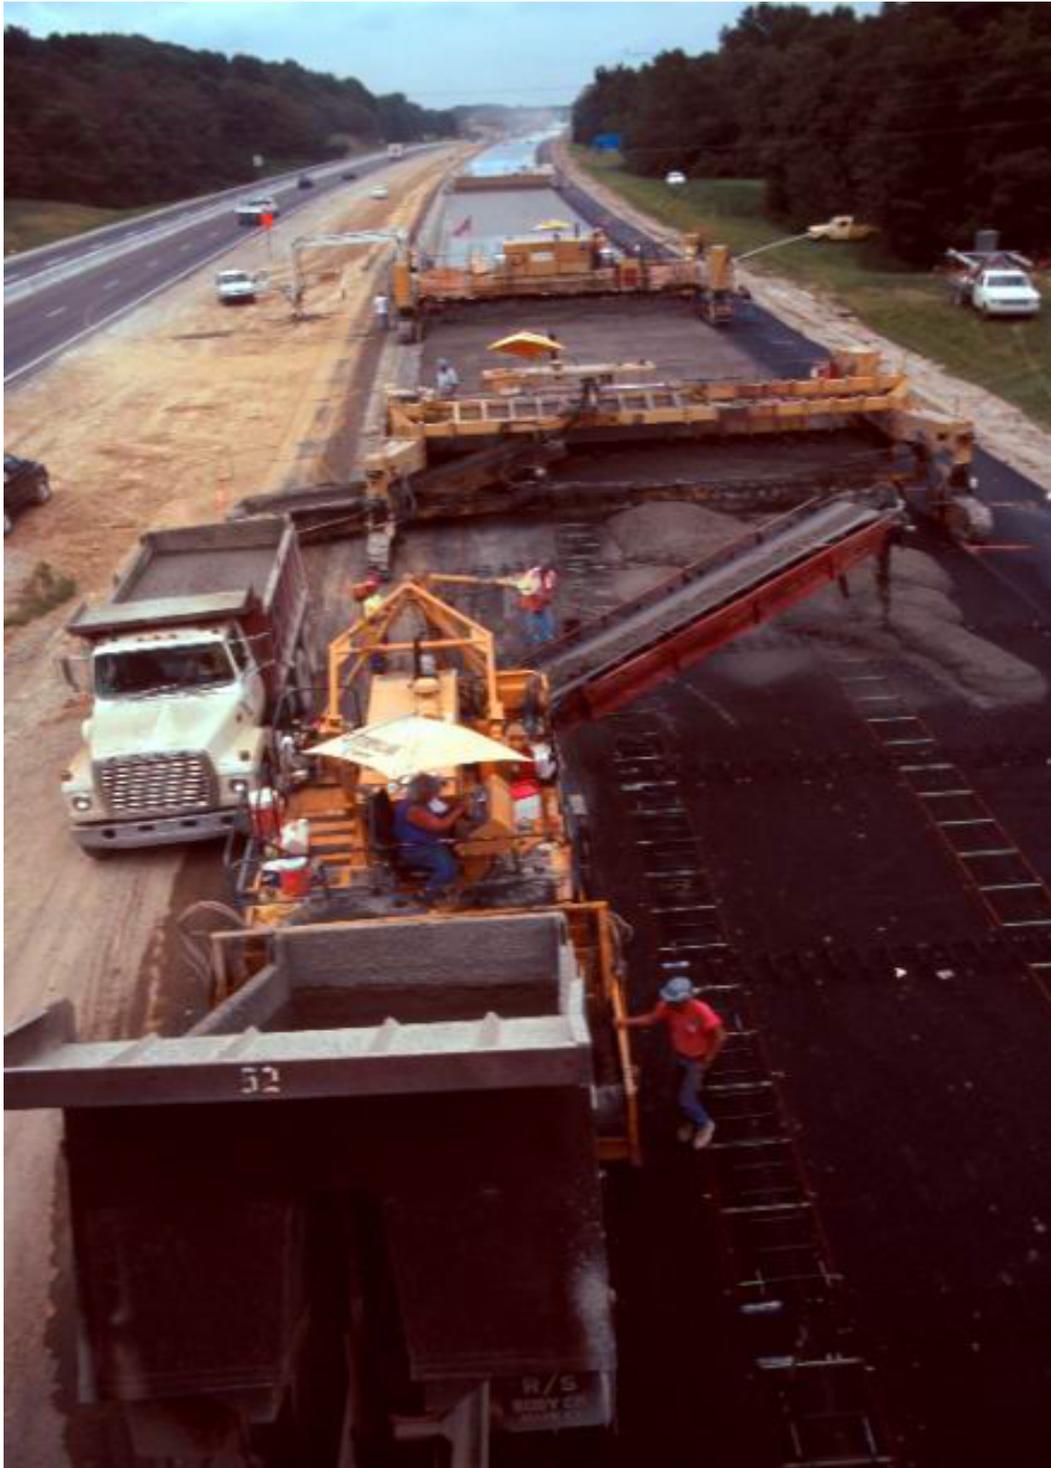
Figure 12. Paving Train (Courtesy Tom Hale Construction Digest).

Paving on this project marks the first time a contractor attempted to pave 36 feet of roadway in one pass. To achieve this feat, the Harper Company had to retrofit a 24 foot paver. Figure 12 shows the paving train starting with a conveyer dumping concrete across all three lanes. Following behind the conveyer is a CMI spreader, spreading 24-36 feet of concrete, depending upon the number of lanes to be paved. An auger on the front of this spreader moves the concrete evenly across lane. A CMI Model 550 follows, lightly finishing the concrete in preparation for the crew to bull float. At the end of the paving train is the CMI 250, tining machine placing tine marks on the pavement.

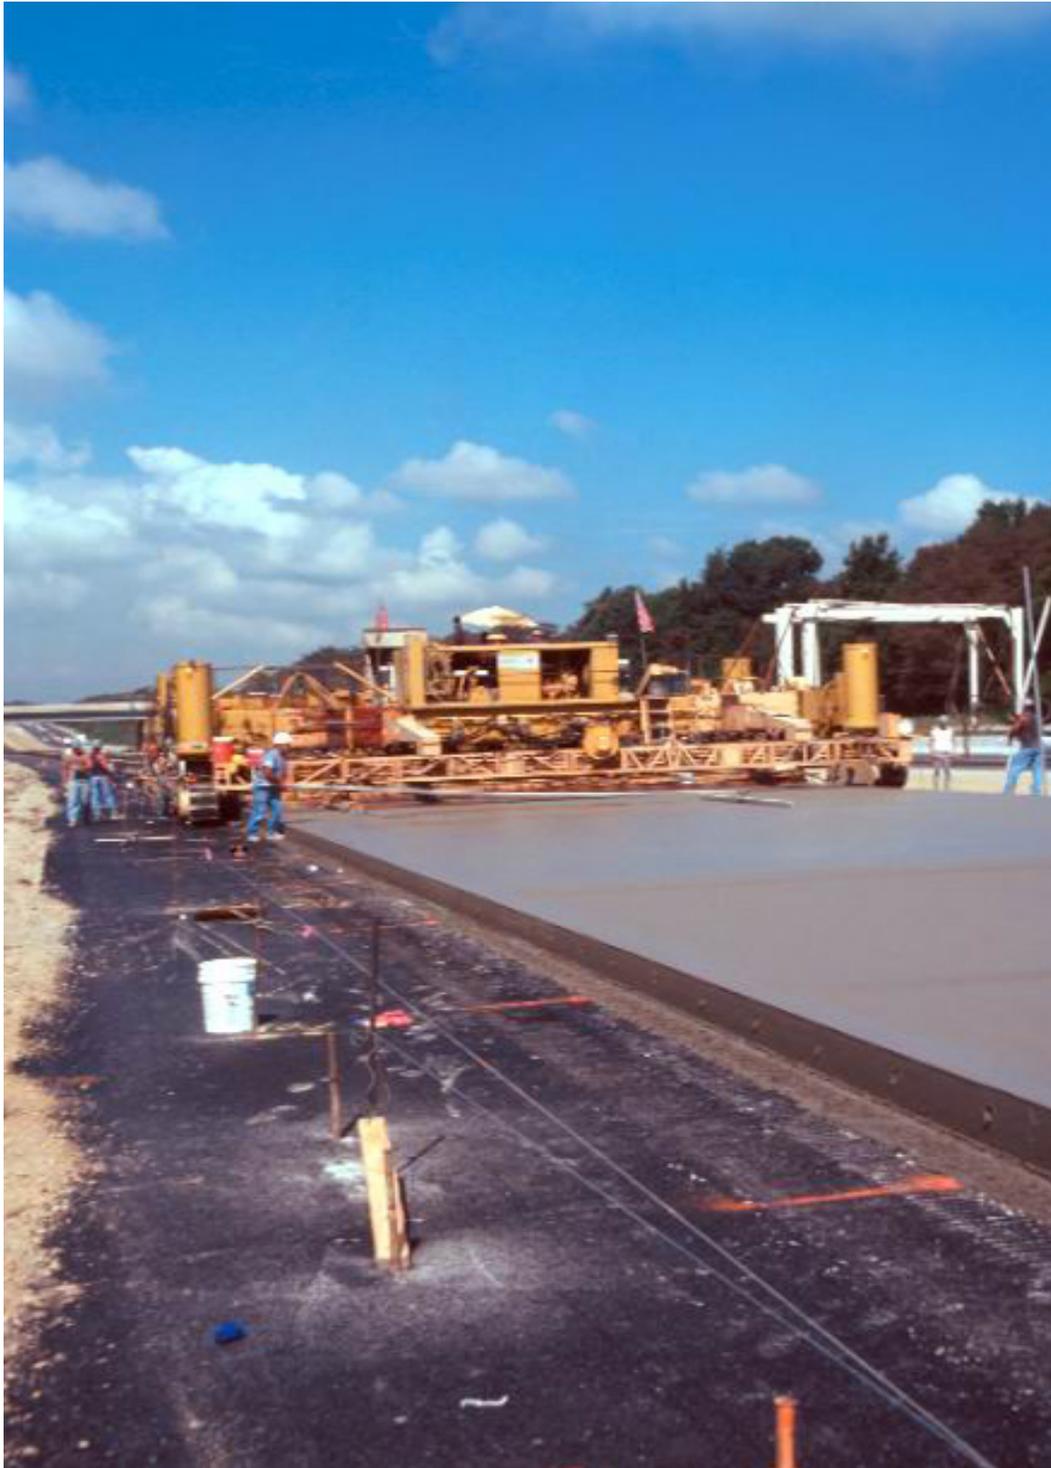
Figure 13. Paving Train with View of Gantry (Courtesy Tom Hale Construction Digest).

The Paveset Company provided a road profiler to attain a longitudinal profile of the project before any paving was to start. The profile data was programmed into the pavers to assist the pavers in achieving the proper amount of bond breaker to be placed (one inch nominal). Once the bond breaker is placed, a grade wire was aligned along both sides of the mainline allowing the pavers to follow this wire to maintain proper PCC thickness. In an effort to provide access to the concrete supply trucks, a gantry was attached to the pavers allowing trucks passage without disturbing the wire grade line. See Figure 13.
