**CORROSION EVALUATION OF MECHANICALLY  
STABILIZED EARTH WALLS**

**Research Report KTC-05-28/SPR – 239-02-1F**

**Kentucky Transportation Center  
College of Engineering  
University of Kentucky**

September 2005

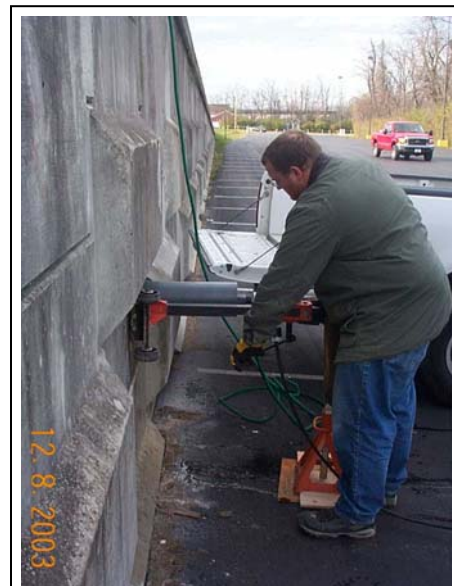
**Figure 5. Coring an Access Hole.**

Procedures established for the Federal Highway Administration (Elias, 1990, 1997, 2000), (Berkovitz and Healy, 1997) for wiring, installation of coupons, and corrosion monitoring for MSE walls were generally followed. At the panel selected for monitoring a six-inch diameter core was drilled, as illustrated in Figure 5, through the concrete panel adjacent to a galvanized steel-reinforcing strip attached to the panel. The hole was drilled by mounting a portable, electric powered, pavement-coring machine to the face of the MSE wall. When possible, a second six-inch hole was drilled next to another reinforcing element, at the same elevation. A third six-inch diameter hole was drilled adjacent to a reinforcing strap attached to the panel. Panels typically have four or more reinforcing strips attached. After removing the core, backfill material was removed and stored in sealed plastic containers for future testing. Any

material contaminated from the core drilling process was discarded. An additional boring (2.5-inch diameter) was drilled through the panel to allow access for a copper-copper-sulfate half cell (an electrode with a copper element inside a copper sulfate solution) to contact with the backfill during corrosion testing.

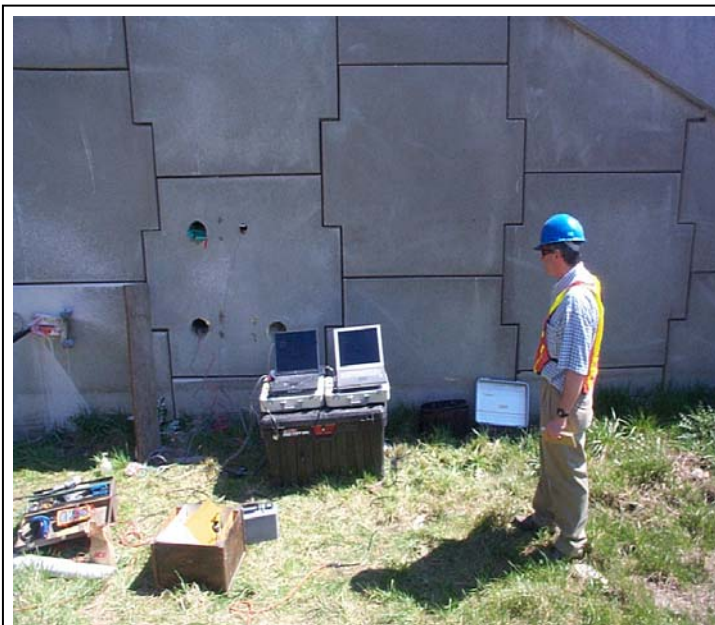
**Figure 6. Corrosion Monitoring of a MSE Wall.**

The backfill at one of the six-inch diameter holes was excavated until the adjacent galvanized metal reinforcing strip was exposed. A ten-gage wire with red coating was attached to the

reinforcing element. This element is classified as the “working electrode.” The process is repeated for another location where an additional wire is attached to another reinforcing element for use as a “counter electrode.” A galvanized steel coated coupon and a carbon steel coupon obtained from the Reinforced Earth Company with white and black wires, respectively, attached were placed in the backfill at two of the holes. These two coupons are the type currently manufactured by the Reinforced Earth Company. A zinc coupon, with a green wire attached, was placed in the back fill through the third six-inch core hole. A typical view of the corrosion monitoring of a MSE wall is shown in Figure 6.

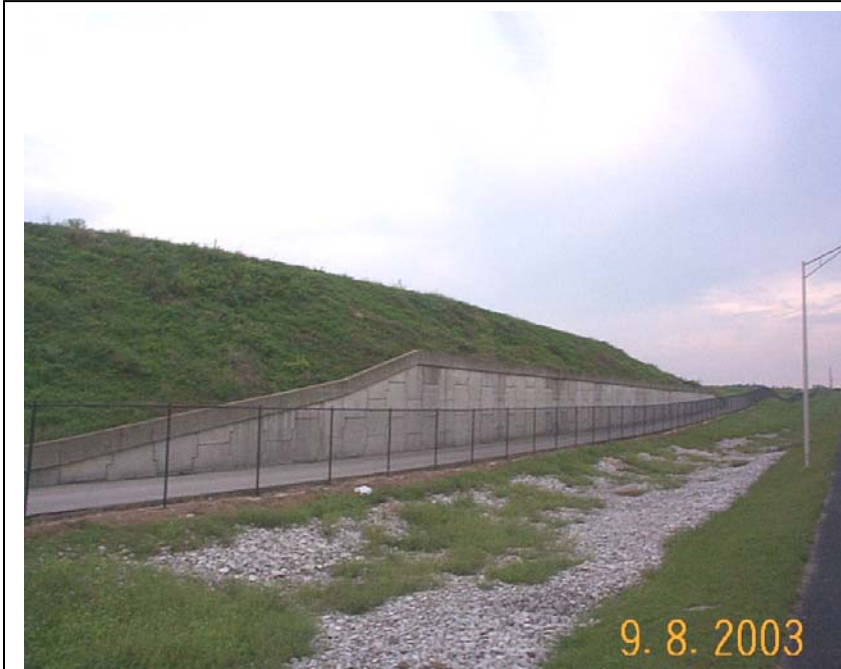
**Figure 13. MSE Wall at Bluegrass Airport; Lexington, Kentucky**

A MSE wall, manufactured by the Reinforced Earth Company, was constructed at Bluegrass Airport in Lexington, Kentucky in the early 1980's. The wall was located at the end of a runway and adjacent to a highway, US route 60. The wall was demolished in March 2004 to allow for construction of a runway safety zone. The wall was in service for more than 20 years. Photographs of the wall before and during demolition are shown in Figures 13 and 14, respectively. Photographs of two sections of a reinforcing strip are shown in Figure 15. The

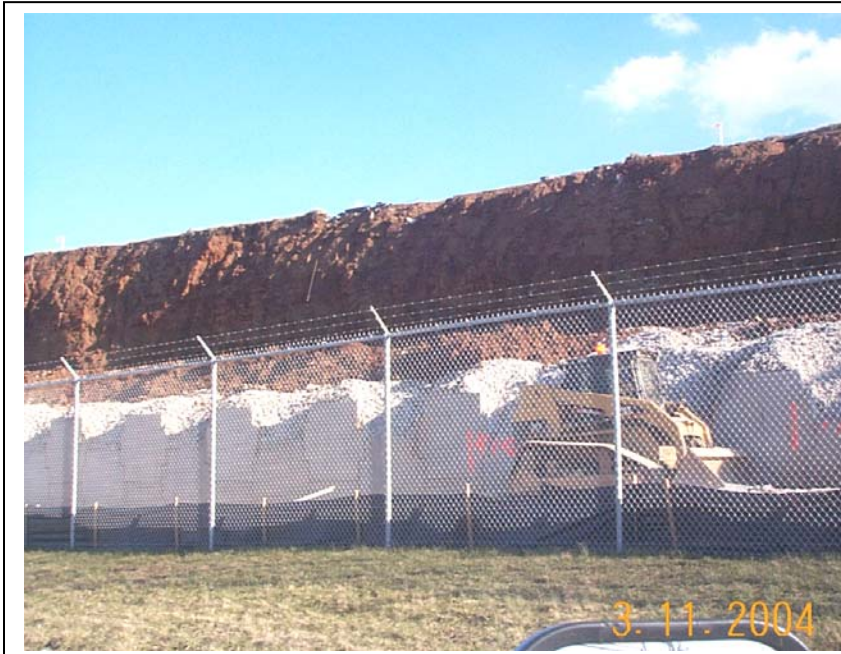
**Figure 14. Demolition of an MSE Wall at Bluegrass Airport; Lexington, Kentucky.**

reinforcing straps sections were obtained adjacent to the wall panel and at the free end where the limestone backfill and compacted clay meet. No visible corrosion was observed. The brown color seen in the photographs is soil. Crushed limestone was used for the back fill of the MSE wall is shown in Figure 15. Compacted clay was used to construct the embankment behind the backfilled area.
