NONDESTRUCTIVE TESTING OF A WELD REPAIR ON THE I-65 BRIDGE OVER THE OHIO RIVER AT LOUISVILLE

KTC-09-17A/SPR 364-07-1F

June 2009

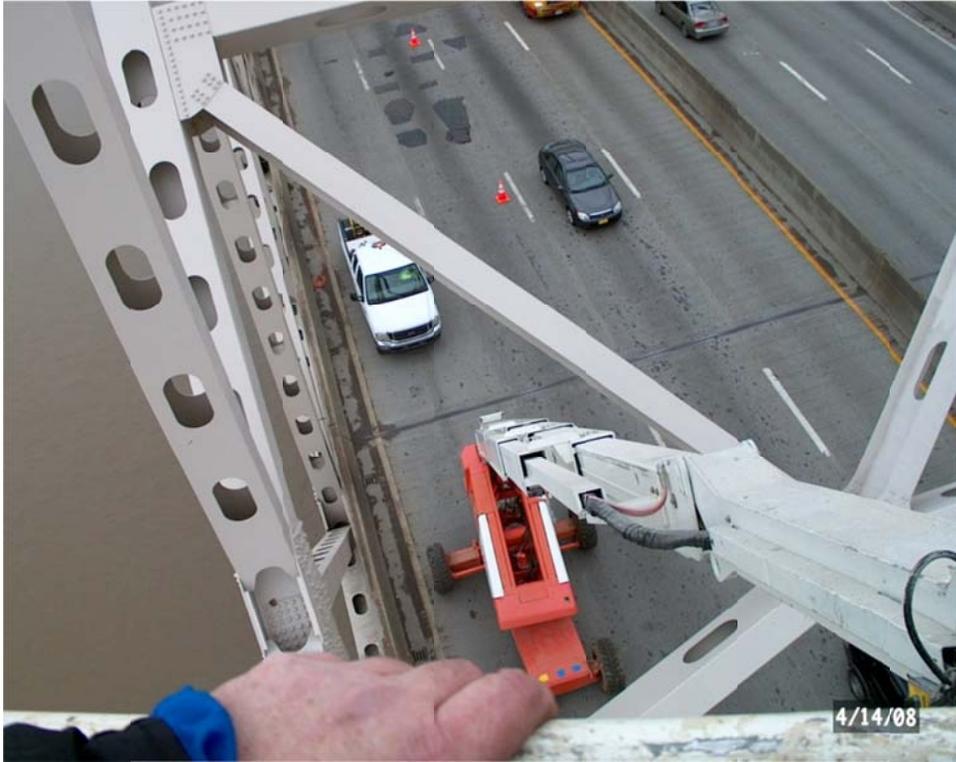
Figure 5. Intervening Bridge Members that Impacted Sizing and Siting of Manlift to Access Panel Point 28.

Mobilization began after receiving quotes from the various test parties and arranging with KYTC District 5 for traffic control. The work was to be performed on the northbound lanes of the bridge to access the East truss. Panel 28 was located near the second tower on the bridge at pier 3. Due to some intervening cross members on the upper chord, a direct extension of a man-lift boom could not be effected and the man-lift had to be repositioned several times to allow the work basket to access the upper chord (Figure 5). This required a manlift with a 125 ft. reach and the wheels of the man lift had to be extended as well to provide proper support. That required closure of two lanes of traffic and the extended track of the manlift partially extended into the second lane.

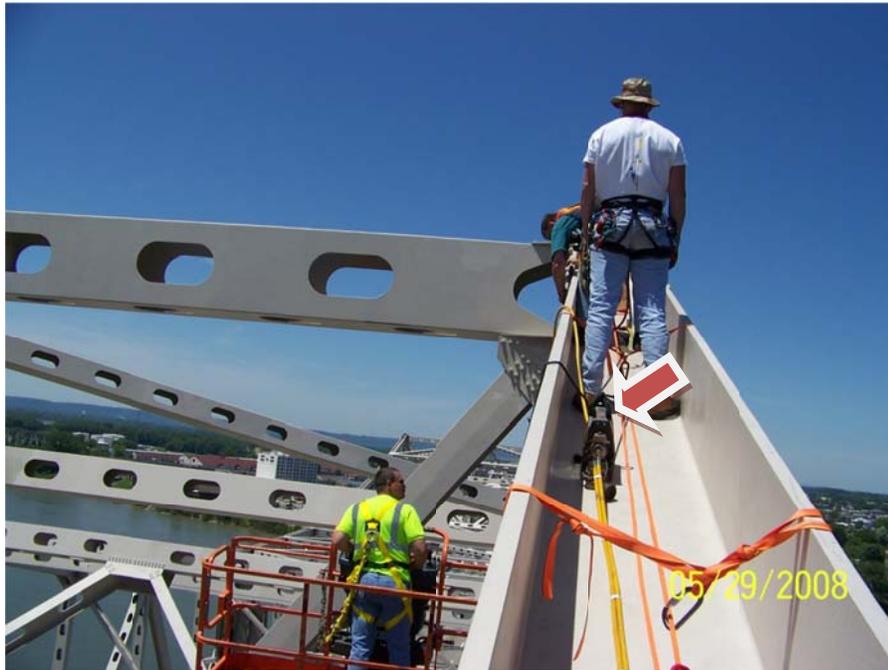
Figure 11. RT Camera (Arrow) Mounted on H beam. Note Yellow Guide Tube Running from Camera to Location Under the Beam.

RT provides detection capabilities somewhat similar to UT. RT was also performed at Panel Point 28. Huntington Testing personnel used a gamma ray source of iridium 192 housed in a lunch-box sized container called a “camera” (Figure 11). A yellow guide tube was extended from the camera to a collimator that guides gamma rays along a path into a face of the test piece (Figure 12). A film pack was placed on the opposite face to the test piece and exposed by the gamma radiation that passed through it (Figure 13). The camera contained a flexible cable run by a hand crank. This allowed the operator to operate the camera at a safe distance from the gamma ray. The operator turned the crank which extended another flexible cable mounted inside the camera. At the end of that cable was a small pellet of iridium 192. The cable/gamma ray source traveled along the guide tube stopping at the collimator. The operator timed the exposure ending the shot by cranking the cable/gamma ray source back into the camera. He then removed the film pack from the test piece and developed it. Afterward, he inspected the developed film on a light table looking for overdeveloped/dark lines/shapes that would indicate flaws. The resulting radiographs revealed the 5-1/16 inch crack, but no other significant flaws in either the web or the inboard flange.

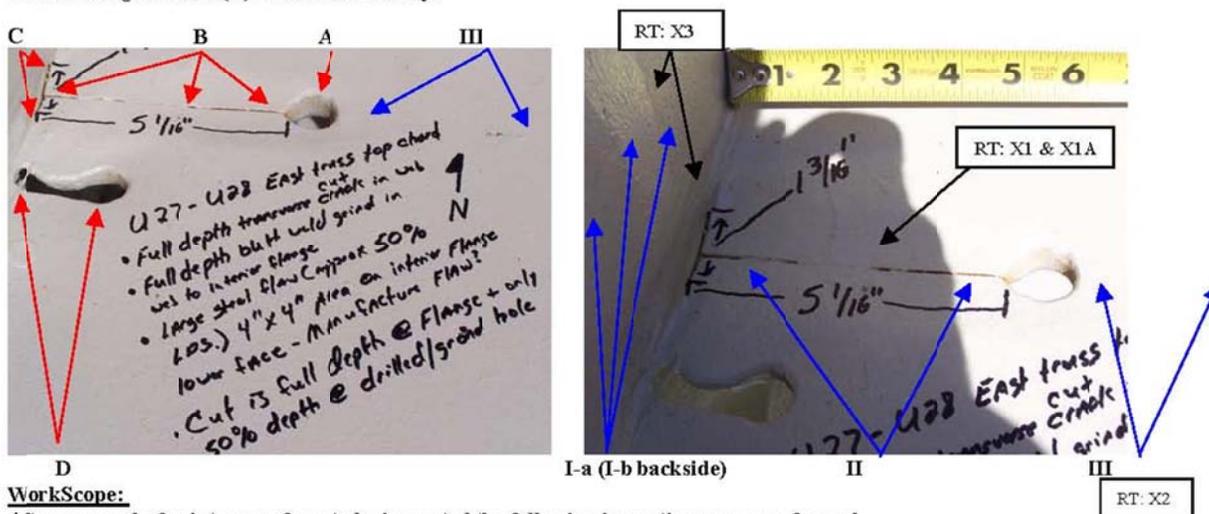
The following is a summary of the U27-U28 Truss Area containing "original construction" defects which were explored for size and growth and particularly for any subsurface cracking in the area resulting from the presence of the defects. Defects visibly present (see below) are a drilled hole (A) with an apparent transverse crack (B) running to the inner flange with a longitudinal saw cut (C) at the inner web-flange corner perpendicular to the transverse crack and an elongated hole (D) in the near vicinity.

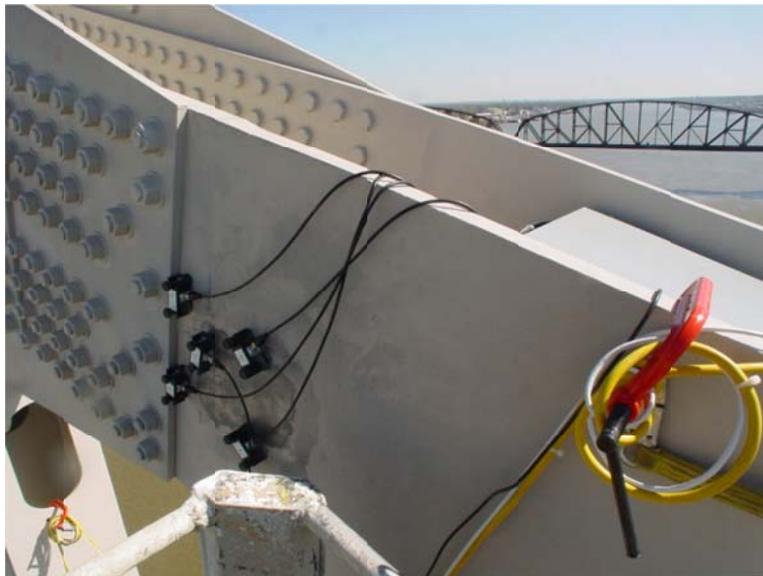
Figure 2: AE Sensors on Vertical Flange

Two separate test configurations were necessary due to the geometry of the location and its proximity to a large bolted connection. The first test configuration monitored only the vertical flange on the west side of the chord adjacent to the crack. Sensor one was placed on the web as a guard channel so that acoustic events originating in the web could be filtered out. Sensor two was placed on the flange immediately opposite the crack, and the remaining four sensors were placed on the flange in a rectangular array around sensor two, as shown in **Figure 2** below.

Conclusions: The AE data collected in April of 2008 shows no significant acoustic sources on the vertical flange in the area of interest on the east truss top chord near U27-U28. The horizontal web in that area does show a significant number of acoustic events along the transverse crack, but they are of low amplitude and are most likely the result of fretting between the existing crack faces. It is not possible to determine if the crack is actively growing based solely on this AE test, but AE location analysis suggests that it has not jumped the stop hole. Only one location generated AE activity which passed the clustering filter. This detail was later confirmed by radiography to be a slag inclusion in the horizontal web.

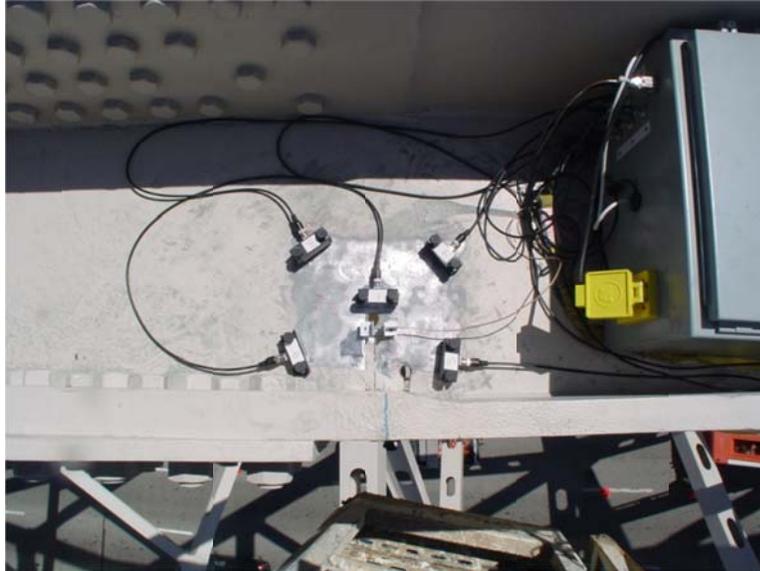
Figure 3: AE Sensors on Horizontal Web

The second test configuration monitored only the web of the chord near the crack. Channel two was placed on the outside of the west flange opposite the crack and served as the guard channel so that acoustic events originating in the flange could be filtered out. Channel one

was placed on the web near the stop hole opposite the crack with the remaining channels placed in a rectangular array around it as shown in **Figure 3** below.

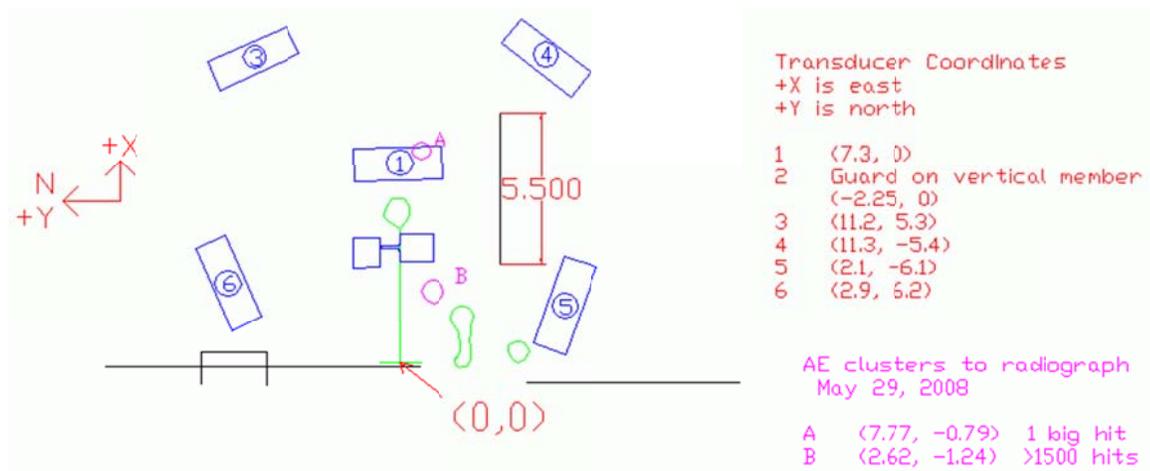
Figure 6: Horizontal Web Layout

The plot in **Figure 5** shows AE events plotted vs. source location in inches. The events have been subjected to both an energy and amplitude threshold to minimize background noise. The plot shows the locations of groups of filtered events that satisfy the clustering criteria (3 events within 1 inch of each other occurring within a one second interval). A group of clusters centered at (2.62", -1.24") can be observed in the green circle. This observation was confirmed by subsequent radiography to be a slag inclusion introduced during original fabrication. **Figure 6** defines the coordinate system used and gives the precise location of the cluster group due to AE from the slag inclusion.
