### **NONDESTRUCTIVE TESTING OF DEFECTIVE ASTM A 514 STEEL ON THE I-275 COMBS HEHL TWIN BRIDGES OVER THE OHIO RIVER IN CAMPBELL COUNTY, KENTUCKY**

**KTC-10-11/KH60-07-1F**

Nondestructive Testing of Defective ASTM A 514 Steel  
On the I-275 Combs-Hehl Twin Bridges over the Ohio River  
In Campbell County, Kentucky

July 2010

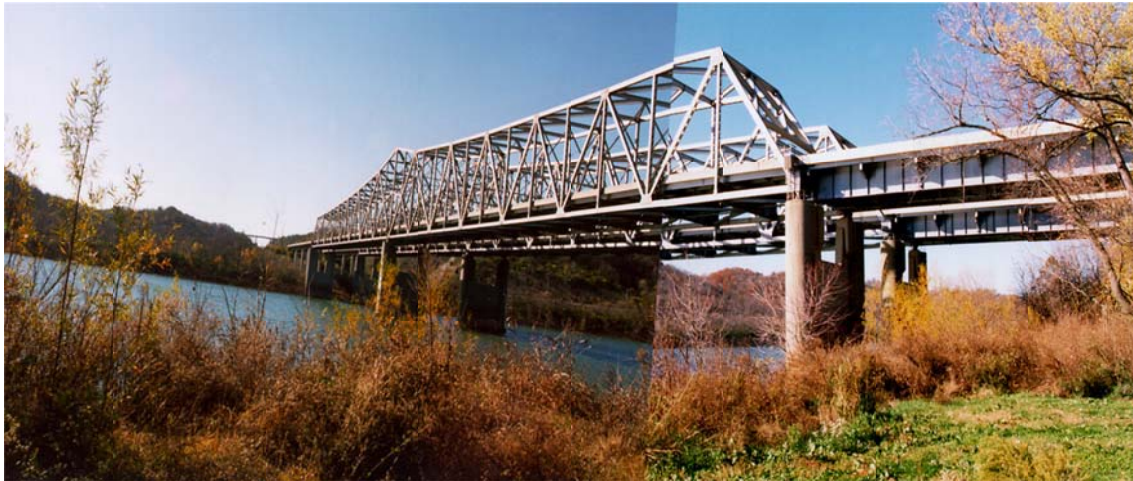
Figure 1. I-275 Combs-Hehl Twin Bridges over the Ohio River (Courtesy J. Mecklenborg).

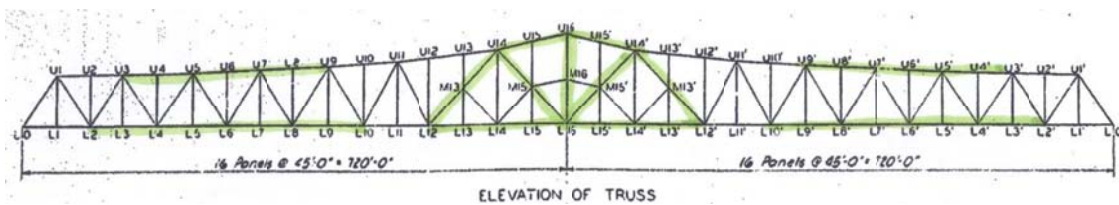
Figure 2. I-275 Combs-Hehl Bridge Truss Showing Highlighted Locations of ASTM A 514 Steel.

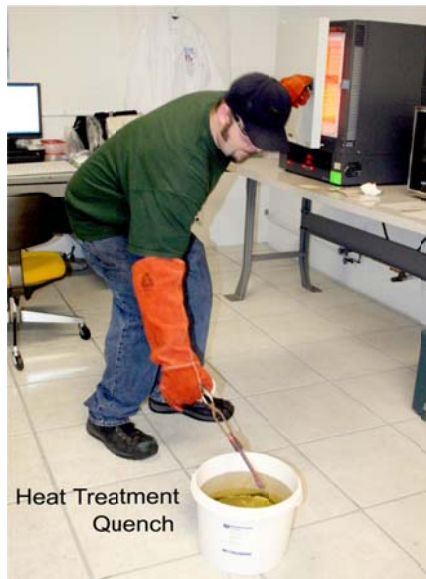
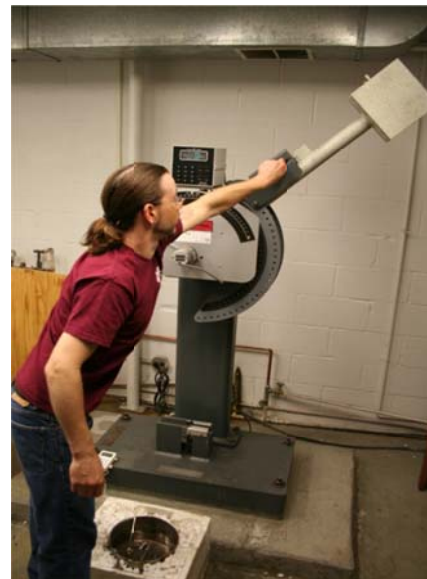
Figure 9 A. Quenching A 514 Pieces after Re-Heating (and Prior to Re-Tempering) and B. Charpy Impact Testing Re-Tempered Pieces to Investigate the Relationship between Indentation Hardness and Impact Toughness.

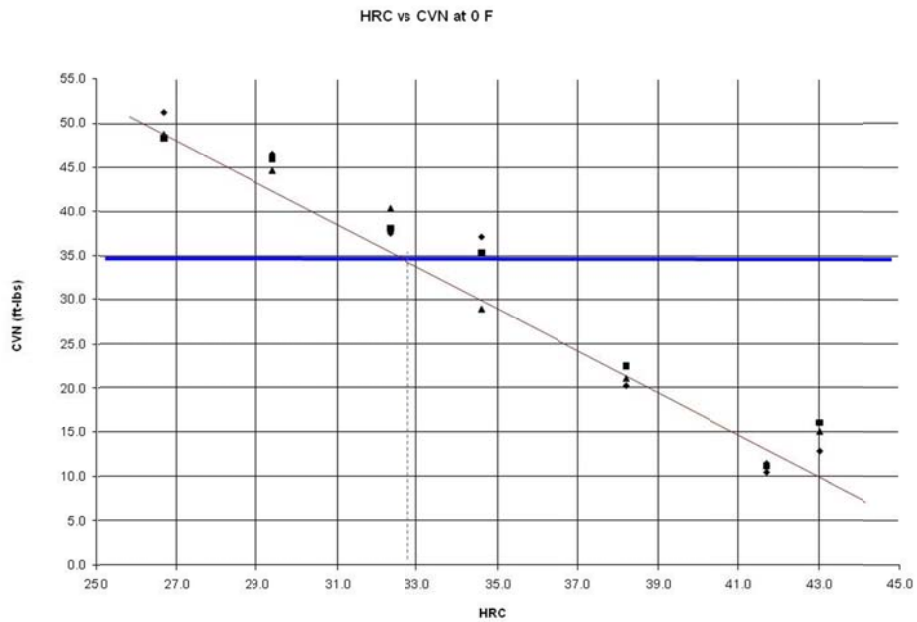
Figure 10. Charpy V-Notch Impact Test Values vs. Rockwell C Hardness for A 514 Steel with Different Tempering Treatments

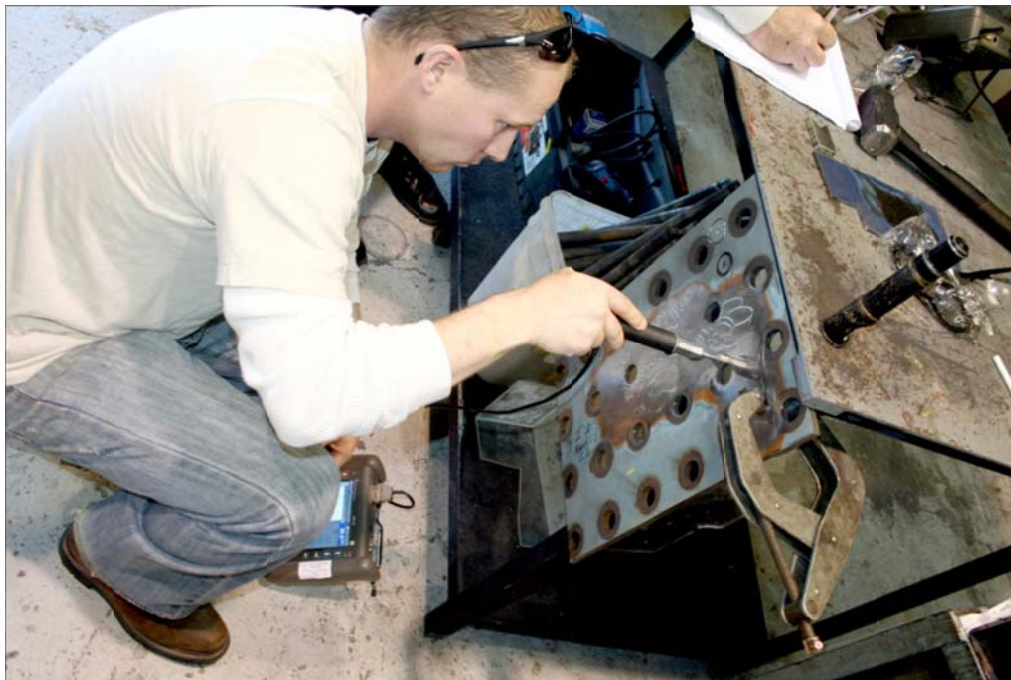
Figure 11. Performing Ultrasonic Hardness Testing on Defective A 514 Steel in Vertical Test Orientation by Pressing Probe into the Steel.

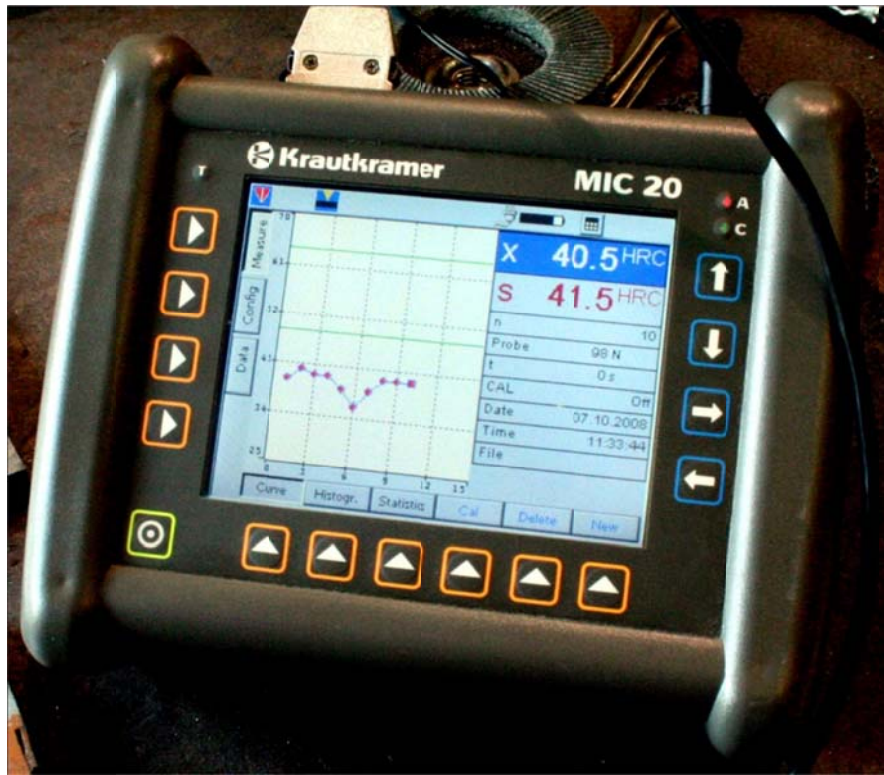
Figure 12. Screen Read-Out of GE/Krautkramer MIC 20 for Tests on Defective Steel. Individual Test Values are indicated by Red Numbers (e.g. 41.5 HRC) in Upper Right Corner of Screen. The Running Average of a Series of Tests is indicated by White Numbers above (e.g. 40.5 HRC).

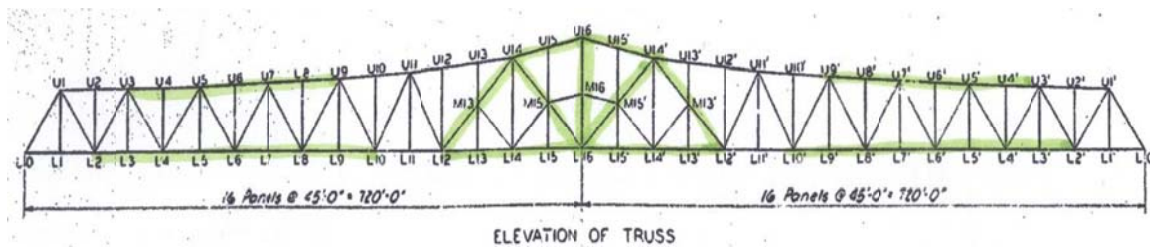
Figure 13. I-275 Combs-Hehl Bridge Truss Showing Highlighted (Green) Locations of A 514 Steel.

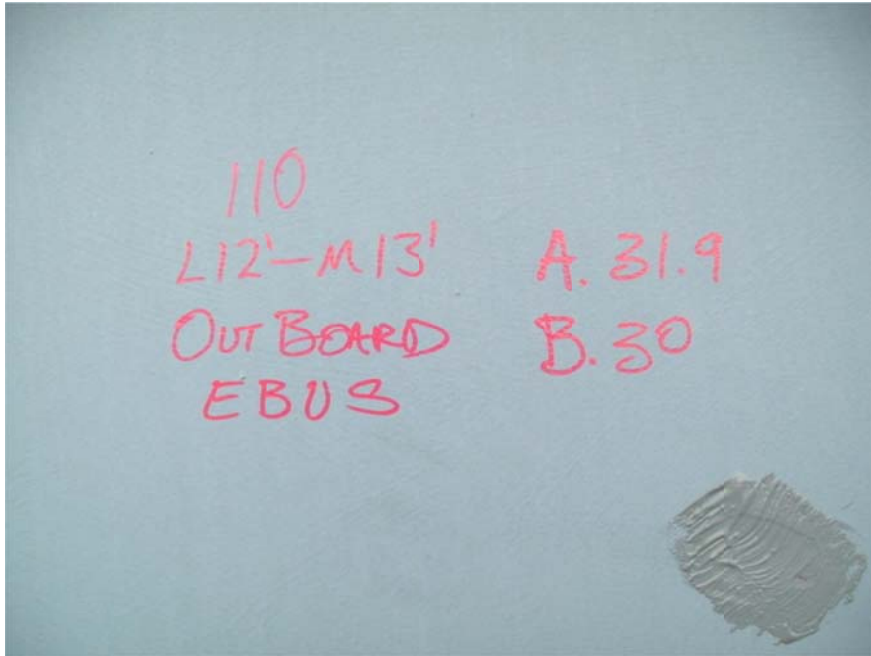
Figure 16. Photograph of Field Hardness Test Location/Result on I-275 Bridge. Note That a Test Location has been repainted.

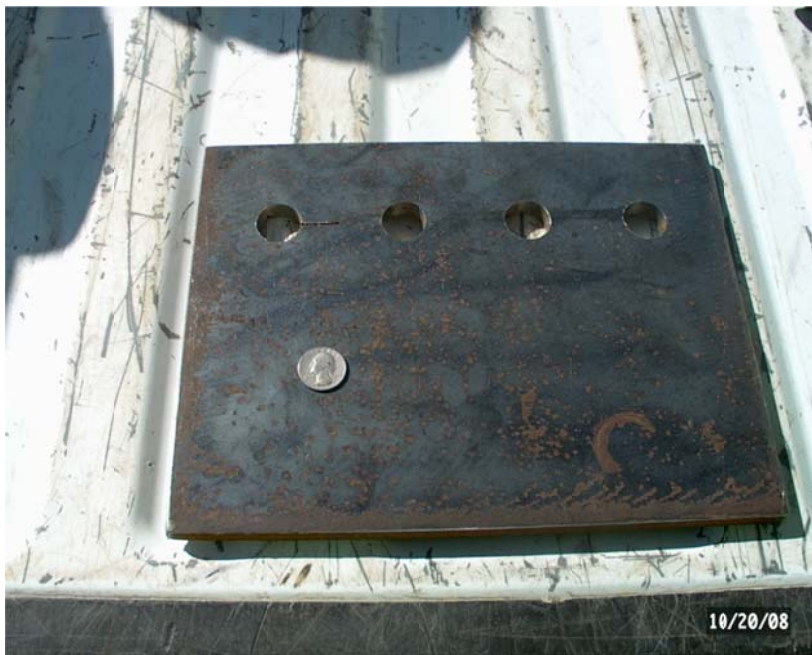
On October 19, Intech shifted the lane closure on the eastbound bridge from the downstream truss to the upstream truss. The HTT NDE supervisor prepared a special defect calibration block to use with the ultrasonic shear wave testing (Figure 21). On

Figure 21. Special Calibration Plate Used for Nondestructive Evaluation of 1/2" Splice Plates at Tower (U16) Locations on the Two I-275 Bridges.

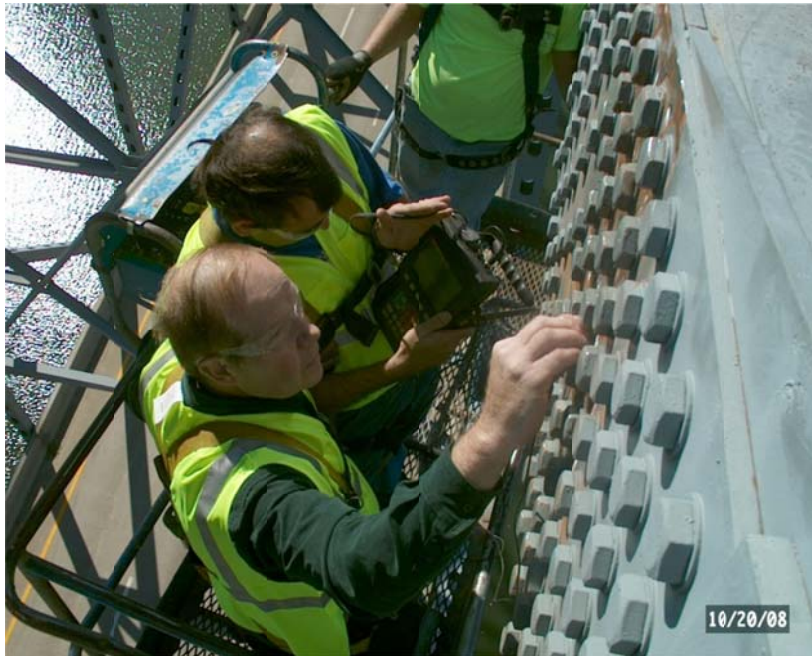
October 20 he performed that test along with the *Telebrineller* hardness tests on the four external splice plates at U16 on the downstream truss of the westbound bridge (Figure 22). That evening, Intech shifted the lane closure on the westbound bridge from the downstream truss to the upstream truss. On October 21 an HTT NDE technician performed the ultrasonic shear wave and *Telebrineller* tests on the U16 external splice plates on the westbound and eastbound upstream trusses. The ultrasonic shear wave testing did not find any additional cracks in the external splice plates. Hardness testing revealed two out-of-spec. external splice plates on the westbound upstream truss and one on the eastbound upstream truss.

Figure 22. HTT NDE Supervisor Performing Ultrasonic Shear Wave Inspections on a 1/2" Splice Plate on the Downstream Truss of the Westbound Bridge.

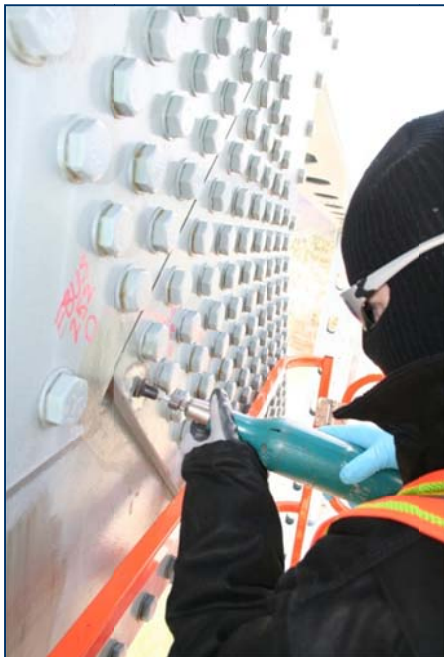
As the work had progressed on the downstream trusses, the NDE technicians occasionally encountered A 514 plates with hardness values below the minimum values specified for A 514 steel (below 235 brinell hardness number-BHN or ~21 HRC), but too high to indicate other types of steel. At first, this was considered a curiosity, but as the number of such findings rose, it became a concern (i.e., under-strength steel). IMR sent technicians to take surface replicas of the steel micro-structure on a piece exhibiting low strength (~200 BHN-Figure 23). The resulting replica indicated a mixed ferritic-fine carbide microstructure not the expected full martensitic microstructure. The decision was made to cut a coupon from the plate for laboratory evaluation (Figure 24). The cross-section of the coupon was polished, etched and subsequently examined using an optical microscope (Figure 25). Inspection revealed a thin decarburized surface ferritic-fine carbide surface layer over a martensitic core. That probably occurred during heat treatment. IMR and KTC investigators decided that the plates providing low hardness values were probably similar and that the low hardness values were due to surface effects. IMR subsequently conducted hardness tests on the interior martensite and found it to be within the specified hardness (9). The decision was made to accept all A 514 steel with similar hardness values as they probably were decarburized as well during tempering.

Figure 23. IMR Technician Polishing A 514 Steel Splice Plate that Provided Low Hardness Readings Prior to Making a Replica of the Surface Microstructure.

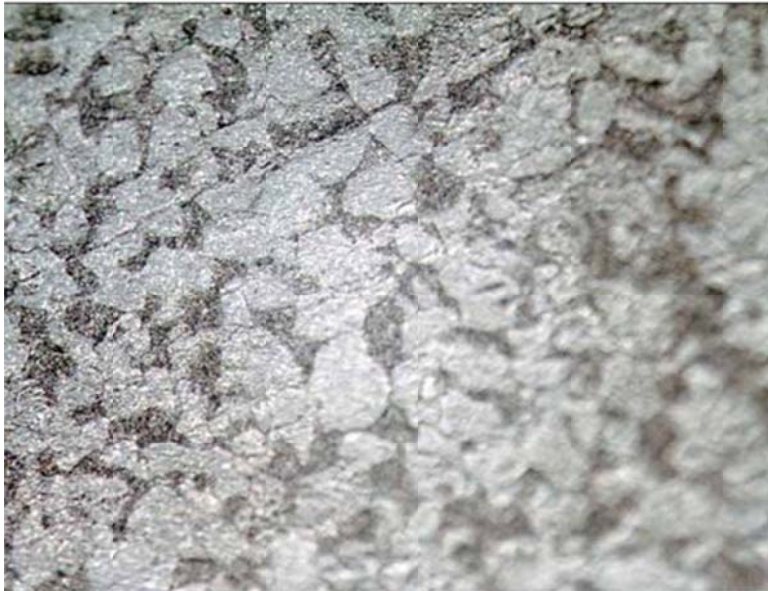
Figure 24. Replica of A 514 Steel Showing Ferritic-Fine Carbide Microstructure (~600X).

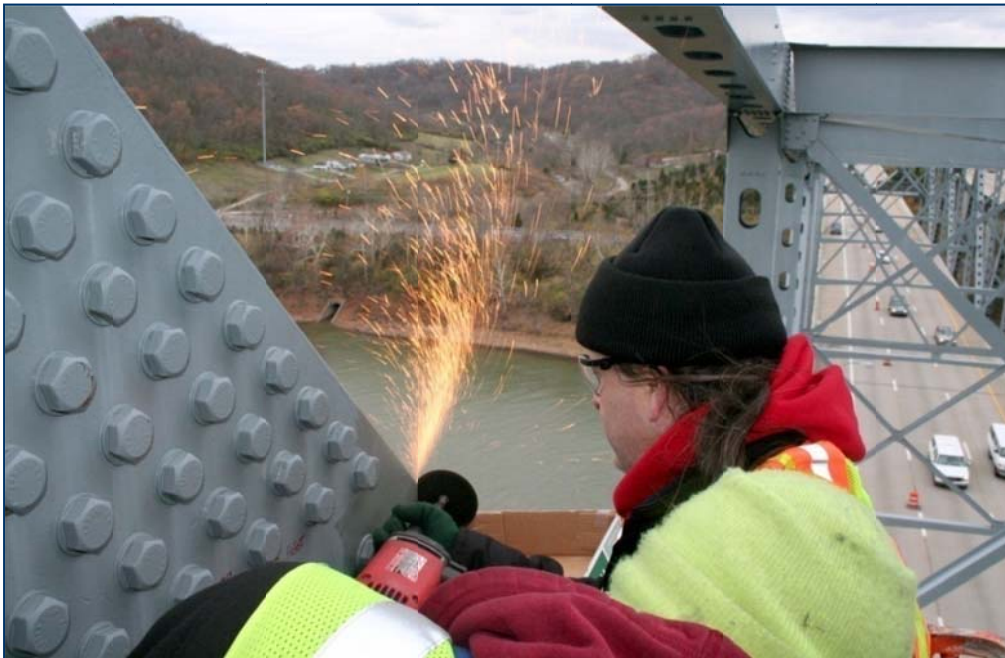
Figure 25. IMR Technician Cutting Corner Specimen from A 514 Steel Splice Plate that Provided Low Hardness Readings.
