EVALUATION OF DRAINAGE PIPE BY FIELD EXPERIMENTATION
AND SUPPLEMENTAL LABORATORY EXPERIMENTATION

Interim Report No. 3

Research Report No. 154

LOUISIANA DEPARTMENT OF TRANSPORTATION AND DEVELOPMENT
Research and Development Section
In Cooperation With
U. S. Department of Transportation
FEDERAL HIGHWAY ADMINISTRATION

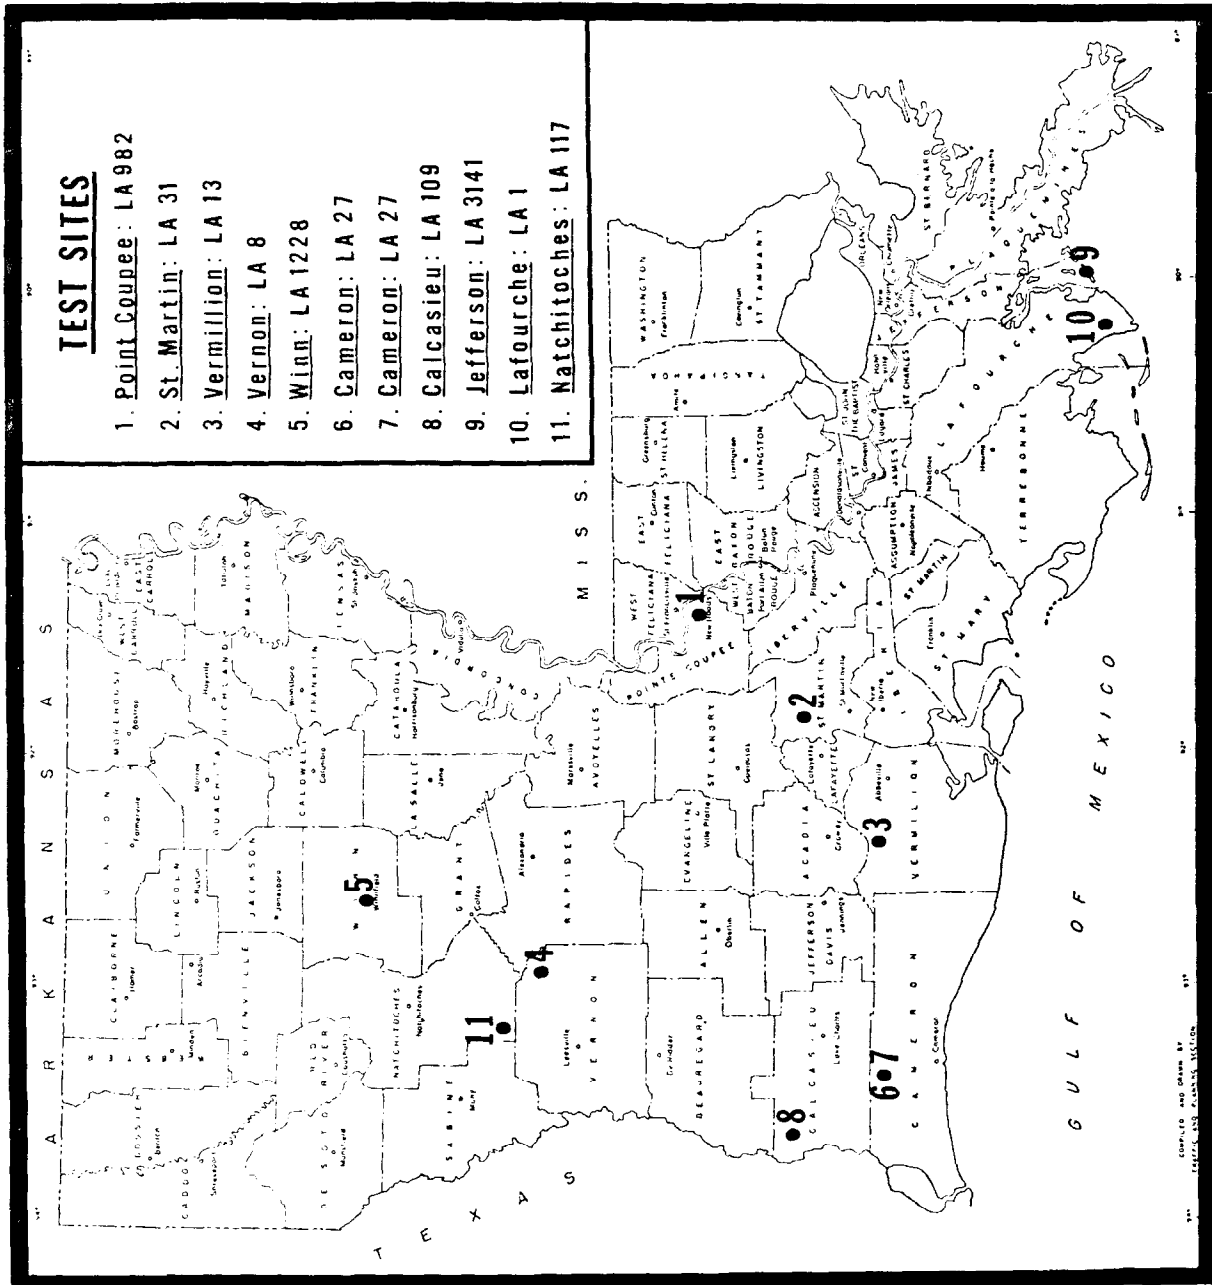
Location of Test Sites
 FIGURE 1

Table 1 on page 5 presents current characteristics of the soil and effluent at the 11 test sites. Figure 1 on page 6 presents the locations of the test sites. Site number 6 is a ditch installation located directly across the road from the canal at site number 7.
