EVALUATION OF AN ASPHALT-TREATED DRAINAGE BLANKET
IN A RIGID PAVEMENT SECTION

Final Report

Report No. FHWA-LA-78-117

Research Project No. 72-8E(B)
Louisiana HPR 0010(001)

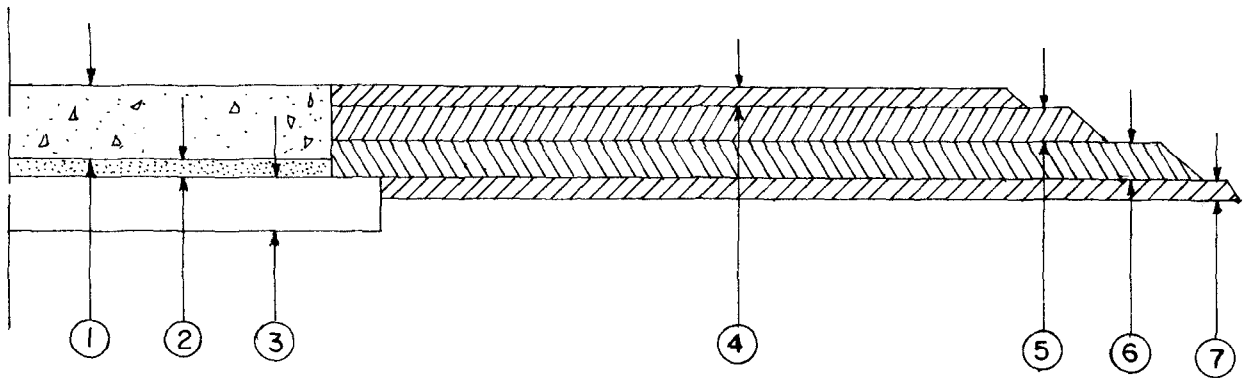
Typical Section - Site No. 1

Shortly after construction it became apparent that this design mix was unstable. Under a static load (truck located near pavement-shoulder joint), the drainage blanket was observed to displace laterally. The unstable nature of this mix was reinforced by high deflection readings, obtained with the Department's Dynaflect. Within six months after construction, a continuous surface patch had been placed along the shoulder edge adjacent to the pavement. Additional surface patches were necessitated by indentations due to truck traffic. Although the stability was not as expected, the mix was so permeable that the available equipment could not measure the flow rate. A decision was made at that time to concentrate efforts towards a new installation with a mix consisting of more fines to stabilize the blanket.

shoulder wall. Thus a condition of lateral movement of the sand cushion from under the concrete pavement to the drainage blanket was creating a dam effect, allowing the water to collect at the pavement-shoulder joint. This discovery was supported by permeability testing. It was found that the permeability of the drainage blanket near the shoulder-pavement interface had substantially decreased.

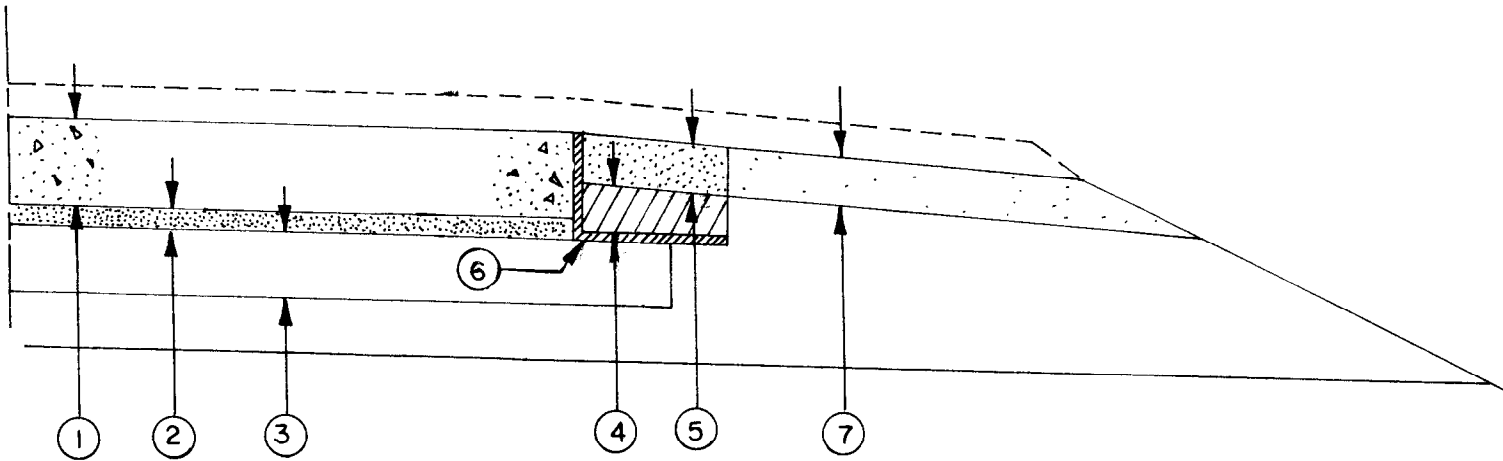
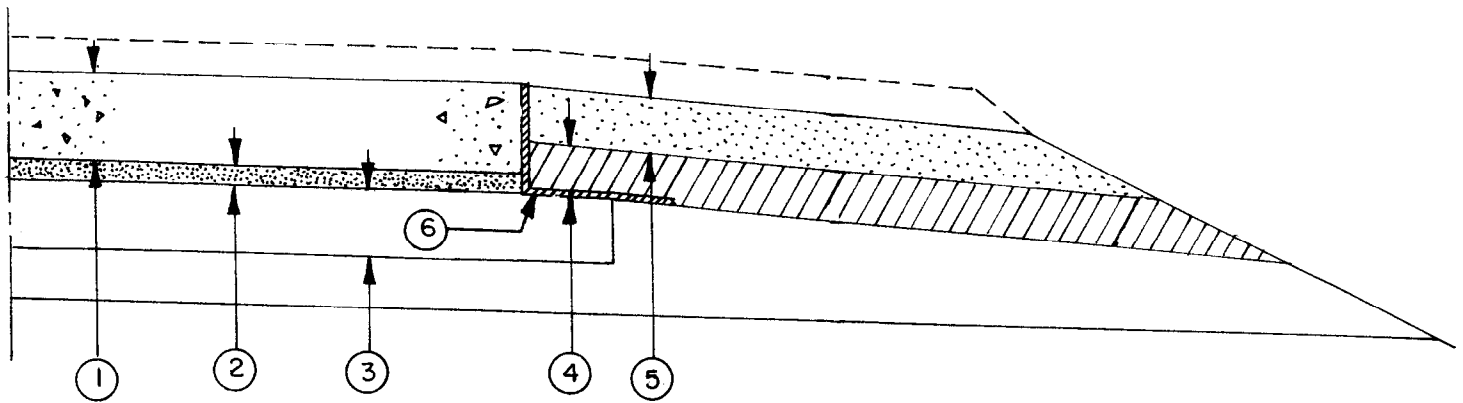
This drainage blanket took three days in construction. Material was delivered between 245° F (118.5° C) to 300° F (149° C) and was rolled between 175° F (79.5° C) to 200° F (93° C). Construction problems occurred in the section where the wearing course was placed in one 6-inch (15.2-cm) lift. The surface in this section rolled out wavy, presumably due to a nonuniform densification. Typical sections are shown in Figure 4.

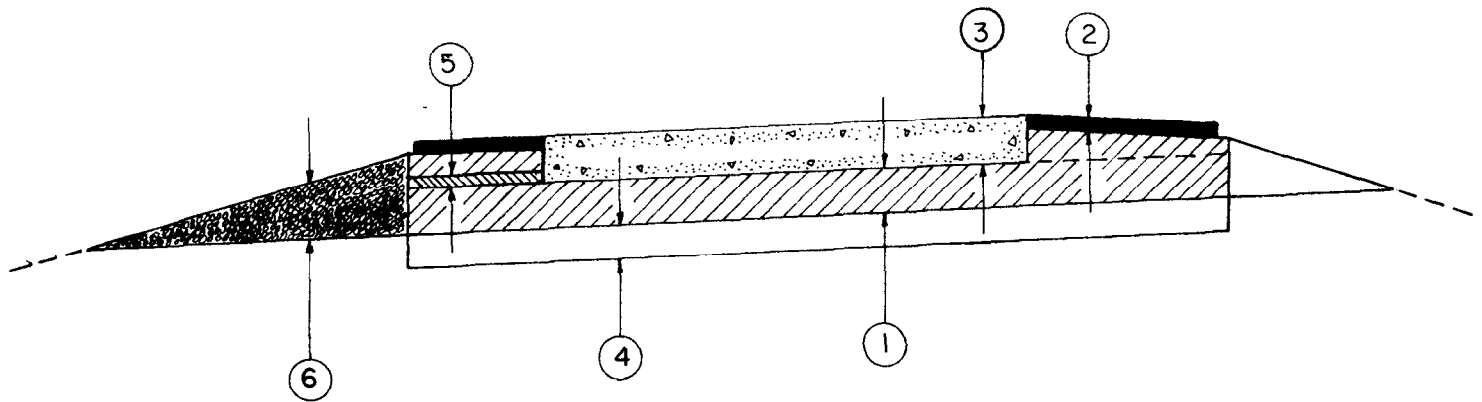
FIGURE 14

Included in the above project is a 1500-foot (457.2-m) section incorporating a full-roadway-width drainage blanket as an integral part of the base course. Typical sections are presented in Figures 14 and 15. As indicated in the section, the full-width blanket is 2 inches (5.1 cm) in thickness and extends between stations 223+00 and 238+00. Densification of the blanket was achieved in a two-pass process by a 10-ton tandem roller. The first pass was for breakdown. The second pass was made for dress-up purposes. It was felt that further compaction would have overdensified the material. While the portland cement concrete surface was being constructed, water was sprayed on the drainage surface in an attempt to prevent the material's absorption of moisture from the concrete. Shortly thereafter, the water was observed as runoff on the embankment.

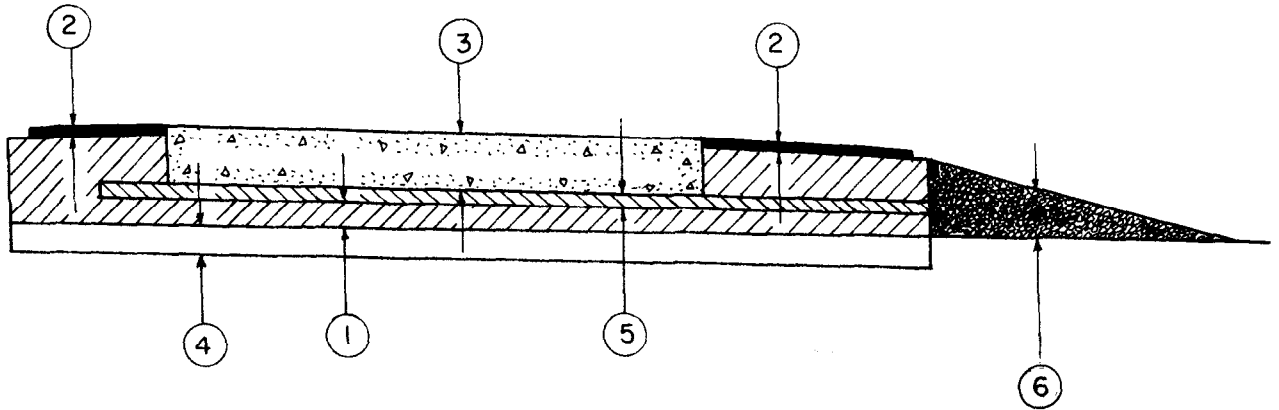
*Full-Roadway-Width Drainage Blanket
Typical Section*

Concern was expressed prior to construction regarding the stability of the full width blanket. It would have to be able to withstand construction service truck loading without being overcompacted. Also, this layer was replacing 2 inches (5.1 cm) of a structural section of the pavement system. Would the drainage layer be an effective replacement? Overdensification occurred only along the edge of the drainage layer. Under the direction of the project engineer, these areas were removed and replaced.

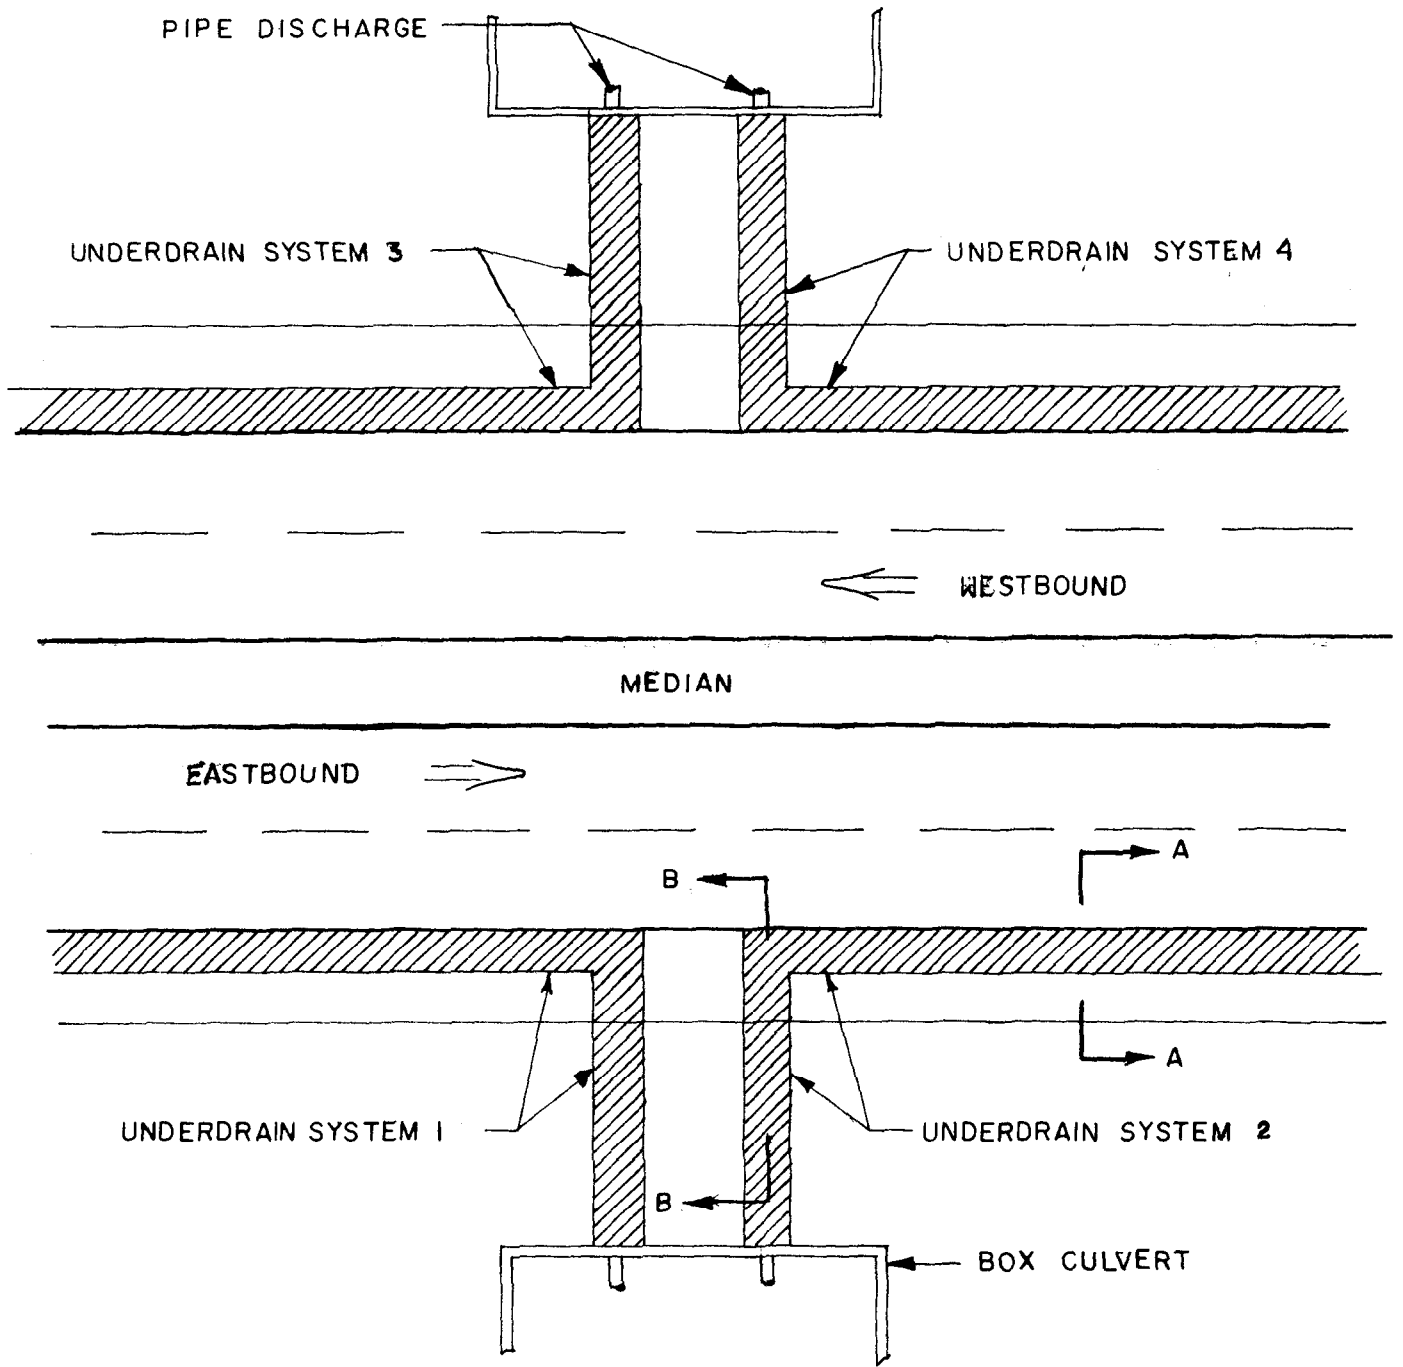
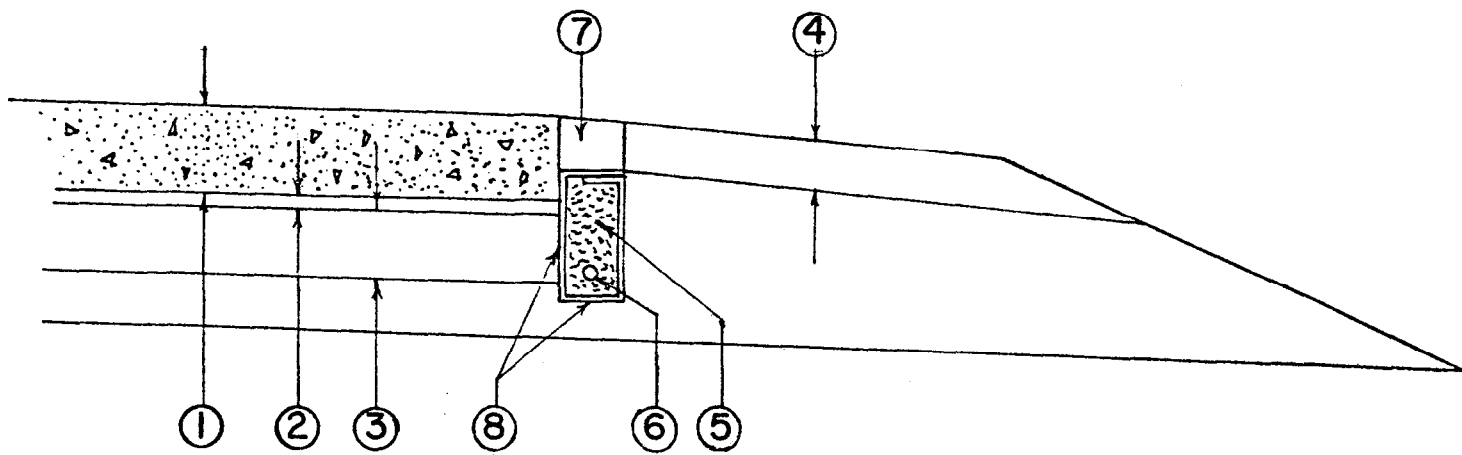
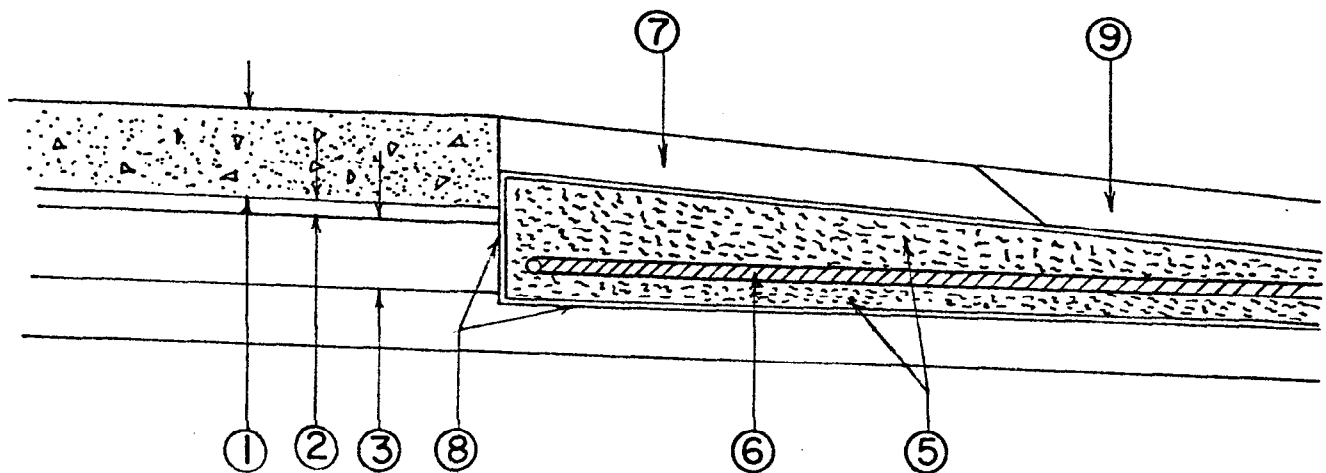
FIGURE 16

Systems 3 and 4 were constructed in much the same manner, using sand as backfill. The construction crew noted that the factory-wrapped pipe provided easier installation, although the filter fabric appeared to be more fragile than the separate filter cloth, as tears due to handling had to be mended.
