EVALUATION OF SYNTHETIC FABRICS
FOR THE REDUCTION OF REFLECTIVE CRACKING

FINAL REPORT

Research Report No.
Research Project No. 70-1B(B)
Louisiana HPR 1 (12)

April 1975

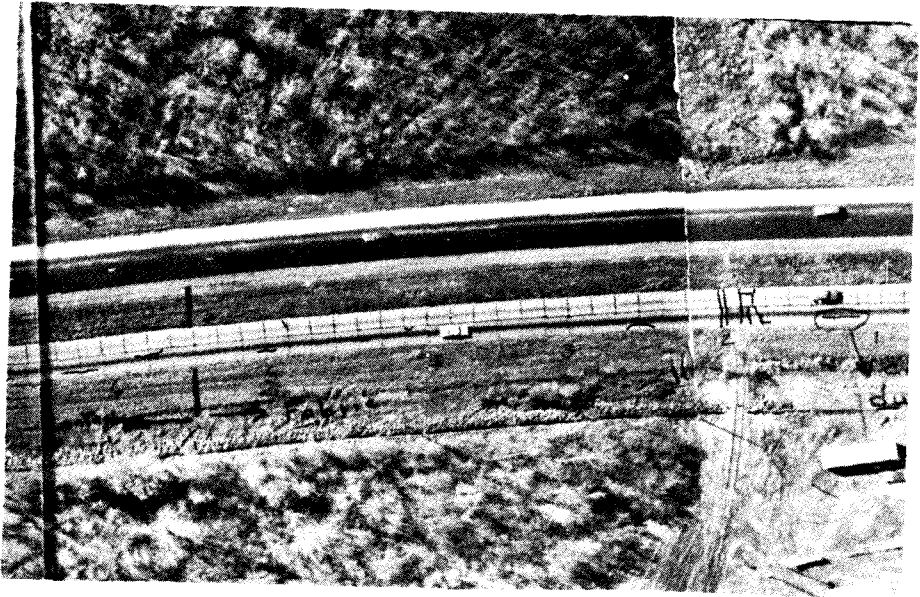
*FIGURE 1
AERIAL PHOTOGRAPH OF ORIGINAL CONCRETE PAVEMENT - U. S. 61*

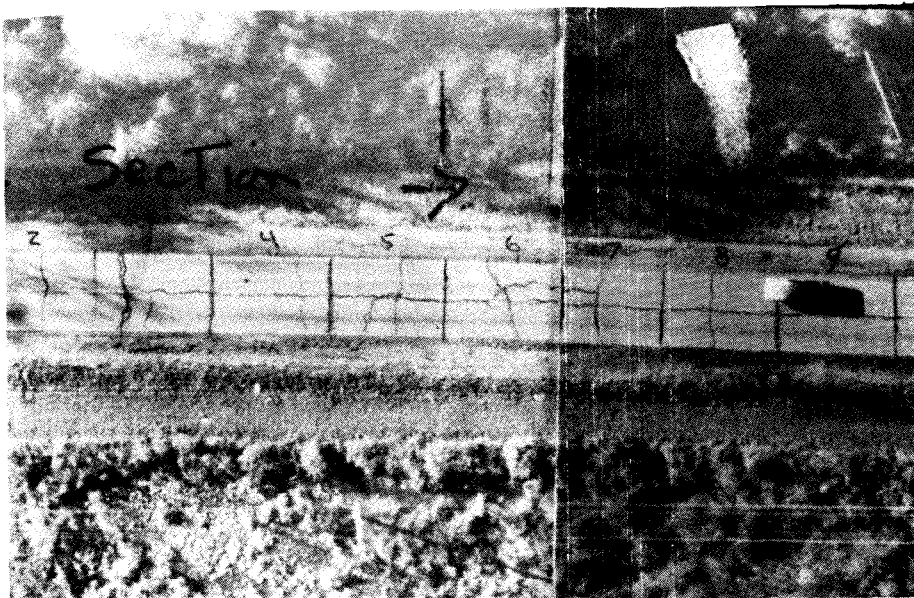
spun-bonded nylon. The test section consisted of a 100-foot (30.48 m) length of full coverage; the control section was the southbound lane immediately adjacent. As was the case with the previous installation, aerial photographs of the sections were taken prior to application and the subsequent overlay. The joints and cracks were noted as before (Figure 6).

FIGURE 6
AERIAL PHOTOGRAPH OF ORIGINAL CONCRETE PAVEMENT - LA. 19
