BRIDGE DECK DETERIORATION STUDY

FINAL REPORT

Research Report No. 85

Research Project No. 72-2C(B)
Louisiana HPR 1 (12)

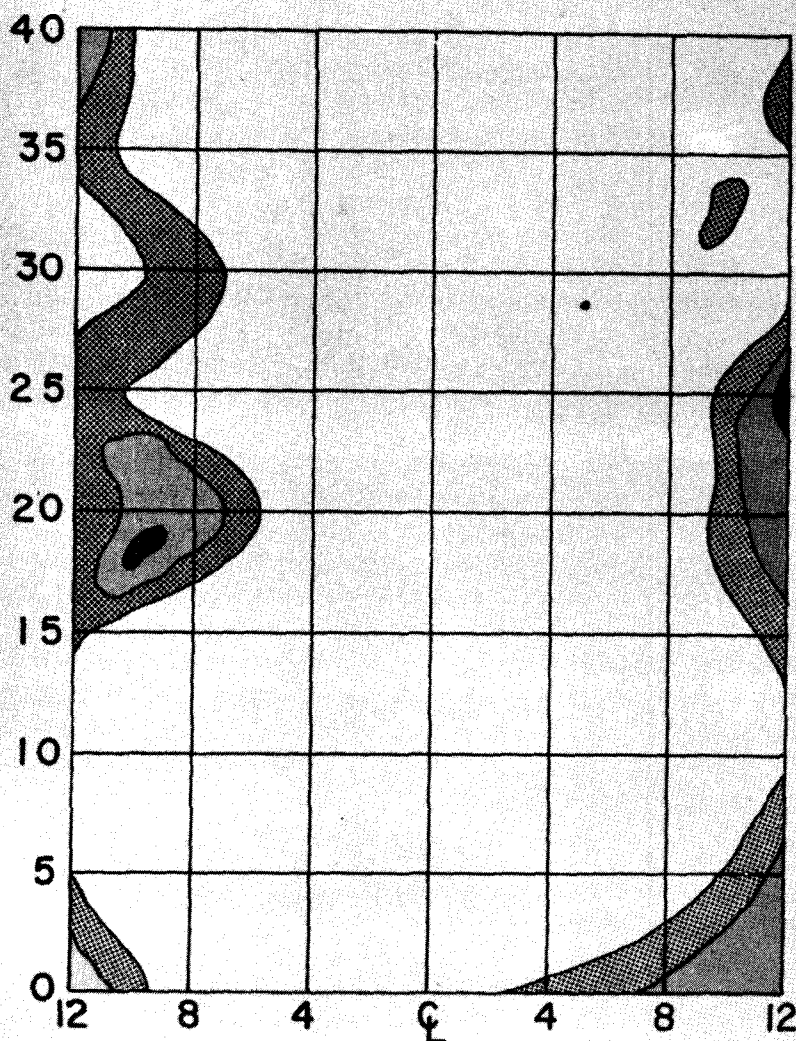
FIGURE 9
Bridge No. 1: Half-Cell Corrosion Chart

1. There is active corrosion occurring adjacent to the gutter lines in all spans investigated.
2. Spans 13 and 14 have more corrosion than spans 2 and 21. This could be due to the fact that the drainage characteristics are different. Spans 13 and 14 are relatively flat and could allow the applied deicing salts to penetrate, while the grades on spans 2 and 21 are much greater and would allow the salts to run off at a much higher rate and thus not have time to penetrate the concrete.
3. There is ample chloride ion content in the bridge deck for corrosion and its effect to continue.

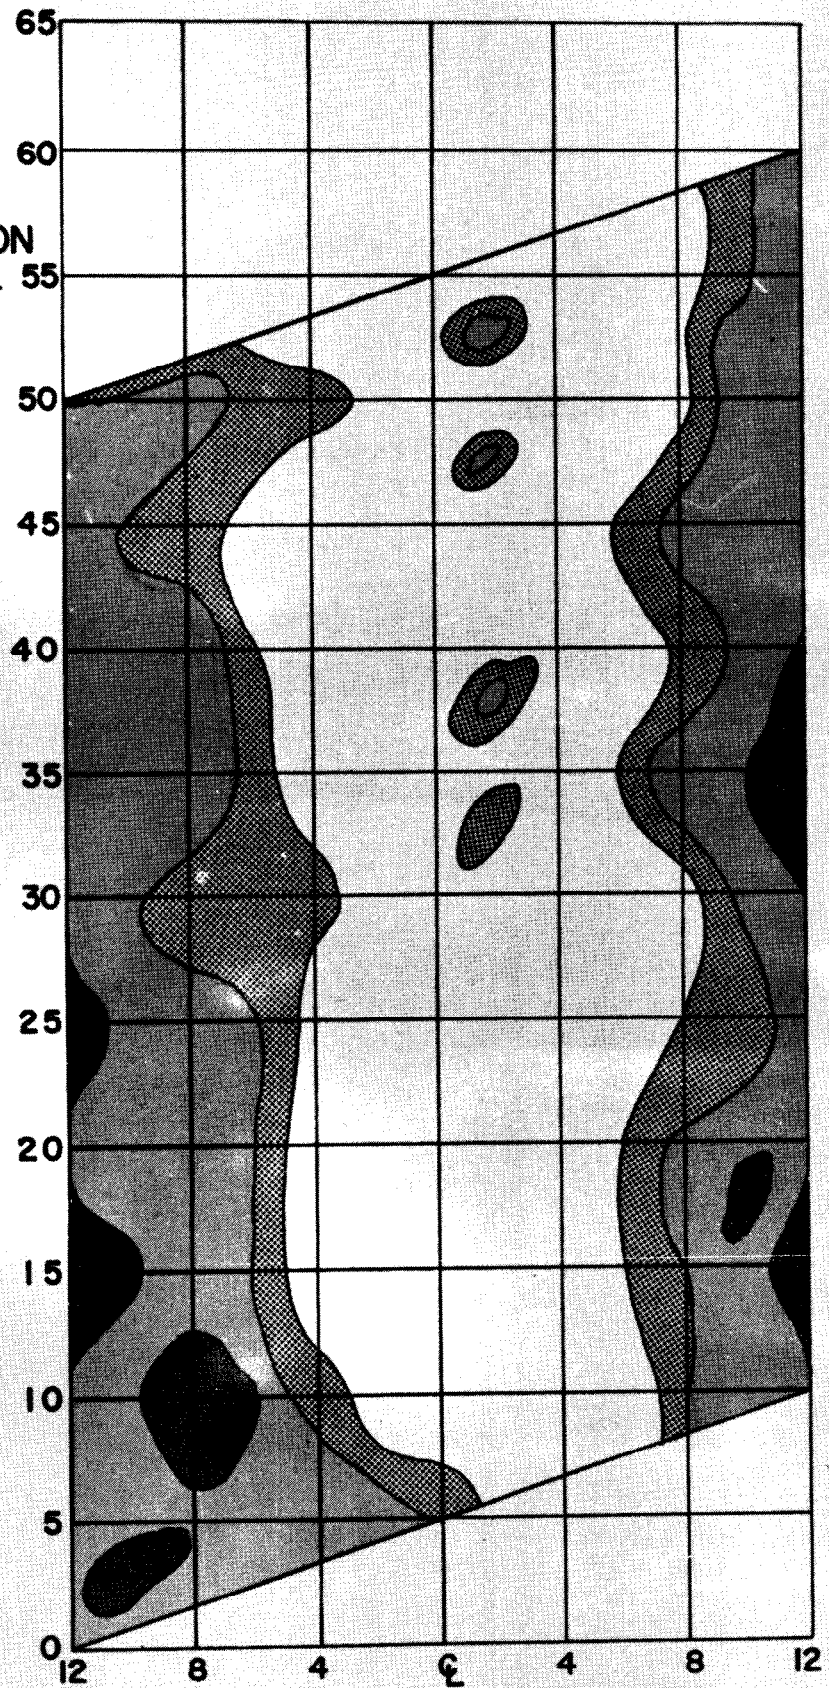
FIGURE 19
Bridge No. 2: Half-Cell Corrosion Chart

1. There is active corrosion in all spans investigated.
2. Most of the corrosion activity protrudes from the gutter line; however, islands of corrosion do occur in each span.
3. There is sufficient chloride ion content in each span for corrosion to continue.
4. The chloride ion content in Span 5L (1936) is, on the average, less than that in those constructed in 1948 and 1956. This could be due to the fact that deicing salts were not applied with any degree of regularity until the late 1940's or early 1950's and that portion had 15 years for a natural road film to develop and form somewhat of a barrier to the intrusion of the deicing salts. The newer spans had deicing salts applied to them at an earlier age; and, therefore, absorbed more of the chloride.
