1. Report No. 363		2. Government Accession No.		3. Recipient's Catalog No.	
4. Title and Subtitle Evaluation of Louisiana's Maintenance Chip Seal and Micro-Surfacing Program		5. Report Date July 2002		6. Performing Organization Code

**EVALUATION OF LOUISIANA'S MAINTENANCE CHIP SEAL
AND MICRO-SURFACING PROGRAM**

LTRC NO. 97-6B
STATE PROJECT NO. 736-99-0457

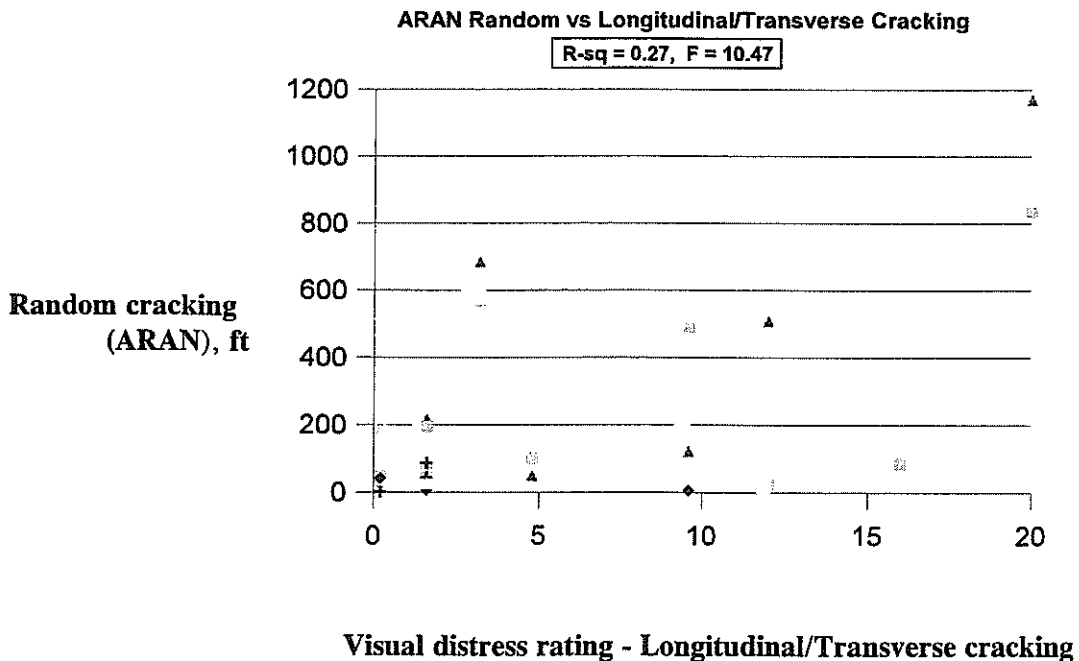
Figure 7.12: Relationship between visual distress and measured distress (ARAN) on cracking

random and alligator cracking at the three severity levels (tables 7.3 and 7.4) were plotted against longitudinal and transverse cracking from the subjective rating evaluation (table 7.2). The relationship between the two surveys is shown in figure 7.12.

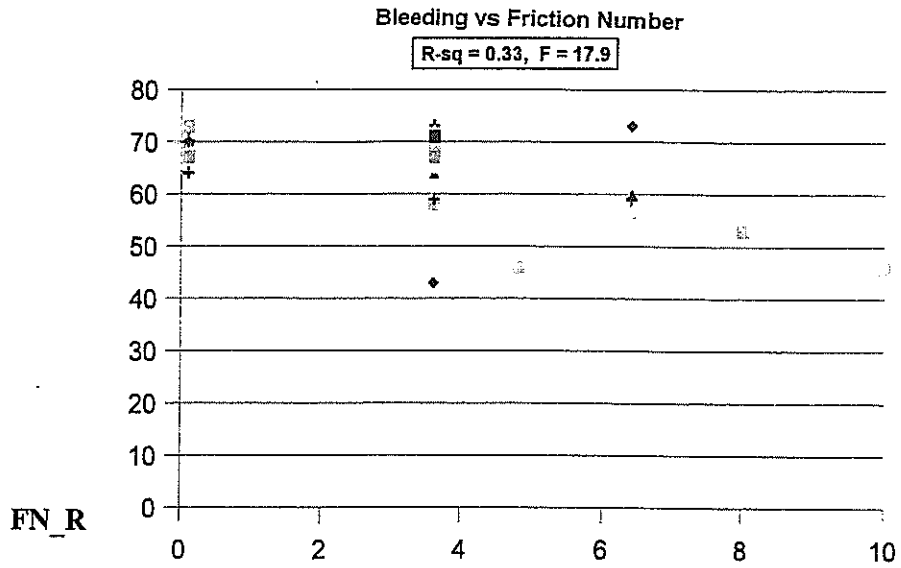
Figure 7.13: Relationship between bleeding and Friction Numbers (FN)

Figure 7.13 exhibits the relationship of bleeding and friction number to ribbed tire. The relationship is significant at the 0.001 level for an R^2 of 0.33. This means that, in the absence of measured data on FN, subjective rating can be used to take corrective action. The plot demonstrates that 27 or about 70 percent of the sections showed bleeding in general (3.6 or more in the figure) and 33 percent of that number showed medium to high severity bleeding. It should be noted (from tables in Appendix A) that these sections had exhibited this distress during the first evaluation, which was within a few months after construction. This may be indicative of construction and/or material related problems.

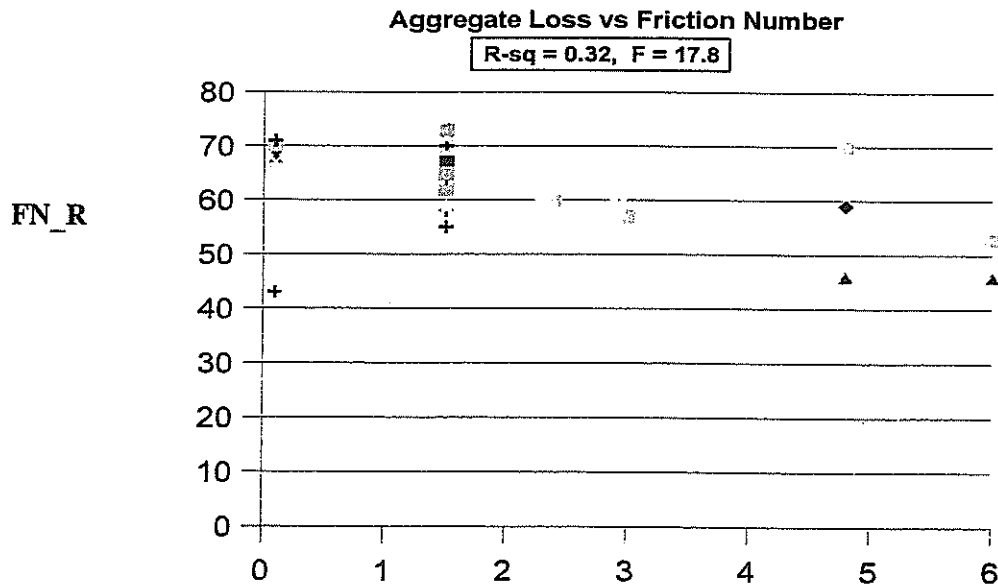
Figure 7.14: Relationship between aggregate loss and Friction Number (FN)

Loss of aggregate also increases the potential for bleeding, which can also result in loss of friction. This relationship is shown in figure 7.14. The fit is significant at the 0.001 level ($R^2 = 0.32$, $F=17.8$) and follows the same trend (negative slope) as the bleeding above, which is a low friction number with increased aggregate loss.

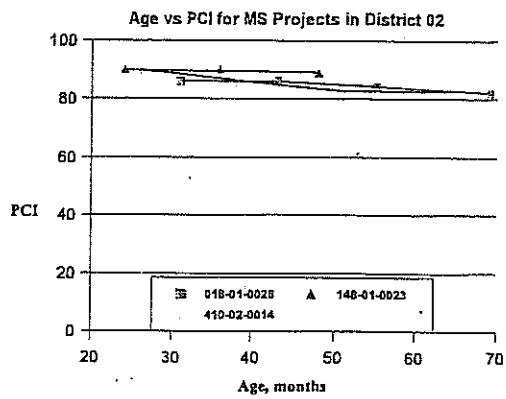
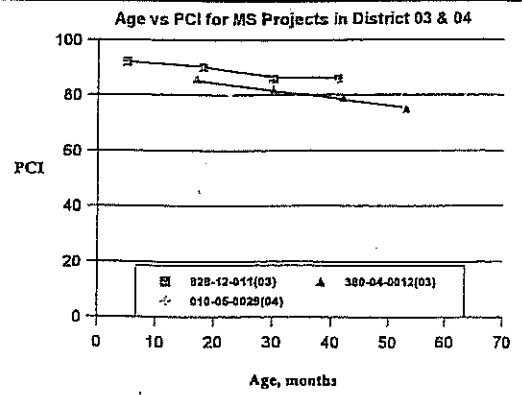
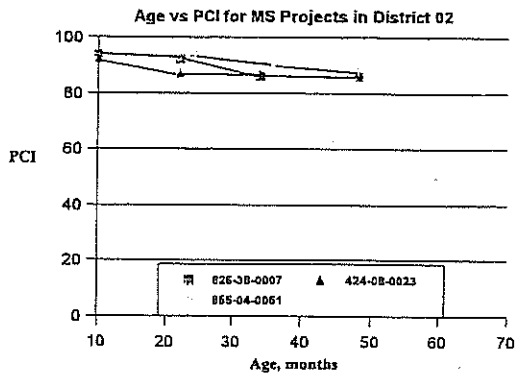
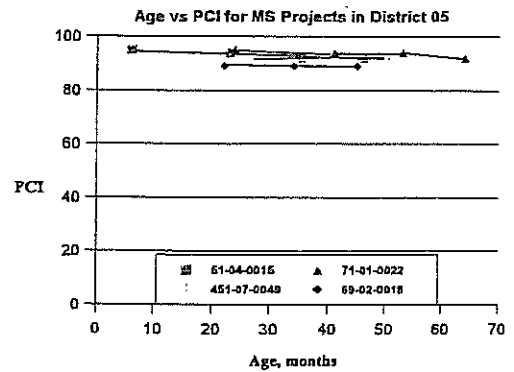
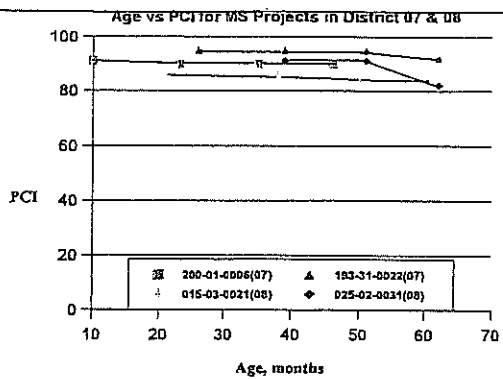
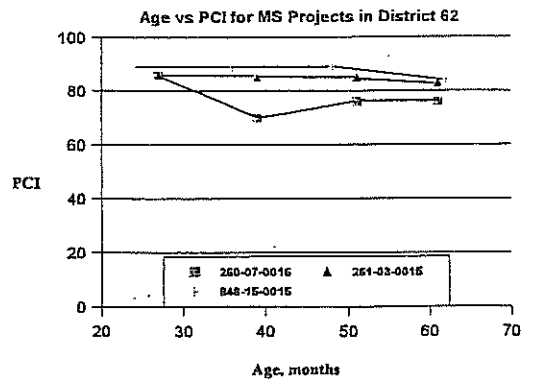
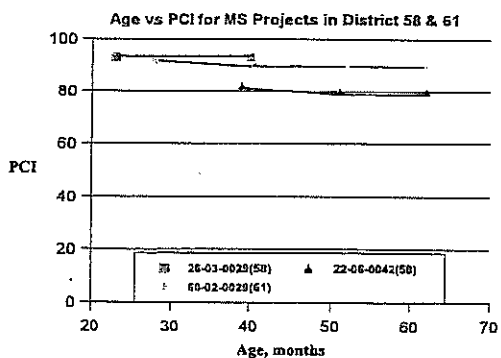
The four surveys for the study sections appear in table 8.1 (AGE3 to AGE6 and PCI 3 to PCI6). Table 8.2 shows the individual distress deduct values (for the last survey) contributing to the final PCI. The data in table 8.1 for the individual study sections is presented in graphic form in figures 8.1a through 8.1g. Figure 8.2 is a bar chart of the average age at last evaluation and corresponding PCI for the projects in each district. Figure 8.3 shows the frequency distribution of all PCI's regardless of age.

The flat trend of the curves in figures 8.1a through 8.1g indicates that most of the sections are still in a steady state of performance. The median statewide PCI is about 85 after almost 60 months of service. From figure 8.3, it is seen that one fourth of the projects are still in the 90s and more than half in the 80s. Two sections are in the 70s with the lowest PCI of 75 on a section in District 03 after 53 months of service.

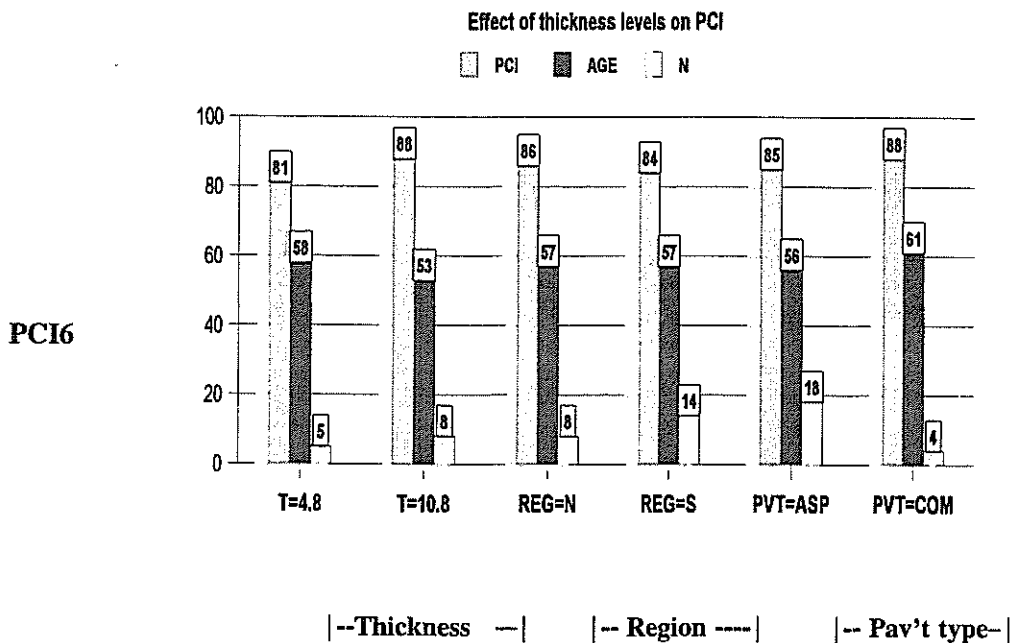
Figure 8.4: Effect of levels of variables shown on performance

Figure 8.4 shows the effect of some of the other variables on PCI. Only the variable thickness exhibits a statistical difference (at 0.05 level) in the PCI at the two levels shown.

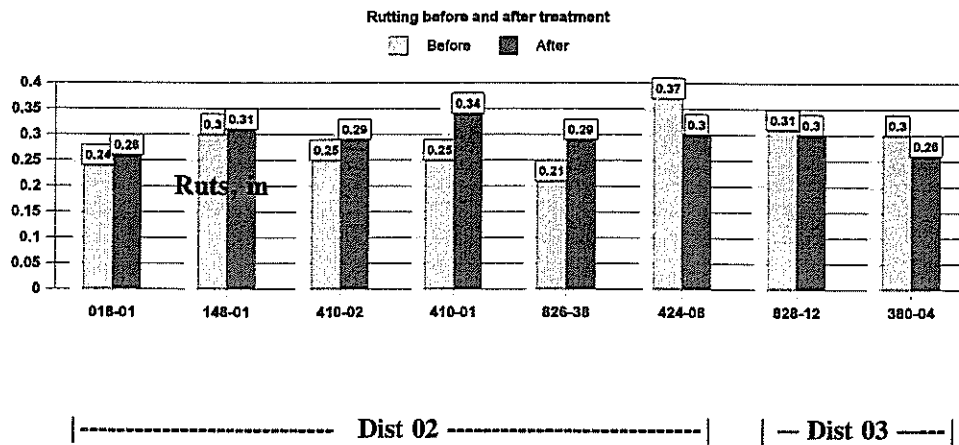
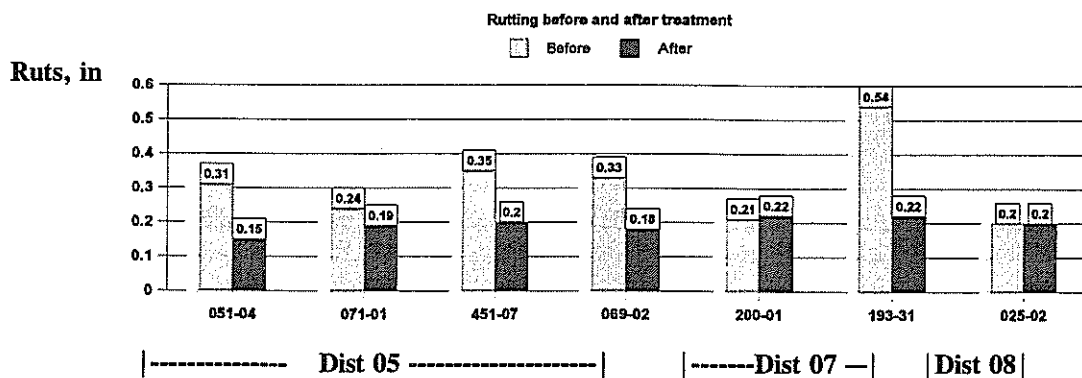
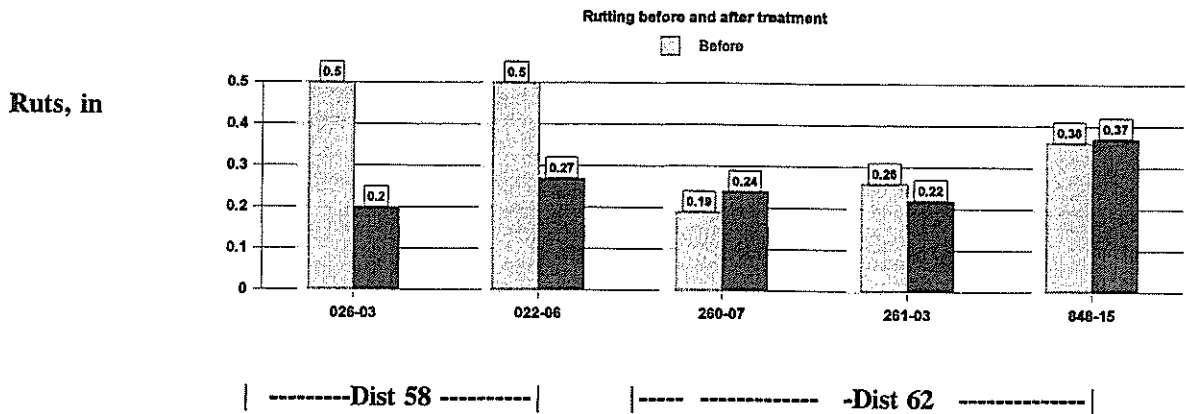
As noted earlier, micro-surfacing has been effectively used for filling ruts and for restoring the friction numbers to acceptable and safe values. Figure 8.5 presents the ARAN data on rutting before and after treatment. As was the case with chip seals, the period between the two ARAN measurements was three years. Individual data on rutting is listed in table 8.4. Notice that only three projects show rut measurements that can be considered marginally critical at best.

Most of the projects show preconstruction ruts around 0.30 inches. Whether rutting or a low friction number was the deciding factor for micro-surfacing these projects cannot be ascertained due to absence of pretreatment friction numbers on these projects. It also raises the question of whether the appropriate projects were selected for micro-surfacing.

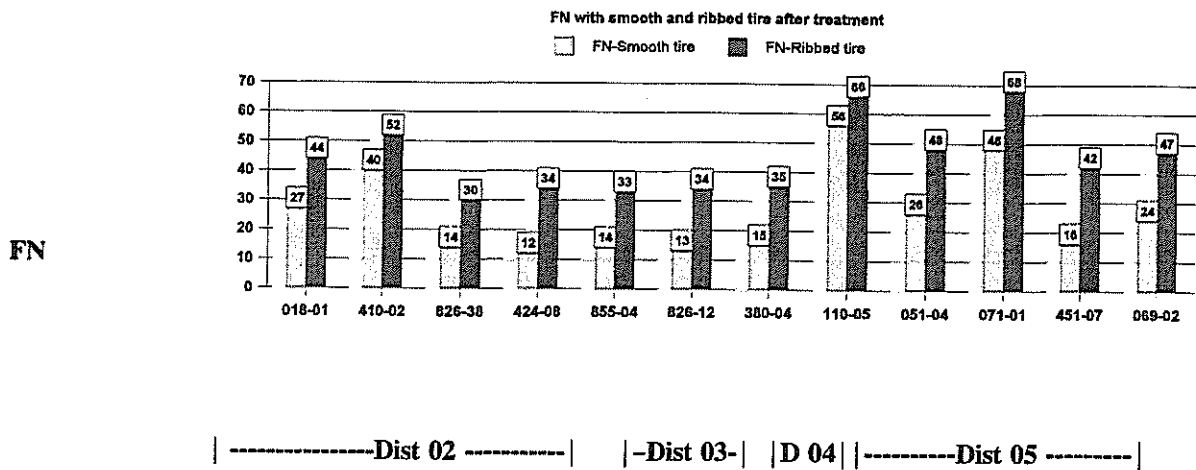
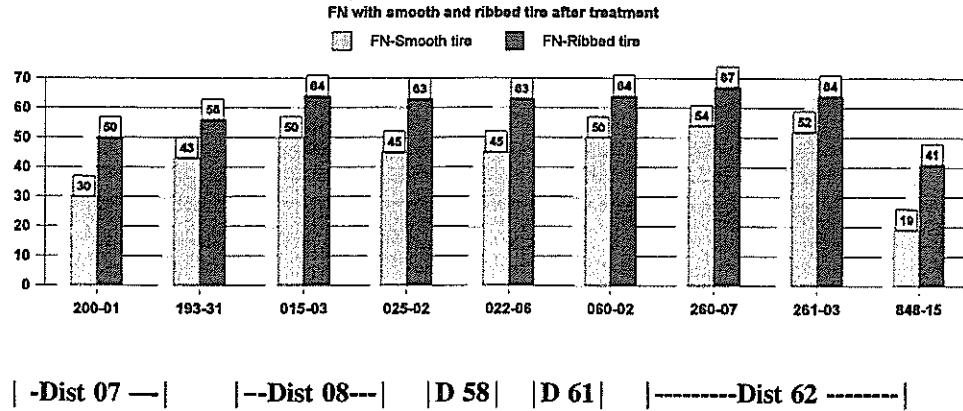
Figures 8.6a and 8.6b are plots of friction numbers (FN) for the projects using smooth and ribbed tire. Data on friction numbers is listed in Table 8.5.

Almost half the project sections have smooth tire FN's of less than 30 with seven of these in the teens. Such low numbers are generally indicative of a lack of adequate macro-texture, which increases the hydroplaning potential. Sections with low smooth tire FN (teens) also show low FN's (low 30s) for ribbed tire. A review of the aggregate type used on most of these projects revealed that the low FN's may have been a result of limestone aggregate. The type and source of aggregates used on these projects is shown in Table B3 in Appendix B. The high numbers were from the polish resistant sandstone aggregates (11). These aggregates have sharp and angular faces and provide a flat age gradient. Most of these sandstone projects are more than four years old.

- ▶ careful consideration be given to the use of limestone aggregate, which reduces the service life from a safety perspective when other mechanisms are performing satisfactorily.

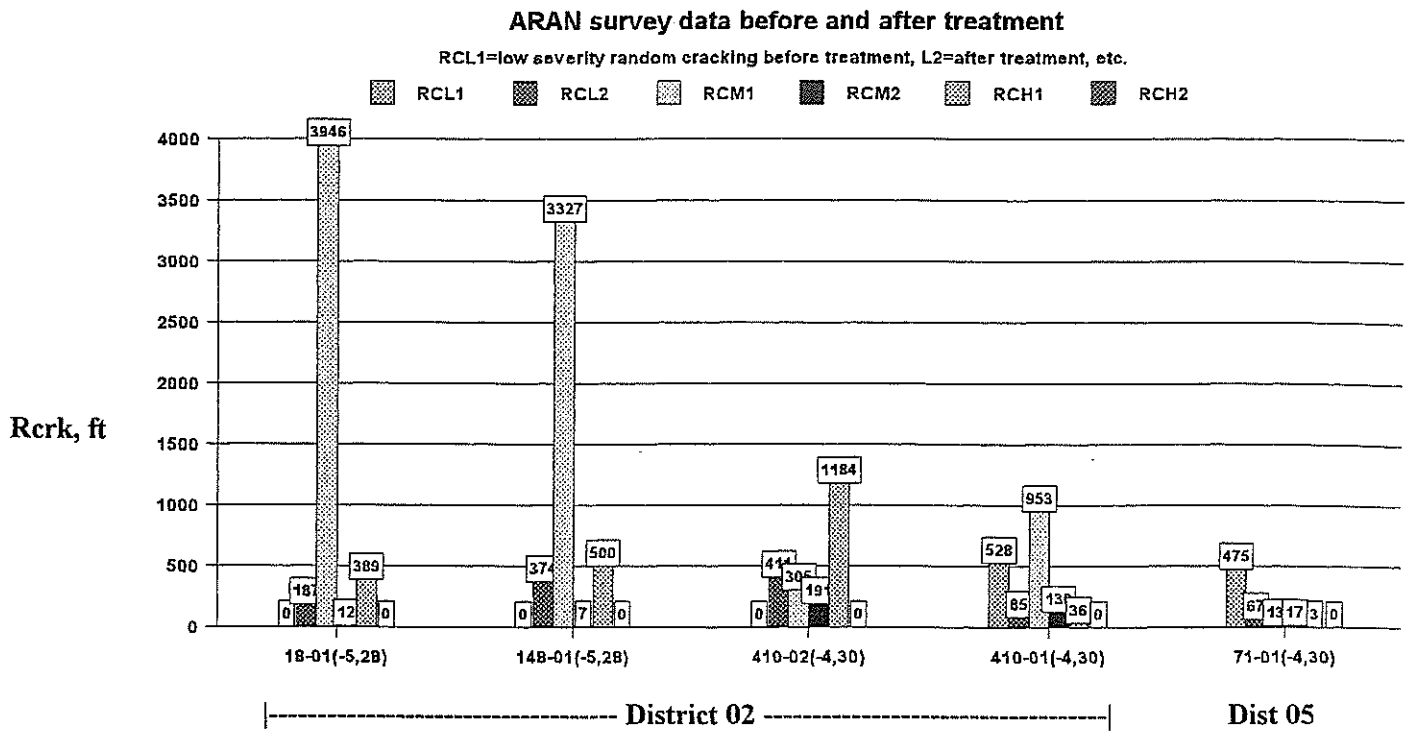
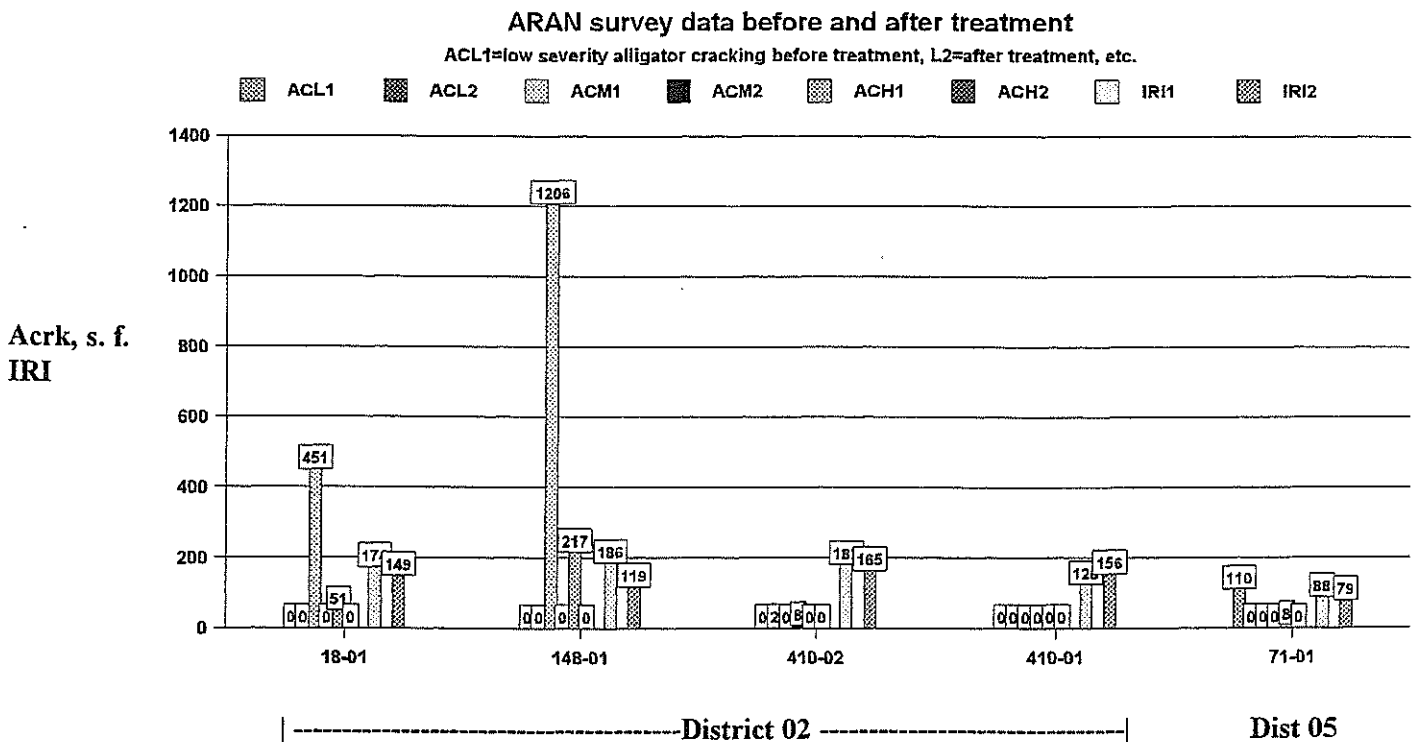
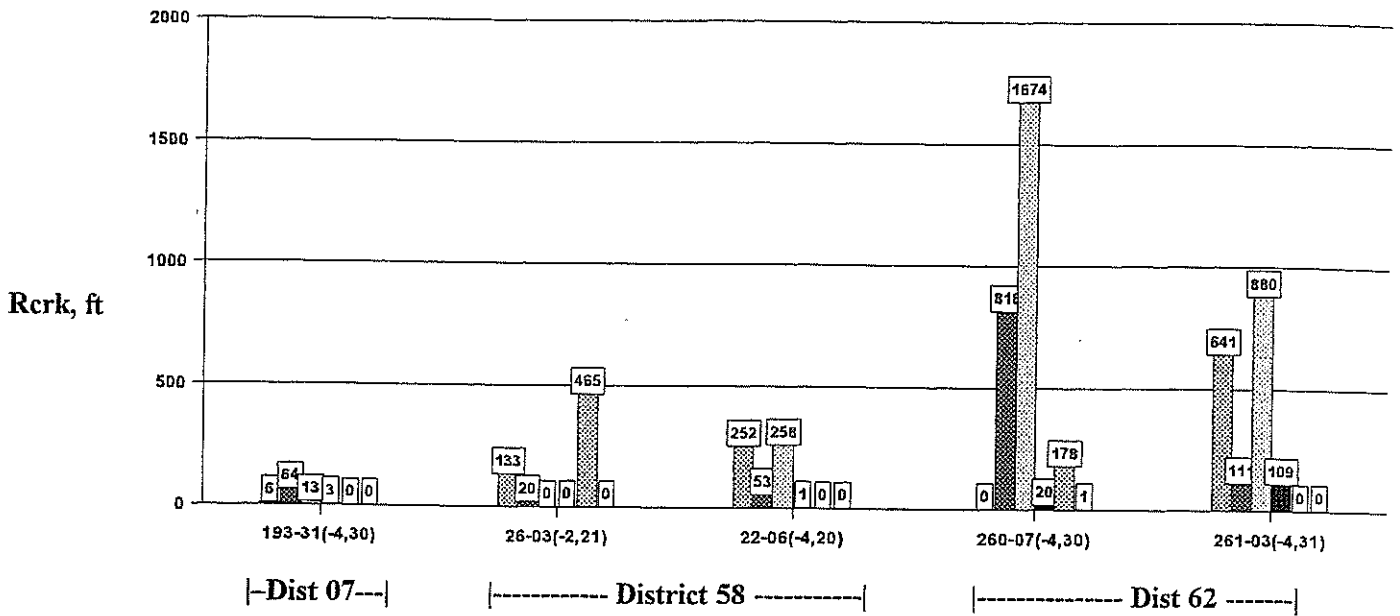
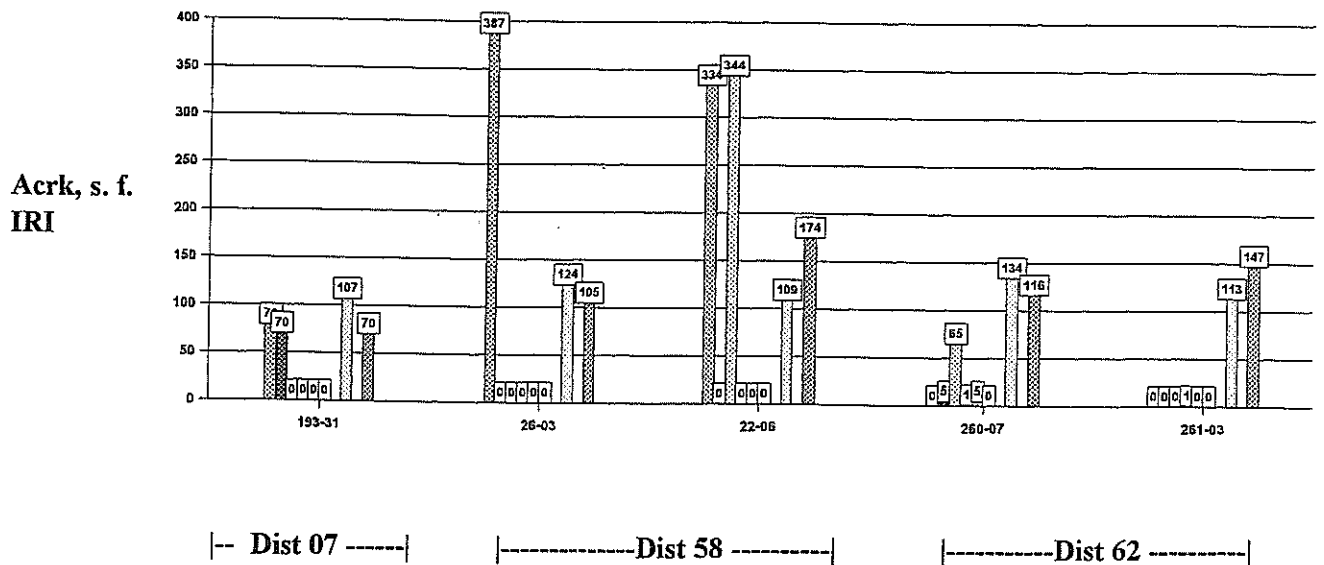
This analysis on micro-surfacing projects is similar to the one presented for chip seal projects in chapter 7. The ARAN data on the distresses are listed in tables 8.3 and 8.4. The before and after evaluation of these distresses are plotted in figures 8.7 and 8.8. As with chip seal data, only projects constructed within six months of construction are included in the plots.

The charts show that in most cases there is a substantial reduction in the magnitude and severity of the measured distress. As was evident on chip seal projects, there is a marked reduction in alligator cracking after the treatment. An increase in low severity random cracking after the treatment application similar to that noticed with the chip seal sections was indicated in some cases.

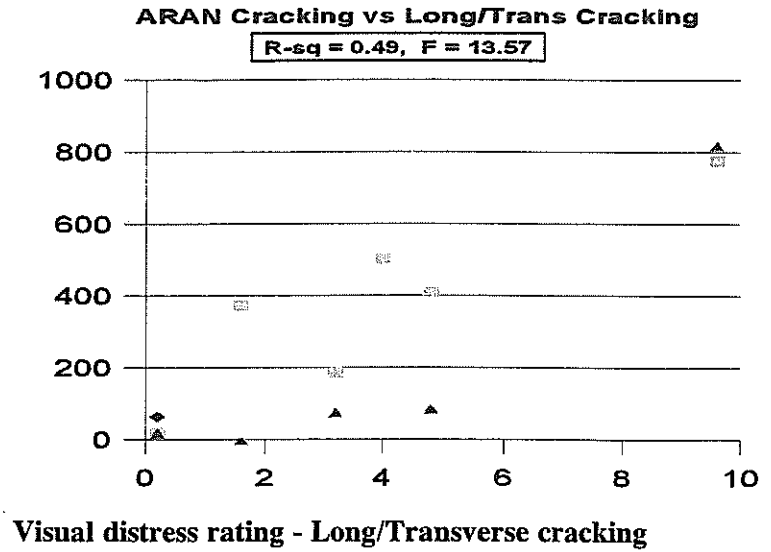
Figure 8.9: Relationship between visual distress and measured distress on cracking

Figures 8.9 and 8.10 show some of the relationships between subjective rating and measured rating. Figure 8.9 shows the relationship between the longitudinal/transverse cracking survey data of table 8.2 and random cracking as measured by ARAN and shown in table 8.3. The R^2 for this relationship is 0.49 and is significant at the 0.01 level ($F=13.57$). However, as with chip seal data, alligator cracking did not show any noticeable trend.

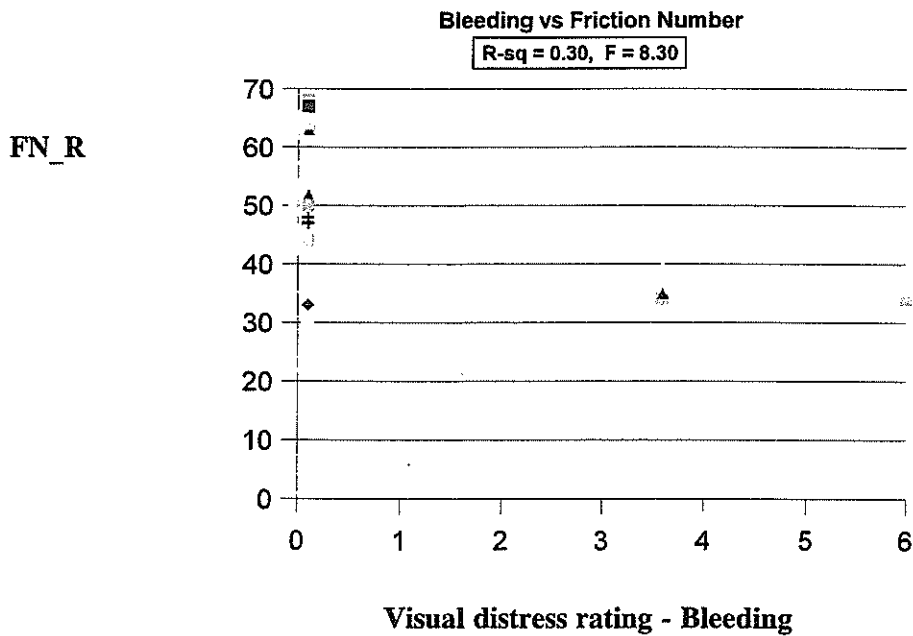
Figure 8.10: Relationship between bleeding and FN

The association of bleeding to FN is shown in figure 8.10. The R^2 for this relationship is 0.30, which is significant at the 0.01 level ($F=8.30$). The low friction numbers (30 and below) should be attributed to the type and/or source of aggregate used in the mix and not to bleeding since there was practically none. In essence, there is a confounding effect of aggregate on the friction number.

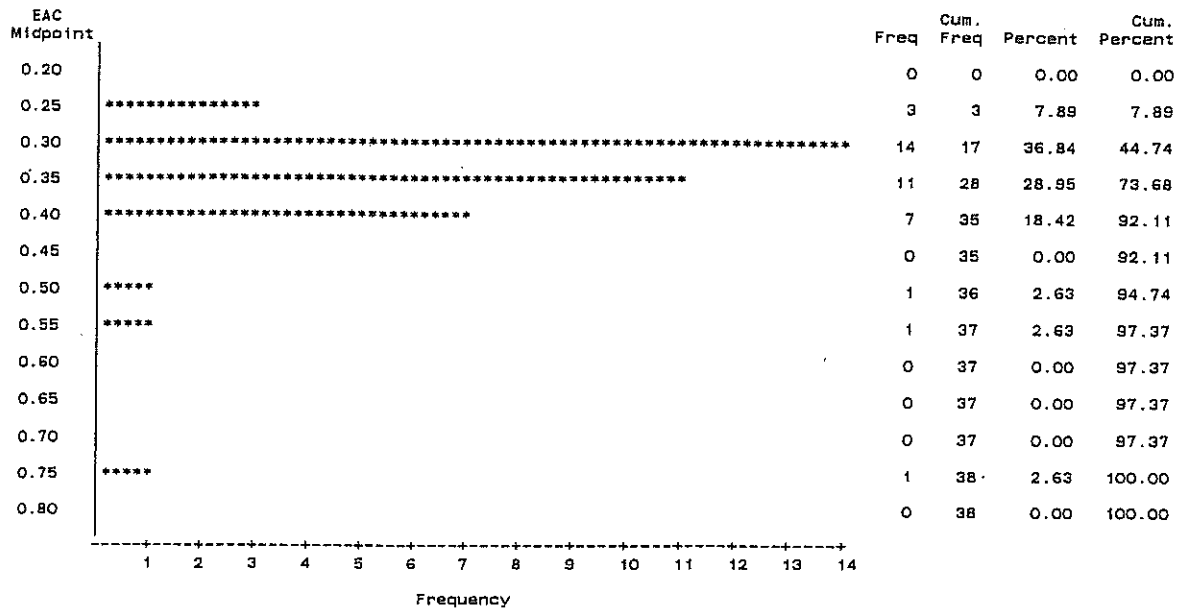
Figure 9.1: Frequency distribution of EAC for chip seal projects

Table 9.1 lists the unit construction and maintenance cost and the Equivalent Annual Cost EAC for each chip seal project. Figure 9.1 is the frequency distribution of EAC. The maintenance cost reported in the tables represents the entire control section. This is because such costs are not reported by project but by control section, which may be only a portion of the total control section length.

Although the life expectancy of most of the sections is unknown, the EAC varies from a low of \$0.25 per year to high of \$0.75 per year based on their current condition. Assuming a life of five years for all projects, the EAC varies from a low of \$0.22/year to a high of \$0.59/year. This wide variation in EAC is a result of project and/or regional variation in bid price and lack of accurate data on maintenance cost. There may be a need to develop a limiting value of this parameter to evaluate the effectiveness of chip seals.

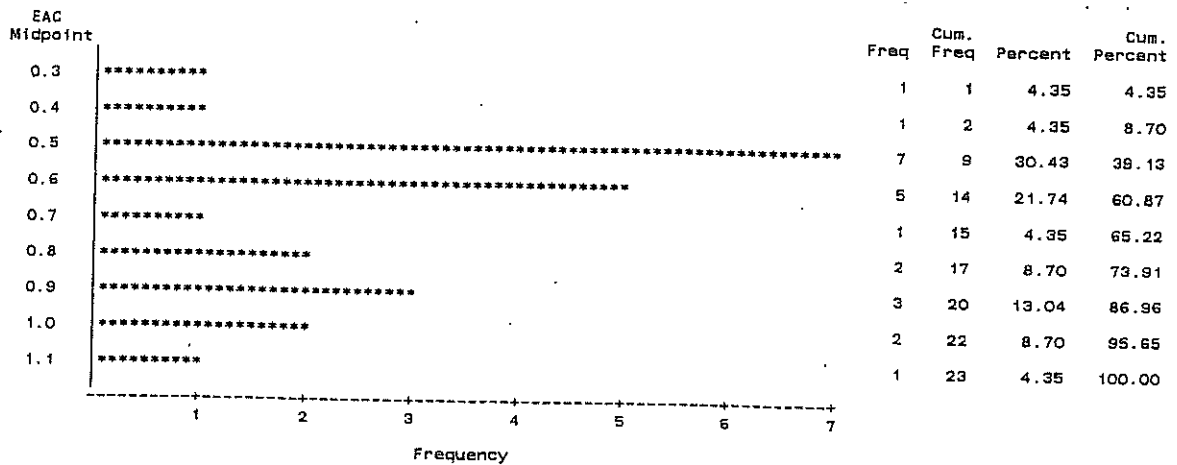
Figure 9.2: Frequency distribution of EAC for micro-surface projects

The various cost data are listed in table 9.2. The frequency distribution of EAC for study projects/sections is shown in figure 9.2. In the table, the cost of micro-surfacing in the state varies considerably from a low of \$1.71/sq yd (\$2.05/sq m) to a high of \$4.85/sq yd (\$5.80/sq m). The average statewide construction cost is about \$2.93/sq yd (\$3.50/m²). This is more than double the amount reported in reference 12. The average maintenance cost is \$0.16/sq yd (\$0.19/sq m).

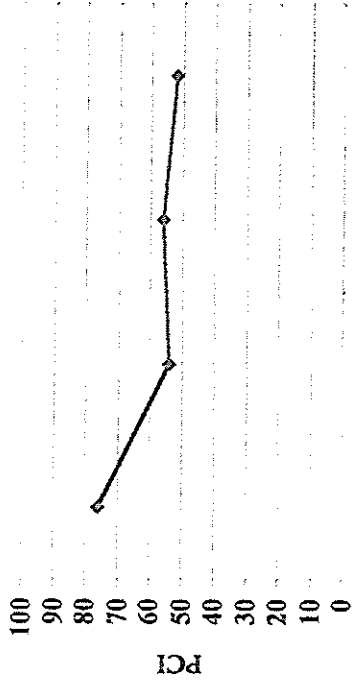
LA 999 Chip Seal

December 1998

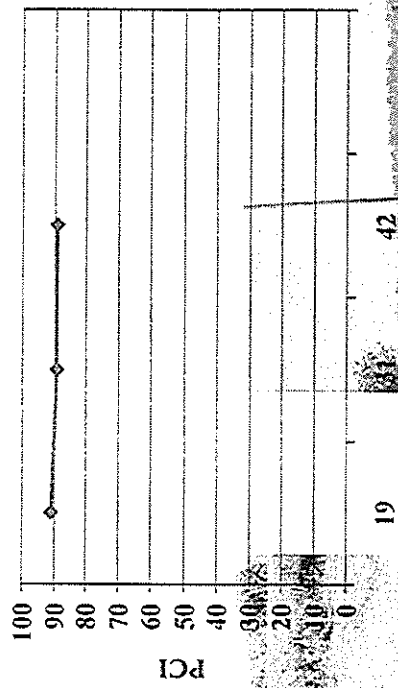
LA 4 Chip Seal

November 1998

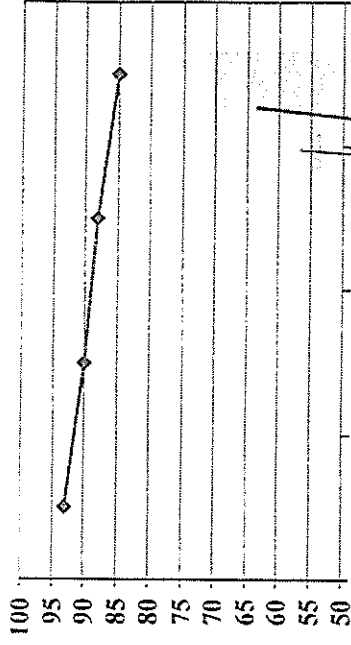
LA 659 Micro Surfacing, Houma

December 1998
