1. Report No. FHWA/LA-92/258		2. Government Accession No.	3. Recipient's Catalog No.
4. Title and Subtitle CRASH TESTING OF LOUISIANA'S MULTI-DIRECTIONAL, SINGLE STEEL POST, SMALL SIGN SUPPORT		5. Report Date JUNE 1992

CRASH TESTING OF LOUISIANA'S
MULTI-DIRECTIONAL, SINGLE STEEL POST,
SMALL SIGN SUPPORT

JULY 1992

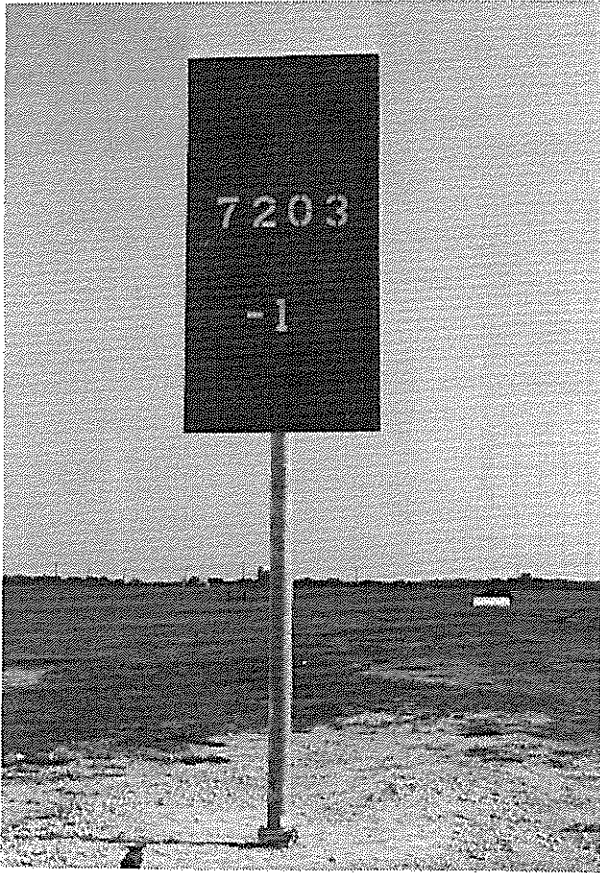
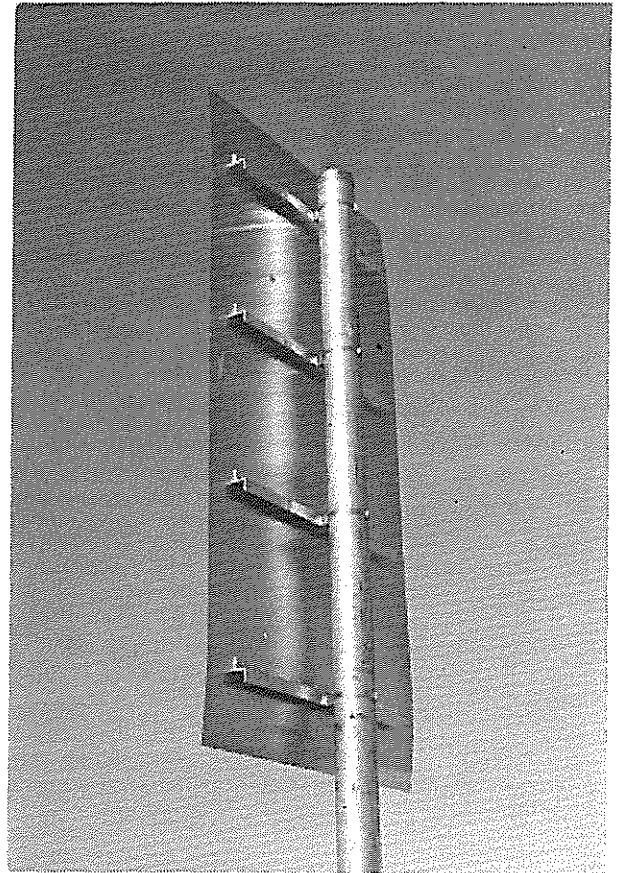
Figure 2. Multi-directional slip-base, single steel sign support installation before test 7203-1.

A single-support sign installation was constructed from 5 in diameter schedule 40 steel pipe. The ground stub was anchored in a 1 ft-6 in dia. x 4 ft-0 in concrete footing placed in NCHRP Report 230 S-1 (strong) soil. The length of the sign support was 15 ft-6 in and the ground stub was 4 ft-0 in. The post and ground stub were fitted with a multi-directional slip base. The slip-base connection utilized 3/4 in diameter high strength bolts torqued to 369 in-lb, as specified in Louisiana DOTD standards. Attached to the support was a 4 ft x 8 ft type A sign panel. The sign panel was mounted to four Z-stiffeners with rivets. Each stiffener was attached to a flared leg mounting bracket with 2 bolts (5/16"-18 N.C.). A 3/4 in strap attached the sign blank assembly to the mounting brackets and support. The bottom of sign mounting height was 8 ft-0 in to the center of the slip-base. Figure 1 illustrates construction details of the sign installation. Figures 2 and 3 show the actual sign installation as tested.

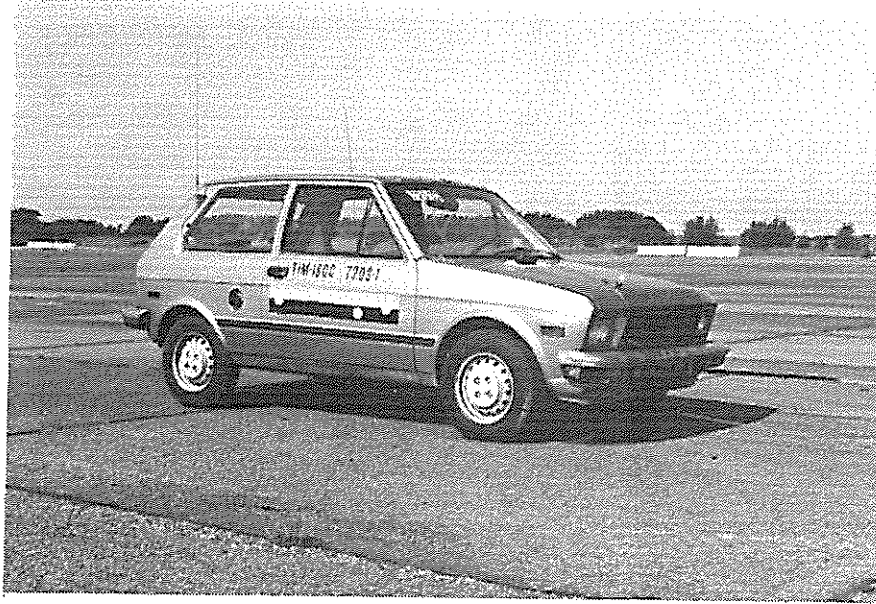
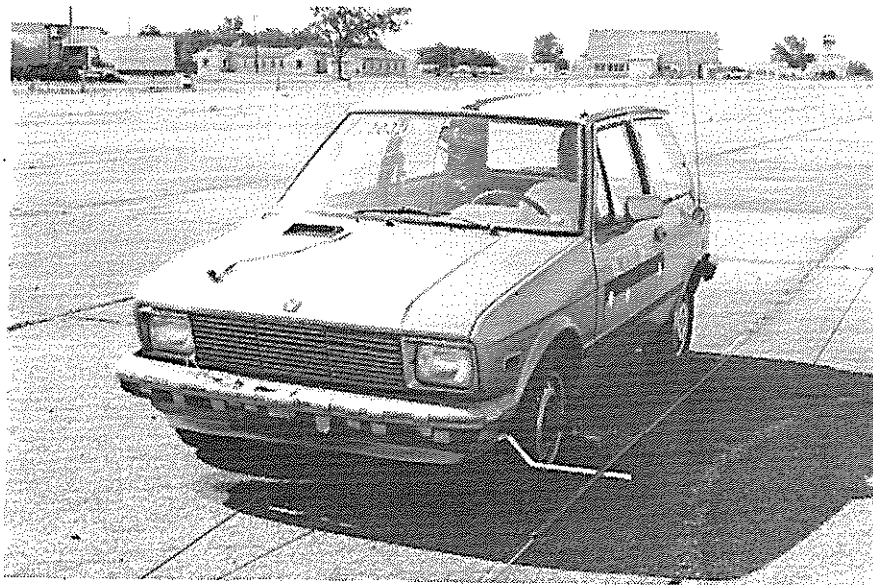
Figure 4. Vehicle before test 7203-1.

A 1986 Yugo (shown in Figures 3 & 4) impacted a 5 inch diameter steel pipe, multi-directional slip-base, sign installation (Figures 2 & 5) in strong (S-1) soil. The impact was at 20.8 miles per hour (33.4 km/h) using a cable reverse tow and guidance system. The point of impact was the front left quarter point of the vehicle bumper with the sign installation. Test inertia weight of the vehicle was 1,800 lb (817 kg) and its gross static weight was 1,970 lb (894 kg). The height from roadway surface to the lower edge of the vehicle bumper was 13.8 inches (34.9 cm) and 19.0 inches (48.3 cm) to the top of the bumper. Other dimensions and information on the vehicle are given in Figure 6.

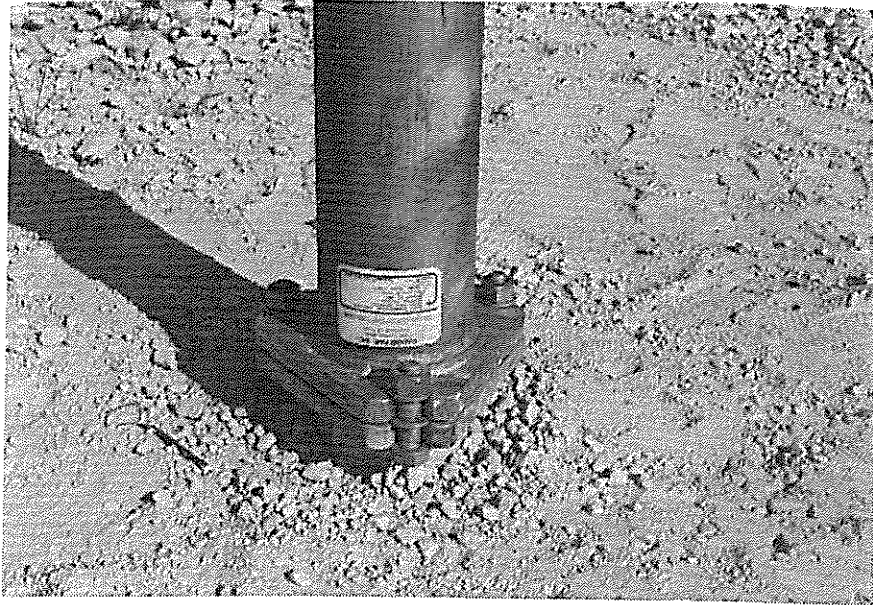
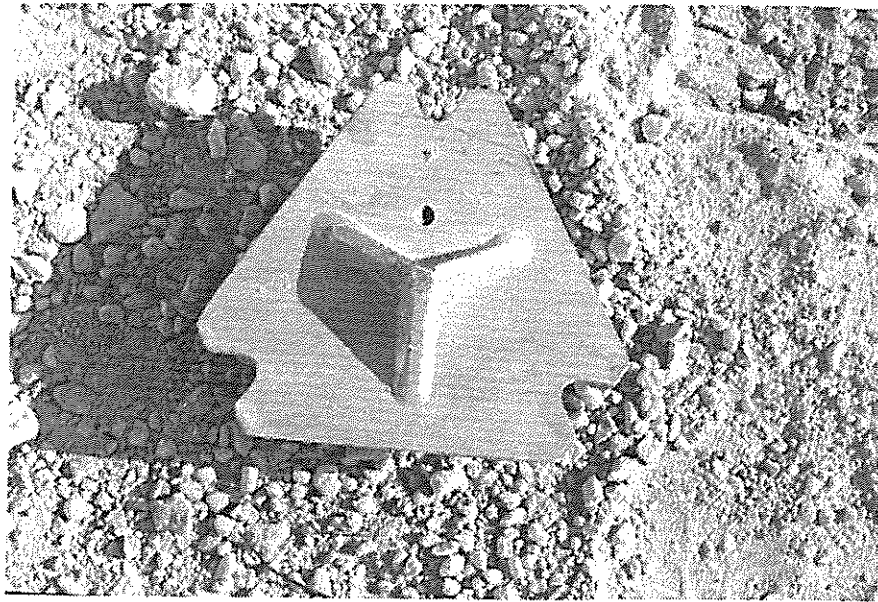
Figure 5. Details of multi-directional slip-base.

The vehicle was free wheeling and unrestrained just prior to impact. Shortly after impact, the sign support displaced the bolts in the slip-base and began to rise up off the base plate. By approximately 0.068 seconds, the vehicle had reached maximum engagement with the support. As the support released, the vehicle yawed counterclockwise. The vehicle lost contact with the sign support temporarily at approximately 0.147 second. As the vehicle continued to move forward, the support was displaced over the hood of the vehicle. The sign panel impacted the roof (over the occupant compartment) of the vehicle at approximately 0.929 second. The vehicle came to rest 23.0 ft (7.0 m) from the point of impact and against the displaced sign installation as shown in Figure 7. Sequential photographs of the test are shown in Figure 8.

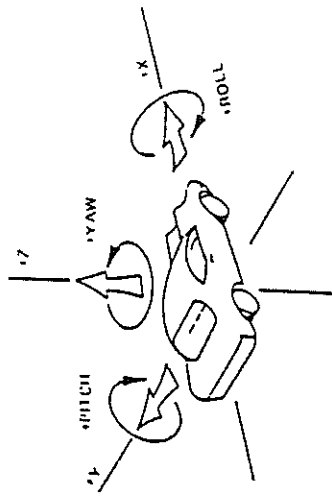
Figure 12. Vehicle angular displacements (test 7203-1).

given in Figure 11. The maximum 0.050 second average acceleration experienced by the vehicle was -7.8 g in the longitudinal direction and -1.8 g in the lateral direction. Vehicle angular displacements are plotted in Figure 12 and vehicle accelerometer traces are displayed in Figures 13 through 15. Occupant impact velocity was 16.2 ft/s (4.9 m/s) in the longitudinal direction and -4.3 ft/s (1.3 m/s) in the lateral direction. Occupant ridedown accelerations in the longitudinal and lateral directions were -1.6 g's and 0.5 g's respectively. Change in vehicle velocity was 20.8 mi/h (33.4 km/h) and change in momentum was 1702.9 lb-s.
