# **FACTORS FOR IMPROVED FISH PASSAGE WATERWAY CONSTRUCTION**

**Final Report**

**SPR 654  
OTREC-RR-11-19**

**ODOT/OTREC**

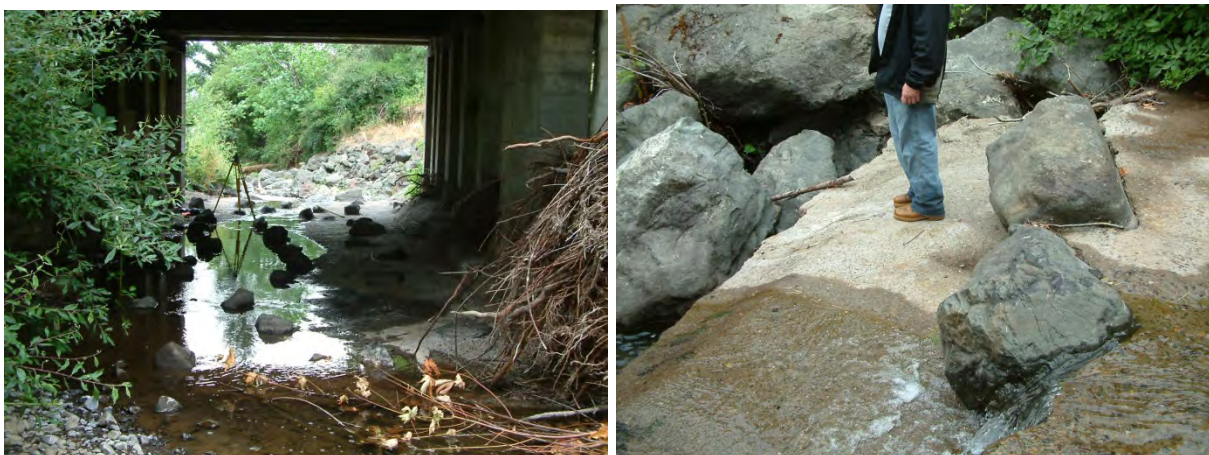
Figure 4.4: Site 01 – Gooseneck Creek upstream and downstream

Gooseneck Creek is located in Polk County; it is a roughened channel under a bridge carrying Highway 22 at Mile Post (MP) 3.97. The area under the bridge is concrete, embedded with boulders. The concrete seems to have been cast in two sections since there are two jumps created at the end of the concrete bed downstream. The downstream and upstream channels have a large accumulation of gravel and cobble (Figure 4.4).

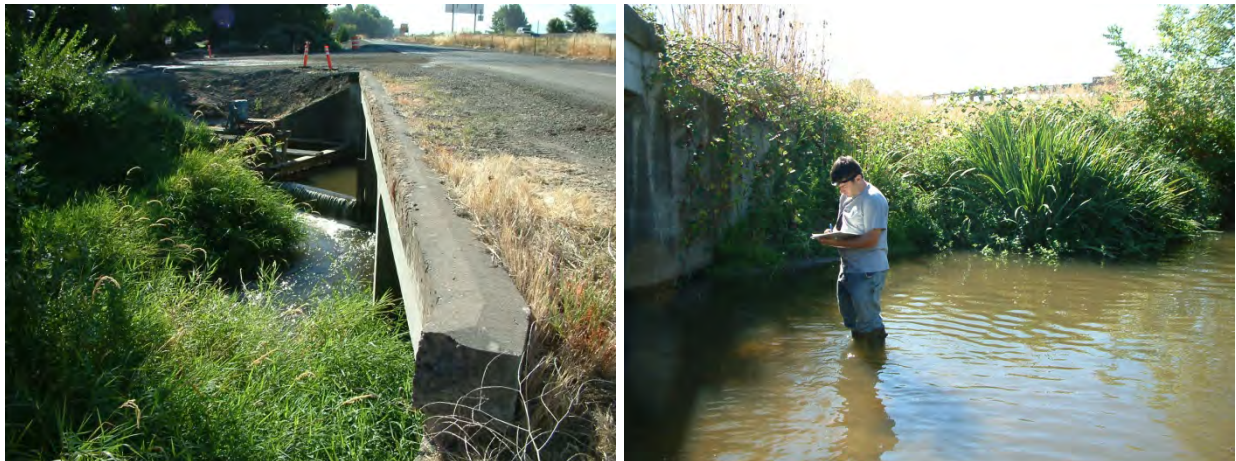
Figure 4.10: Site 08 - Jackson Creek downstream and upstream

Jackson Creek (2) is in Jackson County and crosses Interstate 5 at a location close to Central Point. The creek is accessible from the downstream side after following an exit from the interstate towards Blackwell Road and then following an unnamed gravel road. The upstream side is not accessible from the road, and was accessed after walking through the culvert. The investigators had to clear the area of some vegetation in order to perform some measurements. The structure consisted of three culverts side by side. One of the culverts had a water pump close to it that was used by a local farmer to pump water for the fields. Cross-sections of the flow were not possible due to vegetation. Photos of the site appear below in Figure 4.10.

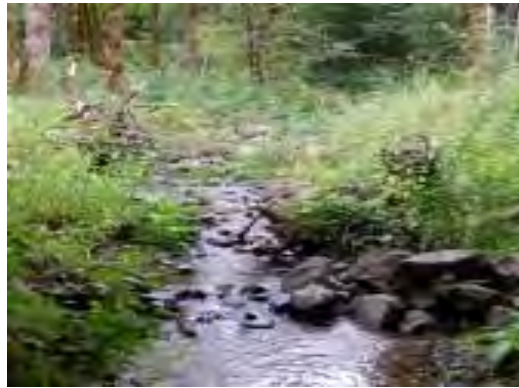
Figure 4.15: Site 13 - Bateman Creek downstream

site has an easy access from the road. Cross sections of the flow were produced, and the slopes were easily measured. A photo of the downstream side of the culvert is shown in Figure 4.15.

Some history of this site was available: The slope of Bateman Creek is 4 to 6%. In summer 2006 the culvert at the site was replaced by a roughened channel and a bridge. At this site bed slope was reduced from 6% to 4.3% by introducing sinuosity to the channel. Grade control structures were buried in the streambed to prevent the stream from head-cutting. The banks of the stream were armored with large rocks to prevent erosion. ODOT used a 50 yr event as their design flow for this installation (*HDR 2004*).

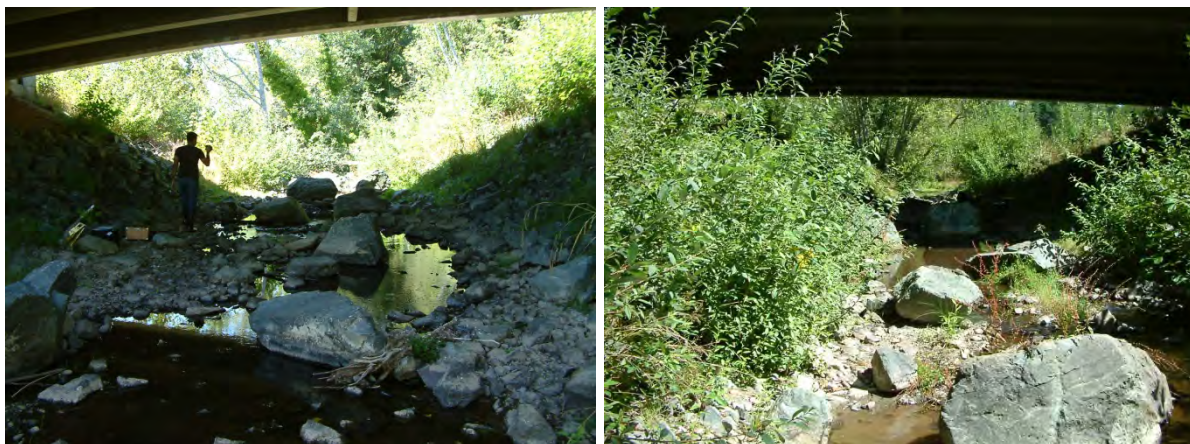
Figure 4.16: Site 14 - Bethel Creek under structure and downstream

Bethel creek is located in Coos County and crosses highway 101 at MP 284.79. The site was easily accessible, but the investigators had to jump the protecting fence separating the highway from the surrounding area. Access to the creek was from upstream. There were no major concerns about the area and river cross-sections were taken. Views of the structure are shown below in Figure 4.16.

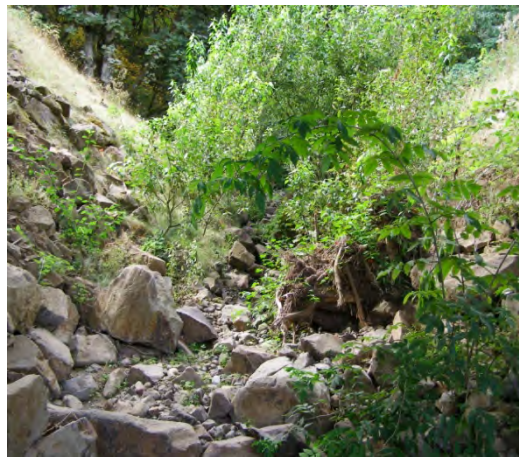
Figure 4.17: Site 15 - Miller Creek upstream

Miller Creek is located in Multnomah County, and crosses Highway 30 at MP 10. It consists of a channel reconstruction and was the second site visited by the investigating team. Access to the river bed was from upstream of the creek and was very steep (Figure 4.17). Measurements were taken for slope and cross-sections. The creek had very few fines, and all the flow was subsurface.
