SERB GUARDRAIL
SOUTH ASHLAND INTERCHANGE CALIFORNIA
STATE LINE SECTION PACIFIC HIGHWAY
(INTERSTATE 5) JACKSON COUNTY, OREGON

Final Report

Oregon Experimental Features
Project Number or 88-02

February 1997

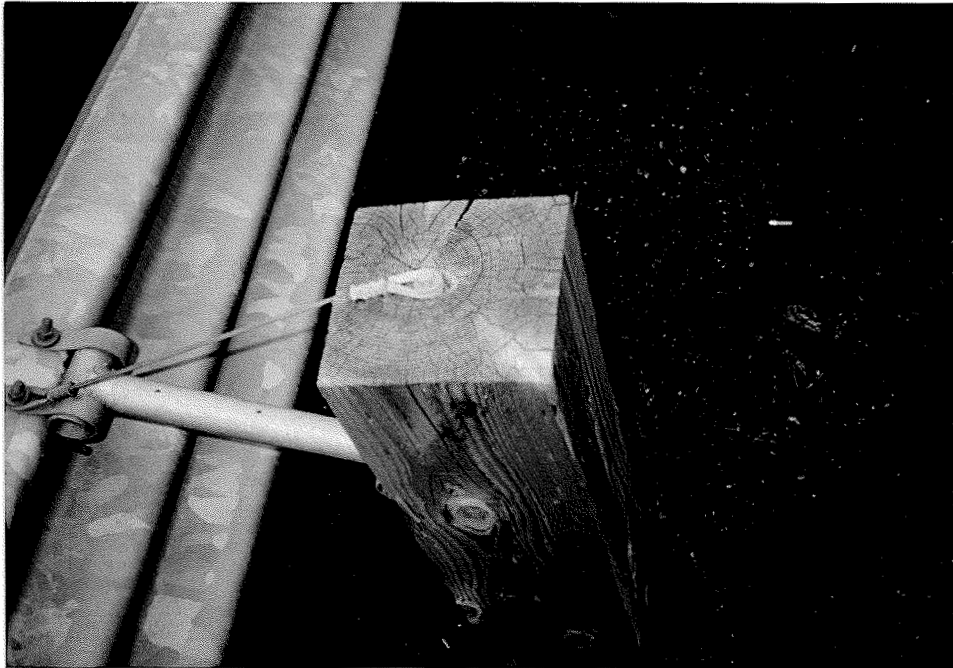
Figure 2.2: Pivot bar and support cable.

The assembly is held up by 18 1/2" long x 3/16" diameter steel support cable connecting the rail to the top of the wooden post as shown in Figure 2.2. This type of connection is used on every other post. The remaining posts are placed in line, and serve to support the guardrail against horizontal forces when it is pushed up against the Posts.

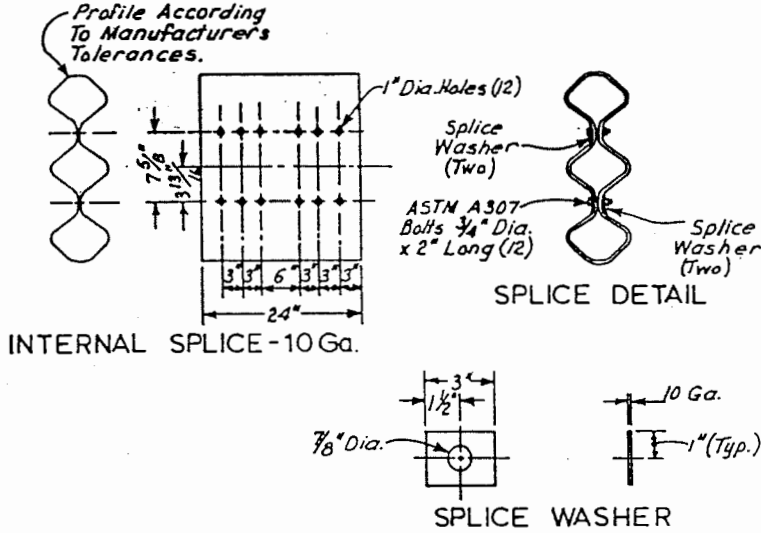
Figure 2.3: Internal splice used in the SERB guardrail

The SERB guardrail is held together longitudinally by an internal splice, as shown in Figure 2.3. This splice plate slides into the ends of two adjoining rails. Six 3/4" diameter x 2" long bolts are used to fasten the internal splice to the end of the rail.

Since there has been no damage requiring maintenance, no maintenance costs have incurred. In the event that a section of the SERB guardrail would require replacement, the cost to repair the guardrail would be dependent on the distance from the ends of the guardrail to the location of the damaged section. With the design of the splice the way it is, to replace a section of the

guardrail requires ODOT Maintenance staff start at one end of the guardrail system and remove one section at a time until the target segment is reached. At this point, the damaged section can be replaced, and the guardrail may be reassembled. Unless the damaged section was near an end, the labor costs of the repair potentially could be very high.

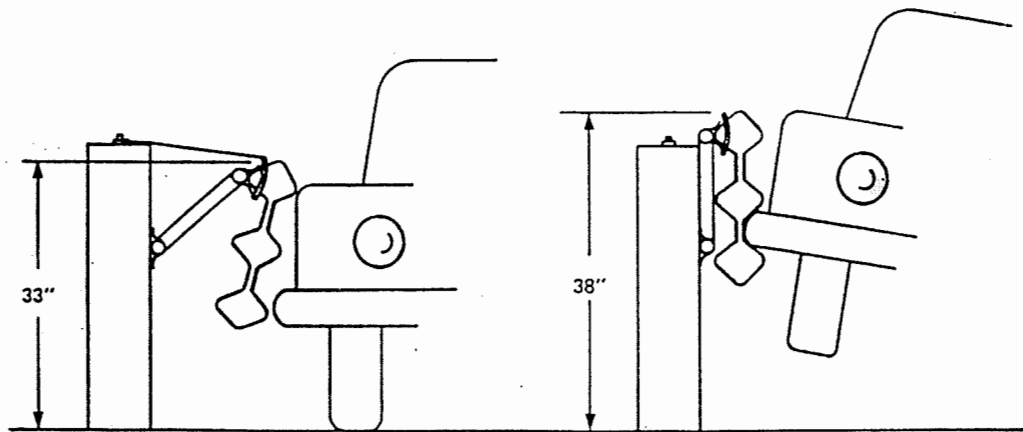
Figure 2.4 SERB reaction to a small angle collision.

If the SERB guardrail is hit, the pivot bar allows the rail to deflect upward and outward, and then return to its original position, as shown in Figure 2.4. This allows the guardrail to follow the upward motion of the vehicle, and makes the redirection of the vehicle smoother.

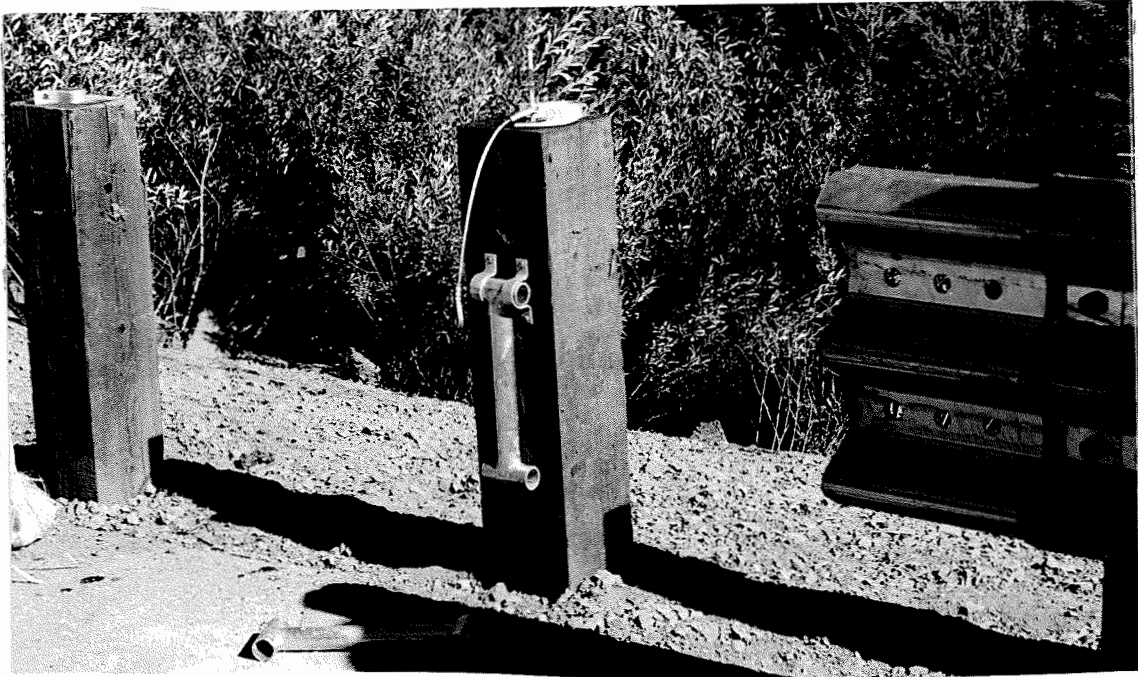
Figure 3.1 Splice plate used in the SERB guardrail construction.

Probably the most difficult task in working with the SERB guardrails was the installation of the splice plates. The thrie beams were very stiff and it was often impossible to slide the splice plates between the thrie beams. To install the splice plate, the thrie beams had to be wedged apart and the splice plate then inserted. Sometimes the splice plate had to be hammered into place. However, extra care was given to preserve the galvanized coating. Once the splice plate was in place, it was fastened to the ends of each rail section with six 3/4" diameter x 2" long bolts, each with a pair of 2" x 3" 10-gauge splice washers (Figure 3.1).
