**BASE ISOLATION BEARINGS  
(Dynamic Isolation Systems, Inc.)**

**Construction Report**

**OR-EF-91-02**

Steve Starkey, P.E.  
Senior Structural Design Engineer  
Bridge Design Section  
Oregon Department of Transportation

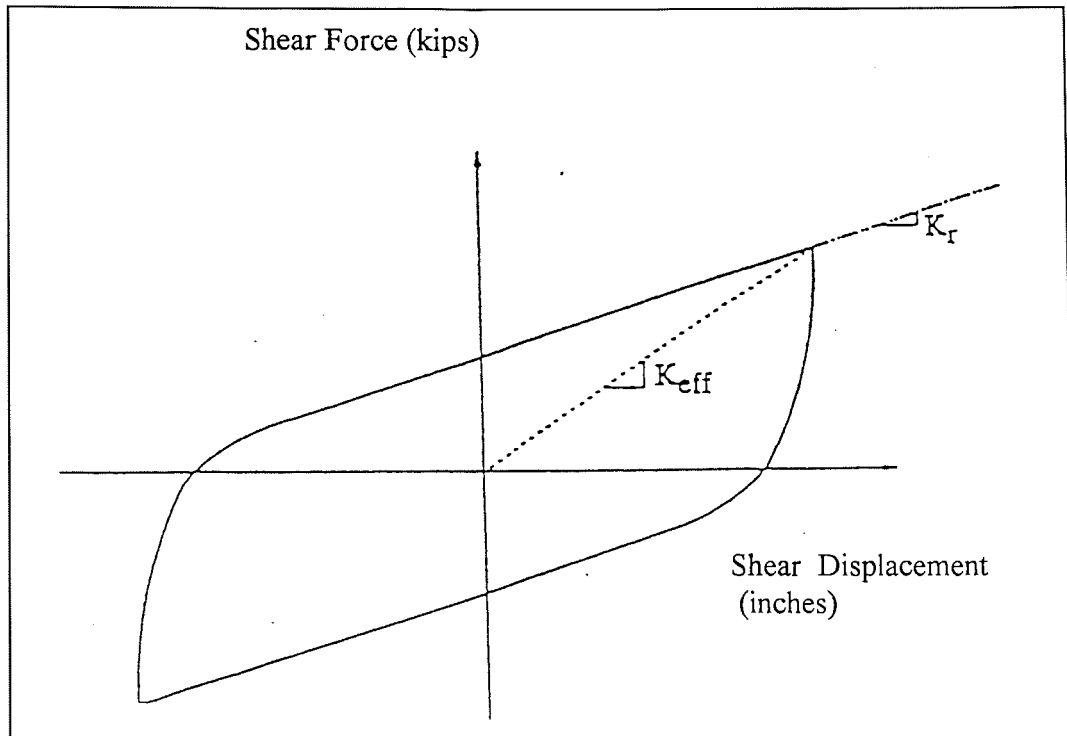
Figure 3.3 Typical Hysteresis Loop for bearing testing.

The supplied bearings met the project specifications except that the tested value of  $K_r$  (the slope of the inelastic limb of the hysteresis loop (see Figure 3.3) was one percent beyond the allowable range for two bearings.  $K_{eff}$ , the bearings' effective lateral stiffness at the design deflection, was within the specification limitations. The design was performed using  $K_{eff}$  rather than  $K_r$ , and this slight deficiency in  $K_r$  is deemed insignificant. Appendix B contains the Force-deflection. Summary and sample curves.
