**INVESTIGATING PREMATURE  
PAVEMENT FAILURE DUE TO  
MOISTURE**

**FINAL REPORT**

**SPR 632**

Oregon Department of Transportation

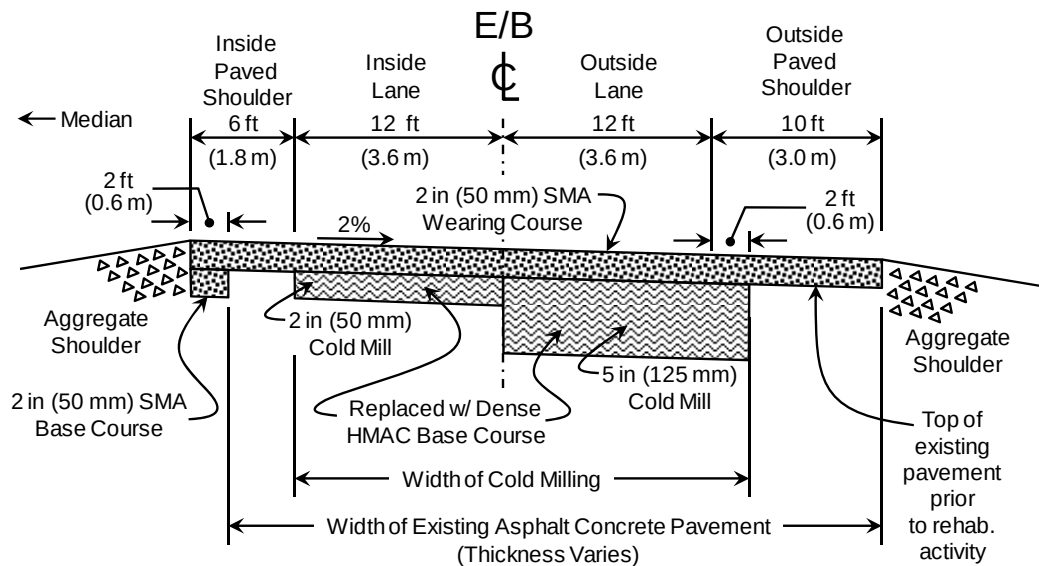
Figure 1.2: As-Built Profile of the Bound Layers for the Pleasant Valley – Durkee Project.

**Observed Problems.** Within months of the initial rehabilitation activity (while the project was still under construction) and before the SMA wearing course was placed, several areas exhibited rutting to depths of 1 inch (25 mm) and greater. Trenching operations revealed stripping of the material and the presence of free water under the new inlay to a depth of about 5 inches (125 mm). Five inches (125 mm) of material from the outside lane was removed and replaced with a 3/4 inch (19 mm) NMAS, dense-graded, lime-treated HMA. Due to low truck traffic volumes on the inside lane, only 2 inches (50 mm) of material was removed and replaced on the inside lane. A 1½-2 inch (40-50 mm) SMA wearing course was placed over the entire roadway. Figure 1.2 illustrates the as-built profile of the bound layers. No effort was made at the time of these activities to determine the source(s) of water that contributed to the stripping. Within 6 months of final construction activities, water was observed to be leaking from longitudinal construction joints and in the wheel paths in several areas of the project. Rutting and potholes began forming in several of these areas within a short period thereafter. ODOT maintenance forces have ground and patched the failed areas. Several of the patches also failed.

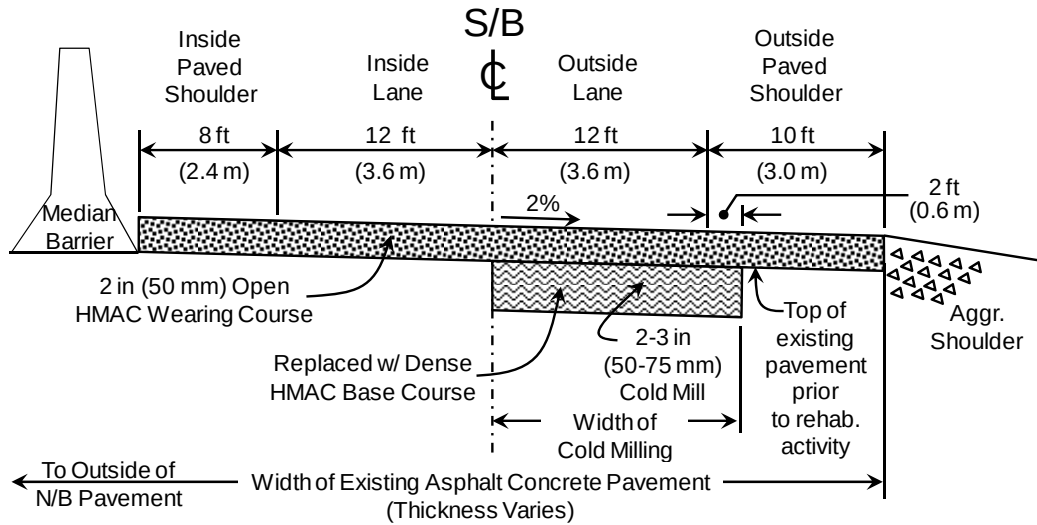
Figure 1.4: As-Built Profile of the Bound Layers for the Anlauf – Elkhead Road Project.

**Observed Problems.** Rutting to depths of 1 inch (25 mm) and greater began to form within 2 years following rehabilitation, principally within the inside lanes, but also in some isolated areas within the outside lanes. ODOT maintenance forces have ground and patched the distressed areas and observations during these activities suggested that the material under the newer material was failing.

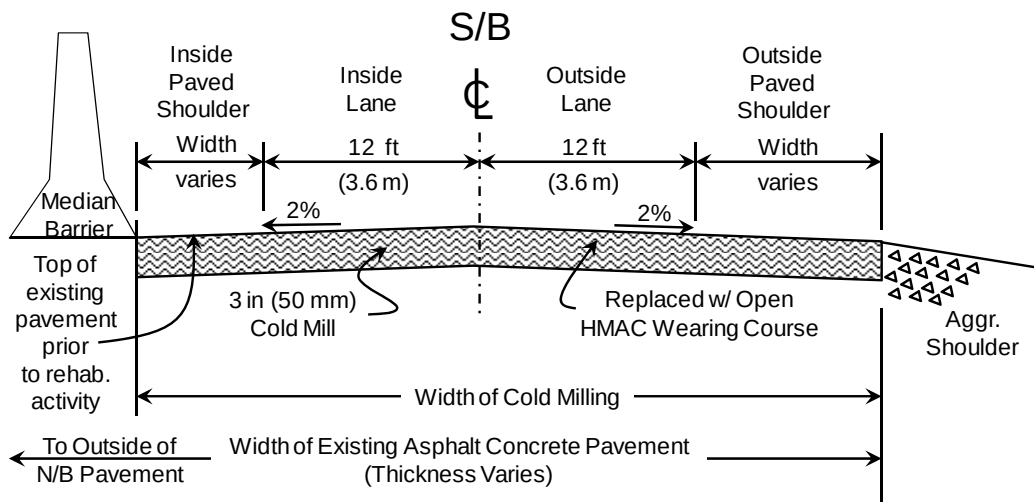
Figure 1.6: As-Built Profile of the Bound Layers for the Vets Bridge – Myrtle Creek Project.

**Observed Problems.** Within approximately 9 months following the rehabilitation activity rutting to depths of 1 inch (25 mm) and greater began to form. Rutting continued to form in additional areas thereafter. Trenching operations at several locations revealed that the material immediately under the new 3/4 inch (19 mm) NMA, open-graded HMA appeared to be stripping.

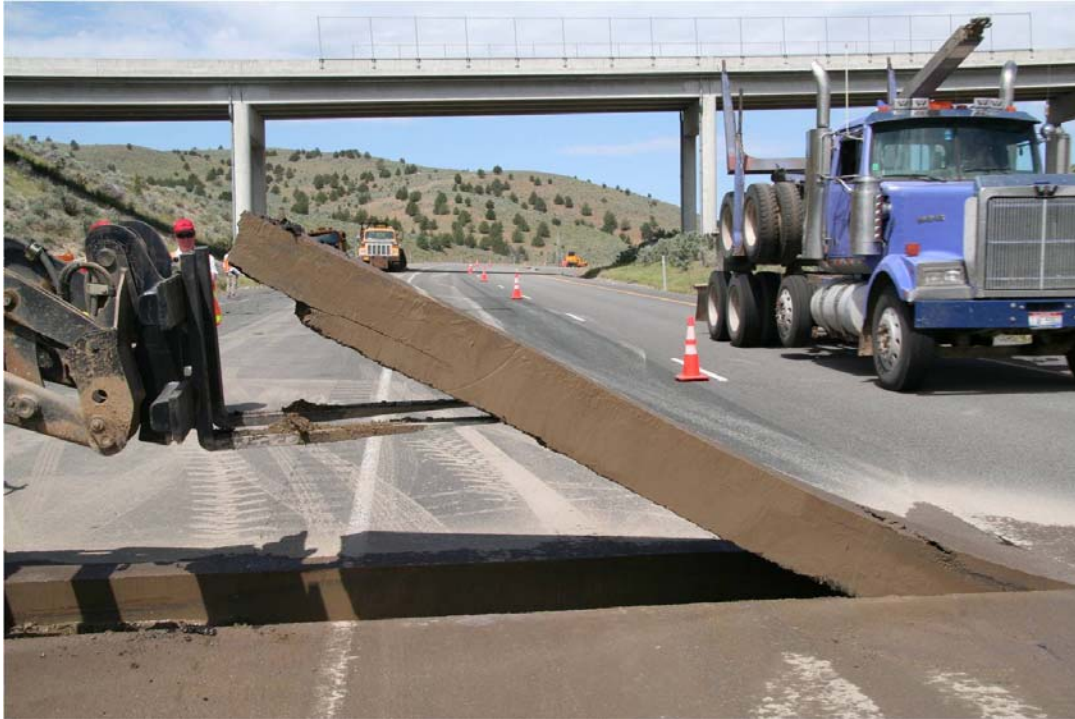
Figure 3.5: Excavation of the Travel Lane Slab with SMA Wearing Course Intact.

- During the trenching operation it was observed that the stone-matrix asphalt (SMA) layer delaminated from the underlying dense-graded layer during the removal of the shoulder slab (Figure 3.4), but not during excavation of the pavement slab across the travel lane (Figure 3.5).

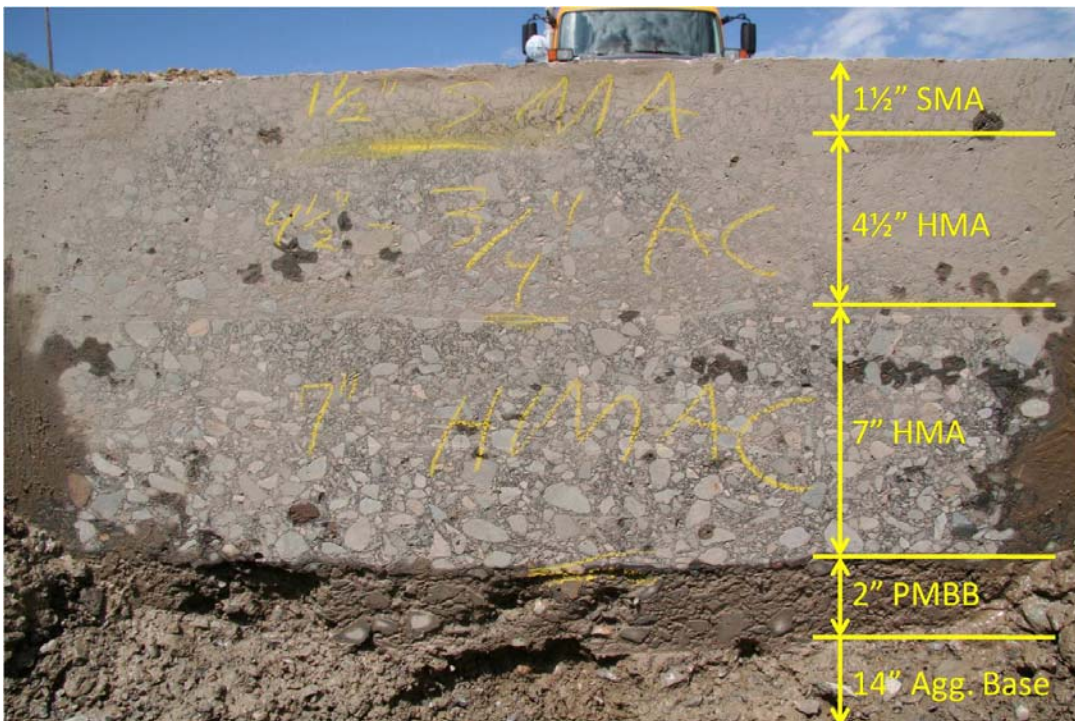
Figure 3.6: Profile of Bound Layers at MP 323.5.

- The bound layers of the pavement structure consisted of 1½ inches of SMA over 4½ inches of dense-graded HMA, over 7 inches of dense-graded HMA, over 2 inches of plant mix bituminous base (PMBB) as shown in Figure 3.6. Note that this picture was taken shortly after the cut face of the upper pavement layers had been wiped clean. Note also that the PMBB appeared to be saturated.

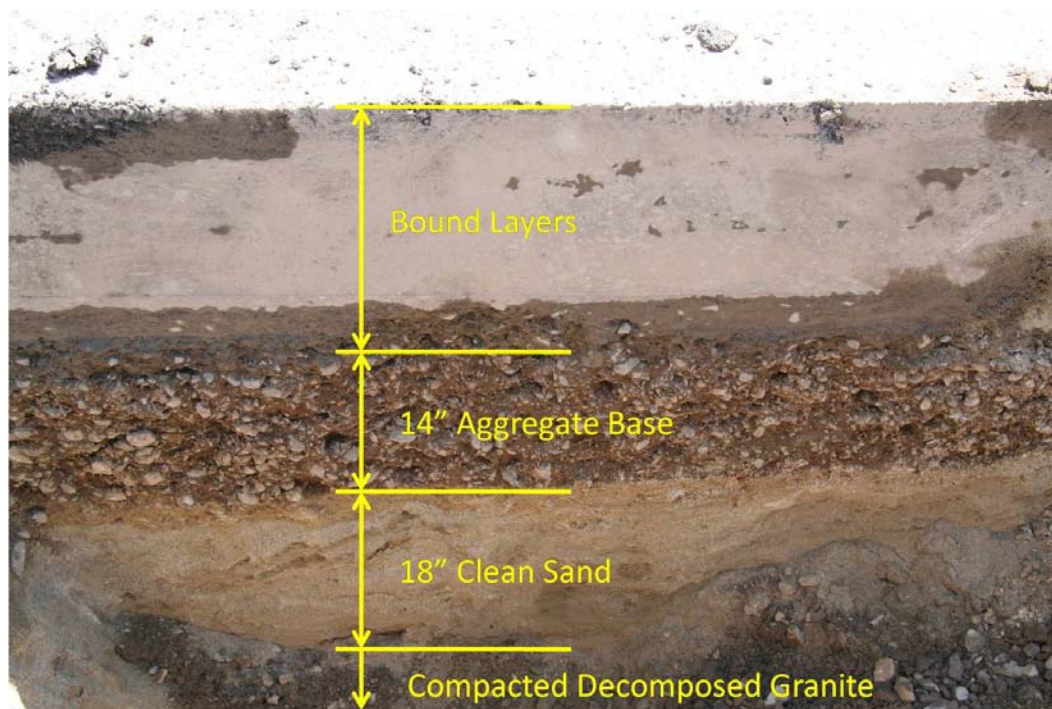
Figure 3.7: Profile of Unbound Layers at MP 323.5.

- The unbound layers consisted of 14 inches of 1”-0” aggregate base, over 18 inches of moist sand, over compacted, sandy decomposed granite as shown in Figure 3.7. It was noted that the aggregate base consisted of mostly round rock with very few fractured faces and that it was highly contaminated with fines.

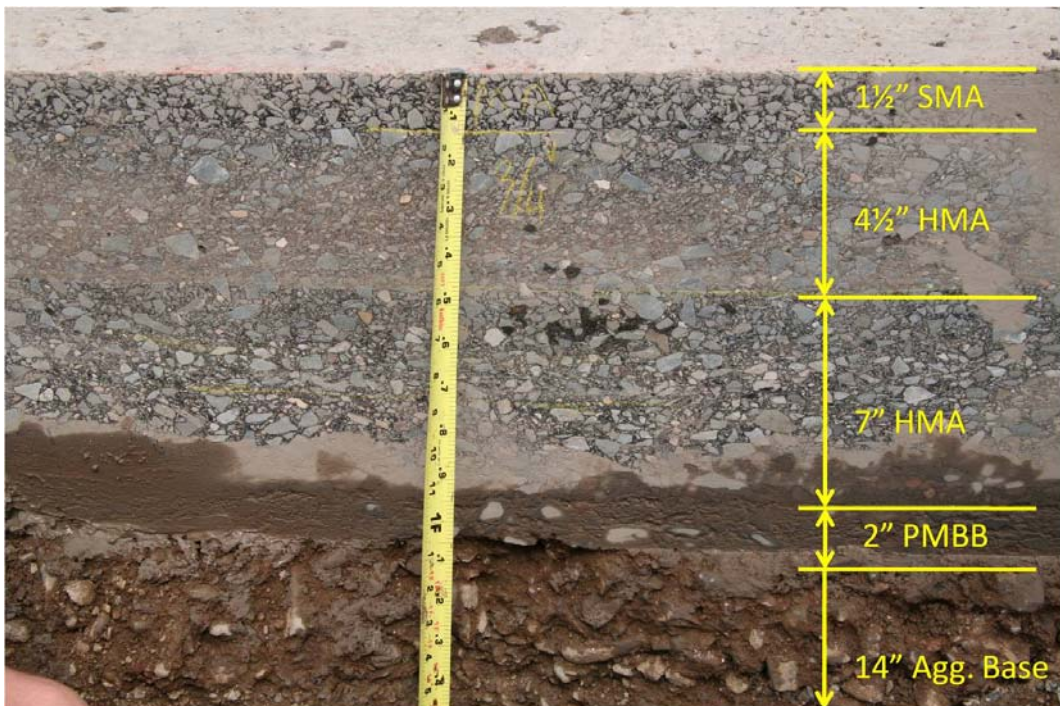
Figure 3.14: Profile of Bound Layers at MP 324.9.

- Figure 3.14, taken shortly after the trench was opened, shows that the depths of the bound layers were essentially the same as those at MP 323.5. Note that the PMBB layer appeared to be saturated and that some water seepage was evident between the upper and lower dense-graded HMA layers.

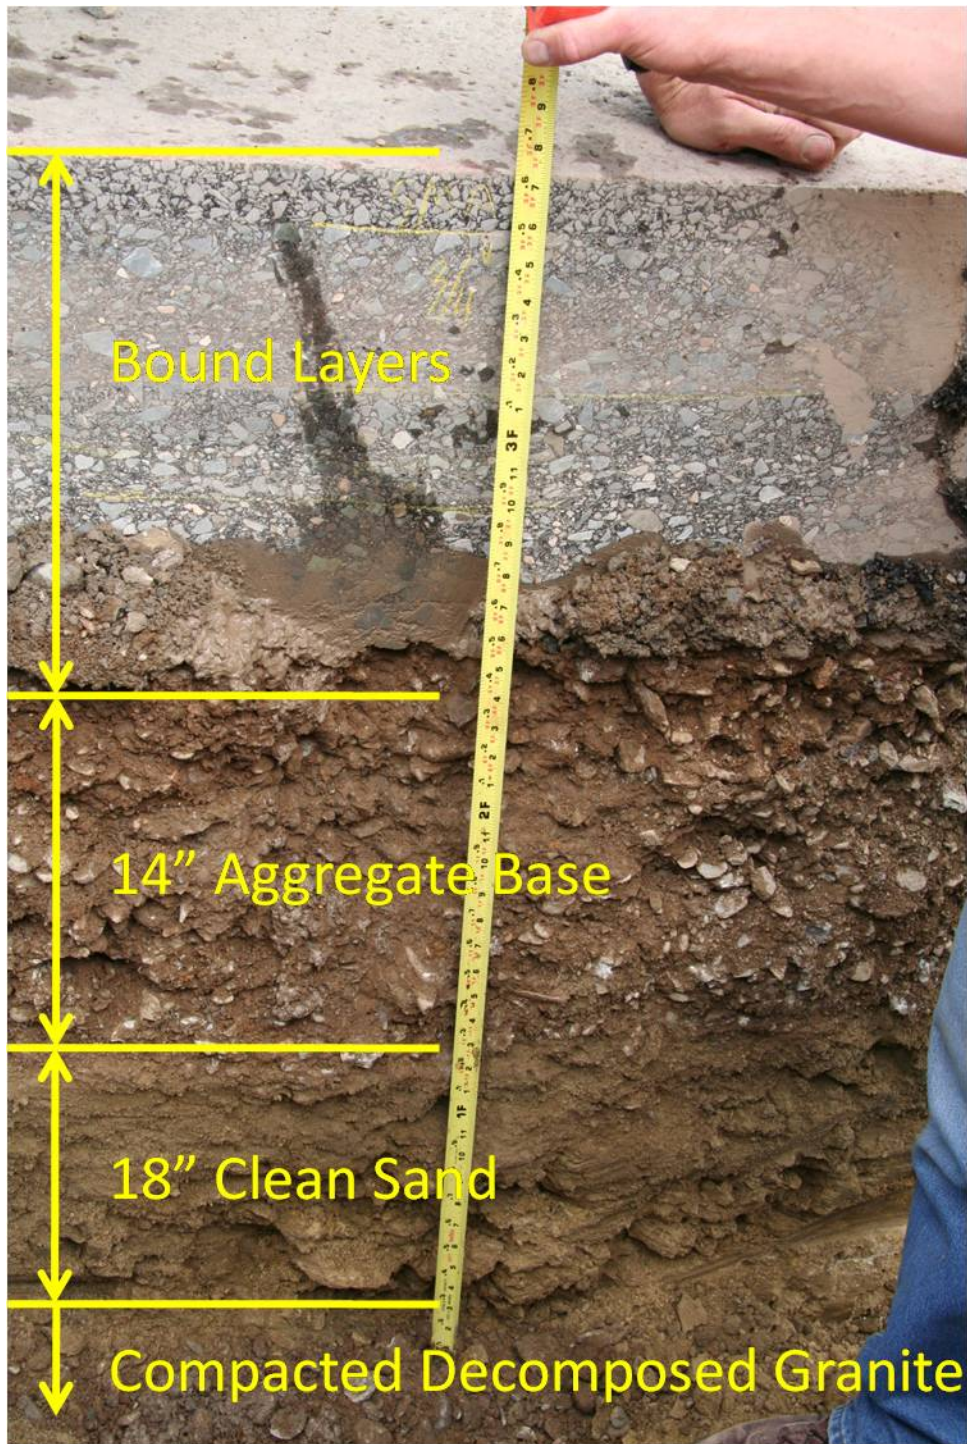
Figure 3.15: Profile of Unbound Layers at MP 324.9.

- Figure 3.15 shows that the depths of the unbound layers were essentially the same as those at MP 323.5.
- Figure 3.16 shows two photos of a portion of the slab removed from the trench indicating clear evidence of significant stripping in the upper and lower portions of the dense-graded HMA layers. Further, these photos indicate that the SMA layer contained a significant amount of asphalt binder, possibly indicating migration of the binder from the HMA layer into the SMA layer.

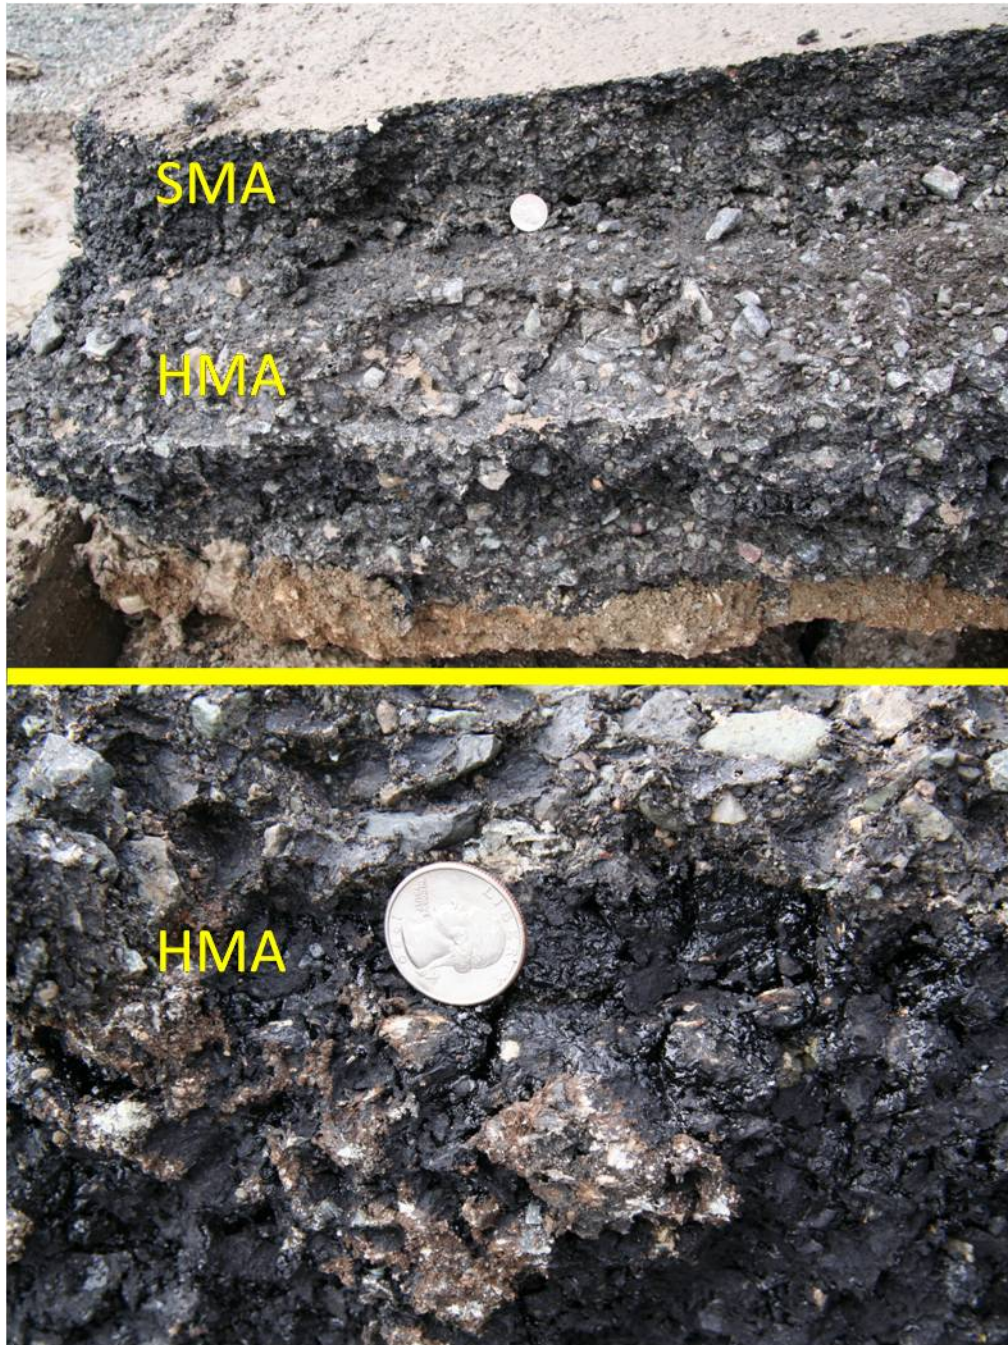
Figure 3.17: Photos of Another Portion of the Slab Removed at MP 324.9.

- The upper half of Figure 3.17 shows a photo of another portion of the slab removed from the trench indicating stripping had occurred in the SMA layer and throughout the HMA layers. The lower half of this figure shows a close-up photo of the upper HMA layer indicating pockets of asphalt binder and bare (stripped) aggregate particles.

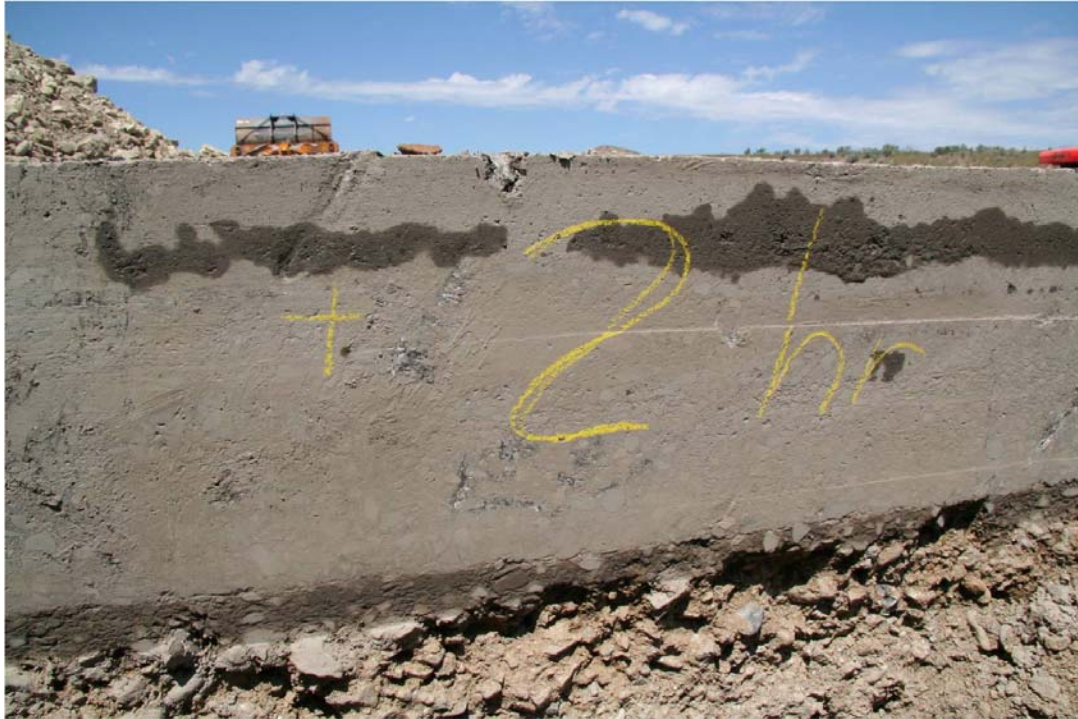
Figure 3.18: Uphill Face of Trench at MP 324.9 Approximately Two Hours After Excavation.

- The photo in Figure 3.18, taken over two hours after the trench had been opened, clearly indicates water seepage between the SMA layer and the underlying HMA layers. It can also be seen from this photo that the PMBB layer appeared to be saturated.

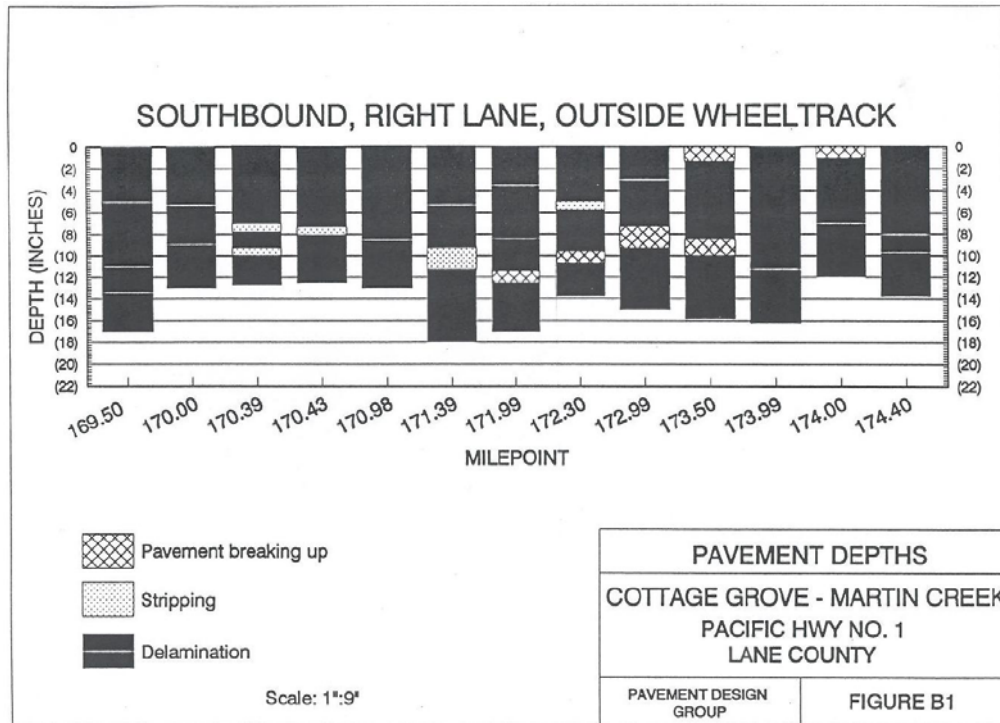
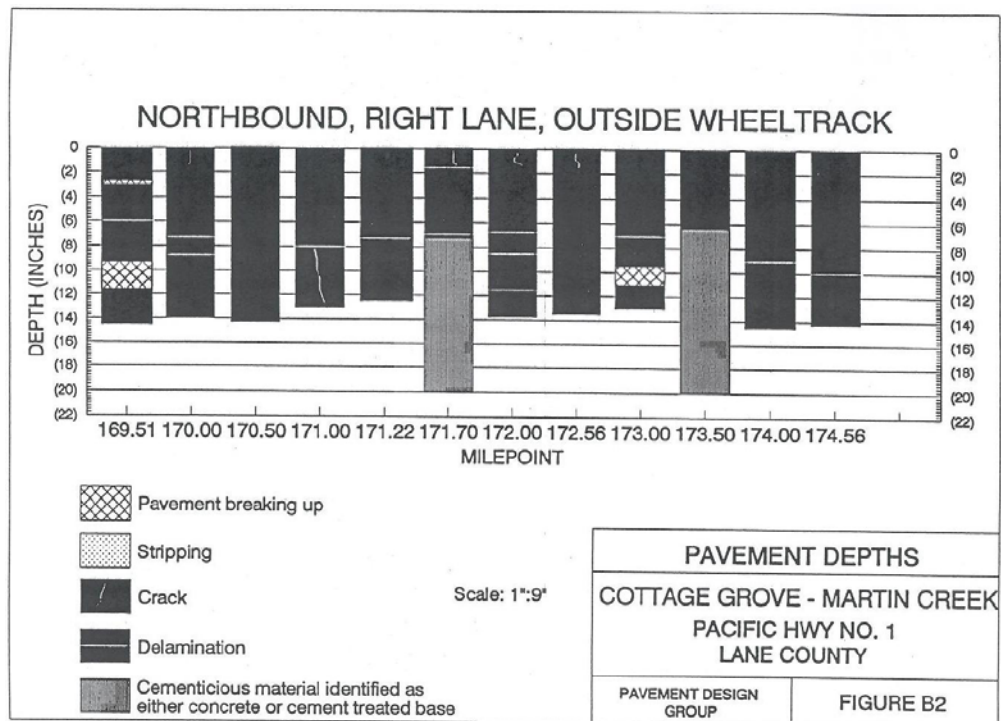
Figure 3.20: Summary of Core Logs for the Cottage Grove – Martin Creek Project.

Figure 3.20 provides a summary of the condition of cores obtained from the outside wheel path of the outside lane in 1995 prior to the rehabilitation activity for this project in 2000. Ignoring the top 2 inches (50 mm), which was removed during the rehabilitation activity, it can be seen from Figure 3.20a (for the cores obtained in the southbound direction) that most of the cores had layers that delaminated during extraction. Three of the four cores obtained between mile points 170.39 and 171.39 showed signs of stripping at depths between about 7 and 11½ inches (180 to 290 mm), and all cores obtained from the stretch between mile points 171.99 and 173.50 had layers with disintegrating material.

The summary for the cores obtained from the northbound direction (Figure 3.20b) indicates that most of the cores had layers that delaminated during extraction, and two cores (from mile points 169.51 and 173.00) had layers with disintegrating material at depths between about 9½ and 11½ inches (240 and 290 mm). Additionally, the log for the core obtained from MP 171.00 indicated that the bottom layer of the pavement core from about 8 to 13 inches (200 to 330 mm) had a crack.

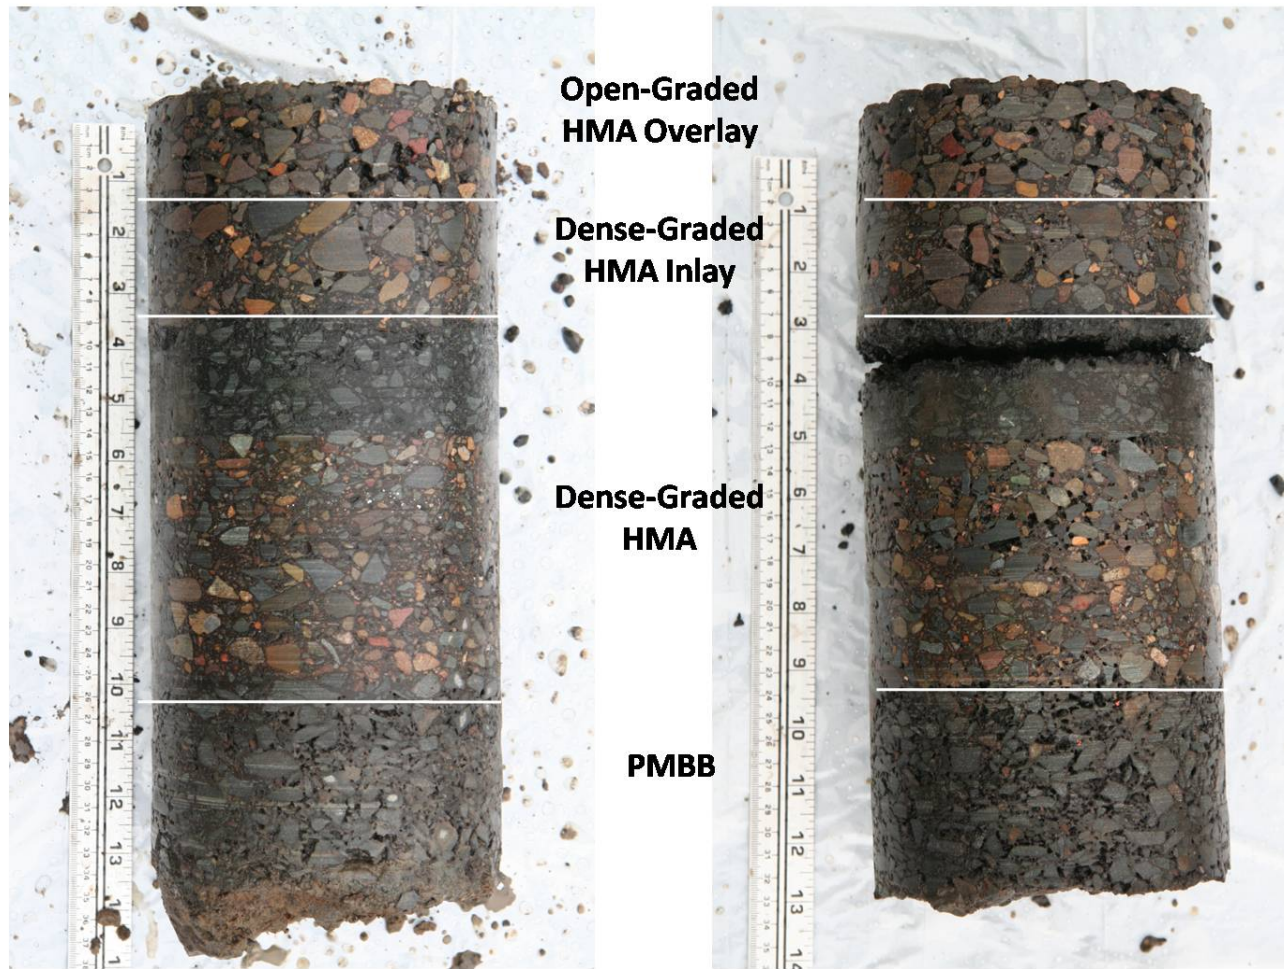
Figure 3.24: Typical Difference Between Adjacent Cores Obtained from MP 157.20 of the Anlauf – Elkhead Road Project.

Figure 3.24 shows a break in the C-Mix layer for the core obtained from the outside wheel track, but not for the core obtained from between the wheel tracks. Four of the six cores obtained from the outside wheel track broke at approximately the same depth, whereas only one core obtained from between the wheel tracks broke at this depth as indicated in Figure 3.25.

Figure 3.25 shows that the core obtained from the outside wheel track broke at both interfaces of the C-Mix layer. It also appears that stripping had occurred in the C-Mix and underlying B-Mix layers as evidenced by the core obtained from between the wheel tracks.

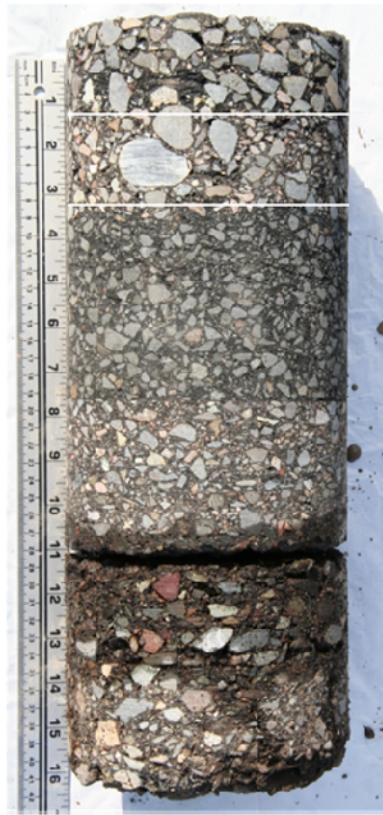
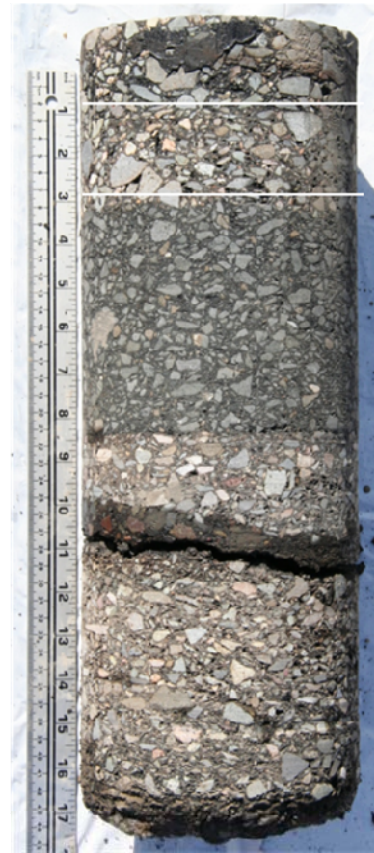
Figure 3.28: Adjacent Cores Obtained from the Garden Valley – Roberts Creek Project.

Two sets of twelve cores (six from the outer wheel path of the outside lane and six from between the wheel paths of the outside lane) were obtained from mile points 118.0 and 118.6 approximately 4 years after the rehabilitation activity. Figure 3.28 shows a comparison of adjacent cores characterizing the typical condition of the pavement layers. In most cases, the cores delaminated at a depth of approximately 11 inches (280 mm). The layer immediately below this was rated on the core logs as being in “Fair” or “Poor” condition in most cases, and stripping was identified for this layer on several of the logs. Appendix I includes the pavement core logs for these cores.

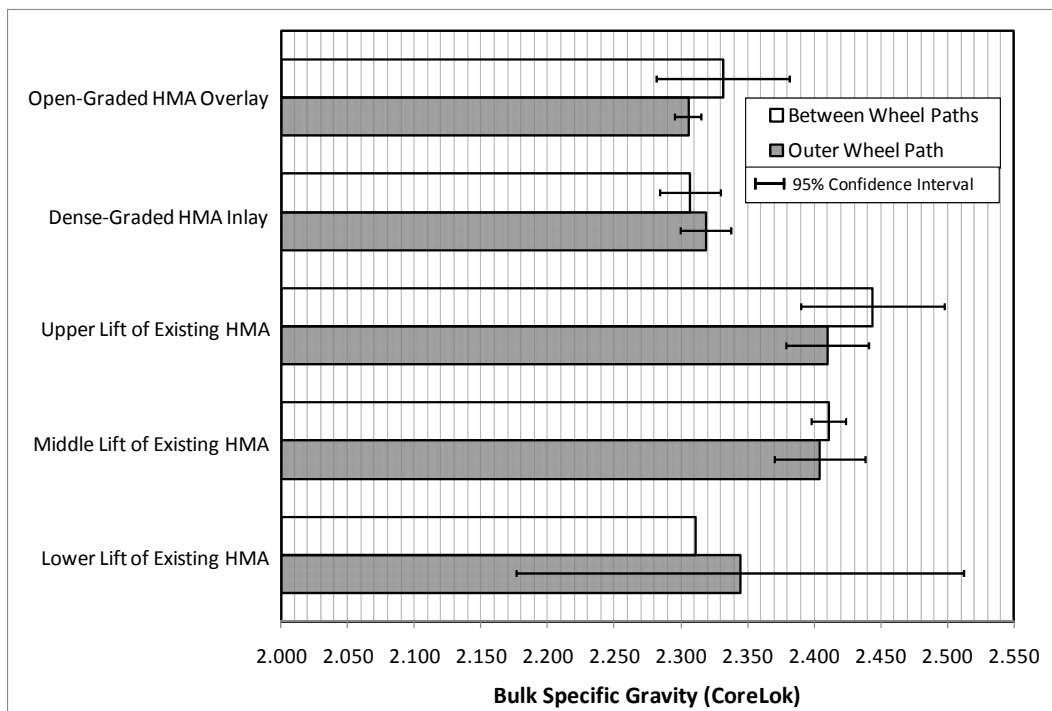
Contrary to expectations, Figure 4.5 also indicates that there is not a significant difference between the densities of the open-graded HMA overlay and the underlying dense-graded HMA inlay. However, there is some evidence to indicate a significant difference in densities between the dense-graded HMA inlay and the top two lifts of the underlying (existing) dense-graded HMA pavement.

Figure 4.5: Comparison of Bulk Specific Gravity Test Results for Cores Obtained Between the Wheel Paths and from Within the Outer Wheel Path at MP 118.0.

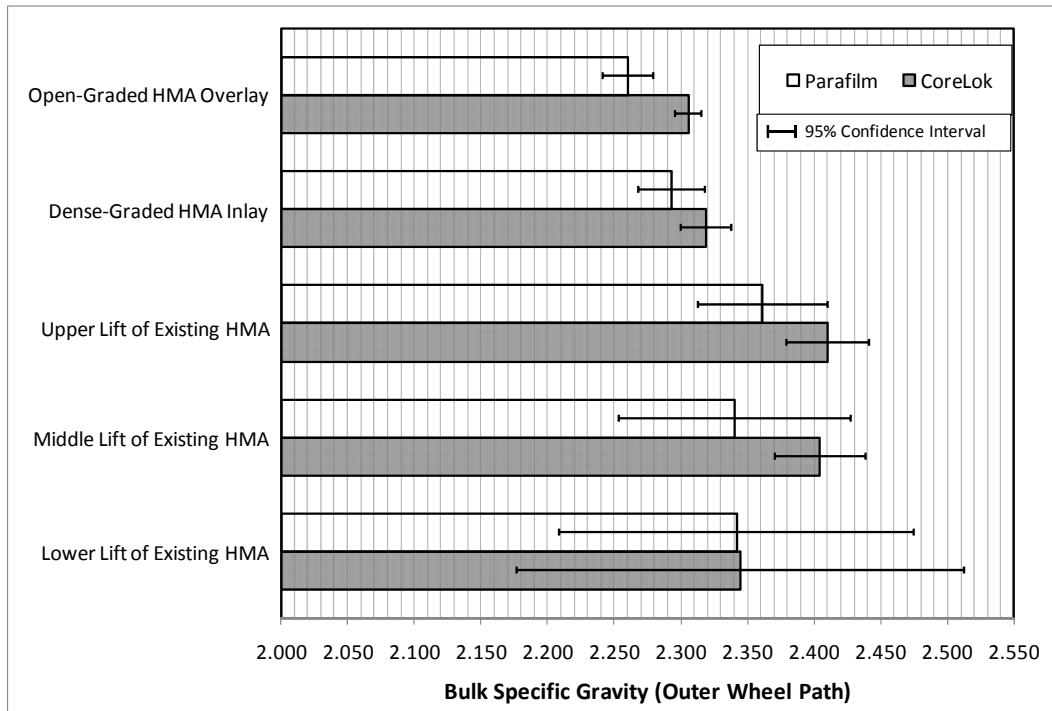
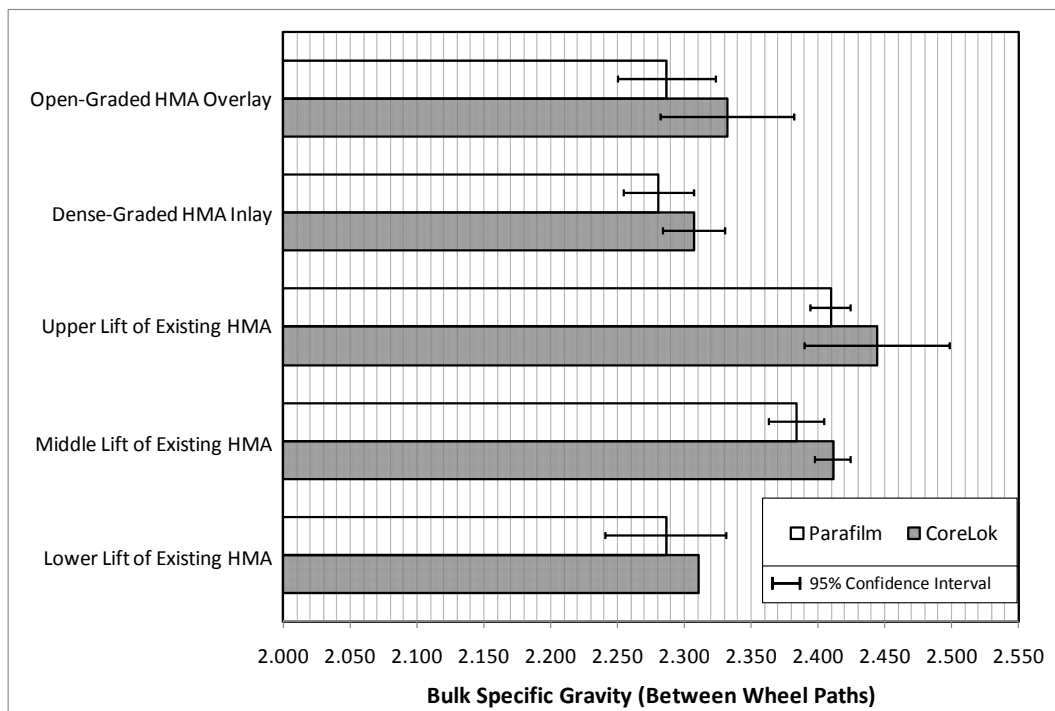
Figure 4.6: Comparison of Bulk Specific Gravity Test Methods for Cores Obtained from MP 118.0.

determining the submerged mass of the specimens. Comparison of the results revealed a slight difference between the two methods, with the parafilm sealing method consistently giving lower values (Figures 4.1, 4.2, 4.3, 4.4, 4.6, 4.8, and 4.12). However, based on statistical comparisons at a 95% confidence level, there was sufficient evidence to indicate that the results were not significantly different in 23 of the 26 cases (88%) of the cases evaluated (Figures 4.6, 4.8, and 4.12).

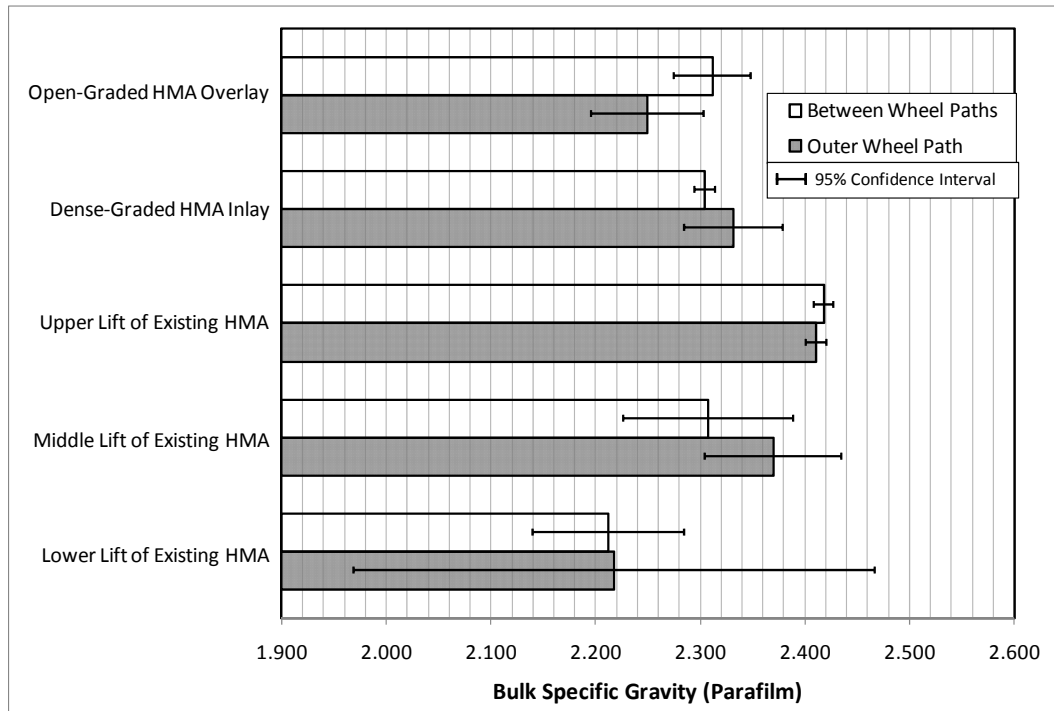
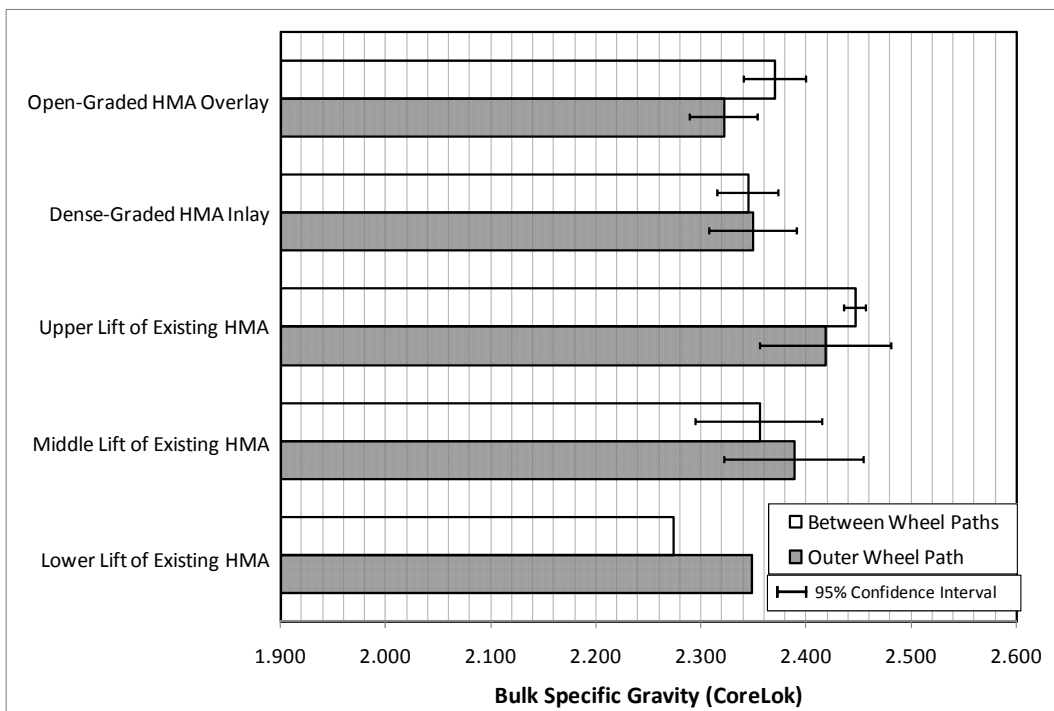
Figures 4.7 and 4.8 show comparisons of densities of the cores obtained from MP 118.6. Inferences nearly identical to those drawn from the results from cores obtained from MP 118.0 can be drawn from these results.

Figure 4.7: Comparison of Bulk Specific Gravity Test Results for Cores Obtained Between the Wheel Paths and from Within the Outer Wheel Path at MP 118.6.

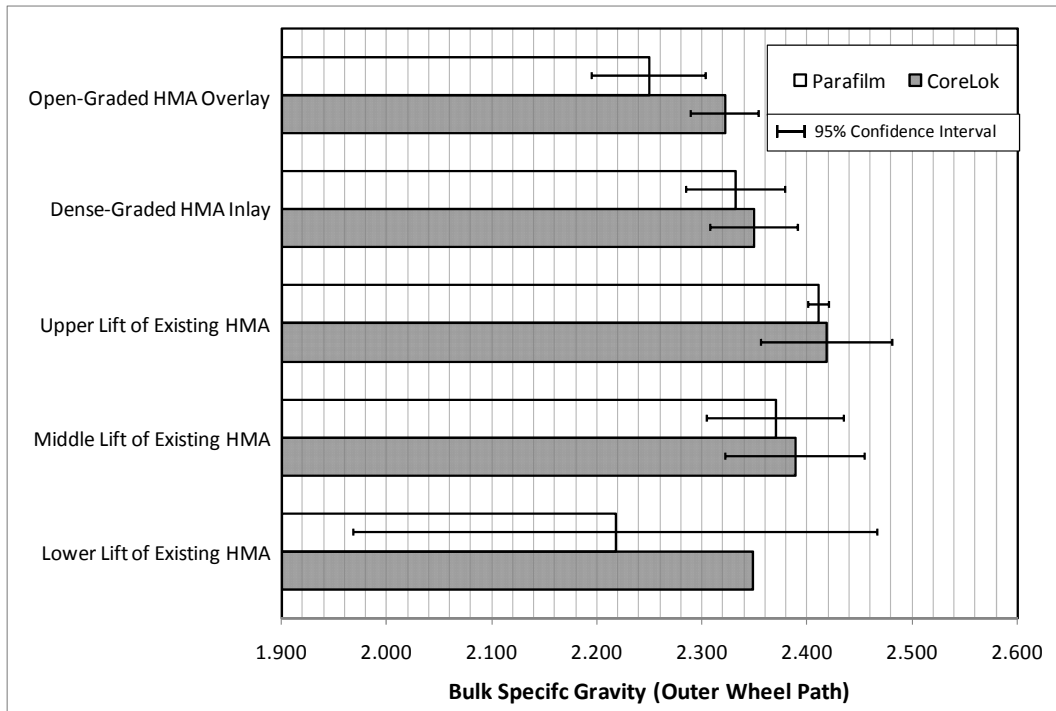
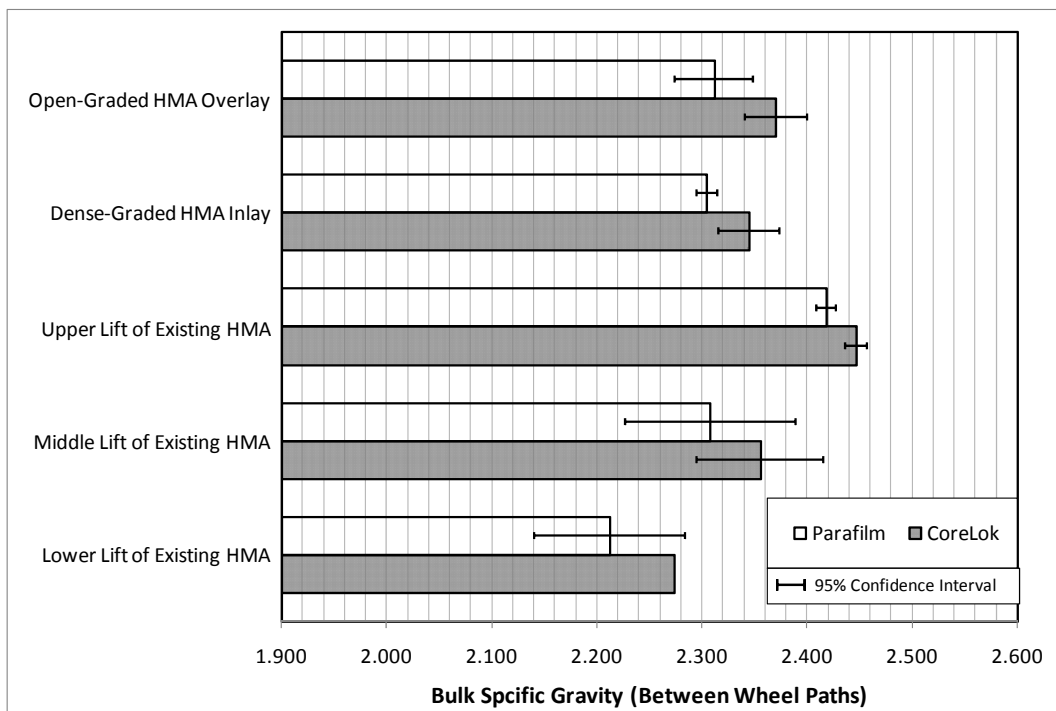
Figure 4.8: Comparison of Bulk Specific Gravity Test Methods for Cores Obtained from MP 118.6.

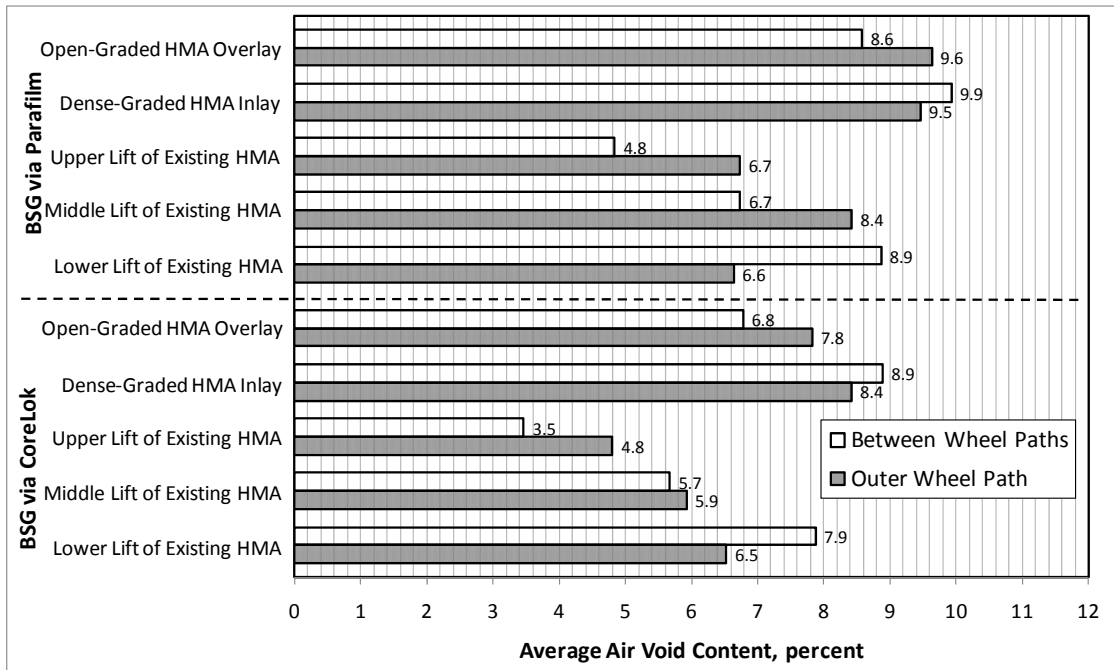
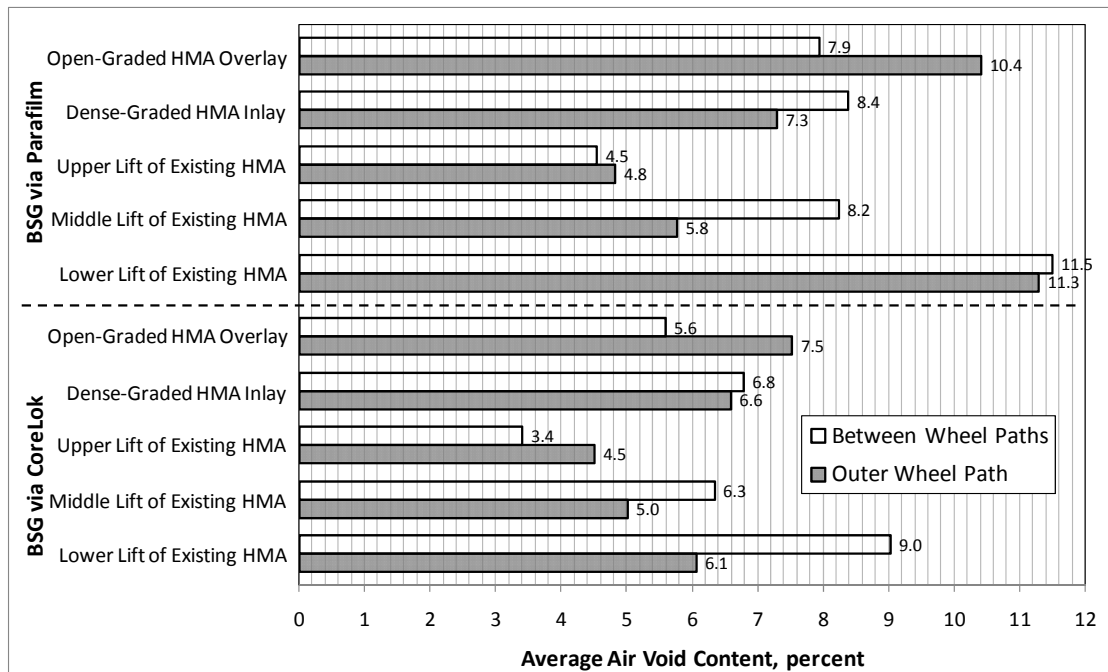
Air void contents of the core slices were determined from the bulk specific gravity and theoretical maximum specific gravity test results in accordance with AASHTO T 269. Figure 4.9 shows the air void contents for the cores obtained from both coring locations. As indicated, the dense-graded HMA inlay had similar or slightly lower air void contents than the overlying open-graded HMA overlay and higher air void contents than the top lift of the underlying (existing) dense-graded HMA pavement. The results also indicate that the air void contents of the three lifts of existing dense-graded HMA pavement increased with depth.

Figure 4.9: Air Void Content of Cores from the Garden Valley – Roberts Creek Project.

The air void content was determined for the core slices from the Garden Valley – Roberts Creek and Vets Bridge – Myrtle Creek projects. For the former project, the results indicated that the dense-graded HMA inlay had an unexpectedly high air void content very similar to the overlying open-graded HMA overlay (Figure 4.9). Assuming that the test results are reasonably accurate, this indicates that the dense-graded layer was probably not adequately compacted in the stretch of pavement from which the cores were obtained and/or that moisture damage had occurred. The presence of water in the dense-graded layer hours after excavation of the trench along this project (Figure 3.29) indicated that the layer was conducting water and, thus, provides corroborating evidence to indicate that the layer was not adequately compacted or had incurred moisture damage, or both. It should be noted that the air void content of the open-graded HMA overlay was much lower than the design air void content of 13½ to 16%, possibly due to the mixture being clogged with debris or over-compacted during construction. The presence of water in the open-graded layer hours after excavation of the trench (Figure 3.29) indicated that the layer was retaining water, which likely contributed to the presence of water in the underlying dense-graded layer.
