**INVESTIGATING PREMATURE  
PAVEMENT FAILURE DUE TO  
MOISTURE**

**FINAL REPORT**

**SPR 632**

Oregon Department of Transportation

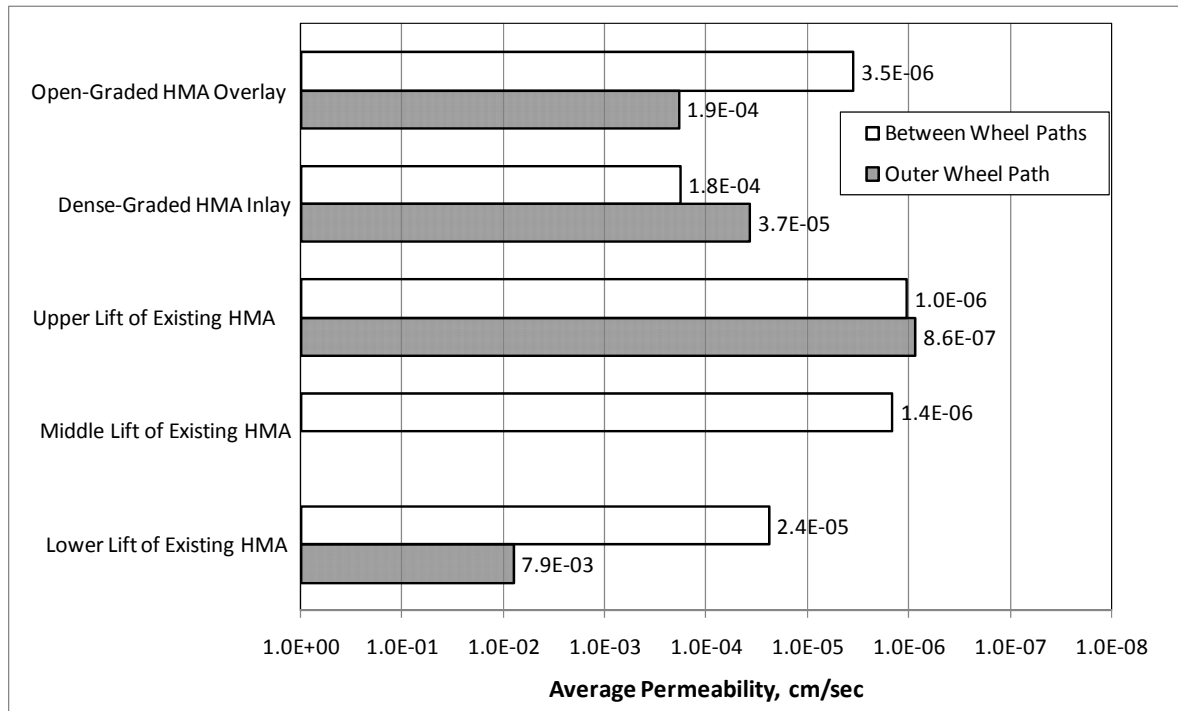
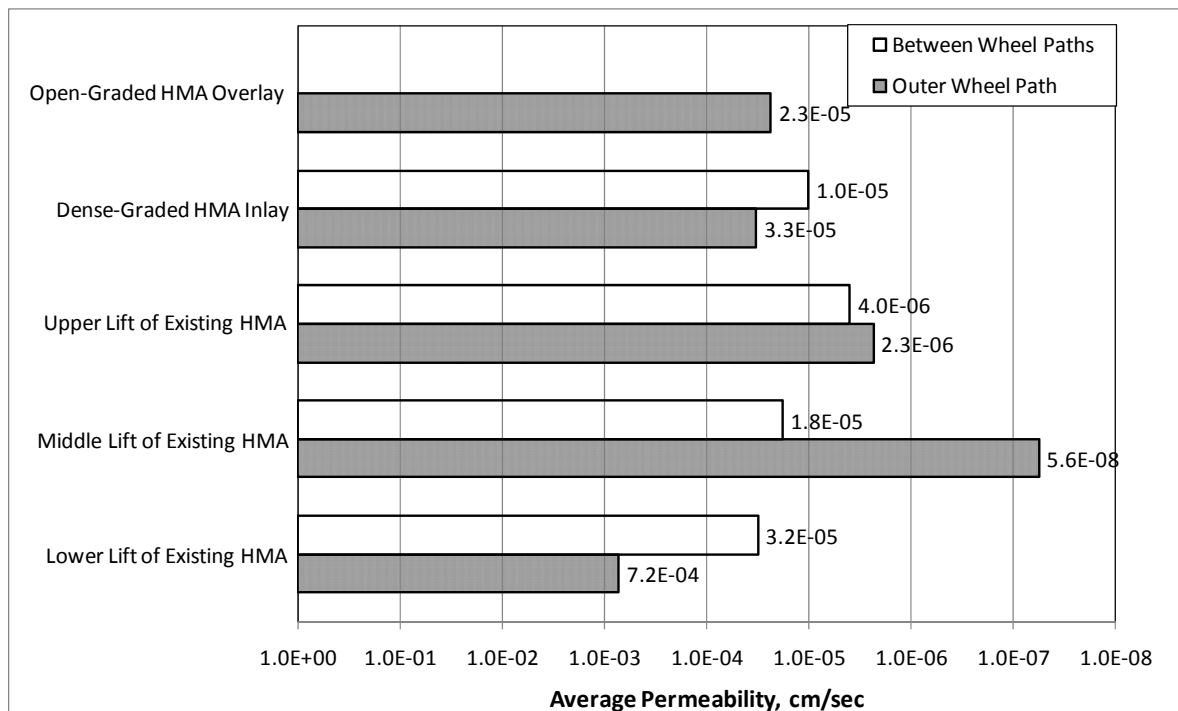
Several of the core slices were tested for permeability in accordance with Florida DOT test method FM 5-565 as shown in Table 4.9. The results shown in Figure 4.10 indicate that the permeability of the core slices from the dense-graded HMA inlay were of similar magnitude to the core slices from the overlying open-graded HMA overlay and higher than the top lift of the underlying (existing) dense-graded HMA pavement.

It is also evident from the results that the permeability of the existing dense-graded pavement increased with depth. At both core locations the permeability of the lowest portion of the existing dense-graded HMA pavement was of similar magnitude to, or slightly higher than, the open-graded HMA overlay layer.

Figure 4.10: Permeability of Cores from the Garden Valley – Roberts Creek Project.

As found by other researchers (*McGhee, et al. 2008*), considerable variability existed amongst the permeability test results (Tables 4.3, 4.9, and 4.13). Nevertheless, the means (averages) of the test results indicated reasonable trends that generally corroborated the observations made during the trenching activities of the three projects that were trenched. That is, layers with relatively high permeability values were observed to conduct water, whereas layers with relatively low permeability values did not (compare Figure 3.29 with Figure 4.10 and compare Figure 3.34 with Figure 4.14).

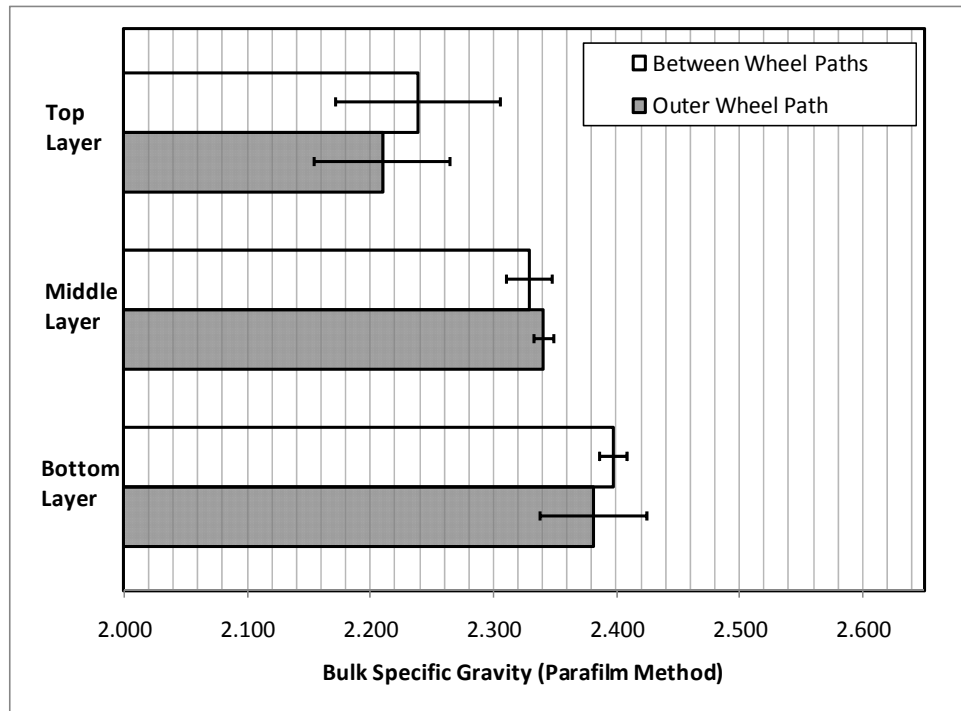
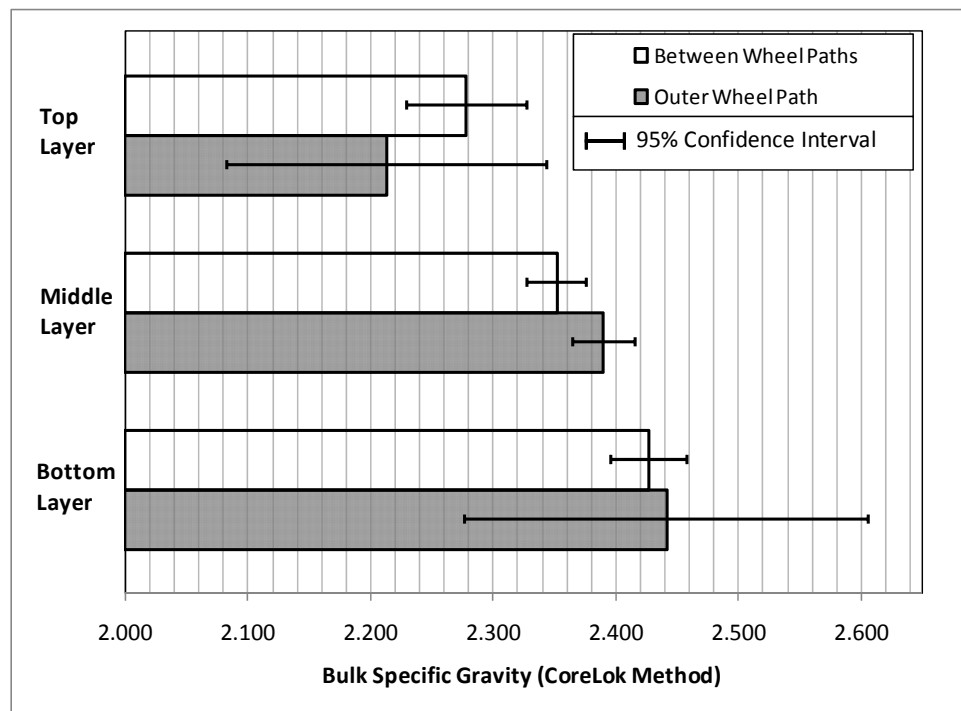
Figure 4.11 compares the results of bulk specific gravity tests conducted on the cores obtained between wheel paths to those of cores obtained in the outside wheel path from MP 109.9 for both methods of measurement. In all cases for a given lift, there exists sufficient evidence at a 95% confidence level to indicate that there is not a significant difference between results from cores obtained between wheel paths and those obtained from the outside wheel path.

Figure 4.11: Comparison of Bulk Specific Gravity Test Results for Cores Obtained Between the Wheel Paths and from Within the Outer Wheel Path at MP 109.9.

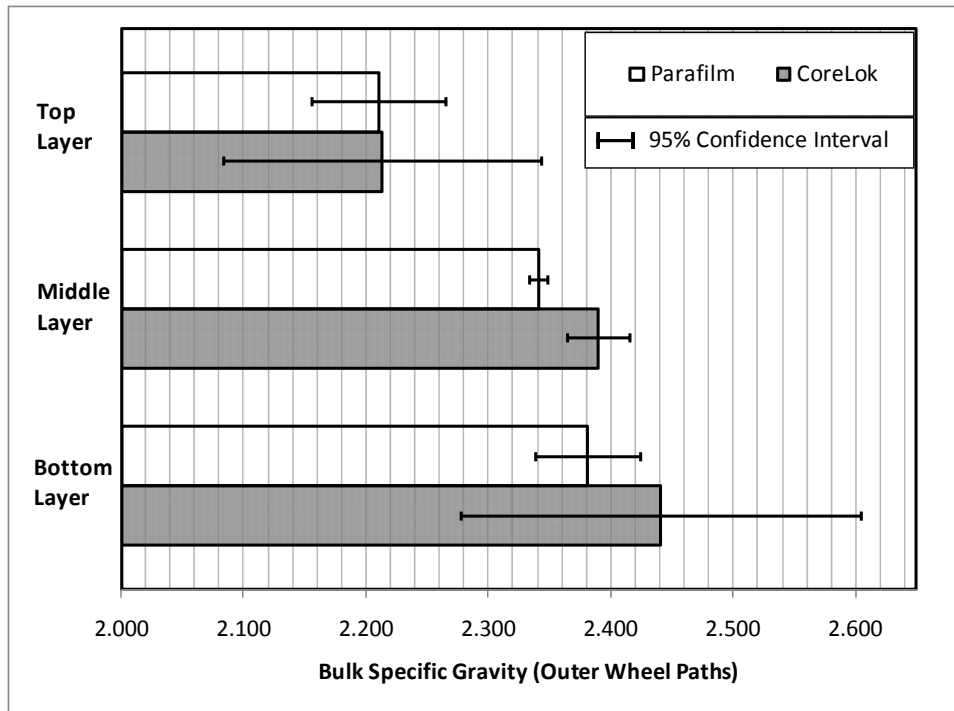
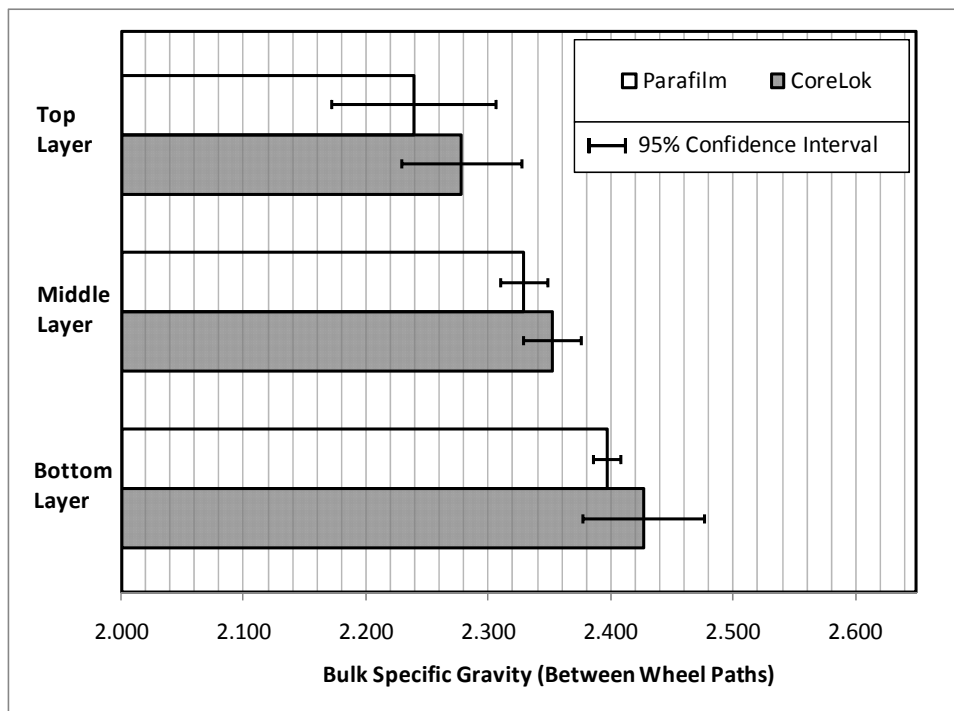
Figure 4.12 compares the bulk specific gravity test results based on method of measurement for the cores obtained from between wheel paths and those obtained from the outer wheel path from MP 109.0. In all but one case for a given lift, there exists sufficient evidence, at a 95% confidence level, to indicate that there is not a significant difference between results based on method of measurement.

Figure 4.12: Comparison of Bulk Specific Gravity Test Methods for Cores Obtained from MP 109.9.

determining the submerged mass of the specimens. Comparison of the results revealed a slight difference between the two methods, with the parafilm sealing method consistently giving lower values (Figures 4.1, 4.2, 4.3, 4.4, 4.6, 4.8, and 4.12). However, based on statistical comparisons at a 95% confidence level, there was sufficient evidence to indicate that the results were not significantly different in 23 of the 26 cases (88%) of the cases evaluated (Figures 4.6, 4.8, and 4.12).

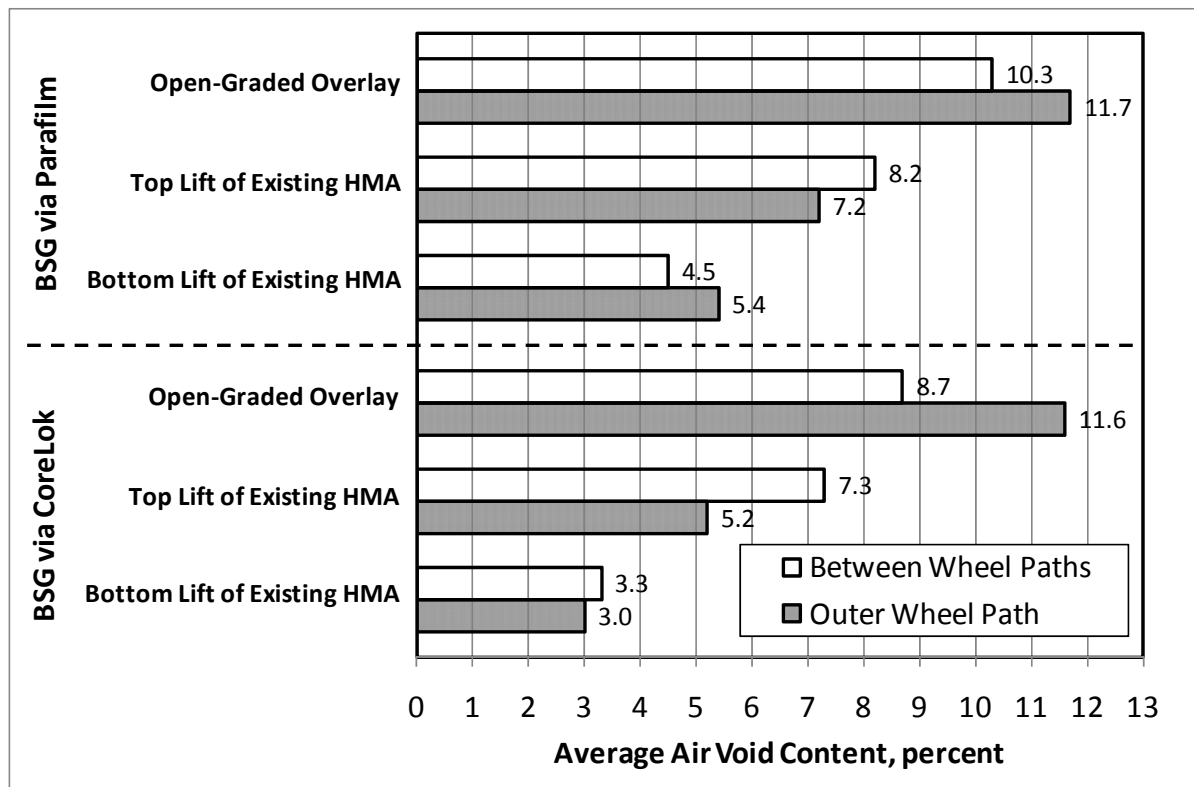
Air void contents of the core slices were determined from the bulk specific gravity and theoretical maximum specific gravity test results in accordance with AASHTO T 269. Figure 4.13 summarizes the results derived from both methods of bulk specific gravity (BSG) measurement. It indicates that the open-graded HMA overlay layer had the highest air void content (although lower than expected), and air void content decreased with depth in the existing HMA layer. Comparing results derived from cores obtained in the wheel path to those of cores obtained between wheel paths, it can be seen that there is greater than 2% difference between air void contents for the open-graded HMA overlay layer and top lift of the existing dense-graded HMA layer, but essentially no difference for the bottom lift of the existing dense-graded HMA layer.

Figure 4.13: Air Void Content of Cores from the Vets Bridge – Myrtle Creek Project.

For the Vets Bridge – Myrtle Creek project, the test results indicated that the air void content of the dense-graded layer (top lift of existing HMA in Figure 4.13) was higher than expected for a pavement that had received years of trafficking, likely indicating that moisture damage had occurred assuming the layer had been properly compacted. The presence of moisture in this layer, as observed hours after the trench along this project had been excavated (Figure 3.34), provides corroborating evidence that moisture damage had likely occurred in this layer.

Another interesting observation of the results is that the air void content of the open-graded wearing course layer was greater in the outer wheel path than between the wheel paths (Figure 4.13). Given this, and that bleeding in the wheel paths had occurred in the stretch of pavement from which the cores were obtained, it is possible that moisture damage had occurred in the wheel paths of the open-graded HMA overlay.

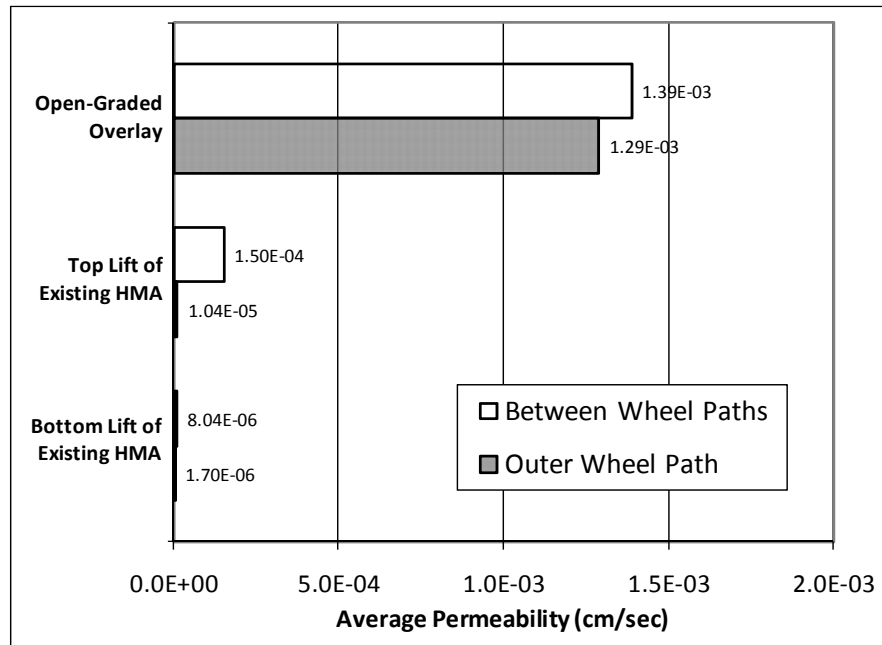
Several of the core slices were tested for permeability in accordance with Florida DOT test method FM 5-565 as shown in Table 4.13. The results shown in Figure 4.14 indicate that the open-graded HMA overlay layer had a much higher permeability than either lift of the underlying dense-graded HMA layer, and that the bottom lift of the dense-graded HMA layer had a much lower permeability than the top lift of the dense-graded HMA layer. Comparing the results shown in Figure 4.13 with those shown in Figure 4.14, it can be seen that there appears to be a reasonable correlation between air void content and permeability of the pavement layers, with higher air void content corresponding to higher permeability.

Figure 4.14: Permeability of Cores from the Vets Bridge – Myrtle Creek Project.
