**INVESTIGATING PREMATURE PAVEMENT
FAILURE DUE TO MOISTURE**

FINAL REPORT

SPR 632

July 2009

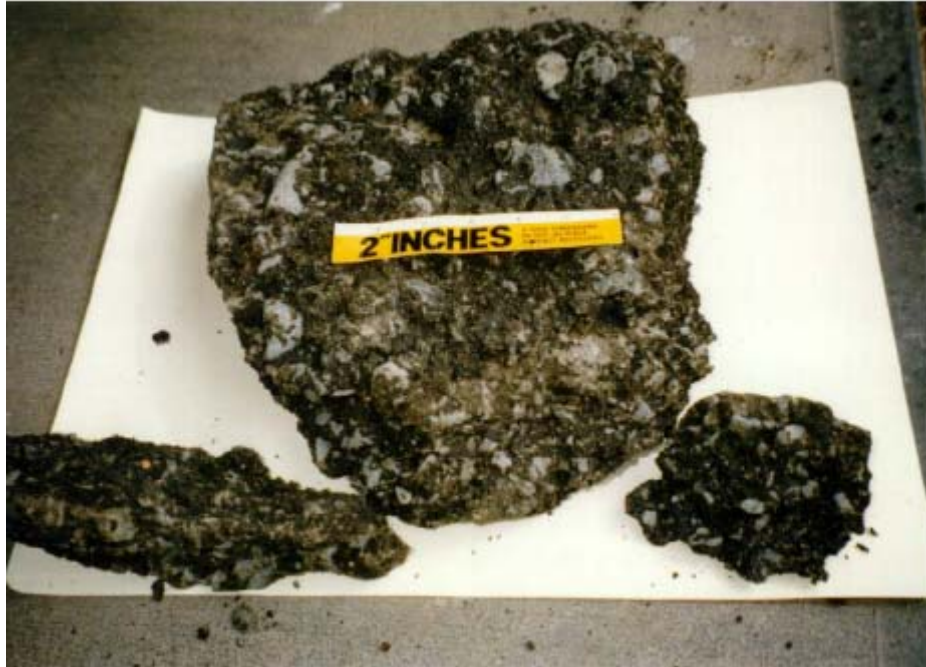
Figure A-3.3: Example of Badly Stripped AC 28 and AC 14 Courses.

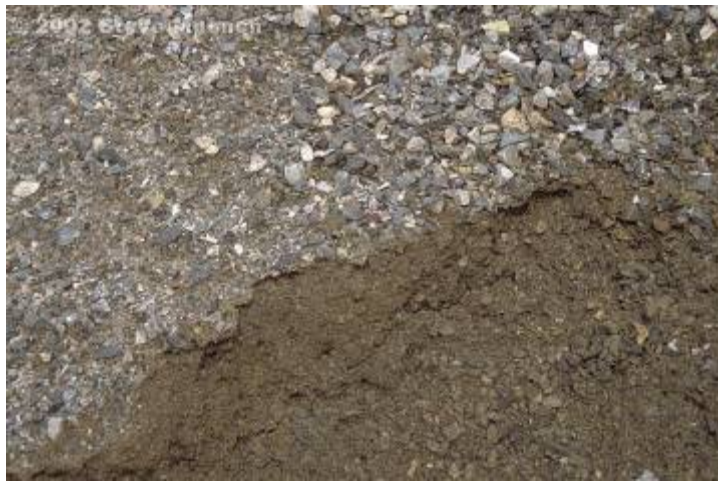
Figure A-5.4: Aggregate Segregation in Stockpile (*After WAPA 2002*)

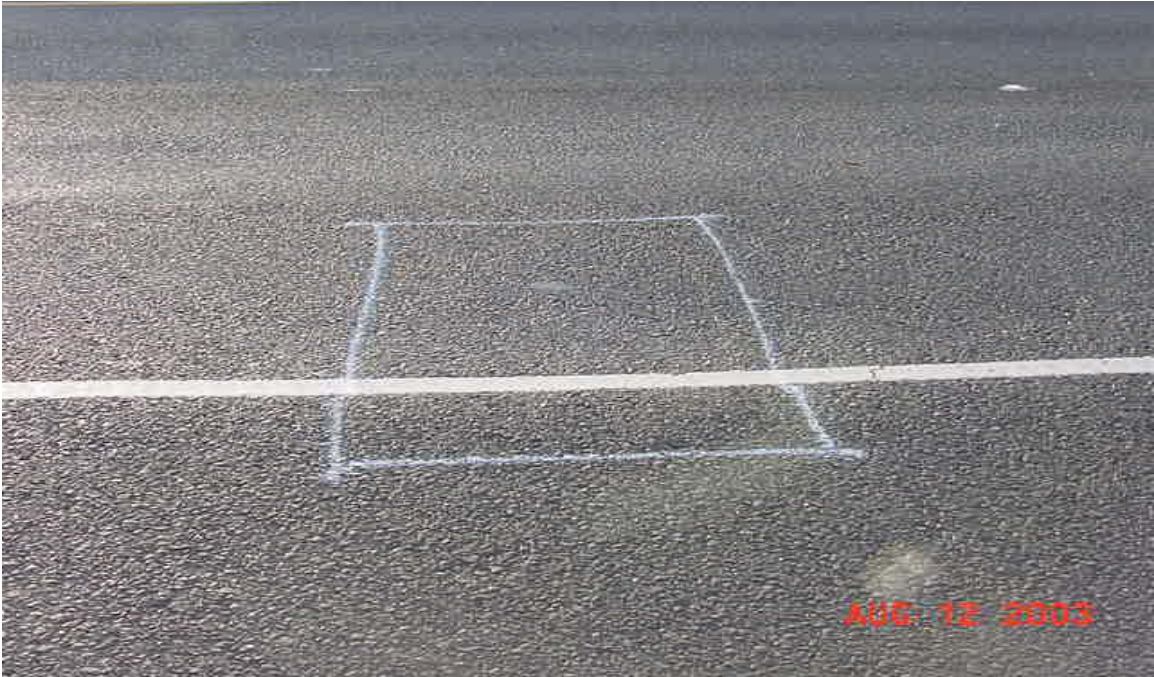
The first trench was cut in the outside wheelpath approximately 3 feet from the end of the bridge-end panel along the fog stripe (Figure C-1.1). ODOT personnel reported that an area of unstable HMA at about 3.5 to 4 inches below the surface was observed (Figure C-1.2). It was concluded that the mix was stripping, as evident from the pictures (Figure C-1.3 and C-1,4) that showed a dry mix consisting of mostly uncoated aggregates. The investigation team was unable to distinguish the layer to which the uncoated aggregates belonged. This was due to the fact that the trenching was performed using a backhoe. The sides of the trench clearly showed a layer of stripping in the wheelpath (Figure C-1.4).

Figure C-1.1: First Trench Cut in an Area of Observed Distress

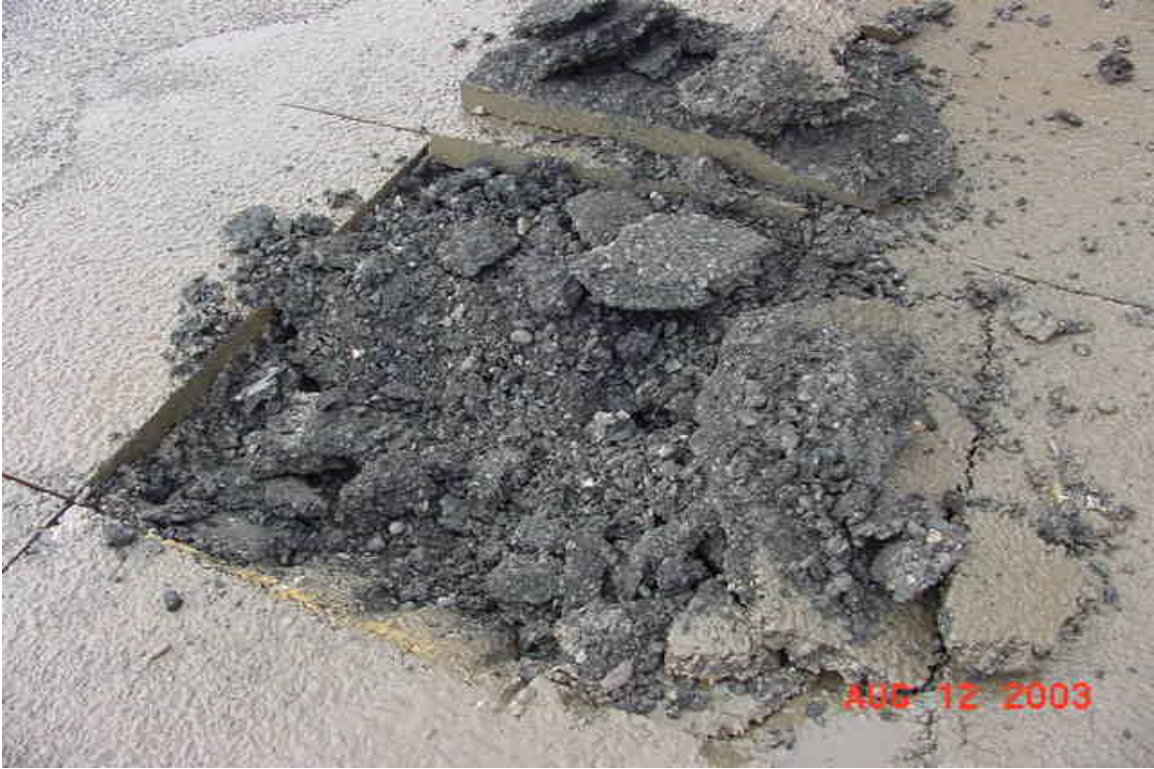
Figure C-1.2: Unstable Mix from the Trench

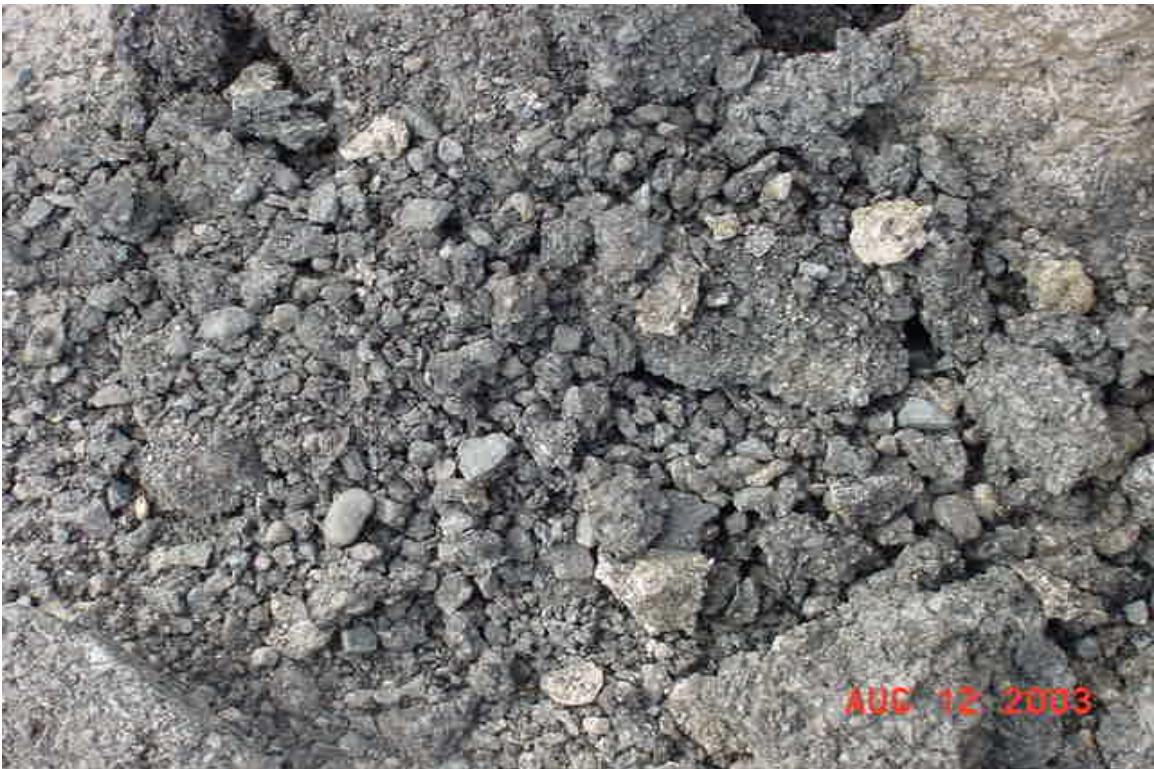
Figure C-1.3: Aggregates Removed From the Trench Showed Signs of Stripping

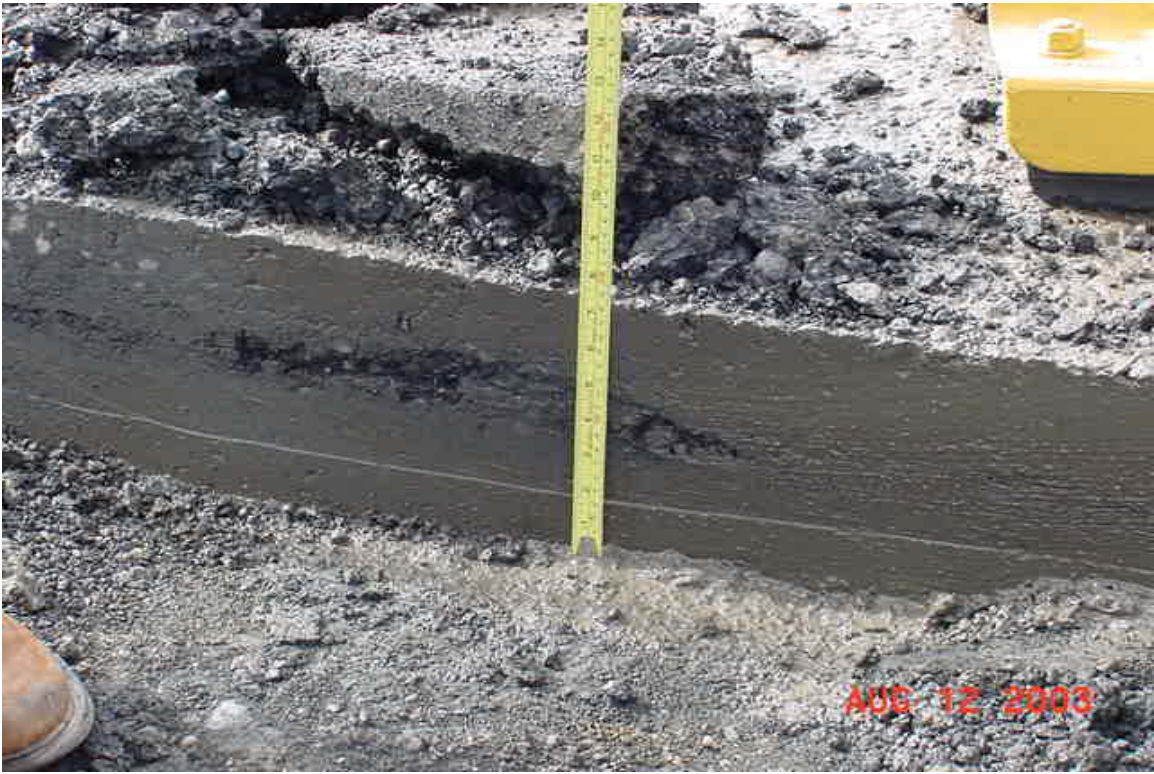
Figure C-1.4: Sides of Trench Showing Evidence of Stripping

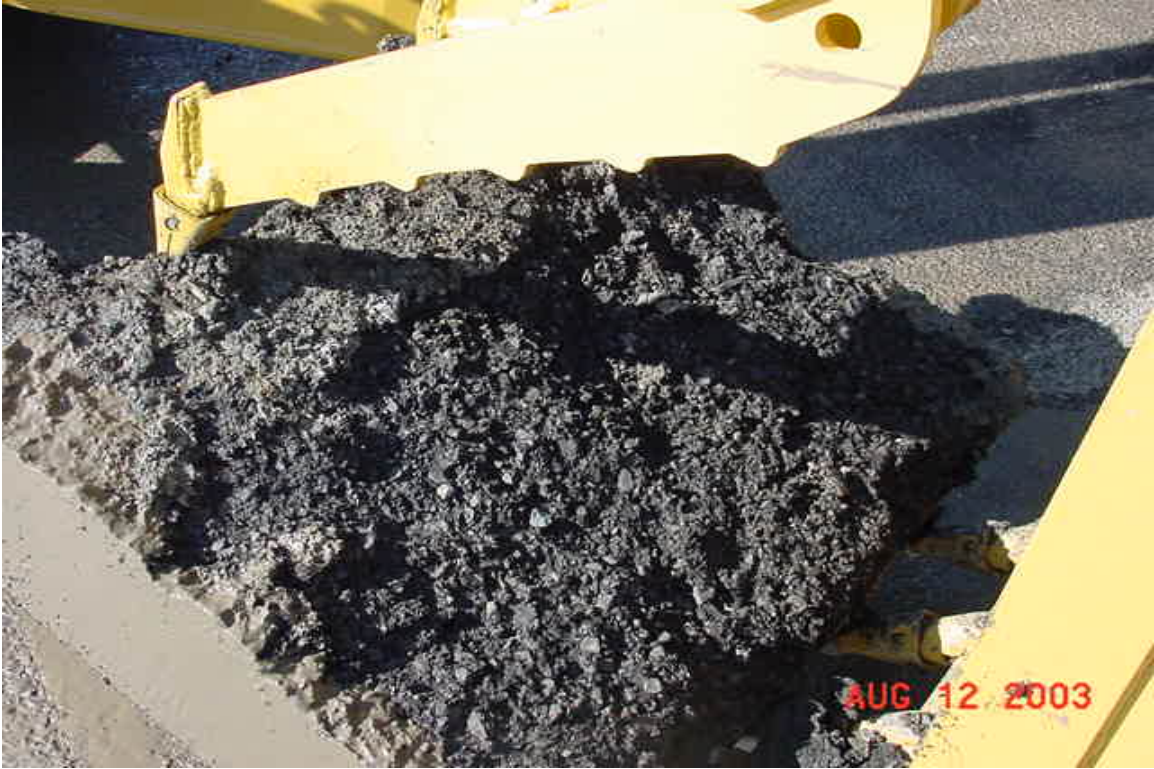
The second trench was cut in an area that did not experience any failure. The material was in much better condition, did not show much stripping, and the stripping had not progressed to the same extent as the previous area (Figures C-1.5 and C-1.6).

Figure C-1.5: HMA Layer Trenching With Back Hoe in Second Trench

Figure C-1.6: Picture of the Sides of the Second Trench

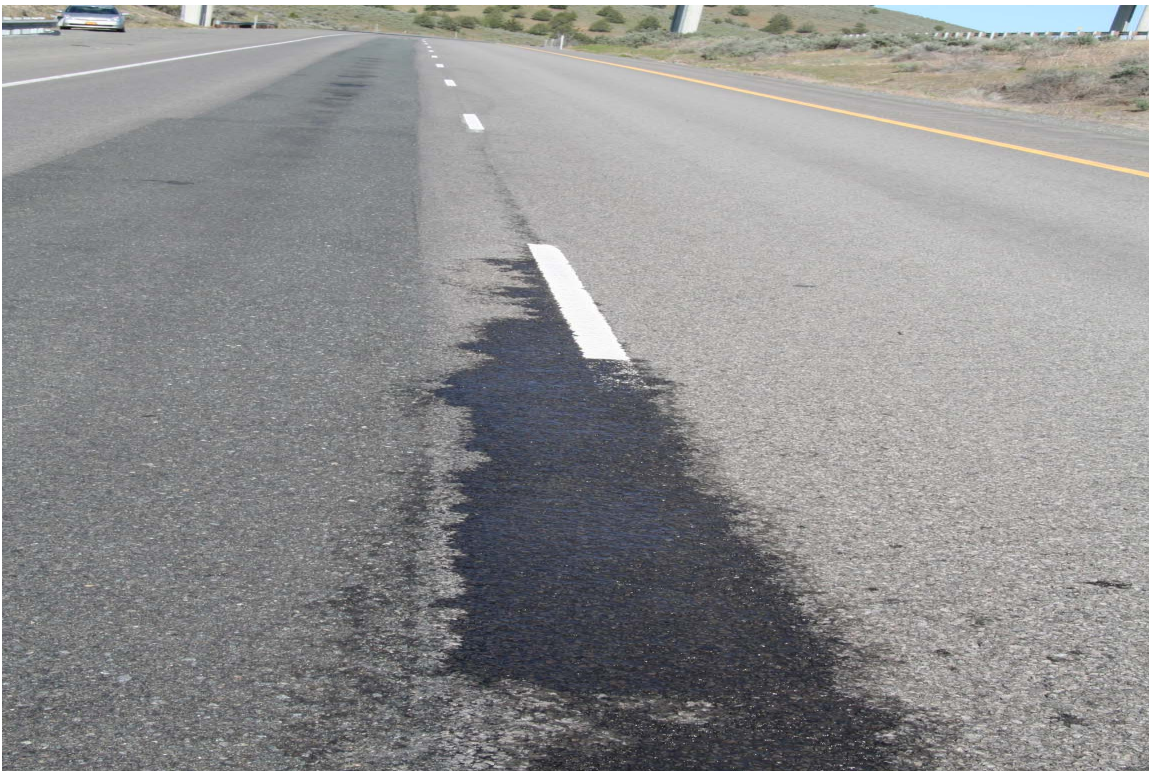
Eastbound Direction: The eastbound lanes were in good condition for about three miles and only one pothole was observed. The pavement condition became poorer just east of MP 323 near the underpass approximately at MP 323.5. Water was seen coming out of the construction joints at isolated locations as shown in Figure D-1.1 and D-1.2 and the water had a greenish brown color as shown in Figure D-1.3. Rutting was also noticed in some locations. Several patches were noticed east of MP 323.5 throughout the remainder of the project. Several of the patches exhibited severe distress as shown in Figure D-1.4. Drains close to the patch were clogged and appeared to be non-functional.

Figure D-1.1: Water Coming Out Of the Construction Joints

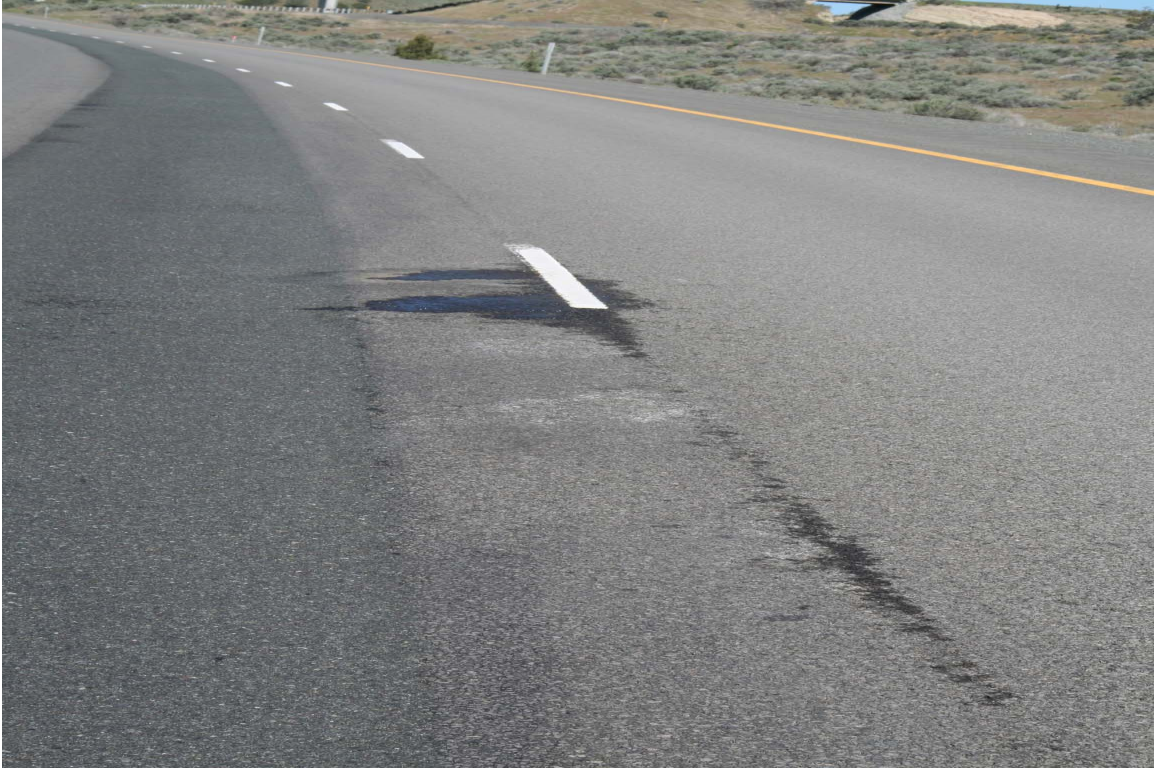
Figure D-1.2: Example of Water along the Construction Joints Close To a Long Patch

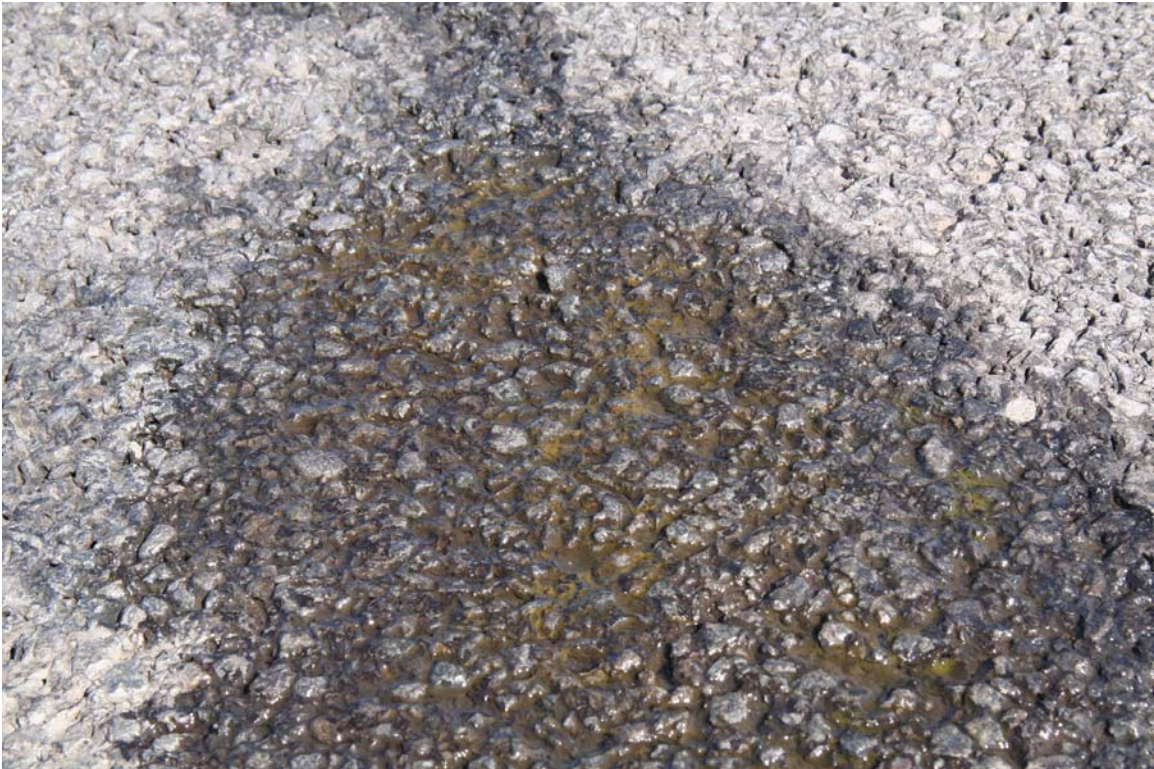
Figure D-1.3: Colored Water Coming Out Of the Pavement Joints

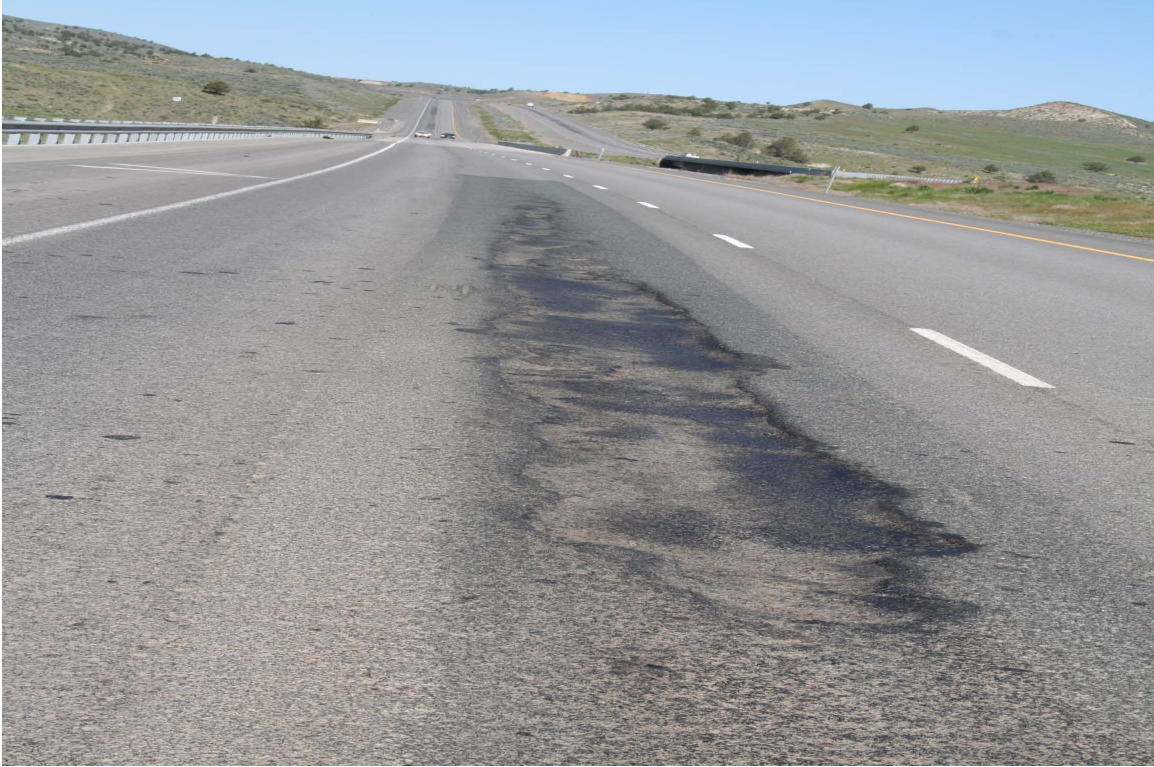
Figure D-1.4: Patch with Severe Distress Visible On the Outside Lane of the Project

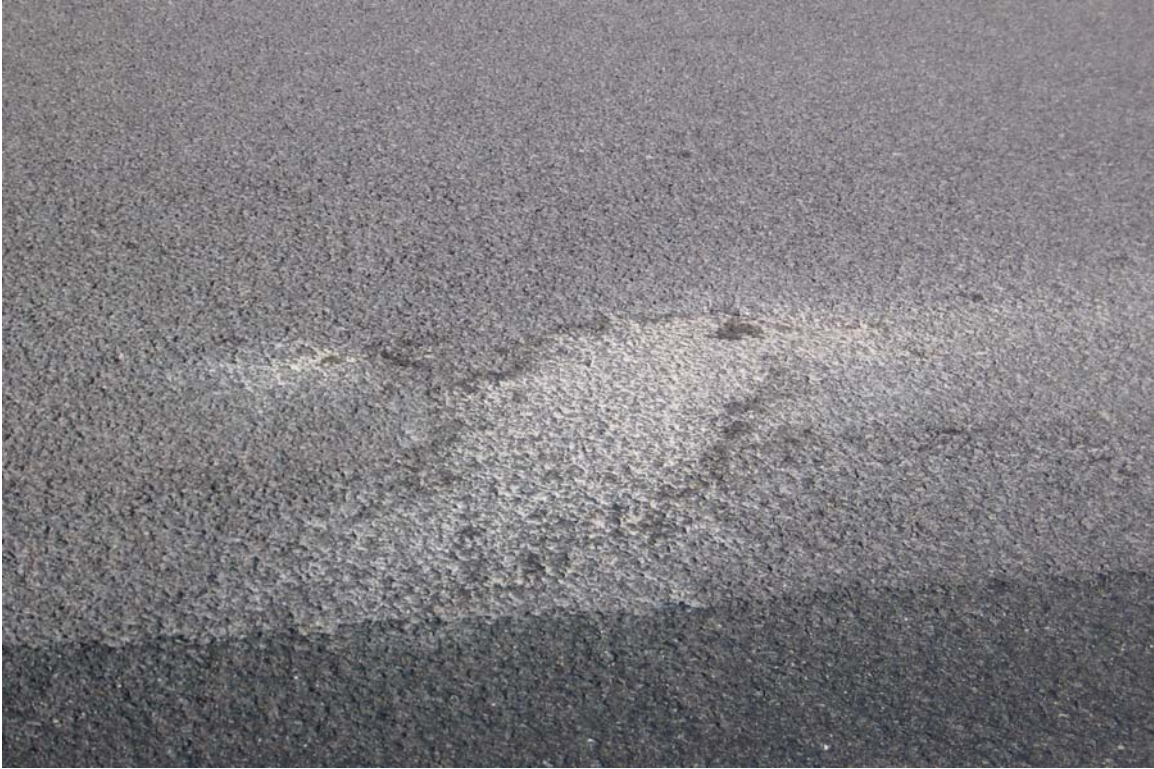
Westbound Direction: The westbound section (starts at the end) with a patch close to 100 feet in length. There were several patches observed along this section, predominately in the left wheel path on the outside lane. A bigger patch that was almost one mile in length was also observed in this section. Further to the west, patches were found in both lanes with several of them exhibiting rutting and raveling. Several locations that were patched earlier had been re-patched (‘patched the patch’) by the maintenance personnel. Through construction joints, water was seen coming out with the greenish tint color similar to the eastbound lanes. In certain locations pumping of fines were seen as shown in Figure D-1.5. Overall, the westbound lanes appeared to be in a worse shape compared to the eastbound lanes.

Figure D-1.5: Silt Deposits on the Pavement Surface Close To a Patch

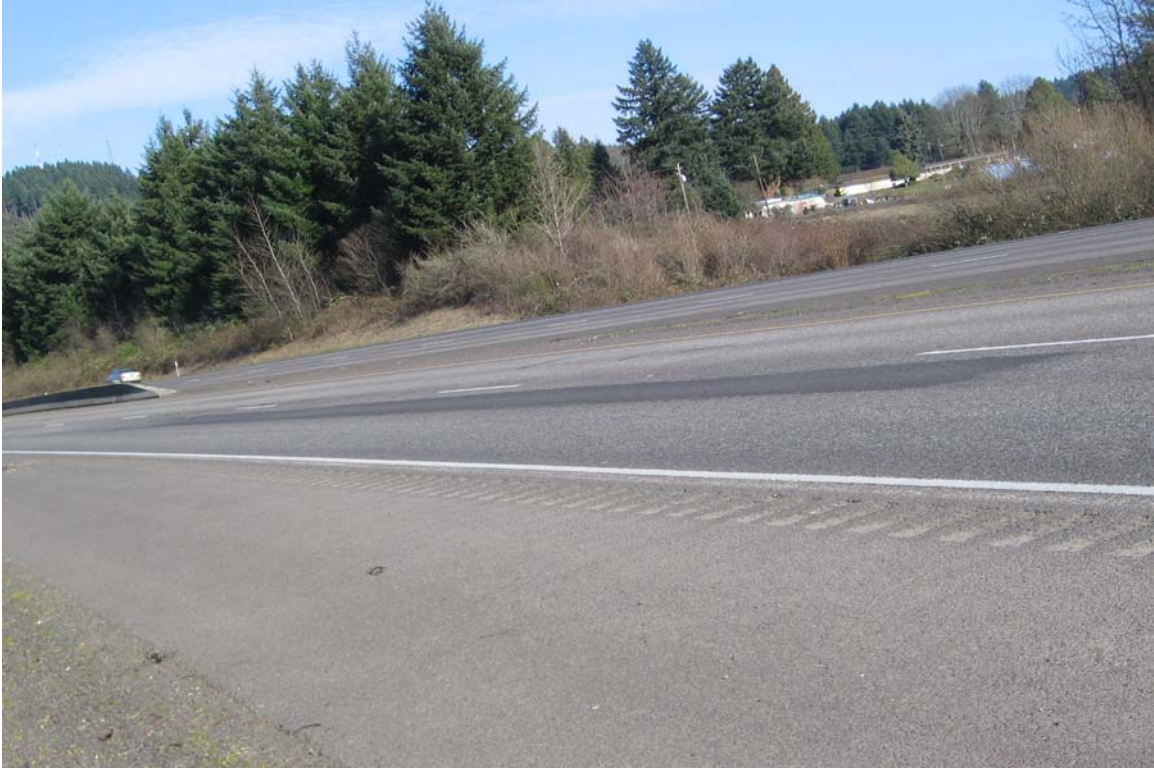
Southbound Direction: Pavement condition in this project was found to be similar to Vets Bridge-Myrtle Creek and Garden Valley-Roberts Creek projects. The pavement showed large patches in numerous locations, indicative of the significant amount of maintenance works done by the ODOT personnel in the last 4 years. In contrast to the previous two projects, to get an accurate picture of the project, the patches were counted. There were roughly 23 patches in the southbound lanes, nearly five patches per mile in this project. Figures D-1.6 and D-1.7 represent a typical pictures of the patches found throughout this project.

Figure D-1.6: Patch Visible On the Outside Lane inside Wheel Path

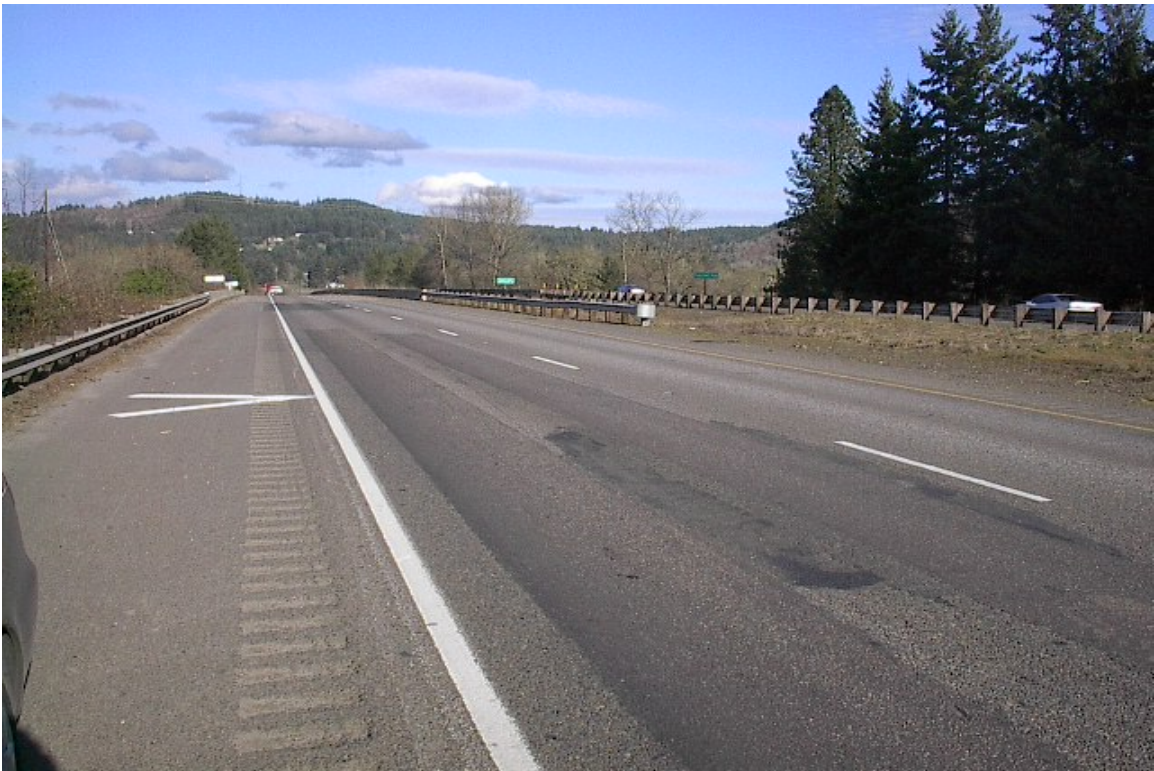
The location presented in Figure D-1.7, was identified as a potential trenching location. In addition to numerous patches, there were infrequent fat spots in the southbound lanes. In certain locations bleeding was observed, especially in the wheel path of the inside and outside lanes of the pavement.

Figure D-1.7: Example of Two Patches in the Wheel Paths of the Outside Lane

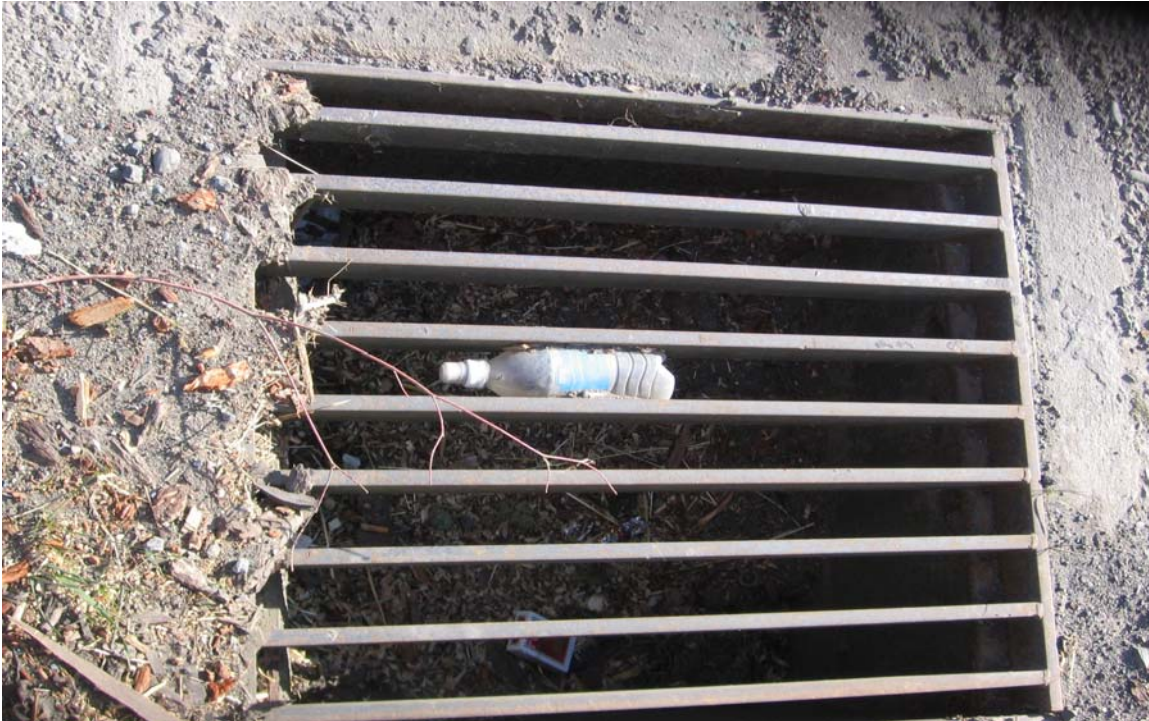
A brief stop was made roughly at southbound MP 171.6 close to a bridge. This section of the pavement had considerable patches. In addition, the pavement appeared to have severe rutting problems. The investigators assessed the surrounding conditions by inspecting the drainage systems located near these distressed location. Four drains were examined during the inspection. Two of the drains contained a significant amount of debris; whereas the other two were appeared to be in good condition. One of the drains containing debris is shown in Figures D-1.8. The sides of the bridges had debris and vegetation growth as shown in Figure D-1.9.

Figure D-1.8: A Partially Clogged Drain That Was Found Close To the Patches in the Previous Pictures (Figures D-1.6 and D-1.7)

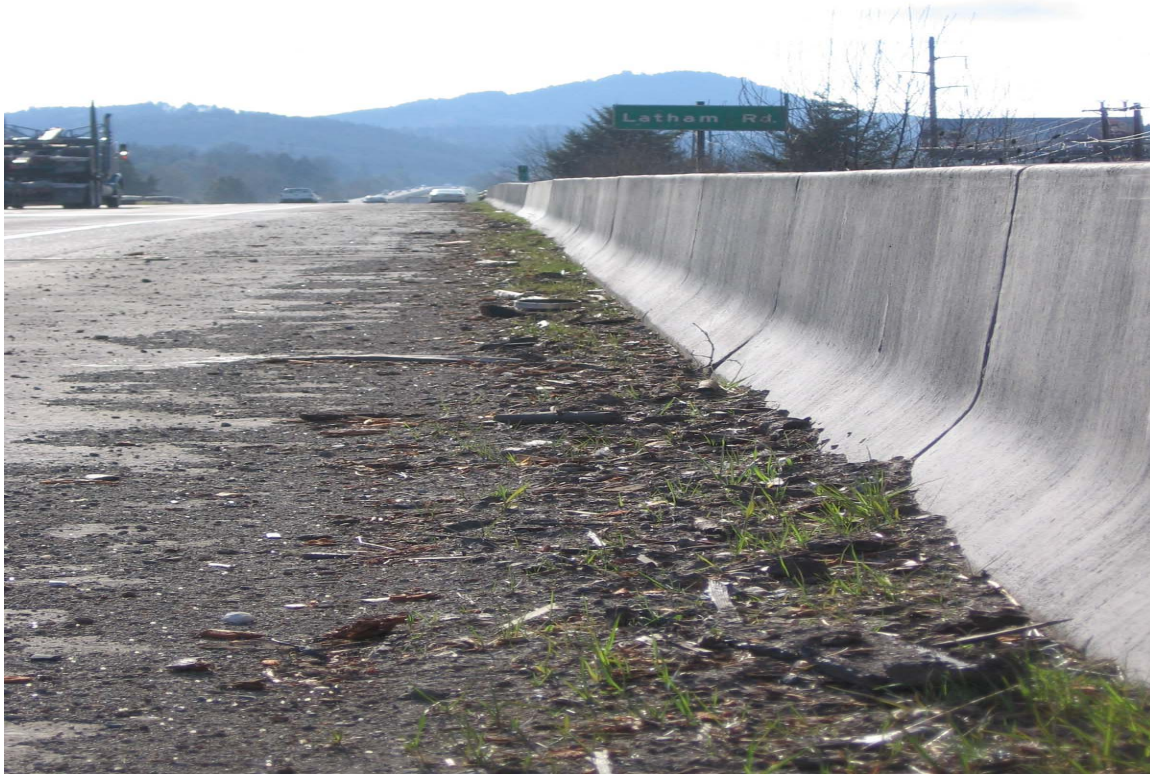
Figure D-1.9: Condition on the Sides of a Bridge Where Vegetation Has Grown

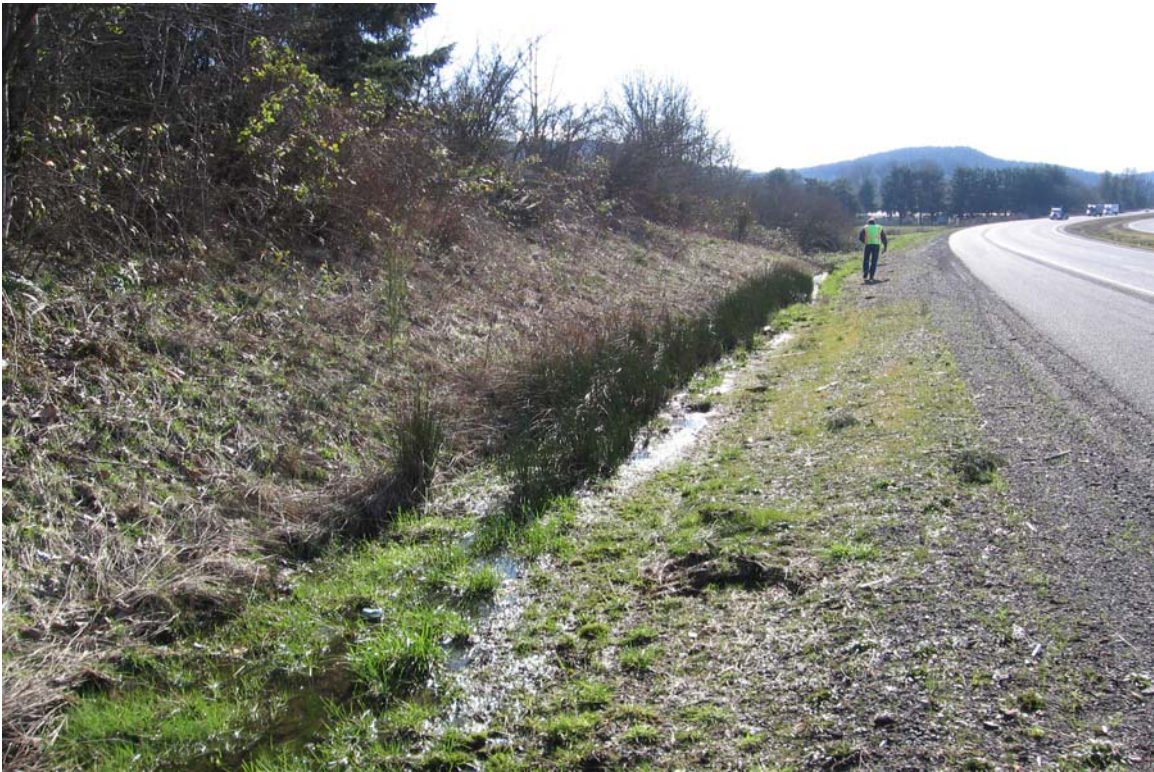
Figure D-1.11: Very Low Flow Rate of Water in This Ditch Has Allowed the Growth of Algae and Other Plants Commonly Found In Ponds

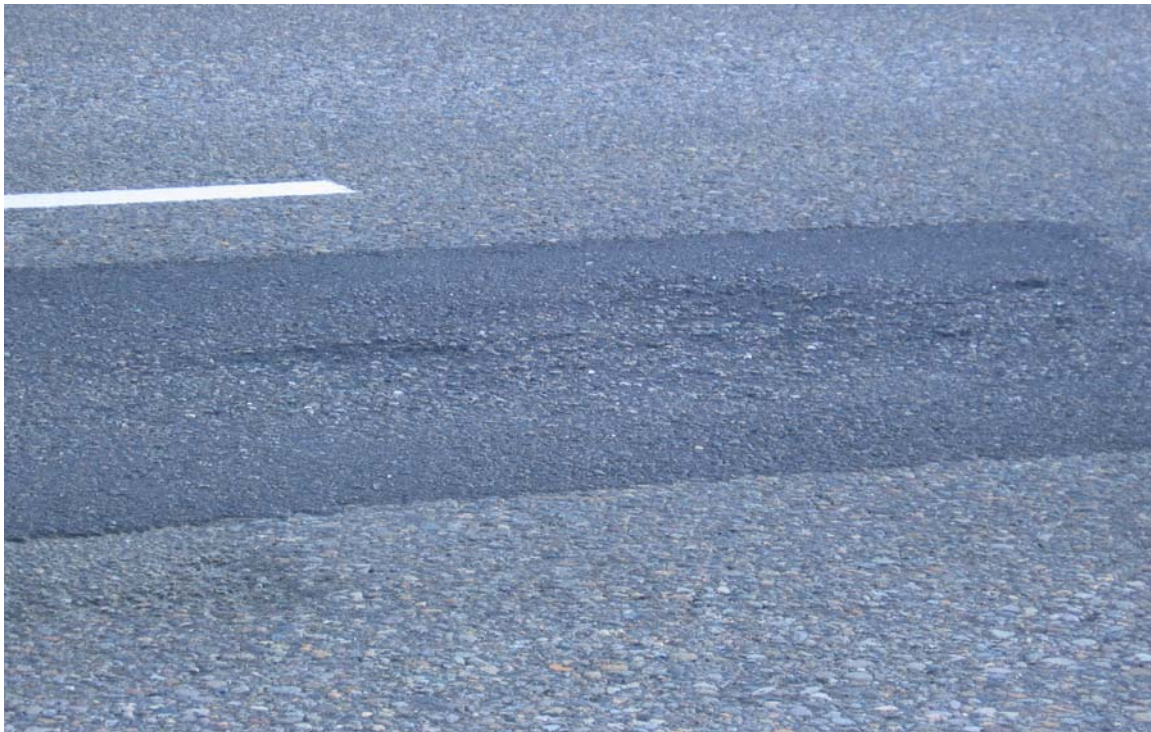
Southbound Direction: Several patches were found in the direction of this road. Near MP 157 three patches were found and this location was identified as a good location to perform trenching operations during the field investigation. Figure D-1.12 presents a typical patch found in this road section. Evidence of bleeding was found on the outer wheel path on the inside lane. In addition, the pavement exhibited ‘shoving’ on the inside lane, inside wheel path. On the outside lane, the wheel path had low severity raveling at certain locations. At one location the pavement surface looked pitted and raveled (Figure D-1.13). Stripping failure was noticed in certain locations of this project. In case of the drainage systems, fewer drains were found along this section. The section of the roadway was on a slope.

Figure D-1.12: Typical Patch Found Along This Project

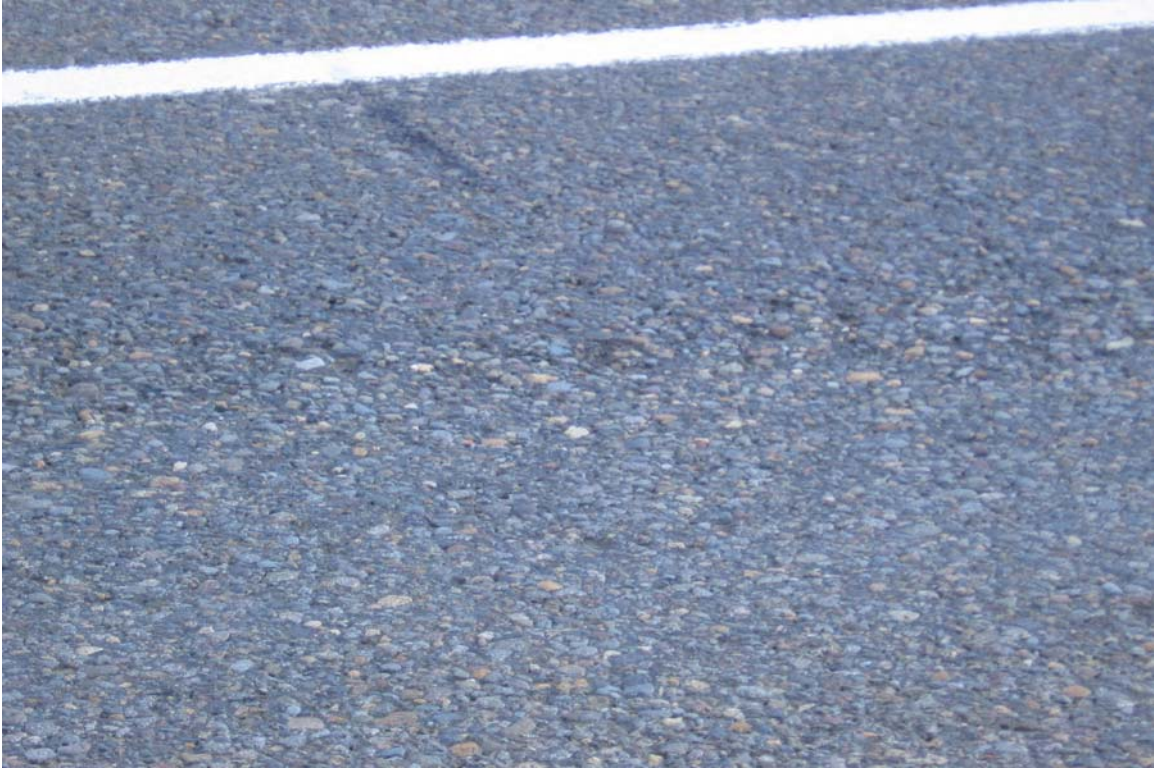
Figure D-1.13: Part of the Pitted and Raveled Pavement Section

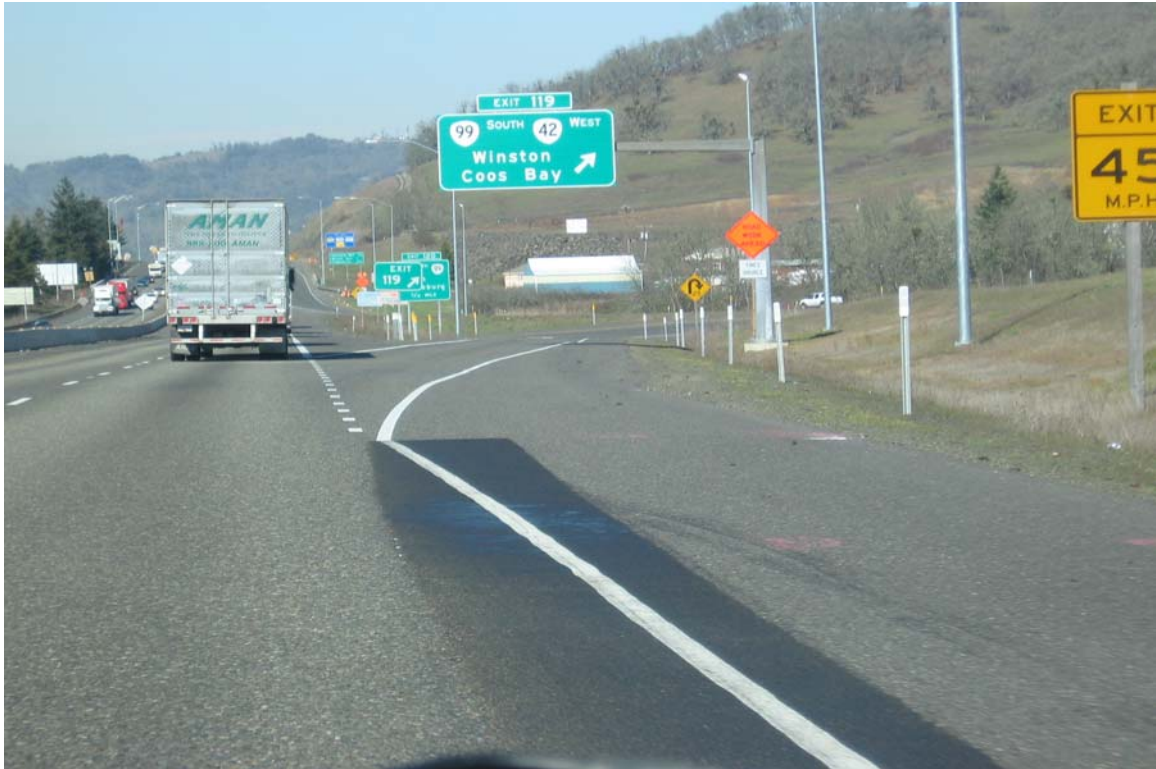
Figure D-1.14: Patch on the Outside Lane

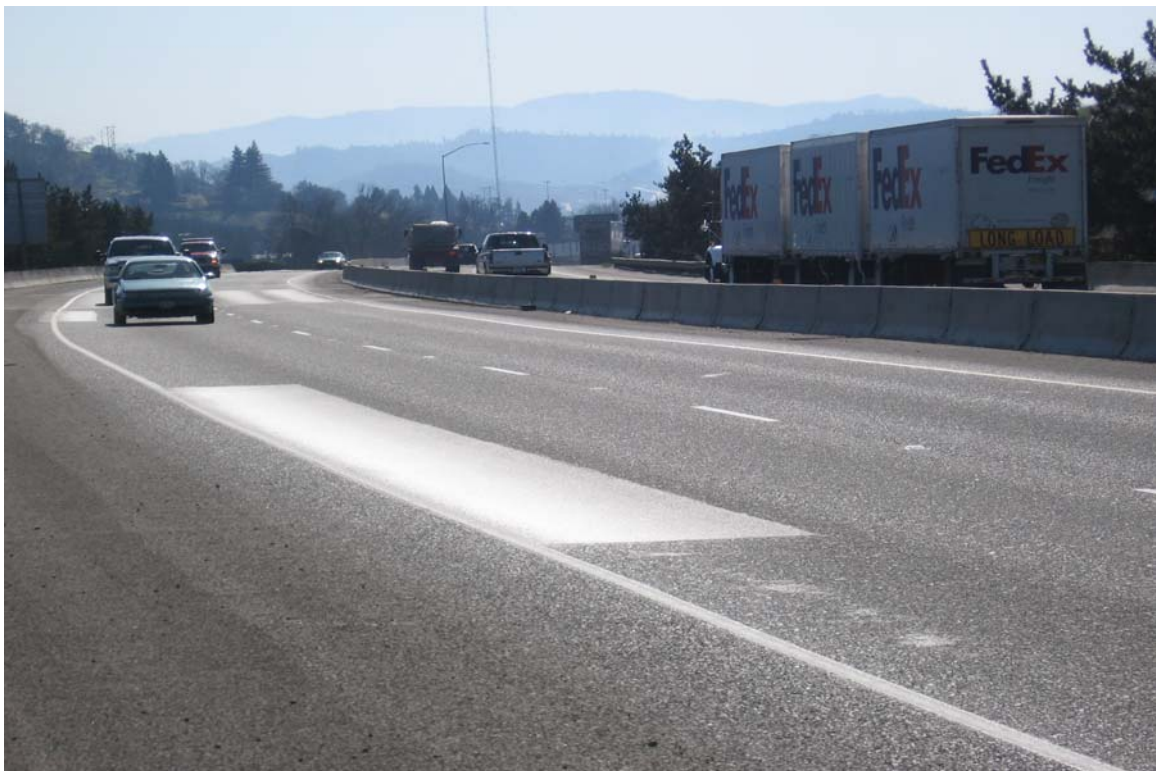
Figure D-1.15: Representative Example of the Numerous Patches Found In This Project

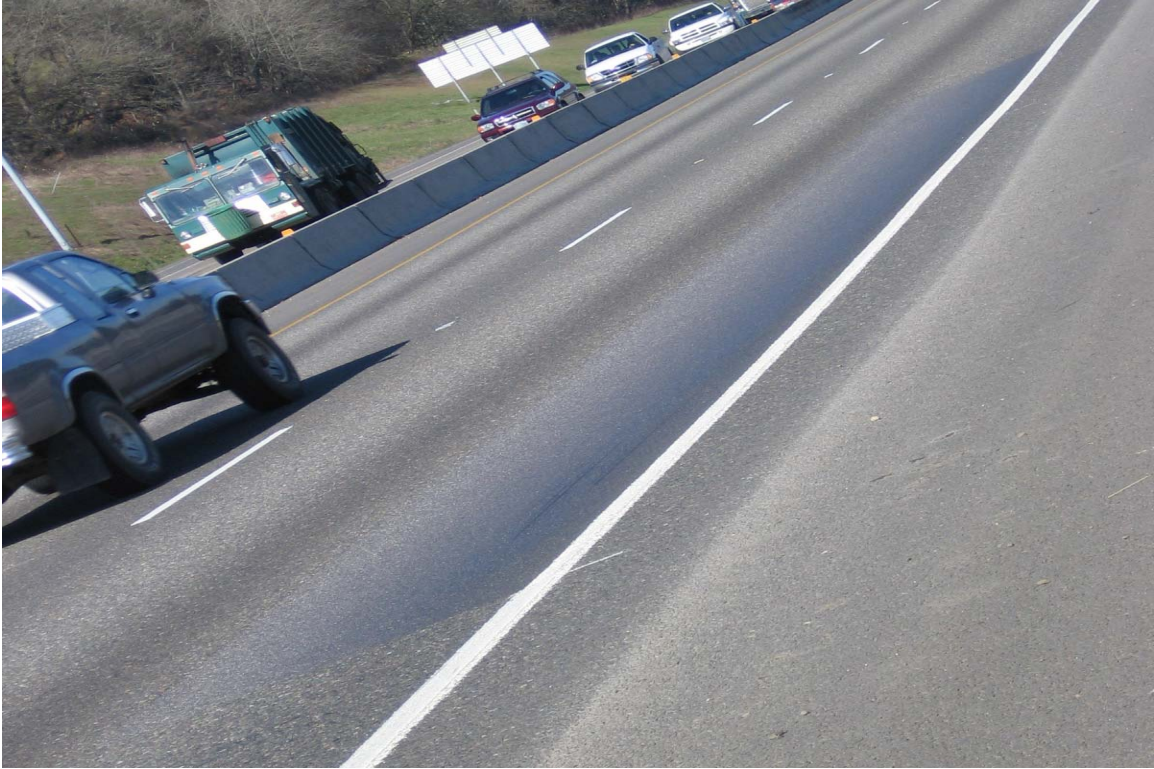
Figure D-1.16: Close-up of the patch on the outside lane wheel path

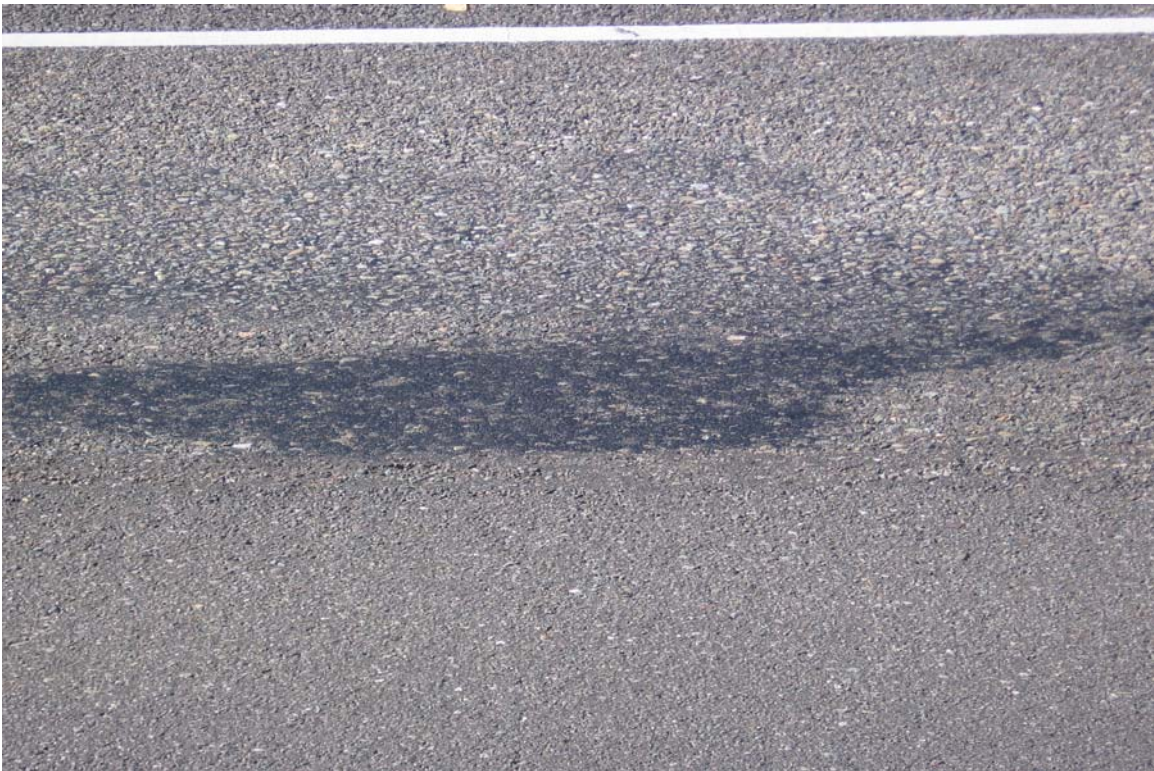
Figure D-1.18: Bleeding Of Binder, a Common Sight in This Part of the State

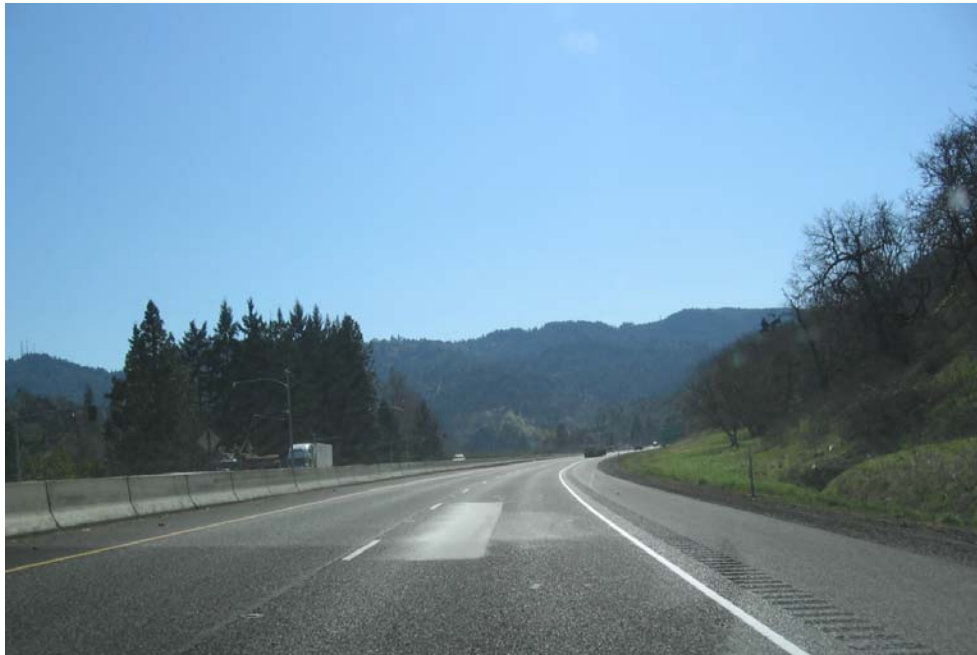
Southbound Direction: Numerous locations on the southbound (SB) lanes exhibited blade and pothole patches in both wheel paths. The investigators assume these patches were placed to treat rutting distress. Figures D-1.19 and D-1.20 show patches observed in the southbound lanes of the project. Fat spots were observed frequently in the southbound lanes and no cracking was noted. The drains that were located close to these cracks were inspected. The drains appeared fully functional, without any clogging. An informal assessment of the topography was performed by taking several photographs. Rock cuts were observed at certain locations as shown in Figure D-1.21.

Figure D-1.19: Patch Visible In the Wheel Path of the Outside Lane

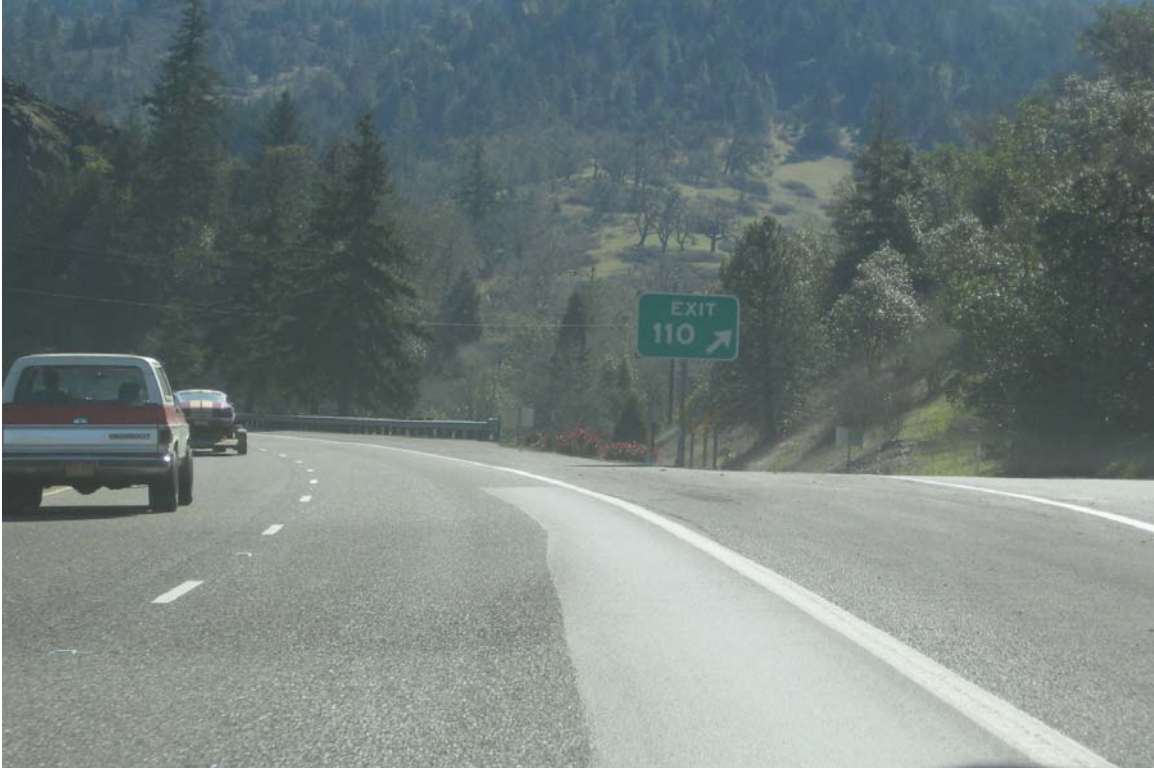
Figure D-1.20: Patch along the Outside Lane Wheel Path at MP 110
