**INVESTIGATING PREMATURE PAVEMENT
FAILURE DUE TO MOISTURE**

FINAL REPORT

SPR 632

July 2009

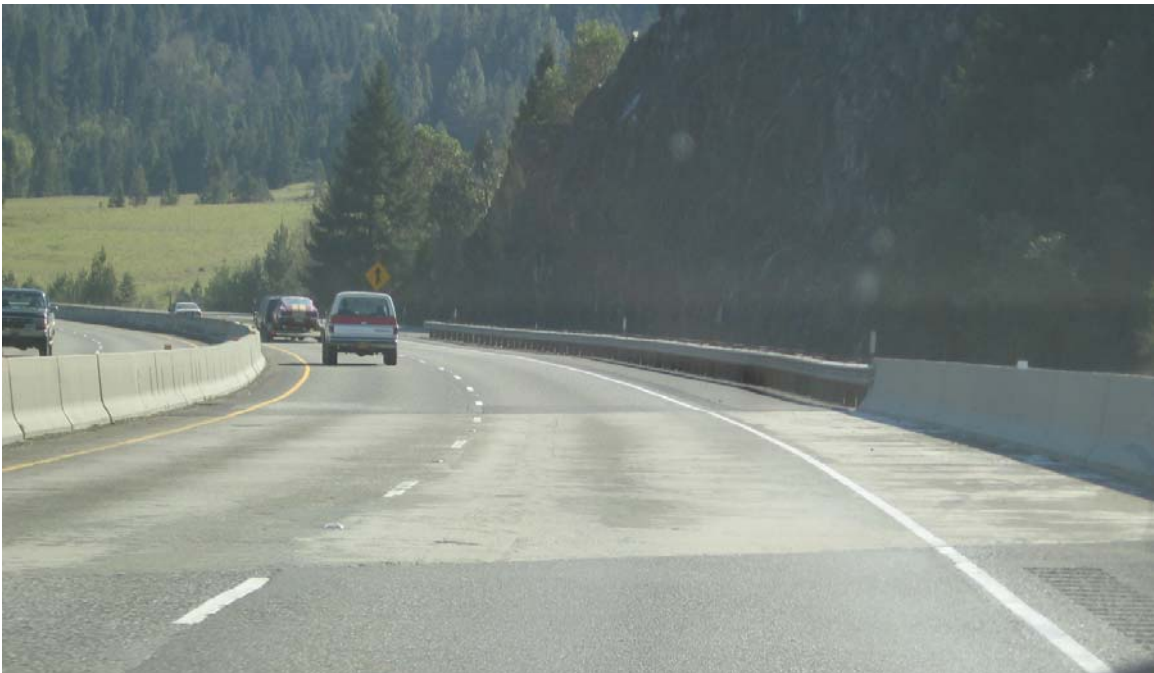
Figure D-1.21: Rock Cut Was Observed On Certain Locations of the Section

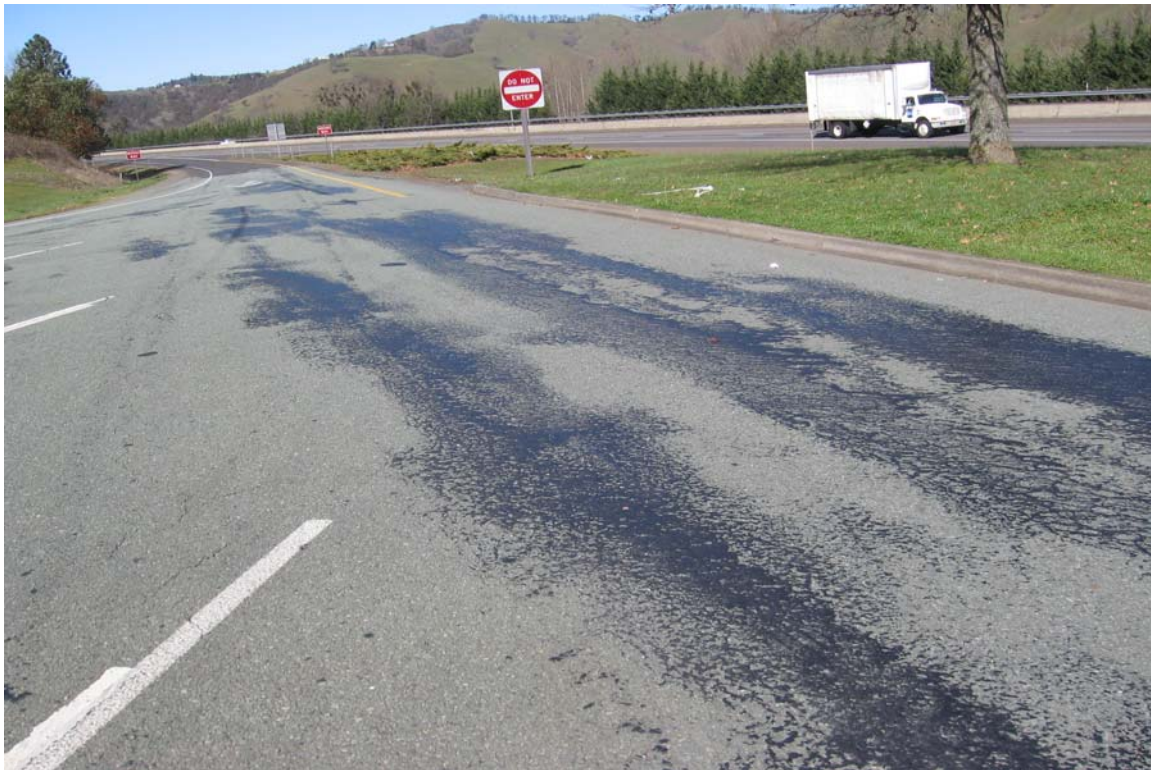
that could be used to identify the cause of distress. Severe bleeding was observed on the pavement section near the rest area. It should be noted that bleeding was found to be a common problem throughout the project. A typical representation of the bleeding is presented in Figures D-1.22 and D-1.23. Inadequate slope was witnessed near the southbound MP 111 and the pavement section was almost at the same elevation as the sides. This condition is presented in Figure D-1.24. Based on the impromptu interview with a maintenance worker who was scraping the vegetation along the roadside, it was found that the vegetation was scraped once a year in addition to the application of herbicides (Figure D-1.25). Closer examination of the pavement section near south MP 111 indicated that some areas had stripping problems as shown in Figure D-1.26.

Figure D-1.22: Bleeding Observed on the Pavements near Rest Area at MP 111

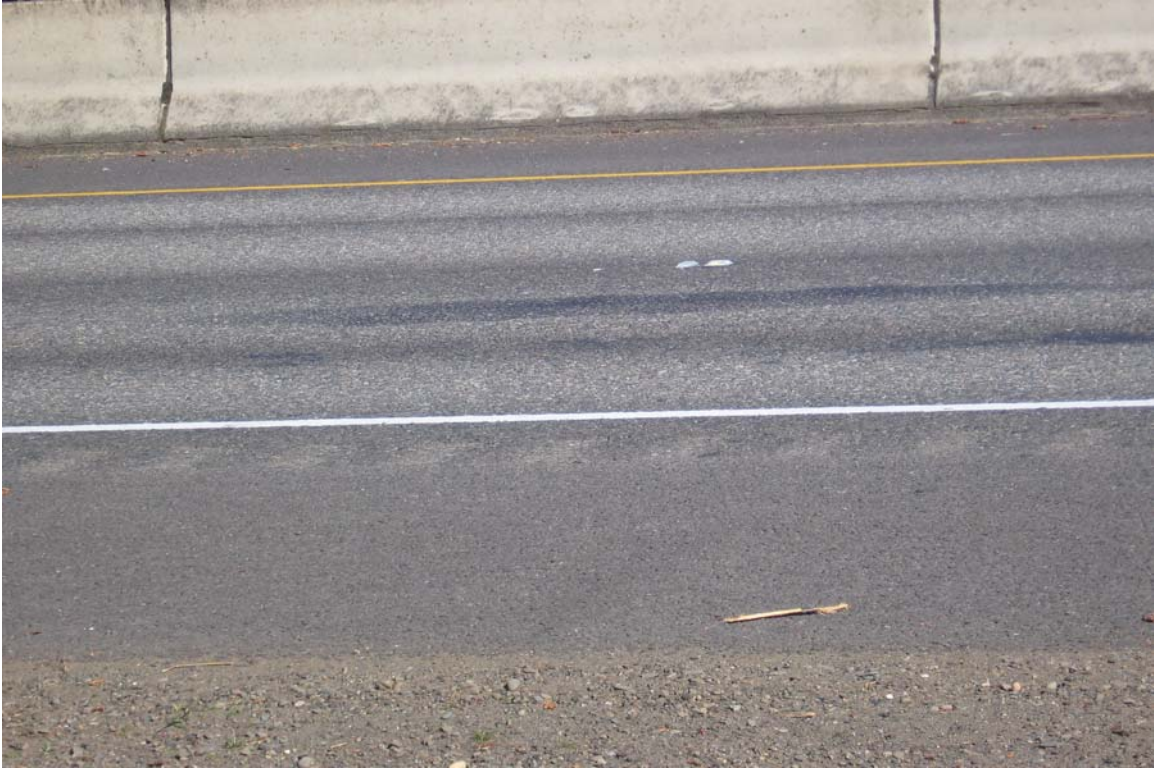
Figure D-1.23: Bleeding Observed On the Pavement Section Adjacent To the Rest Area at MP 111

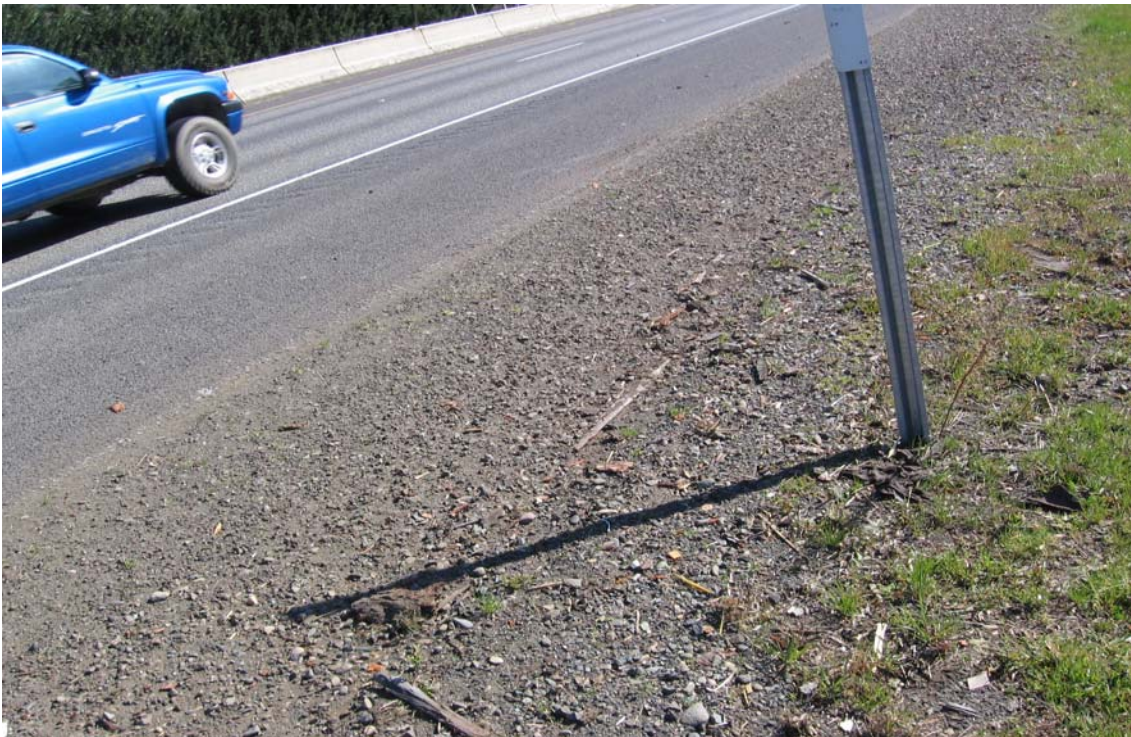
Figure D-1.24: Inadequate Slope and Vegetation Growth Seen Close To the Pavement at MP 111

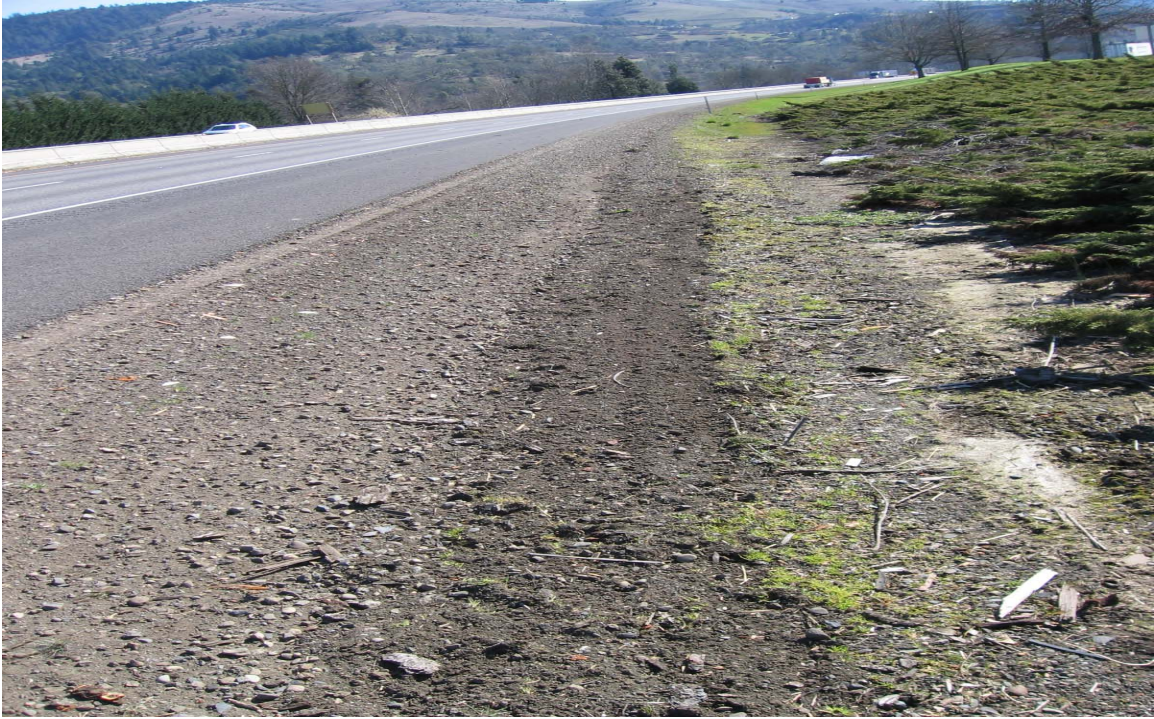
Figure D-1.25: Vegetation Scraped Along the Pavement Section (Scraped Once A Year)

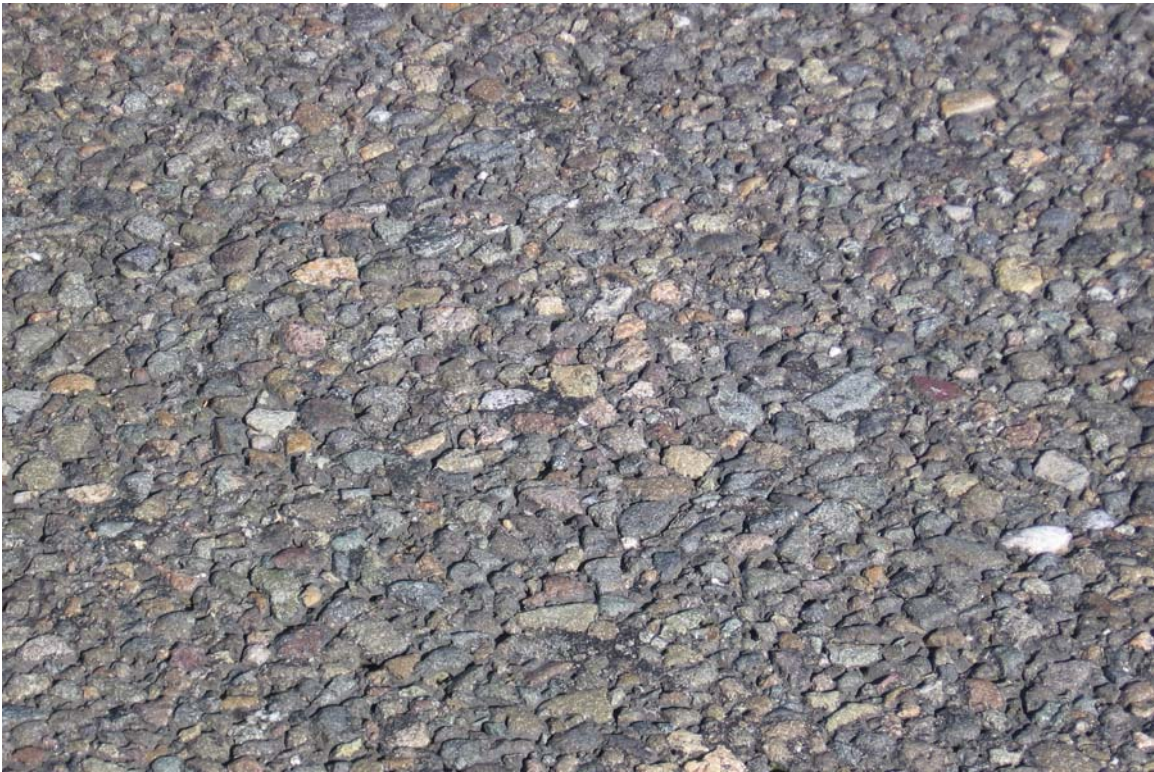
Figure D-1.26: Closer Look at the Pavement Section at MP 111

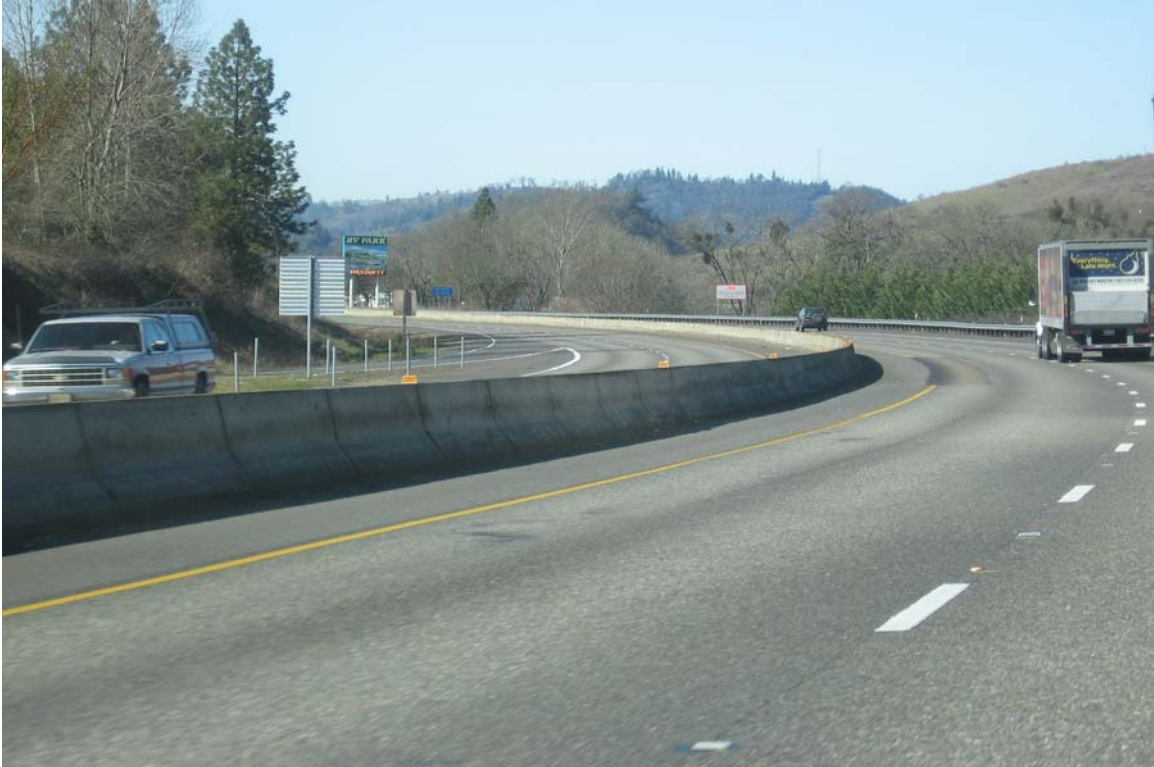
Northbound Direction: A similar survey was conducted along the northbound section of the project. This section had patches in numerous locations, similar to the southbound lanes. Most of the observed patches in the northbound section were in the inside lanes. Figure D-1.27 and D-1.28 show a typical example of patches witnessed during the survey. At one location, a section of the pavement had a combination of distresses such as bleeding, rutting, and patches (Figure 3D-1.29). Fewer fat spots were observed in this direction as compared with the southbound direction. Visual inspection of the drains along the pavement sections revealed proper maintenance and an absence of clogging (Figure D-1.30).

Figure D-1.27: Example of a Patch Found On the Inside Lane of the Pavement Section

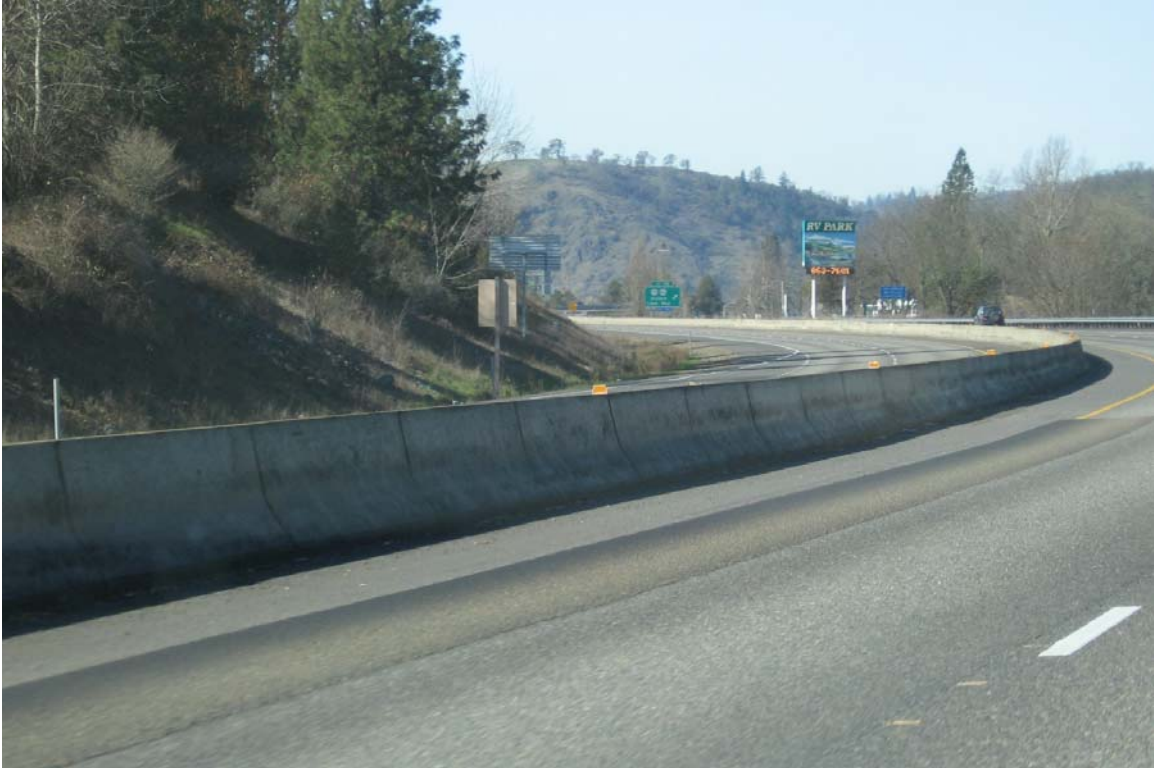
Figure D-1.28: Another Example of a Patch Found On the Inside Lane

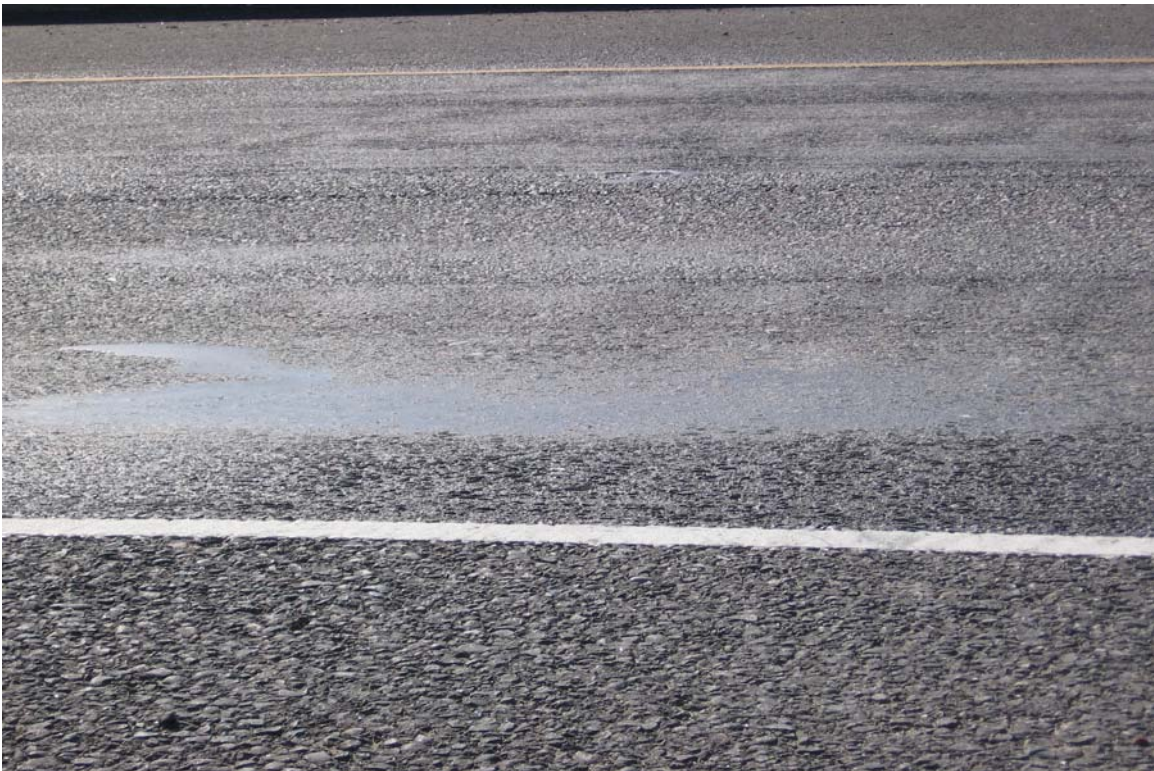
Figure D-1.29: Combinations of Rutting, Patches, and Bleeding

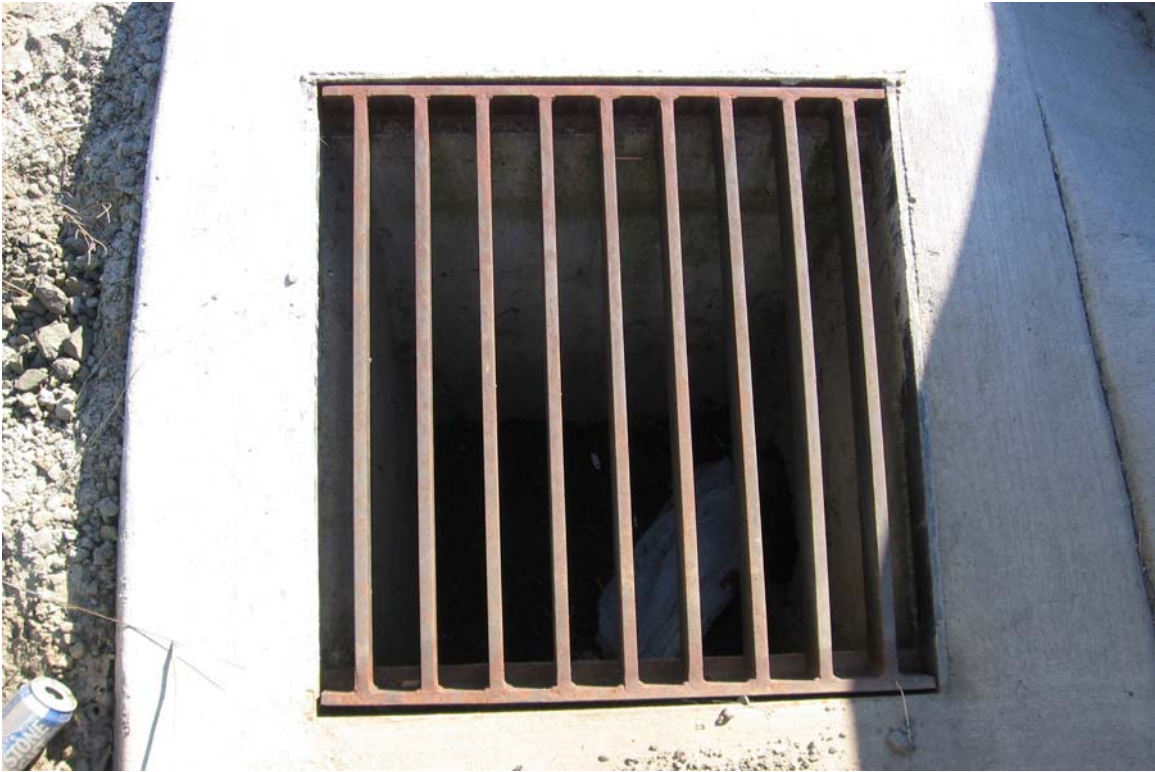
Figure D-1.30: Properly Maintained Drain with No Clogging
