**GEOTEXTILE FABRICS UNDER AN
ASPHALT CONCRETE OVERLAY TO
RETARD REFLECTIVE CRACKING**

FINAL REPORT

East 39th Avenue – East 47th Avenue Section
East Burnside Street, Portland

Experimental Features Project OR 91-03

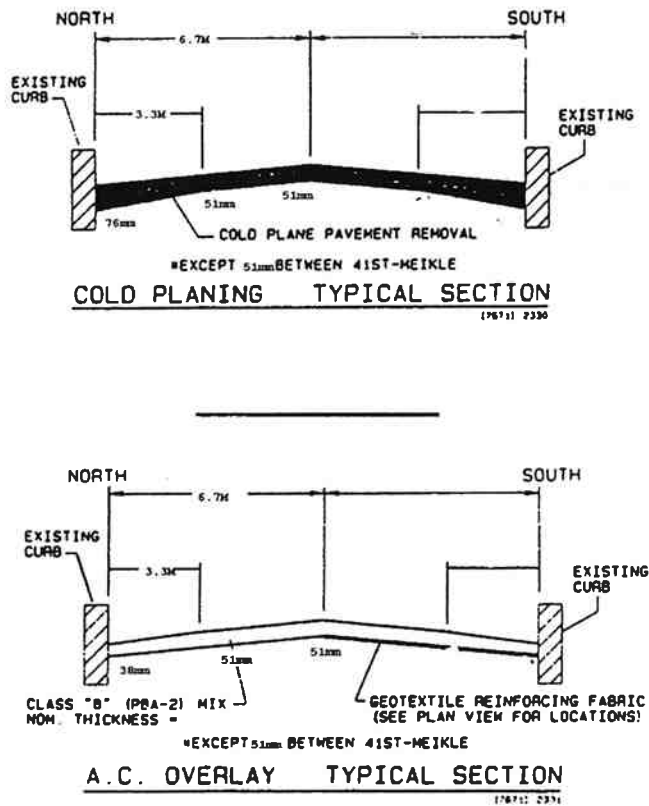
Figure 2.2: Pavement Cross-section

Typical cross-sections of the pavement are shown in Figure 2.2. The top 51 mm of the old pavement surface was cold planed. The new pavement surface is 51 mm of Class "B" (dense-graded) asphalt concrete. Underneath the new pavement surface is 180 mm of PCC. On the south side (eastbound lanes) of Burnside Street, Glasgrid 8501 and Polyguard NW-75 were placed between a leveling course and asphalt concrete overlay at four locations as shown in Figure 2.3. In addition, Glasgrid was placed for pavement reinforcement with no overlaps to a total width of 6.1 m and for 76.3 m on the south side of Burnside Street between 44th and 45th Avenues. On the north side of the street, no geotextiles were utilized.

The old pavement next to the curbs was rotomilled deeper than the rest of the cross-section and overlaid 13 mm less than the rest of the section, as shown in Figure 2.2. The taper effectively increased the curb height to improve drainage. Reflective cracks were first reported near the curb a couple of years after construction.

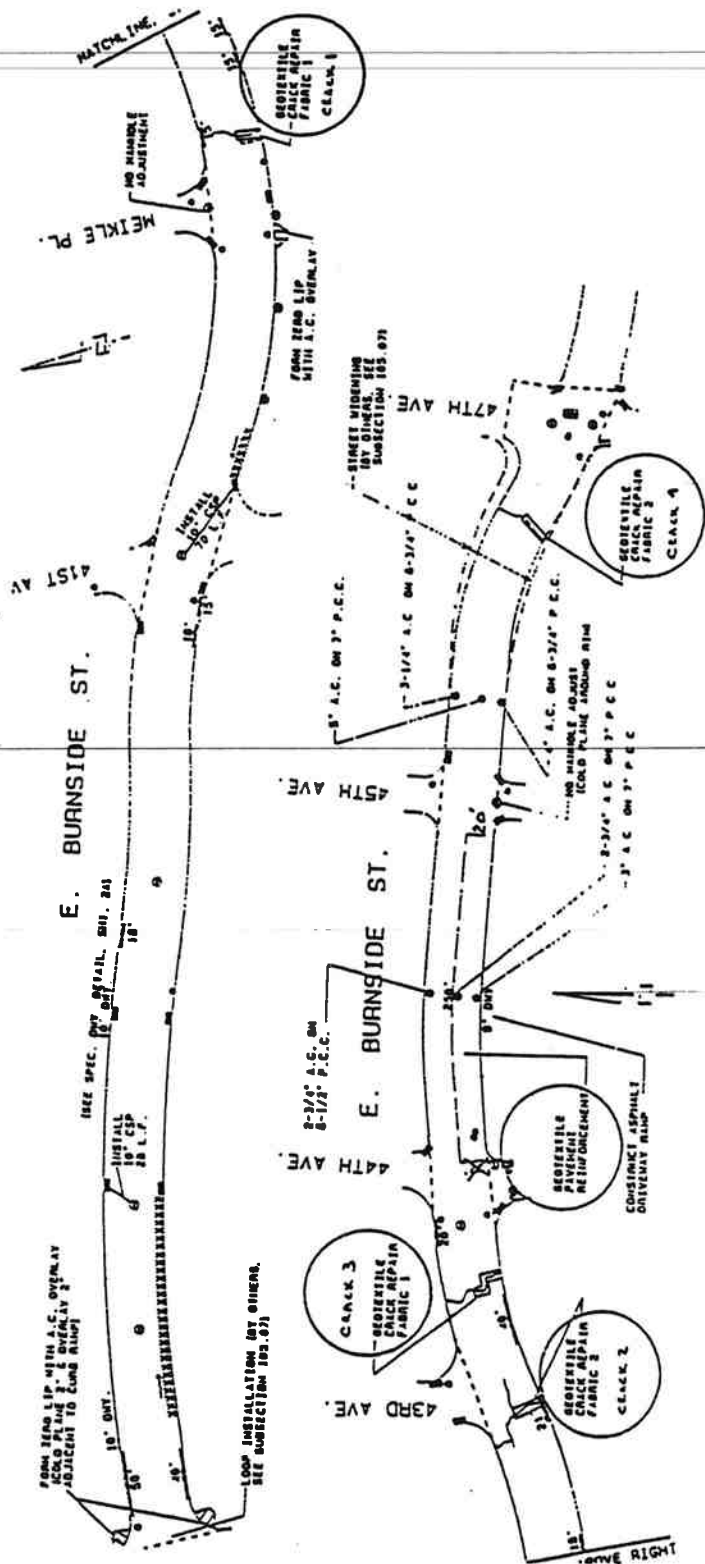
Figure A.1: Location of Crack Repairs

Crack #1, Fabric 1
E. of N.E. Meikle Pl.

Crack #2, Fabric 2
W. of 43rd Avenue
Two sheets of 2-foot wide Polyguard
placed with 1-foot wide lap
