FOLLOW UP OF INJECTED POLYURETHANE SLAB JACKING

Keely Heintz
Apprenticeships in Science and Engineering Intern

Oregon Department of Transportation
Research Unit
200 Hawthorne SE, Suite B-240
Salem, Oregon 97301-5192

August 2003

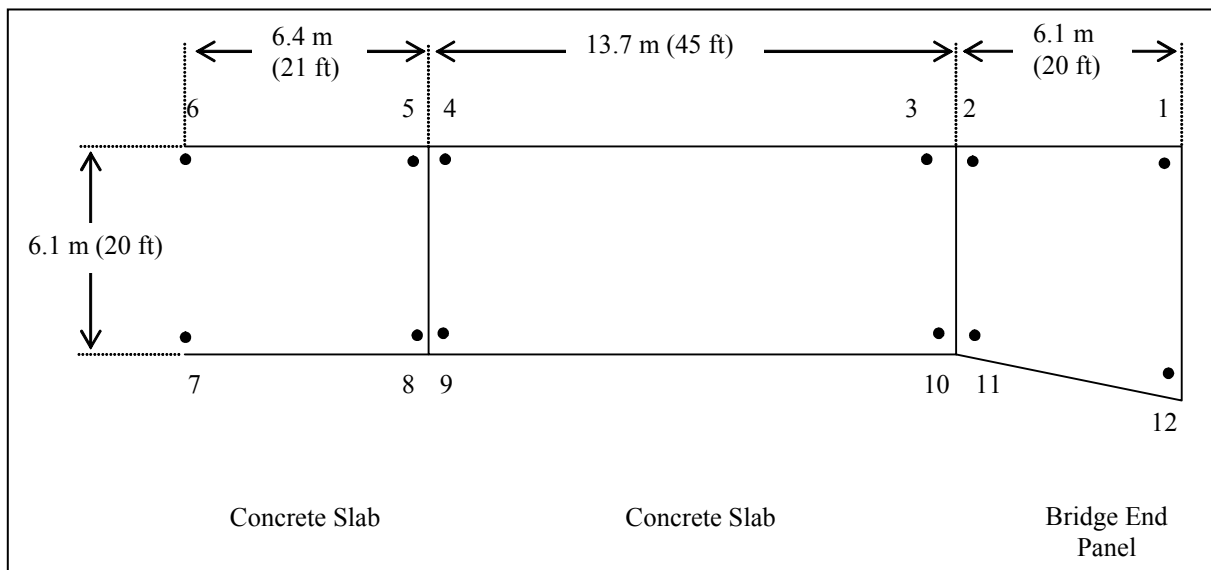
Figure 2.1: Arrangement of the brass surveying nails used to take elevation measurements

Brass survey nails were placed at twelve positions in the roadway for the first survey shortly after slab jacking. These positions were used to monitor the change in elevation of the slabs. The arrangement of the positions is shown in Figure 2.1.

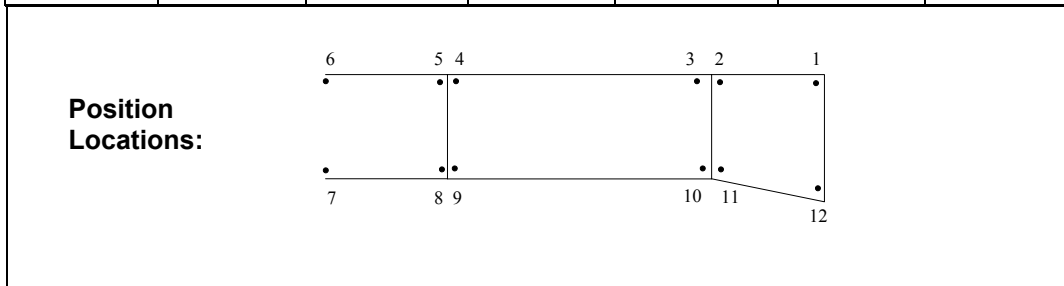
After three years, ten of the twelve positions show continued settling. The rate of settling (change in elevation of the slab) has decreased but has not stopped altogether. The results are shown in Table 3.1 and Figure 3.1.

Table 3.1: Relative change in elevation over time with respect to the first, post-injection survey on 6/14/2000. All measurements are in millimeters. Position locations are shown in the diagram.

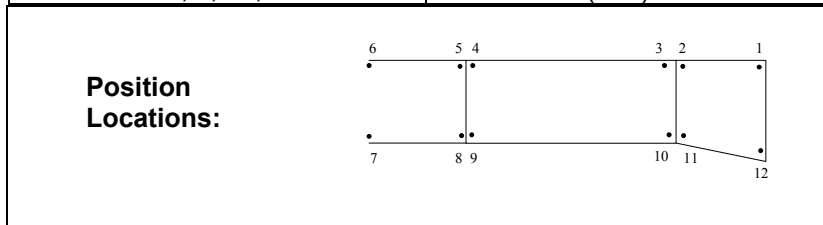
Table 3.2: Results of linear regression for each position and the average settling rate for groups of positions calculated from the slopes
