PERFORMANCE OF ULTRA-THIN WHITETOPPING (UTW) IN OKLAHOMA

FINAL REPORT ~ FHWA-OK-10-05
ODOT SP&R ITEM NUMBER 2222

DECEMBER 2010

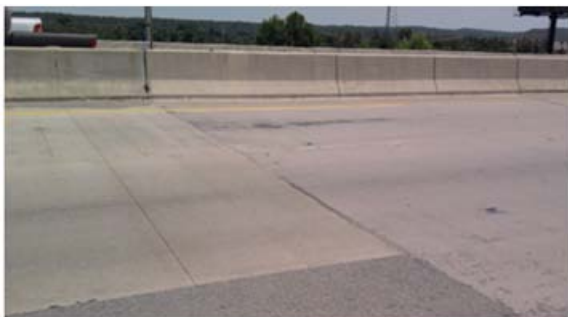
Figure 2.12 – The overlay terminates at a bridge and does not show any distress.

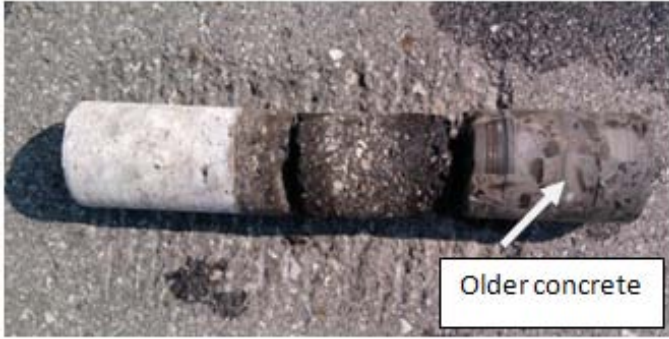
Coring on the Chockie Overlay showed that the asphalt that was placed on top of an old concrete layer. The asphalt layer was 8" to 9" in the driving lane and 10" to 12" in the passing lane. The constant depth of the old concrete pavement was 6". Four cores were taken at the locations 2 and 7 in the passing lane and 3 and 9 in the driving lane from Table 2.11. Figure 2.27 shows the core at location 9.

Figure 2.27 – Core from location 9.

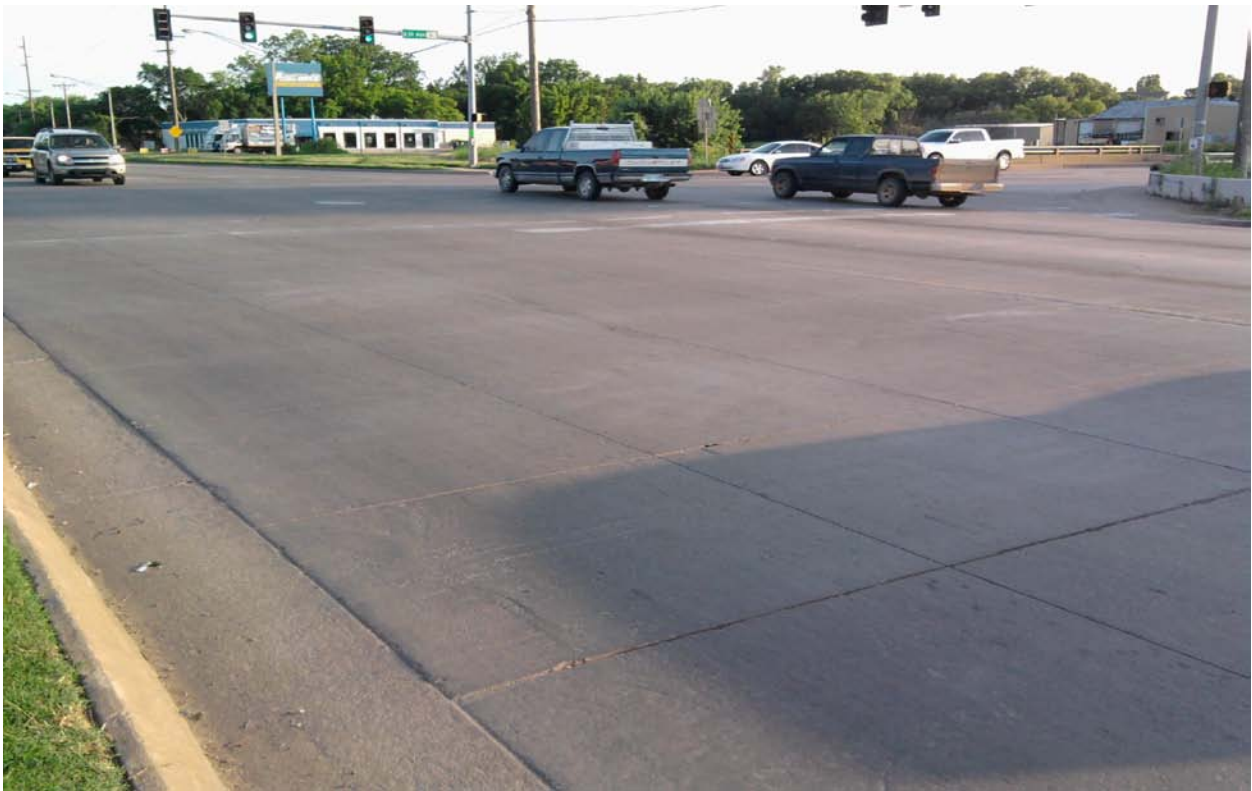
Figure 2.34 - Photo of intersection seen on US 177 towards south-west showing excellent condition of overlay.

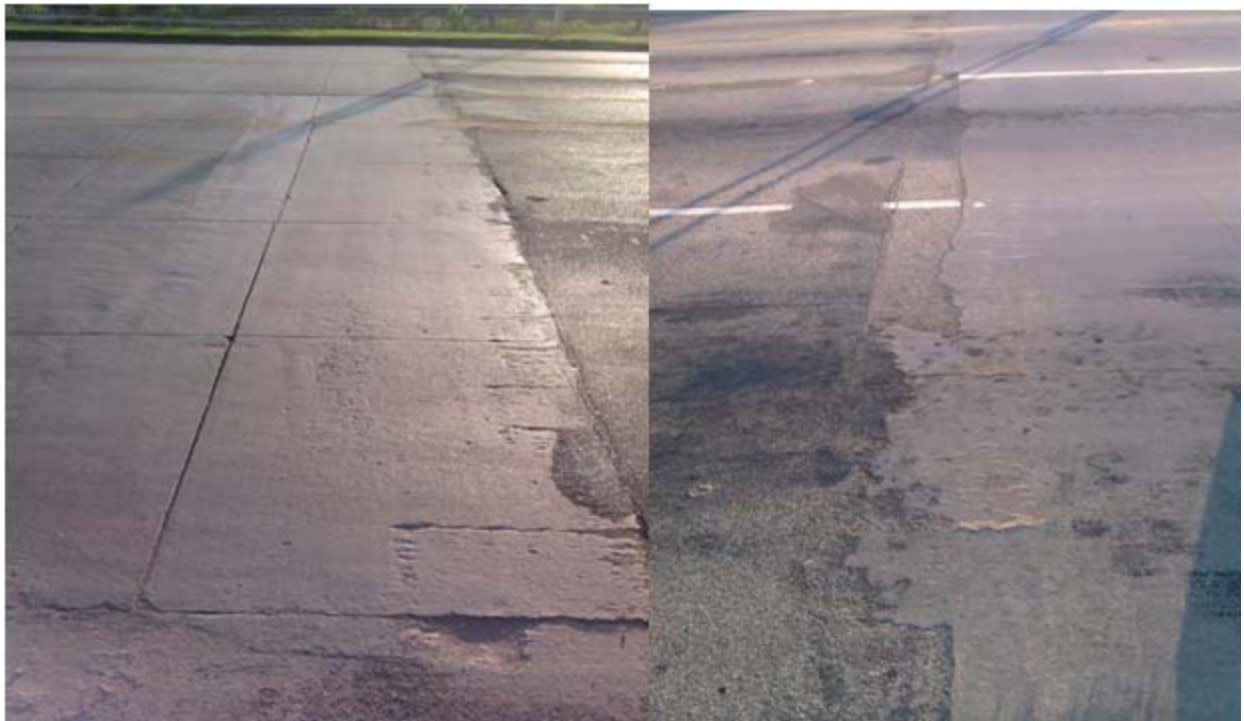
Figure 2.35 - Approach on US 177 from north showing absence in panel failures. Note the small difference in the elevation between the approach and leave pavements.

2. Maintaining close elevation difference at the approach panels may reduce the possibility of initial panel failures due to impact loading.

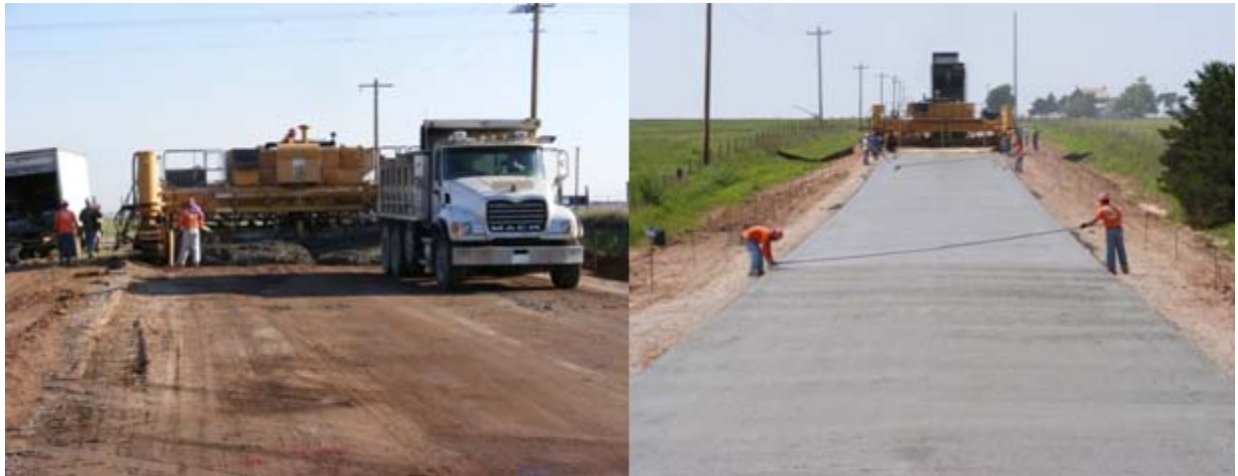
- 3) During the construction the old asphalt pavement surface was not milled and may not have been accurately cleaned. This can be seen in Fig. 2.48. Therefore, it is possible that the asphalt and concrete may not have a good bond. If de-bonding occurs then one would expect a significant decrease in performance for the overlay.

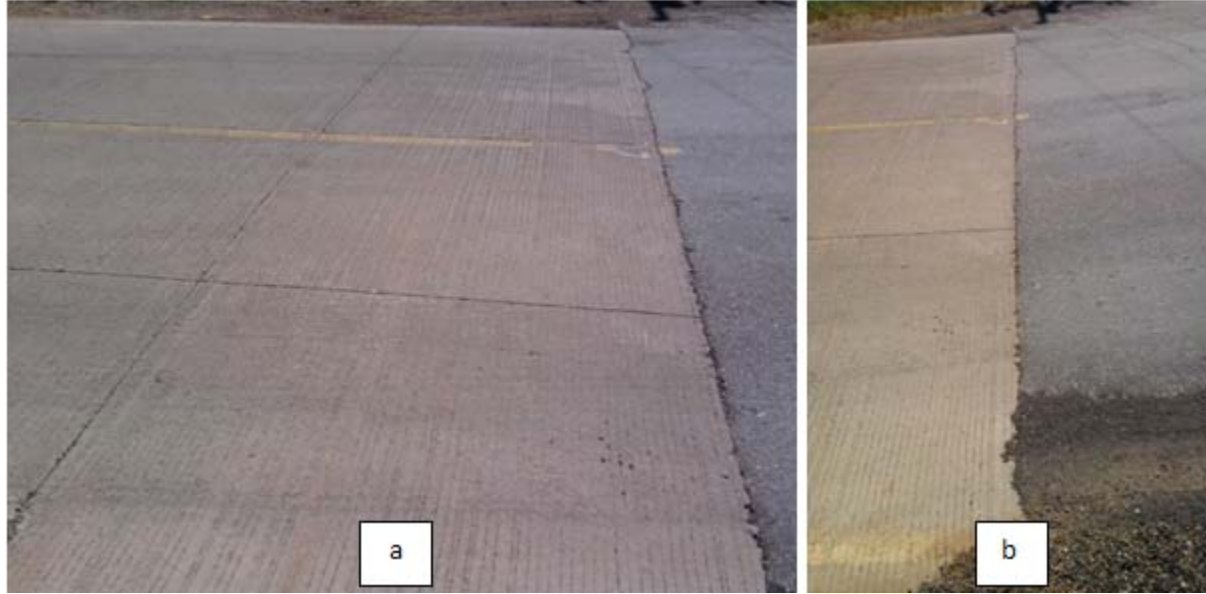
Figs 2.50 & 2.51 show the beginning of the overlay on its south side. The initial panels, which from previous experiences are the most critical, look un-cracked.

Figure 2.50 - Photos a and b show approach panels in un-distressed condition. Elevation difference between leaving asphalt pavement and approaching concrete panels is almost zero.

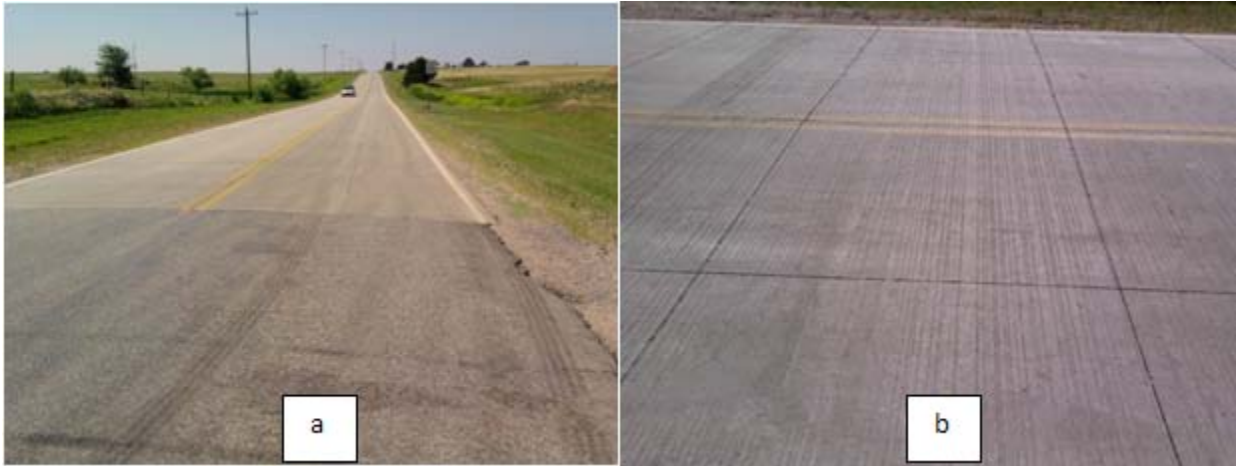
Fig. 2.52 shows the condition of the overlay where it ends on the north side. The elevation difference in between concrete and asphalt pavements was thought to be insignificant. The good condition of the initial panels suggests that if the same elevation for approach and leave pavements is maintained, the initial panels on the overlay are less likely to fail assuming that there is good bond between the concrete and the underlying asphalt.

Figure 2.52 - North end of overlay. Photo a is taken looking towards south direction. Photo b is seven panel series from the end of the overlay.

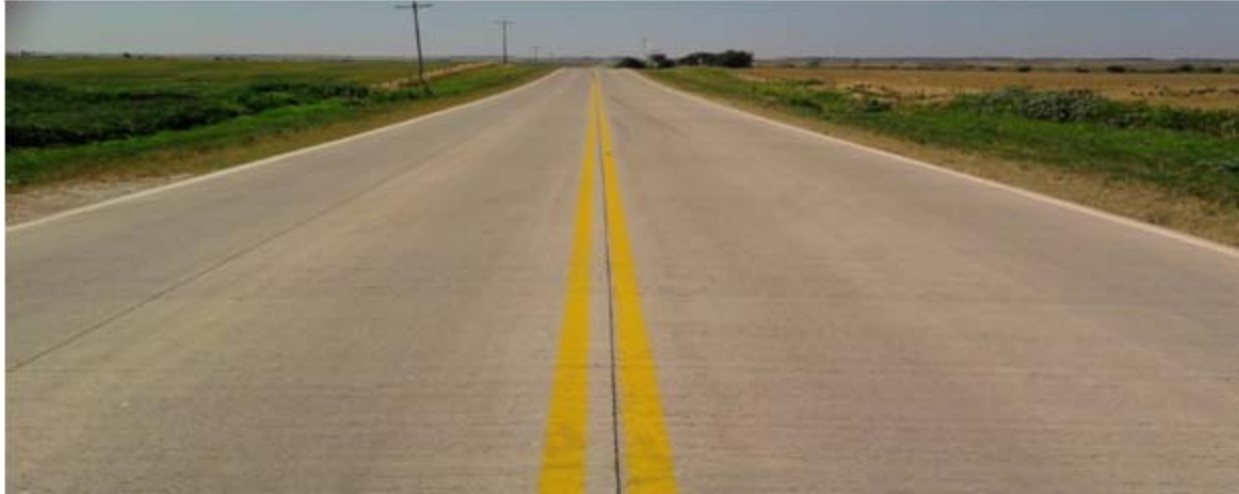
Figure 2.53 - Photo showing the excellent condition of the overlay.

The overall condition of the thin white topping is excellent as shown in Fig. 2.53. The research team did not notice any longitudinal cracks, transverse cracks, fatigue distress or pop outs.
