DETECTION OF STRIPPING IN HOT MIX ASPHALT

Final Report

March 11, 2005

**Office of Materials and Research
Georgia Department of Transportation
Forest Park, GA 30297-2599**

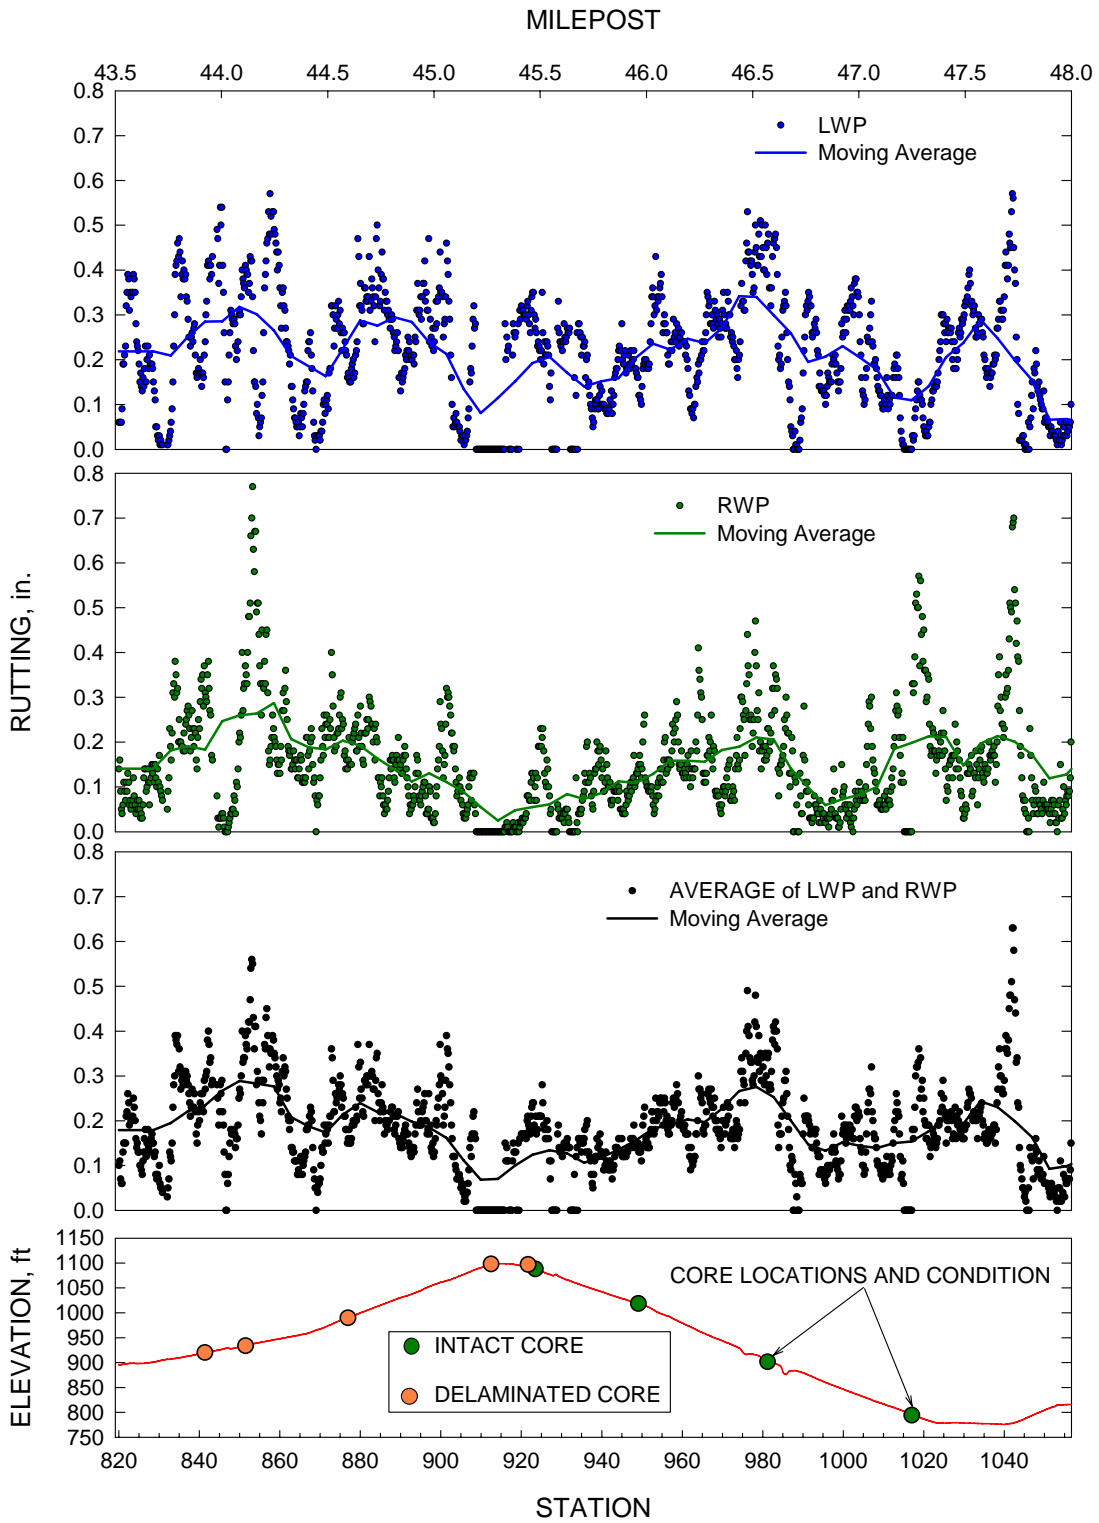
Figure 3-5. I-20 Lane 3 rutting summary plot

Transverse profile measurements were used to calculate the average rut depths in the left wheel path (LWP) and right wheel path (RWP) within each 20-ft-long sample unit. The average of the LWP and RWP rut depth was calculated, as well. The data points in Figure 3-5 shows the rut depths for the LWP, RWP, and the average rut depth. The smoothed curves are moving averages with a sampling window of approximately 1000 ft. It appears that the depth of rutting is greater at lower elevations than at the higher elevations.

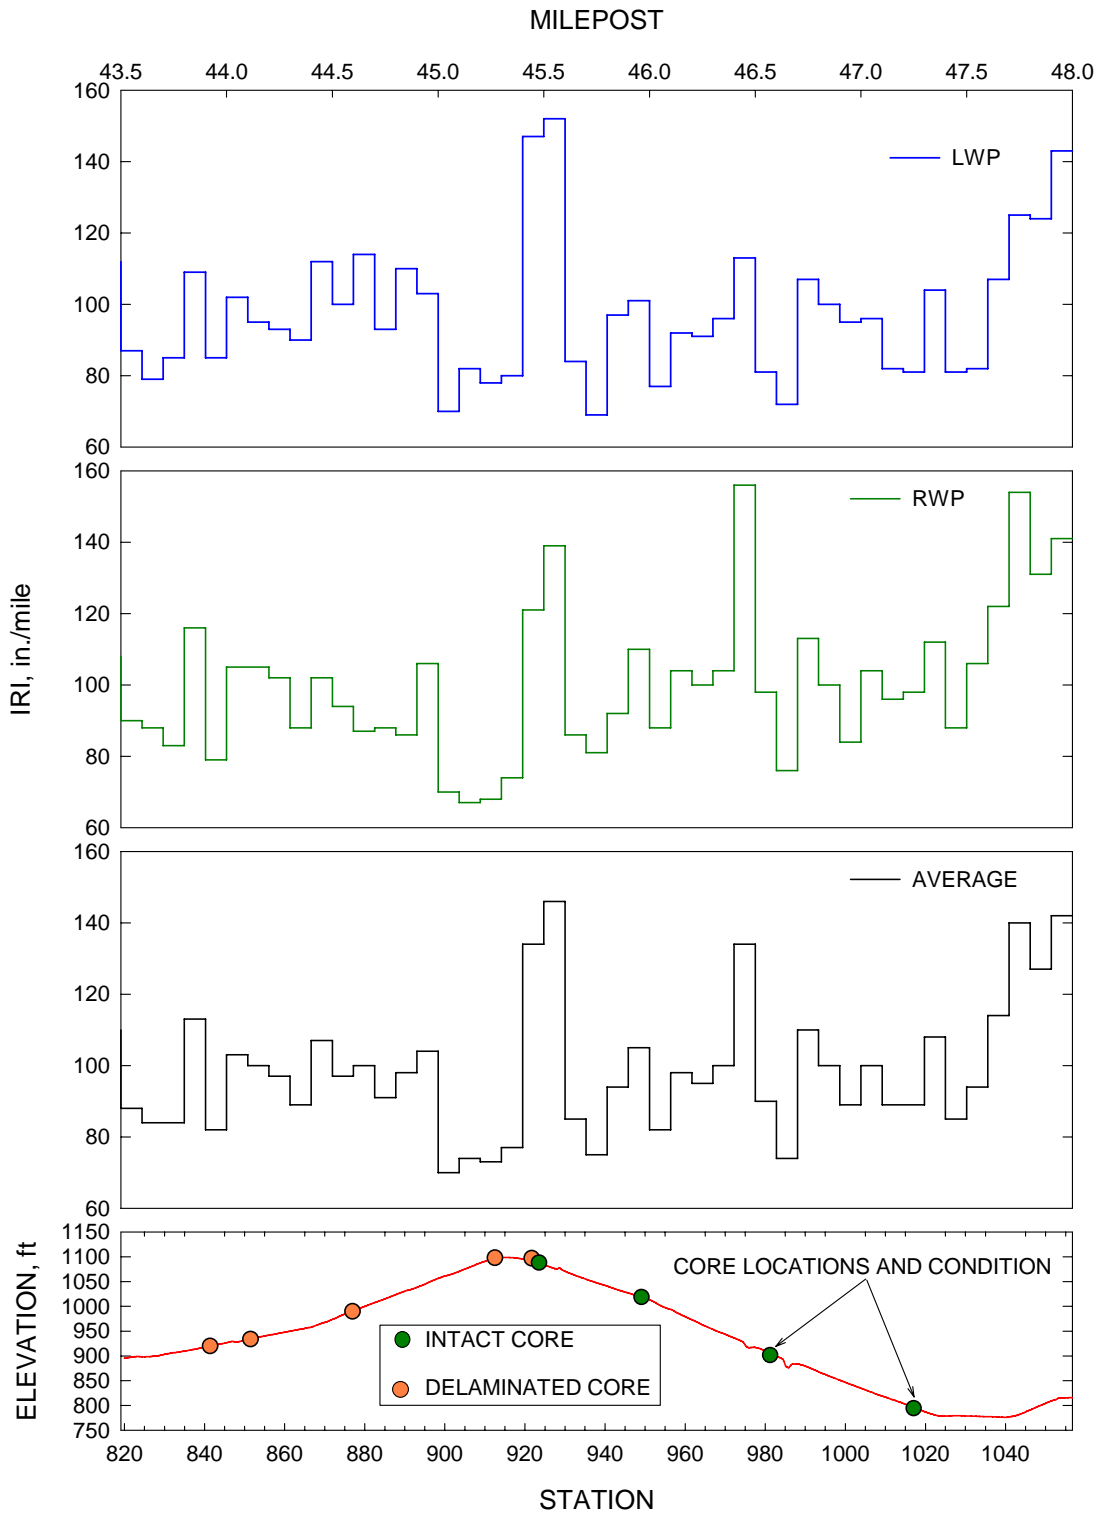
Figure 3-6. I-20 Lane 3 roughness summary plot

The longitudinal profile measurements were used to calculate the IRI for 0.1-mi roadway segments in the LWP, RWP, and average of the LWP and RWP. These data are plotted in Figure 3-6. No discernable pattern emerges from these graphs with the possible exception of increased roughness near the end of the pilot sections. This may be due to the presence of several bridges in the last half-mile of the test section.

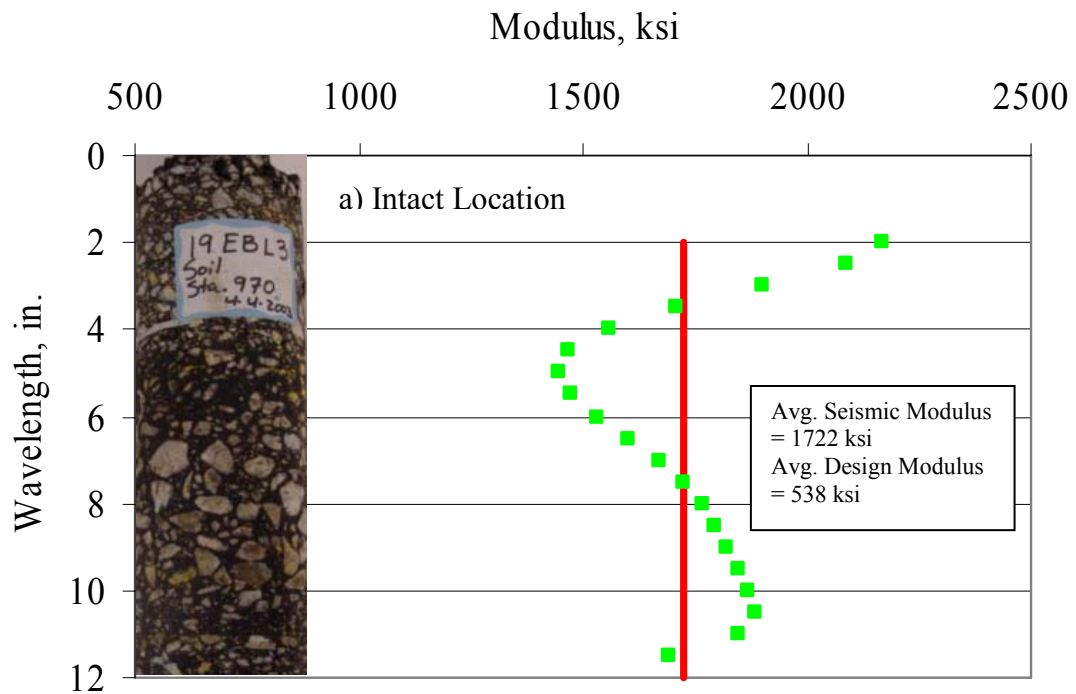
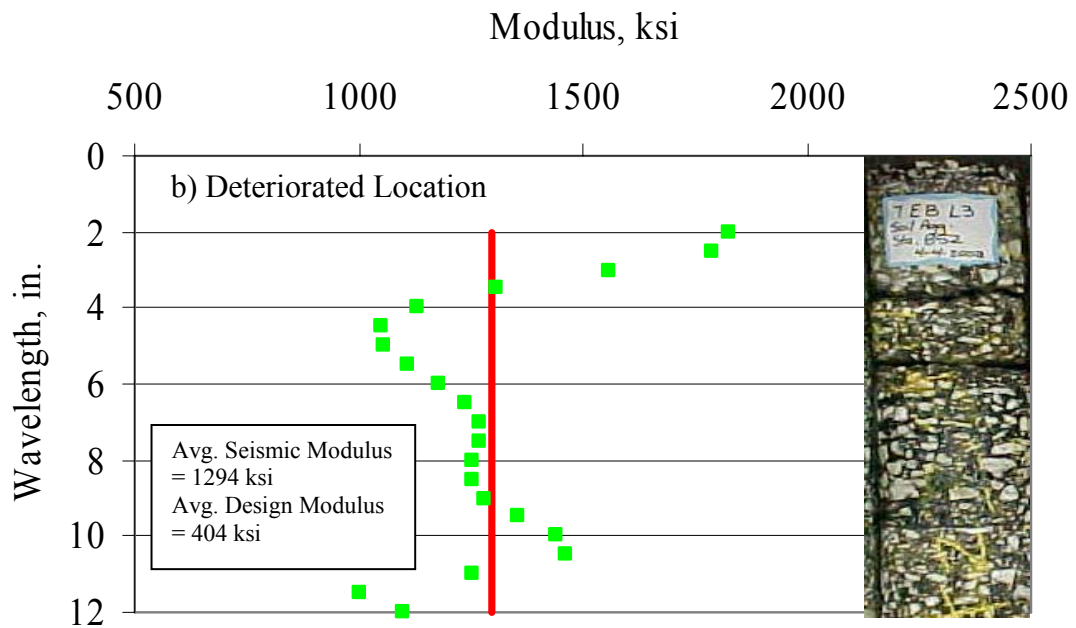
Figure 3-8. Typical dispersion curves from intact and deteriorated I-20 sections

Similarly, a typical dispersion curve from a deteriorated core location is shown in Figure 3-8b. Once again, the top layer is stiff. At the debonding depth the modulus drops significantly, which gradually increases in the lower intact material. Once again, there is rational correspondence between the shape of the dispersion curve and the locations of the deteriorated materials.

As shown in Figures 3-11 and 3-12, the same exercise was carried out with the deteriorated core. In this case the simulated dispersion curve is similar to the measured one for shorter wavelengths, but the two curves deviate significantly at longer wavelengths. This pattern demonstrates that the damage due to stripping is causing a significant drop in the modulus of the intermediate layers.

Eight cores were obtained at this site in April 2003. The location and condition of each core as reported by GDOT are also superimposed on Figures 3-16 and 3-17. In general, the conditions of the cores and the results from the USW and IE amplitude correlate reasonably well. All the intact cores are in the areas where their moduli are within the reasonable quality and higher except for the depths of 4 to 6 inches, where they are in the marginal condition. For the last intact core, which is located around MP 46.800, our analyses contradict the condition of the core as being intact.

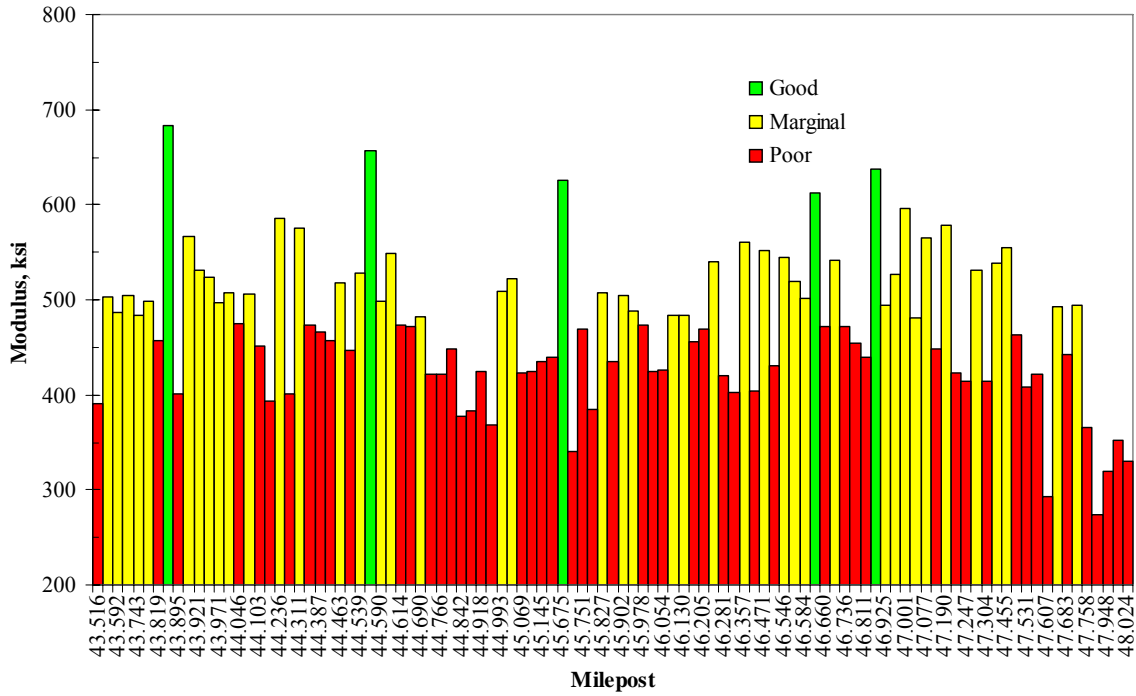
Figure 3-13. Variation in average modulus obtained with USW method along I-20 pilot project

The variation in average modulus along the site is shown in Figure 3-13. The data are categorized into three groups: good, marginal and poor. Since the site was located on an interstate highway, we assigned a value of 600 ksi and above for a good-quality HMA layer. Very few points place in this category. The marginal category was considered as a material with an average modulus between 475 ksi and 600 ksi. As reflected in the figure, most points fall in this category. Finally a poor material is any material with a modulus less than 475 ksi. Several areas tested fall into this category.

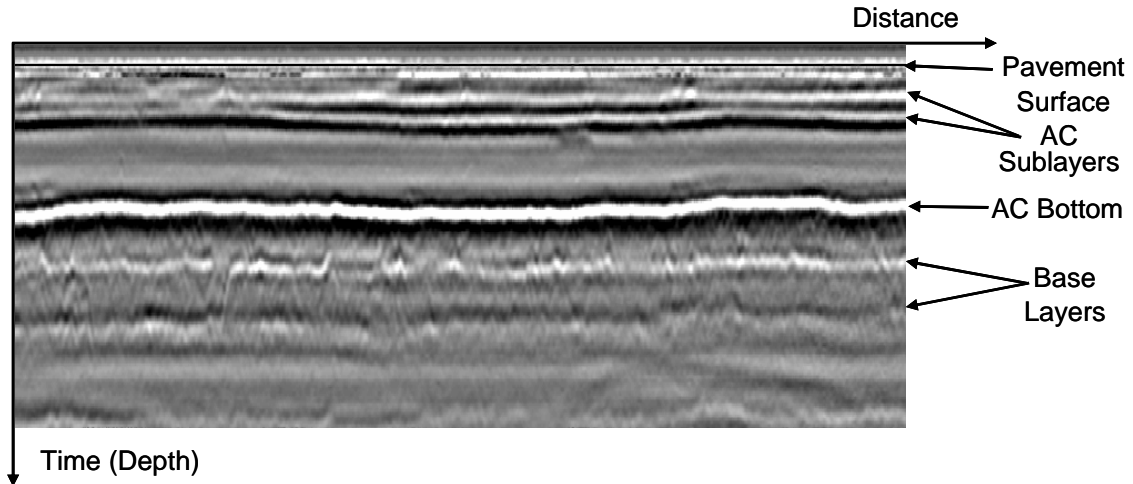
The GPR data for I-20 for the full depth AC section shows three major layers within the AC structure, with the layer bottoms at approximately 3 inches, 5 to 6 inches, and 16 inches. Figure 3-21 shows an example of the raw GPR data showing these layer boundaries.

Figure 3-21. Sample GPR section data from I-20 Lane 3, centerline

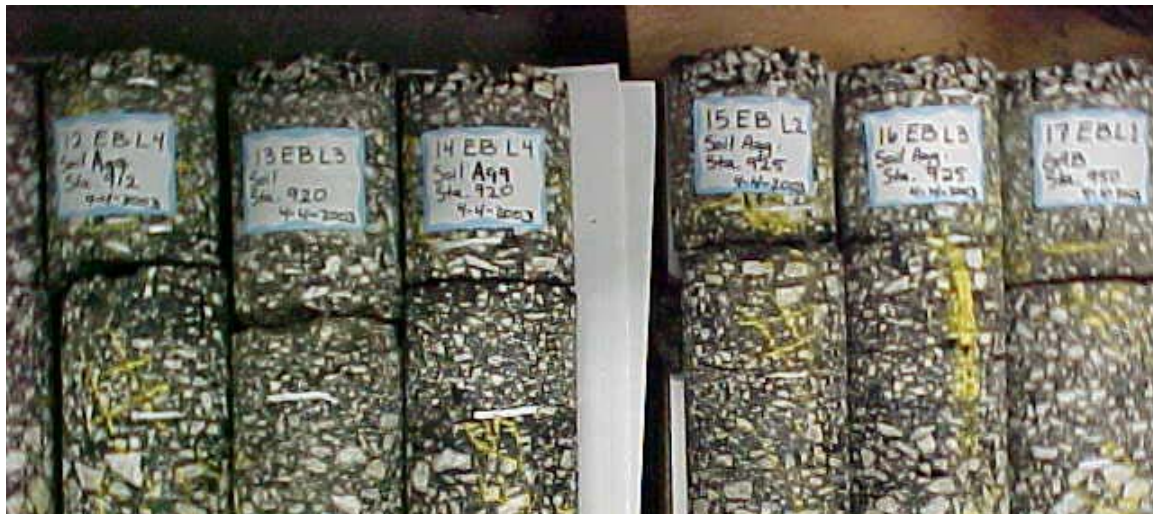
The core data provided by GDOT for I-20 shows that stripping occurs at the boundaries of, and within the second of the three asphalt layers. Examples of cores showing this behavior are shown in Figure 3-22.

Figure 3-22. I-20 cores showing stripping from 4 to 6 inches from the surface

The above observation suggests that the occurrence of stripping is associated with strong reflections from the interfaces above and below the second layer. The GPR system produces a sequence of scans

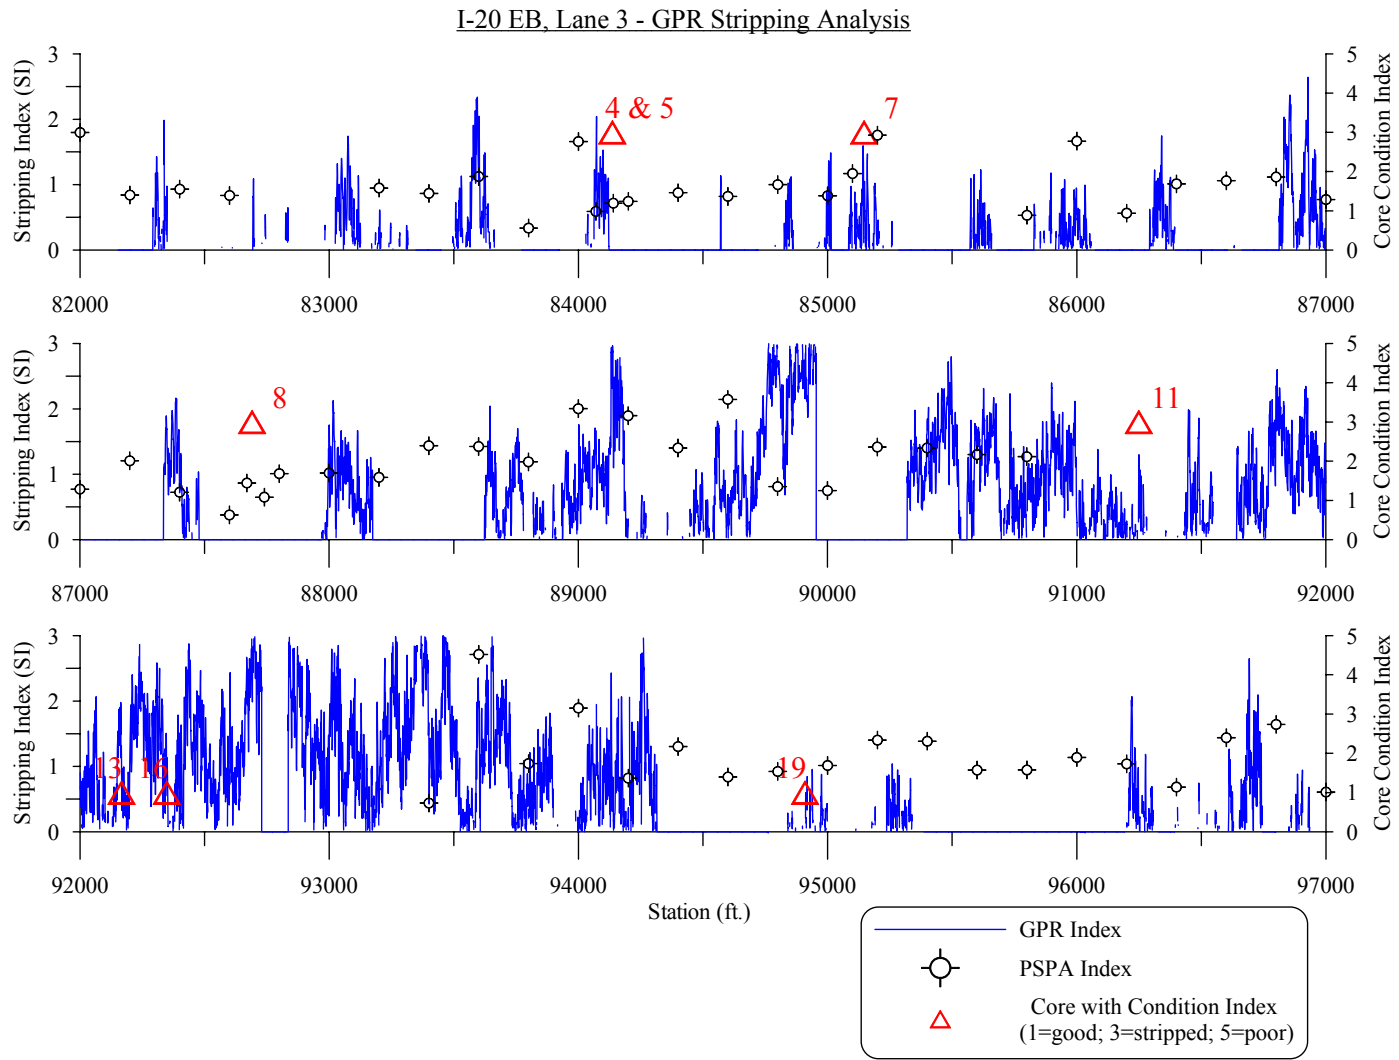
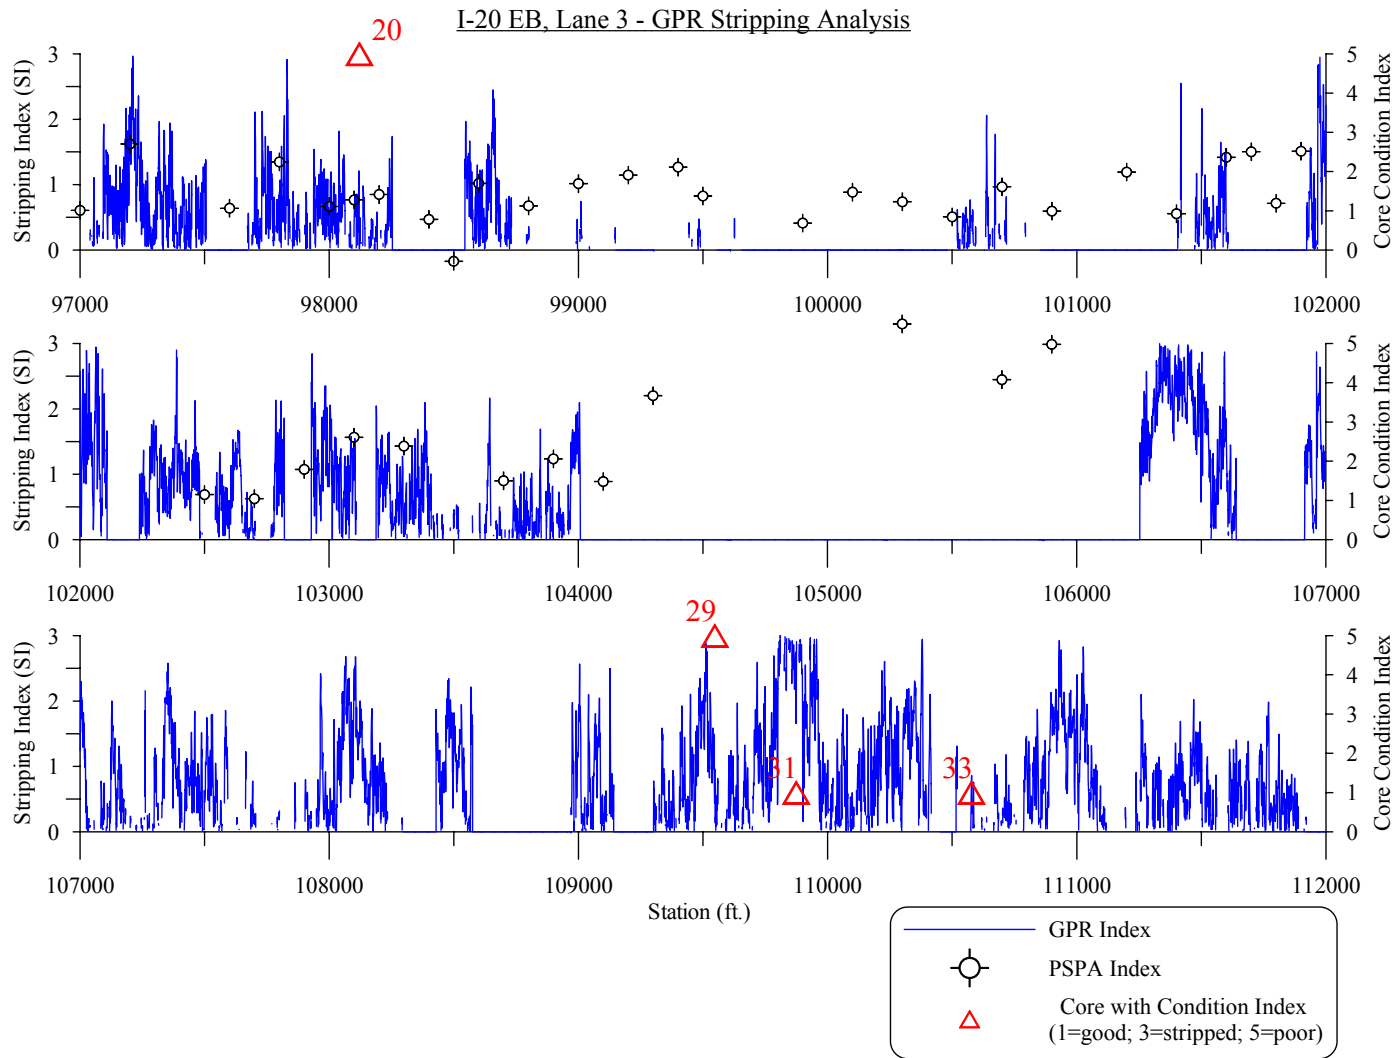
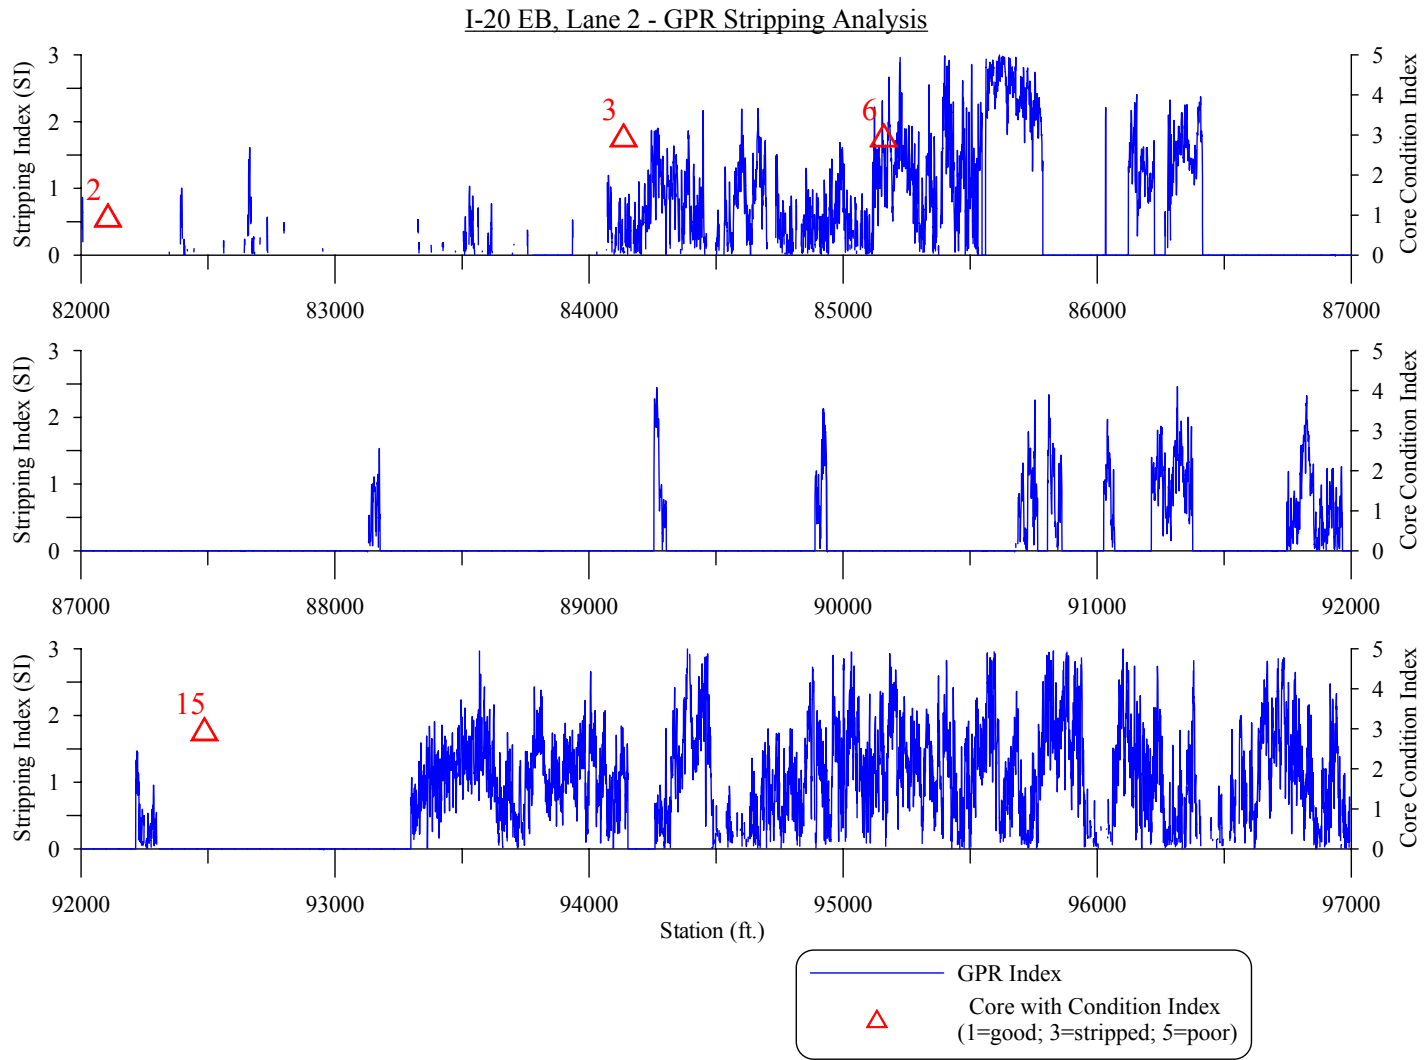
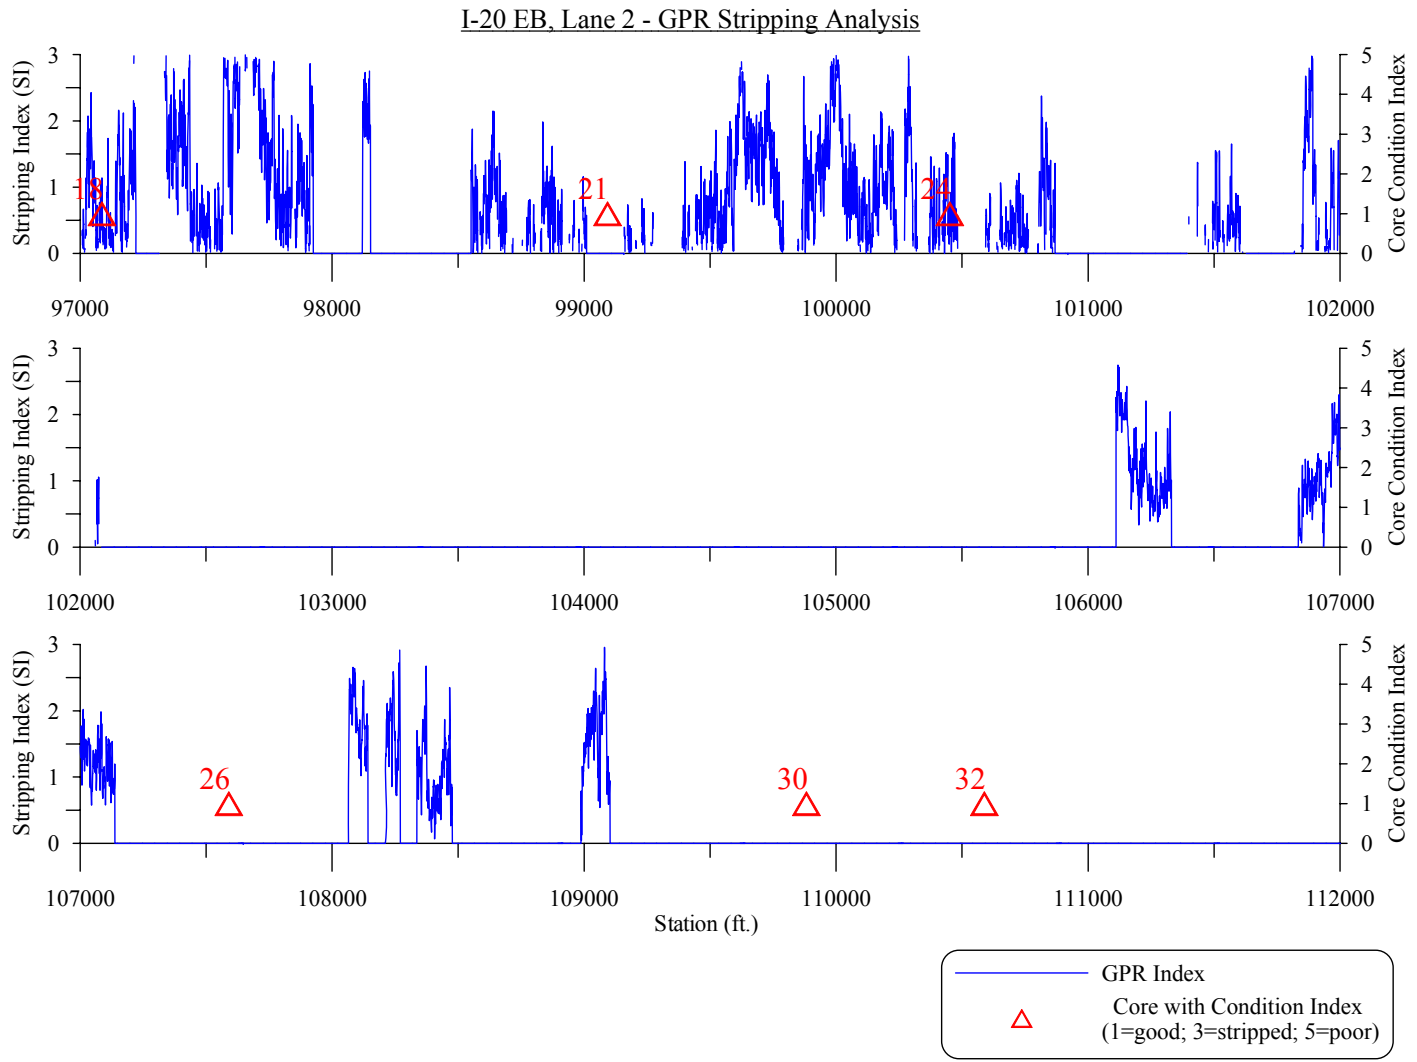
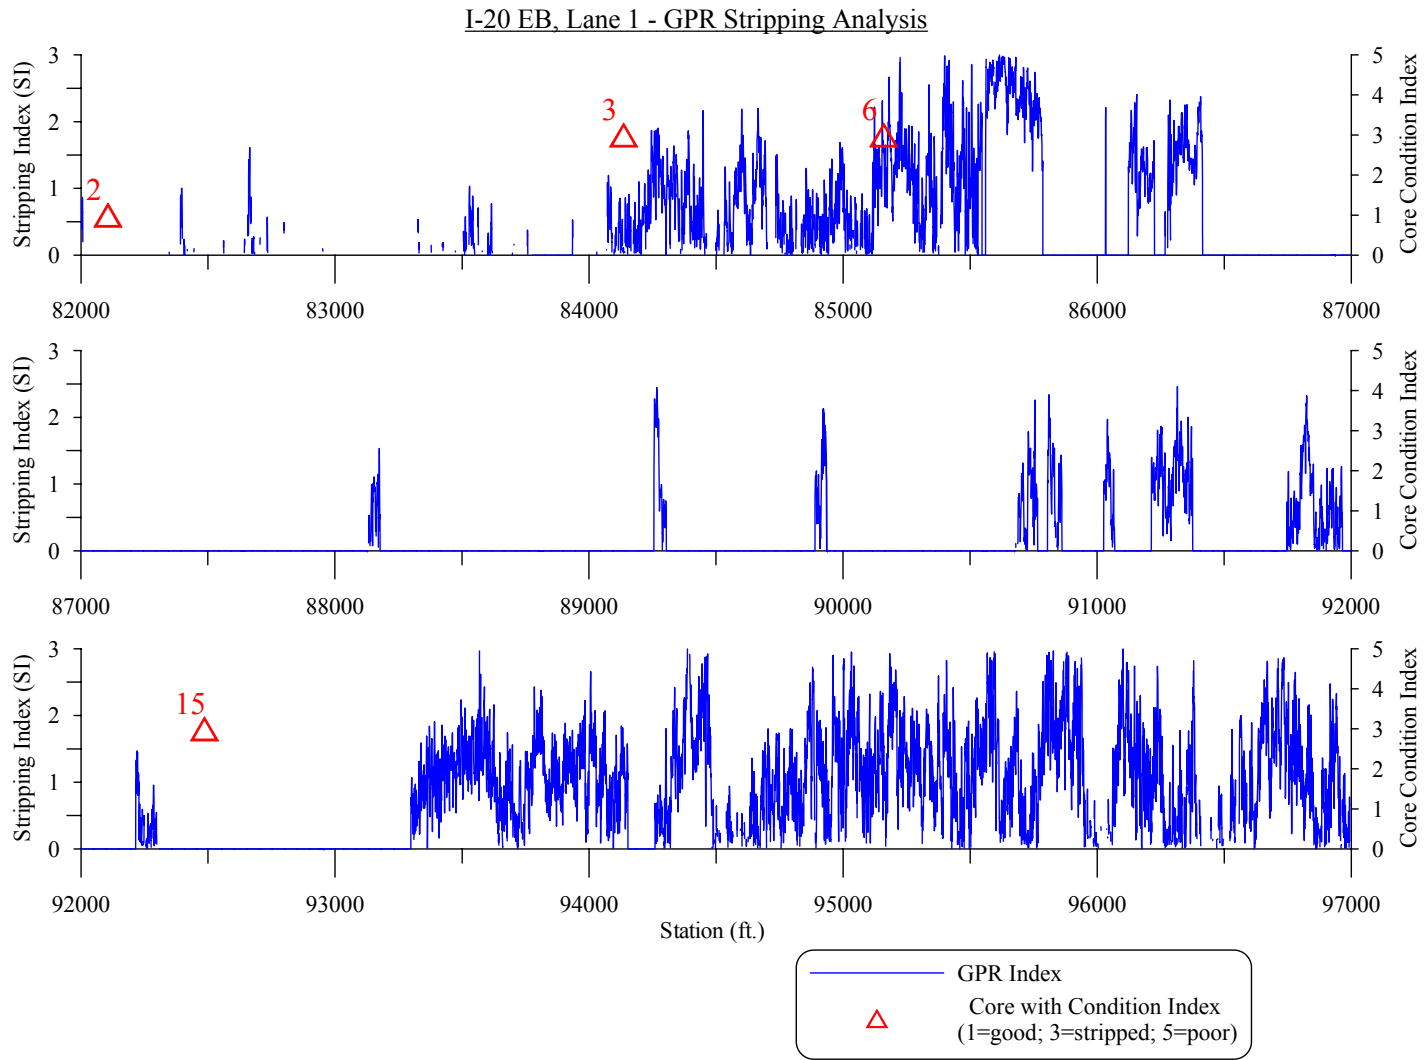
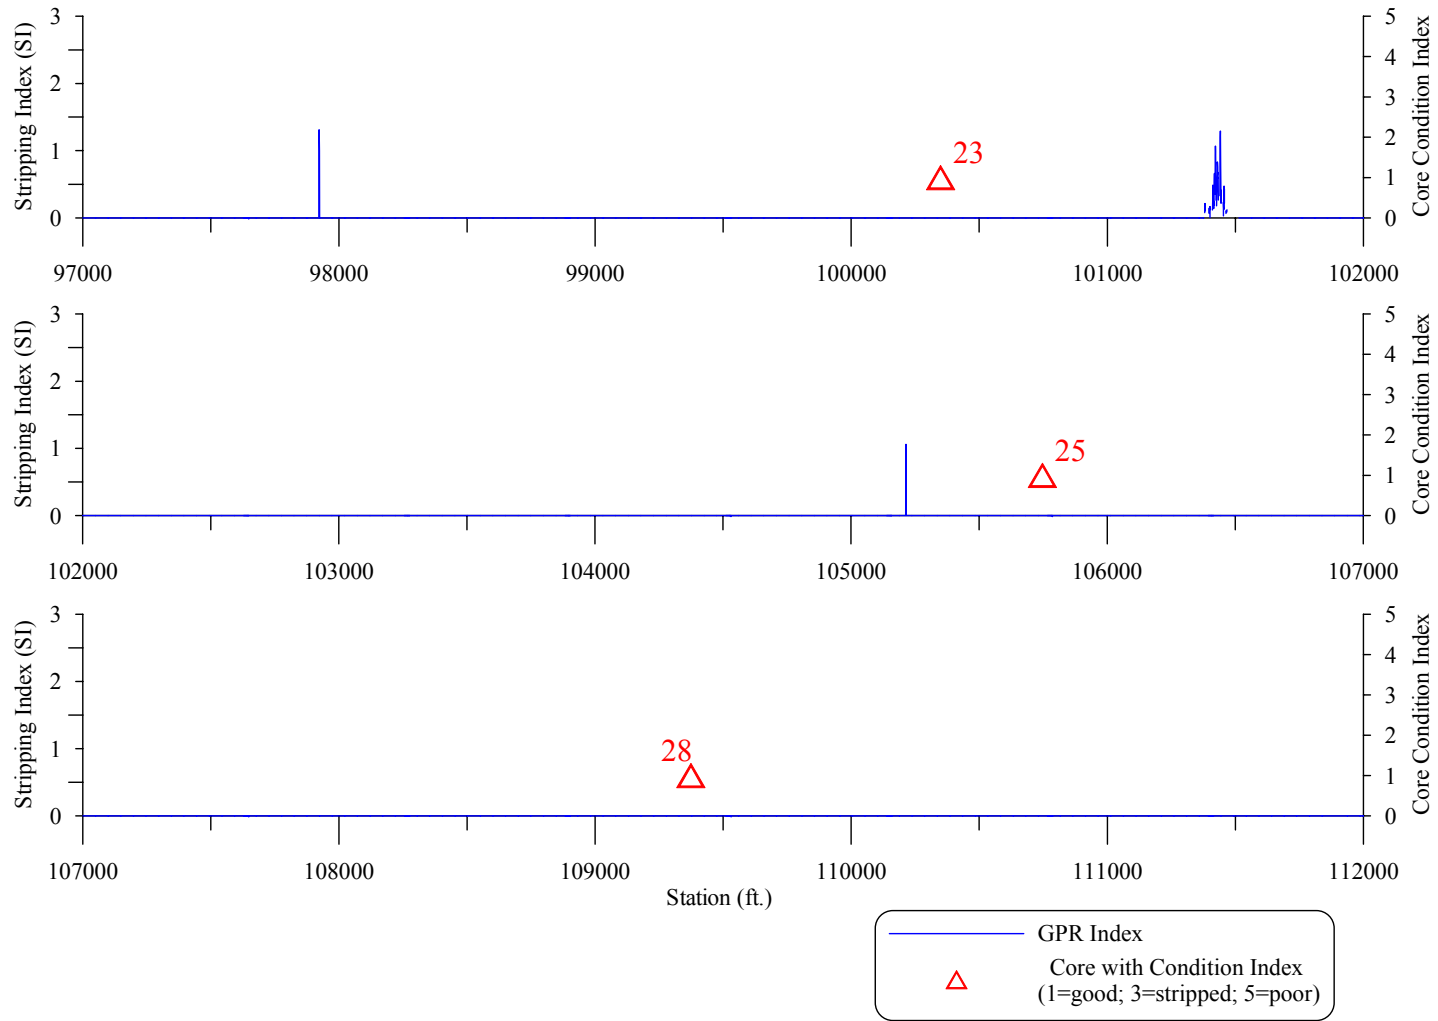
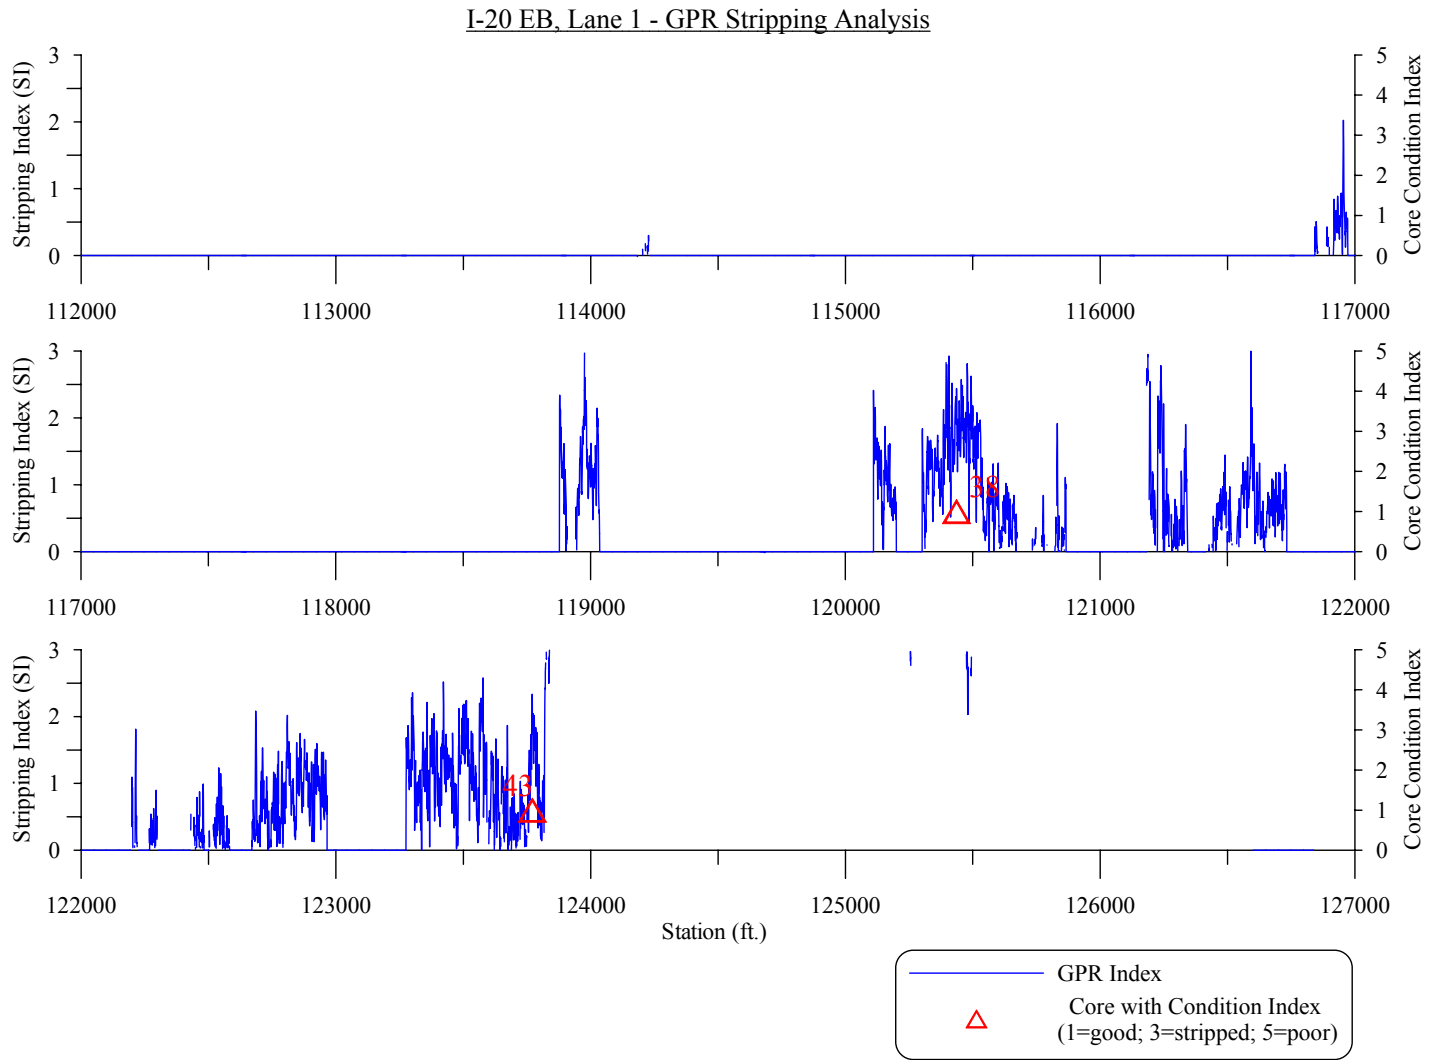
Figures 3-23 through 3-29 show plots of the SI , core index, and PSPA index. The PSPA index axis is on the left with the SI axis. It appears that a good match between the SI and the core condition might be achieved by setting a stripping threshold of 0.5 for the SI .

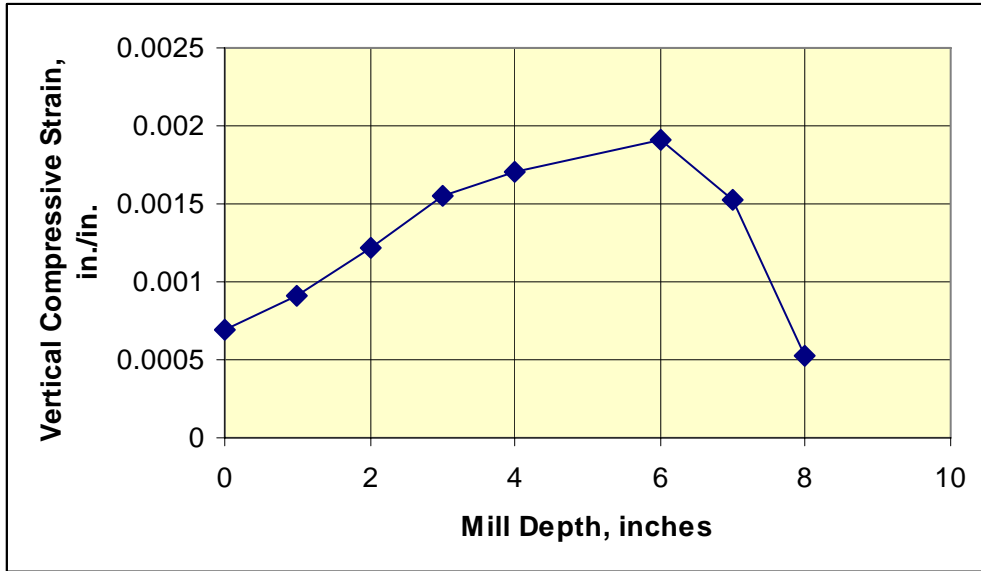
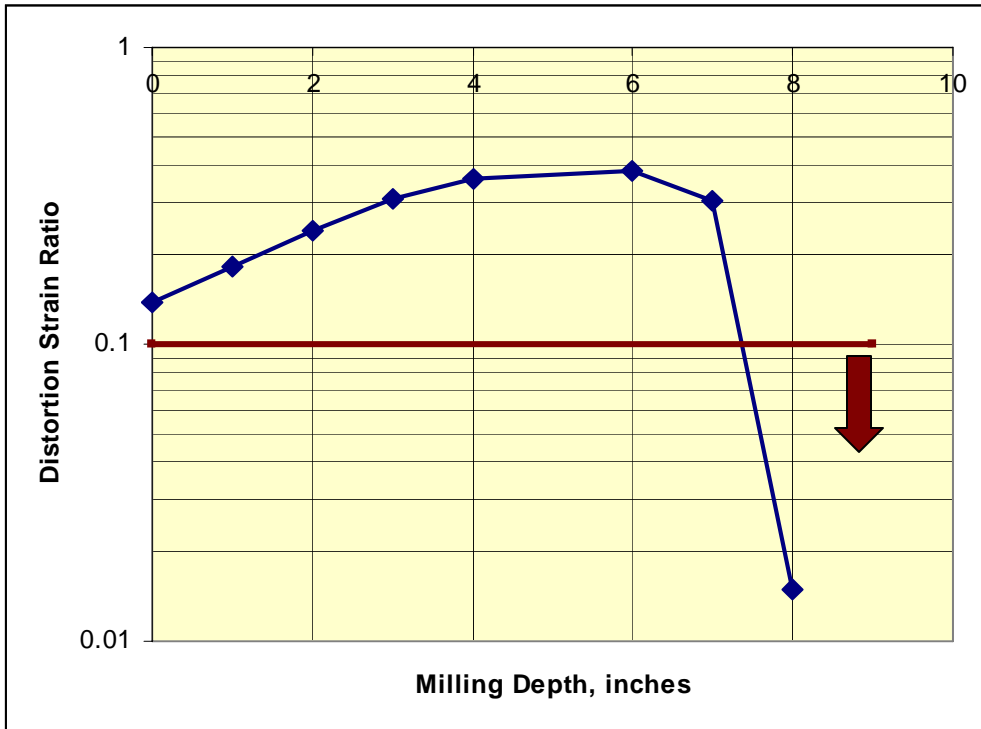
Figure 3-44. Maximum vertical compressive strain in the HMA layer for different milling depths

Figure 3-45. Distortion strain ratio for different milling depths

A distortion strain ratio criteria of 0.10 is shown on Figure 3-45 and represents a value during construction or placement of the HMA overlay. The milling depth is selected to keep the distortion strain ratio less than 0.10. As a result, any milling requires that the wearing and HMA layer with the moisture damage be removed. If the HMA layer with moisture damage and stripping remains in place, significant distortions would be expected under the HMA delivery trucks that would damage that layer and result in significant rutting after HMA overlay placement. However, the HMA overlay thickness can be designed to prevent this distortion with future truck traffic. The HMA overlay thickness to prevent significant rutting was not determined within this initial analysis.

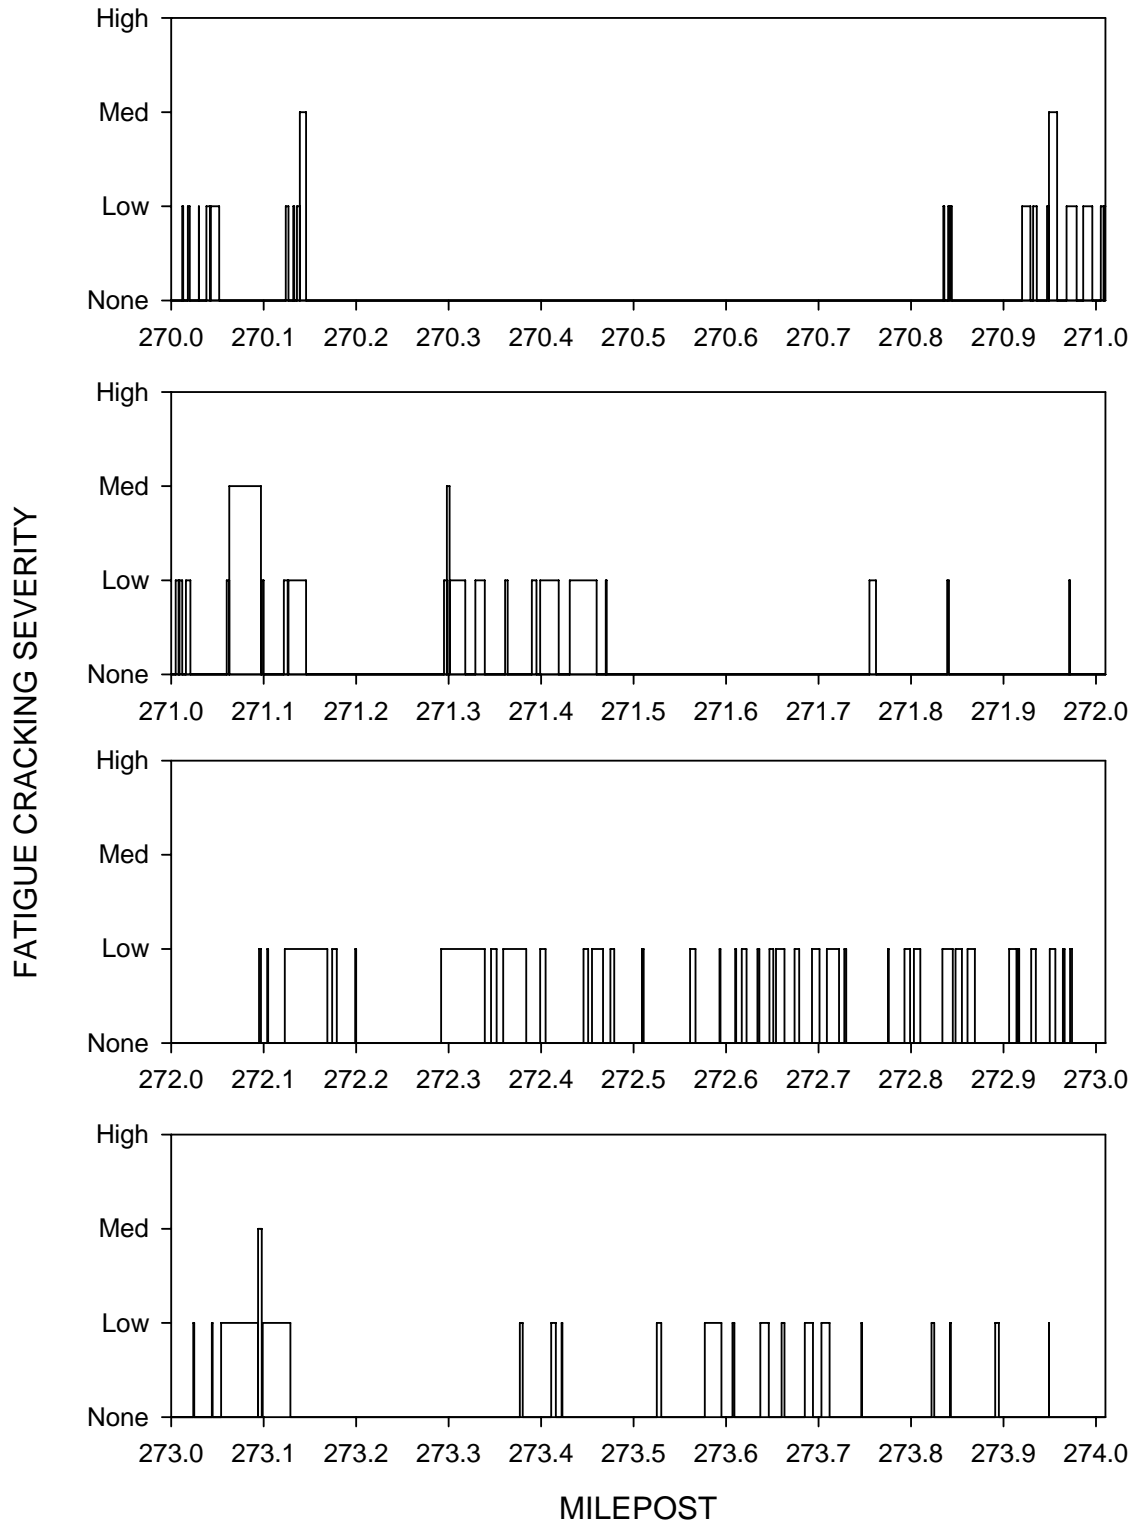
Figure 4-4 summarizes the cracking observed in the Lane 3 of the pilot section. To simplify the interpretation of the data, the maximum observed level of severity of fatigue cracking has been plotted. The plot shows that at the time of the survey, the majority of Lane 3 did not exhibit fatigue cracking. Where fatigue cracking was observed, the majority was low in severity, with only a few locations having medium severity cracking and no areas having high severity cracking.

Figure 4-4. Fatigue cracking summary plot, I-75 Lane 3

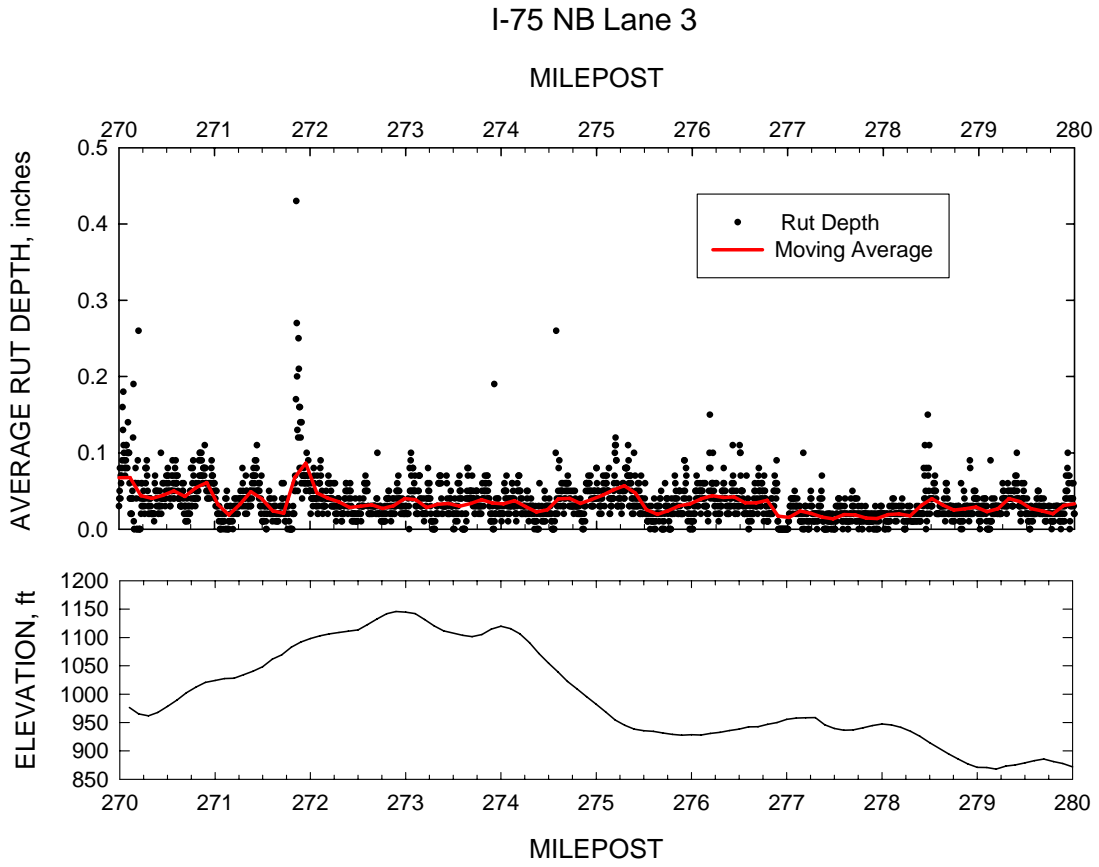
Transverse profile measurements were used to calculate the average rut depths within each 20-ft-long sample unit in Lane 3 between MP 270 and 280. The data points in Figure 4-5 shows the average rut depth. The smoothed curve is a moving average with a sampling window of approximately 1000 ft. The average rut depth was typically less than 0.1 inch. Unlike the surveyed section of I-20, the magnitude of the rut depth does not appear to correlate to changes in elevation.

Figure 4-5. I-75 Lane 3 rutting summary plot
