DETECTION OF STRIPPING IN HOT MIX ASPHALT

Final Report

March 11, 2005

**Office of Materials and Research
Georgia Department of Transportation
Forest Park, GA 30297-2599**

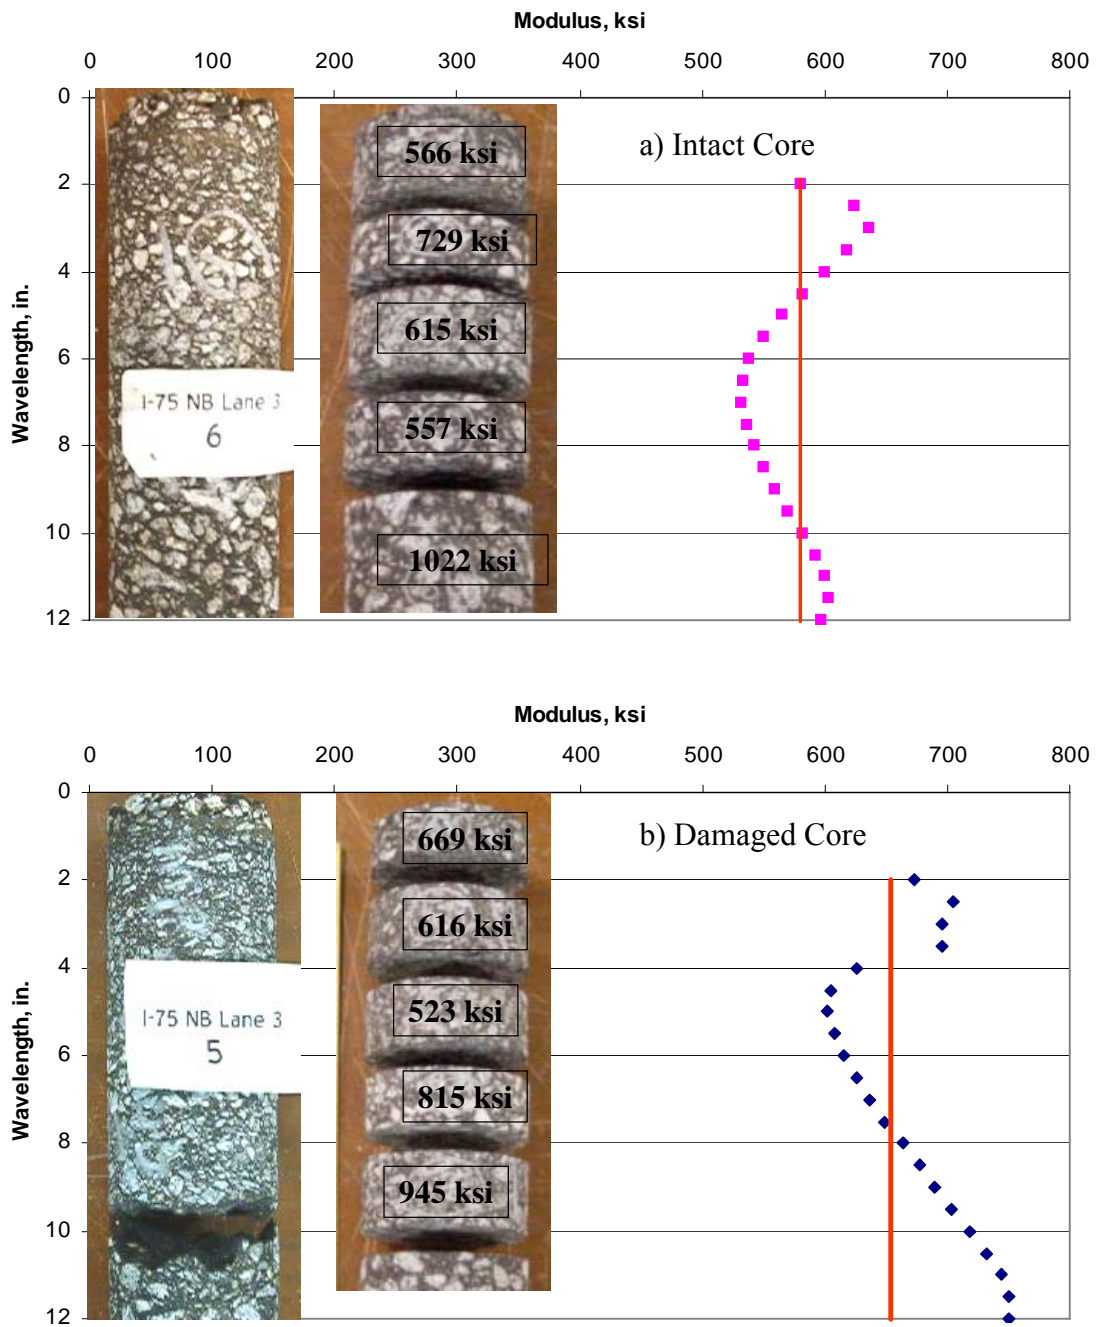
Similarly, a typical dispersion curve from a deteriorated core location is shown in Figure 4-7b. The top layer seems to be stiffer than the one from the intact location. At depths between 4 inches and 6 inches, the HMA is of lower quality than the intact core. Below 6 inches, the modulus increases significantly, which is reflected in the dispersion curve as a rapid increase in modulus. The deteriorated material is not directly detected because it is sandwiched between two layers of extremely stiff HMA.

To further quantify the reasonableness of the results, the intact and damaged cores were cut into distinct layers and the seismic modulus of each layer was determined in the laboratory. The core pieces and their corresponding moduli are also shown in Figure 4-7. Considering experimental errors, fairly reasonable agreement between the dispersion curves and the quality of the materials is observed.

Figure 4-7. Typical dispersion curves from intact and deteriorated sections of I-75

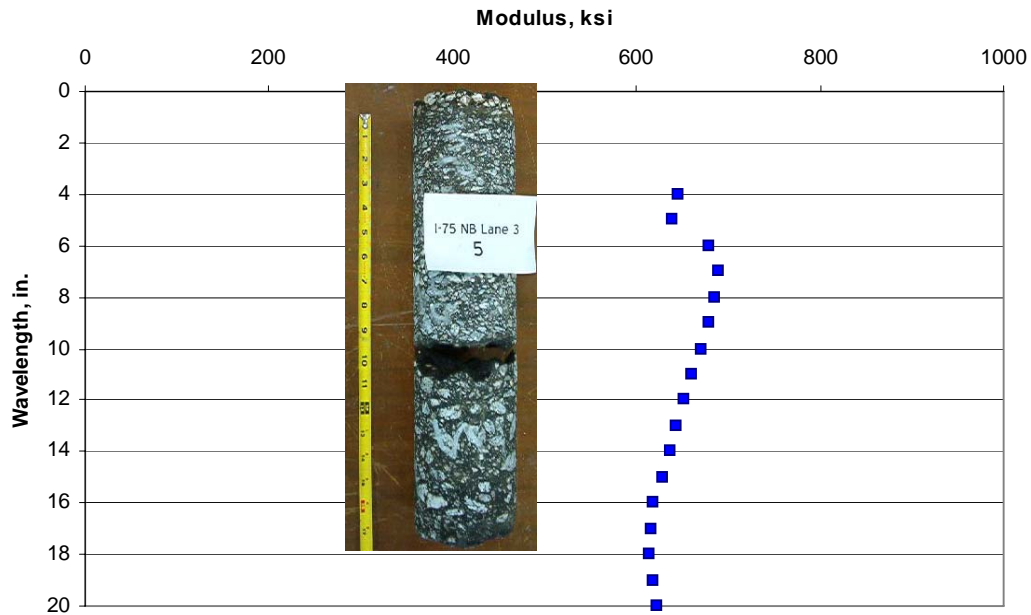
As indicated before, all points were tested using a PSPA sensor spacing of 6 inches. A number of points were also tested using 12-inch spacing so that the dispersion curve deeper within the HMA section can be obtained. The results from the deteriorated core are shown in Figure 4-8. In this case, the properties down to a depth of 24 inches can be sampled. However, the dispersion curve from depths less than 4 inches is not available. The dispersion curve below a depth of 10 inches tends toward lower moduli, even though the material below the damaged area is stiff. Again, this indicates that the less than 1-inch thick deteriorated layer at a depth of 10 inches cannot be detected. However, one should also consider that such a small region deteriorated at such a depth may not be considered a threat to the structural integrity of the pavement section.

Figure 4-8. Typical dispersion curve from deteriorated section of I-75 using 12-inch PSPA sensor spacing

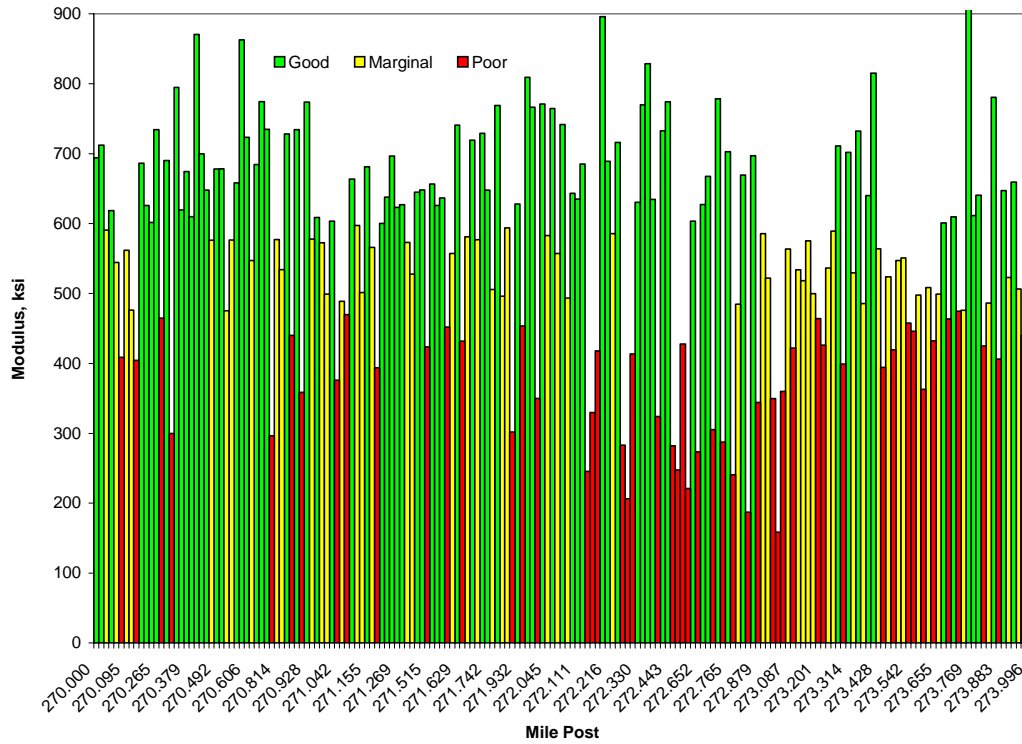
The variation in average modulus along the site is shown in Figure 4-9. The data are categorized into three groups: good, marginal and poor. Since the site was located on an interstate, we assigned a value of 600 ksi and above for a good-quality HMA layer. Majority of points between MP 270 and 272.2 place in this category. The marginal category was considered as a material with an average modulus between 475 ksi and 600 ksi. As reflected in the figure, most points north of MP 272.2 fall in this category. Finally a poor material is any material with a modulus less than 475 ksi. Several areas tested fall into this category.

Figure 4-9. Variation in average modulus obtained with USW Method along the length of the I-75 pilot project

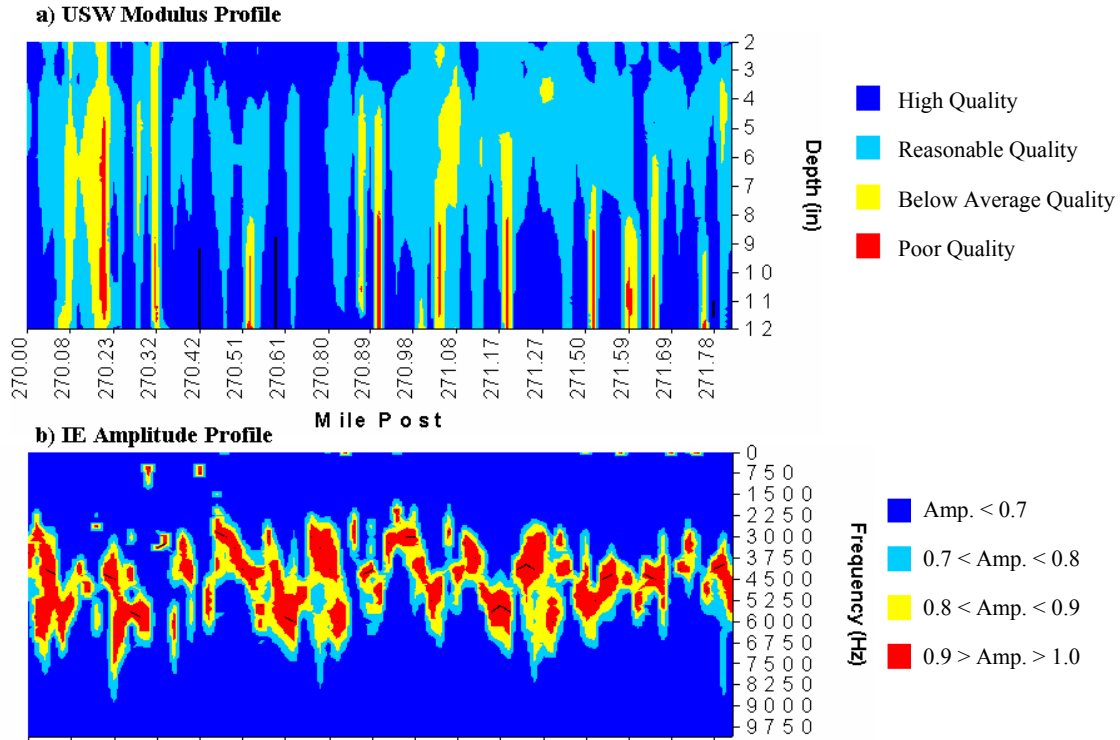
Figure 4-10. Variation in modulus and impact-echo amplitude from Day 1 of I-75 field tests

The red and yellow zones indicate of the areas of concern. It should be emphasized that the red and yellow contours may occur for several reasons. The most obvious reason is low quality materials that are either poorly constructed or have experienced moisture damage. The second reason can be the debonding of the HMA layers.

For tests conducted during the first day, as reflected in Figure 4-10a, the section between MP 270.0 and 270.3 are of concern. Past that point, the first 4 to 6 inches of the AC layer is typically of good quality. The quality of the material below a depth of 4 to 6 inches varies. The impact echo demonstrates signs of deterioration in some of the areas with good quality materials, especially between MP 271.500 and 271.900, and in the vicinity of MP 271.400.

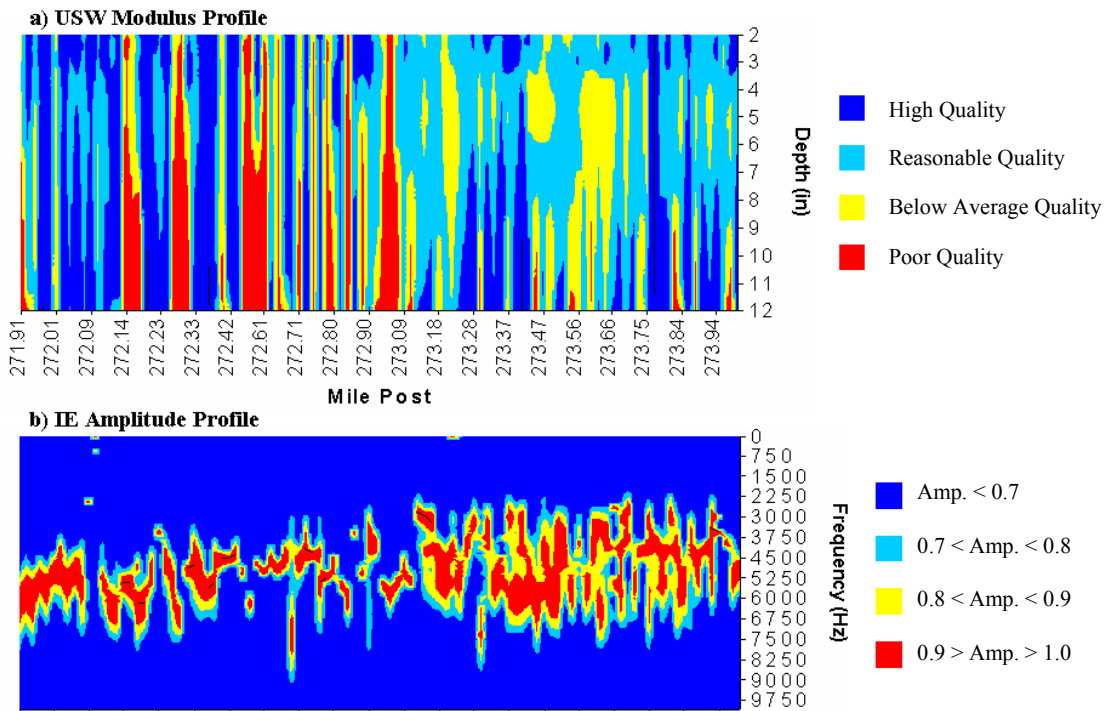
Figure 4-11. Variation in modulus and impact-echo amplitude from Day 2 of I-75 field tests

The results from Day 2 of field work are shown in Figure 4-11. Once again, the top 3 to 4 inches of the material seems to be in good condition. Areas north of MP 272.3 are of concern. The materials north of MP 273.3 seem to be more reasonable, but the impact-echo graph indicates the possibility of delamination.

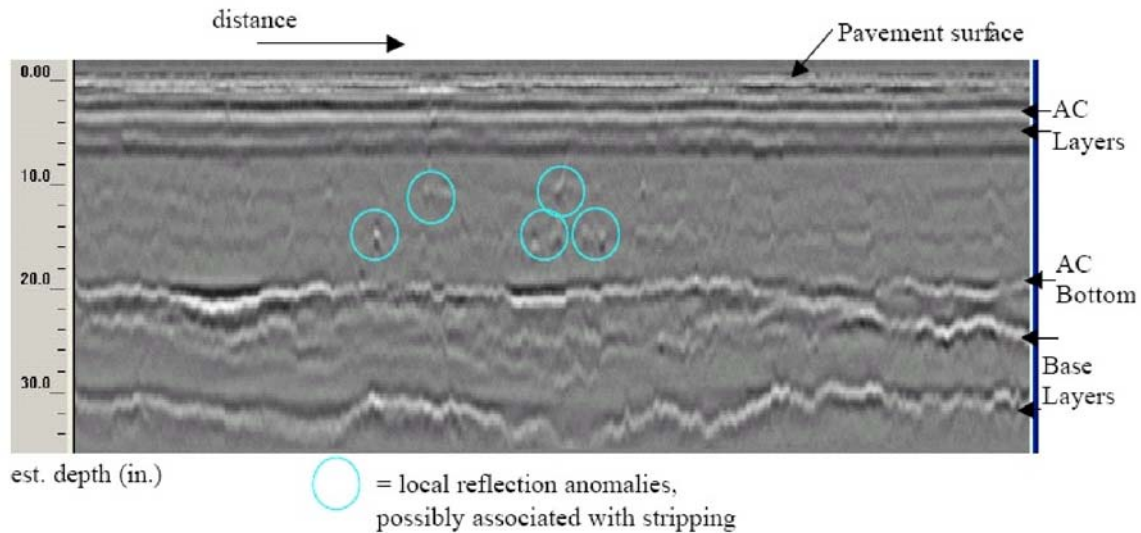
Figure 4-12. Sample GPR section data from centerline of Lane 3, I-75

The GPR data for I-75 for the full-depth HMA section shows three major layers within the HMA structure, with the layer bottoms at approximately 4, 7, and 21 inches below the surface. Figure 4-12 shows an example of the raw GPR data showing these layer boundaries.

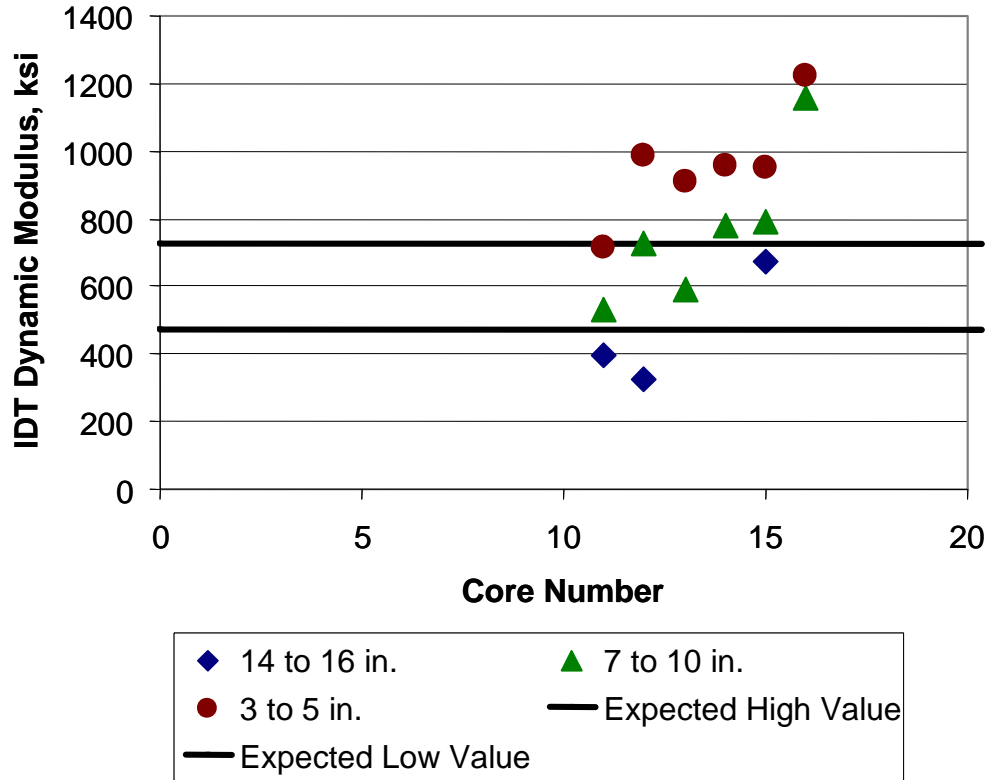
Figure 4-16. Comparison of measured IDT dynamic modulus from I-75 cores to expected values from non-aged mix

The dynamic modulus measured in two of the three test specimens taken from the lower base layer (placed in 1977) are below the lower baseline value. These lower modulus values could suggest moisture damage, but could be the result of higher air voids, lower asphalt contents, or micro-fatigue cracks near the bottom of the layer. If the lower modulus values for the lower base layer are a result of moisture damage, the relationship between strength and modulus for the moisture damaged layer should be different from those layers without moisture damage. Figure 4-18 shows the relationship between the indirect tensile strength and dynamic modulus for the different layers included in the test program. As shown, all three layers have consistent relationship between strength and modulus, suggesting that the lower modulus values may be related to differences in volumetric and asphalt properties, rather than related to moisture damage.

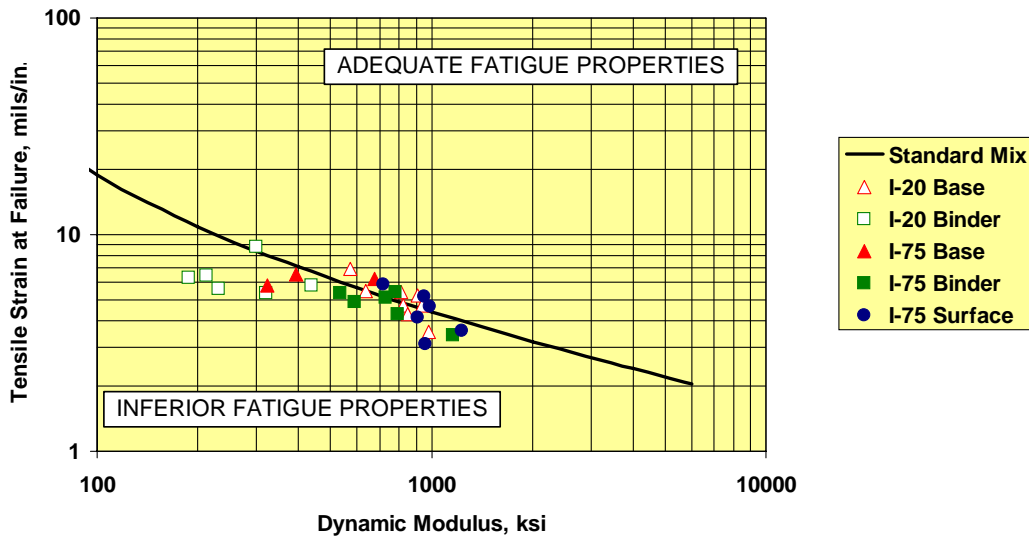
Figure 4-18. Comparison of the IDT dynamic modulus and strain at failure to typical values expected for a mix without moisture damage

Figure 4-18 compares dynamic modulus and tensile strain at failure on a standard mixture without moisture damage to test data from the I-75 and I-20. Values below the standard mixture curve exhibit low tensile strain at failure, and thus can be said to have inferior fatigue properties. Two general categories of materials with inferior fatigue properties are represented: *moisture damaged* and *brittle* materials. HMA mixtures with moisture damage have low modulus and low tensile strain at failure, while brittle HMA mixtures exhibit high modulus with low tensile strain at failure. From Figure 4-18, we see that the I-20 base mixture appears to be significantly affected by moisture damage, while the I-20 binder mixture is consistent with undamaged material. For the I-75 cores, one base course sample exhibits behavior consistent with moisture damage. The I-75 binder and surface course exhibit behavior typical of normal to brittle HMA materials.

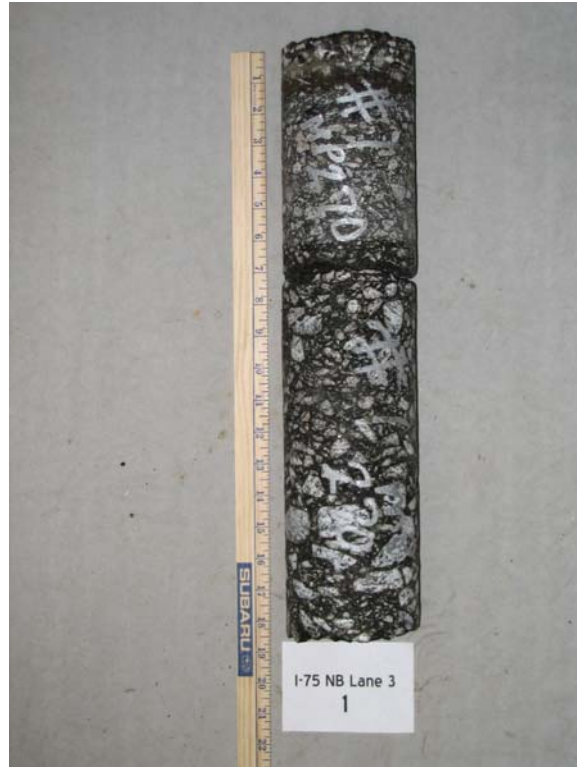
Core 1 (Lane 3)

Cores 1, 4, 6, and 14, all of which appear to be in good condition, have UI values all less than 1.05. Cores 3, 5, and 15, all either damaged or likely stripped, have a high UI values (at least one value > 1.34). Core 8, however, also obviously in poor condition based on PSPA data, has low UI values. Based on the UI values, we would expect poor conditions in Cores 9 and 13. There is no PSPA data for Core 9, but the observations show fractures at 9.5 inches and 13.5 inches. These fractures could be related to moisture damage. Core 13 PSPA data shows weakness from 2 to 4 inches, but it is not clear whether this is moisture damage.

Core	UI		Core/PSPA Analysis
	3 to 7 inches	7 to 16 inches	
1	0.98	1.03	No damage below 2 inches
2	1.37	0.73	Weaker from 4 to 6 inches
3	1.07	1.72	Damaged at 3 inches and below 11 inches; low modulus and modulus ratio
4	1.05	0.72	No damage
5	0.82	1.10	Damage at 3 to 4 inches
6	1.05	0.66	No damage
7	1.07	0.88	Weaker from 3 to 5 inches
8	0.82	0.80	Damaged at 3 and 8 inches
9	1.16	1.96	Fracture at 9.5 inches and 13.5 inches
10	0.81	1.75	Fracture at 12.5 inches
11	0.82	0.89	Weaker from 2 to 4 inches, fracture at 14.5 inches
12	1.08	1.00	Weakness at 3 inches; fracture at 13.5
13	1.67	1.45	Weaker from 2 to 4 inches
14	0.88	1.07	No damage
15	1.60	1.80	Fracture at 6 inches; rubble from 12 to 14 inches
16	0.78	0.63	Broken at 6 and 15 inches; high modulus

Core Number	Milepost	Condition of Core	Visual ID for Stripping	Seismic Adjusted Modulus, ksi
1	270.000	Damage near surface, fractured at mid-depth	Low	566
2	270.095	Fractured at interface in base layer	None to Low	510
3	270.208	Disintegration near surface from coring	Likely in surface	425
4	270.284	Fractured at interface; damage in base layer	Low	553
5	270.379	Fractured and loss of material from coring in base layer	Likely in base	650; damage below test depth
6	270.473	Intact	None	507
7	270.568	Fractured at interface in binder & base layers	Low	680
8	270.663	Fractured at interface in surface & base layers; damage in base mix	None to Low	566
9	271.818	Fractured at interface in base layers	None to Low	608
10	271.932	Fractured at interface in base layers	None to Low	641
11	272.092	Fractured at interface in binder & base layers	None	721
12	272.100	Fractured at interfaces throughout core, loss of material in base mix	Likely in base	594; damage below test depth
