Final Report for Research Project

**LONG-TERM MAINTENANCE MONITORING  
DEMONSTRATION ON A MOVABLE BRIDGE**

September 2011

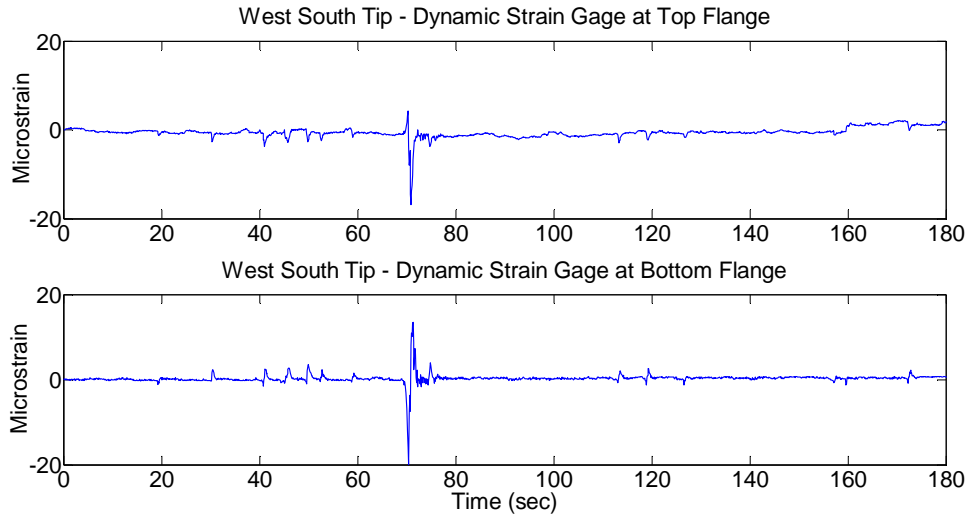
Figure 33: WS1 top and bottom flange dynamic strain gage sample data

holding the main girder up, or behind the trunnions resisting the upward movement of the counterweight. The former type is the most common type, and is the type used for the Sunrise Boulevard Bridge. This location was instrumented with accelerometers to see the impact loading due to pounding and with strain gages to observe the excessive strains on the cross section and strain rosettes to see the shear effects of the traffic loading. Sample data for acceleration (Figure 31), sample data from EN3 strain gages (Figure 32) and sample data from WS1 strain gages (Figure 33) can be seen in the following figures.

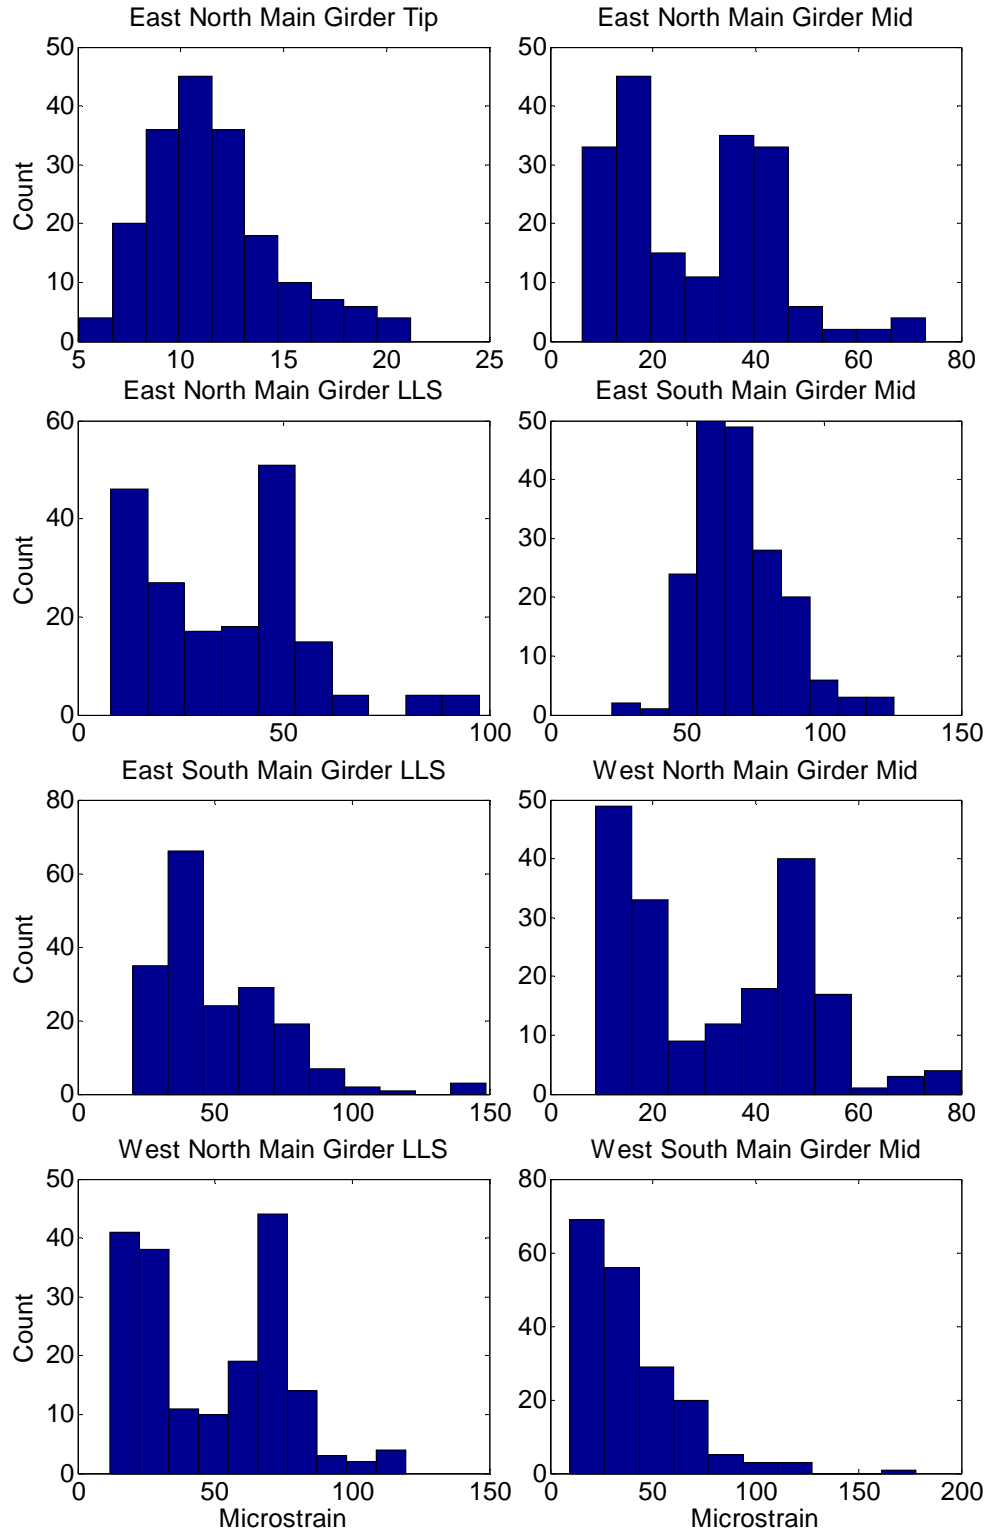
Figure 34: Traffic induced extreme strain distributions for different components

Long-term traffic monitoring is very important to collect statistical parameters. Therefore traffic induced strain data over two months is employed for demonstration. More than two months (5/15/11-7/24/11) traffic induced strain data histograms and traffic induced acceleration data histograms can be seen in Figure 34 and Figure 35, respectively.

These histograms are generated from the maximum observed values from the collected data during the pre-defined rush hours. For strains, it is seen that the critical locations are LLS areas, but for accelerometers, tip and mid areas of the main girders have the highest vibrations.

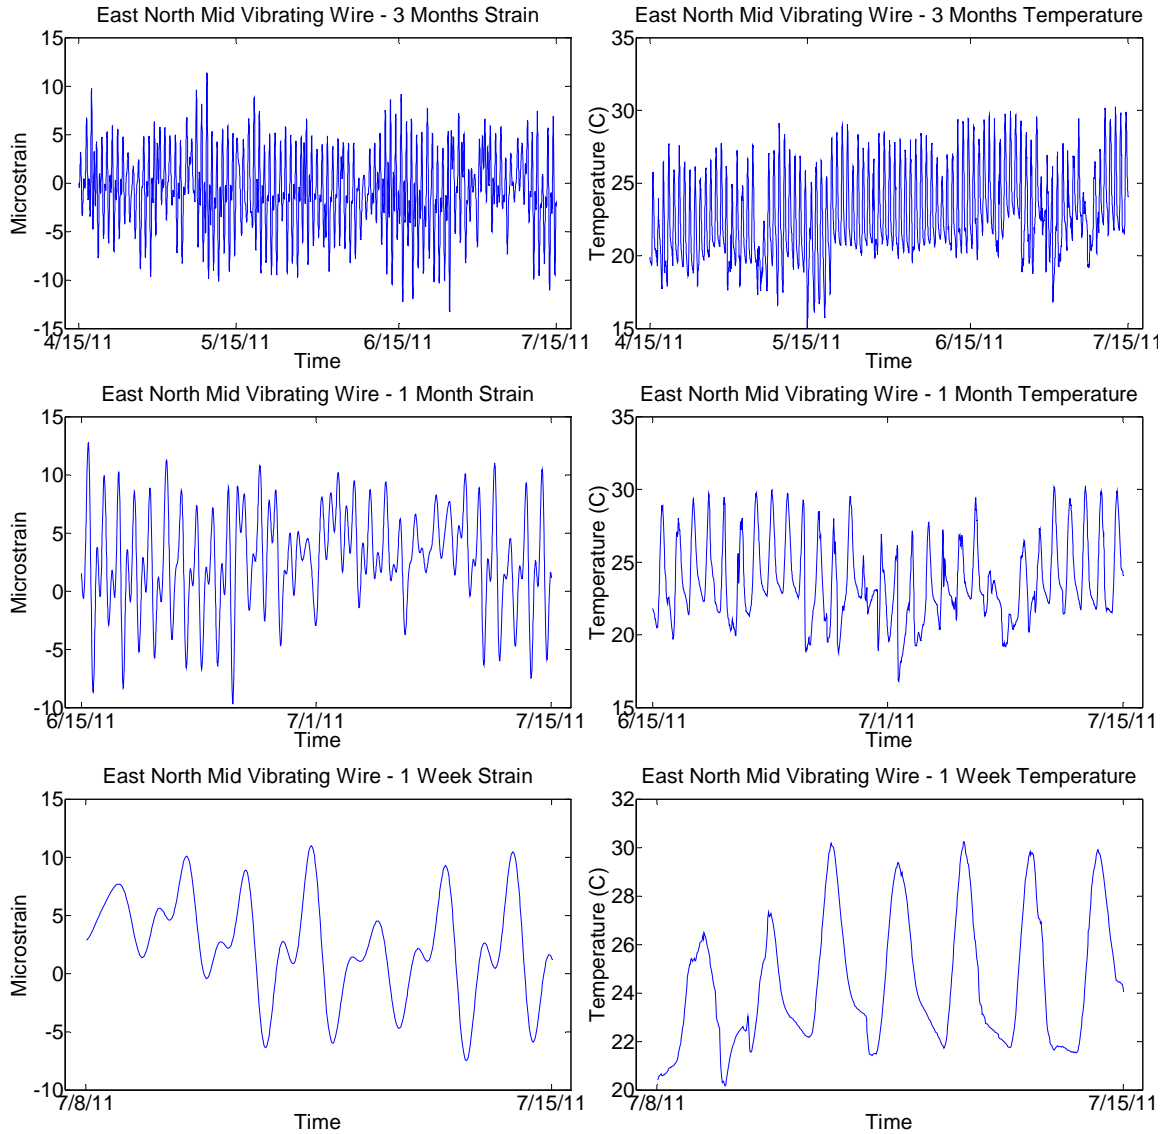
Figure 36: EN2 vibrating wire 3-months, 1-month and 1-week strain and temperature readings

The temperature induced effect on a structure is best observed through the long-term monitoring. Seasonal and daily temperature induced changes, as well as sudden temperature shocks need to be captured to establish the effects on different components of the bridge. Depending on the material type and boundary conditions temperature induced stresses may vary. In order to explore the effects of temperature, different windows of data such as 3-months, 1-month and 1-week are investigated. For the sake of brevity, only one location from each leaf is presented in this report. Figure 36 shows the East North Mid vibrating wire data for different windows and it is seen that for this location the daily strain cycles are around 25 microstrain and range of the temperature cycles are around 15 degrees.

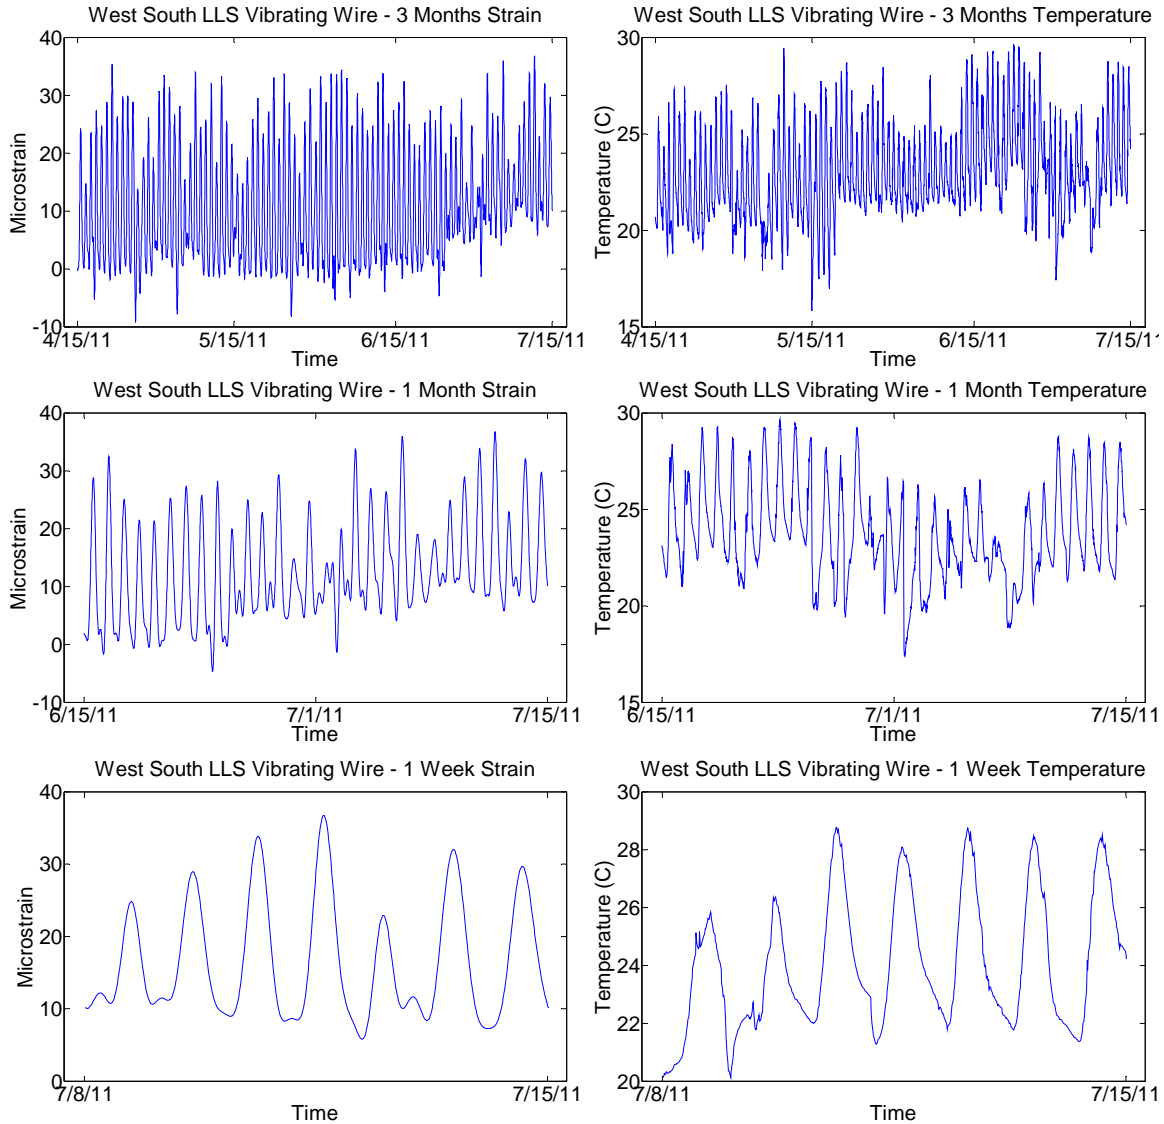
Figure 37: WS3 vibrating wire 3-months, 1-month and 1-week strain and temperature readings

For the west leaf representative data West South LLS area is selected and the data for different periods of this location is presented in Figure 37. It is seen that the strain cycle level is higher at LLS regions. For West South LLS region the strain cycles are around 50 microstrains whereas the temperature cycles are around 15 degrees.

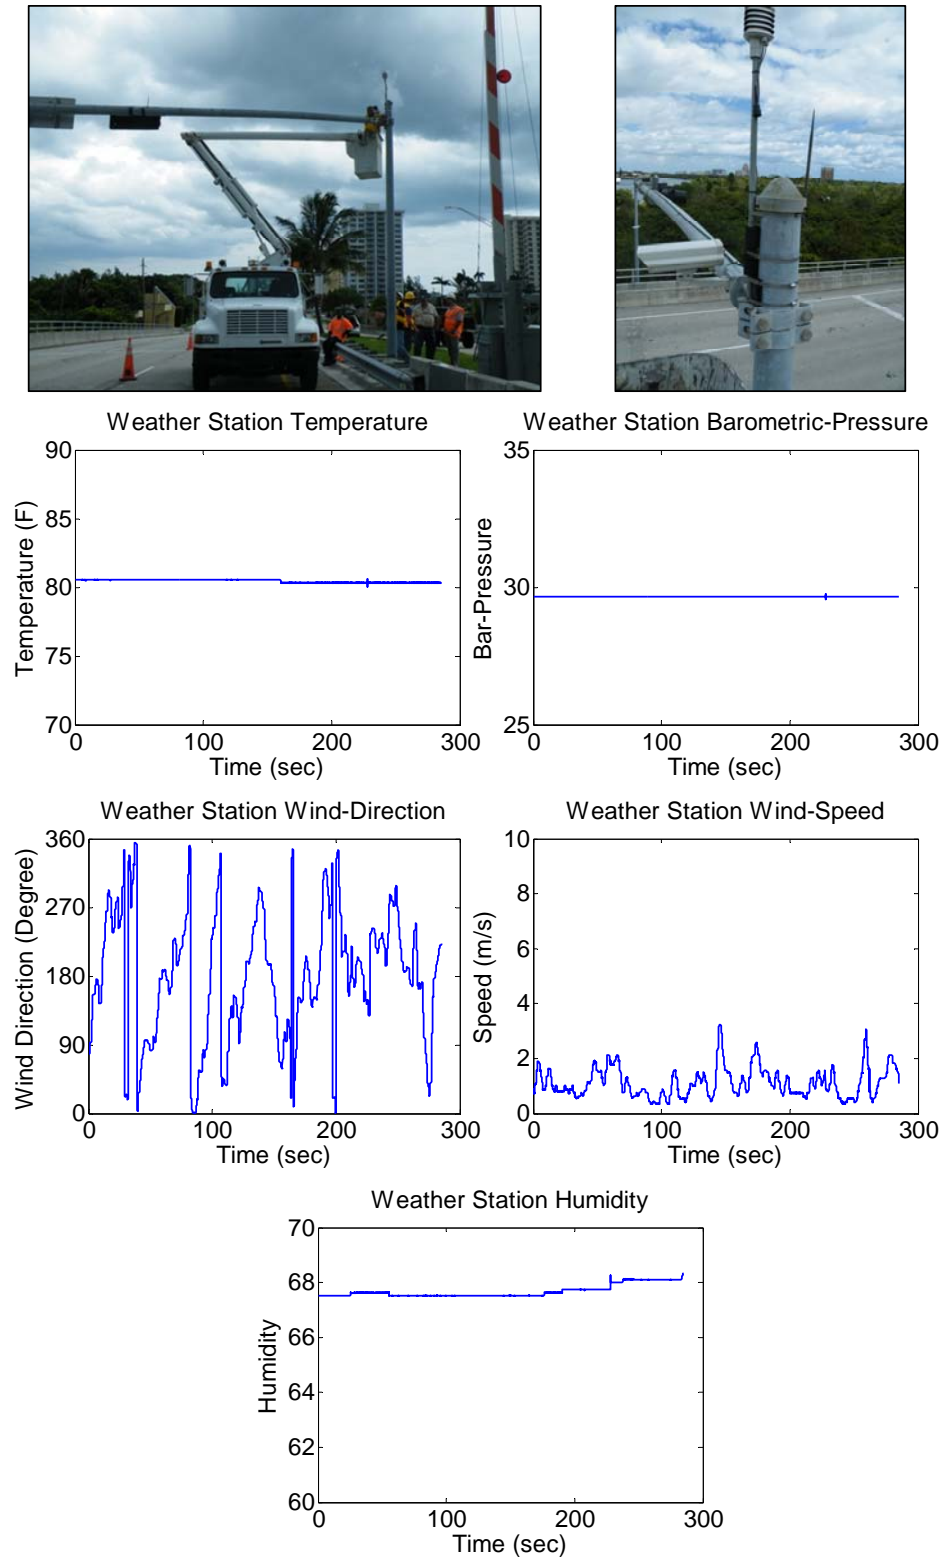
Figure 38: Weather station and sample data

Bascule bridges are slender and lightweight, and are significantly affected by strong wind forces, especially when they are open. In addition to wind, ambient temperature, humidity and rain related information need to be monitored. Therefore, the instrumentation plan consisted of a weather station to measure wind speed, wind direction, temperature, humidity, and rain quantity, duration and intensity. Wind monitoring can be used for determining the input load on the structure caused by air currents. Measured wind speed and direction can also be useful during hurricane-strength

winds, indicating excessive force on the girders. Wind station and sample data are presented in Figure 38.

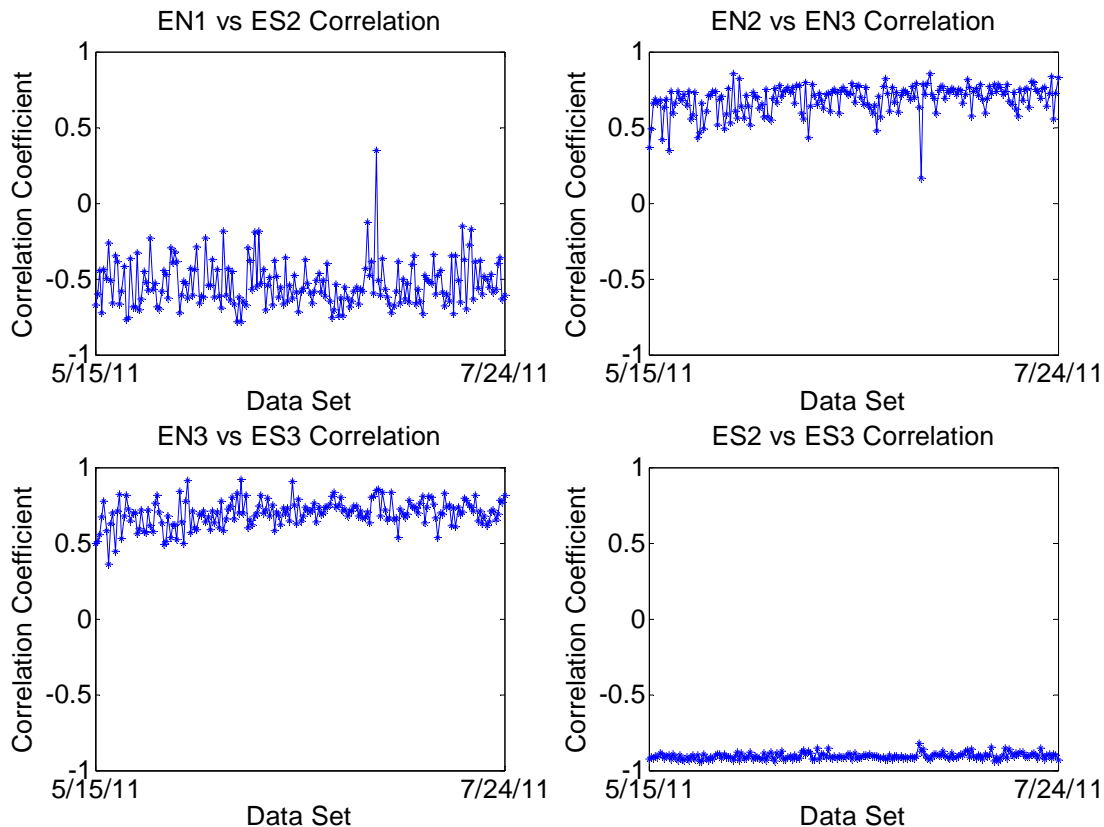
Figure 39: East leaf strain data correlations

Based on the findings for span lock and live load shoe shims removal summarized in previous report, the correlation coefficients are also tracked to identify any structural boundary change. It was shown in the previous report that structural change (or simulated damage) can be detected by means of strain measurements, and more specifically, strain correlations of strain monitoring under any traffic loading. Individual strain measurements can be analyzed and checked; however, these measurements will vary due to loading magnitude and placement. Although maximum measurement can be an indicator for the stress levels due to traffic, any change of structural configuration due to damage cannot be easily detected by just looking at the strain levels. Cross correlations of the measurements, however, indicate a level of correlation when monitored over long-term. The cross correlation trends of different sensor couples for east leaf are presented in Figure 39 whereas the same trends for west leaf are presented in Figure 40. No significant change in the cross correlation trends is seen for both figures during 5/15/11-7/24/11.

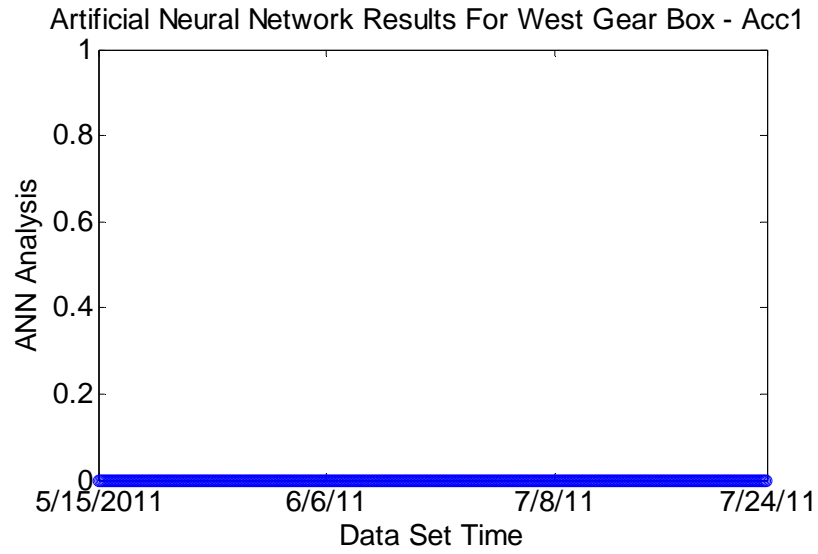
Figure 41: ANN results for gearbox oil level

ANN results for gearbox oil level and open gear grease level are illustrated in Figure 41 and Figure 42, respectively. It is seen that ANN produces zero values for the openings between 5/15/11-7/24/11 which concludes both components have healthy levels of oil and grease.

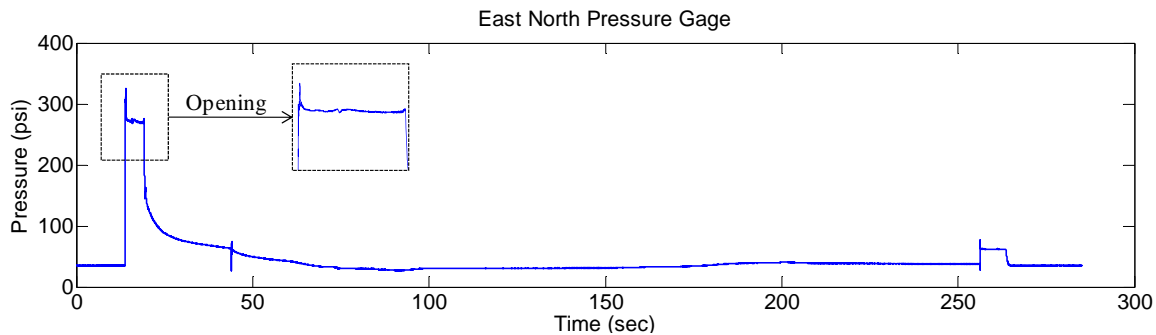
Figure 43: Typical span lock pressure gage behavior

Span locks are one of the critical components of the operation. The issues related to the span locks and the problems that can be observed due to its malfunctioning are explored in the previous report. The general behavior of the span lock pressure data in which a single peak is followed with an almost flat region is given in Figure 43.

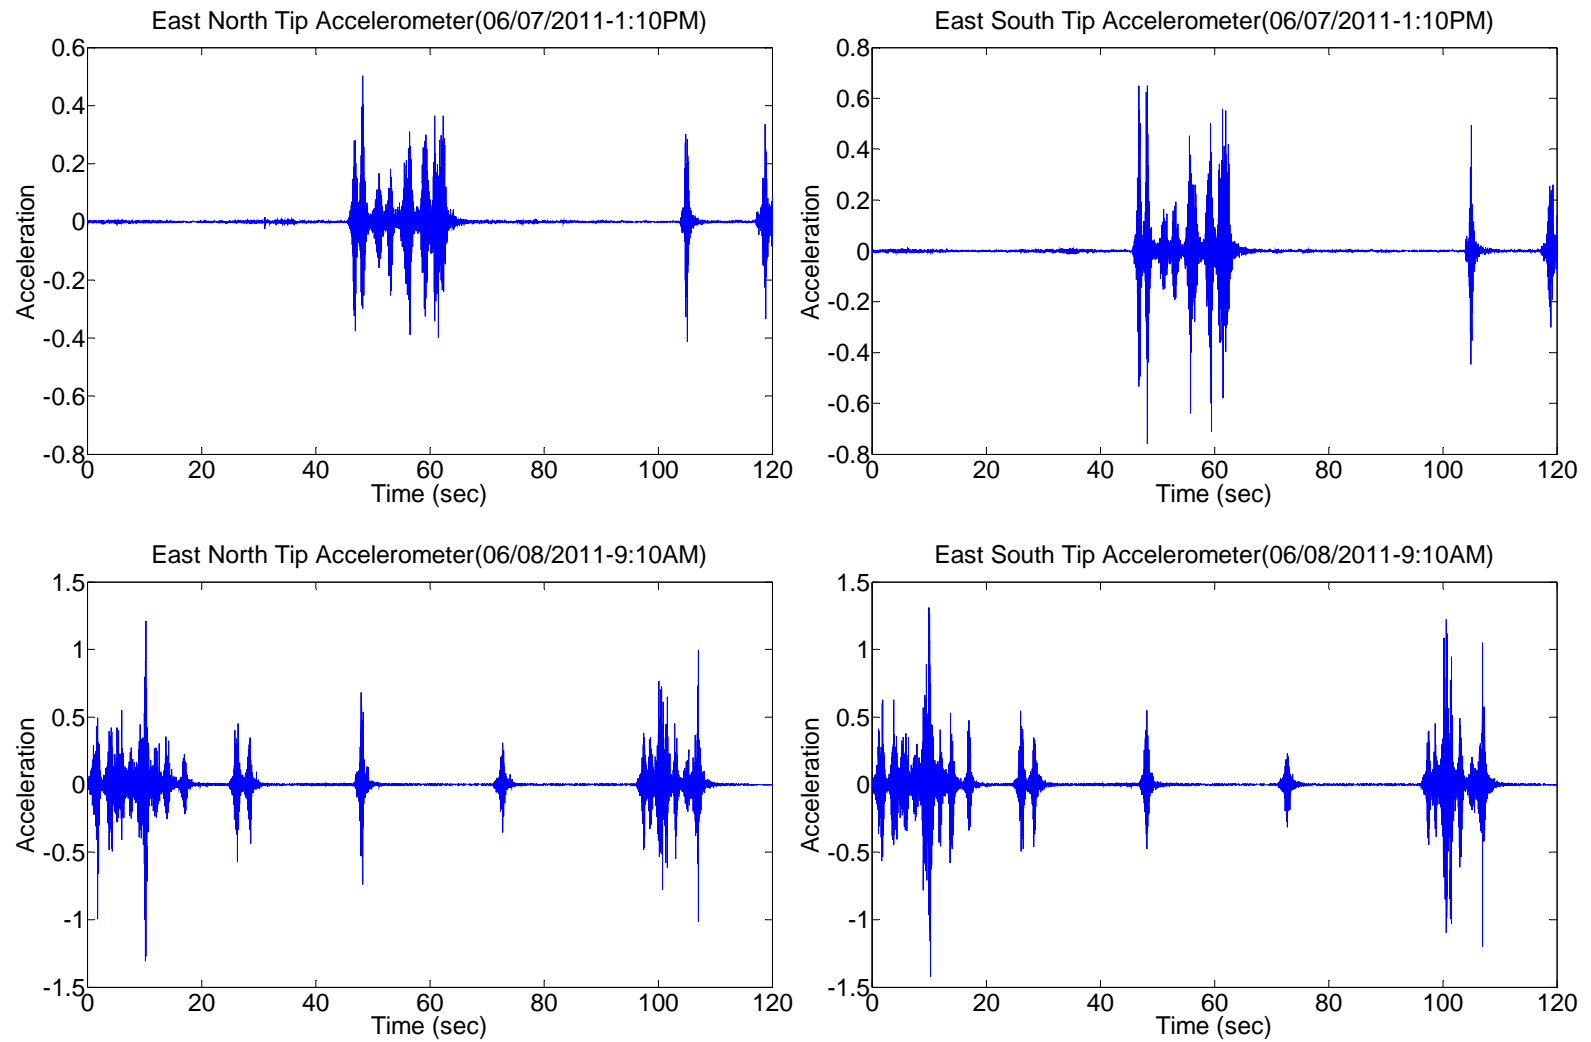
Figure 45: Vibration recorded at the tips of the main girders

In addition to pressure data, changes in the acceleration and rosette strains during this period are also investigated. The accelerometers at the tip at North and South tip near the span lock are evaluated. After 6/7/2011, higher levels of vibrations are observed at both (Figure 45). It should be noted that while the increase in acceleration and strain

levels corroborate with the changes observed at the span lock pressure gages, these are also affected by the traffic on the bridge.
