# Structural Evaluation of LIC-310-0396 and FAY-35-17-6.82 Box Beams with Advanced Strand Deterioration

September, 2011

# **Structural Evaluation of LIC-310-0396 and FAY-35-17-6.82 Box Beams with Advanced Strand Deterioration**

## **Draft Final Report – Phase II**

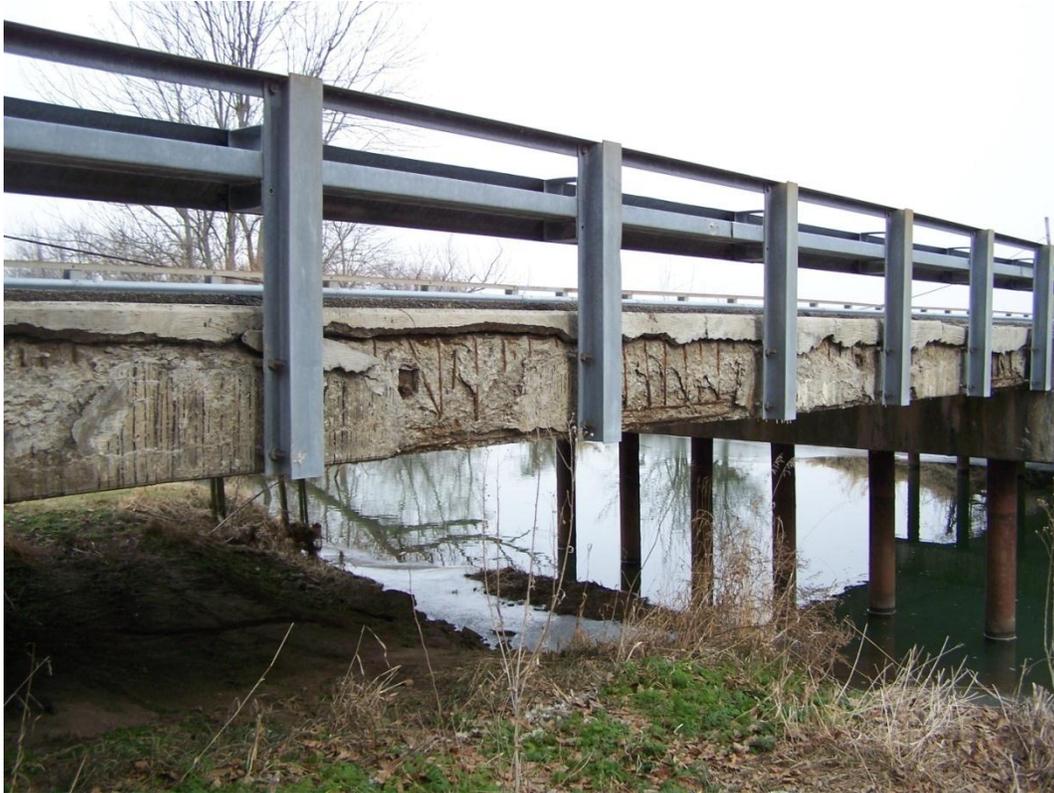
**Figure 6: Exterior South Beam (Beam 1) – West Span**

For the FAY 35- 17-6.80 bridge used in this research, the outside beams were in very poor condition. The top flange separated from the lower portion of the beam for the north outside beam (Beam 9) of the west span (see Figure 5). The south outside beam (Beam 1) of the west span was in similar condition (see Figure 6). The stirrups were exposed for these outside beams of the west span. The top flange had been patched by the County some years prior to testing, but this was not completely successful. Beam 1 of the center span had some degradation of the top flange concrete (see figure 7) but was in relatively good condition. The north beam (Beam 9) of the center span was comparable to Beam 1 of the center span (see Figure 8). The south beam (Beam 1) of the east span had some separation of the top flange near the abutment (see Figure 9). The exterior beam on the north side of the east span also had separation of the top flange and strands exposed (see Figures 10 and 11).

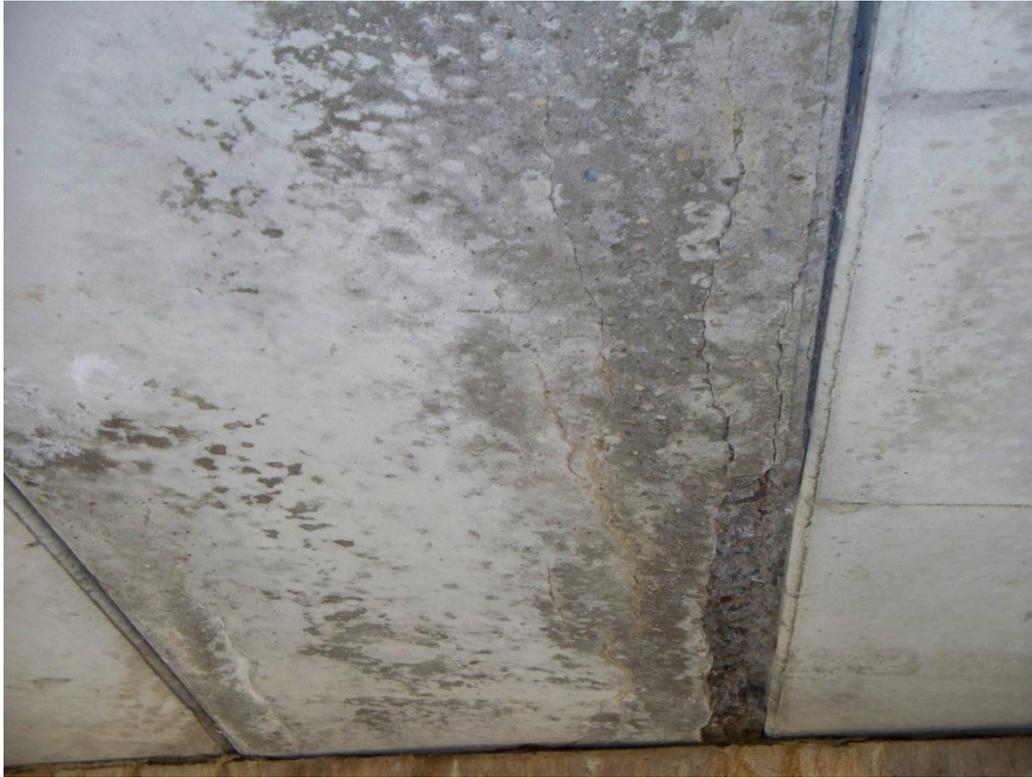
**Figure 12: Interior Beam 3 - East Span**

The interior beams were in very good condition with the exception of Beam 3 on the east span (see Figure 12). The beam showed longitudinal cracking and some spalling of concrete near east pier. The spalling did not expose any strands, but staining was visible.

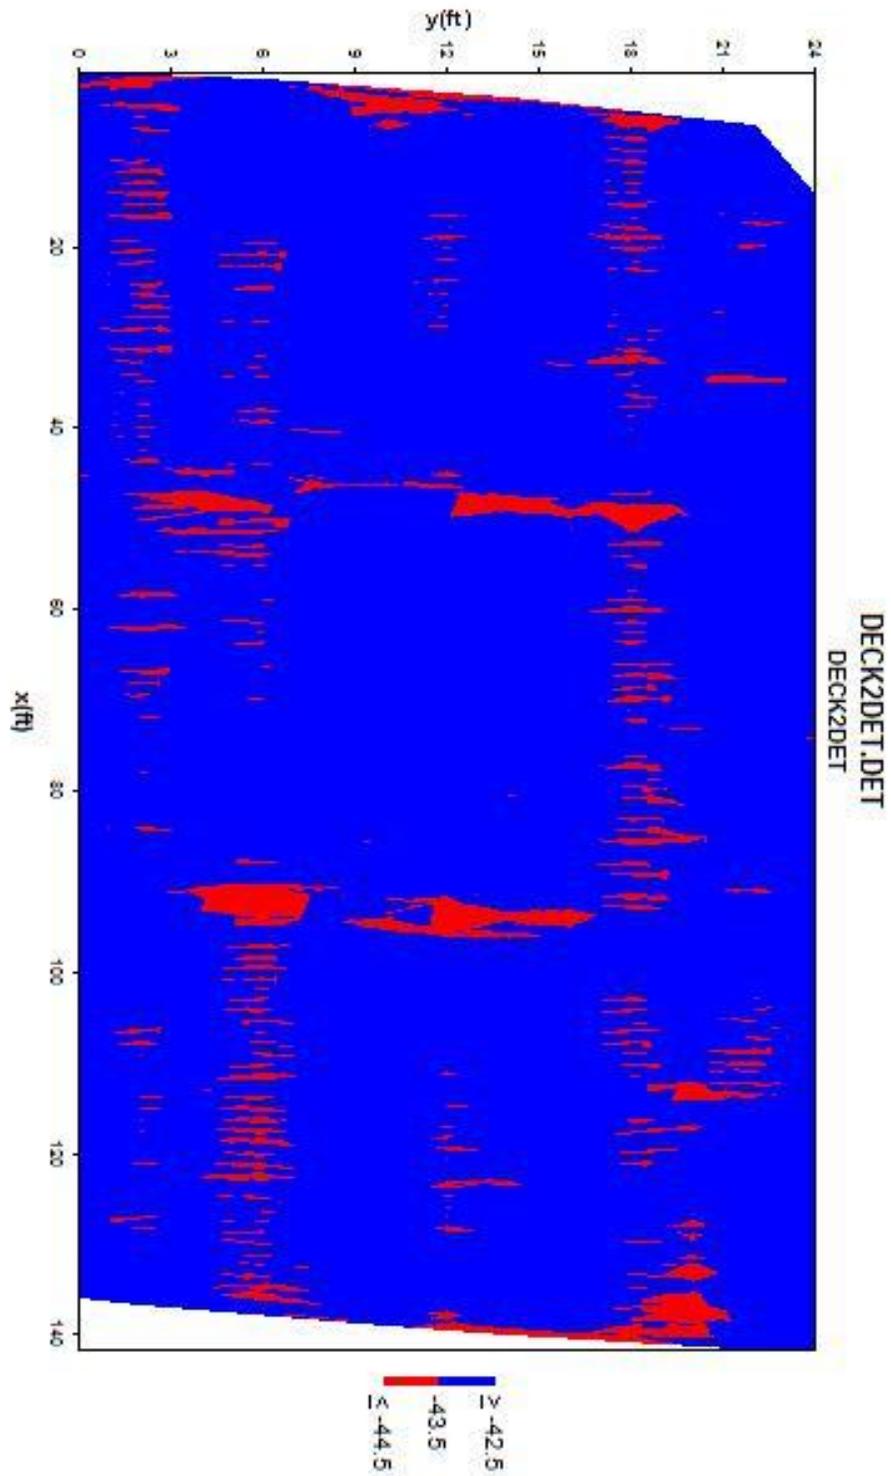
**Figure 43: GPR of Top Surface**

The results of the GPR on the top surface of the bridge are shown in Figure 43. The areas of red in Figure 43 are areas of possible concrete distress. However, this may be slightly misleading. The first issue involves the shear reinforcement being at a different height near the center of the beam (see Figure 3). If the GPR unit scanned right above that location it would show up as poor concrete. The guardrails made access difficult near the edges of the bridge. This was the distress in the concrete was actually visible. The piers also show up differently since the shear reinforcement of the beams no longer exists at these closure pour locations. Based on these issues and the GPR plot in Figure 43, the overall condition of the top surface of the bridge was relatively good.

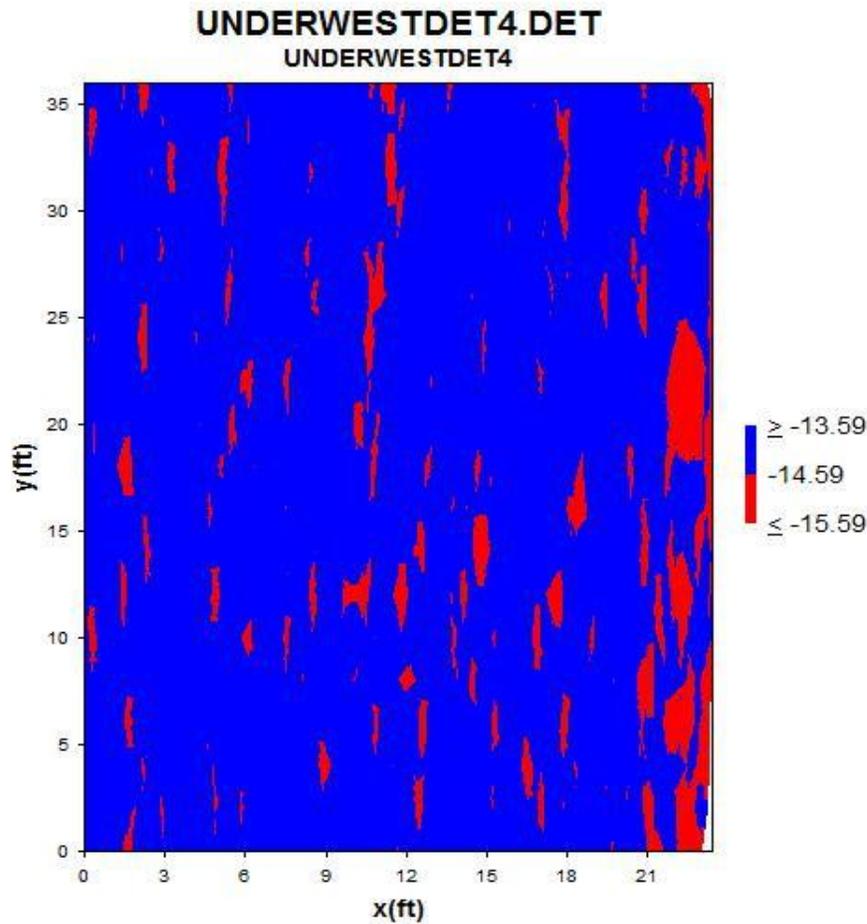
Figure 44 shows the GRP data from scanning the underside of the west span. The figure is shown as if viewed upward from below the bridge. The origin of the plot is the southwest corner (Beam 1 near the abutment). Red areas in Figure 44 are locations of concern. However, one major difficulty with scanning below the bridge is related to the gaps between the beams. The surfaces between the beams are often at slightly different elevations causing difficulty in performing a smooth transition from one beam to the next. These gaps appear as the long streaks in the GPR data. In addition, the width of the bridge in Figure 44 is less than the actual bridge width. This is caused by having to lift the scanning cart slightly for the gaps and unevenness between the beams. Water in the stream also did not allow access to reaching the full length of the span. However, the GPR method does point out an issue with the far right hand edge of the bridge in Figure 44. This is Beam 9, which did have significant damage and performed poorly in the destructive testing.

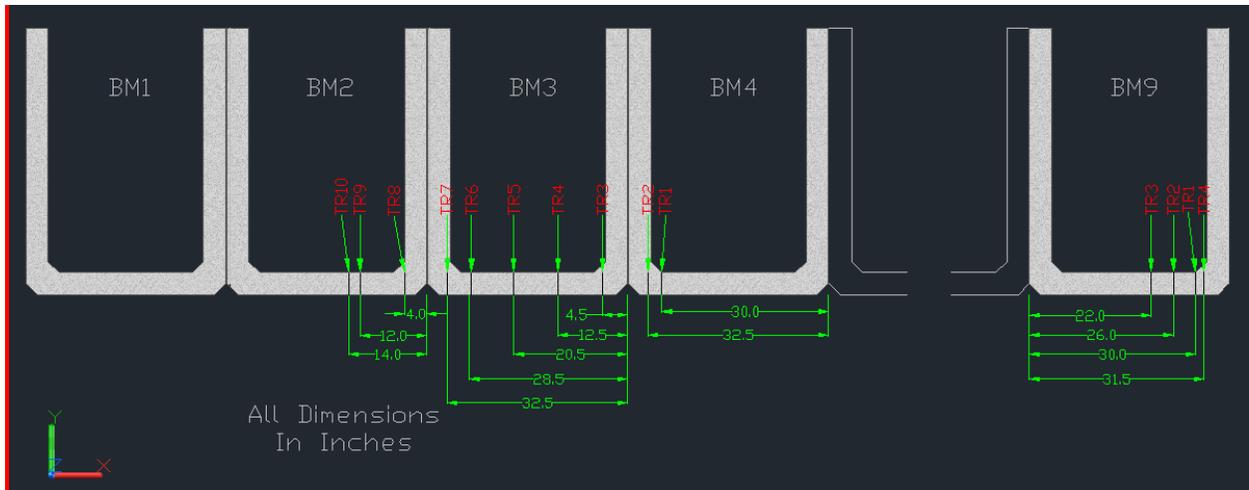
**Figure 45: MFL Test Tracks**

The University of Toledo performed magnetic nondestructive testing on a portion of the bottom of beams 2, 3, 4, and 9 of the East span on August 11<sup>th</sup> and 12<sup>th</sup>. The test area existed on interior Beams 2, 3, and 4 and exterior Beam 9. Areas were selected based upon visual inspection to encompass areas ranging from little to no corrosion up to heavily corroded areas.

Each Magnetic Flux Leakage (MFL) test for the interior beams was approximately 12.5 feet (3.8 m) long and started at approximately 189 inches (4.8 m) from the pier cap. For Beam 9, each MFL test was approximately 9 feet (2.7 m) long that started approximately 186 inches (4.7 m) from the abutment. Each MFL test is identified with data for a specific track which covers an area with a scan width of 8 inches (203 mm) and a scan length indicated for the beams. The transverse locations of all of the MFL tracks are shown in Figure 45. All MFL tests were performed by supporting the MFL equipment on a temporary wooden platform and moving the equipment on a set of wheels along the underside of the box girders. The start and end points for all tests were marked on the underside of the box girders.

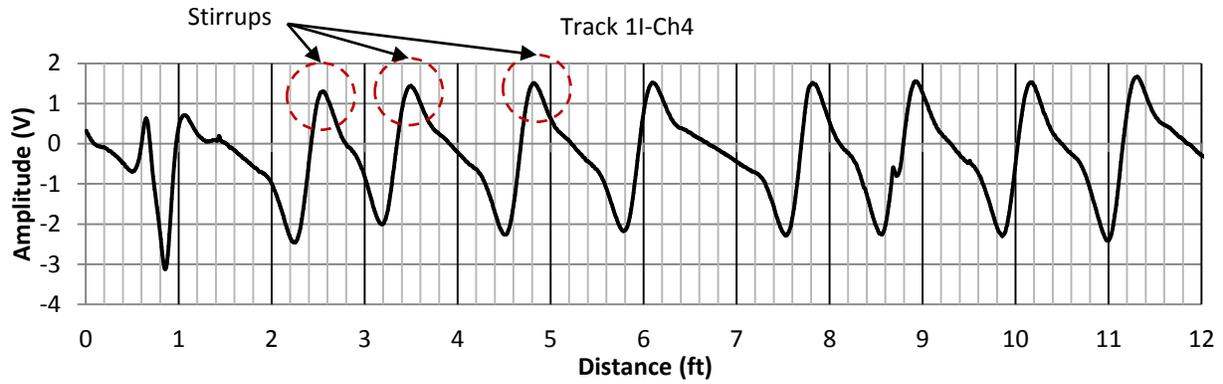
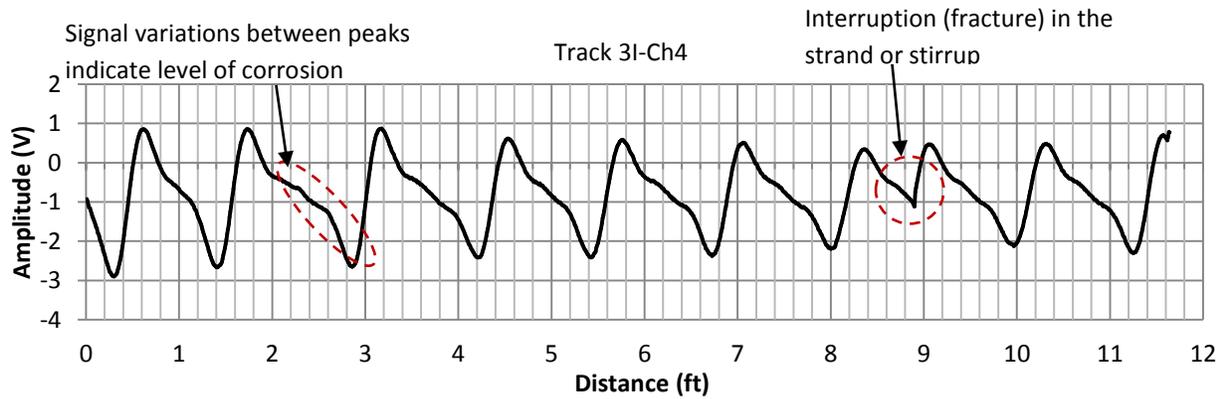
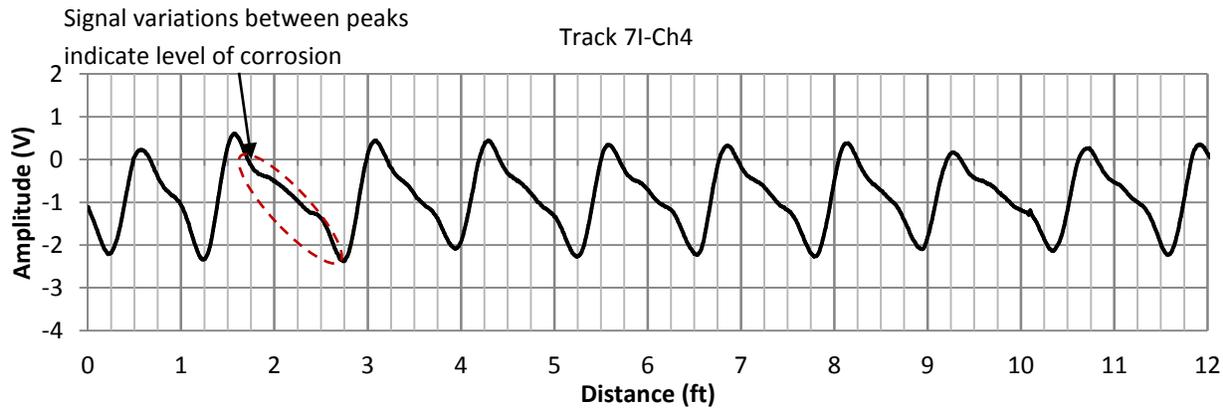
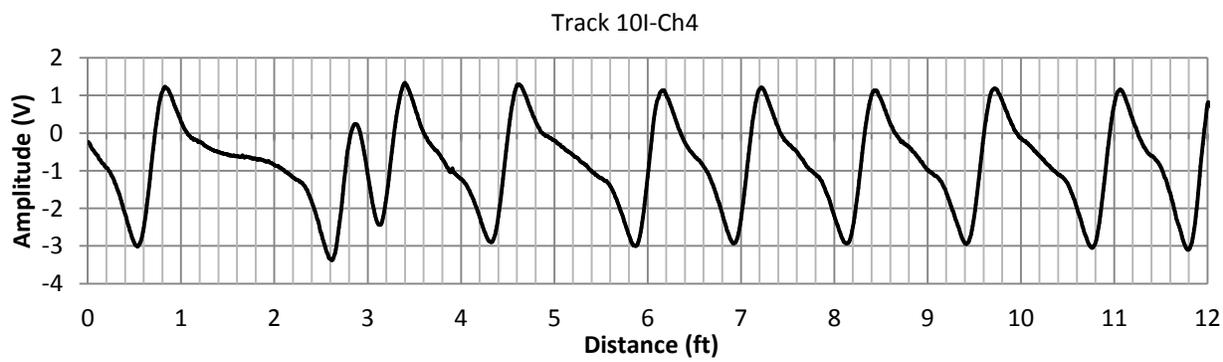
**Figure 47: MFL Scan Data Tracks 1I, 3I, 7I, and 10I**  
 (Note: 1' = 0.305 m)

Figure 47 shows MFL results for sensor 4, which was located at the center of the scan width, for Tracks 1I, 3I, 7I and 10I. The graph is a plot of magnetic leakage field (in terms of Hall sensor output voltage) as detected along the length of the track scanned. The peaks in the graph indicate the presence of transverse stirrups along the beam. The peak-to-peak width of the signal indicates the stirrup spacing in the box-beam. Indications of irregular spacing of stirrups can also be seen for Track 10I in the figure within the first 3 ft. (0.9 m) of the test scan. The signal variations between peaks indicate the level of corrosion along the prestressing strand indicated in the figure. The evidence of strand fracture, or abrupt change, at the location of 9 ft. (2.7 m) can be seen for Track 3I as an abrupt interruption in the signal. It can also be noted that the decreasing nature of peak-to-peak signal amplitude indicates the increasing depth of steel inside the concrete.

The results shown in Table 6 for MFL show an accurate correlation between the test results and actual condition of the strand. MFL indicated moderate corrosion (20%) in Track 7I, but upon concrete removal, very little corrosion was found in the strands. While the inaccuracy of a false positive is not desirable, bridge inspectors would be erring conservatively as opposed to the more dangerous situation of not finding corrosion in a damaged strand. The MFL testing predicted medium to heavy corrosion in Area 2 of Beam 3, which can be seen in Figure 51. The strands from 8 – 10 in. (203 – 254 mm) which were all/partially exposed show heavy corrosion. The previously embedded strands, from 4 – 7 in. (102 – 178 mm), show corrosion that gets

progressively lighter as the tape measure numbers decrease. The magnetic testing was accurate in this region, except that a full break in strands as depicted in the MFL scan was not found.

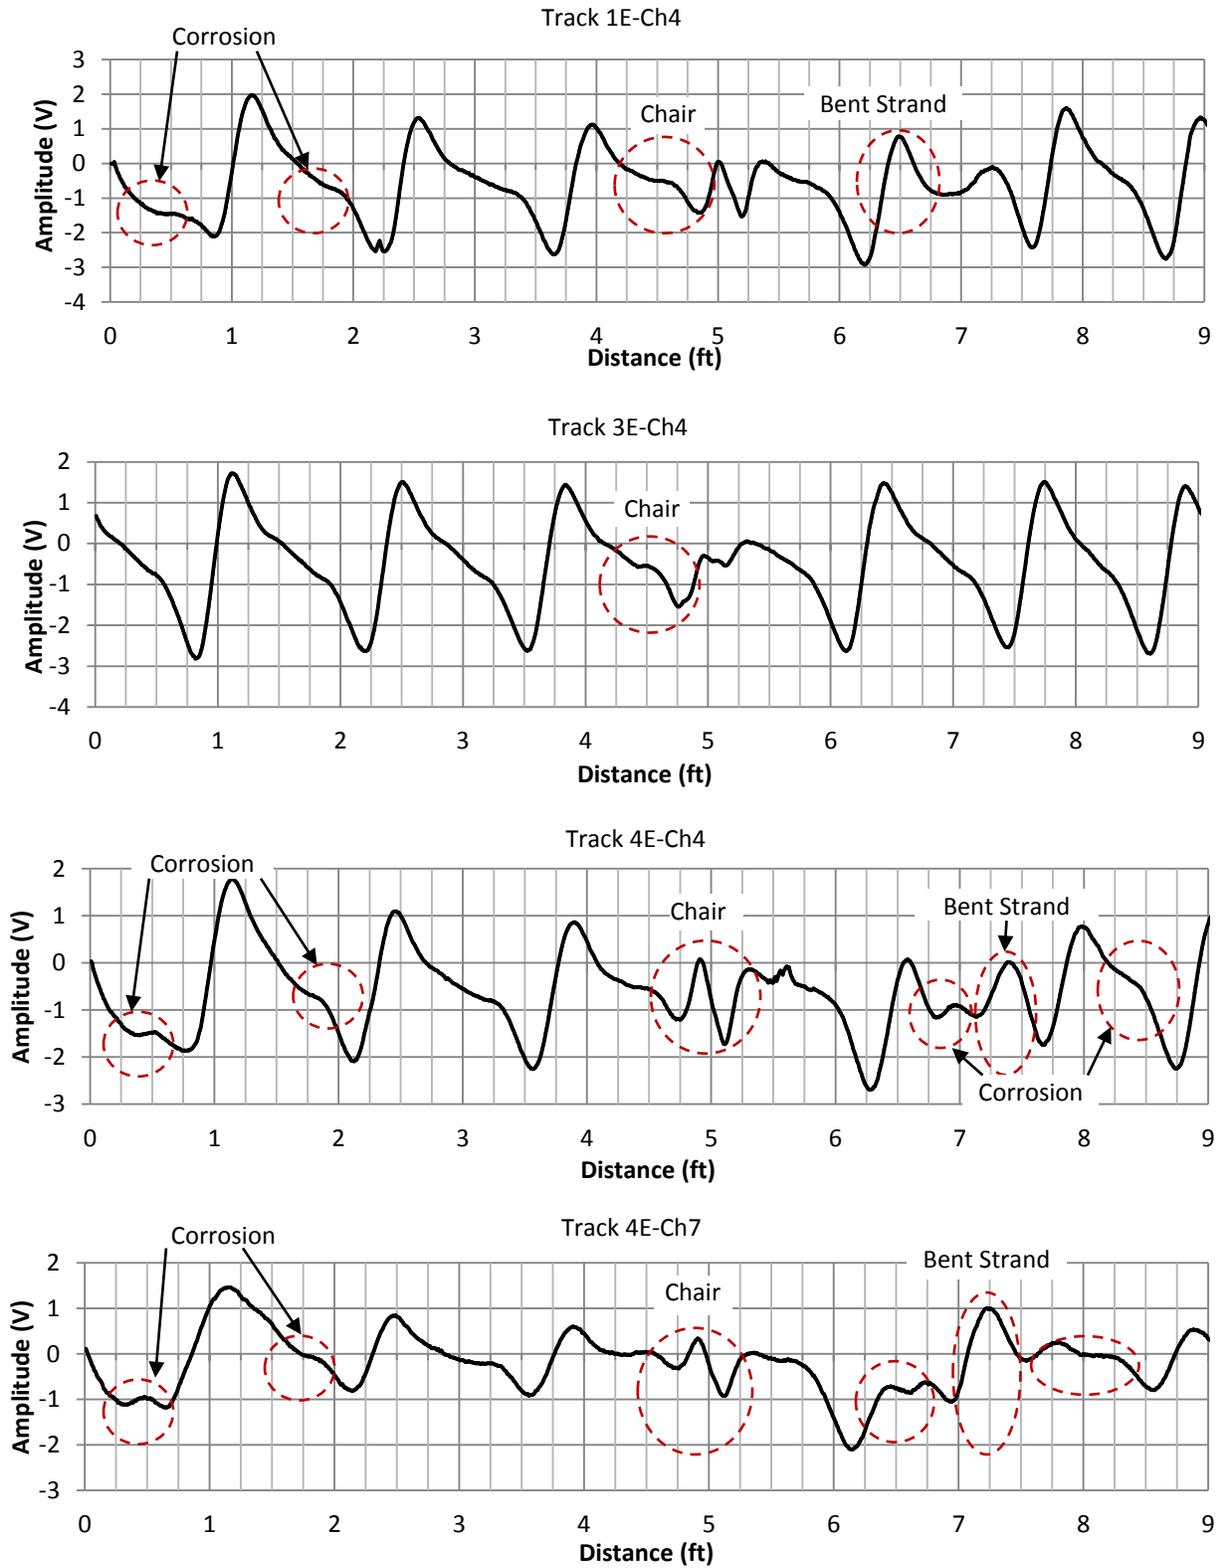
**Figure 48: MFL Scan Data Tracks 1E, 3E, and 4E**  
 (Note: 1' = 0.305 m)

Figure 48 shows MFL data for Tracks 1E and 3E from sensor 4, which is located at the center of the scan width. For Track 4, the data is displayed from sensors 4 and 7 where sensor 7 is located at the outside edge of the beam (north edge) of the scan width. Clear indications of the presence of steel chairs as well as exposed and bent strands are shown in the data from different tracks as marked in Figure 48. The bumps or bends in the signal between the peaks indicate the presence of chairs at that point inside the box beam. Points of corrosion are indicated by uneven signal amplitude between peaks of the signal. The bent strand refers to exposed strand on the exterior of the beam which is hanging down. The estimate of corrosion is made by zooming in on the magnetic field signal and making a correlation to the existing laboratory measurements. This method for determining the corrosion is qualitative and provides estimates of corrosion in ranges, (e.g. 10%-15%). While this estimate is not precise, it is sufficient to allow DOT officials to accurately assess the condition of the box beams in a bridge.

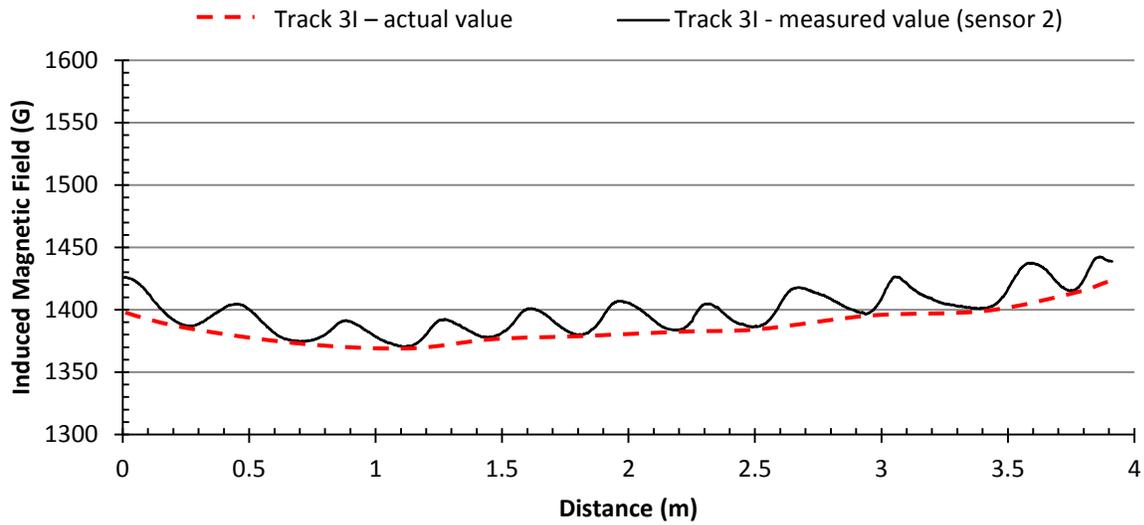
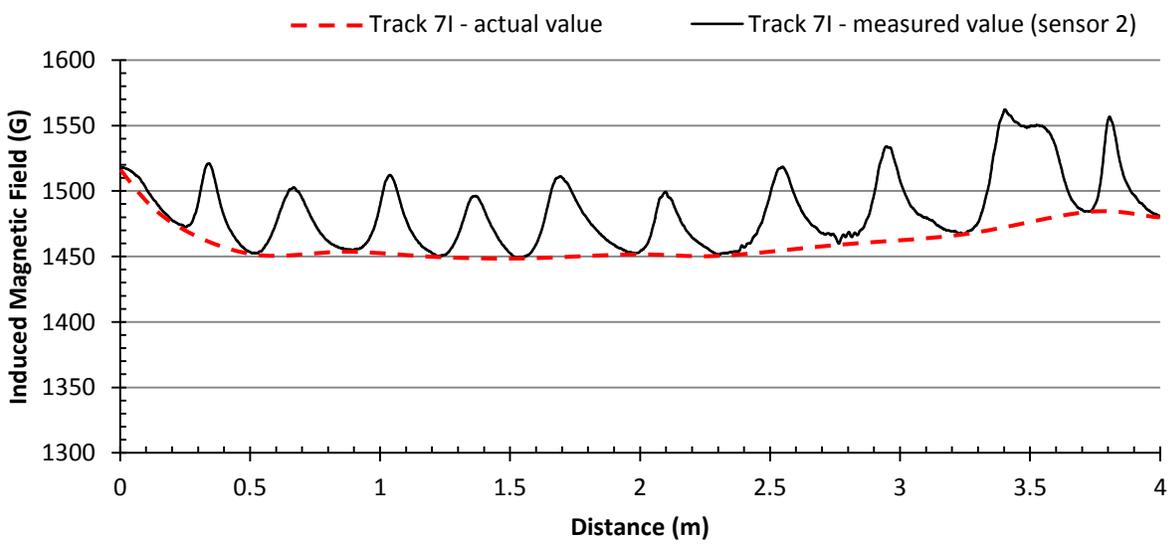
**Figure 49: IMF Field Results for Interior Beam**

For the Induced Magnetic Field (IMF) procedure, tracks 3I and 7I were scanned along a length of approximately 12 ft. (3.7 m). For the bridge test, the strand closest to the bottom of the box beam is embedded 1.75 in. (44.5 mm) deep inside the beam. Accounting for the diameter of the strand, the edge of strand is approximately 1.5 in. (38.1 mm) from the concrete surface. During testing, a gap of roughly 0.5 in. (13 mm) – 0.75 in. (19 mm) was maintained between the pole face and the concrete surface being scanned in order to avoid damage to the sensors fixed on the pole face. Thus, the average gap between the pole and the strand was 2 in. (50.8 mm) - 2.25 in. (57.2 mm). However, the surface under the bridge is not completely flat. This curvature caused for a slight variation of distance between sensor and strand. This needs to be taken into consideration during estimation of strand cross-section from the measured data. The magnetic field induced in the strand is very sensitive to the distance between the strand and the sensor. It was assumed the strands inside the box beams were at a constant distance from the magnet pole face. However, the natural deflection of the beam and the unknown of the actual cover between strand and pole face could lead to inaccuracies in the test results. There were uncertainties in the estimate of the healthy cross-section area for the strand due to the uncertainty in the distance between the strand and the sensor on the electromagnet. Another uncertainty in the test data is stability of magnet strength. The electromagnet used in the test varies in strength as the magnet heats up with use. An estimation of the stable strength of the magnet was made to obtain these results. In the future, a thermocouple should be used to monitor temperature of the scans, which can be used to determine the stable strength of the magnet for specific test scans. Figure 49 shows the test results for IMF scan for Tracks 3I and 7I.

The results from the IMF test indicated corrosion in the prestressing strand. However, when compared with the findings after concrete removal, the IMF method needs to be refined to improve its accuracy. In order to obtain a truly accurate reading, the distance between strands and sensor face must be known. In the future this issue must be addressed. Commercial methods have been identified as possible solutions, such as using a device to measure the depth of strand inside a concrete beam (e.g. Proceq Profometer 5+). A thermocouple can also be installed which can measure temperature which can be correlated to stable magnetic strength.

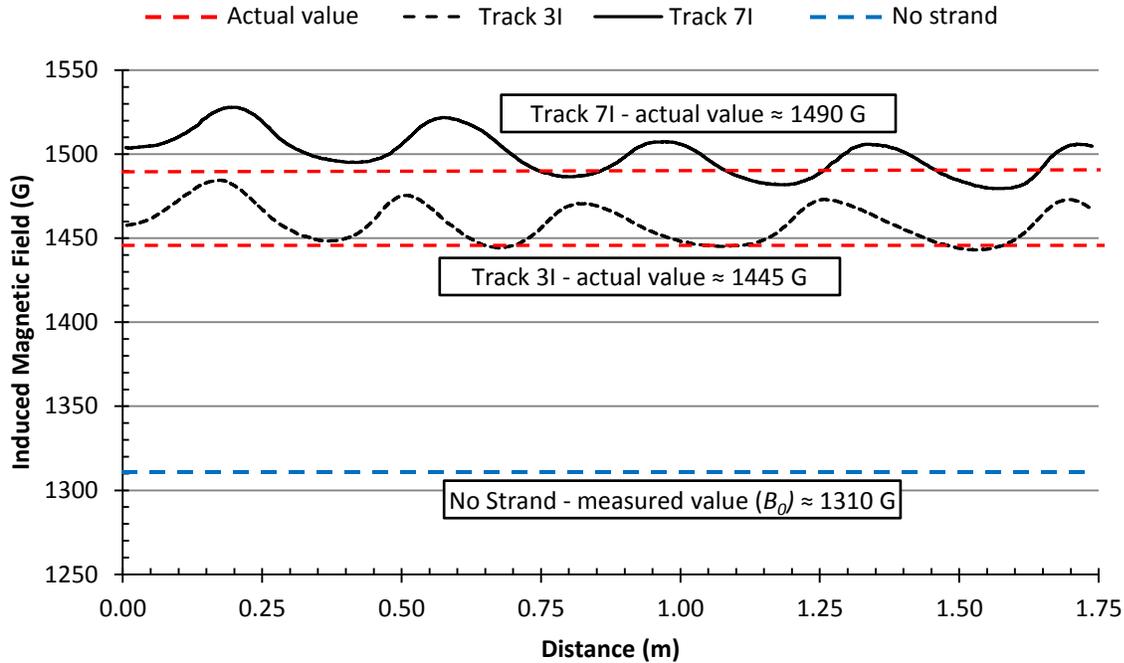
**Figure 50: Laboratory Results Tracks 3I and 7I w/ 2.2” between Pole Face/ Strand**  
 (Note: 1’ = 0.305 m)

Figure 50 shows the magnetic field values for a laboratory test replicating the IMF scans for track 3I and track 7I. This laboratory test utilized prestressing strand magnetized using the same electromagnet used in the field test, held at a constant distance of 2.2 in. from the sensor. The graphs show the healthy value of gauss ( $B_{healthy}$ ) for tracks 3I and 7I as well as the baseline value with the electromagnet on and no steel present ( $B_0$ ). The values from Figure 50 were obtained using the same wooden beam that was performed in conjunction with this research (Titus, 2011). In order to determine the percentage corrosion for the scanned width, the values obtained from the field test ( $B_{corr}$ ) from Figure 49 are used in the following equation.

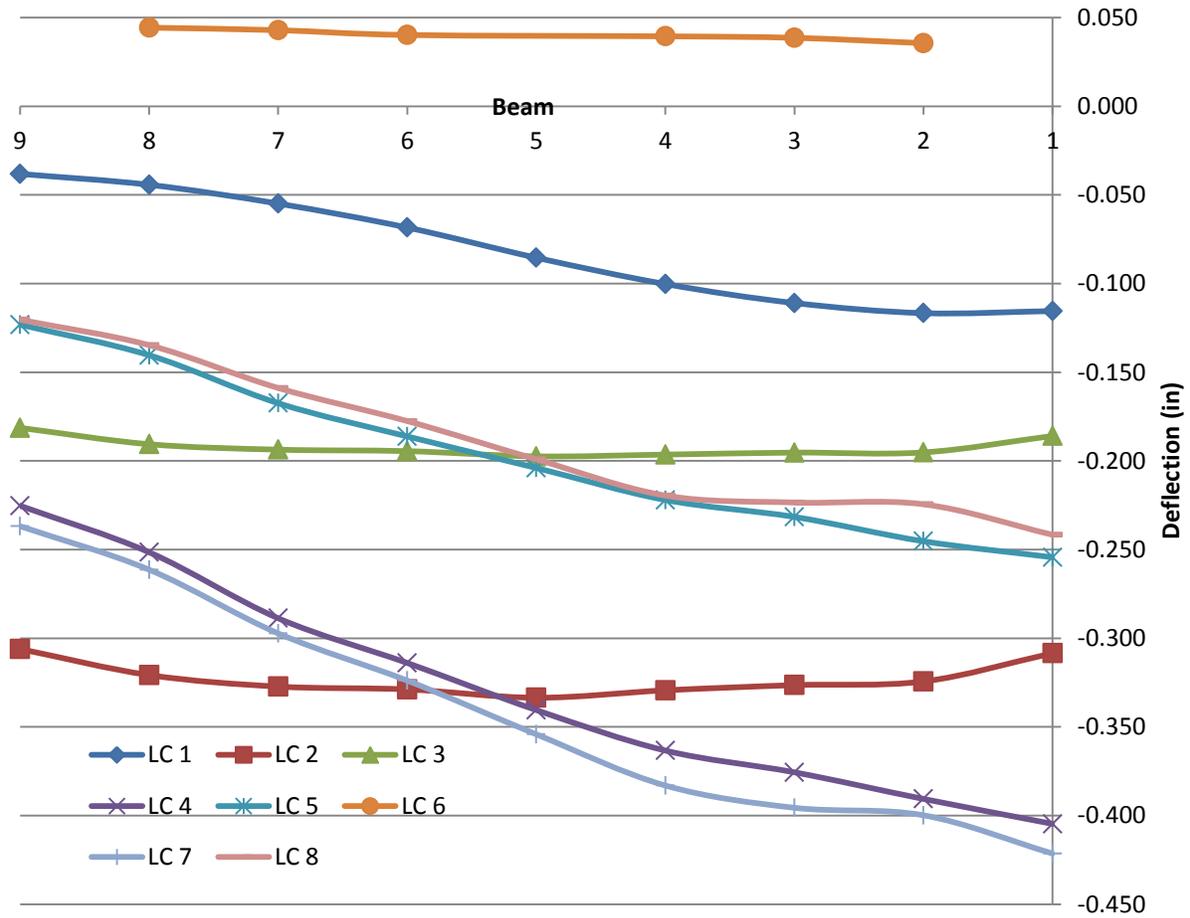
**Figure 52: Instrument Line A - Truck Tests**  
 (Note: 1" = 25.4 mm)

The results of the deflections across the width of the bridge along instrument lines A and B from static truck loadings are summarized in Figures 52 and 53, respectively. For almost all load cases, the deflection of the beams along instrument line A was larger than instrument line B. This is expected since line A is near midspan and line B is closer to the west pier. LC1 with the placement of a single truck (#8) resulted in small deflections but shows the larger deflections occurring near the position of the truck with lower deflections near the opposite side for both instrument lines. This shows good distribution of the load in both transverse and longitudinal directions. LC 2 and LC 3 was placement of the trucks in both driving lanes to produce maximum positive and negative moments, respectively. Both LC2 and LC3 show nearly constant deflection across the bridge except for the exterior beams which show slightly less deflection. This shows good transverse distribution of the loads. LC4 and LC5 were similar to truck placement of LC2 and LC3, respectively, except the trucks were positioned as far south as possible instead of in the lanes. This resulted in higher deflections in beams 1-4 and lower deflections in beams 6-9 and nearly the same deflection in Beam 5. LC7 and LC8 loading and positioning of loads were similar to LC4 and LC5, respectively. Recall, LC7 and LC8 were performed after cutting of the continuity steel over the west pier. The recorded deflections between LC4 and LC7 as well as LC5 and LC8 show minimal differences. This leads to the conclusion that just cutting the continuity steel over the pier was not sufficient to separate the

effect of the adjacent span. The bearing of the bottom of the beams against the closure pour concrete over the pier likely limited rotation of the beams and created continuity over the pier. LC6 was placement of all trucks in the center span after the continuity steel at the pier was cut. Upward deflection occurred at both instrument lines A and B and deflections were similar. This again reinforced that continuity still existed even though the steel had been cut.

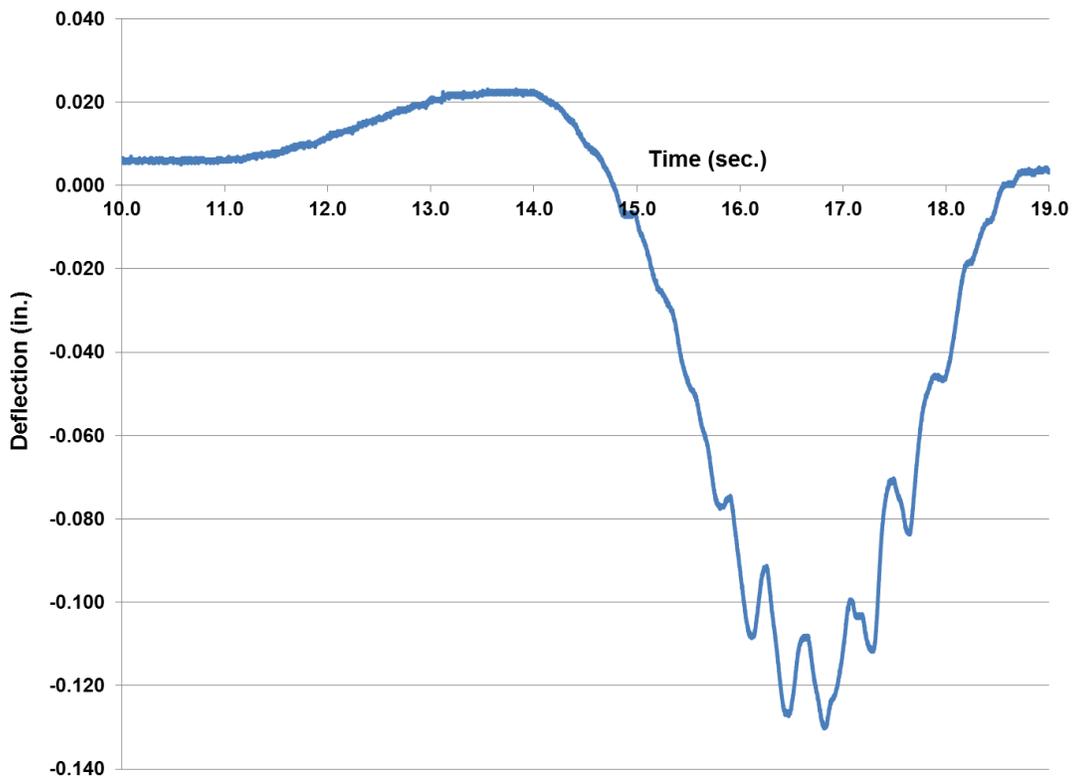
**Figure 54: 10 mph Moving Truck Deflection (Beam 8 – Instrument Line A)**  
(Note: 1mph = 1.61 kph, 1" = 25.4 mm)

Figures 54 and 55 show the instrument line A data for Beam 8 as the truck passes at 10 mph (16 kph) and 35 mph (56 kph), respectively. As both figures show, Beam 8 deflects upward as the truck is in the center span and prior to the truck entering the west span. This is again showing continuity of the bridge over the pier. As the truck enters the span, deflections increase downward until the truck begins leaving the span and bridge. The maximum deflections by the two truck speeds are approximately the same. The rapidly changing deflection, as the truck is within the span, is likely the vibration caused by the truck loading. This effect is more noticeable in the 10 mph (16 kph) speed than the 35 mph (56 kph) speed. Plots were created for all beams and were similar to Figures 54 and 55, but the magnitude of the deflections changed. The data from individual beams was then used to generate maximum deflections across the width of the bridge.

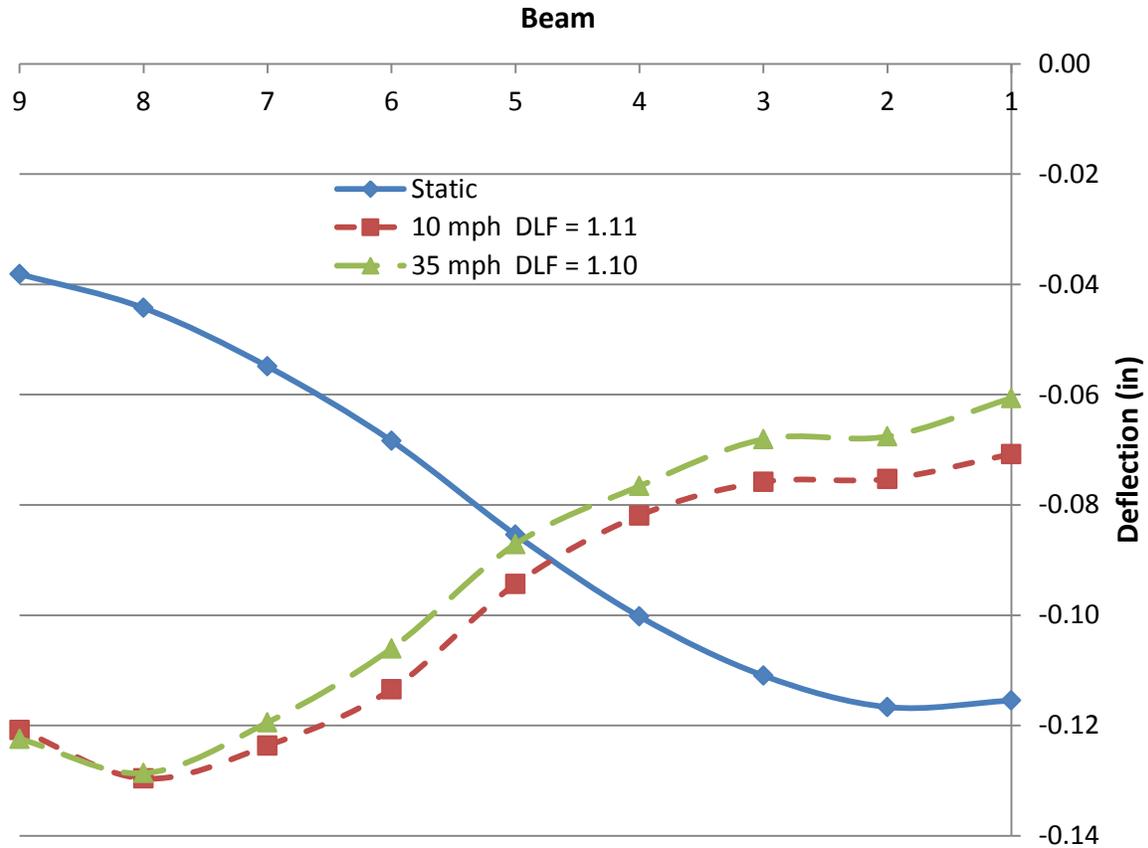
**Figure 56: Maximum Dynamic and Static Deflection (Truck # 8)**  
 (Note: 1" = 25.4 mm)

Figure 56 compares the maximum deflections at instrument line A across the width of the bridge from static LC1 and the moving truck at 10 mph (16 kph) and 35 mph (kph) prior to cutting of the continuity reinforcement over the pier. In both dynamic loading cases the truck traveled from east to west. Interestingly, the response to the truck moving at higher speed was slightly less except on Beam 9. However, this difference was less than 0.01" (0.25 mm) and DLF was basically the same at 1.10.

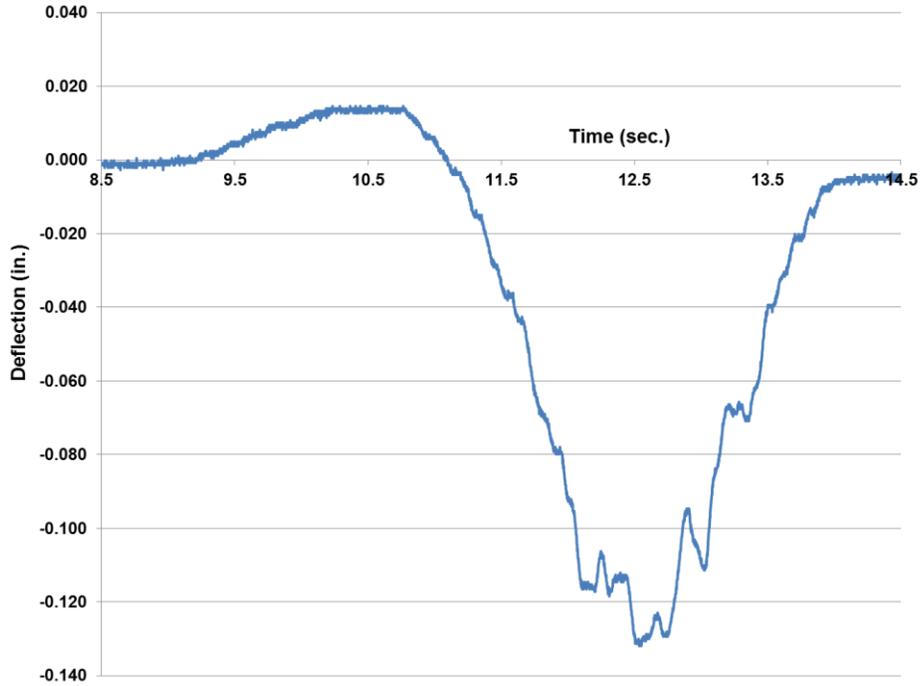
**Figure 57: 10 mph Moving Truck Deflection w/o Continuity Reinforcement  
(Beam 8 – Instrument Line A)**  
(Note: 1mph = 1.61 kph, 1” = 25.4 mm)

Figures 57 and 58 show the instrument line A data for Beam 8 as the truck passes at 10 mph (16 kph) and 35 mph (56 kph), respectively, after the cutting of the continuity reinforcement over the pier. As both figures show, the Beam 8 deflects upward as the truck is in the center span once again showing continuity between spans even though the reinforcement was cut. Figure 58 also shows that the truck was actually run in the opposite direction (from approach slab to west span) compared to the other truck tests (from center span to west span). However, the results were still very similar in magnitude. The results in Figures 57 and 58 show more vibration than in Figures 54 and 55, where the continuity reinforcement had not been cut. This is likely due to the bump that was created at the pier when the asphalt was removed to cut the continuity reinforcement and then patched.

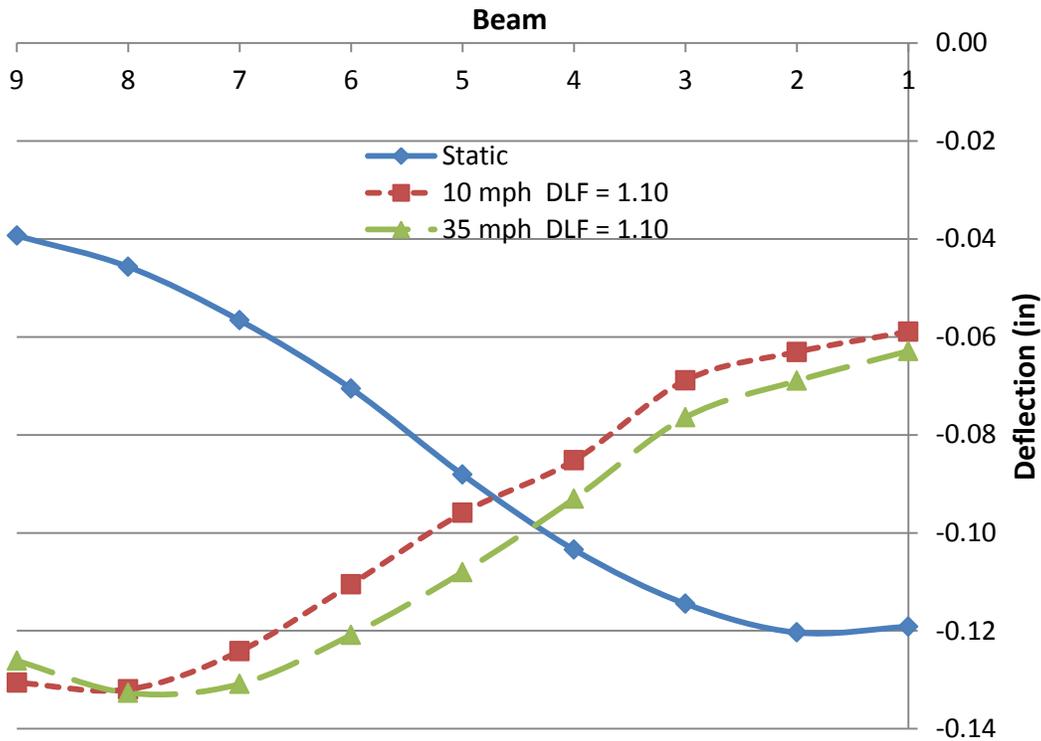
**Figure 59: Max. Dynamic vs. Static (Truck #26)**  
 (Note: 1mph = 1.61 kph, 1" = 25.4 mm)

Figure 59 shows the results from static LC1 and the dynamic truck loading after the cutting of the continuity reinforcement over the pier. In this instance the higher truck speed resulted in slightly higher deflections, except at Beam 9. It should also be noted that in these particular tests, the truck moved east to west at 10 mph (16 kph) and west to east at 35 mph (56 kph). In addition, truck 26 was slightly heavier than truck 8 that was used for the static case. Therefore, the static deflections were magnified by the increased weight of truck 26. For both cases, the DLF was equal to 1.10 which was no change from prior to cutting the continuity reinforcement over the pier.

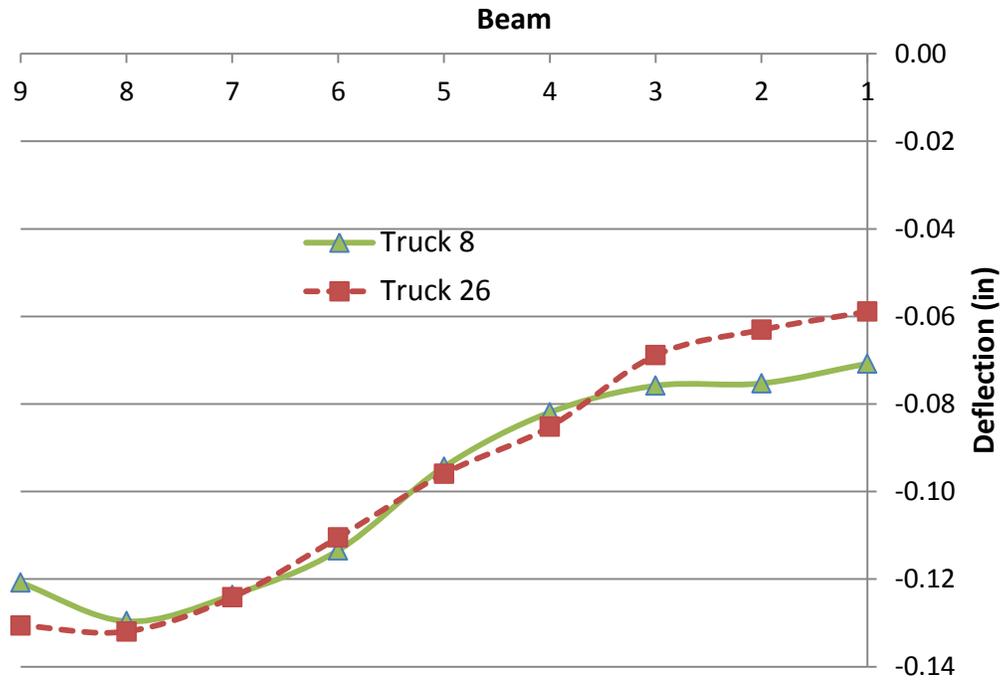
**Figure 60: Joint Effect (10 mph)**  
 (Note: 1mph = 1.61 kph, 1" = 25.4 mm)

Figures 60 and 61 compare the deflections from the moving truck loads prior to (truck 8) and after (truck 26) cutting the continuity reinforcement for 10 mph (16 kph) and 35 mph (56 kph), respectively. For the 10 mph (16 kph) condition, no significant differences occur. For the 35 mph (56 kph) case, slightly higher deflections were measured on the majority of the beams after the continuity reinforcement was cut (truck 26). However, it should be noted the truck was slightly heavier and traveled west to east, while truck 8 traveled east to west.

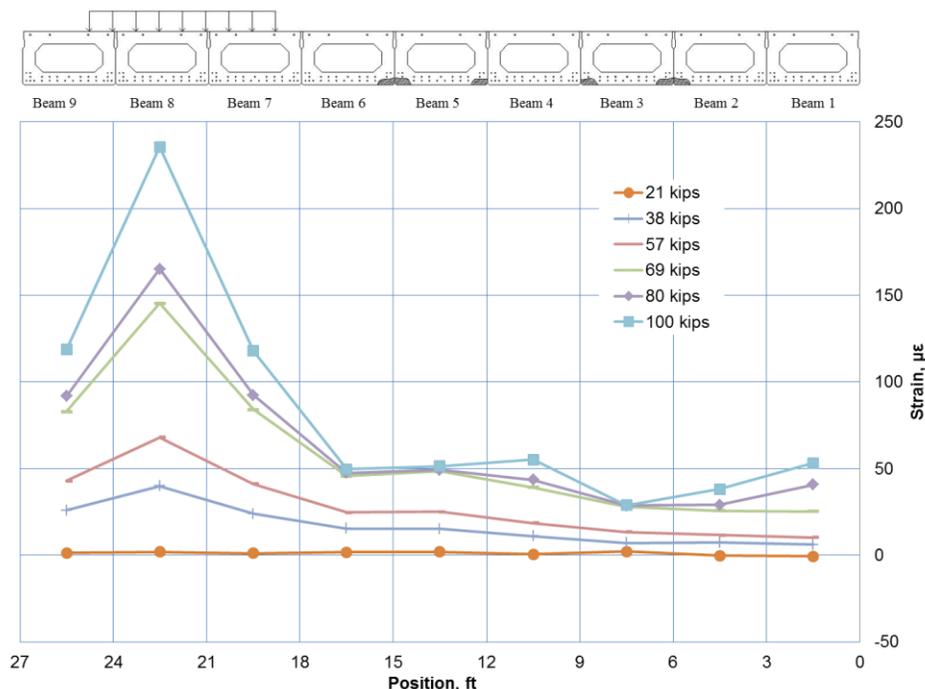
**Figure 62: Bottom Strain Profile Instrument Line H (Cylinder 1 – 100 K)**

Figures 62-64 show the strains in the bottom of the beams along instrument line H for the individual loading of cylinders 1-3 to 100 kips (445 kN). Positive strains are tensile. In Figure 62 where cylinder 1 was loaded to 100 kips (445 kN), the behavior of the bottom strains across the width of the bridge were generally expected. The strain was highest for Beam 8, which was at the location of the loading from cylinder 1. The strains increased in the beams as the load increased. It should also be noted that as the load increases from 69 kips (307 kN) to 100 kips (445 kN), the strain in Beams 3, 5, and 6 show almost no increase in strain while Beams 1, 2, and 4 increase. Beams 3 and 5 were the most damaged beams with 6 strands cut each and Beam 6 had 3 strands cut. Beam 2 also had 3 strands cut but Beams 4 and 1 did not have any damage induced. Therefore, it appears the undamaged beams start to acquire more load more than the damaged beams.

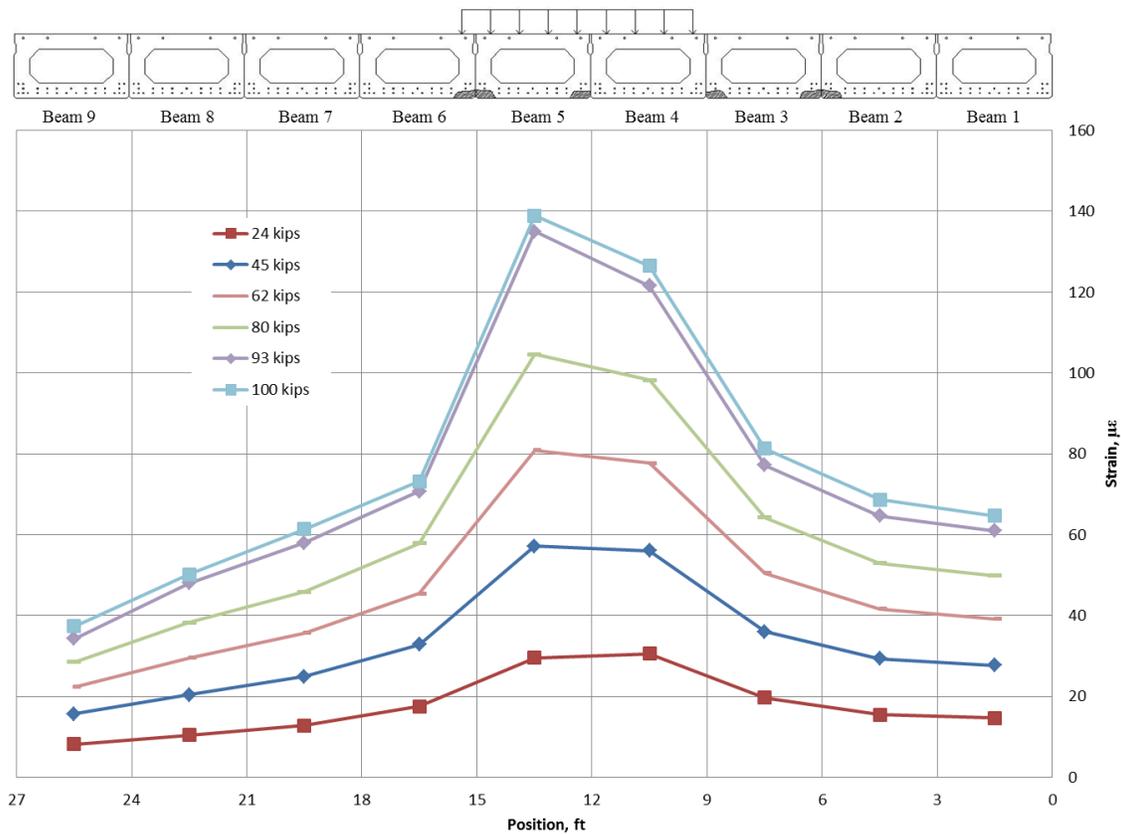
**Figure 63: Bottom Strain Profile Instrument Line H (Cylinder 2 – 100 K)**  
 (Note: 1 kip = 4.45 kN)

Figure 63 shows the strains across the bottom of the bridge along instrument line H for the 100 kip loading sequence at cylinder 2. At lower load, the strains are relatively symmetric about the center of the bridge with higher strains existing on Beams 4 and 5 where the load was applied. As the loading increases, the strains in Beams 4 and 5 become significantly larger than the other beams. However, the peak strains in Beams 4 and 5 are less than the peak strains in the fully loaded beam (8) for the cylinder 1 loading sequence (Figure 62).
