# Structural Evaluation of LIC-310-0396 and FAY-35-17-6.82 Box Beams with Advanced Strand Deterioration

September, 2011

# **Structural Evaluation of LIC-310-0396 and FAY-35-17-6.82 Box Beams with Advanced Strand Deterioration**

## **Draft Final Report – Phase II**

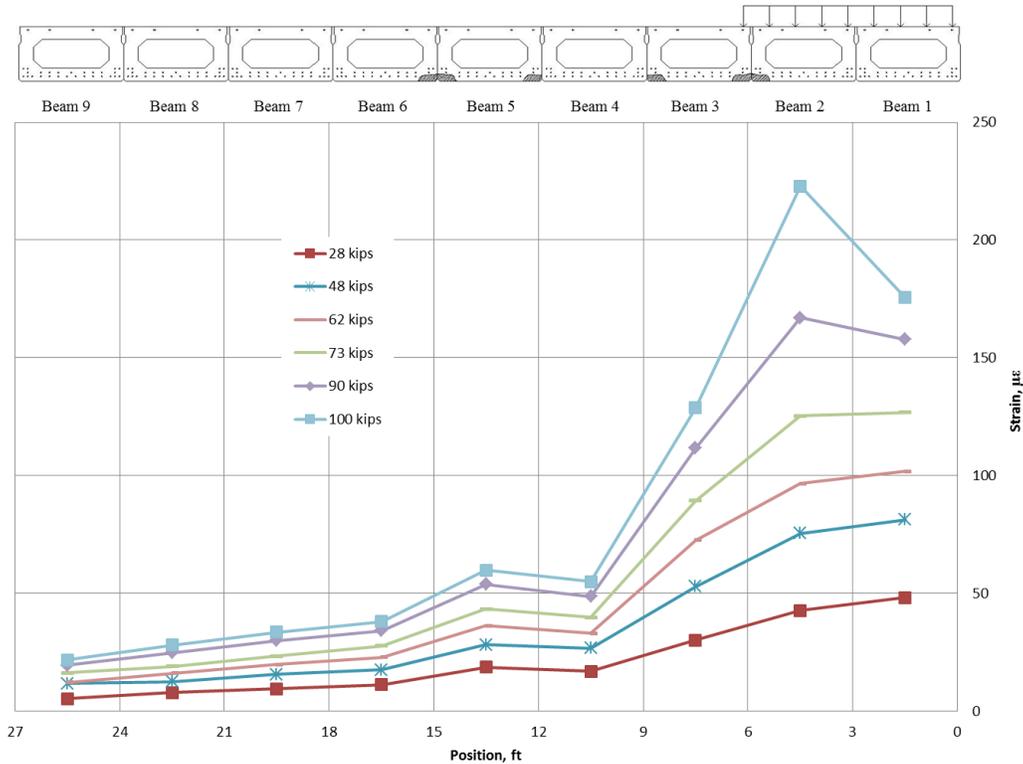
**Figure 64: Bottom Strain Profile Instrument Line H (Cylinder 3 – 100 K)**  
 (Note: 1 kip = 4.45 kN)

Figure 64 provides the bottom strains in the beams along instrument line H for the 100 kip (445 kN) cylinder 3 loading sequence. As with the other loading locations, the strains are highest at the location of the load and taper off away from the loading. However, the strains on the opposite side of the loading are much less than the opposite side strains when the load was at cylinder 1 (Figure 62). In addition, the effective of the damaged beams does not show up in the plots.

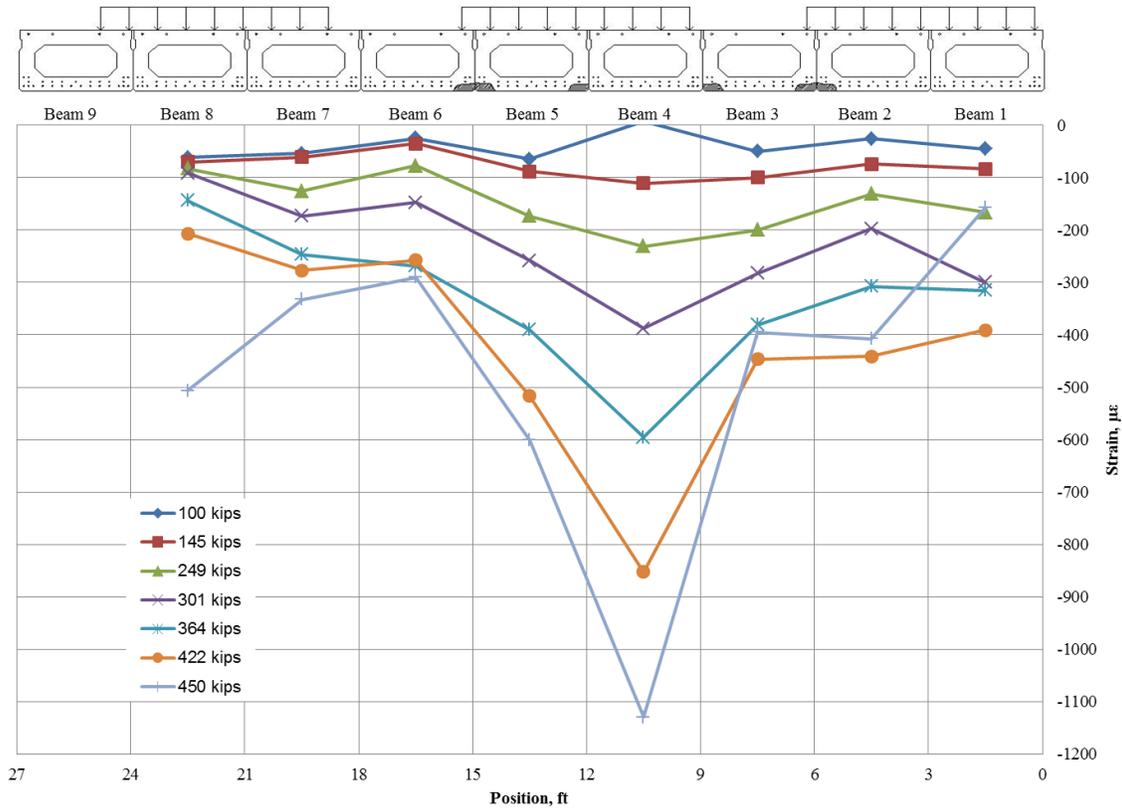
**Figure 65: Top Strain Profile Instrument Line H (All Cylinders)**  
 (Note: 1 kip = 4.45 kN)

The top strains along instrument line H across the width of the bridge while loading is applied to all cylinders is shown in Figure 65. The top strains are shown since at higher loads the strains in the bottom of the bridge become unusable due to cracking of the concrete. Strain was not monitored in Beam 9 since the poor condition of the concrete did not allow the mounting of a top gage to the beam. In general, the strains increase with increasing load. However, Beam 4 has significantly higher strain as the total loading increased above 249 kips (1,108 kN). Table 9 provides the cylinder loads for each total load the strains were plotted for in Figure 65. Though the load is highest on cylinder 2 for some of the total load plots, it is not significantly higher than the load in cylinder 1 or 3. At the 364 kip (1,620 kN) total load, the load on cylinder 2 is even lower than the load on cylinder 2. Therefore, it is concluded that a larger portion of the load is being transferred into Beam 4. This makes sense since Beam 4 was not damaged.

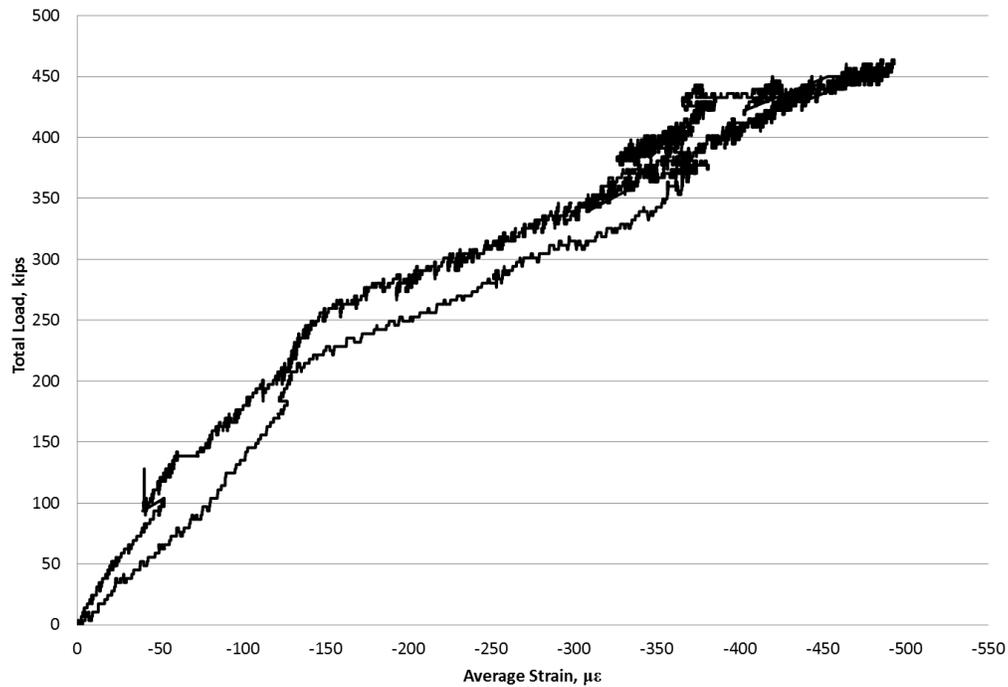
**Figure 66: Average Top Strain vs Load - Instrument Line H (All Cylinders)**  
 (Note: 1 kip = 4.45 kN)

Figure 66 provides the average top strain along the instrument line H versus the total applied load to the East span. Though the strains are negative (compression), the absolute values were plotted for comparison with other data from other spans. As can be seen from Figure 66, the plot is relatively linear until approximately 250 kips (1,113 kN). The plot then becomes relatively linear again with a reduced slope. The behavior shown in the plot is somewhat similar to that of a single beam.

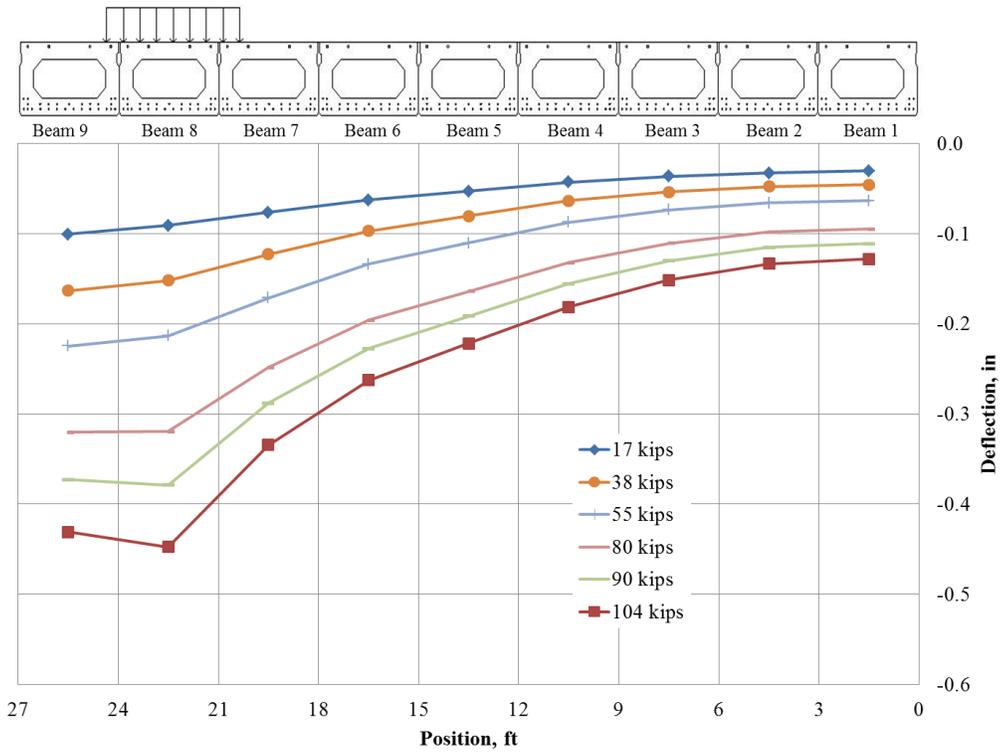
**Figure 72: Deflection Profile Instrument Line E (Cylinder 1 – 100 K)**  
 (Note: 1 kip = 4.45 kN, 1" = 25.4 mm)

Figures 72-77 show the deflection response of the bridge as the load increases to approximately 100 kips (445 kN) on a single cylinder while no load is applied to the other cylinders. Deflections were not monitored on Beam 9 for instrument line D because of the poor condition of the top of Beam 9 would not allow an anchor to be set in order to mount the wire of the string potentiometer. In general, for all three cylinders and both instrument lines, the deflections increased fairly consistently across the bridge as the load was increased. However, for the loading applied to cylinder 2, larger deflections occurred on the north edge of the bridge (Beams 8 and 9) than on the south edge (Beams 1 and 2). This was observed at both instrument lines E and D. This implied that the northern beams were less stiff than the southern beams or load transfer was not completely symmetrical. This may have been due to the effect of the asphalt being left in place on the south side. The asphalt may not have directly increased stiffness, but rather shifted the neutral axis of the beams and/or improved the distribution of the load to the beams longitudinally and transversely. The figures for the loading applied by cylinder 3 showed that once the loading was reduced to 55 kips (245 kN), the deflection was higher than at slightly higher loads of 59 kips (263 kN) during the initial loading stage. This implies some damage to the beams accompanied by permanent deformation.

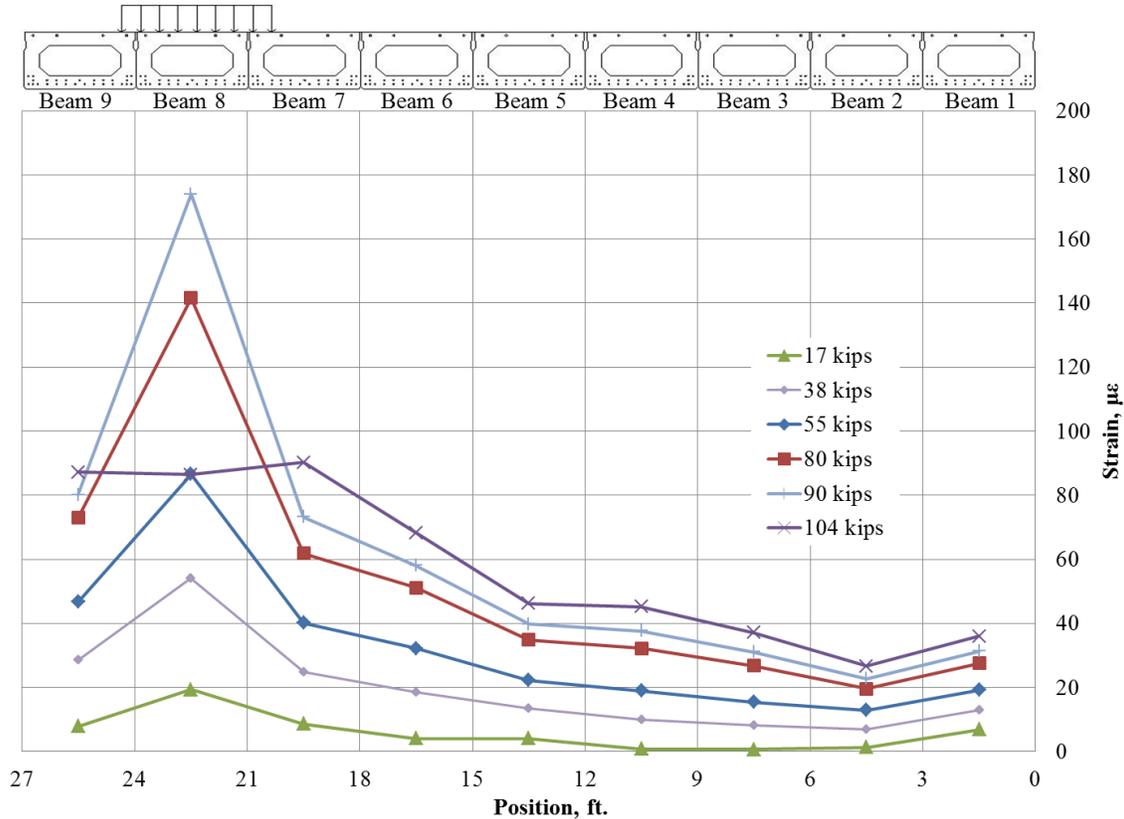
**Figure 80: Bottom Strain Profile Instrument Line E (Cylinder 1 – 100 K)**  
 (Note: 1 kip = 4.45 kN, 1" = 25.4 mm)

The strains in the bottom of the beams along instrument line E for the individual 100 kip cylinder loads are shown in Figures 80-82. In Figure 80, the strains increase with load as expected. The strains are highest in the beams that are directly loaded. However, the strain in Beam 8 drops when the load increases from 90 to 104 kips. This appears to be an issue with the concrete the gage was adhered to or the strain gage itself. The strains across the beams appear to be slightly more linearly distributed than the strains experienced in the East span for the same loading condition. This was likely due to the damage caused in the East span.

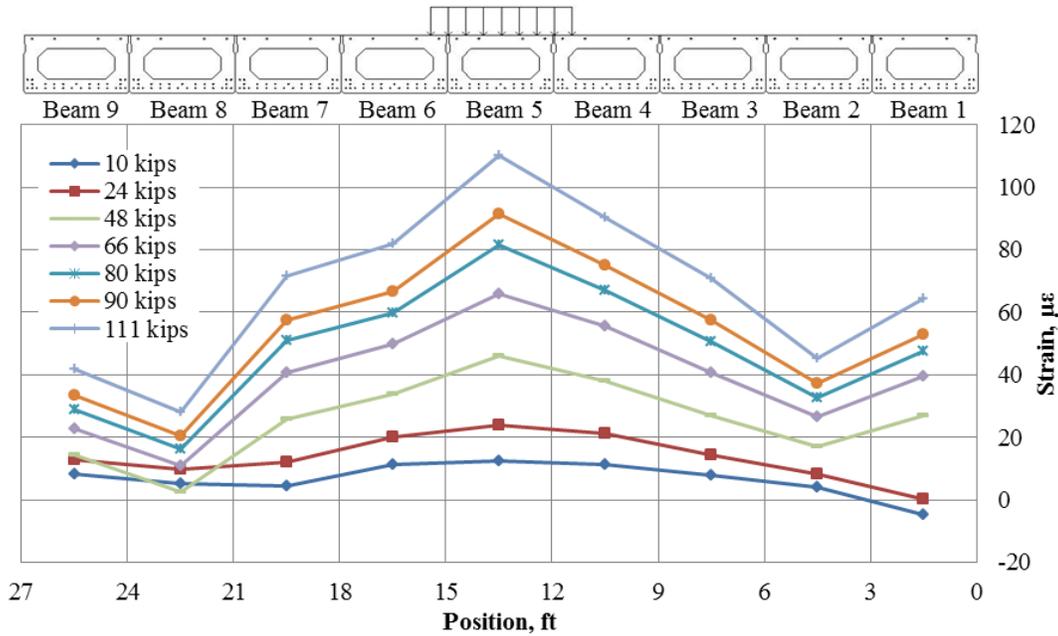
**Figure 81: Bottom Strain Profile Instrument Line E (Cylinder 2 – 100 K)**  
 (Note: 1 kip = 4.45 kN, 1" = 25.4 mm)

Figure 81 shows the bottom strain at instrument line E for the 100 kip (445 kN) loading in cylinder 2. The strain in Beam 8 shows a large drop in strain and may signify something occurred either to the gage or concrete during the loading of cylinder 1 above 90 kips. Another interesting observation is that the strain in Beam 2 also shows and relatively large drop in comparison to the surrounding beam strains.

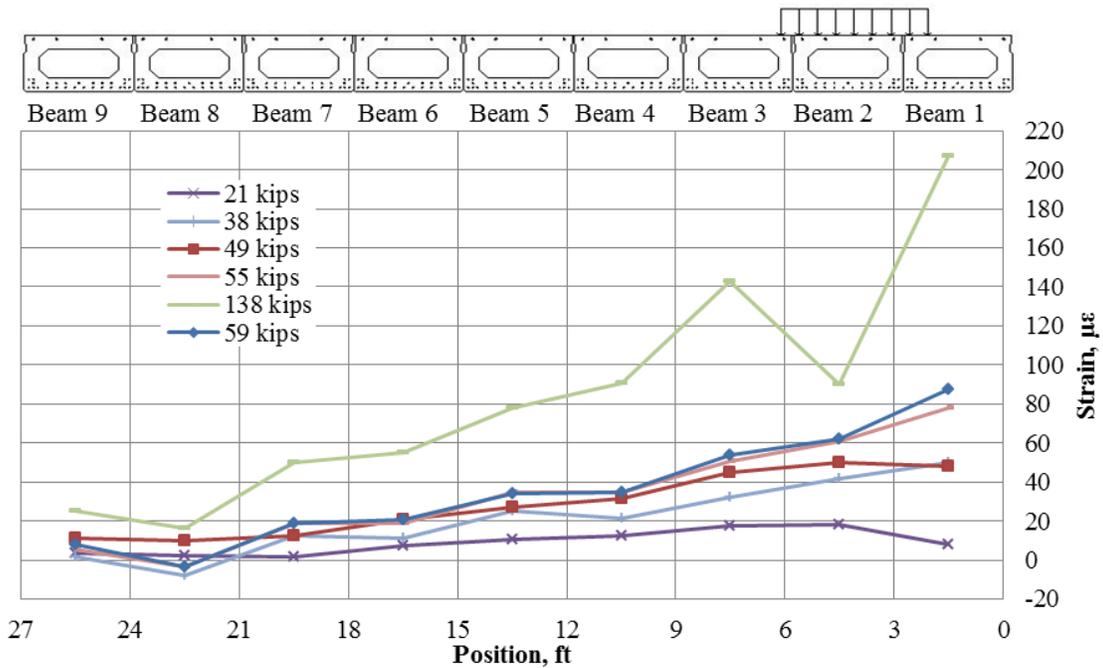
**Figure 82: Bottom Strain Profile Instrument Line E (Cylinder 3 – 100 K)**  
 (Note: 1 kip = 4.45 kN, 1" = 25.4 mm)

The bottom strain at instrument line E for the 100 kip (445 kN) loading in cylinder 3 is shown in Figure 82. At low loads the strain in Beam 8 was actually slightly negative which continues to indicate something occurred either to the gage or concrete during the loading of cylinder 1. The strain in Beam 2 also shows expected behavior until the load increases to 138 kips (614 kN), in which the strain in Beam 2 drops in comparison to the surrounding beam strains.

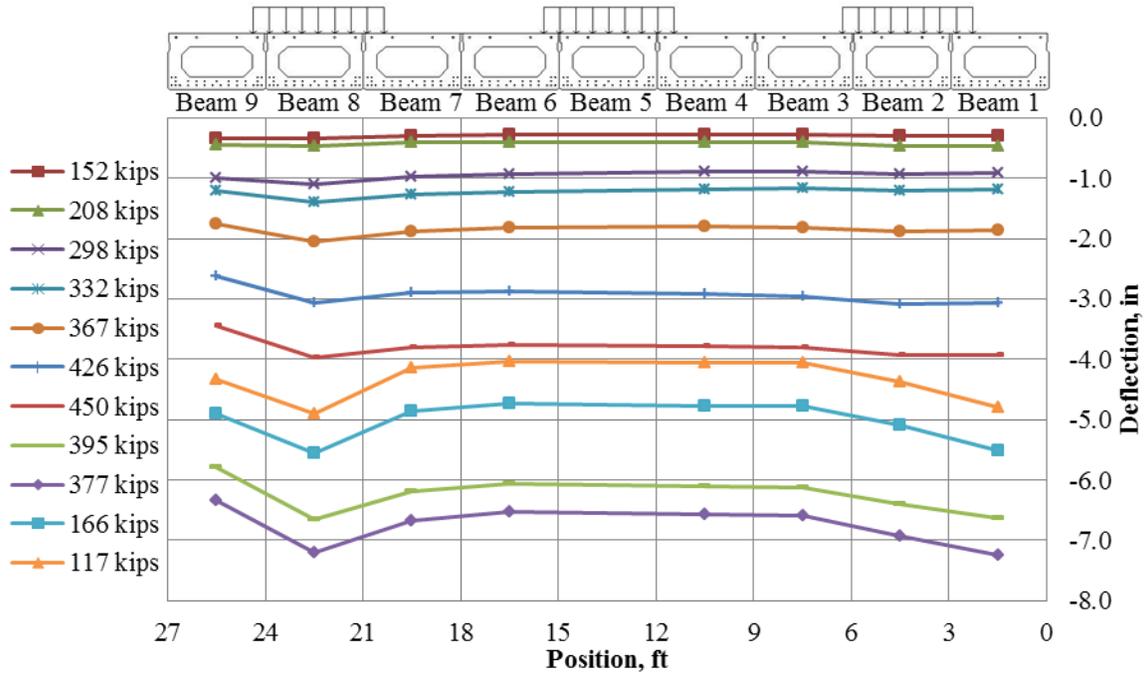
**Figure 83: Total Load and Instrument Line E Deflection (Center Span)**

After loading and unloading with each individual cylinder, load was applied to each cylinder and maintained as another cylinder increased load. Figure 83 shows the deflection across the bridge at instrument line E as the total load from all cylinders increased. Table 10 provides how the total load was distributed from the three cylinders. When the maximum load of approximately 450 kips (2,003 kN) was obtained, the bridge was no longer able to support

higher total load and deflections increased. Initially, the deflections are fairly consistent across the width of the bridge. However, after the maximum load was reached Beams 1, 2 and 8 showed slightly higher deflections even though more load is applied from cylinder 2 to the middle bridge beams compared to the outside beams. The deflection profile remained the same even after the load was decreased. The deflection across the width of the bridge is much higher at lower loads after the peak loading was reached, resulting in permanent deformation. It should be noted that the data for the string potentiometer attached to Beam 5 was not usable from the test.

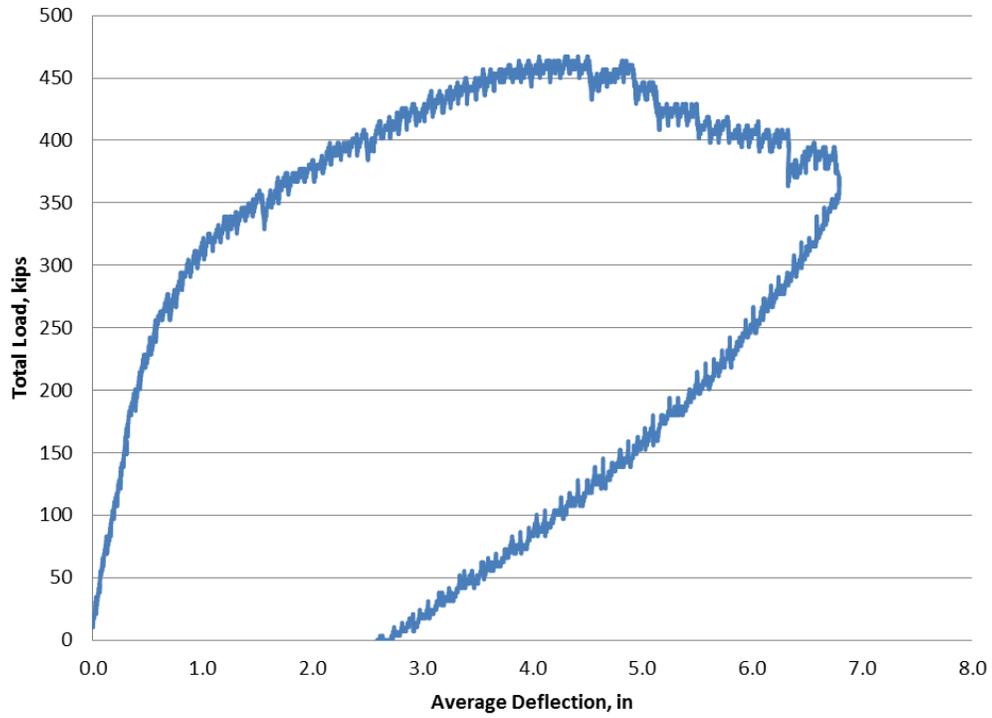
**Figure 85: Total Load and Instrument Line E Average Deflection (Center Span)**  
 (Note: 1 kip = 4.45 kN, 1" = 25.4 mm)

Figure 85 and 86 show the total load from all the cylinders versus the average deflection of all the beams along instrument lines E and D, respectively. The figures show a linear behavior for the bridge until the total load reaches approximately 200 kips (890 kN). The average deflection of the bridge then becomes nonlinear. After the maximum load of approximately 450 kips (2,003 kN) was reached, the load dropped off as deflection increased. The bridge was then unloaded and permanent average deflections of approximately 2.75" (69.9 mm) and 1.50" (38.1 mm) remained at instrument lines E and D, respectively.

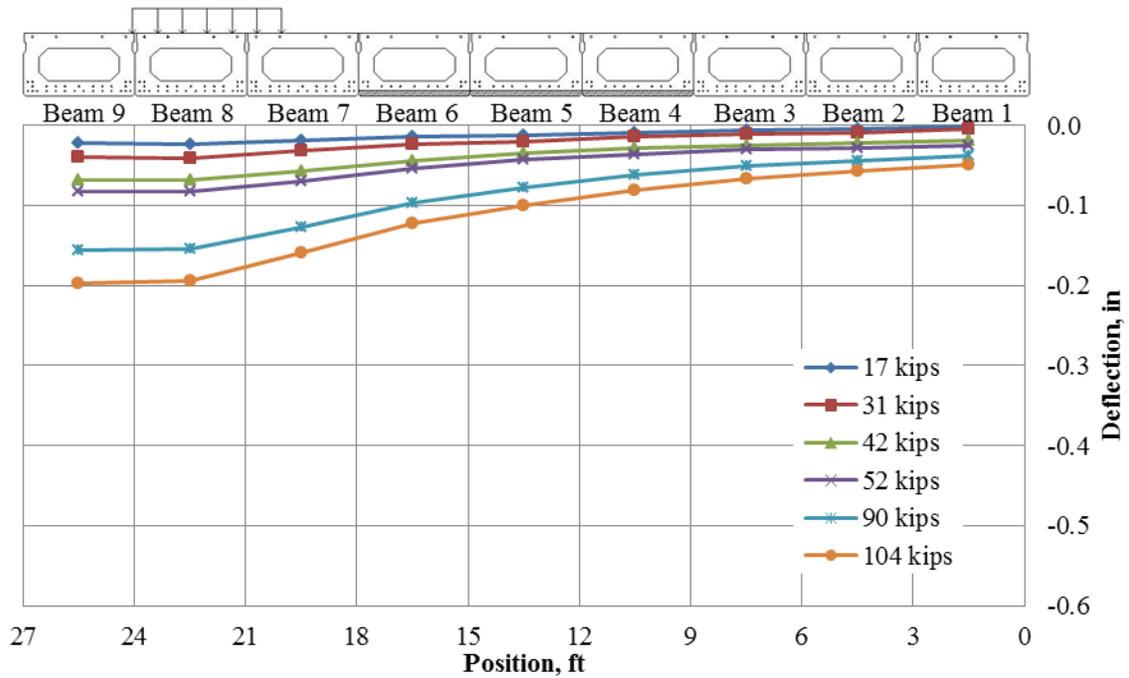
**Figure 94: Deflection Profile Instrument Line B (Cylinder 1 – 100 K)**  
 (Note: 1 kip = 4.45 kN, 1" = 25.4 mm)

Figures 93-98 show the response of the west span as the load increases to approximately 100 kips (445 kN) on a single cylinder while no load is applied to the other cylinders. In general, for all three cylinders and both instrument lines, the deflections increased fairly consistently across the bridge as the load was increased. For the loading on cylinder 1 and deflections along instrument line A (Figure 93), Beam 8 deflected the most as would be expected since the majority of the load was applied to Beam 8. However, the deflection of Beam 9 was greater than that of Beam 7 even though Beam 7 had about 1/3 of the load applied to it and no load was directly applied to Beam 9. Along instrument line B, the deflection of Beam 8 and 9 were basically the same throughout the loading process (Figure 94). The behavior of Beam 9 was likely due to its poor condition.

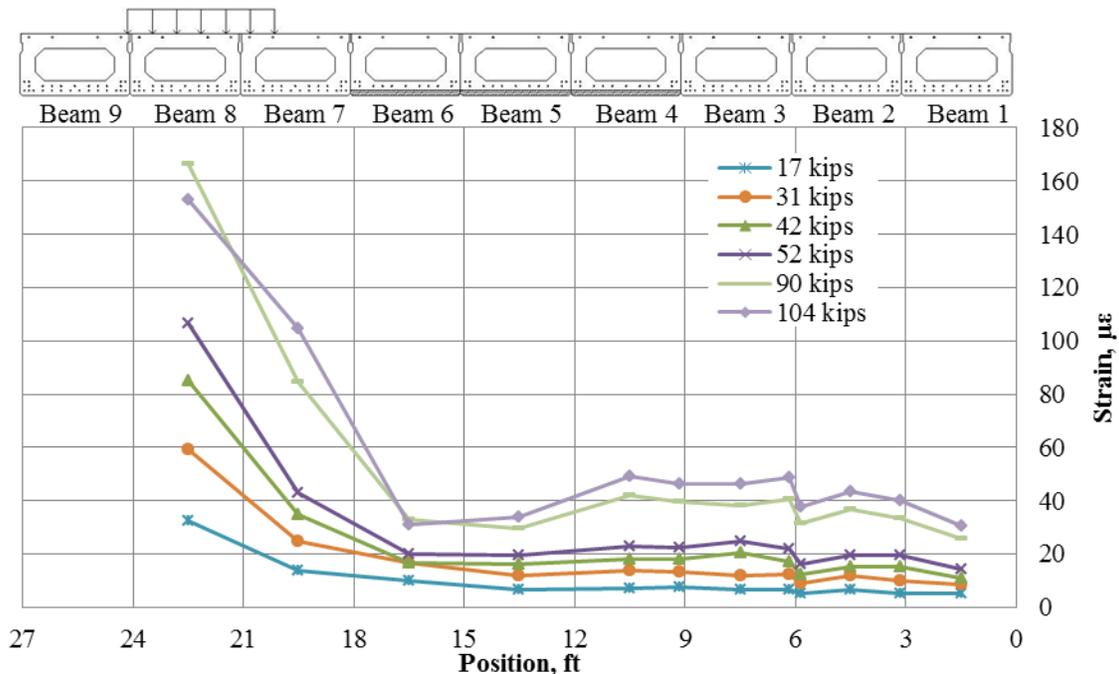
**Figure 101: Bottom Strain Profile Instrument Line A (Cylinder 1 – 100 K)**

In Figure 101 where cylinder 1 was loaded to 100 kips (445 kN), the behavior of the bottom strains across the width of the bridge were generally expected. The strain was highest for Beam 8, which was at the location of the loading from cylinder 1. Beam 9 showed no change in strain is was likely due to failure of the gage. The remaining strains increased in the beams as the load increased. However, it should also be noted that as the load increased from 42 kips (187 kN) to 104 kips (463 kN), the strain in Beams 5 (13.5 ft.) and 6 (16.5 ft.) showed little increase in strain while the strains in the other beams increased. Beams 5 and 6 were two of the three beams that were damaged, but the other damaged beam (Beam 4) did not exhibit the same behavior. At higher loads, the strains between Beams 2 and 3 showed a jump in the strain. It did appear the undamaged beams (Beams 2 and 3) started to acquire more strain than the damaged beams.

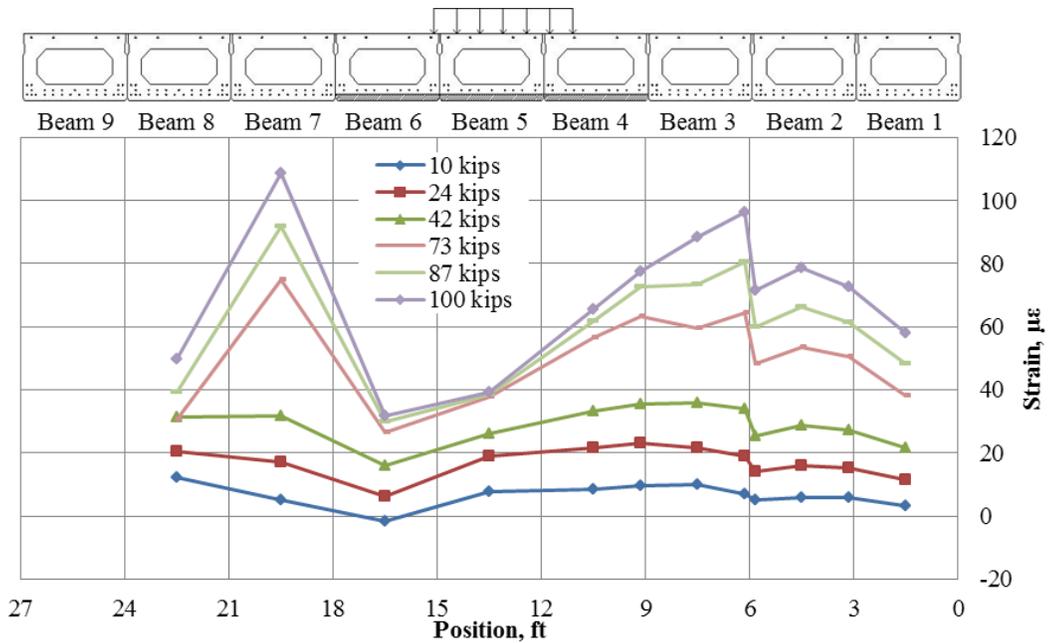
**Figure 102: Bottom Strain Profile Instrument Line A (Cylinder 2 – 100 K)**  
 (Note: 1 kip = 4.45 kN, 1' = 0.305 m)

Figure 102 provides the bottom strain data along instrument line A for the width of the bridge as cylinder 2 was loaded to approximately 100 kips (445 kN). Even though the load was applied primarily to Beams 4 (10.5 ft.) and 5 (13.5 ft.), the strains in damaged Beams 4, 5 and 6 showed lower strain than the adjacent beams (Beams 4 and 7) especially at higher loads. This was likely due to translation of the damaged beams due to their damage states. The jump in strain between Beams 2 and 3 are also still noticeable.

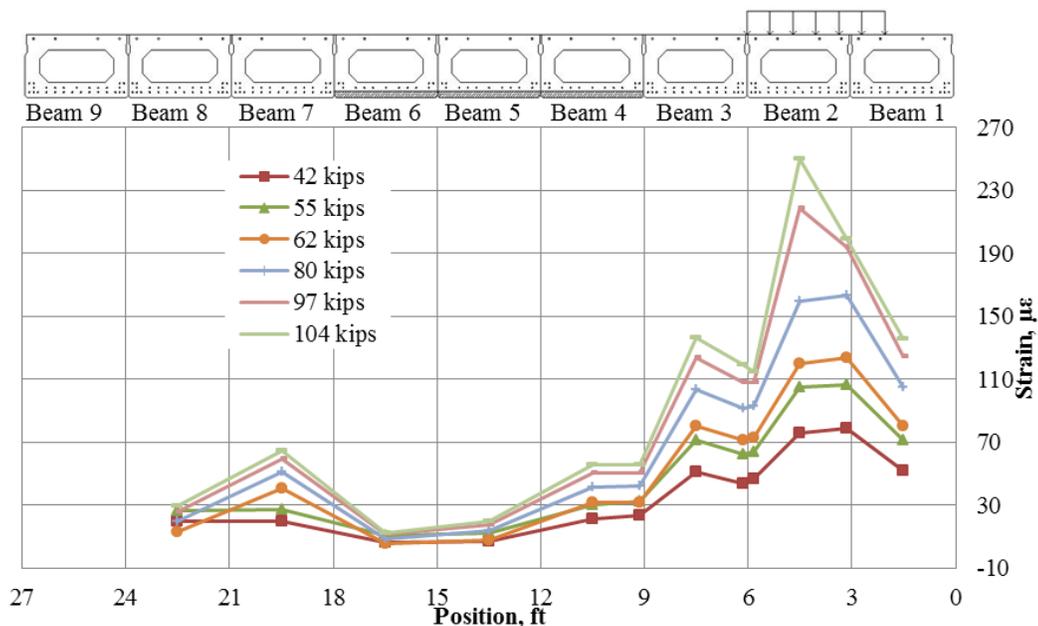
**Figure 103: Bottom Strain Profile Instrument Line A (Cylinder 3 – 100 K)**  
 (Note: 1 kip = 4.45 kN, 1' = 0.305 m)

The bottom strain data along instrument line A for the width of the bridge as cylinder 3 was loaded to approximately 100 kips is shown in Figure 103. Even though the load was applied primarily to Beams 1 (1.5 ft.) and 2 (4.5 ft.), the strains in damaged Beams 4, 5 and 6 showed lower strain than the adjacent beams (Beams 4 and 7) especially at higher loads. This was likely due to translation of the damaged beams due to their damage states. The jump in strain between Beams 2 and 3 is also still noticeable.

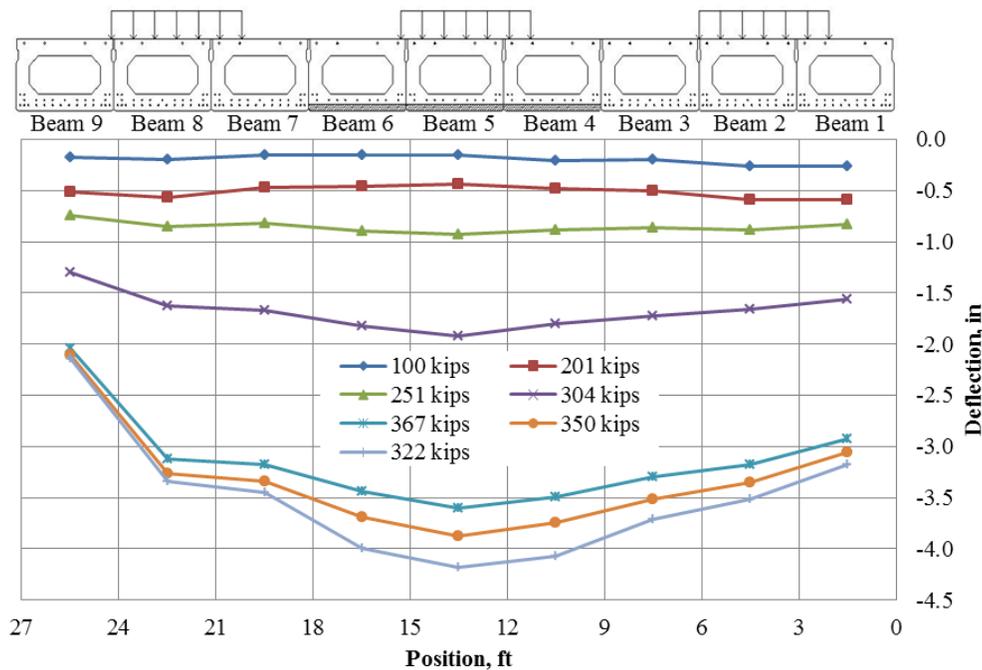
**Figure 104: Total Load and Instrument Line A Deflection (West Span)**

After loading and unloading with each individual cylinder, load was applied to each cylinder and maintained as another cylinder increased load. Figures 104 and 105 show the deflection across the bridge at instrument lines A and B, respectively, as the total load from all cylinders increased. Table 11 provides how the total load was distributed from the three cylinders. When the maximum load of 367 kips (1,633 kN) was obtained the bridge was no longer able to support higher total load and deflections increased. Initially, the deflections are fairly symmetric about Beam 5. The deflection of Beam 9 begins to show less of an increase in deflection compared to all the other beams after a total load of 251 kips (1,117 kN). At the maximum load, the deflection of Beam 9 is approximately 1” (25.4 mm) less than Beam 8 and approximately 1.5” (38.1 mm) less than Beam 5. The behavior is likely due to loss of the shear key for Beam 9. Beams 4-6 show the largest deflection as the load is highest in cylinder 2. With the exception of Beam 9, the deflection is relatively uniform across the bridge even after the maximum load has been reached.

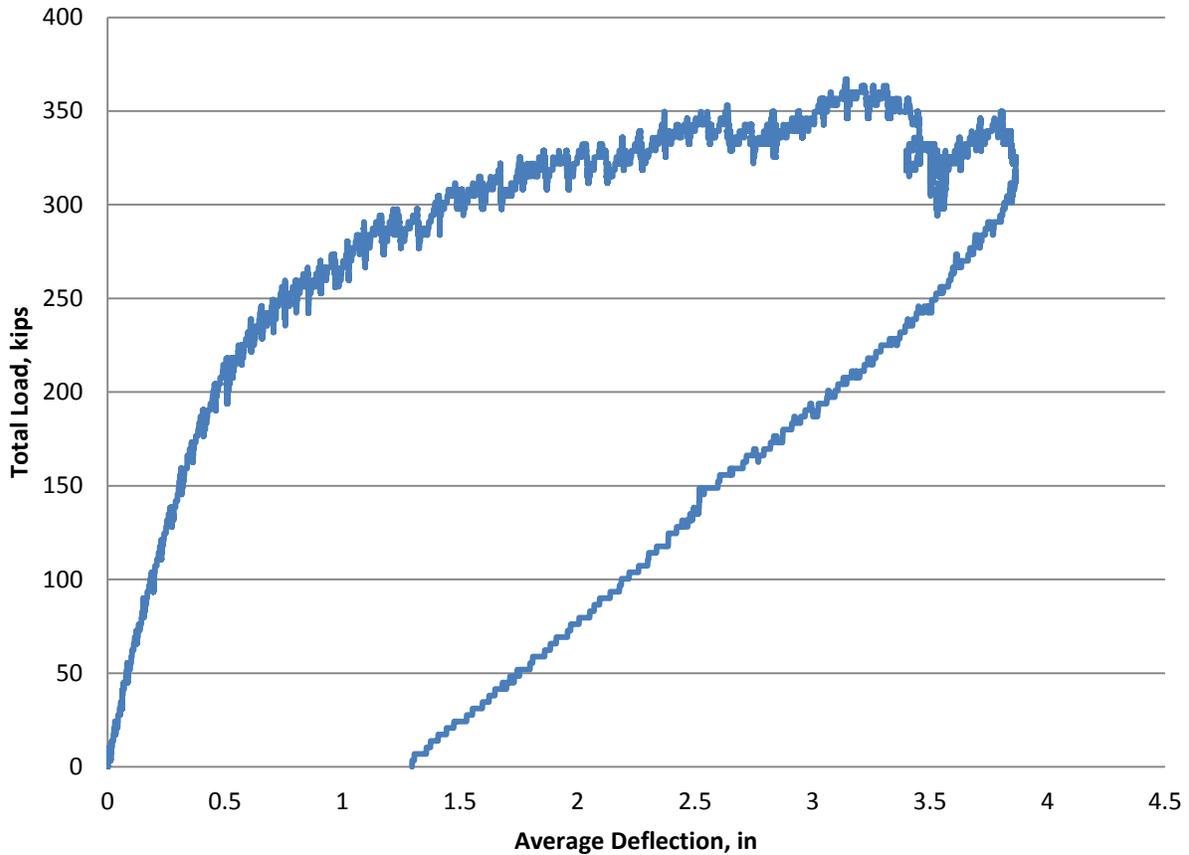
**Figure 106: Total Load and Instrument Line A Average Deflection (West Span)**

Figure 106 shows the total load from all the cylinders versus the average deflection along instrument line A of all the beams. The figure shows a linear behavior for the bridge until the total load reaches approximately 200 kips (890 kN). The average deflection of the bridge then becomes nonlinear. After the maximum load of 363 kips (1,615 kN) is reached, the load drops off as deflection increases. The bridge was then unloaded due to reaching stroke limitations on the cylinders. Upon unloading a permanent average deflection of 1.30" (33 mm) remained.

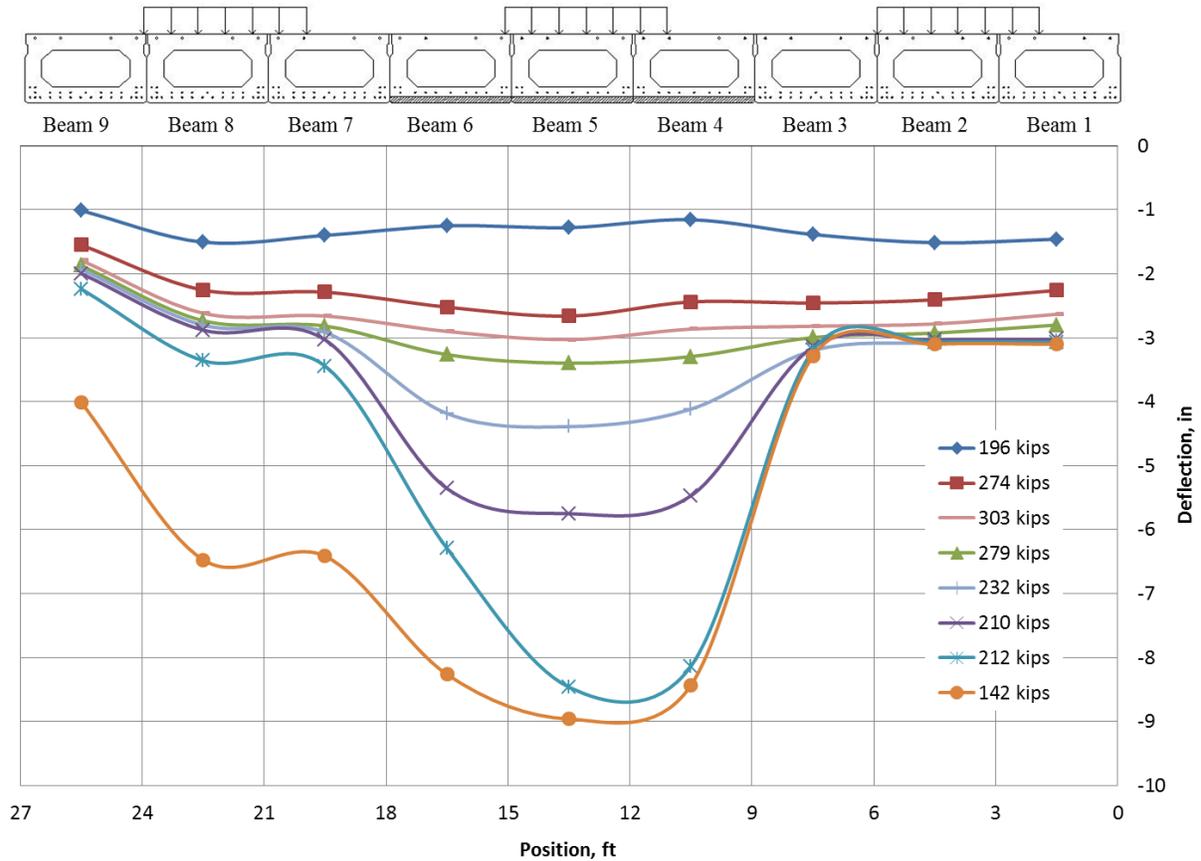
**Figure 107: Total Load and Instrument Line A Deflection after Shimming (West Span)**  
 (Note: 1 kip = 4.45 kN, 1" = 25.4 mm)

After providing additional shims to allow for further deflections, the load was reapplied with the cylinders. The west span's deflection behavior along instrument line A during this loading sequence is shown in Figure 107. Notice the deflections of Beams 4-6 began to greatly exceed that of the other beams once a total load of 274 kips (1,219 kN) was achieved. The bridge was unable to maintain this load level and deflections continued to increase. The 274 kip (1,219 kN) total load did not reach the level of the total load achieved prior to shimming. In addition, load was unable to be increased in the middle cylinder loading Beams 4 and 5 but higher loads were achieved on cylinder 1 loading Beams 7 and 8. Deflections of Beams 7 and 8 increased more rapidly as well. The total loads and the load on each cylinder are provided in Table 12. Figure 108 provides the deflection behavior at instrument line B. The behavior was in general the same as along instrument line A with lower deflections. However, the deflections did not consistently increase even if the load was dropping off.

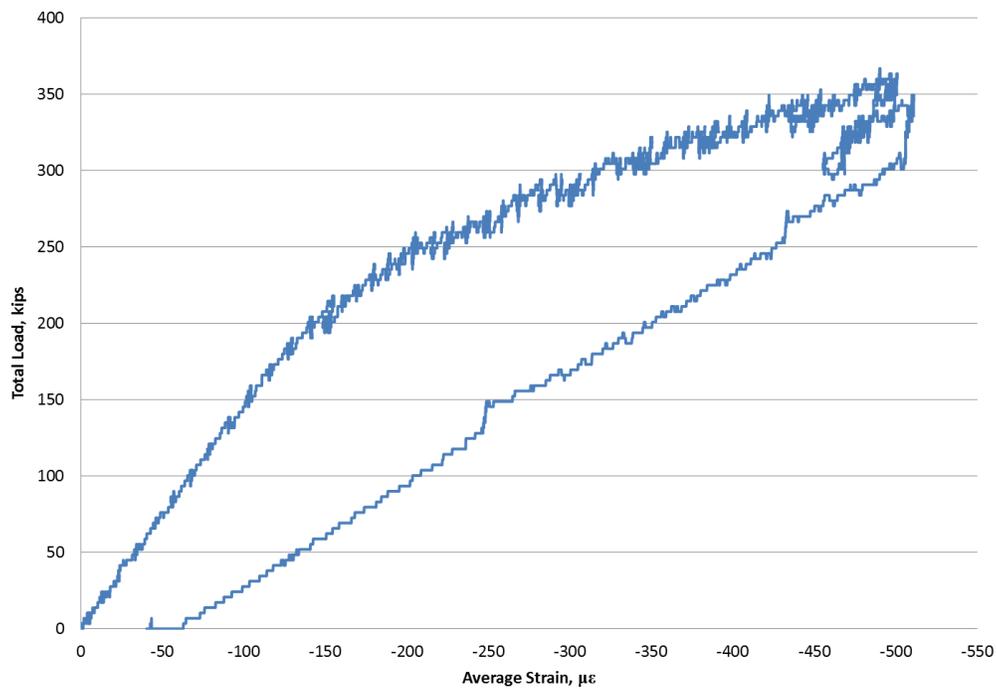
The average strain across the bottom of the bridge along instrument line A versus the total applied load prior to shimming is shown in Figure 110. The average strain is relatively linear up to approximately 200 kips (890 kN). The curve then continues approximately linearly at a flatter slope until the peak load is reached.

**Figure 110: Average Top Strain vs. Load - Instrument Line A (All Cylinders)**  
 (Note: 1 kip = 4.45 kN)

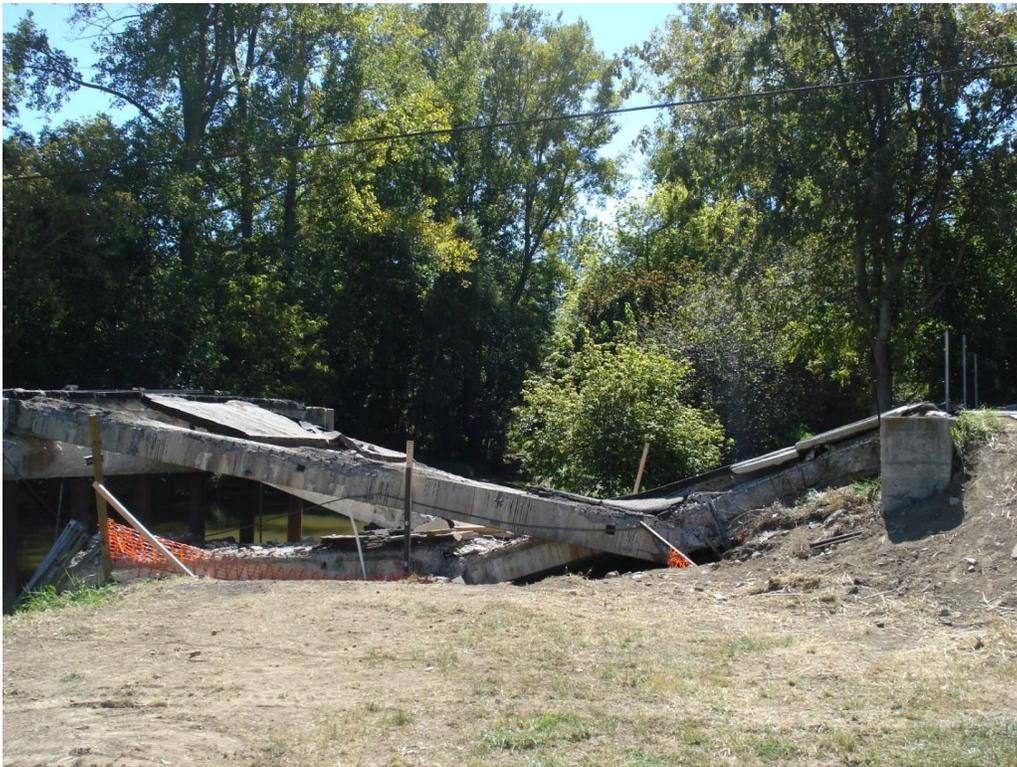
Loading was stopped and the string potentiometers were removed to prevent damage. Loading was again applied to the bridge without being able to exceed the previous maximum total loading. Eventually the bridge completely collapsed in a ductile manner (see Figures 114 - 116). Beams 1-8 failed near midspan close to the loading locations and Beam 9 failed near the abutment. Beams 7 and 8 pulled sufficiently away from the pier and fell to the ground near the pier. The transverse tie between Beams 8 and 9 (see Figure 117) and Beams 6 and 7 fractured allowing Beams 7 and 8 to be separated from the remaining beams. Beam 9 had lost its top flange which was a patched section at this location. A combination of separation of the top flange, poor concrete, and shear resulted in the failure of Beam 9.

**Figure 115: Collapsed Bridge (West Span w/o Frame)**

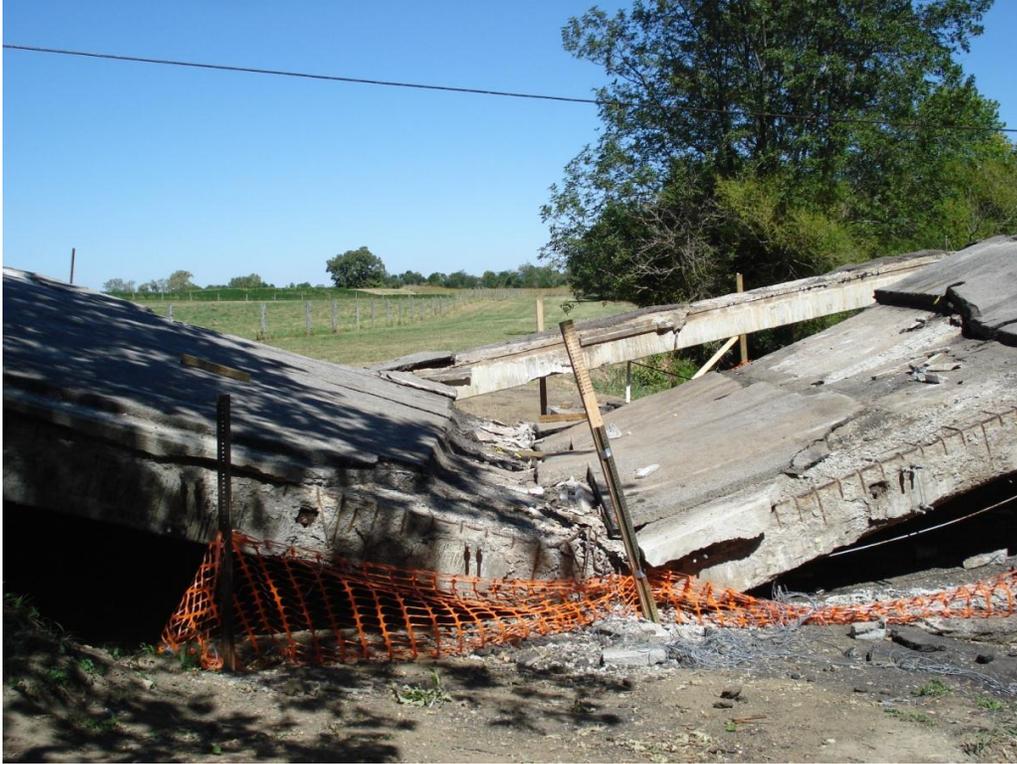
**Figure 116: Collapsed Bridge (West Span w/o Frame)**

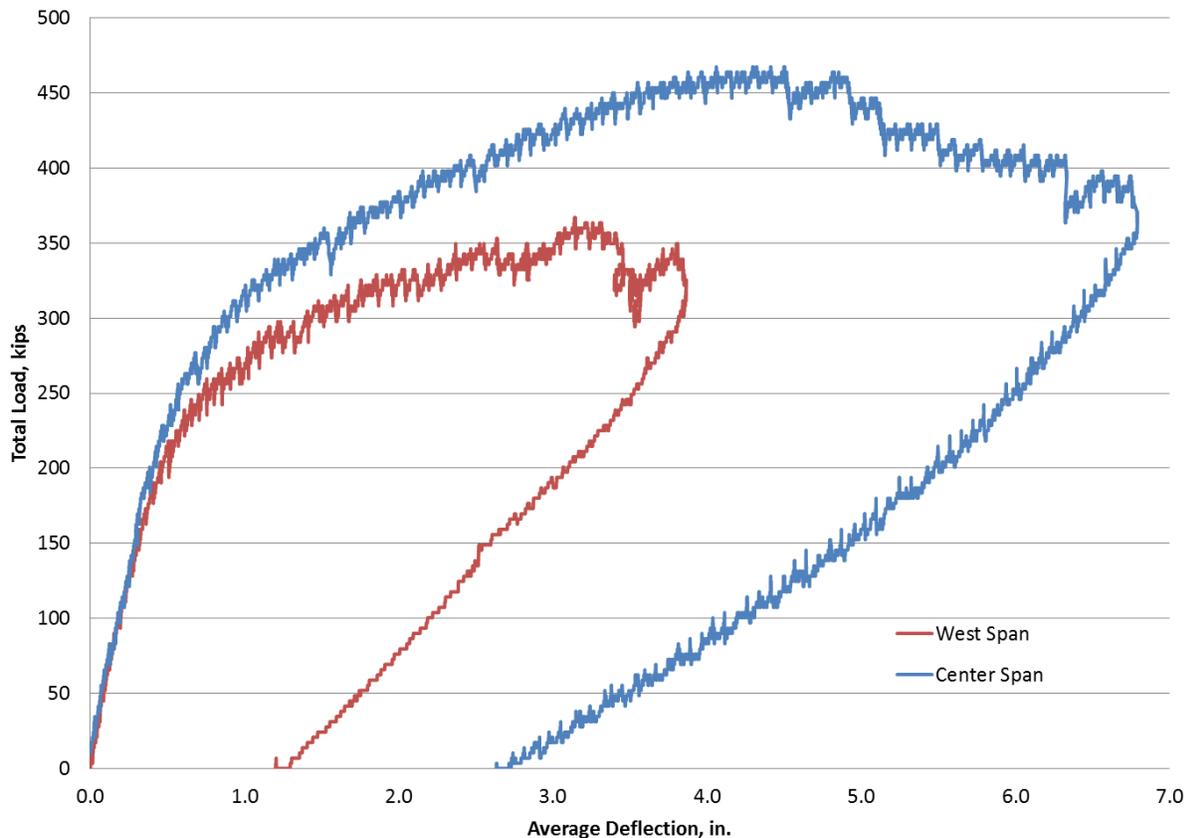
In order to compare the destructive test results for the different spans, the plots of the average midspan deflection for the Center and West spans versus the total applied load was created and is provided in Figure 118. These are Figures 85 and 106 superimposed into the same figure. As can be seen in Figure 118, both spans behave in a similar linear manner up to approximately 175 kips (779 kN) even though the West span had significantly more damage. After approximately 175 kips (779 kN), the West span begins to become nonlinear as the Center span continues to be linear to approximately 225 kips (1,001 kN). At larger loading, the West span shows more average deflection. At the peak load for the West span, the average deflection is approximately twice that of the Center span. The Center span obtains the deflection of West span peak load at approximately an additional 70 kips (312 kN), 430 kips (1,914 kN) compared to 360 kips (1,602 kN).

**Figure 118: Average Mid-span Deflections vs. Load (Center & West Spans)**  
(Note: 1 kip = 4.45 kN, 1" = 25.4 mm)

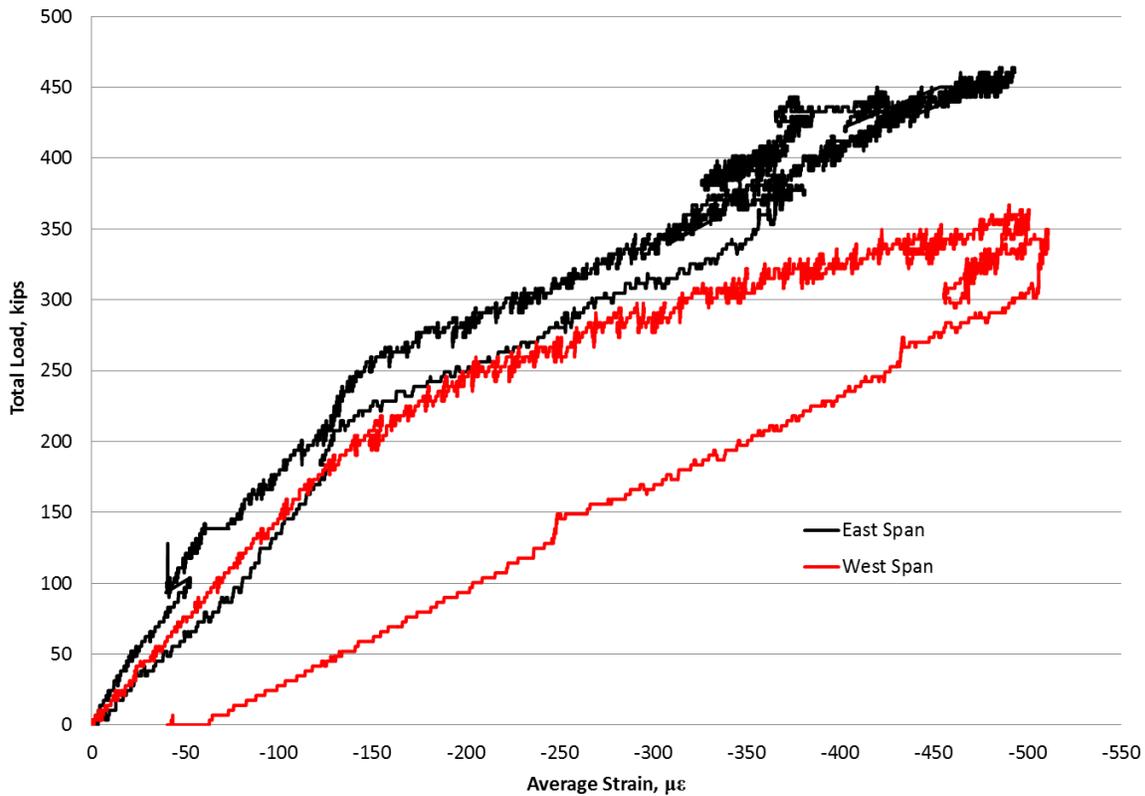
In order to compare the destructive test results for the East and West spans, the plots of the average midspan top strain versus the total applied load was created and is provided in Figure 119. These are Figures 66 and 110 superimposed. As can be seen in Figure 119, both spans show initial linear behavior with the East span being slightly stiffer than the West span. The slope of both curves then change to another approximately linear portion with the East span again being stiffer than the West span. The change in stiffnesses occur at approximately 260 kips (1,157 kN) for the East span and approximately 225 kips (1,001 kN) for the West span. These differences can be attributed to the more severe damage in the West span compared to the East span.

**Figure 119: Average Mid-span Strain vs. Load (East & West Spans)**  
 (Note: 1 kip = 4.45 kN)
