EVALUATION OF ALTERNATIVE DOWEL BAR MATERIALS AND COATINGS

Final Report

Ohio Department of Transportation Office of Research and Development

> > November 2011

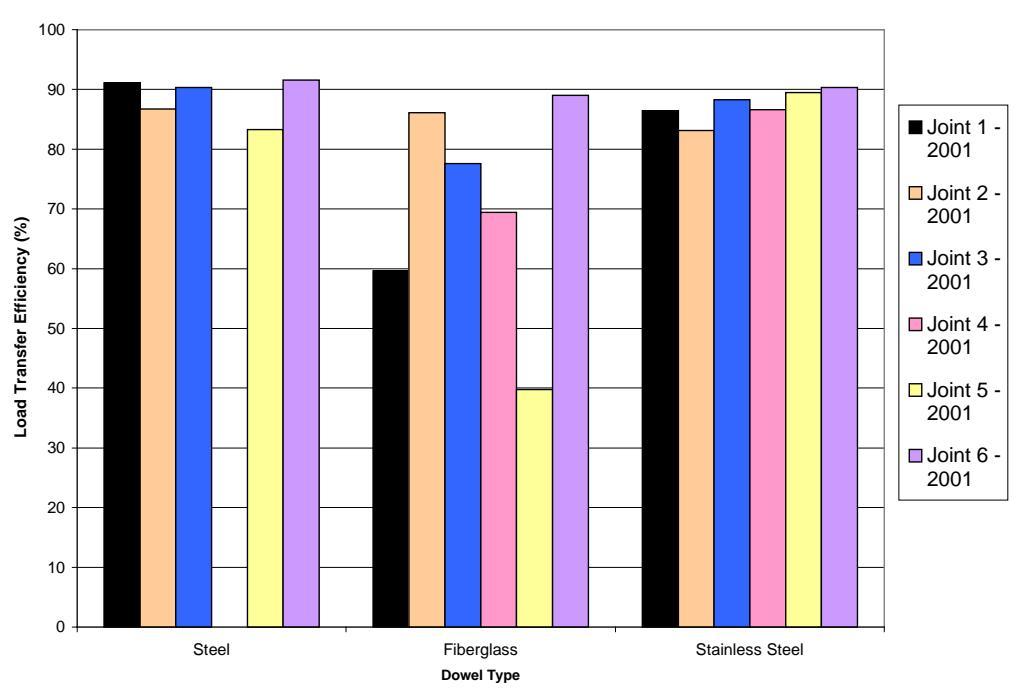
Figure 2. LTE measurements for OH 2 project.

The load transfer efficiencies on the OH 2 project from 2001 are shown in Figure 2. The Type 318 stainless steel clad dowels installed in 1998 on US 50 westbound were not included in this evaluation.

Additional FWD testing and coring was performed on this project in 2004. The 4-in (102-mm) diameter cores (selected photos of which are included in Appendix C) of the epoxy-coated dowels and of the concrete-filled Type 304 stainless steel showed delaminations of the concrete at the dowel bar level. As corrosion of the stainless steel dowel at this age is unlikely, the cause of the cracking is most likely due to the high early environmental stresses noted during construction and/or the poor support provided by the New Jersey unstabilized permeable base combined with the more rigid steel dowel bar properties.

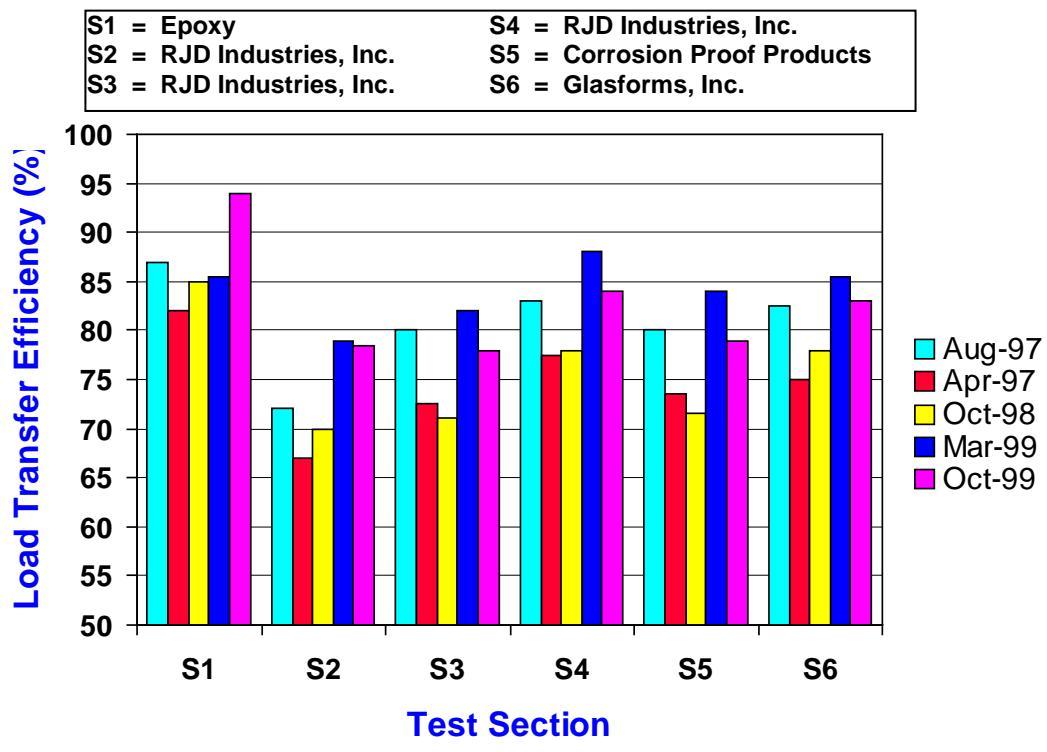
Figure 3. LTE measurements on IL 2 project (Gawedzinski 2000).

The 1997 project, IL 2, consisted of five different FRP sections and the epoxy-coated dowel bar control section. A plot of the LTE measurements is provided in Figure 3. This shows that all five FRP sections had LTEs less than 85 percent soon after construction. Overall performance of the FRP joints (range 65 to 80 percent LTE after 6 years and 1.3 million ESALs) appears to be very close to the behavior of the epoxy-coated steel control set (minimum of 83 percent LTE after 6 years). This project had a granular subbase.

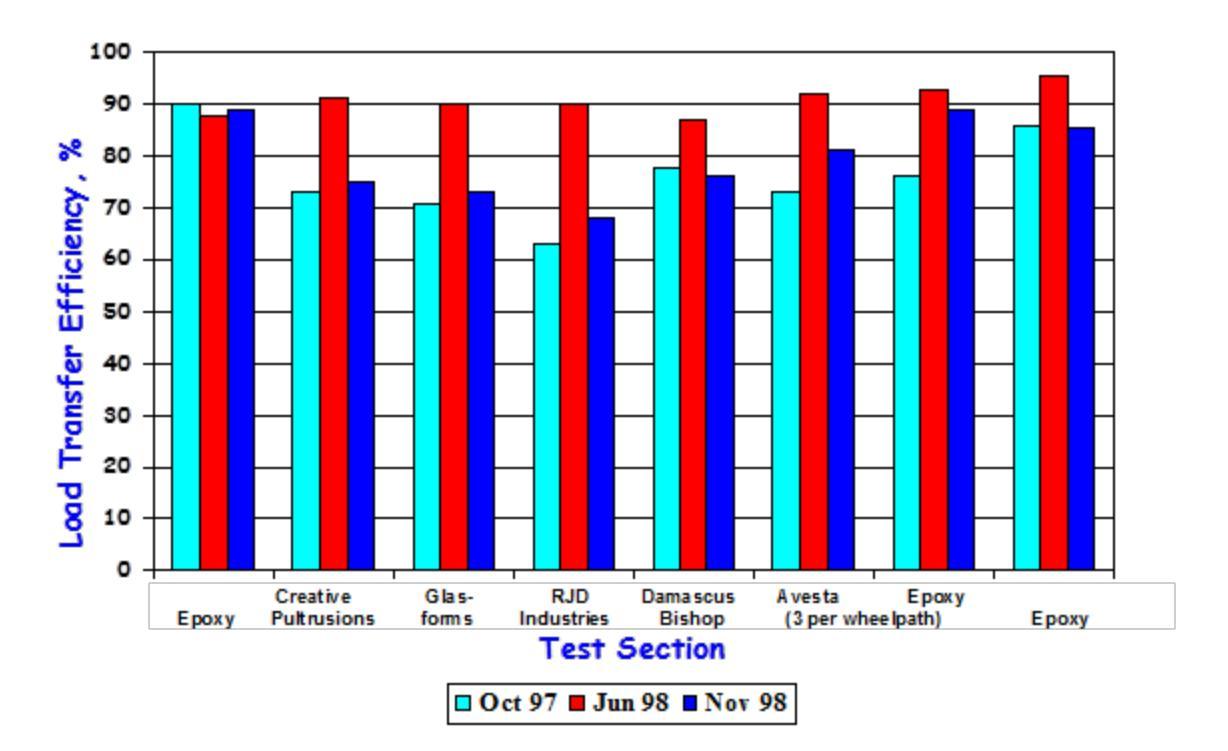
Figure 4. LTE measurements for WI 2 project (Smith 2002b).

These sections were performing well after only a few years of service. FWD testing of transverse joint load transfer has been conducted on the projects, with the results for the outer lane wheelpaths of WI 2 and WI 3 shown in Figures 4 and 5. Generally speaking, the late season tests (October 1997 and November 1998) indicate significantly reduced LTE for the FRP composite dowels, although the LTE measurements in the summer do not indicate any significant differences within the test sections, probably because of the increased aggregate interlock brought about by the closing of the joints due to the warmer temperatures (Crovetti 1999; Smith 2002b). The use of impact echo testing to determine dowel bar locations on WI 2 was inconclusive for the solid stainless steel dowels and the Type 304L stainless steel tubes filled with cement grout.

- Average outer wheel path transverse joint load transfer provided by standard placements with FRP composite (CP, GF, RJD) and hollow-filled stainless steel (HF) dowels is markedly reduced as compared to conventional epoxy coated steel dowels (C1, C2). The overall average joint load transfer for the FRP, HF and epoxy coated steel dowels was 69 percent, 78 percent, and 88 percent, respectively.
- Average wheel path transverse joint load transfer provided by alternate placements with stainless steel (3S, 4S) is slightly lower than comparable placements with conventional epoxy coated steel dowels (3Ea, 3Eb, 4E). Mean test section values for the stainless steel and conventional epoxy-coated steel dowels ranged from 73 to 77 percent and from 76 to 79 percent, respectively.

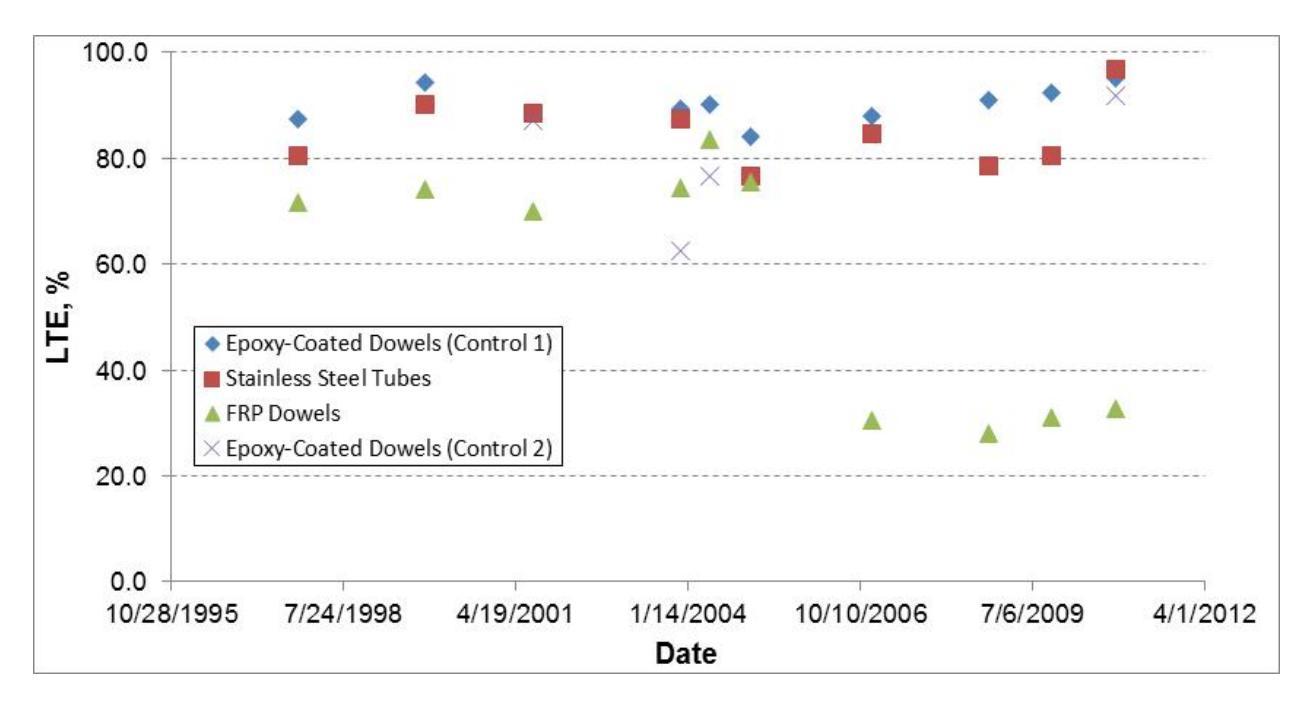
Figure 6a. Summary of historical load transfer efficiency data for OH 2 EB (approach joint).

The summary data provided in Table 3 are presented graphically in Figures 6a and 6b. These figures clearly show that the polyester resin FRP dowels evaluated in the OH 2 project exhibit far lower LTE values than their counterparts. The three types of polyester resin FRP dowels (two types furnished by RJD Industries and one type furnished by CEF, Inc.) all have LTE values averaging less than 40 percent since 2006. The most recent data indicate that LTE values obtained on 10/30/09 averaged 31.3 percent on the approach joint and 28.5 percent on the leave joint, whereas the LTE values measured on 11/03/10 averaged 33.1 percent on the approach joint and 39.9 percent on the leave joint. In general, a deflection-based LTE of 70 percent or less represents less than 50 percent stress load transfer and it is considered a critical threshold level.

The poor performance of the polyester resin FRP dowels might be related to its increased moisture adsorption capacity, as noted previously. In addition, there are other factors that may also be contributing to the performance of these sections, including the poor stability of the unstabilized New Jersey permeable base and the poor quality of the concrete (cores revealed some deterioration at the depth of the dowel bar).

Even though the sections with FRP bars are not performing well (as evidenced by the extremely low LTEs), the sections with the other two dowel bar types are still exhibiting satisfactory LTEs after nearly 14 years of service. The Type 304 stainless steel tubes (mortar filled) average 78.6 percent on the approach joint and 87.9 percent on the leave joint in 2008. Similarly, the epoxy-coated mild steel dowels used as a control averaged 91.3 percent on the approach joint and 90.7 percent on the leave joint. The 1.5-in (38-mm) FRP polyester resin dowels appear to be much more susceptible to poor support (concrete quality and/or base/subbase/subgrade) than the conventional and alternative steel dowels. This suggests that for poor support conditions, vinyl ester resin FRP dowels of diameter greater than 1.5-in (38-mm) will be required. The percentage and type of glass fibers is also a critical design variable in addition to the resin type.

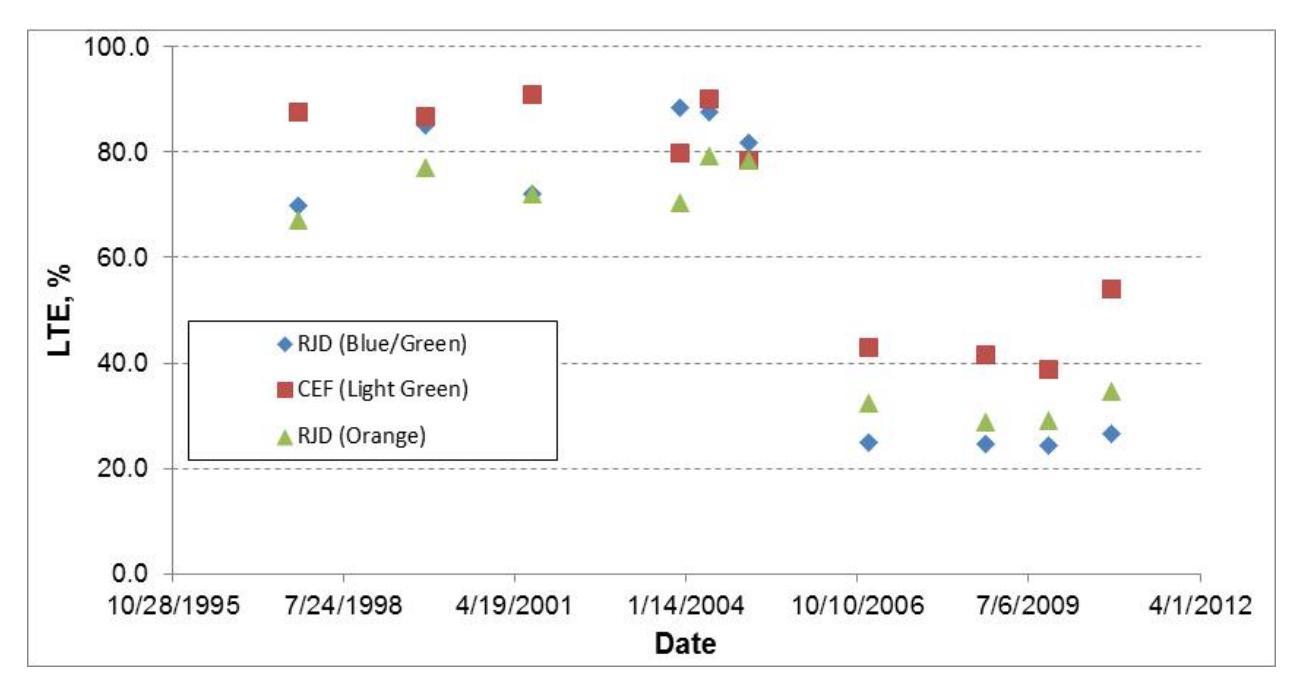
Figure 7. Average LTE (approach and leave) for FRP bars on OH 2.

The three different types of polyester resin FRP bars used on this project (two manufactured by RJD Industries and one by CEF, Inc.) exhibited similar LTE trends over the 16-year monitoring period (see Figure 7). All FRP dowels maintained relatively good levels of LTE until 2006, at which time the LTE values dropped off considerably. The CEF bars are exhibiting slightly higher LTE values than the RJD varieties.

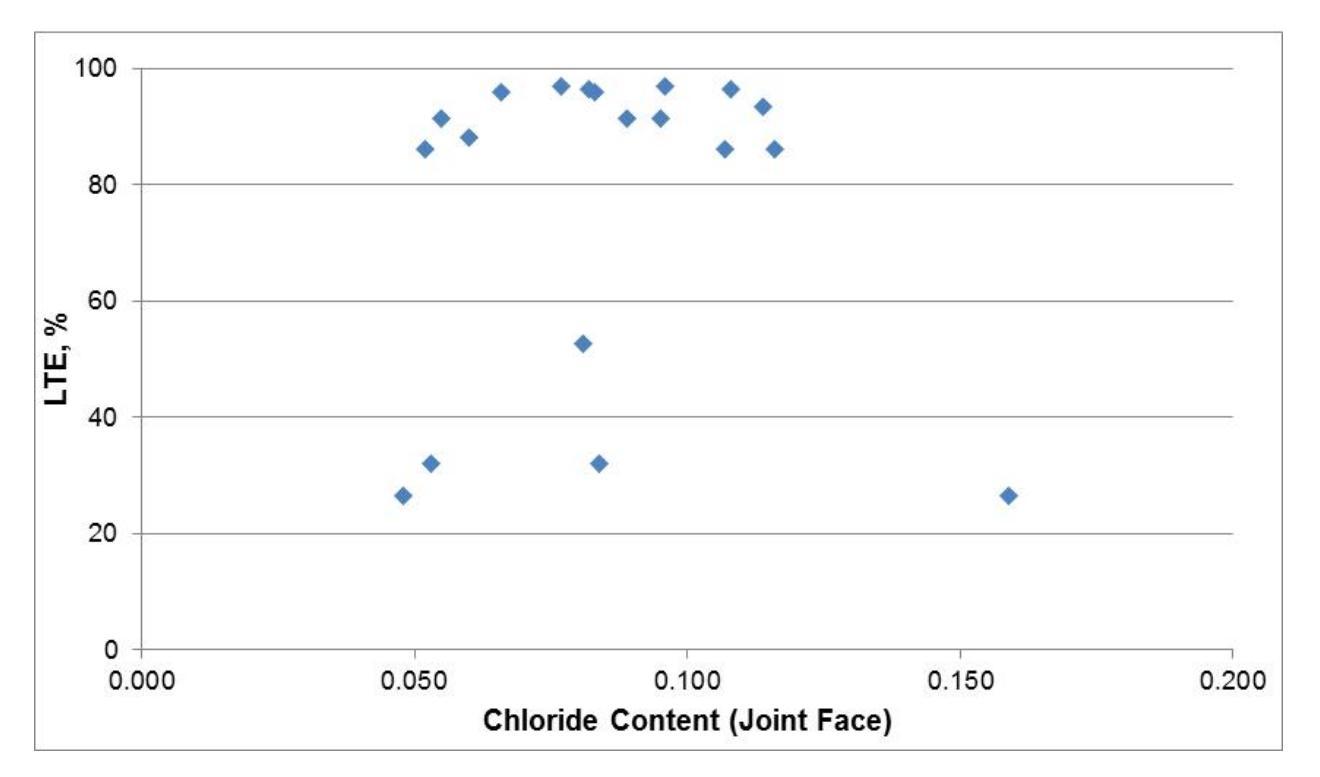
Figure 8. Chloride content (joint face) vs. LTE for OH 2 (ATH-50).

As described in Chapter 4, chloride content testing was performed to determine the level of chlorides at the depth of the dowels, to see if it might have any bearing on the condition or performance of the dowel bars. Testing was performed at the joint face and at the outside edge of the retrieved core. This information is also presented in Table C-1 in Appendix C, but a cursory examination of the chloride contents with the dowel deterioration does not provide any discernable trends. The chloride contents were also plotted against the measured LTE values (see Figures 8 and 9), but there is considerable scatter in the data.

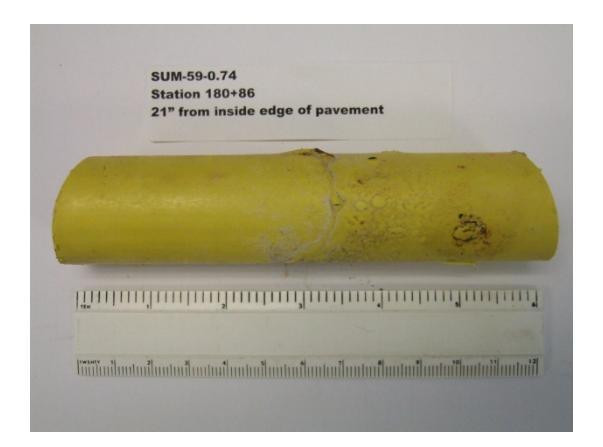
A photo of the dowel coating from a typical core (see Figures 11 and 12) and two photos of the excellent condition of the surface of the pavements (see Figures 13 and 14) demonstrate the outstanding performance of the plastic-coated dowels. Over their 33-year service lives, the pavements on Route 81 in Allen County had sustained nearly 10 million ESAL applications whereas the pavements on Route 59 in Summit County had sustained approximately 6 million ESAL applications.

Figure 12. Photo of plastic-coating of dowel on State Route 59 after 33 years of service.

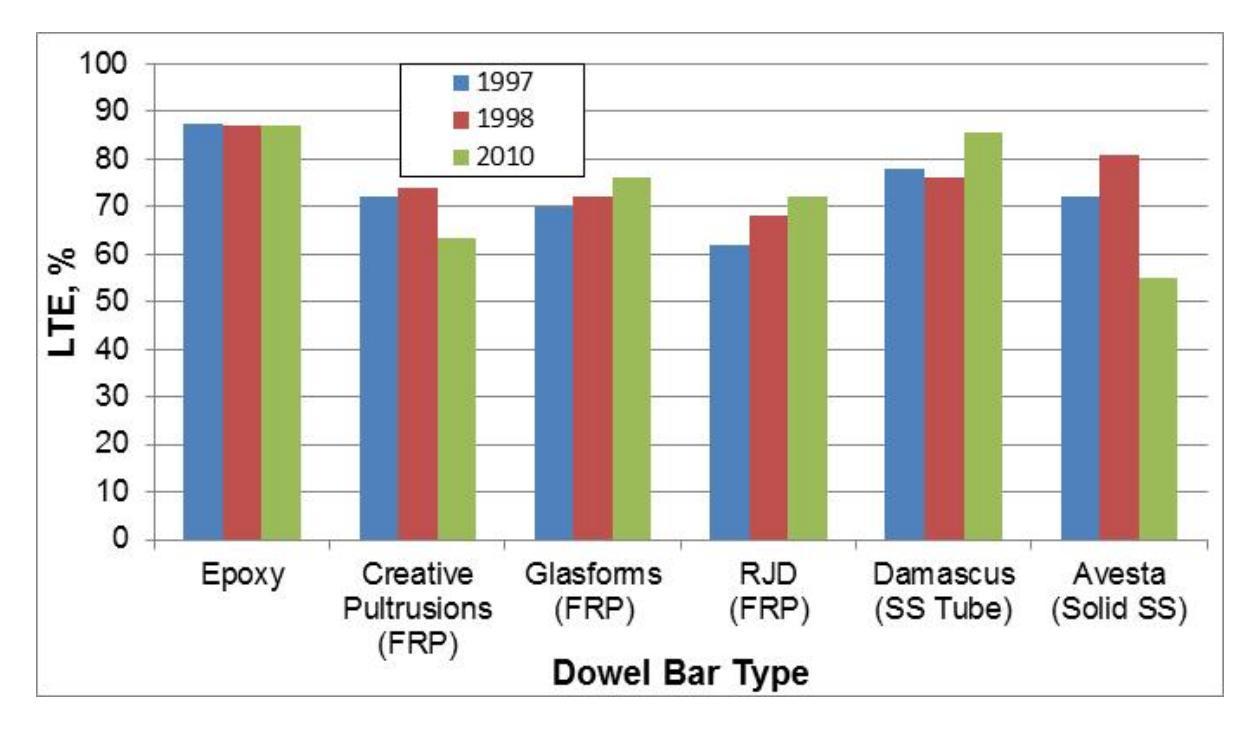
Figure 15. Summary of aggregated, historical LTE values for WI 2.

Figure 15 presents a summary of the available LTE data by dowel bar type (2010 data). This figure shows that the epoxy-coated dowel bars have maintained nearly constant LTE values over the nearly 13-year evaluation period, while the FRP bars (Creative Pultrusions, Glasforms, and RJD) are somewhat lower. The sections containing stainless steel tubes still show acceptable LTE values, but the most recent data for the sections with solid stainless steel bars are very low (just over 50 percent). However, it should be noted that the solid stainless steel dowels on this project were placed in two alternative configurations (one with three dowels per wheelpath and one with four dowels per wheelpath), which likely explains the differences.

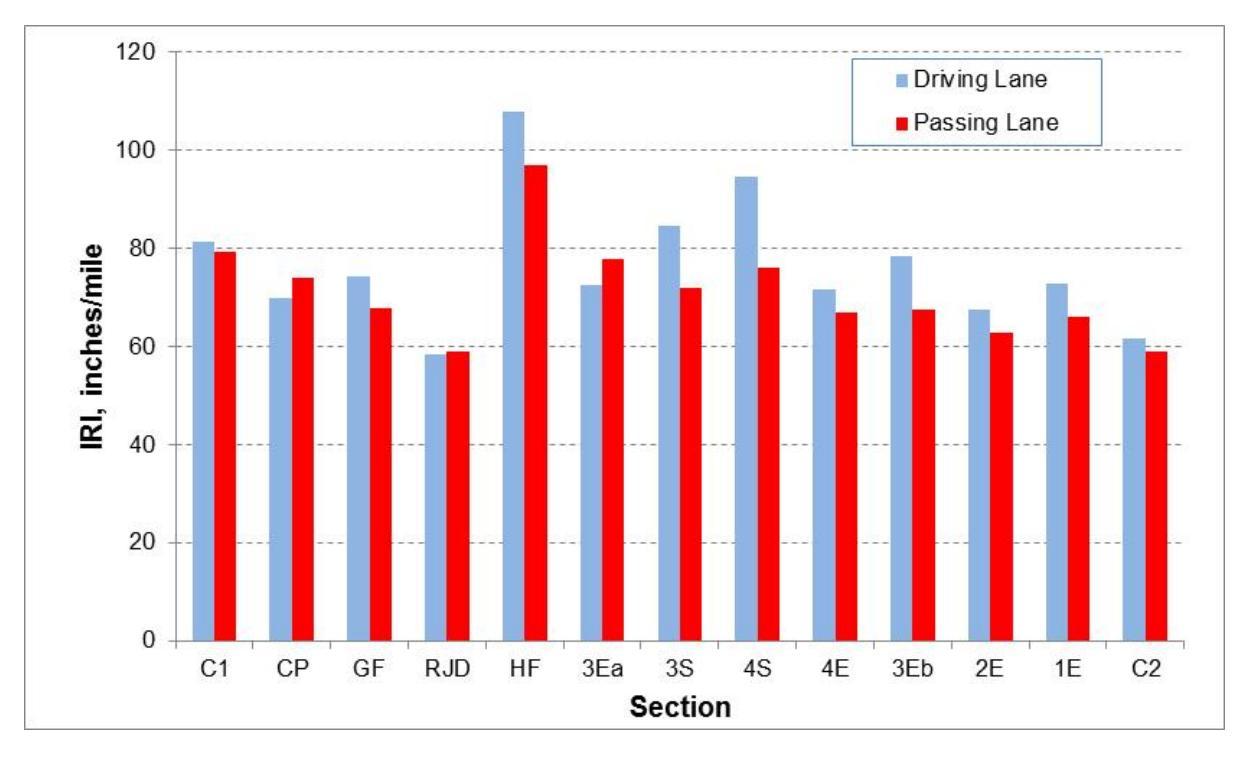
Figure 16. 2010 roughness values for WI 2 sections by lane.

Roughness and faulting measurements were collected on the WI 2 sections in 2010. Figure 16 presents the average IRI values for each section by traffic lane. This figure shows that all sections are providing reasonable levels of rideability, with one of the FRP sections providing the lowest roughness based on 2011 measurements. The highest roughness is exhibited by the section with stainless steel tubes. A historical summary of the IRI values by section is provided in Figure 17 for the 13-year monitoring period. The sections shown in Figures 16 and 17 are designated as follows:

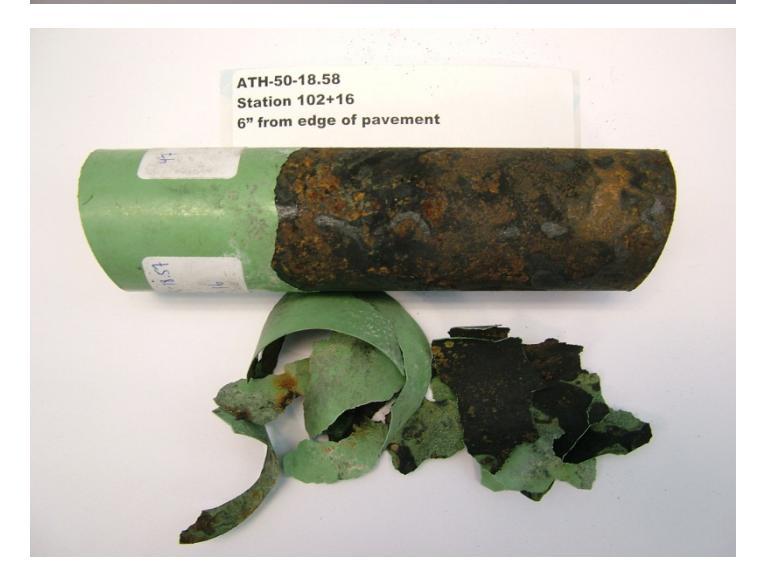
Table A-1 (Appendix A) shows that the LTE values for the conventional epoxy-coated dowel bars have all averaged more than 84 percent from 1997-2010, with most over 90 percent. These data are presented graphically in Figures 6a and 6b. However, cores of the epoxy-coated dowel bars revealed that, in most cases, the epoxy coating could be easily removed, exposing an area of rusted steel; however, at this time (after approximately 14 years of service), there was no significant loss of dowel cross section.

Figure C-2. Epoxy-coated dowels from OH 2 (ATH-50).

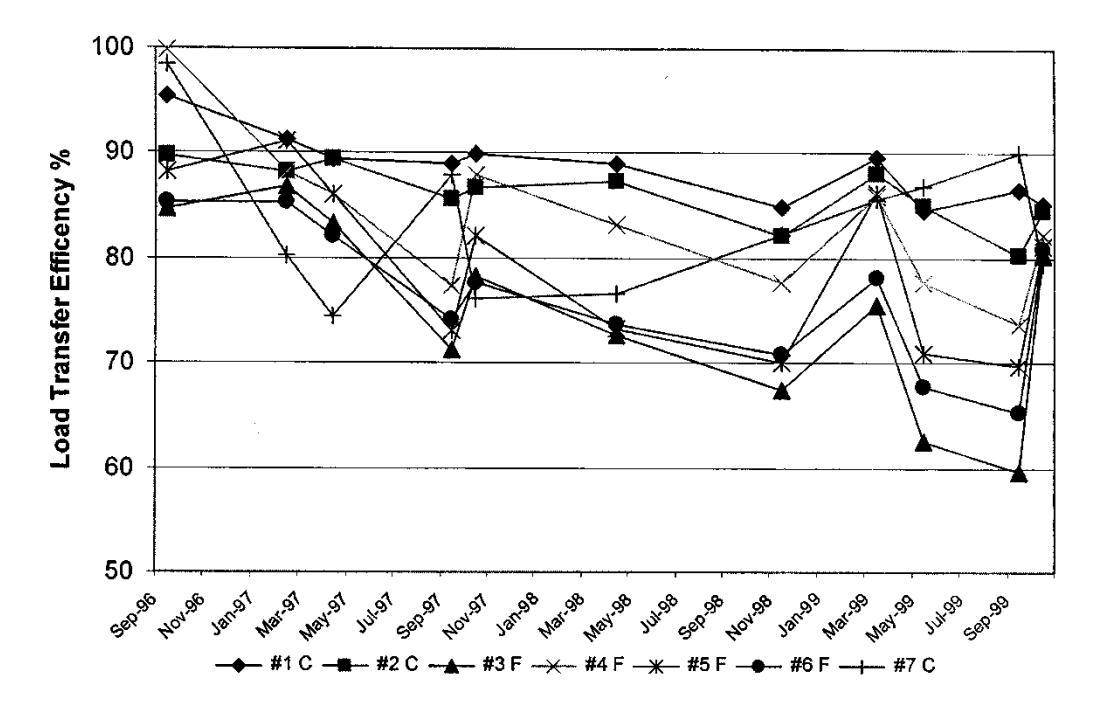
Figure 5. Load transfer efficiency on IL 1 (Gawedzinski 2000).

A gradual decrease in overall load transfer efficiency is observed in figure 5, with the conventional steel dowel bars consistently showing higher levels of load transfer then the fiber composite bars. But, as seen in figure 6, the largest deflection is consistently shown by one of the conventional doweled joints, although the other two conventional doweled joints show consistently low deflections. However, for both load transfer types, the load transfer efficiency is still relatively high and the magnitude of the joint deflections relatively low.

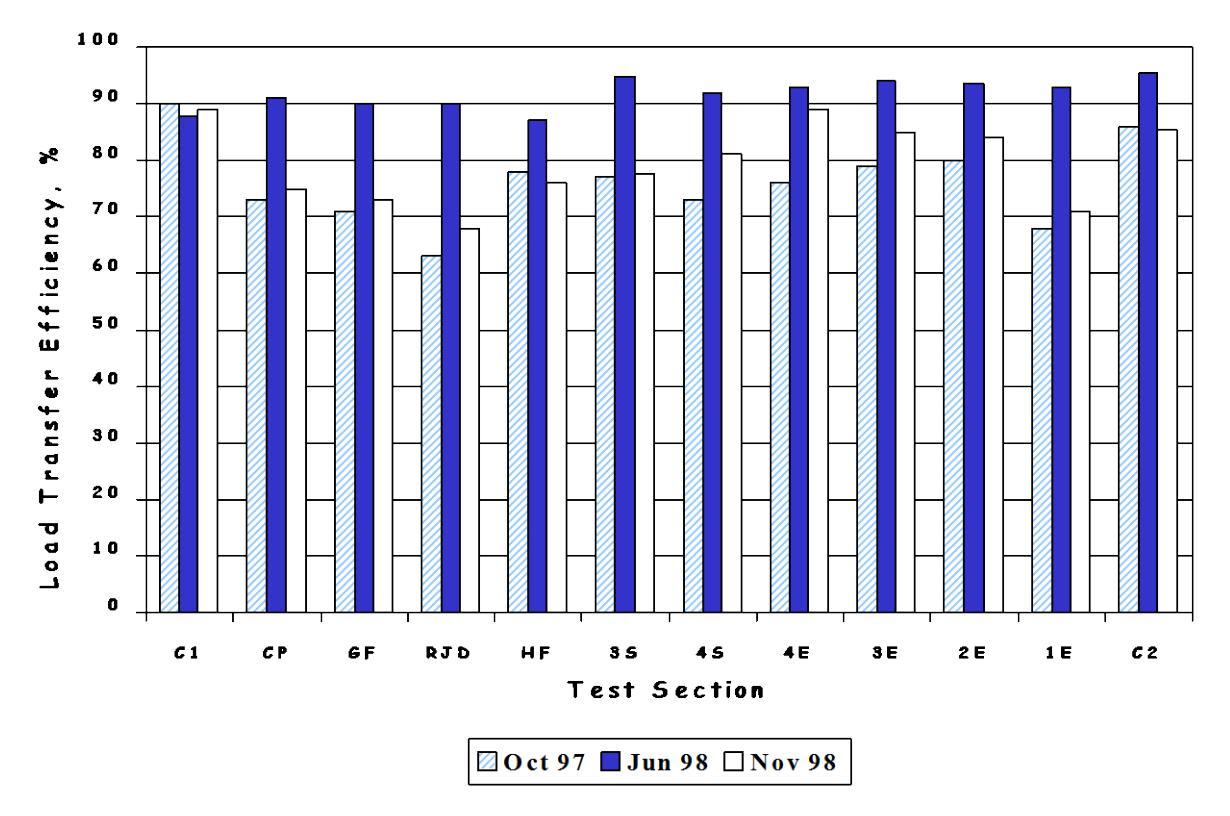
Figure 65. Transverse joint load transfer for outermost wheelpath on WI 2 (Crovetti 1999).

Transverse joint load transfer efficiencies were also measured on all test sections using the FWD. Figure 65 illustrates the average transverse joint load transfer for the outermost wheelpath of the WI 2 project, while figure 66 illustrates the average transverse joint load transfer for the outermost wheelpath of the WI 3 project (Crovetti 1999). For WI 2, the late season tests (October 1997 and November 1998) indicate significantly reduced LTE in the composite doweled sections and in dowel layout 1 as compared to the control sections (Crovetti 1999). However, LTE measured in the summer do not indicate any significant differences within the test sections, probably because of the increased aggregate interlock brought about by the closing of the joints due to the warmer temperatures (Crovetti 1999).

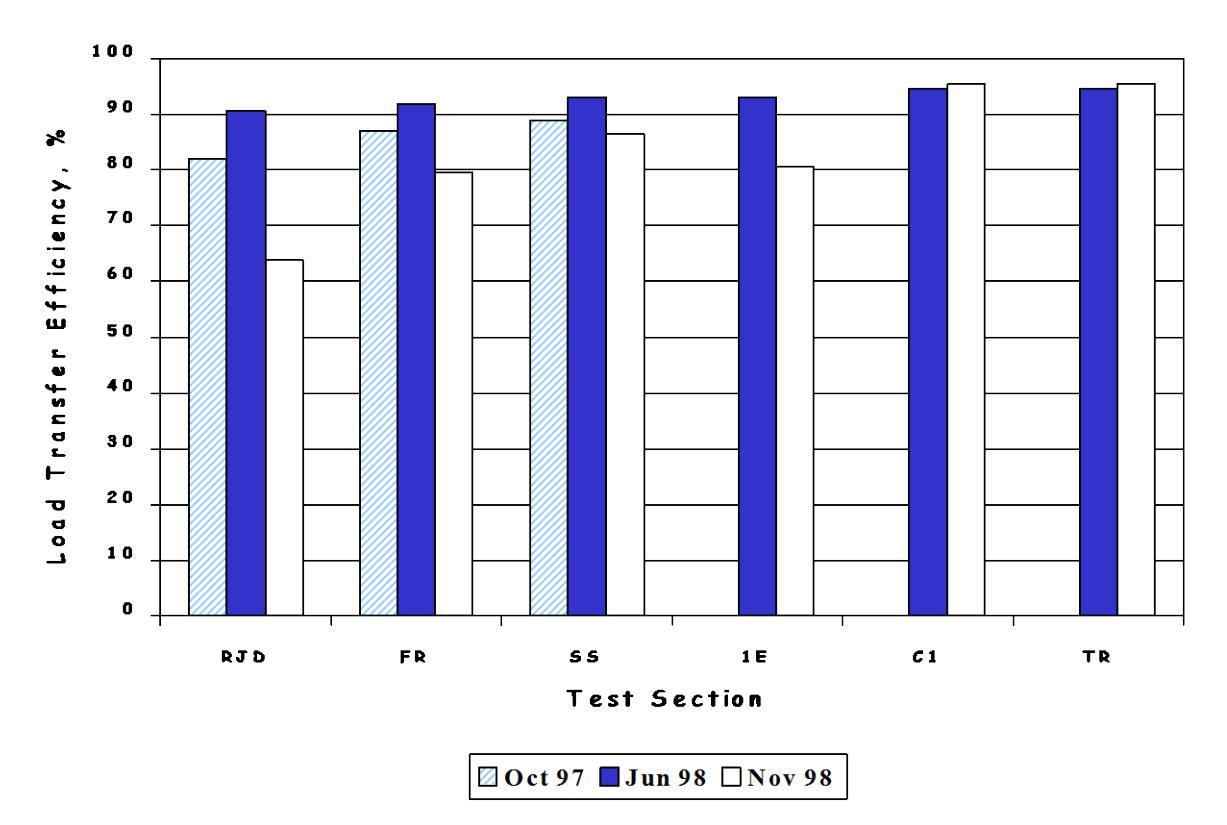
Figure 66. Transverse joint load transfer for outermost wheelpath on WI 3 (Crovetti 1999).

For WI 3, figure 66 shows that the FRP composite dowel sections and dowel layout 1 experience a reduction in LTE in the November 1998 test results; there is also a slight reduction in the LTE of the stainless steel section (Crovetti 1999). However, LTE measured in June 1998 do not indicate any significant differences between the test sections.

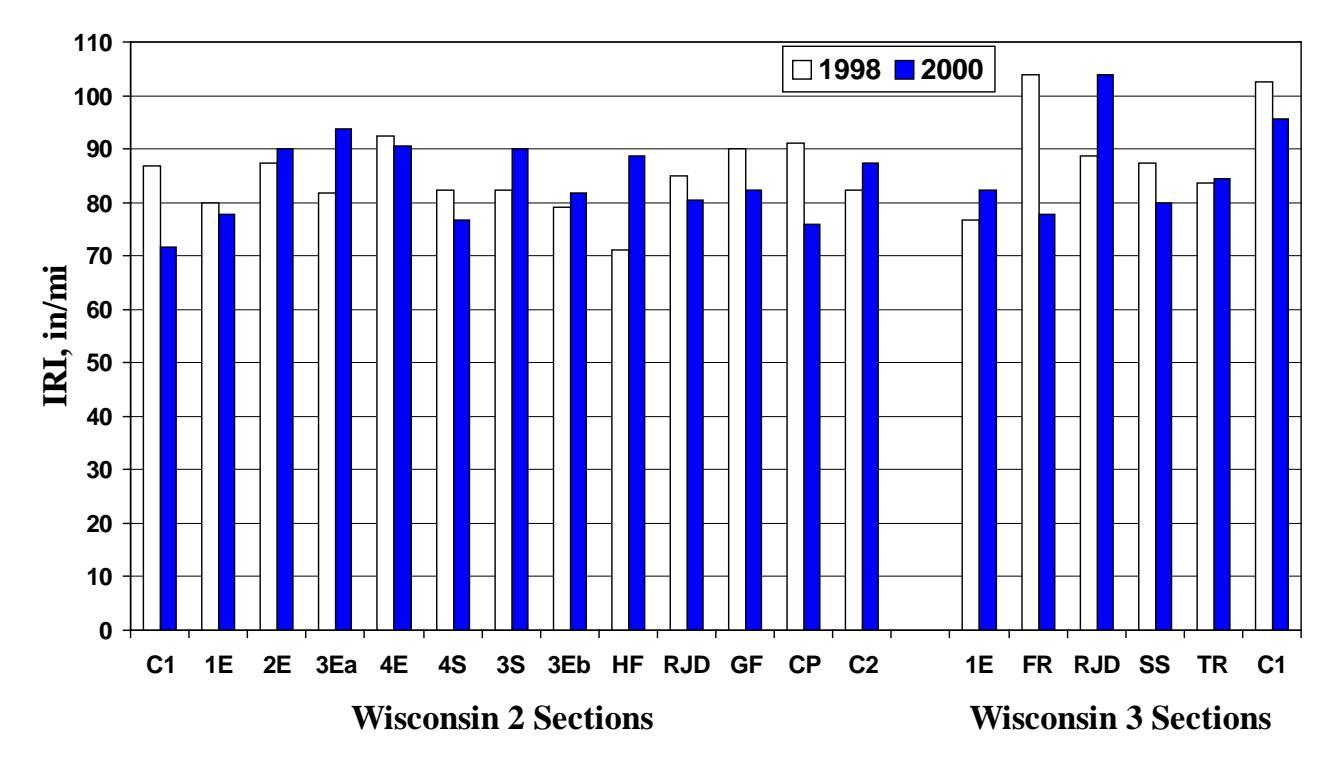
Figure 67. Average IRI values in the outer traffic lanes of WI 2 and WI 3 pavement sections (Crovetti and Bischoff 2001).

Figure 67 presents the average international roughness index (IRI) measurements in the outer lane of the WI 2 and WI 3 pavement sections (Crovetti and Bischoff 2001). These measurements were recorded in the summer of 1998 and the winter of 2000. Although there is some variability in the data, most of the test sections are performing comparably to the control sections (Crovetti and Bischoff 2001).

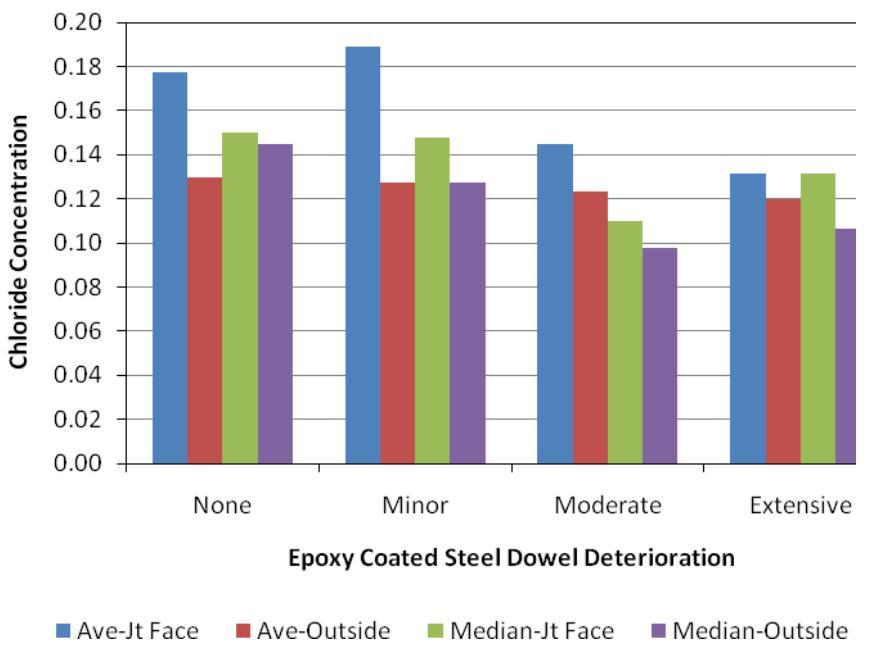
Figure 1: Chloride Concentration vs Dowel Deteioration

The aggregate results of the chloride content tests were compared against levels of dowel bar deterioration as noted for the epoxy coated steel dowels. Figure 1 provides a bar chart of the overall average and median results comparing dowel deterioration to chloride concentration levels. As shown, the overall average and median chloride concentrations are higher for the joint face samples than for the outside core samples for all test bins. However, there is no direct correlation between dowel deterioration and chloride concentrations; in fact overall average and median chloride concentrations are greatest for samples with none to minor dowel deterioration.

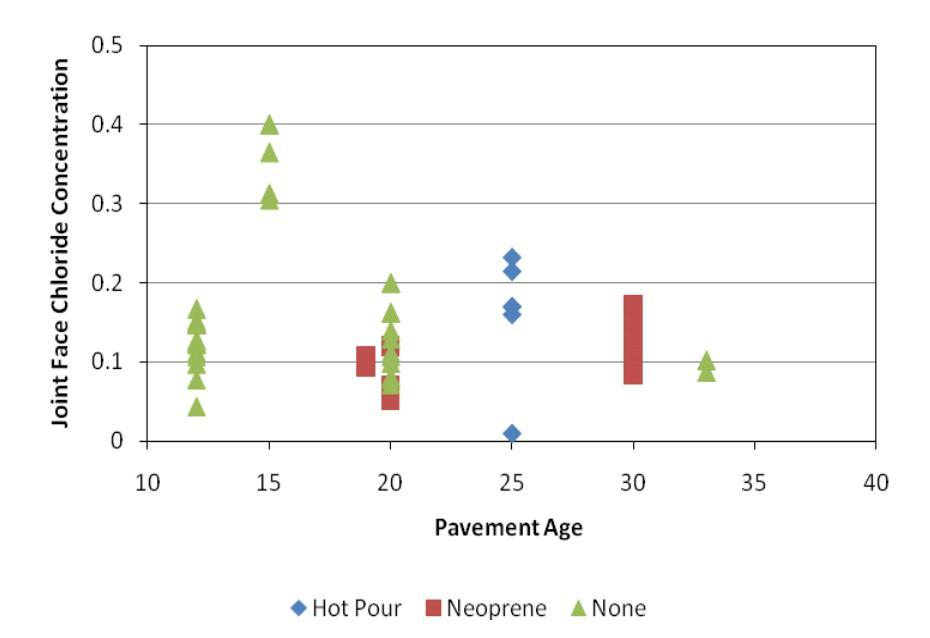
Figure 2: Joint Face Chloride Concentration vs Pavement Age

The effect of joint sealant and pavement age on chloride concentration levels is presented in Figures 2 and 3, with each data point representing and individual core sample test result. As shown, there appears to be little correlation between chloride concentration levels and pavement age for the unsealed joints. For those joints with neoprene sealants, chloride concentrations levels are generally lower than comparable measures for unsealed joints and these levels also increase with pavement age.

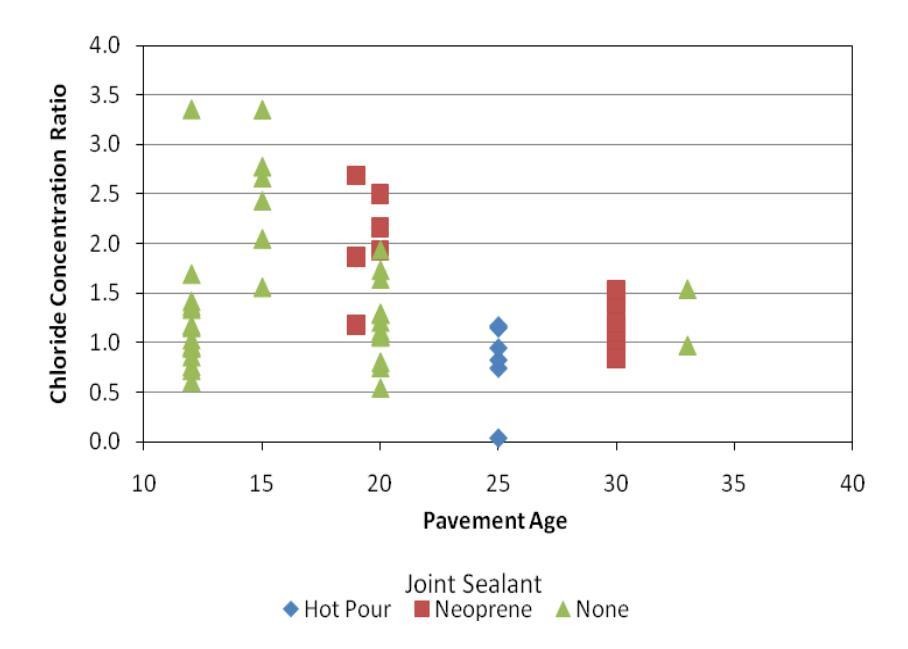
Figure 4: Chloride Concentration Ratio vs Pavement Age

As shown, the concentration levels generally decrease with age, confirming the expected trend that the chloride ions penetrate further into the concrete over time.
