# Precast Concrete Elements for Accelerated Bridge Construction

## Volume 2. Laboratory Testing, Field Testing, and Evaluation of a Precast Concrete Bridge: Madison County Bridge

**Final Report**  
**January 2009**

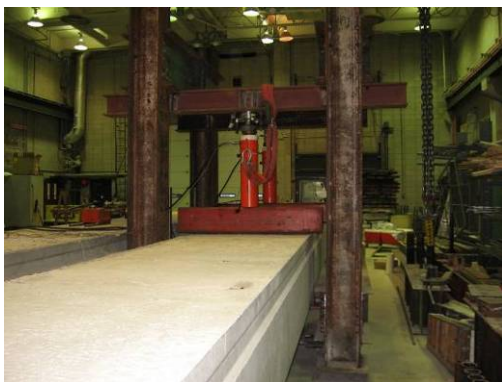
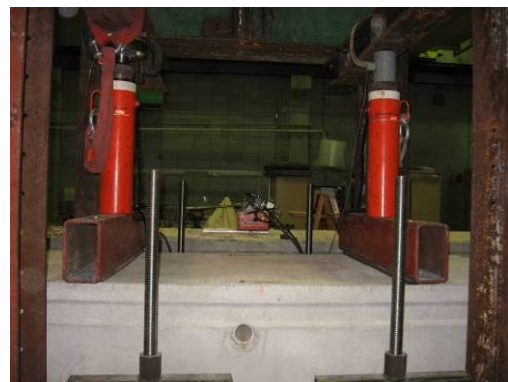
**Figure 3.7. Laboratory setup to test flexural strength of a box girder**

The goal of this testing was to experimentally determine the flexural strength of a single box girder. In order to test the box girder in a moment only condition, two line loads were applied equidistant from the supports. By doing this, a region of constant moment and zero shear was developed between the applied loads. Loads were positioned 20 ft-9.5 in. from the supports and

4 ft-9.5 in. apart. An HSS10x6x1/4 served as the footprint for the line load. The setup and spacing of loads for the flexural strength test is shown in Figure 3.7.

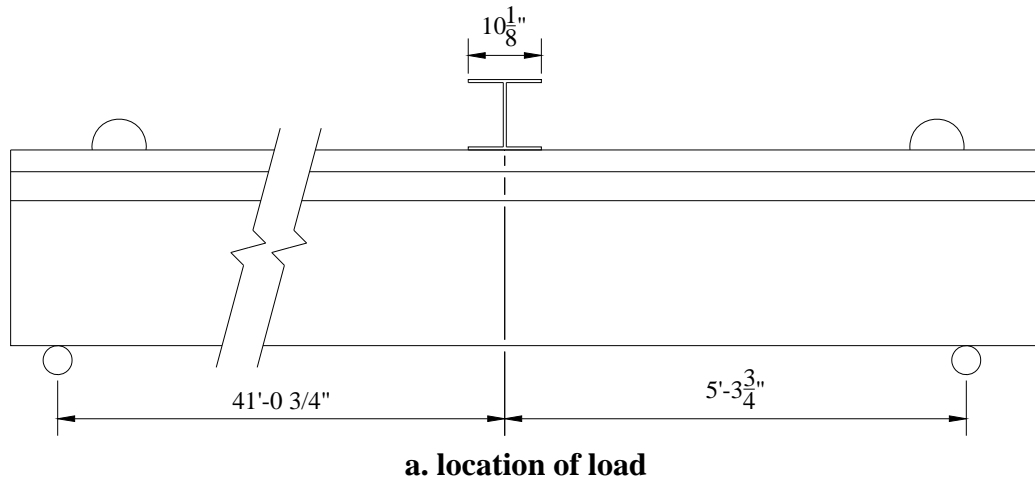
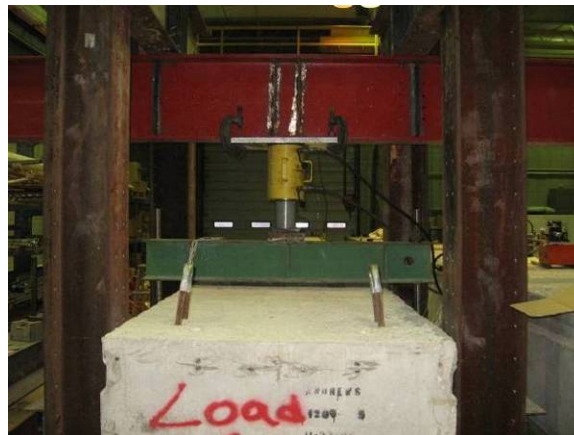
**Figure 3.9. Shear strength test setup**

The goal of this test was to experimentally determine the shear strength of a single box girder. The same girder that was tested in flexure was used for the shear test. For this testing an

HP10x42 beam was used to apply a line load to the girder a distance of 5 ft-3.75 in. from the support. Figure 3.9 shows the load location and general setup for the test.

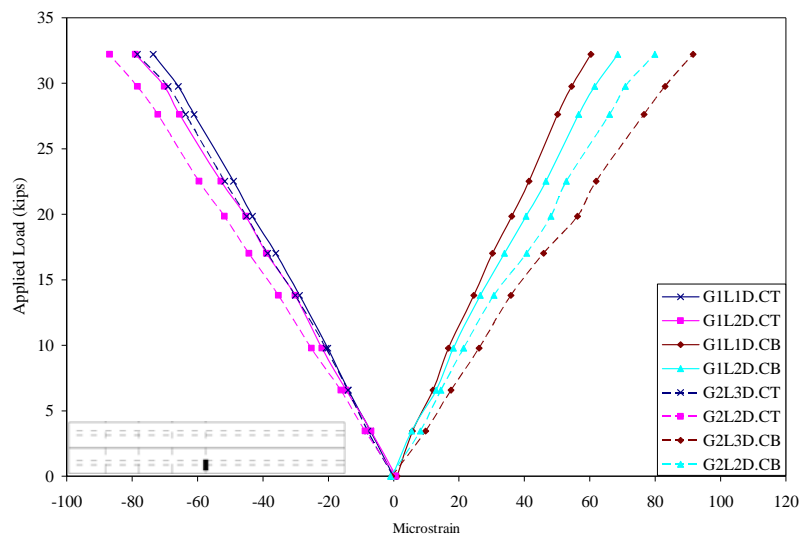
**Figure 4.1. Total strain at midspan with load at D1 and a post-tensioning force of 17 kips**

Figure 4.1 presents the strains at midspan for the case of a load applied at location D1 (see Figure 3.4) and a post-tensioning force of 17 kips. The 17 kip results are representative of the results for any post-tensioning force, as the strain did not vary significantly with the post-tensioning force. Loading along line “D” resulted in the highest magnitude strains.

From Figure 4.1, one can see the induced strains were small in magnitude. Cracking did not occur during this test (or any of the variable post-tensioning tests). Strains along line 2 were similar in magnitude from girder 1 to girder 2, which shows the load is being transferred between the girders.

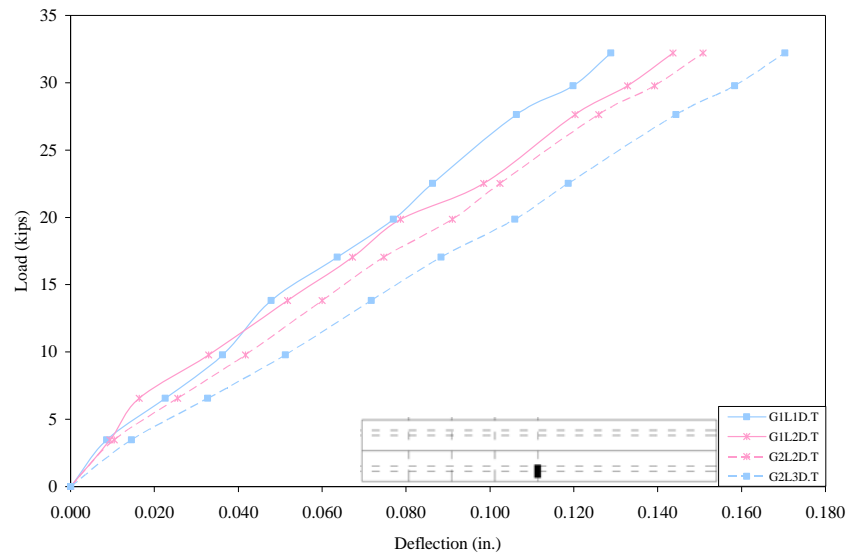
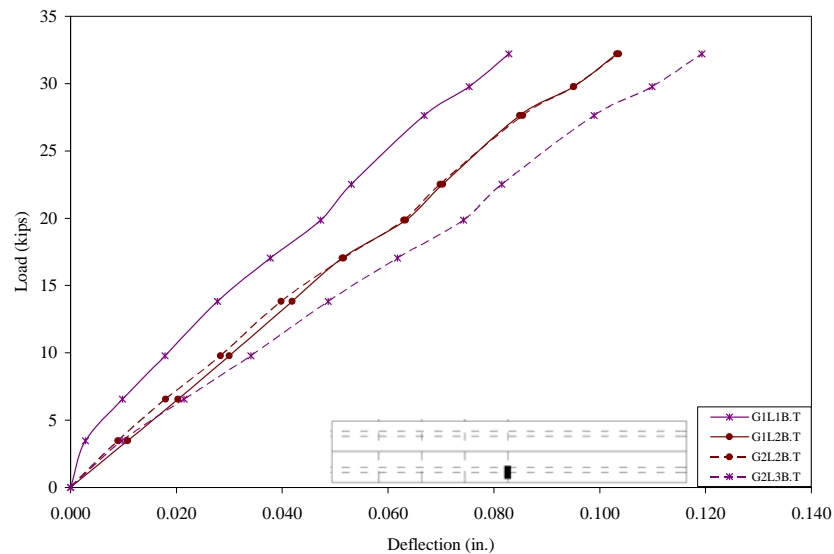
**Figure 4.2. Deflection results at point D1 with a 17 kip post-tensioning force**

Measured deflections for a load at D1 and post-tensioning force of 17 kips are shown in Figure 4.2. As with the strain results, results for this location are typical of all combinations of load along line “D”.

Figure 4.2 shows deflections were largest directly below and in the vicinity of the load. Deflections also generally increase linearly with increasing load. Transducers along line 2, which were located on either side of the shear key, recorded similar deflections for each box girder. This would indicate that there is minimal differential movement between the girders at the shear key.

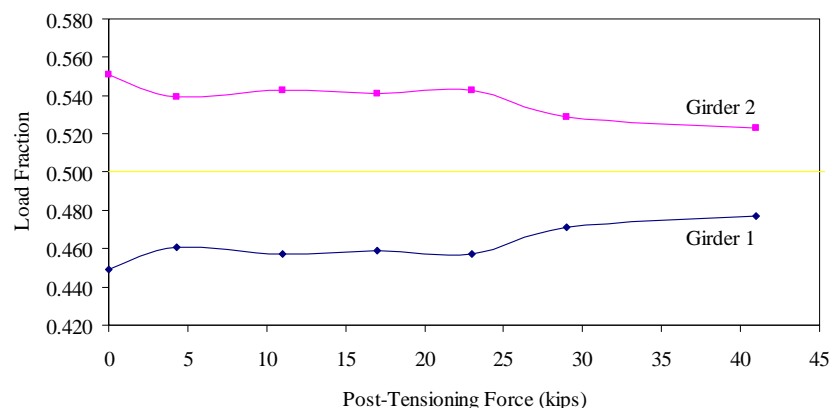
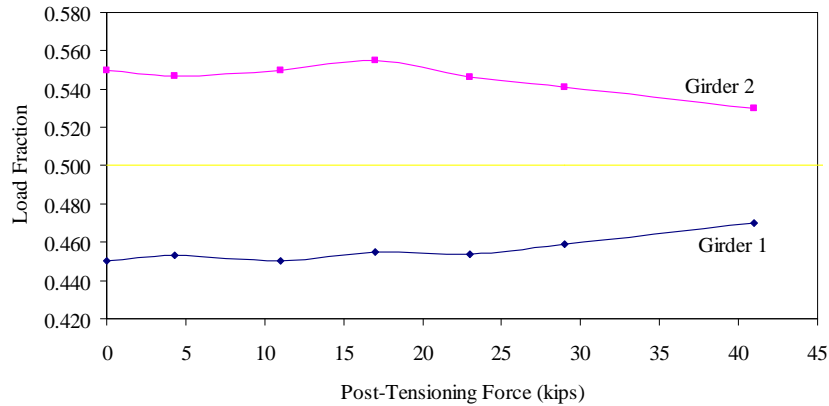
**Figure 4.3. Load fractions at midspan for various post-tensioning forces and load at D1**

**Figure 4.4. Load fractions at quarterspan for various post-tensioning forces and load at D1**

Comparing Figure 4.3 and Figure 4.4 one can see that the load is being transferred equally along the entire length of the box girders. Also shown is that a low post-tensioning force did not negatively impact the load fraction. Once the post-tensioning force reached 25 kips, the load transferred between girders increased. However, testing showed the difference in the load fractions for each girder with zero post-tensioning force and with a 41.3 kip post-tensioning force was approximately 2%, which is likely insignificant.

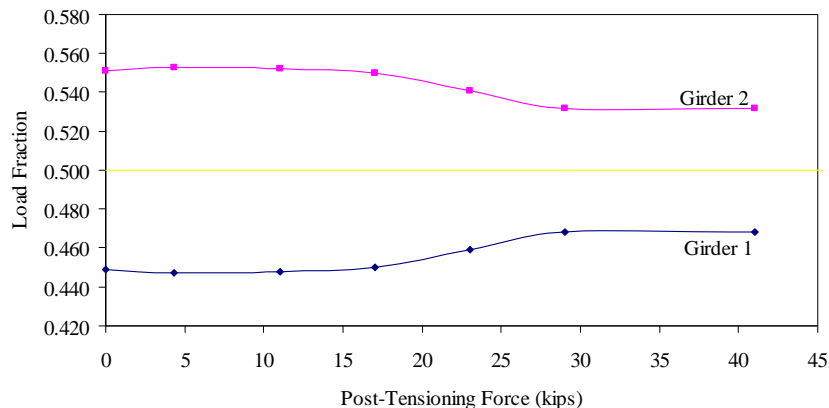
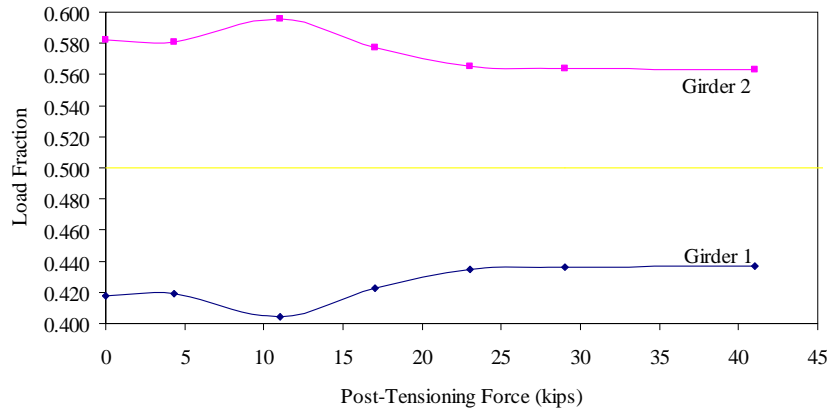
For comparison with Figure 4.3 and Figure 4.4, Figure 4.5 and Figure 4.6 show plots of the load fraction for a load at B1 (as opposed to at D1 in Figure 4.3 and Figure 4.4) for the deflection at midspan and quarterspan, respectively. A comparison of the figures shows load is transferred better at midspan than at quarterspan, because the midspan load fractions are closer to 0.50. This is as one would expect because the post-tensioning force was located at midspan.

**Figure 4.5. Load fractions at midspan for various post-tensioning forces and load at B1**

**Figure 4.6. Load fractions at quarterspan for various post-tensioning forces and load at B1**

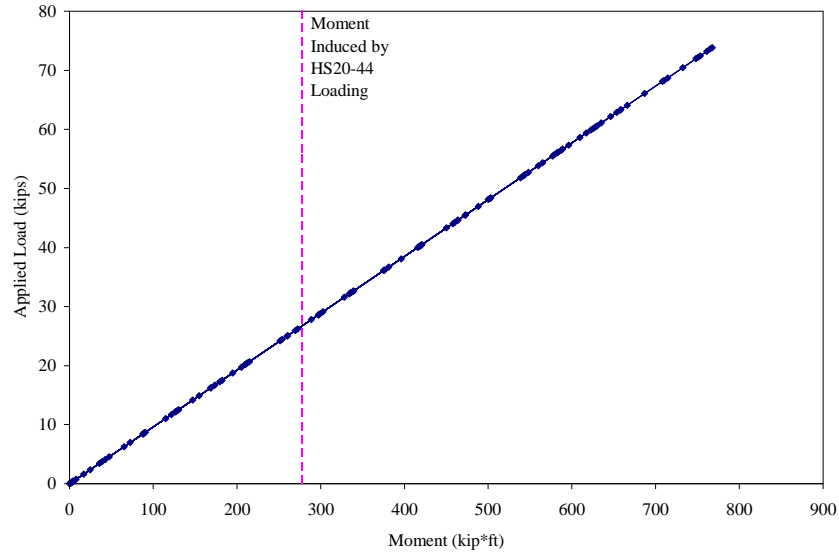
**Figure 4.8. Moment at midspan of the box girder**

The moment at midspan due to the applied loading is plotted in Figure 4.8. Also plotted is the moment induced by the design HS20-44 loading. HS20-44 loading with half the load acting on the box girder and a 14 ft wheel spacing will develop a maximum moment equal to 278 kip\*ft. The midspan moment exceeded the HS20-44 moment at a load equal to 26.7 kips.

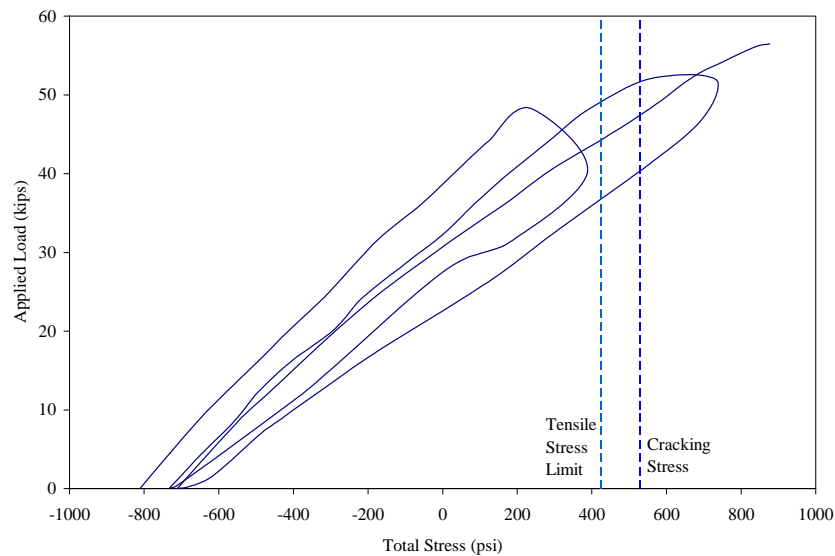
**Figure 4.9. Tensile stress at midspan of the box girder**

A plot of the total stress at midspan versus the applied load is shown in Figure 4.9. These stresses are the total stress in the bottom fiber of the box girder due to the applied load, prestressing force, and self weight. When loading began, the fibers were estimated to be under an 800 psi compressive stress. This was an approximate value calculated using a concrete compressive strength of 11 ksi and a modulus of elasticity determined from an empirical relationship (Nawy, 2003). Assumptions regarding prestress losses had to be made to determine the stresses due to prestressing. Losses due to elastic shortening, creep, concrete shrinkage, and relaxation were assumed to equal 29.6 ksi.

Stresses first became tensile at a load of approximately 38 kips, which exceeds the 26.7 kip applied load that develops a moment equivalent to that of the design truck. During the subsequent load cycles, the bottom fibers experienced tension at lower loads. This resulted from residual stresses in the girder due to nonlinear behavior.

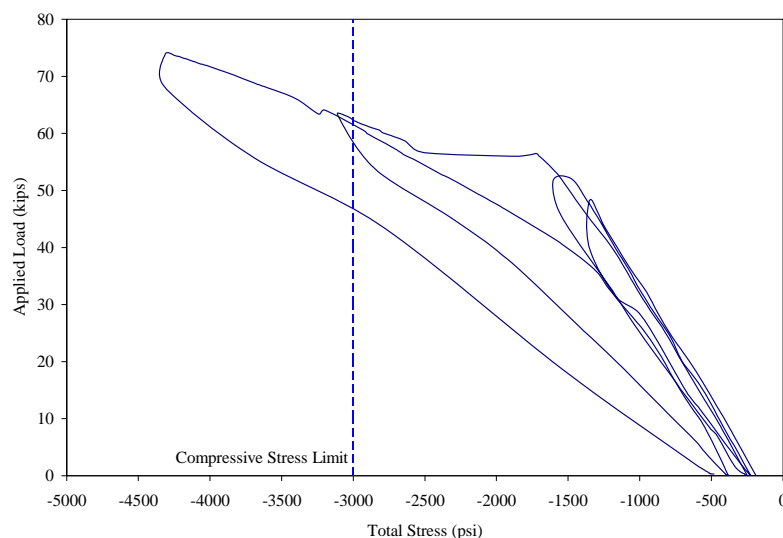
**Figure 4.10. Total compressive stress at midspan of the box girder**

Figure 4.10 shows the total compressive stress at midspan versus the applied load. The total compressive stress is due to the applied load, self weight, and prestressing force. Stresses were calculated by assuming prestress losses related to elastic shortening, creep, concrete shrinkage, and relaxation equal to 29.6 ksi and the using an empirical relationship to calculate the modulus of elasticity. Compressive stresses were a maximum in the top fibers at midspan. AASHTO specifies a maximum compressive stress equal to 3,000 psi for the service limit state and a concrete compressive strength of 5,000 psi. The service level compressive stress was first exceeded at an applied load of 62 kips and at lower loads during subsequent load cycles due to nonlinear behavior.

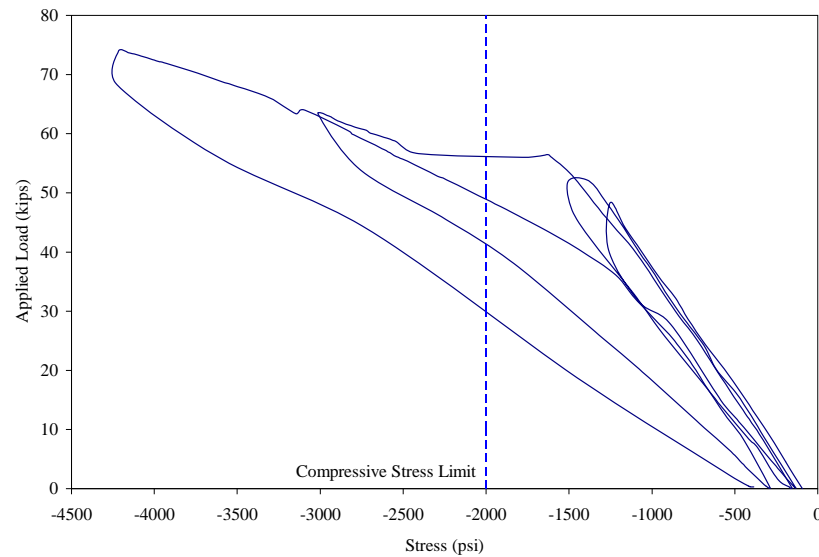
**Figure 4.11. Compressive stress due to applied load and one-half the dead load and prestressing force at midspan of the box girder**

AASHTO also specifies a maximum compressive stress for the service limit state based on the summation of the live load and one-half the sum of the effective prestress and dead load. The allowable stress is 2,000 psi for this limit state for a concrete compressive strength equal to 5,000 psi. Figure 4.11 presents the stresses for this limit state plotted against the applied load. The

service limit state compressive stress is first exceeded at a load equal to 56.5 kips and at lower loads during subsequent load cycles due to nonlinear behavior.

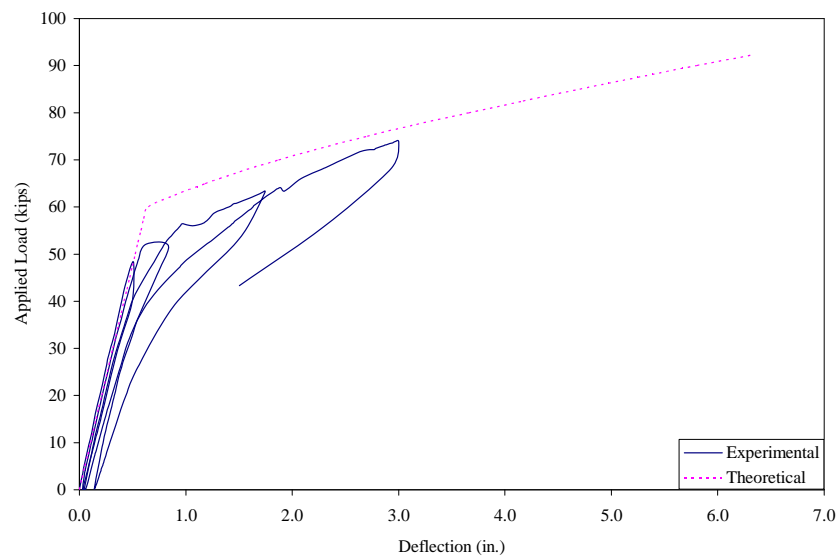
**Figure 4.12. Deflection versus load plot for box girder flexural strength test**

In Figure 4.12 the theoretical deflection at midspan calculated by the research team is compared to the experimental deflection. The experimental results show the box girder had a lower flexural stiffness than the theoretical results predicted for higher loads. When loading ended, the deflection was 3.00 in. Theoretically, the deflection should have been 2.50 in. for the same load.

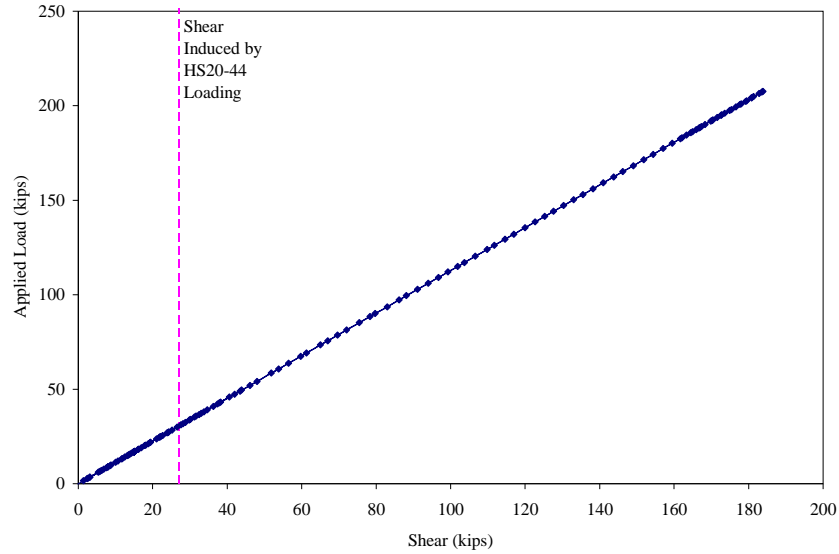
**Figure 4.14. Shear force in the box girder**

A plot of shear force versus the applied load is shown in Figure 4.14. Included in the figure is the maximum shear force induced by an HS20-44 loading. This shear force is equal to 27.0 kips and is reached during testing at a load equal to 30.5 kips.

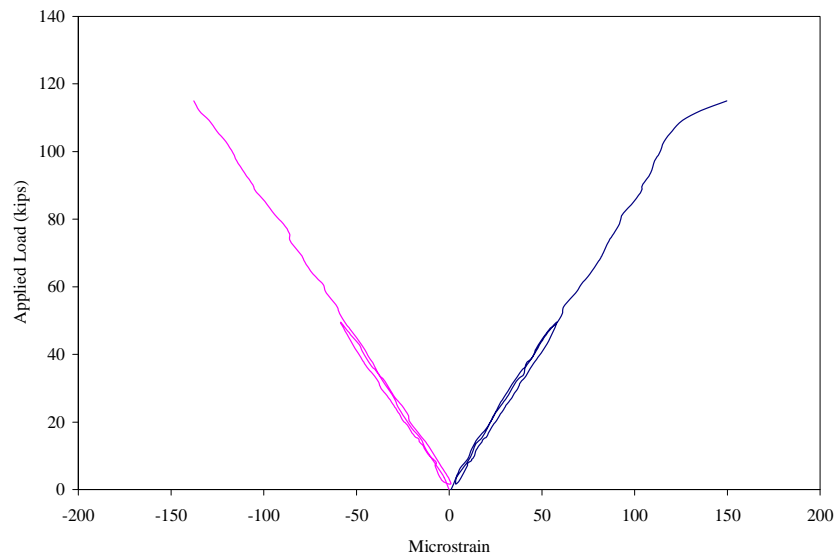
**Figure 4.15. Principle strains due to applied load at rosette 2N during shear strength testing**

The principle strains at rosette 2N due to the applied load are plotted in Figure 4.15. Strains for rosettes at the same height and on opposite webs were the same. As shown in the figure, the tensile and compressive strains were similar for equal loading until just prior to cracking. Prior to cracking the tensile strain increased suddenly, whereas the compressive strain still exhibited linear behavior. The maximum compressive strain was 138 microstrain, and the maximum tensile strain was 150 microstrain.

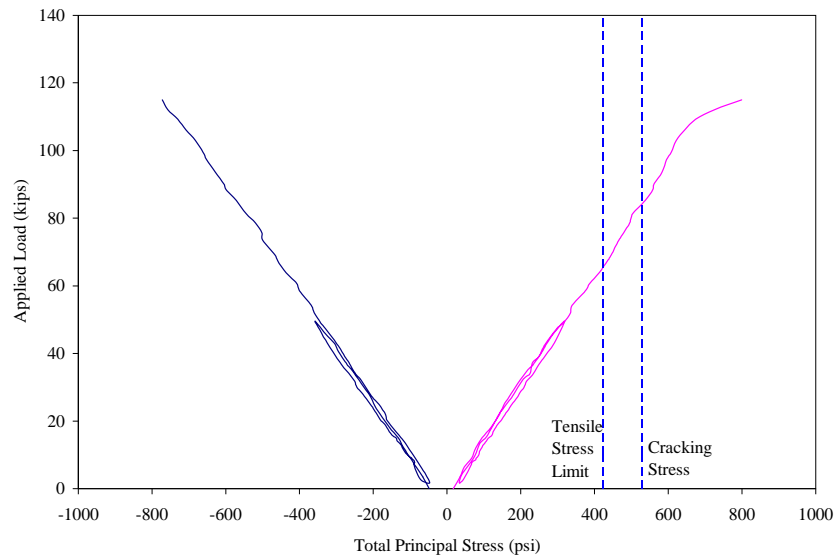
**Figure 4.16. Principal stresses due to the total load at rosette 2N**

Figure 4.16 displays the total principal stress plotted against the applied load for rosette 2N. Stress calculations required assumptions regarding prestress losses related to elastic shortening, creep, concrete shrinkage, and relaxation (the same assumptions used previously were made here). An empirical relationship was used to calculate the modulus of elasticity. At a load of 63.5 kips, the total tensile principal stress exceeded the AASHTO maximum allowable tensile stress for the service limit state, 424 psi. The theoretical cracking stress calculated by the Iowa DOT was 530 psi and was reached at a load of 85 kips. Cracking actually occurred at 115 kips. The difference between when cracking was predicted to occur and when cracking occurred is a

function of the theoretical value using a concrete compressive strength equal to 5,000 psi. Maximum compressive stresses specified by AASHTO for the service limit state were not approached during the shear test.

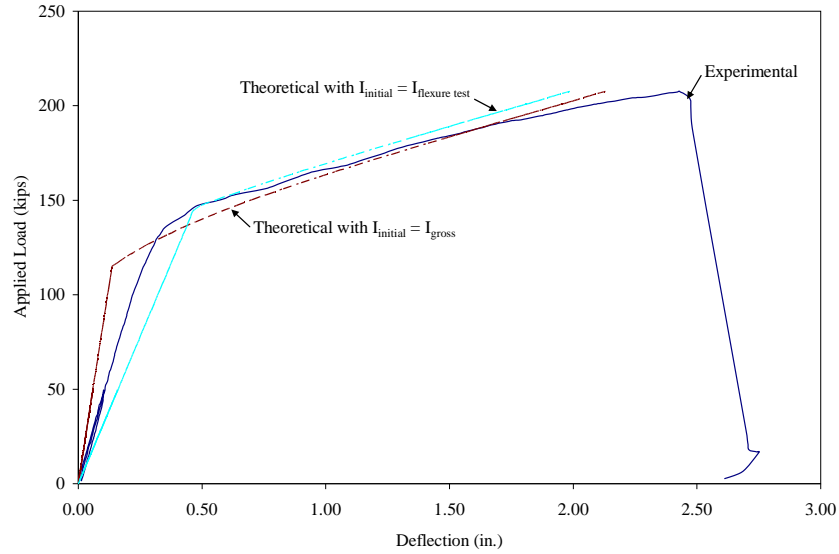
**Figure 4.17. Theoretical and experimental deflections at quarterspan during shear test**

Deflections measured at quarterspan during the shear test are plotted in Figure 4.17. These deflections are plotted along with two plots of theoretical deflections. The theoretical deflections were calculated by the research team. One theoretical deflection uses the gross moment of inertia for the box girder, and the second uses the final effective moment of inertia from the flexural strength test. As can be seen in the figure, the majority of the experimental deflections plot between the two theoretical curves, meaning the moment of inertia lies between the uncracked value and effective value from the flexural test. The deflection prior to failure was 2.48 in., whereas the maximum theoretical deflection was 1.98 in.

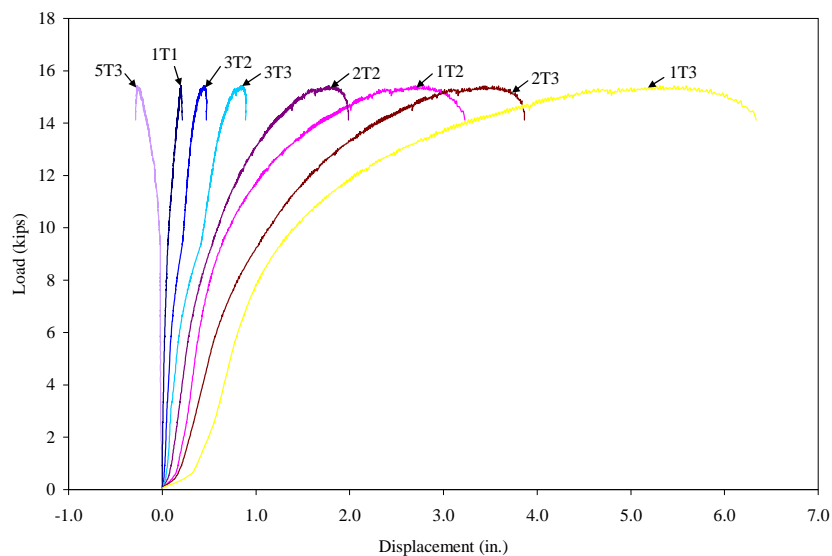
**Figure 4.20. Post deflections during test 1**

Figure 4.20 shows the post deflections during test 1. Post 1 underwent the largest deflection, reaching 6.34 in. prior to failure. Posts 1, 2, and 3 deflected outward from the box girder, whereas posts 4 and 5 deflected inward 0.28 in. Deflections for posts 4, 5, and 6 were excluded from the plot because they were approximately zero. Deflection 5T3 was plotted because this was the largest inward deflection, equaling 0.285 in. Minimal load reached post 6, with the post deflected outward 0.003 in. at failure. The deflected shape of the top of the guardrail immediately prior to failure is plotted in Figure 4.21.
