Performance Evaluation of Arizona's LTPP SPS-1 Project: Strategic Study of Flexible Pavement Structural Factors

Final Report 396-1
February 2012

Nichols Consulting Engineers
1885 South Arlington Avenue
Suite 111
Reno, Nevada 89509

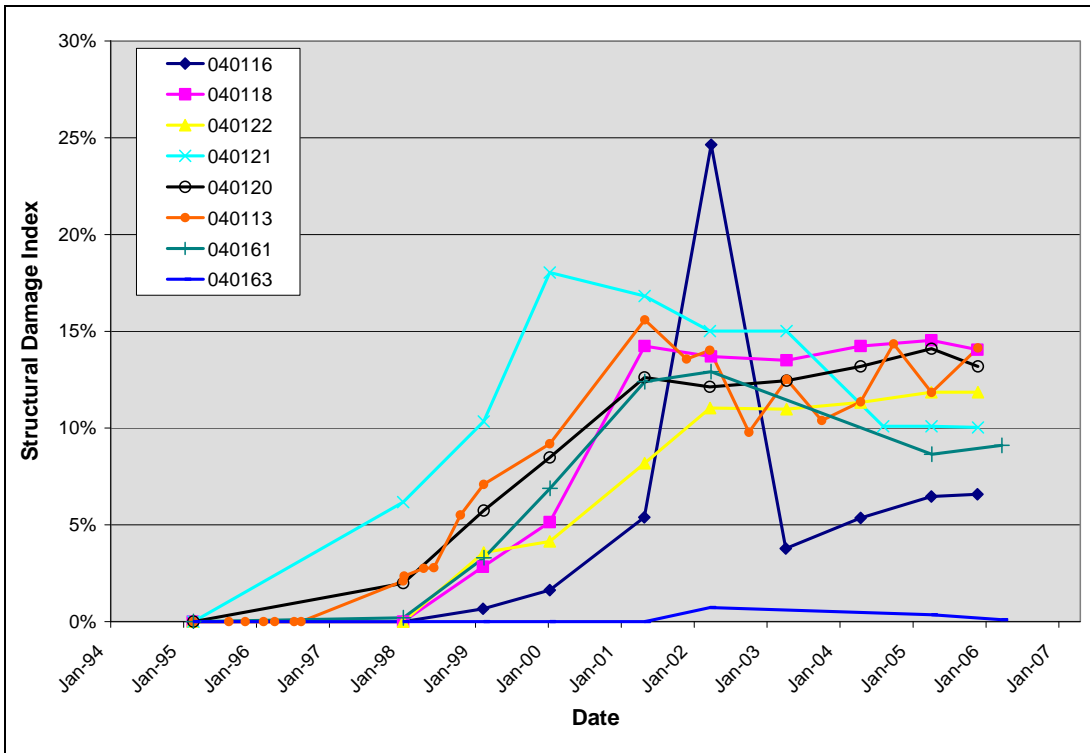
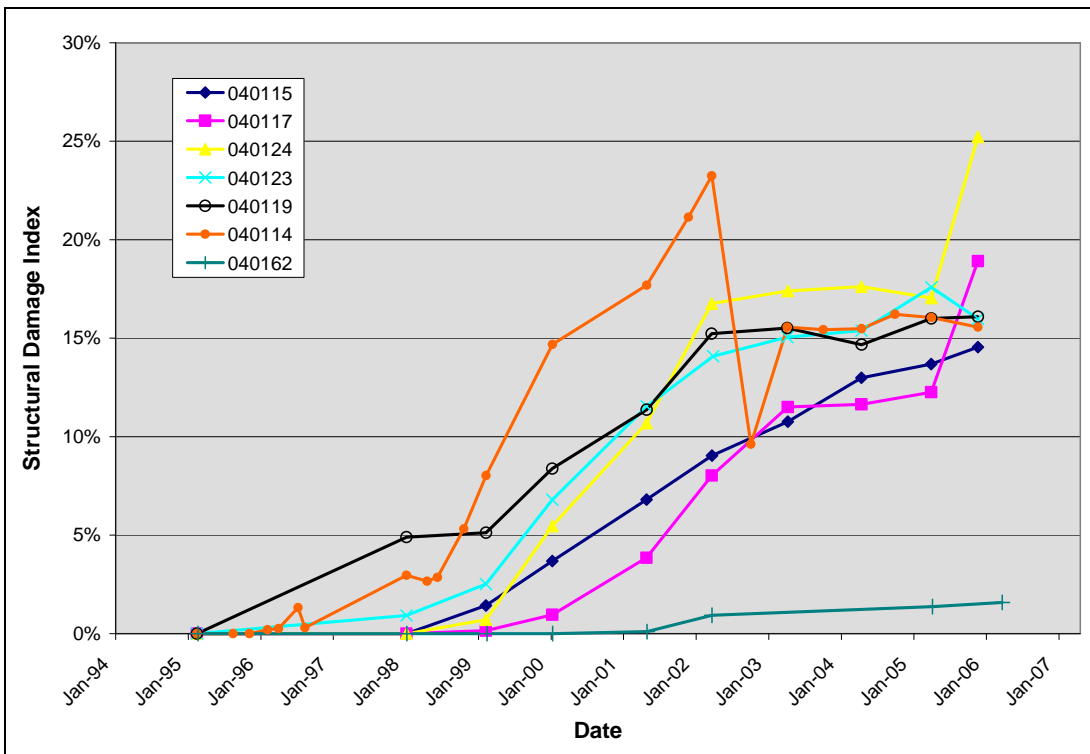
Figure 11. Structural damage trends for SPS-1 test sections with 5 inches or less of AC.

The overall structural damage trends for each section can be found in Figures 11 and 12. The performance trends are relatively consistent and within the expected range of variation. The drop in damage after May 2002 is indicative of the slurry seal masking the underlying deterioration.

All sections (except 0162 and 0163) showed a rapid accumulation of structurally related distresses approximately 9 to 10 years after construction. The accumulation typically slowed in later years.

In comparison with the rest of the SPS-1 project, sections 0162 and 0163 exhibit significantly smaller amounts of structural damage accumulation. The pavement structure for section 0162 is composed of 200 mm asphalt concrete placed directly on the subgrade. Section 0163 has a pavement structure consisting of an asphalt concrete friction course over roller compacted concrete.

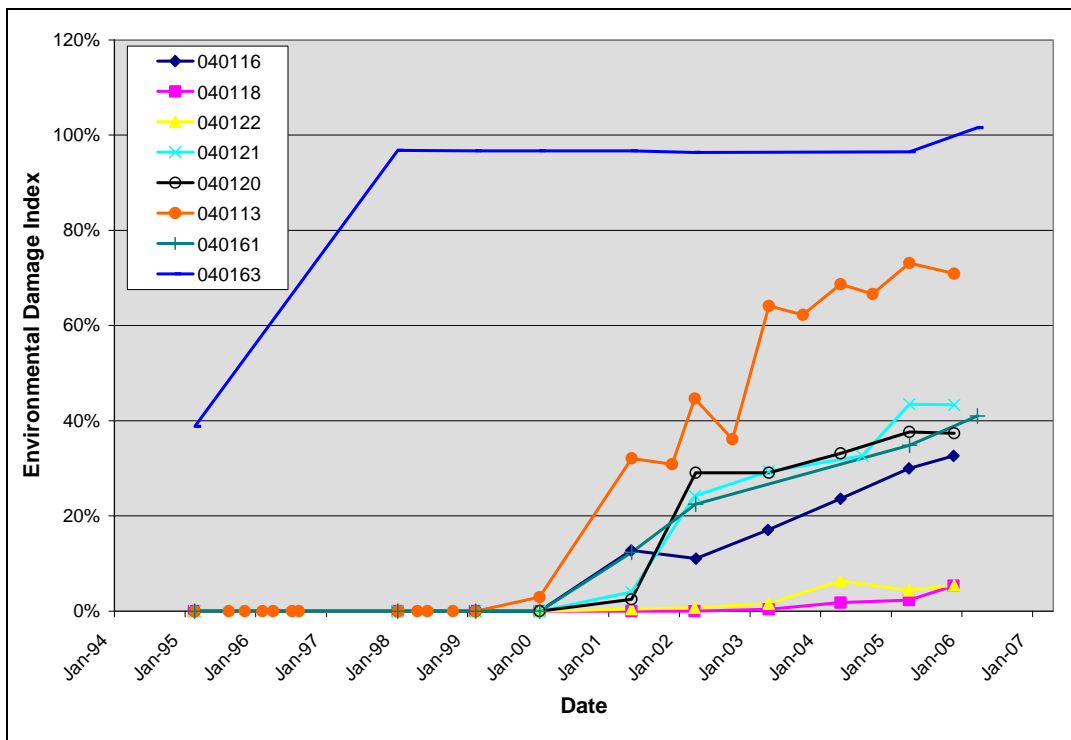
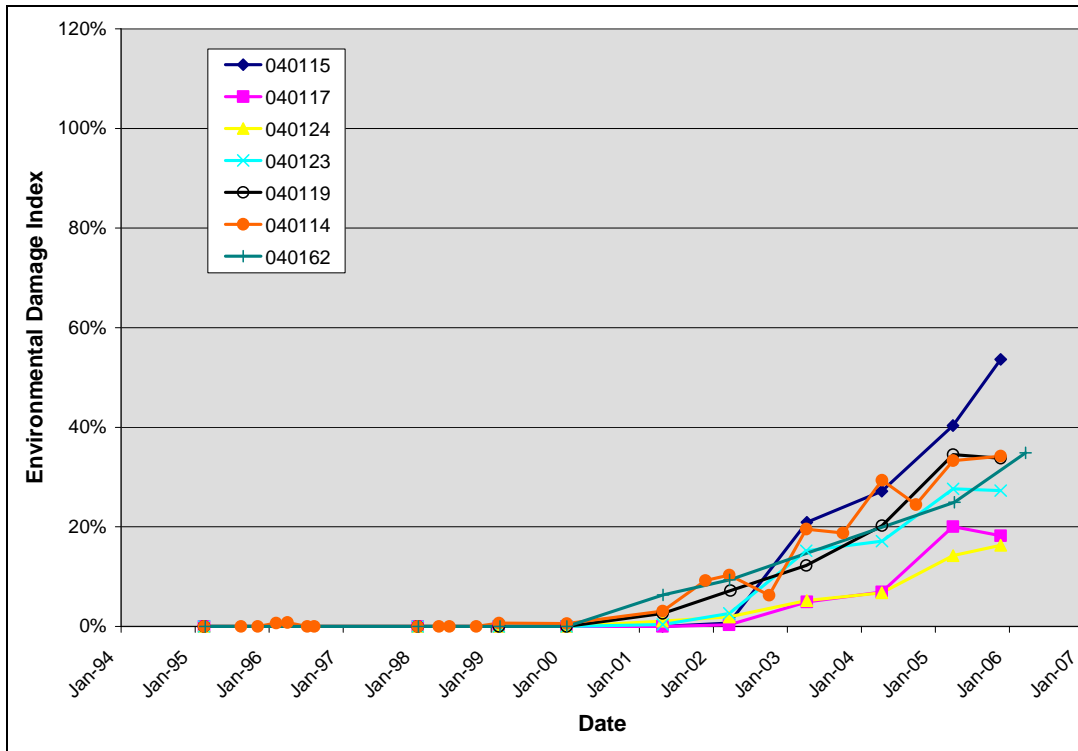
Figure 13. Environmental damage trends for SPS-1 test sections with 5 inches or less of AC.

The overall environmental damage trends for each section can be found in Figures 13 and 14. The performance trends are relatively consistent and within the expected range of variation. Although slight decreases were somewhat discernible for surveys within a year of the slurry seal, environmental distresses clearly increased in magnitude approximately 10 years after construction, and there is not a clear indication that the slurry seal provided any abatement to environmental distress. In fact, environmental damage was observed reflecting through the slurry seal on some sections approximately seven months after placement.

The slurry seal did improve the surface characteristics of the road and eliminated the raveling surface. However, the seal was applied after cracking was present, which was too late to be effectively used as a preventative maintenance treatment. The purpose of such application is to slow crack initiation by reducing oxidation and weathering. Oxidation of the asphalt binder increases the brittleness of the binder and promotes raveling and cracking. Slurry seals do not increase the structural capacity of the pavement and are not thick enough to prevent existing cracks from reflecting through the treatment. If cracks are present in the existing pavement, a slurry seal will quickly reflect this cracking, thereby diminishing the expected resistance to oxidation and weathering.

Timing of surface applications is critical to the effectiveness of the treatments. Figures 4 through 7 indicate that the majority of sections had very little cracking in 1998 and the cracking that was present was likely to be of low severity. Applying the slurry seal in 1998 may have resulted in slower deterioration and improved effectiveness of the treatment.

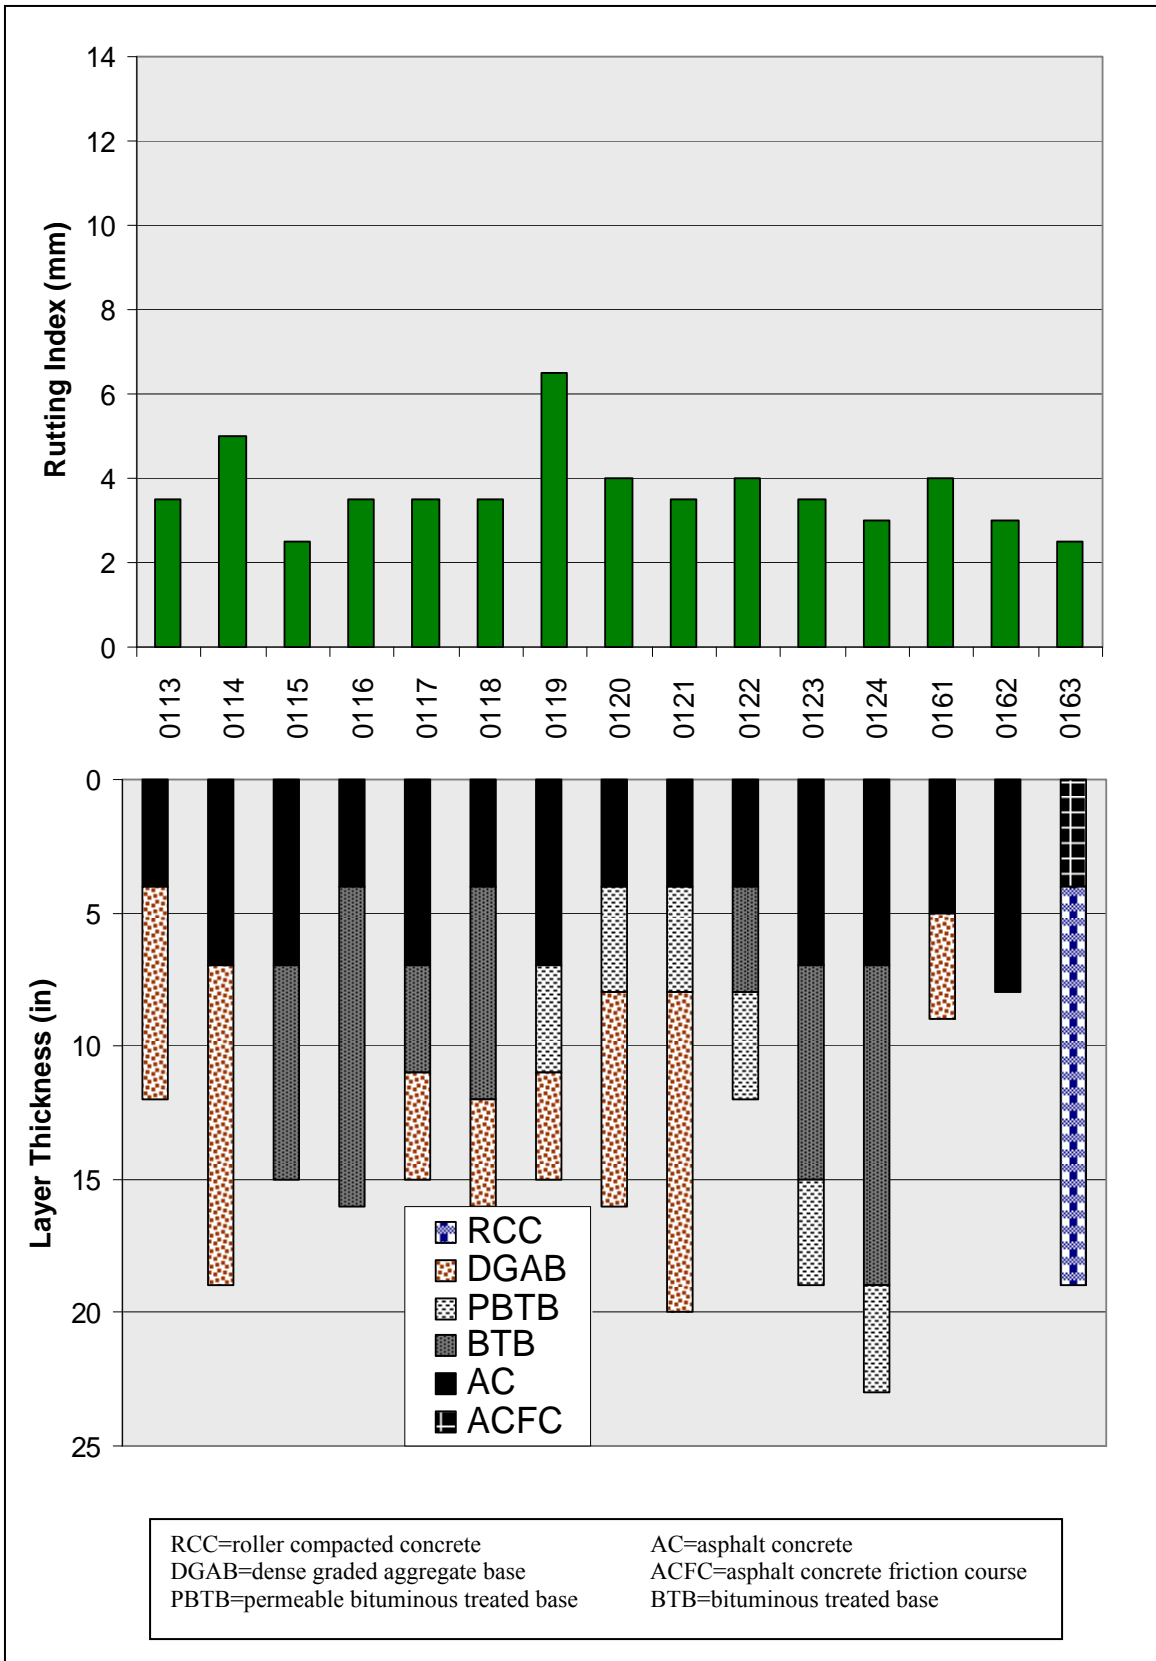
Figure 17. Rutting Index and pavement structure summary.

Figure 17 provides a summary of rutting and pavement structure for each section. Significant variation in rutting performance between the sections did not exist. All sections exhibited less than 7 mm of rutting after more than seven years in service, which is well below the level required to trigger improvements in most pavement management systems. Therefore, rutting was not the driving factor in the overall condition of the pavement.

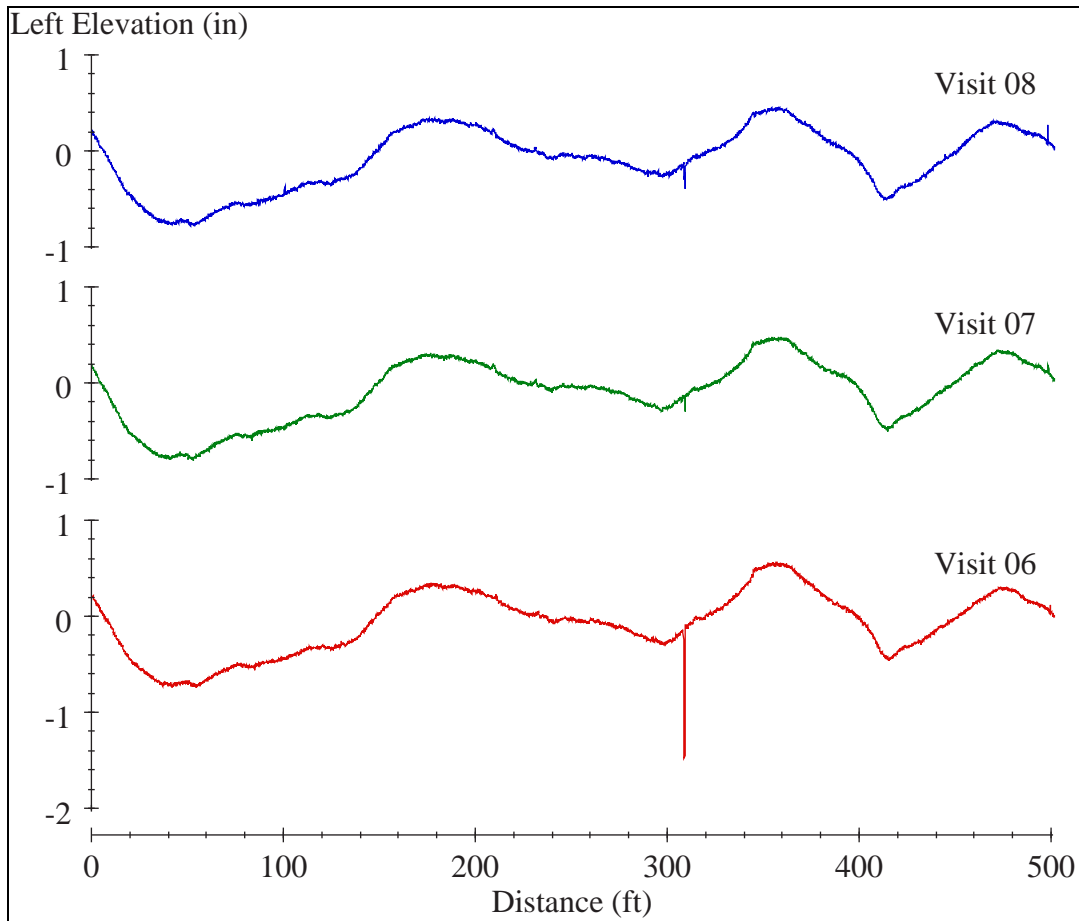
Figure 38. Raw profiles of section 0122.

A simple way to learn about the type of roughness that exists within a profile is to view the trace. However, certain key details of the profile are often not as obvious in a raw profile trace as they may be after the profile is filtered. For example, Figure 38 shows the left raw profile trace for three visits of section 0122. The plot shows that the long wavelength content, or the trend, in each plot is quite consistent with time. However, a narrow dip appears about 309 ft from the start of the section which is much more severe in visit 06 because the profile tracked directly over it.

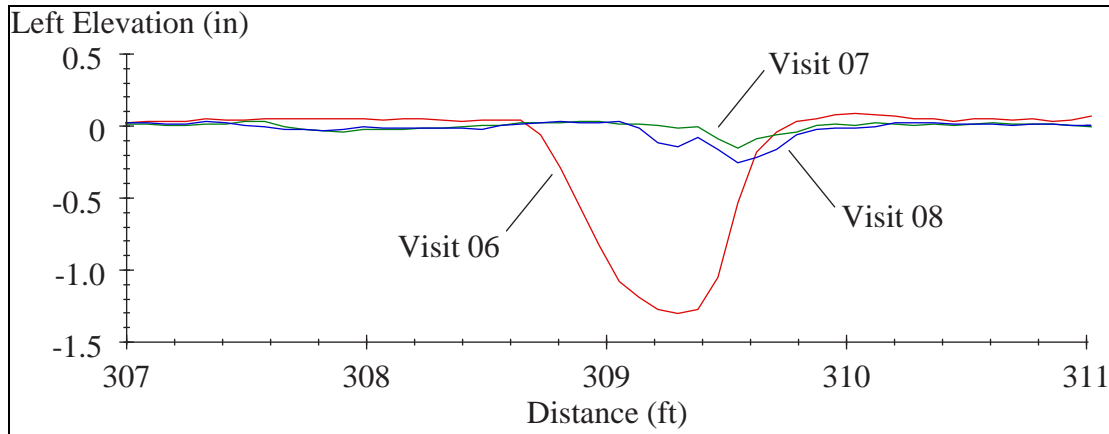
Figure 39. Filtered profile of section 0122.

Although the raw profile plots in Figure 20 provide very useful information about the nature of the roughness on section 0122, a filtered plot may provide a more detailed look at short-duration features of interest, such as the dip at 309 ft. Figure 39 shows a small segment of the profile after it has been high-pass filtered. In this case, a moving average (smoothing) filter with a base length of 20 ft was applied to the profile, and the result was

subtracted from the raw profile. Without the filter, the large changes in elevation along the profile may have masked the dip in visits 07 and 08, such that they may have been ignored. When the profile is filtered, the dip and its shape are much easier to evaluate.

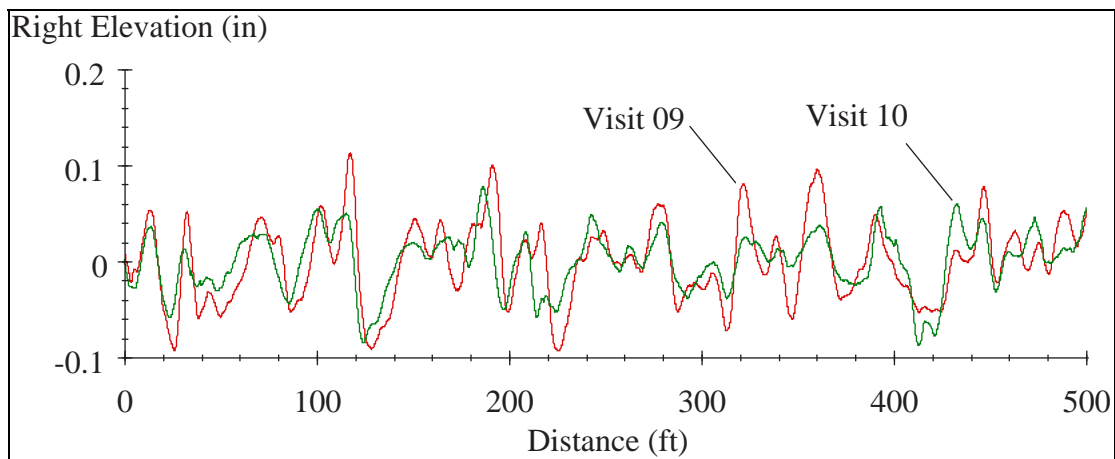
Figure 40. Medium wavelength profiles of section 0122.

Filtered profile plots also helped to characterize the effects of maintenance operations. For example, a slurry seal was applied to nine of the sections on the SPS-1 site in May 2022 (between visit 09 and 10). In most cases, this caused a complete change to the short wavelength profile plots and a significant change to the medium wavelength profile plots. Figure 40 shows an example of the change in the medium wavelength content on section 0122. Local peaks and troughs occur in roughly the same place before and after the slurry seal, but the shape and severity of bumps and dips are heavily altered. This, and the submerging of narrow dips at cracks under the seal, is the source of the change in roughness that occurred after the slurry seal.

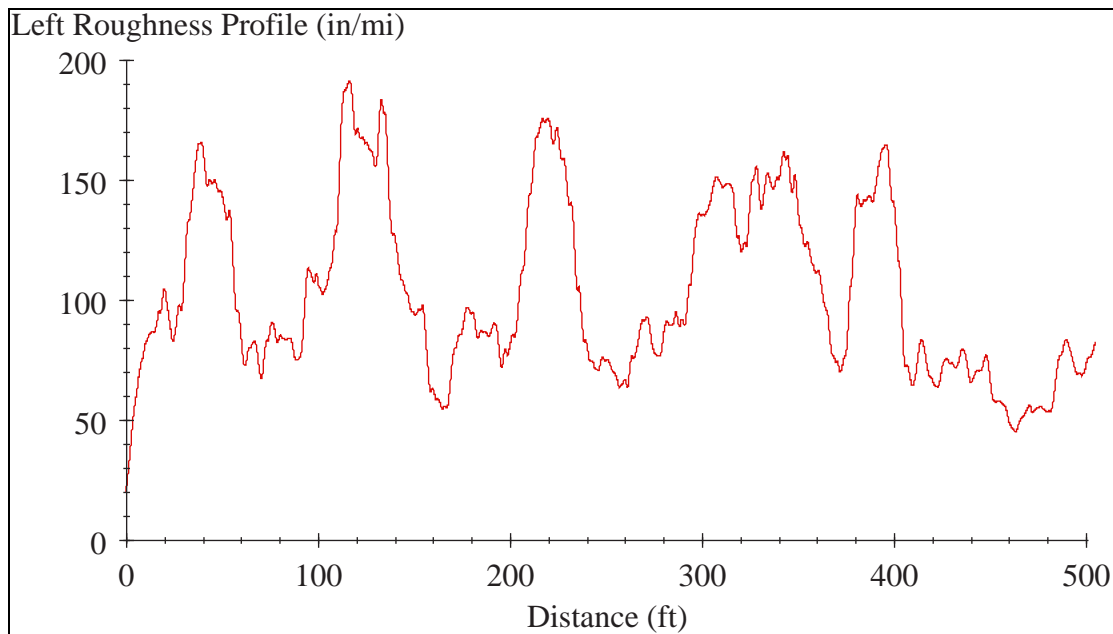
Figure 41. Roughness profile of section 0160, 25-ft base length.

Figure 41 shows an example of a roughness profile for visit 08 of section 0160. The roughness profile was generated using a base length of 25 ft. That means that every point in the plot shows the IRI of a 25-ft long segment of road, starting 12.5 ft upstream and ending 12.5 ft downstream. The plot shows several areas of elevated roughness over the first 400 ft. The smoothest 100 ft segment appears from 400 ft to 500 ft from the start of the section, but it is no smoother than the areas between isolated rough spots over the first 400 ft. Note that isolated roughness is absent over the last 100 ft of the section because it was diamond-ground to smooth the section for an approach to a weigh-in-motion scale just downstream of the section.

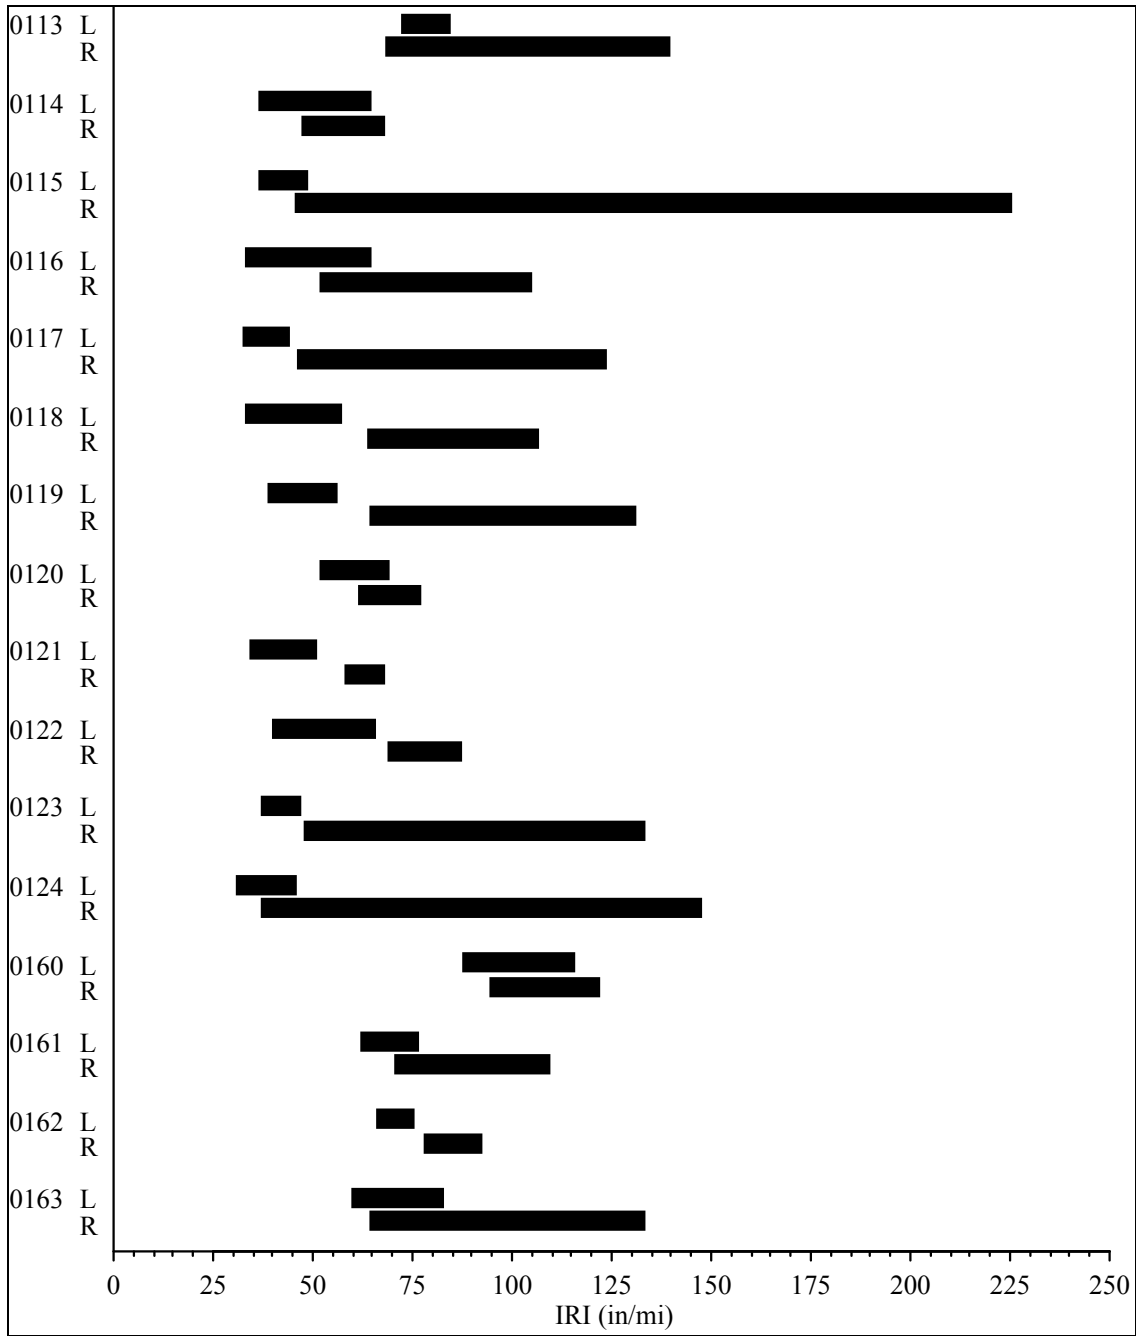
Figure 43. Summary of IRI ranges.

The rest of this report provides a summary of the most important observations made about each test section. The summaries are extracted from Appendix B, which provides detailed notes about each section. To help provide context for the summary statements below, Figure 43 shows the range of left and right IRI for each section. Note that the highest IRI value for some of the sections did not occur in the final visit. (See Appendix A or Figures 20 through 35.)
