Field Testing and Evaluation of a Demonstration Timber Bridge

Final Report
February 2012

IOWA STATE UNIVERSITY
Institute for Transportation

Sponsored by
Iowa Highway Research Board
(IHRB Project TR-604)
Iowa Department of Transportation
(InTrans Project 08-343)

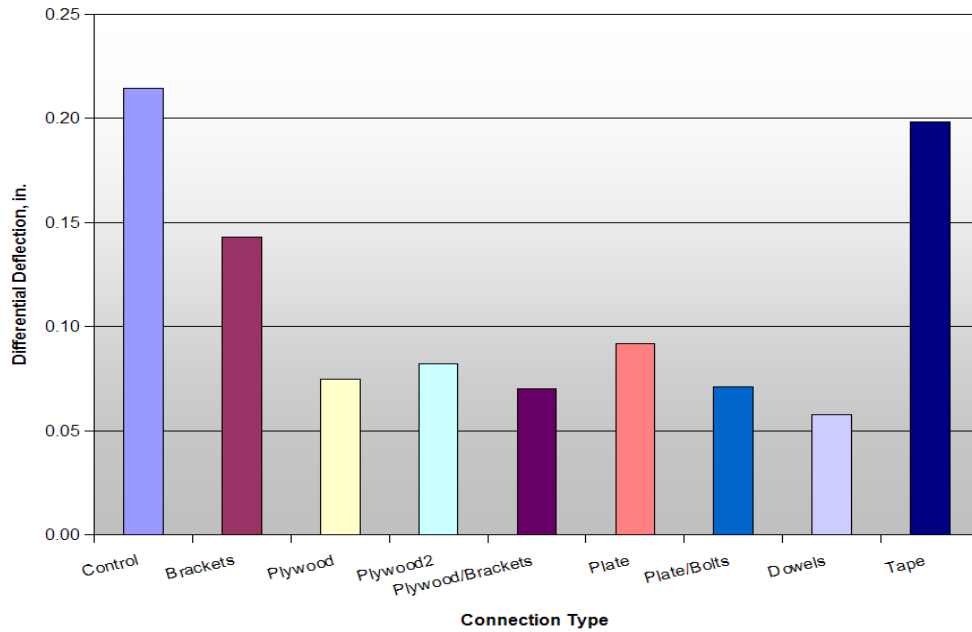
Figure 2.3. Maximum differential panel deflection for the laboratory bridge alternatives

Loading of the structure was performed using hydraulic actuators loaded in 1,000 lb increments up to 16,000 lbs each, which is half of an axle load of the HS-20 design truck, located adjacent to a panel joint. Figure 2.3 shows the maximum differential panel displacements calculated for each alternative investigated with the left-most “Control” bar indicating no special joint treatment.

Based on Figure 2.3, the most promising deck modification (based on both performance and ease of construction) involves adding a layer of treated tongue and groove plywood on top of the timber deck surface prior to placement of the wearing surface, as illustrated conceptually in Figure 2.4.

Differential panel deflection data from the plywood overlay alternative is presented in Figure 2.3 as the data bar labeled Plywood. Compared to the control, the plywood overlay alternative reduced the differential panel deflections by more than 50 percent. In addition, this alternative is less expensive and a more construction-friendly alternative compared to the dowels alternative.

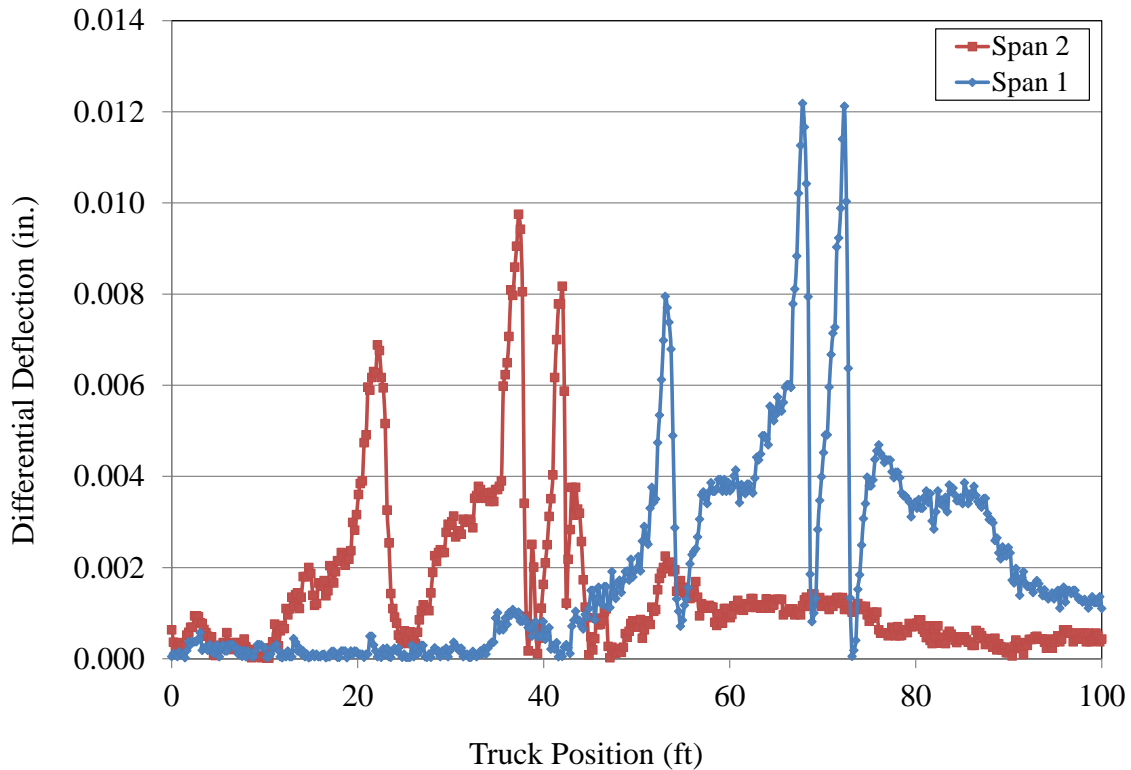
Figure 5.8. Comparison of differential panel deflections for Span 1 and Span 2, 2009 data

The differential panel deflection data calculated from this location on Span 1 (plywood) and Span 2 for Load Case 1 (which was the worst case scenario with a wheel line directly over the instrument location) are illustrated in Figure 5.8.

The data in Figure 5.8 indicate larger differential panel deflections on Span 1, the span with plywood, compared to Span 2, the span without plywood. This same observed behavior is evident in the other load cases, as well, and may be a result of the following factors: 1) the difference in the location of the measurement of the relative deflection longitudinally with respect to load direction on the two spans, 2) changes made to the plywood orientation, or 3) other factors or a combination of these factors.

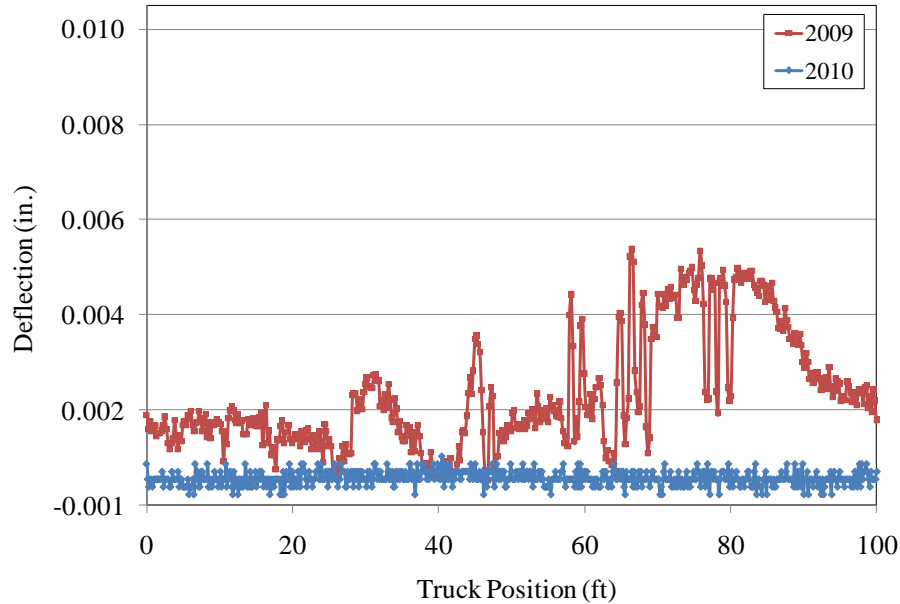
Figure 5.9. PJ6 differential panel deflection comparison, 2009-2010

Figure 5.9 shows the differential panel deflection data from 2009 and 2010 for location PJ6 (which was midway between the middle girders). The data suggest that some reduction in the differential panel deflection magnitude has taken place over the one-year time period. However, with the cracking of the asphalt wearing surface still prevalent, the significance of this decrease is unknown.

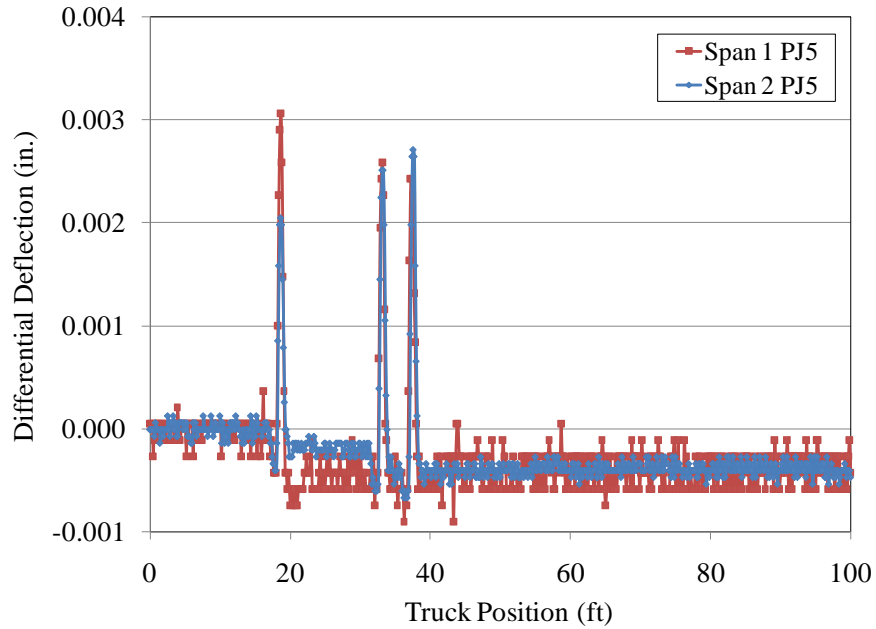
Figure 5.10. PJ5, LC 6, differential panel deflections between G3 and G4

Figure 5.10 shows the differential panel deflections between G3 and G4 at PJ5 for LC 6 and indicates that the differential panel deflections for the demonstration bridge are well below the suggested limit of 0.10 in. However, with the deflection magnitudes of Span 1 and Span 2 being so similar, it also suggests that the plywood on Span 1 has little influence on the magnitude of the differential panel deflections. Similar findings were found at panel joint PJ4, as shown Figure 5.11.

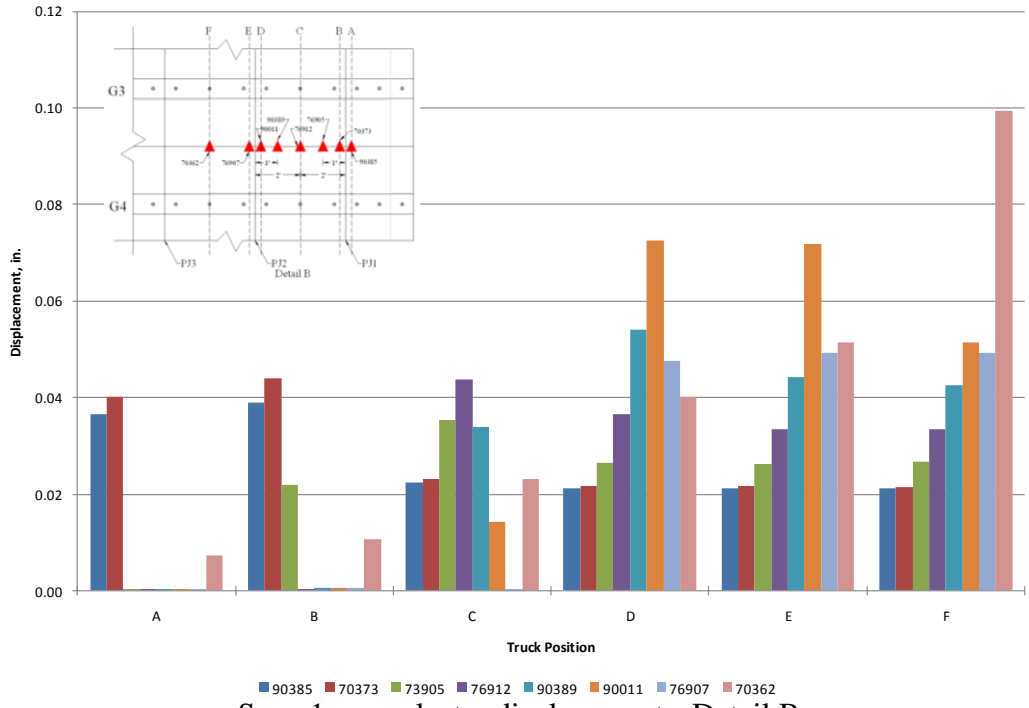
a. Span 1 gage cluster displacements, Detail B

Figure 5.12 shows the global displacements measured at each gage in the cluster for each of the six locations (A-F) detailed in Figure 4.4. Figure 5.12a represents Span 1 and Figure 5.12b represents Span 2.

Moving left to right across both graphs in Figure 5.12 provides a snapshot of the displacement of the cluster of gages as the load truck travels across the section. Not only is the pattern of the displacements similar for both spans at each location of the truck, but the magnitudes are similar as well. There appears to be little to no influence on the global panel deflection or the differential panel joint deflections from the presence of the plywood.
