**Research Project # 2005-051**  
**Accelerated Bridge Paint Test Program**  
**July 6, 2011**

**Introduction**

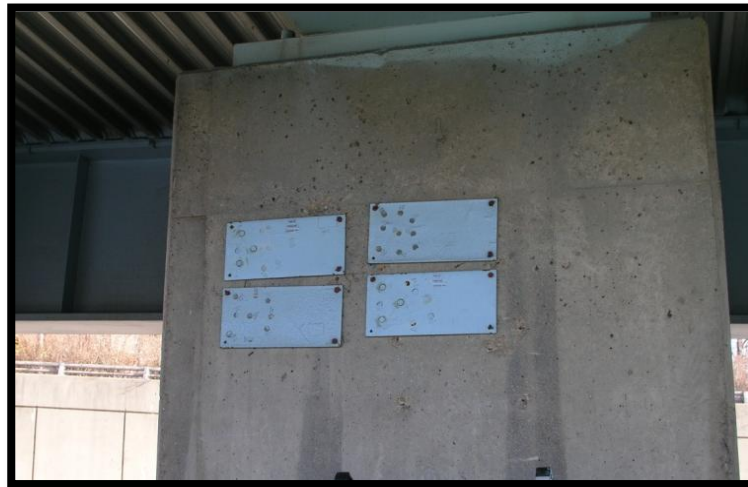
**Photo 3, Control Panels attached to the Bridge**

There was some spot surface rust on the experimental area. Speculation by the KTA-Tator representative was there had been some initial problems during the start-up of the two coat paint system application. Based on these observations the KTA-Tator consultant plans to come back to the bridge to do a more in depth visual inspection and some additional Tooke Gage testing to measure the thickness of each coat. Winson King had taken some spot checking of the coating thickness and found that many rust spots were not meeting the specified thickness of paint. Attached to the end of the report is the dry film thickness readings taken from the experimental and control girder and readings taken from the control panels. It appears from sample testing performed that the three-coat paint system was applied

more consistent and within acceptable coating limits, but the two-coat paint system was applied inconsistently. The construction notes will also, be reviewed to determine if there were application problems that could lead to this early rusting.

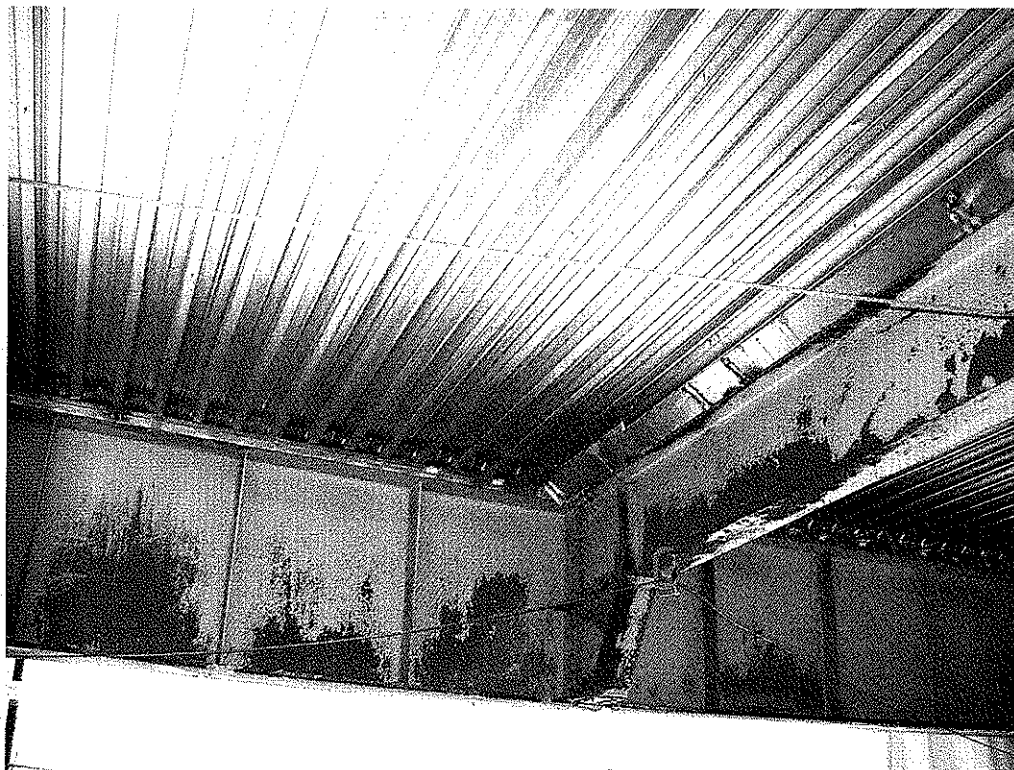
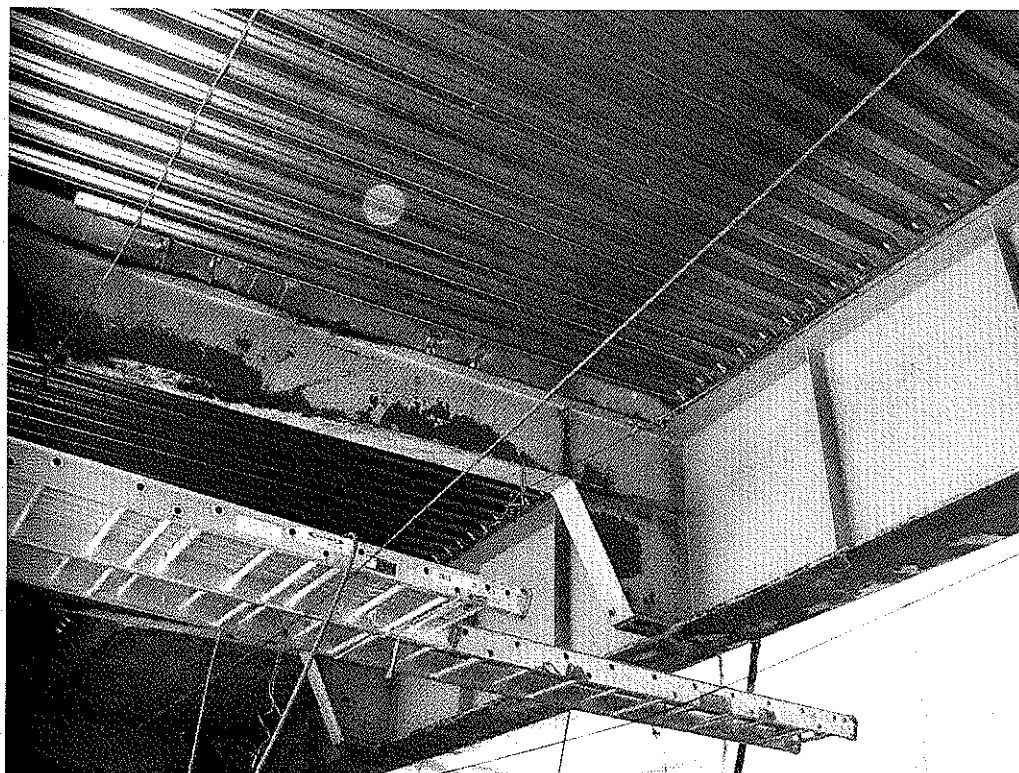
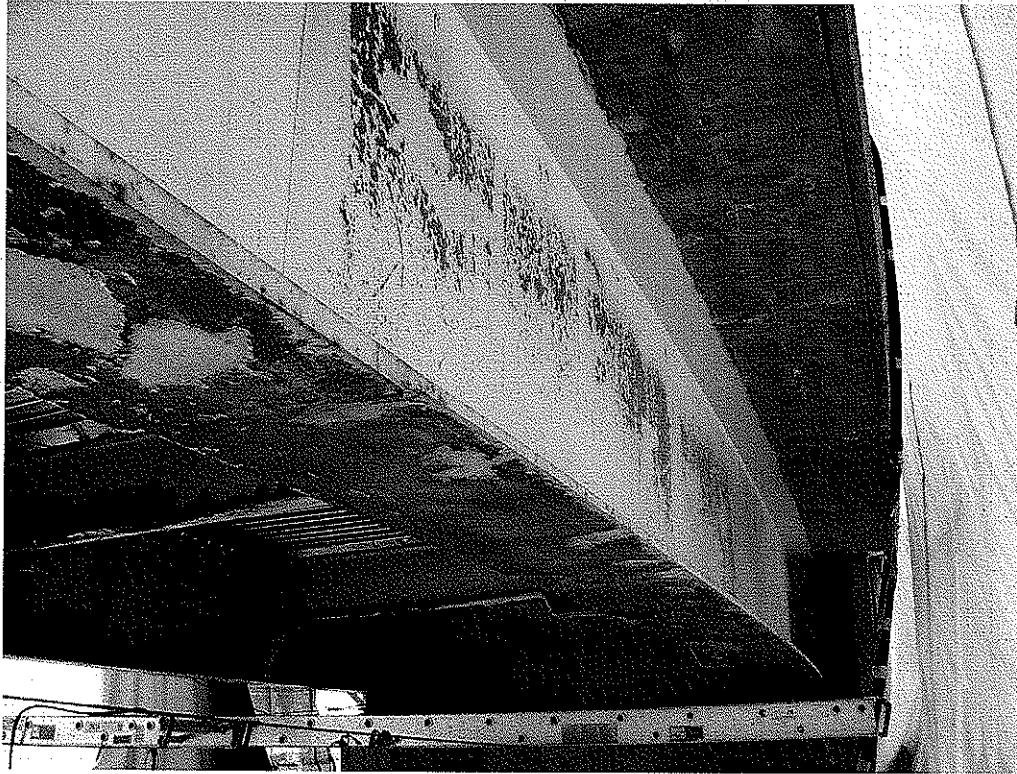
**Photographs 8 through 10 show California Avenue Bridge Span 3 prior to blast cleaning and painting.**

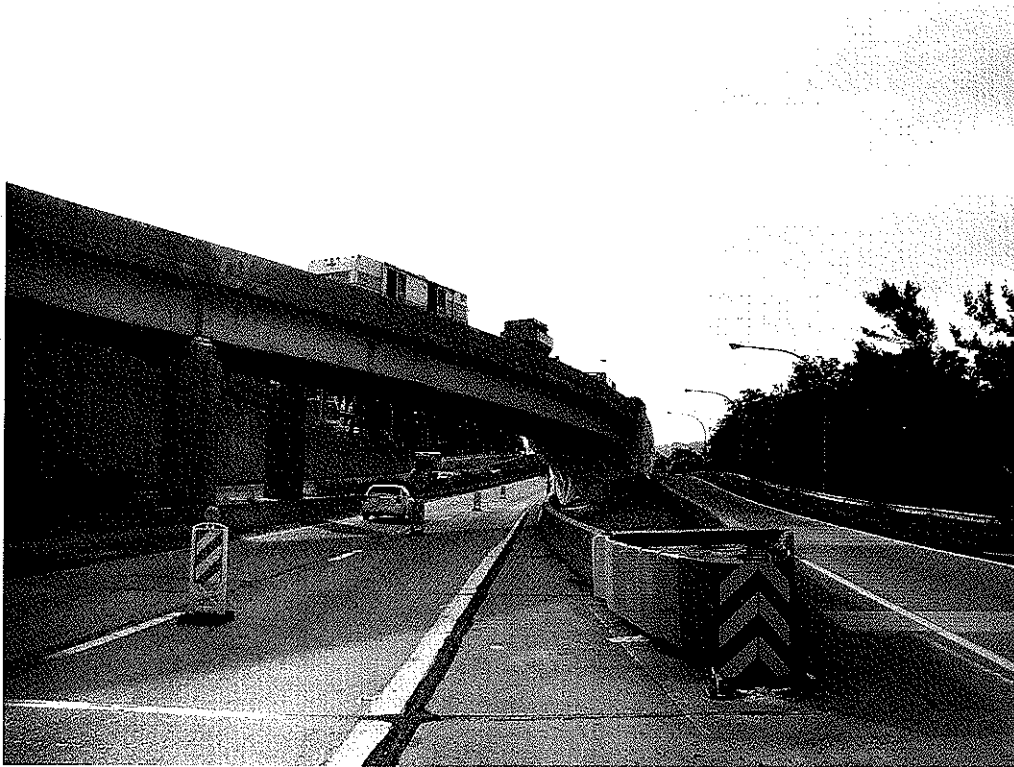
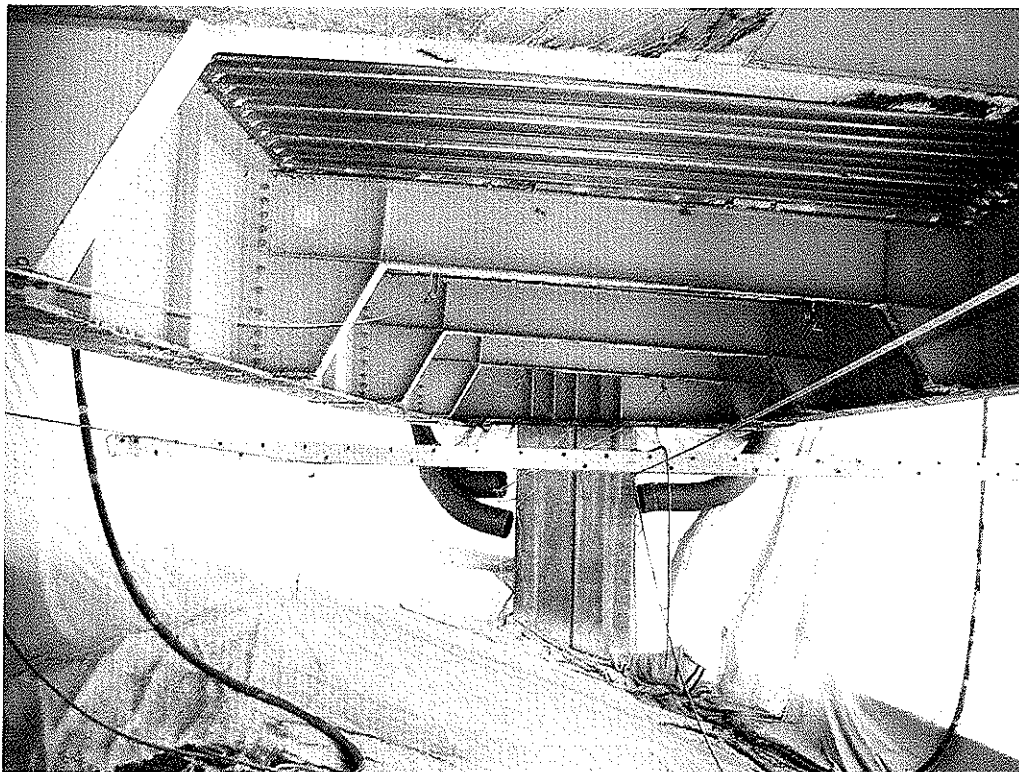
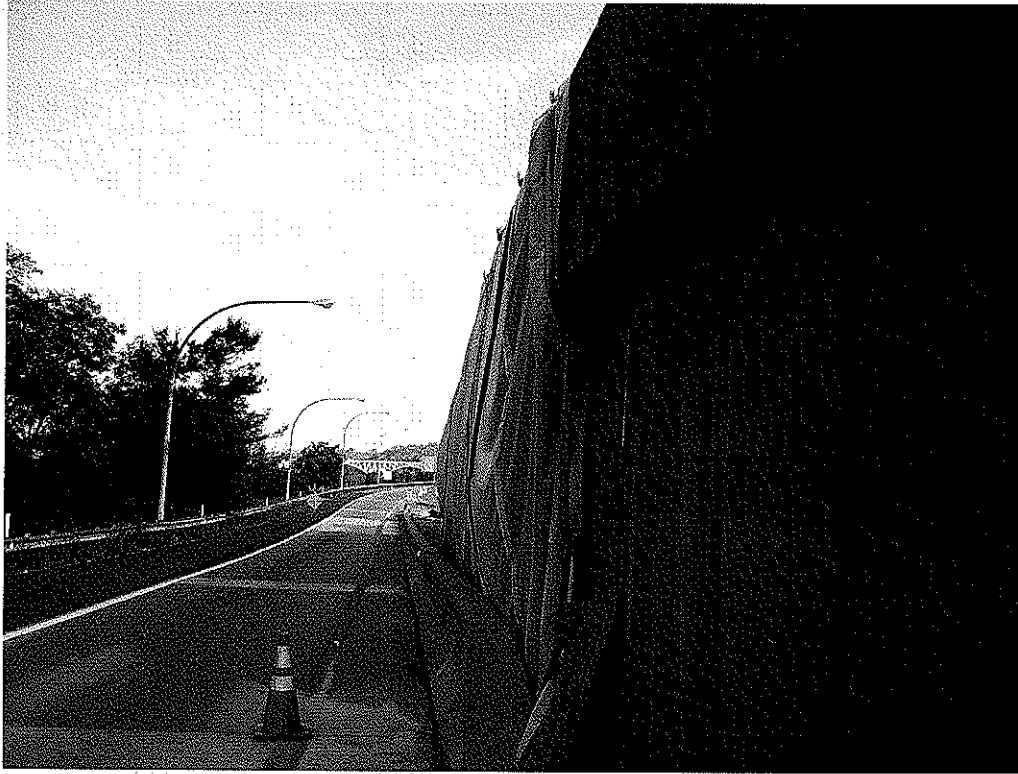
**Photographs 11 through 13 show the containment surrounding Span 3 where control paint systems were applied.**

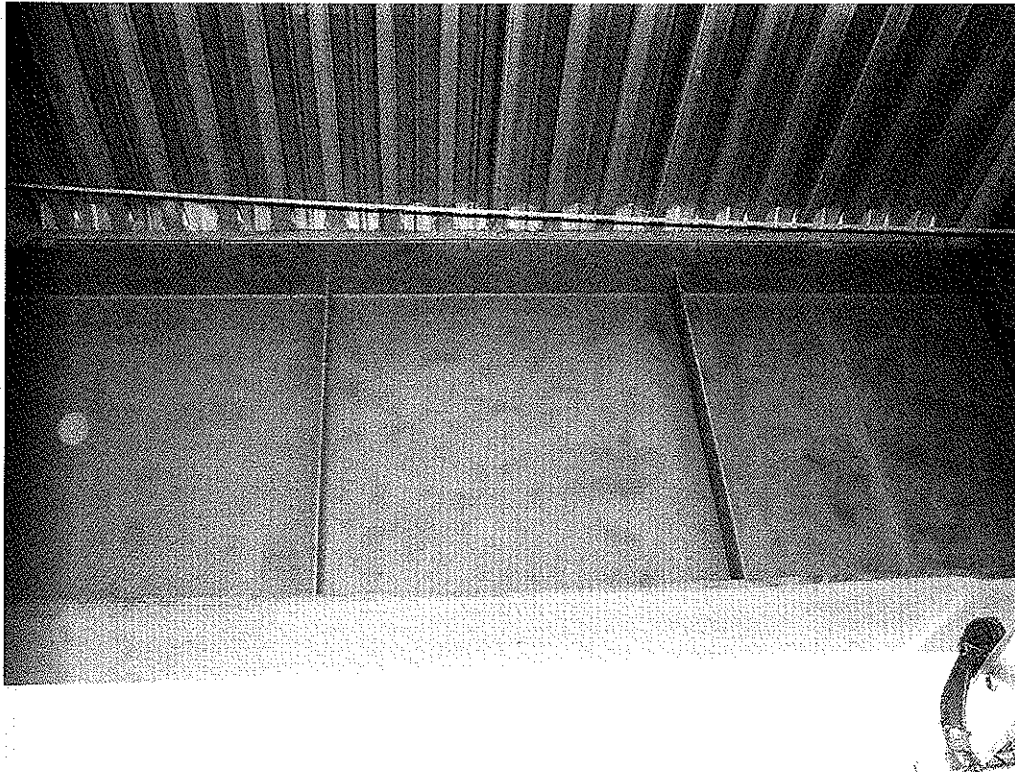
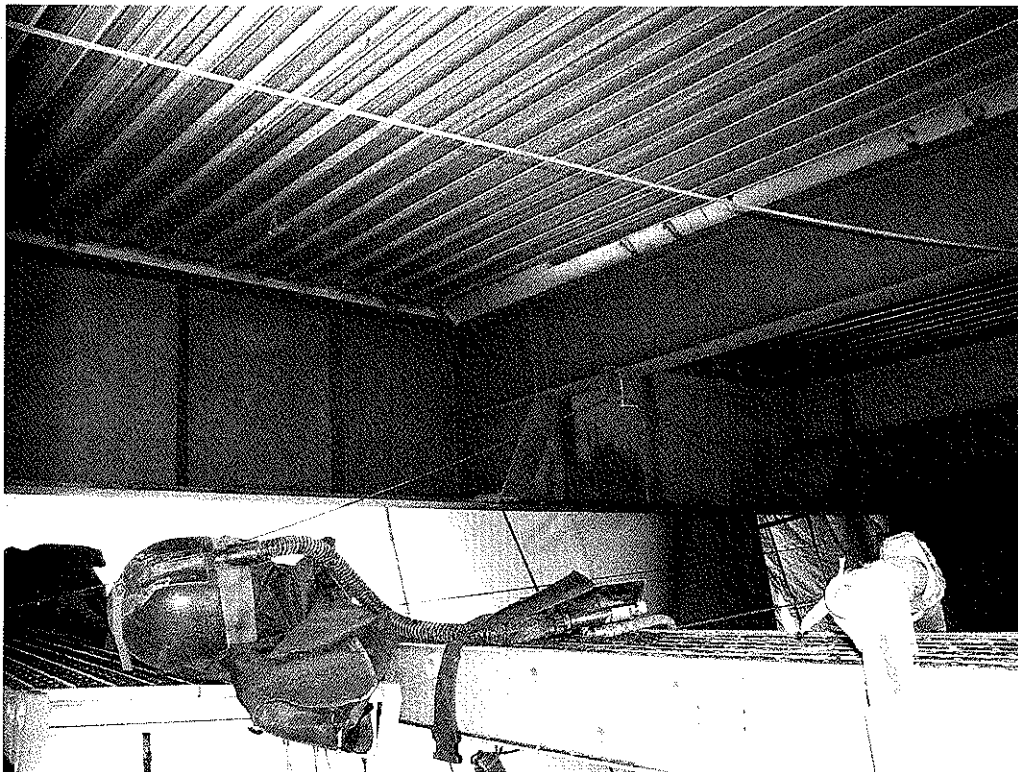
Photographs 14 through 17 show initial abrasive blast cleanliness in Span 3.

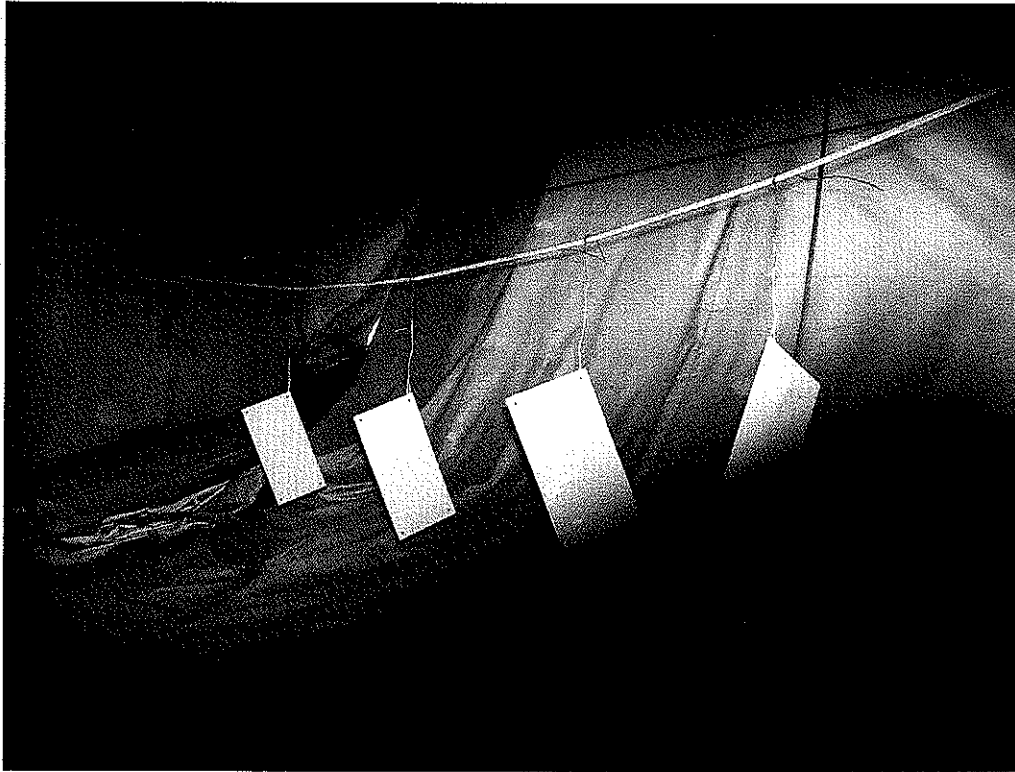
Photograph No. 18

Photographs 18 and 19 show painting of test panels with painting work in Span 3.

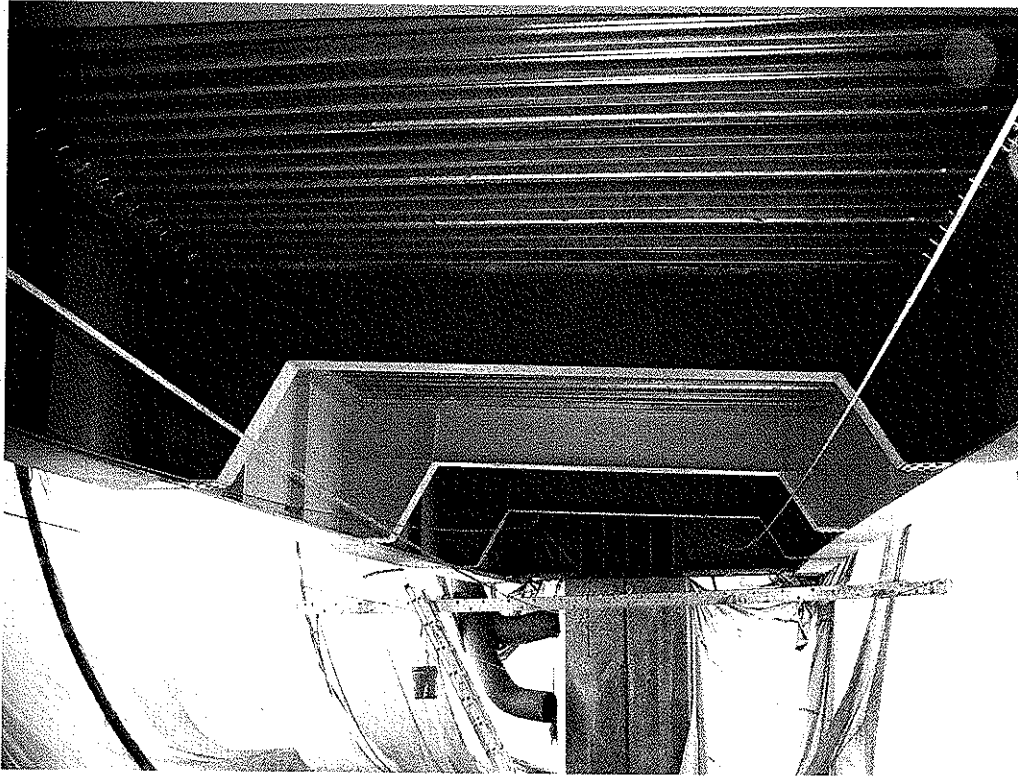
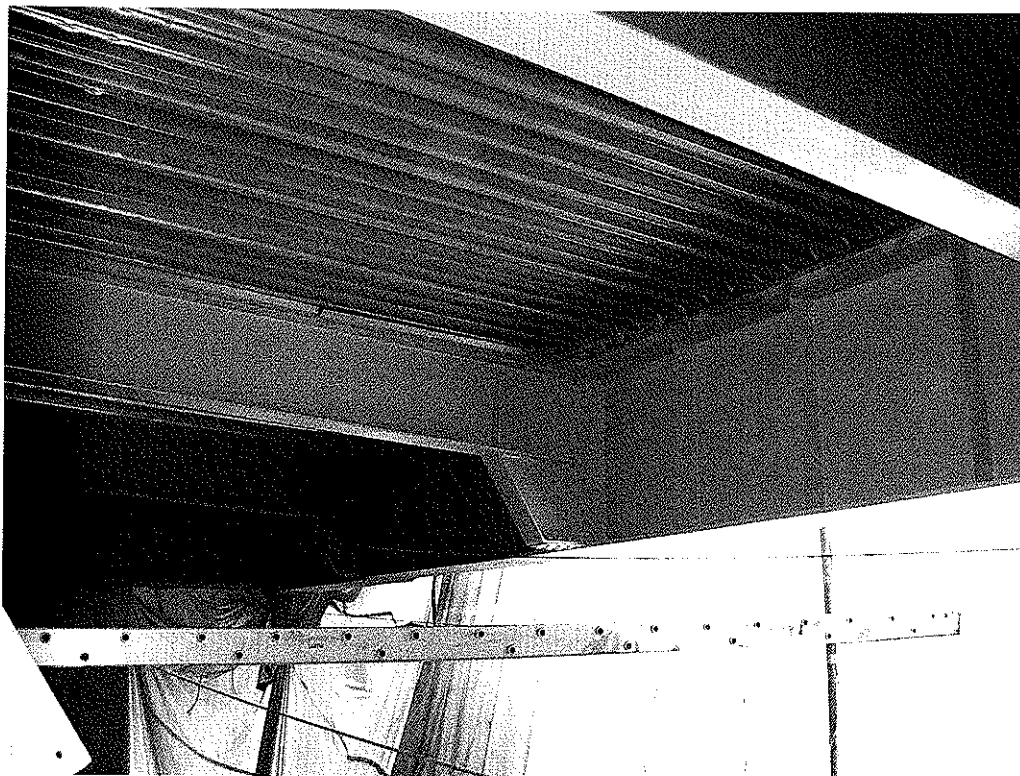
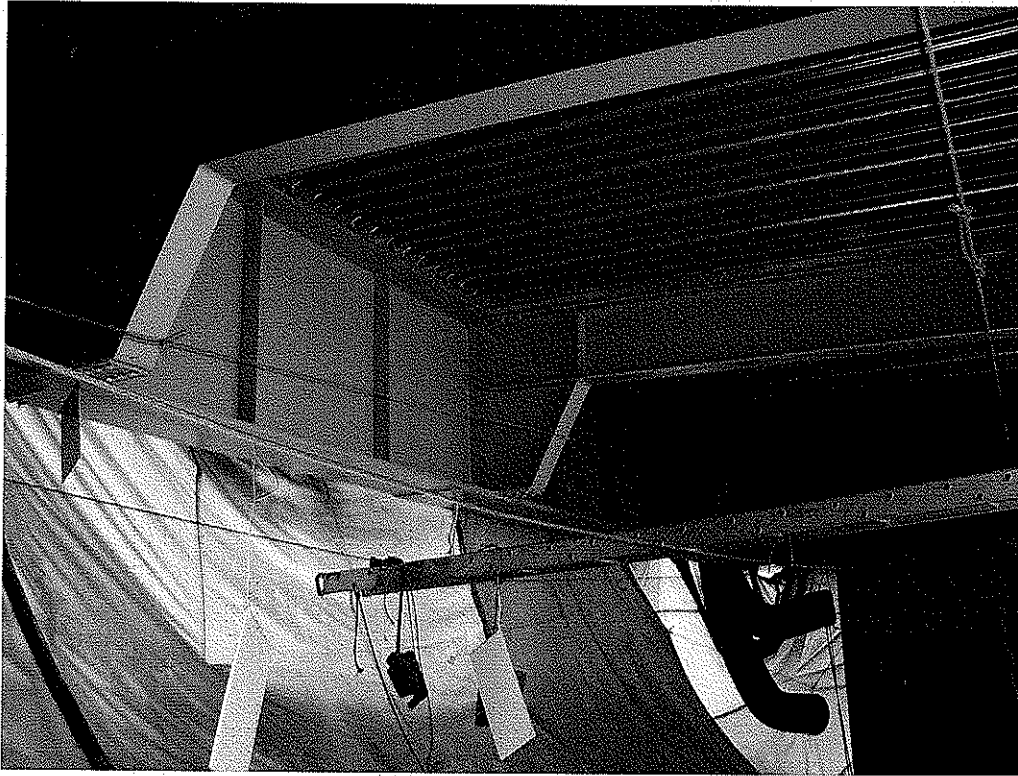
Photographs 23 through 25 show finish coat of 3-coat control paint system in Span 3, Bay 3.

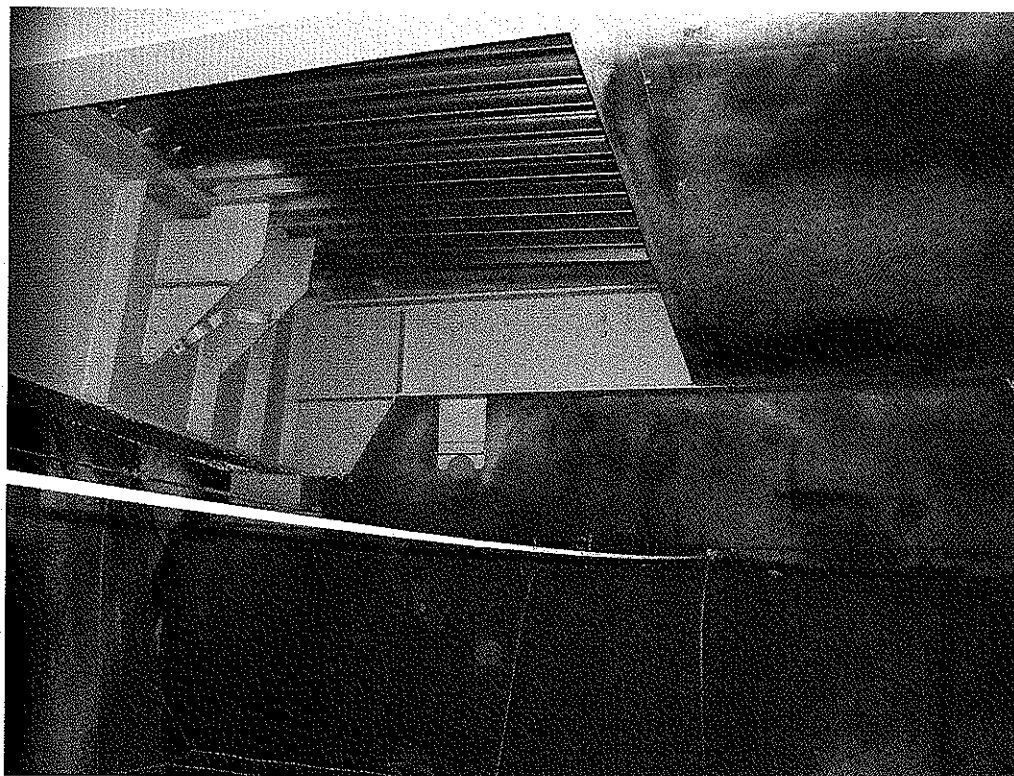
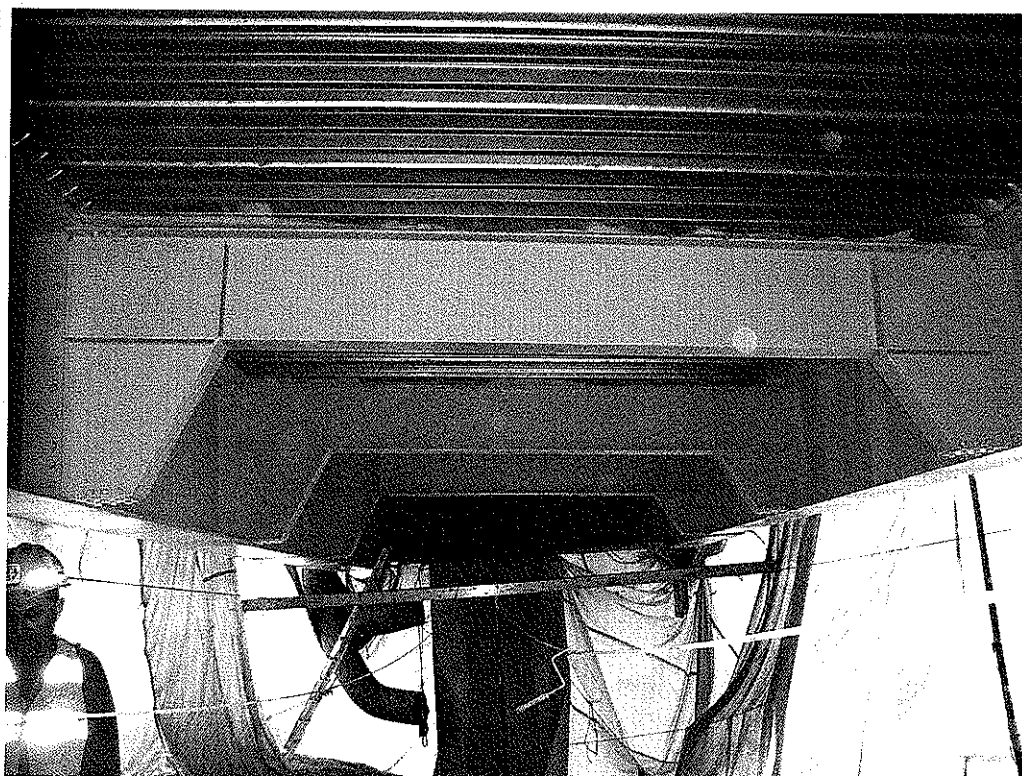
Photographs 26 and 27 show finish coat of 2-coat system in Span 3, Bays 1 and 2.

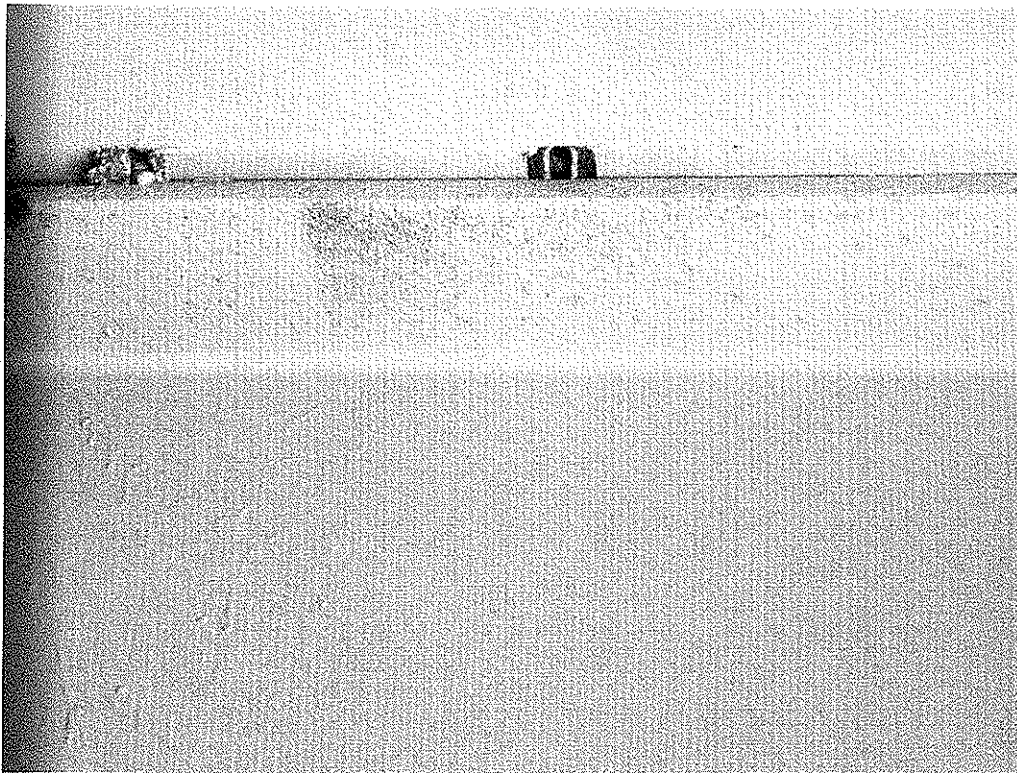
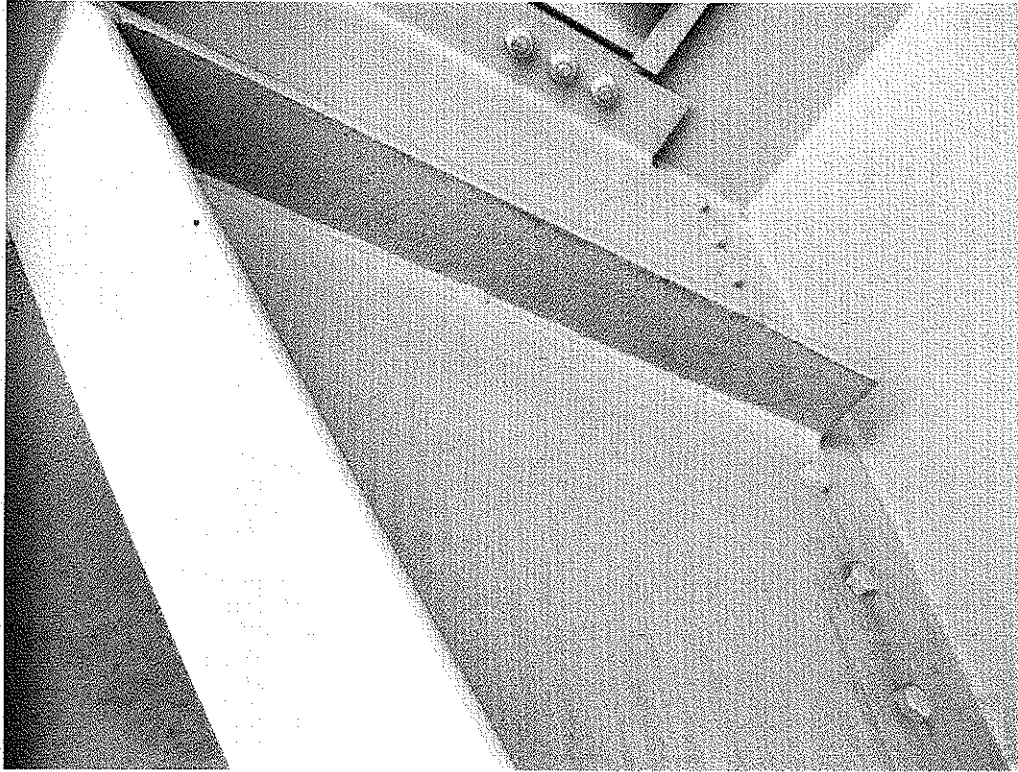
<b>Photograph No.</b>	<b>Description</b>
<b>1-2</b>	General views of Spans 2 and 1 in Year 2, 2008.
<b>3-9</b>	2-coat OZ/U Control Span 3, Bay 1 and 2, Year 2, 2008. Note increase in pinpoint rust on flanges/edges vs. Year 2, 2007.
<b>10-13</b>	3-coat OZ/E/U Control Span 3, Bay 3, Year 2, 2008. Only a few very minor pinpoints of rust were visible.

Photographs 3 through 9 show 2-coat OZ/U Control Span 3, Bay 1 and 2, Year 2, 2008.  
Note increase in pinpoint rust on flanges/edges vs. Year 1, 2007.

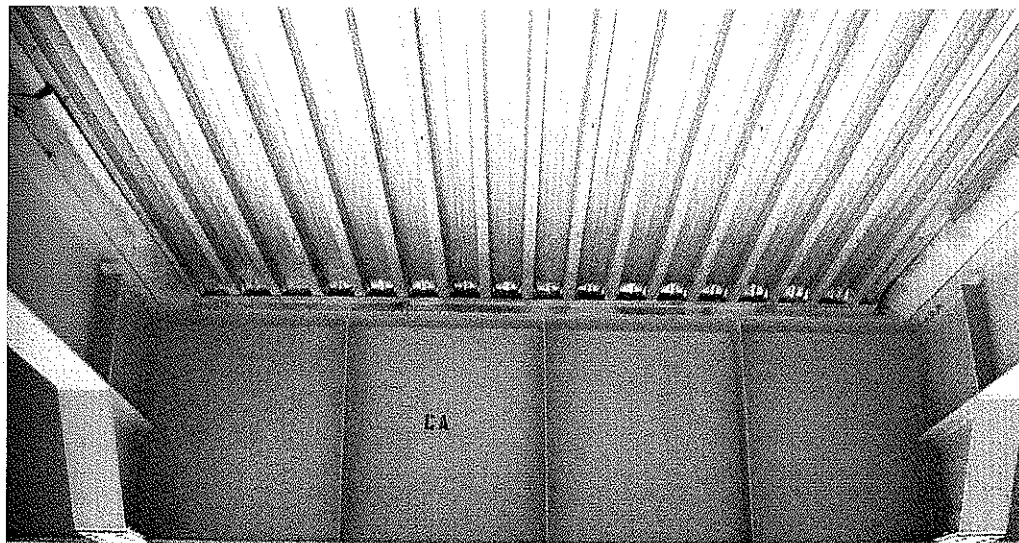
Photograph No. 11

Photographs 10 through 13 show 3-coat OZ/E/U Control Span 3, Bay 3, Year 1, 2008. Only a few very minor pinpoints of rust were visible.

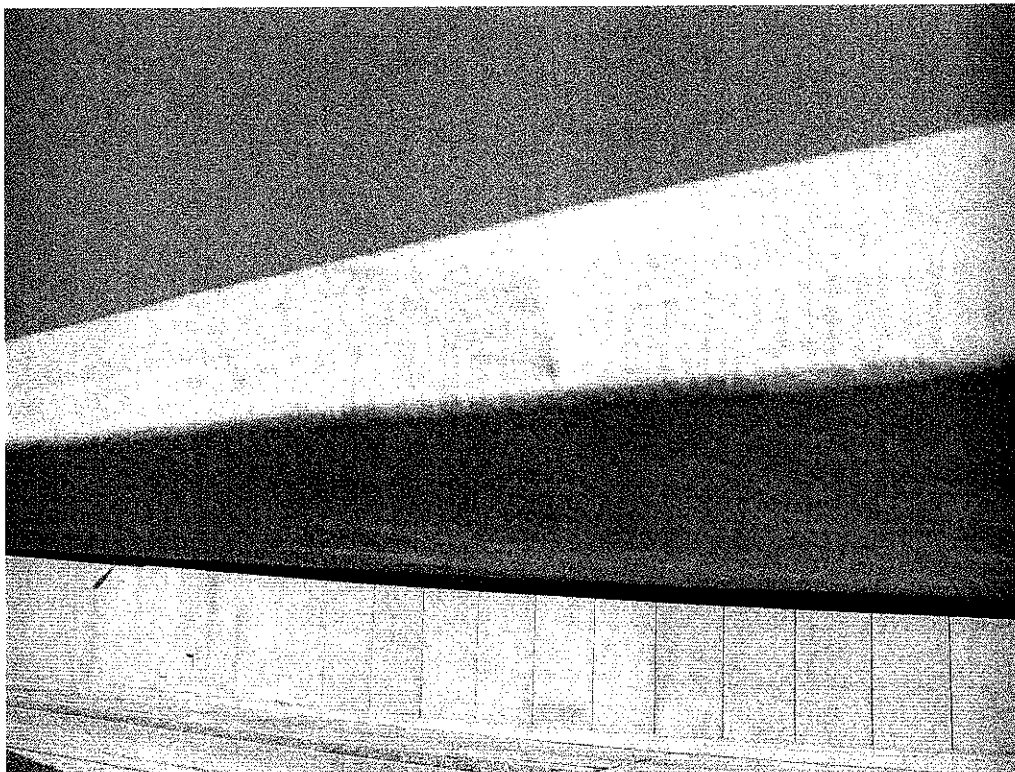
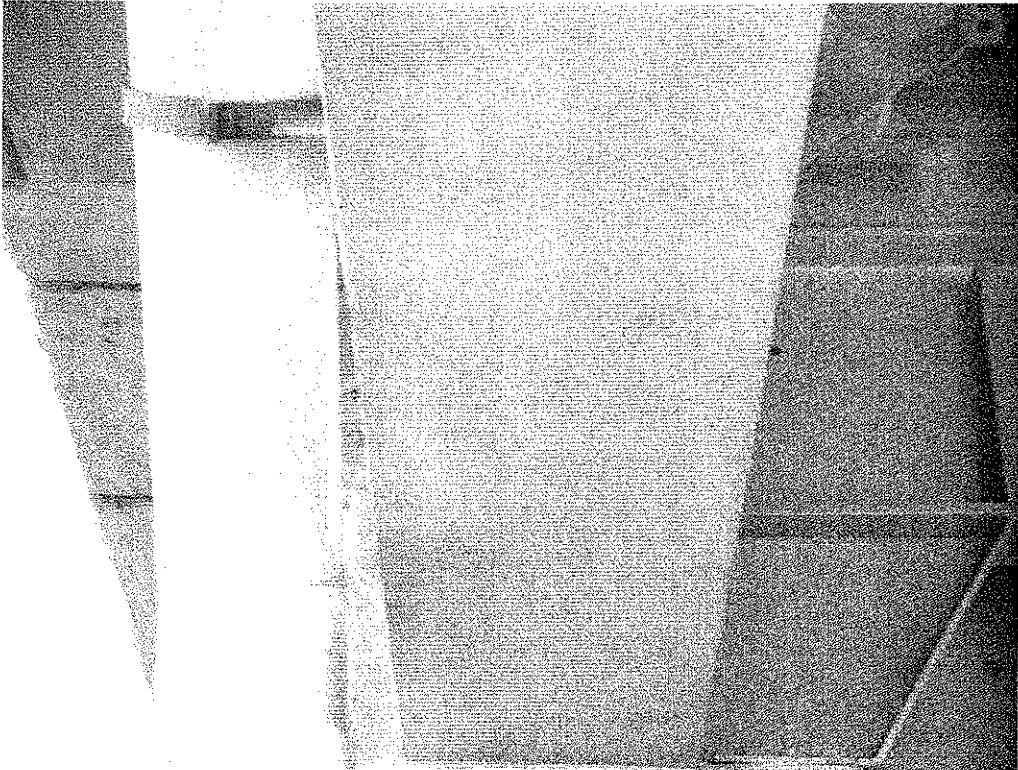
<b>Photograph No.</b>	<b>Description</b>
<b>1-7</b>	2-coat OZ/U Control Span 3, Bays 1 & 2, Year 3, 2009. Note continued increase in pinpoint rust on flanges/edges from Year 2, 2008.
<b>8-14</b>	3-coat OZ/E/U Control Span 3, Bay 3, Year 3, 2009. Only very minor pinpoint rust was noted.
<b>15-18</b>	Shows dry film thickness measurement taken at pinpoint rust locations in 2-coat OZ/U Control Span 3, Bays 1 & 2. Note that there was a definite correlation between the occurrence of pinpoint rust and the coating system dry film thickness. These issues are addressed in the "Discussion" section of this report.

Photographs 1 through 7 show two-coat OZ/U Control Span 3, Bays 1 & 2, Year 3, 2009.  
Note continued increase in pinpoint rust on 1-7 flanges/edges from Year 2, 2008.

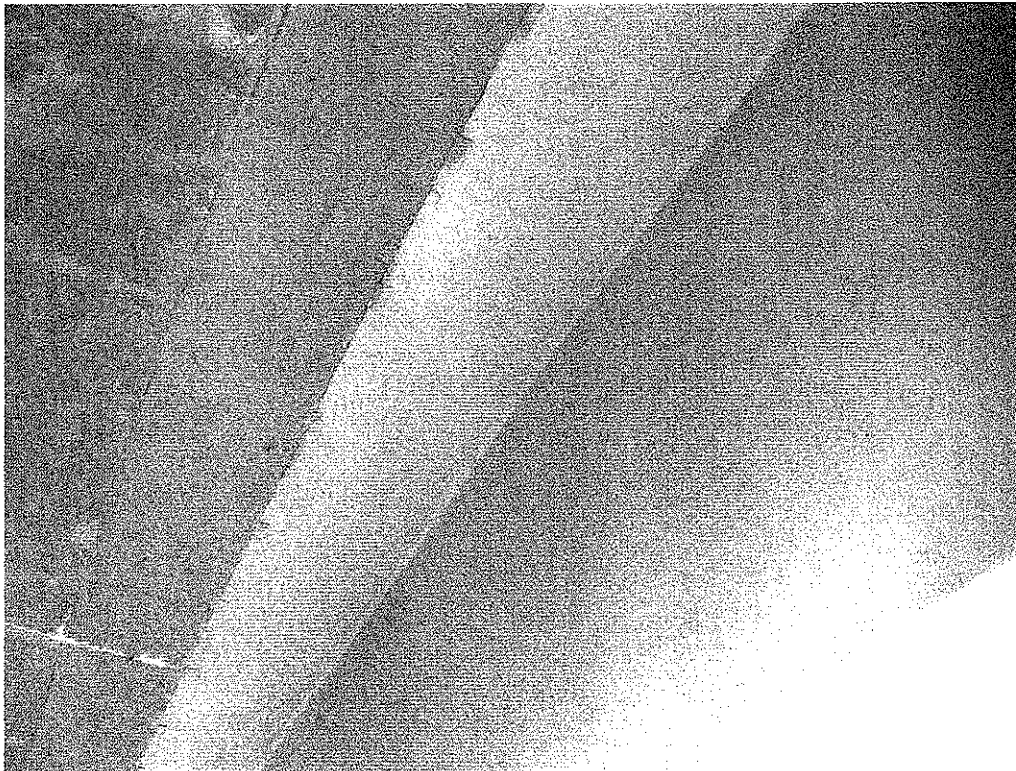
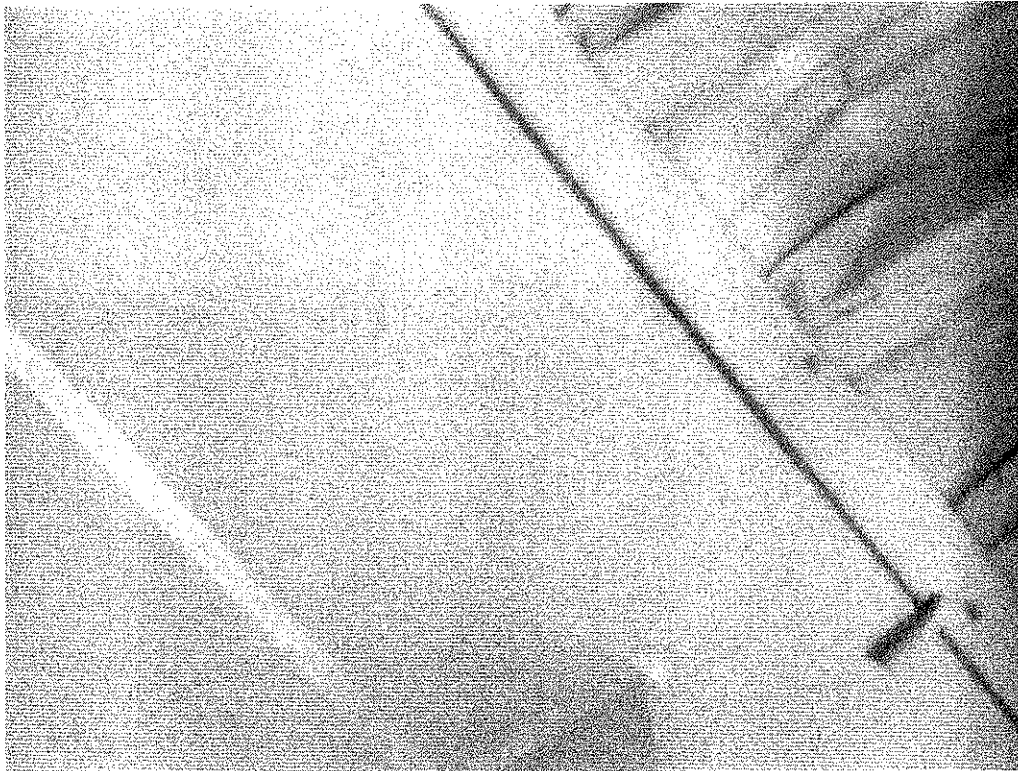
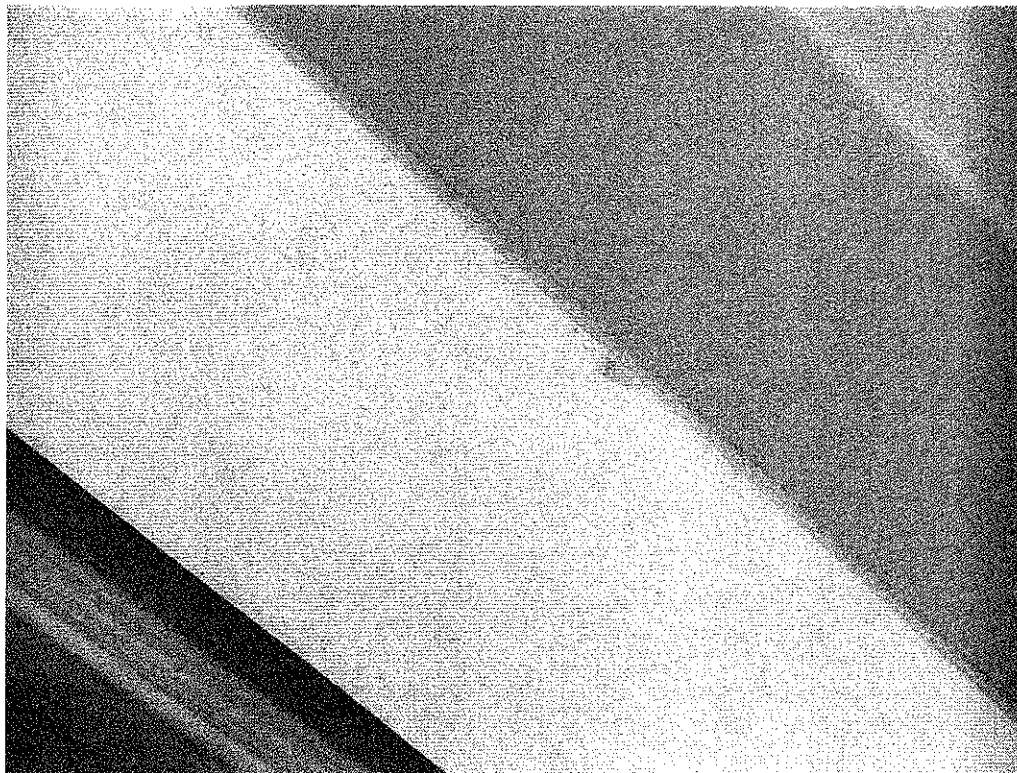
Photographs 8 through 14 show three-coat OZ/E/U Control Span 3, Bay 3, Year 3, 2009.  
Only very minor pinpoint rust was noted.

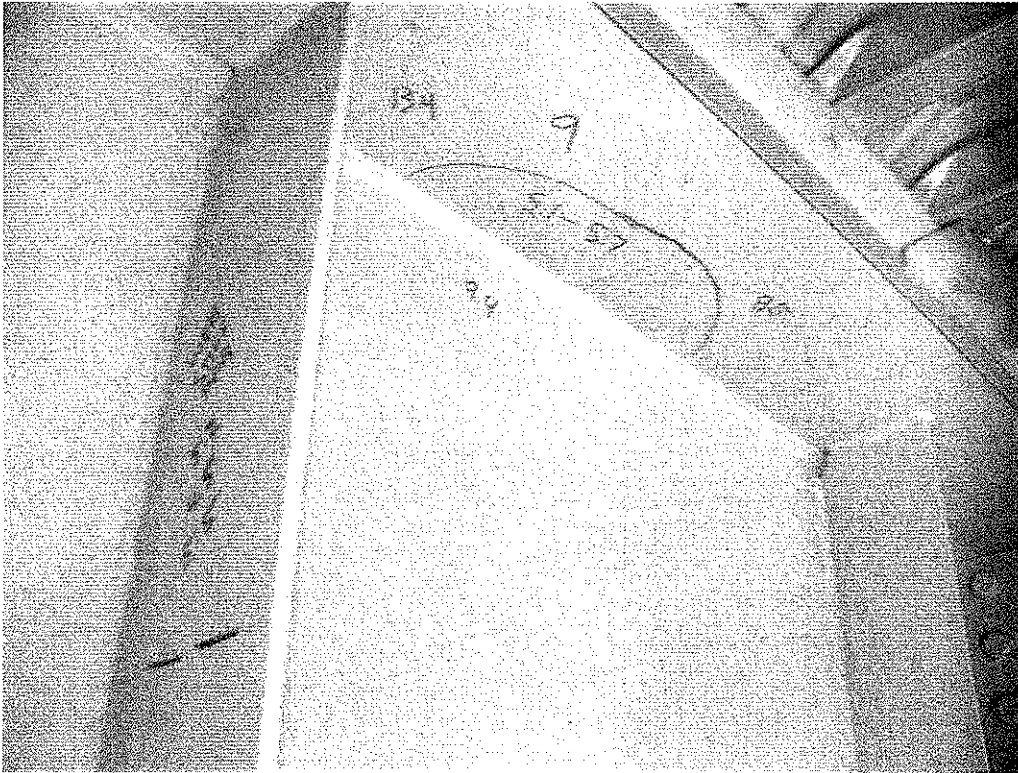
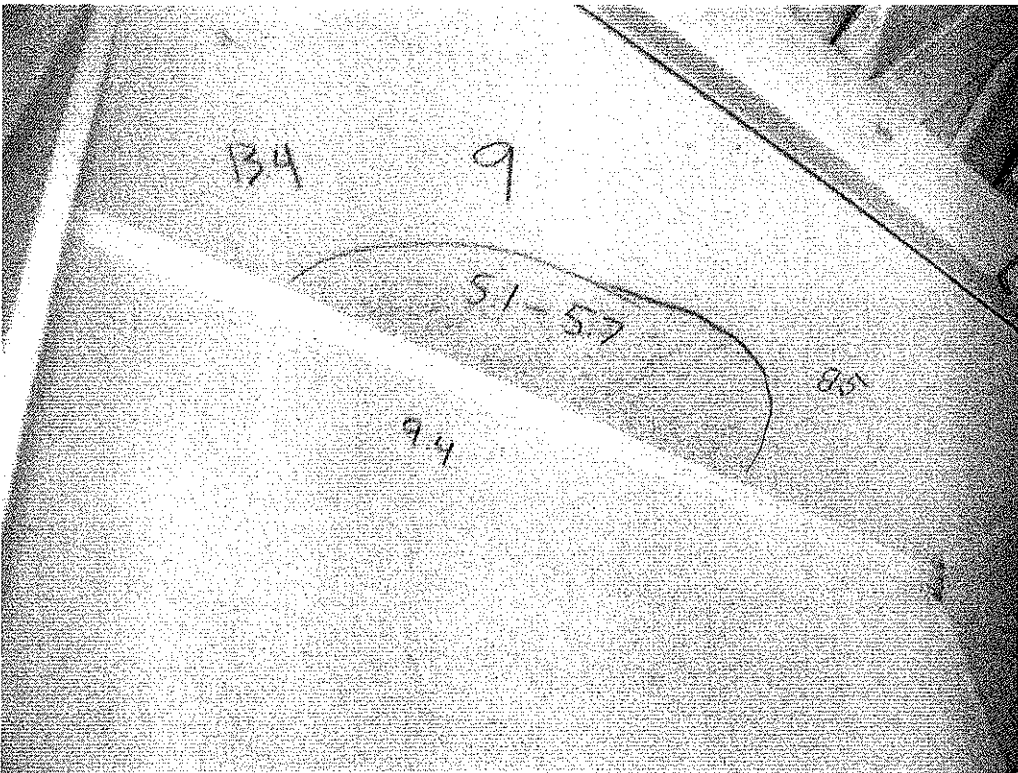
Photographs 15 through 18 shows dry film thickness measurement taken at pinpoint rust locations in two-coat OZ/U Control Span 3, Bays 1 & 2. Note that there was a definite correlation between the occurrence of pinpoint rust and the coating system dry film thickness. These issues are discussed in the "Discussion" section of this report.
