**Final Report**

State Study No. 140

**Evaluation of E-Krete for Rut Filling**

**Research Division Mississippi Department of Transportation**

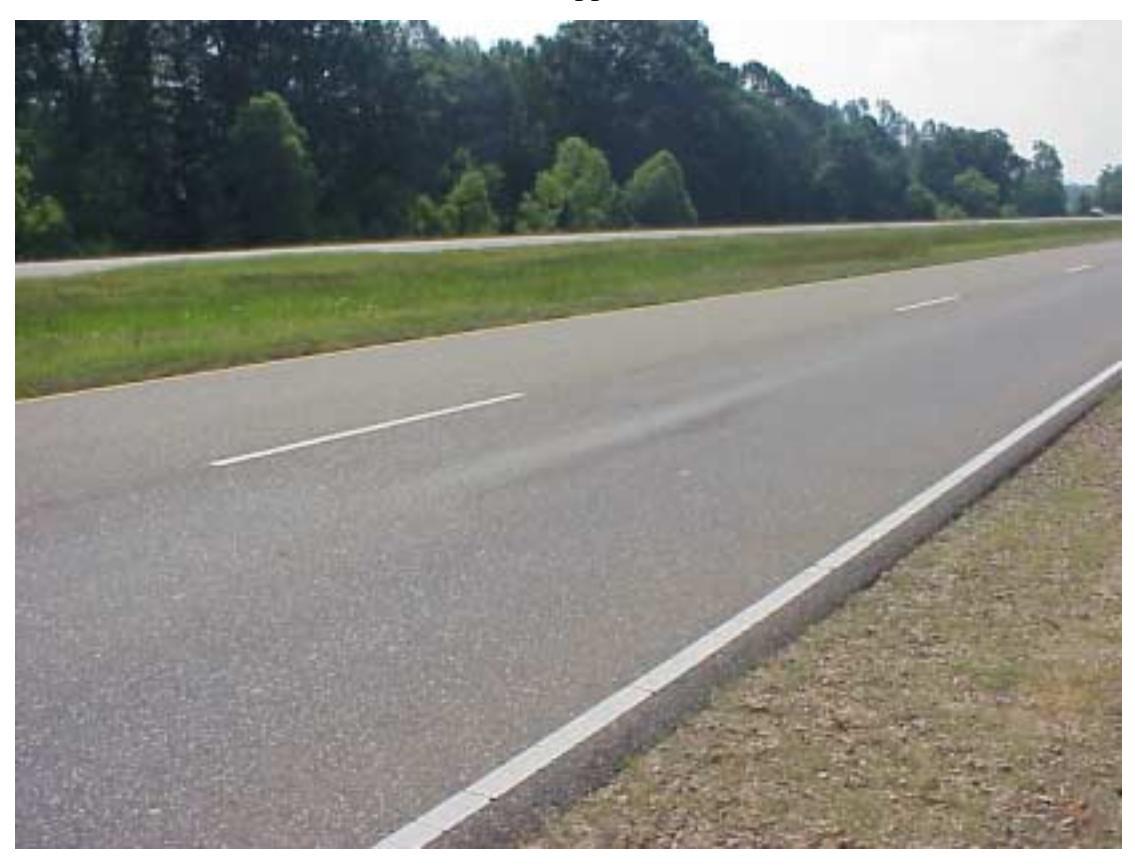
Figure 6 – Project location near Flora, MS prior to E-Krete application

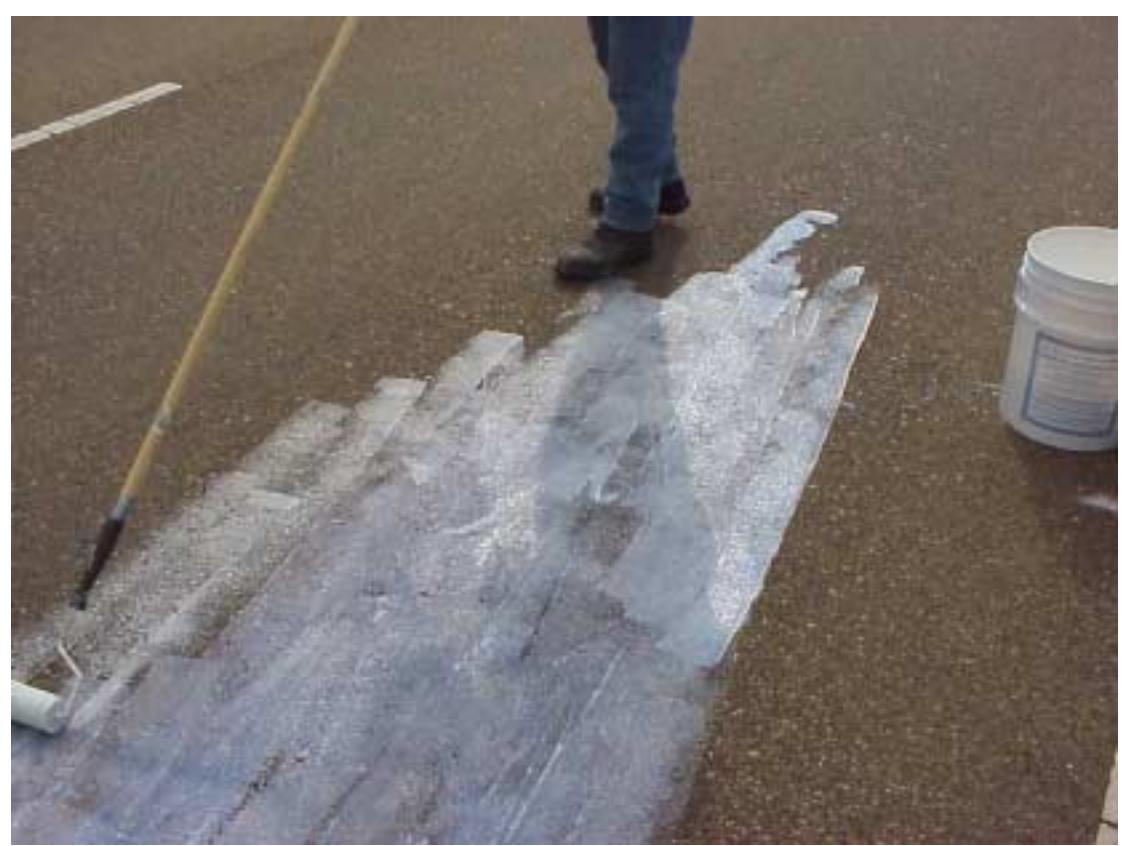
Figure 7 – Priming of the asphalt surface with the liquid solution component of E-Krete's three part system (liquid, dry mix & aggregate)

On September 14, 2000, construction of the evaluation section began. The contractor, Polycon Inc., elected not to perform any surface cleaning of the existing asphalt surface prior to application of the product. A portion of the test section was primed in the wheel path with the liquid component of the E-Krete system (See Figure 7). During the priming process, the three components (liquid, dry mix & aggregate) of the product were mixed in a mortar mixer. Upon completion of the priming, a 4' wide screed assembly was utilized to apply the E-Krete mixture to the wheel paths (See Figure 8). Production was slow with many starts and stops due to the small amount of E-Krete that could be mixed using the contractor's equipment. These delays caused indentions to be placed transversely by the screed and produced a "weak plane" which led to premature cracking (See Figure 9).

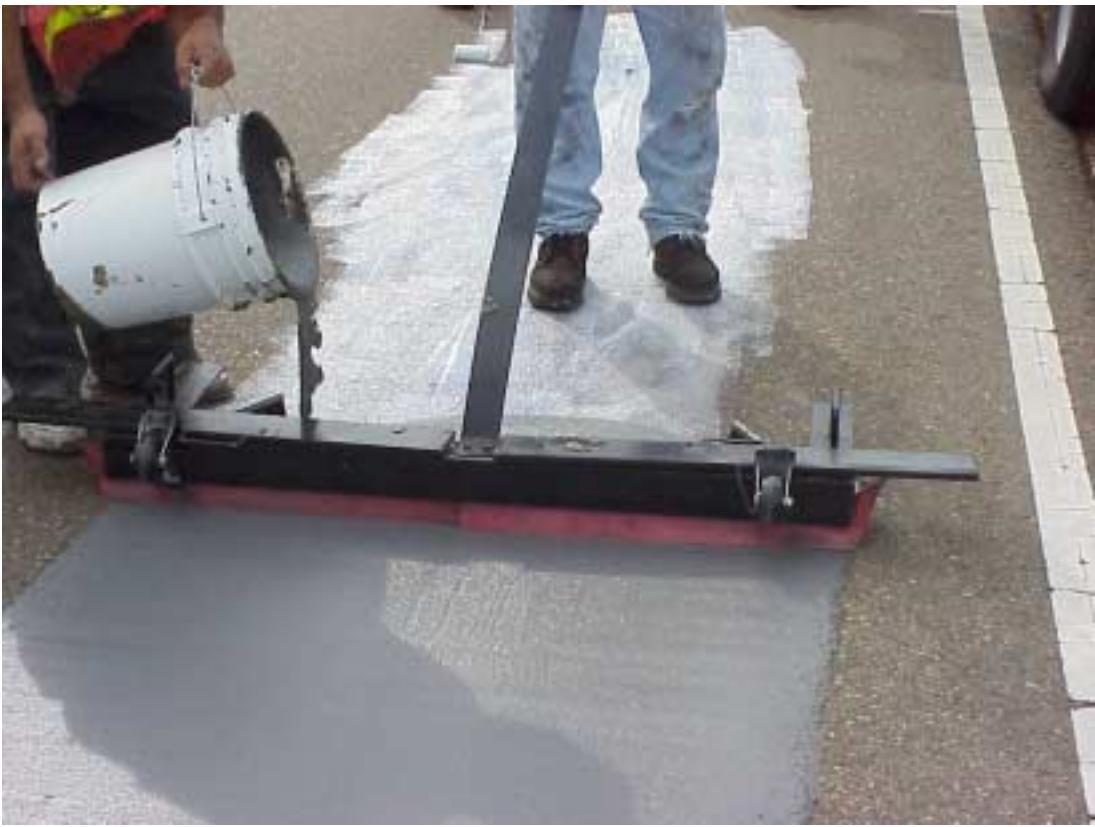
Figure 8 – 4 foot wide screed application for initial application of E-Krete

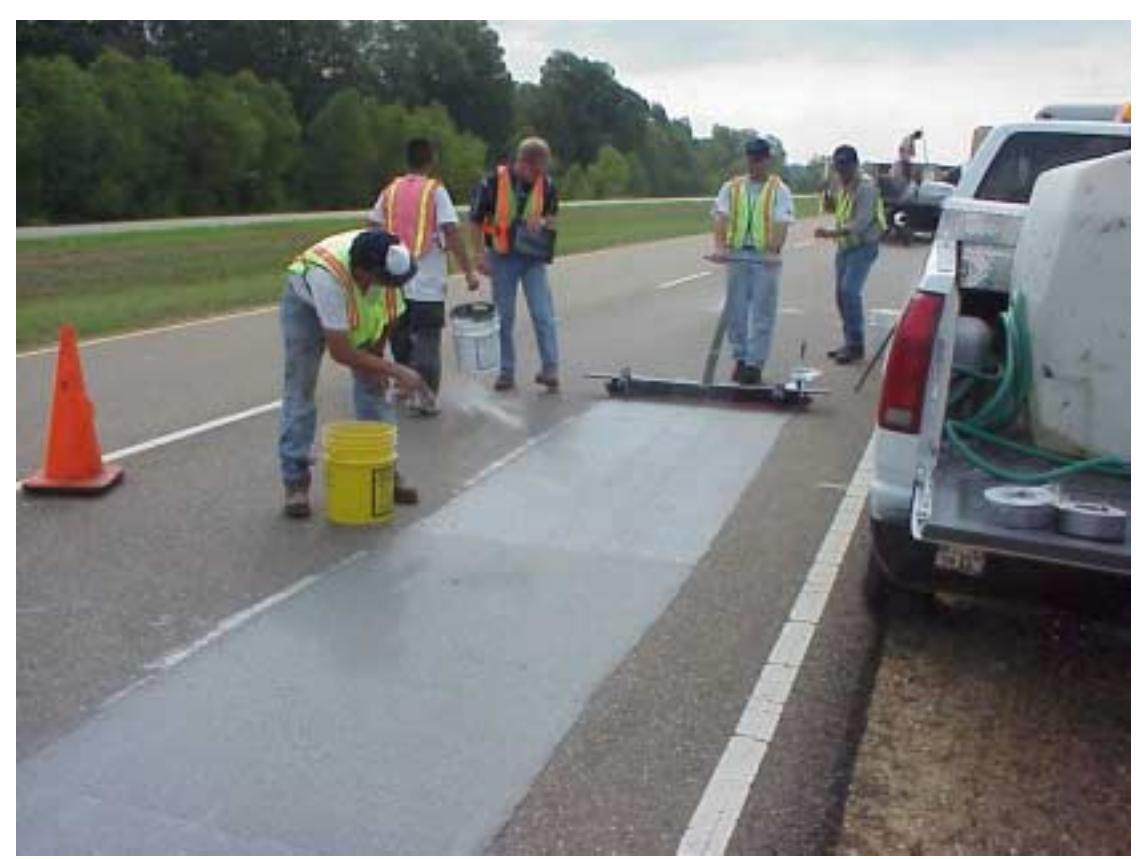
Figure 10 - Broadcasting of Georgia granite on fresh E-Krete for skid resistance

Georgia granite was broadcast behind the screed to improve the skid resistance of the E-Krete surface. This was necessary since traffic would be placed on this lift of E-Krete prior to the application of the final 10'-6" wide surface application.

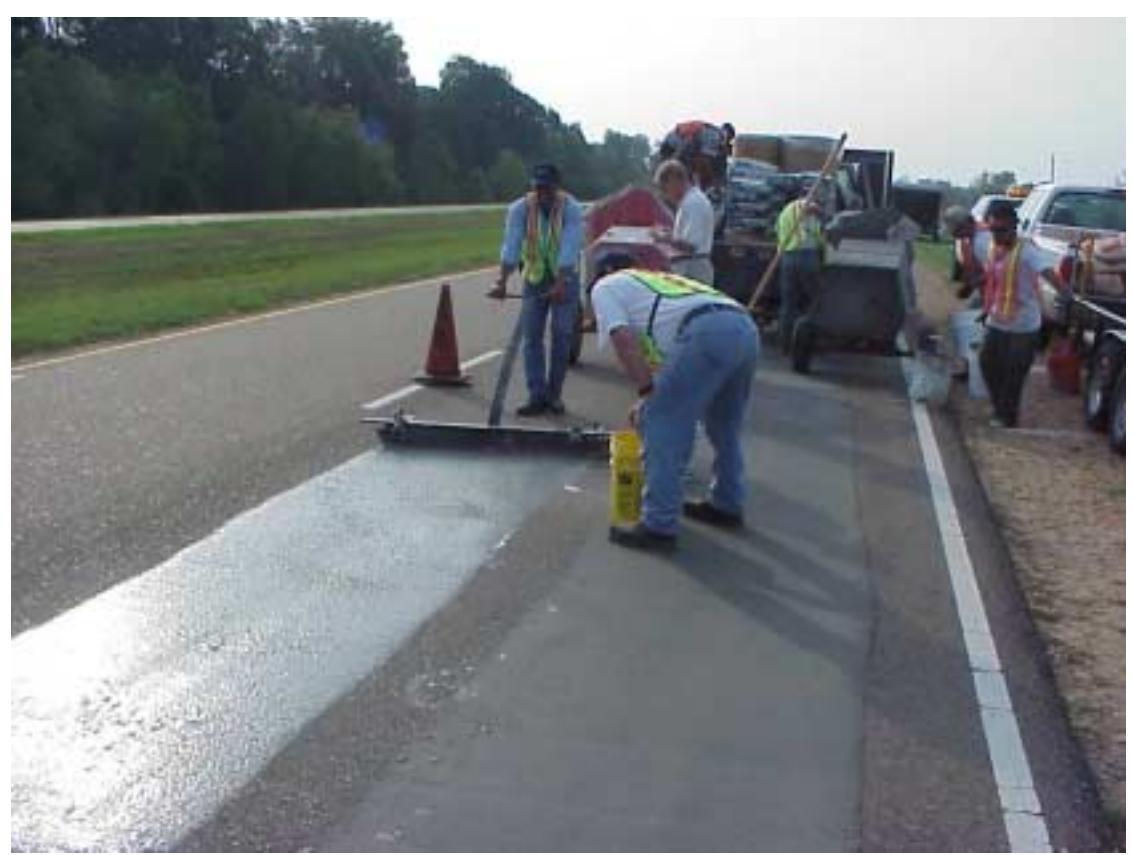
Figure 11 – Second day of construction utilizing two mortar mixers

the increased level of production, the screed was stopping too often to provide a smooth riding surface. During the second day of production, the inside wheel path from Sta. 456+00 to Sta. 450+25 was applied with E-Krete. Before the days activities were completed, the outside wheel path from Sta. 450+25 to Sta 447+75 was also given its initial coat of E-Krete. Once again the E-Krete was allowed to cure for 2 hours before the onset of traffic.

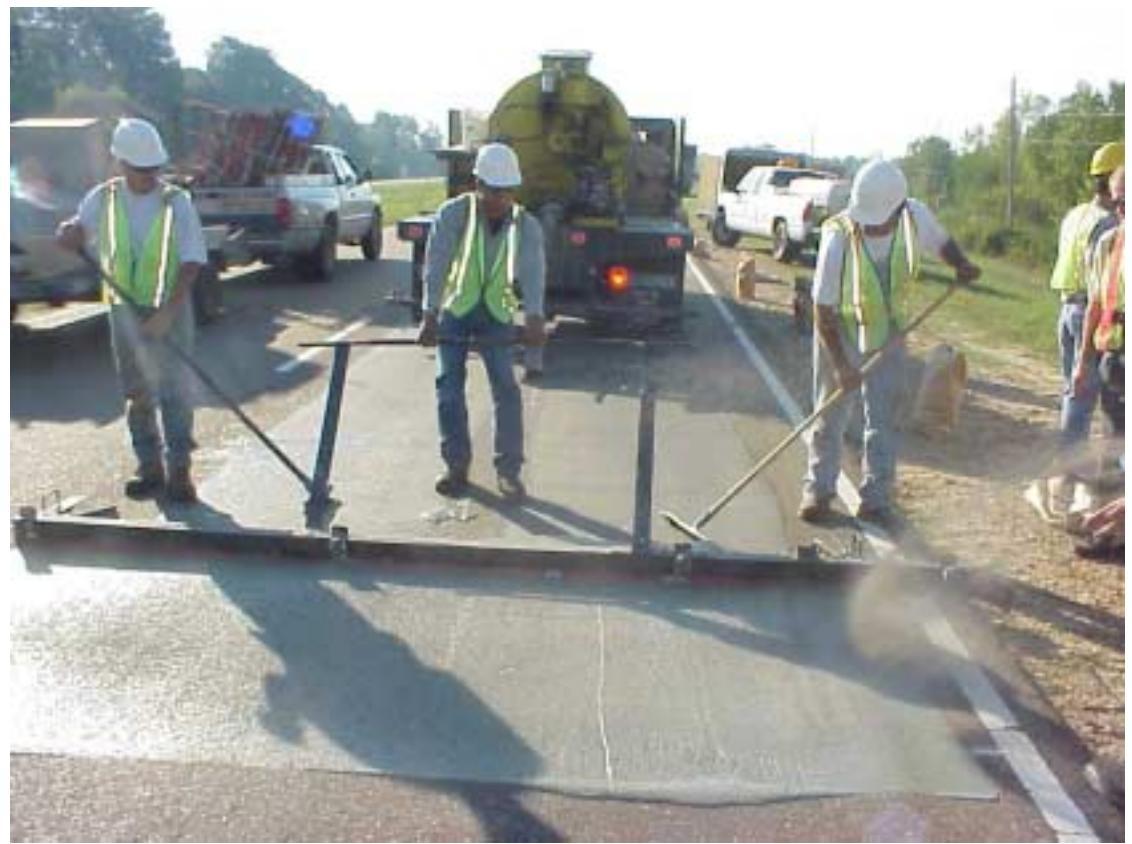
Figure 12 - 10'-6'' Screed utilized for the final surface application

Arkansas granite was broadcast on the wet surface of the E-Krete to ensure adequate surface friction. Utilizing the 540 gallon tank provided a production rate of approximately 800 feet of 10'-6" wide E-Krete per hour. This higher rate of production minimized the need to stop the screed and provided a more acceptable final surface.

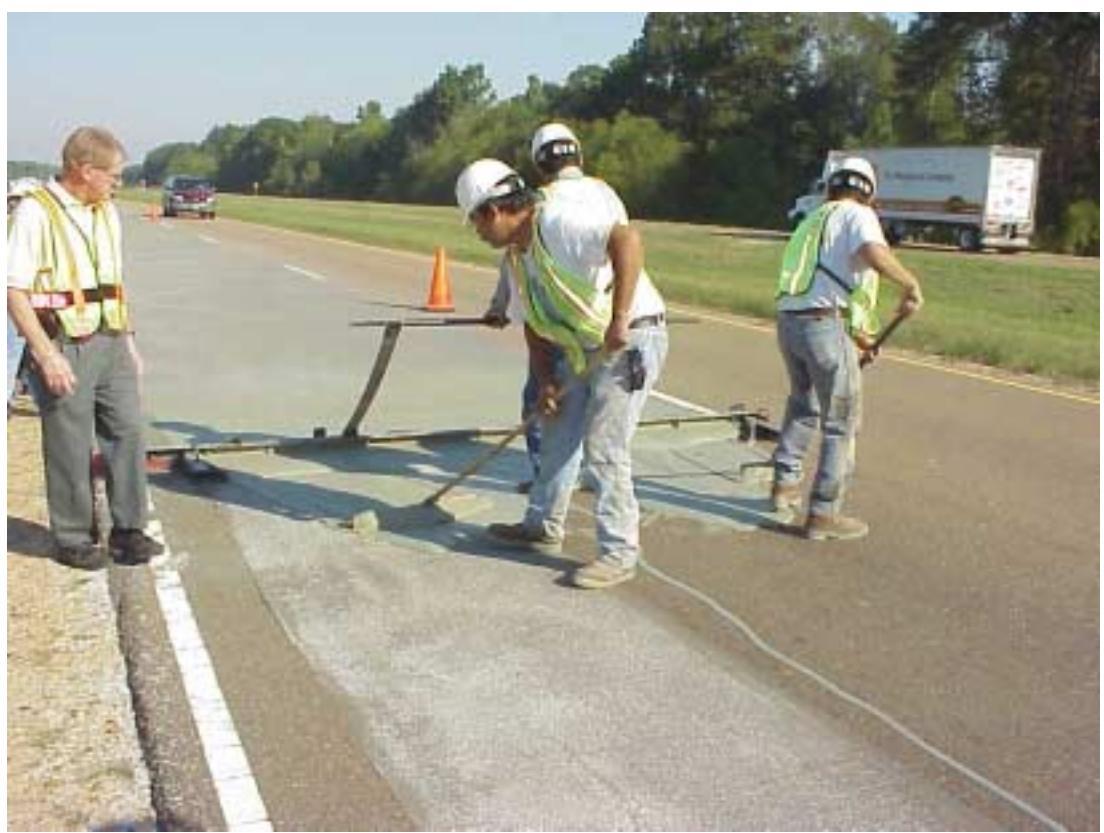
Figure 13 – Using squeegees to distribute E-Krete ahead of the 10'-6" screed

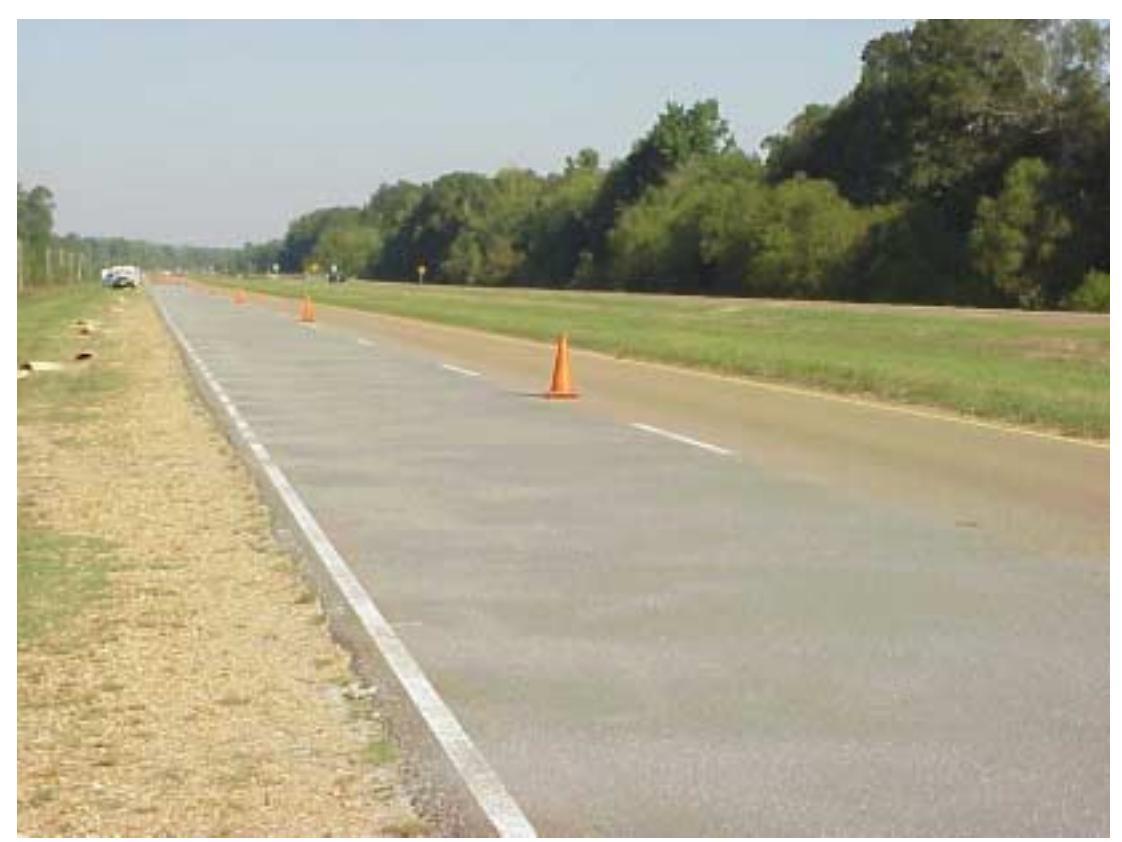
Figure 14 – Completed E-Krete application

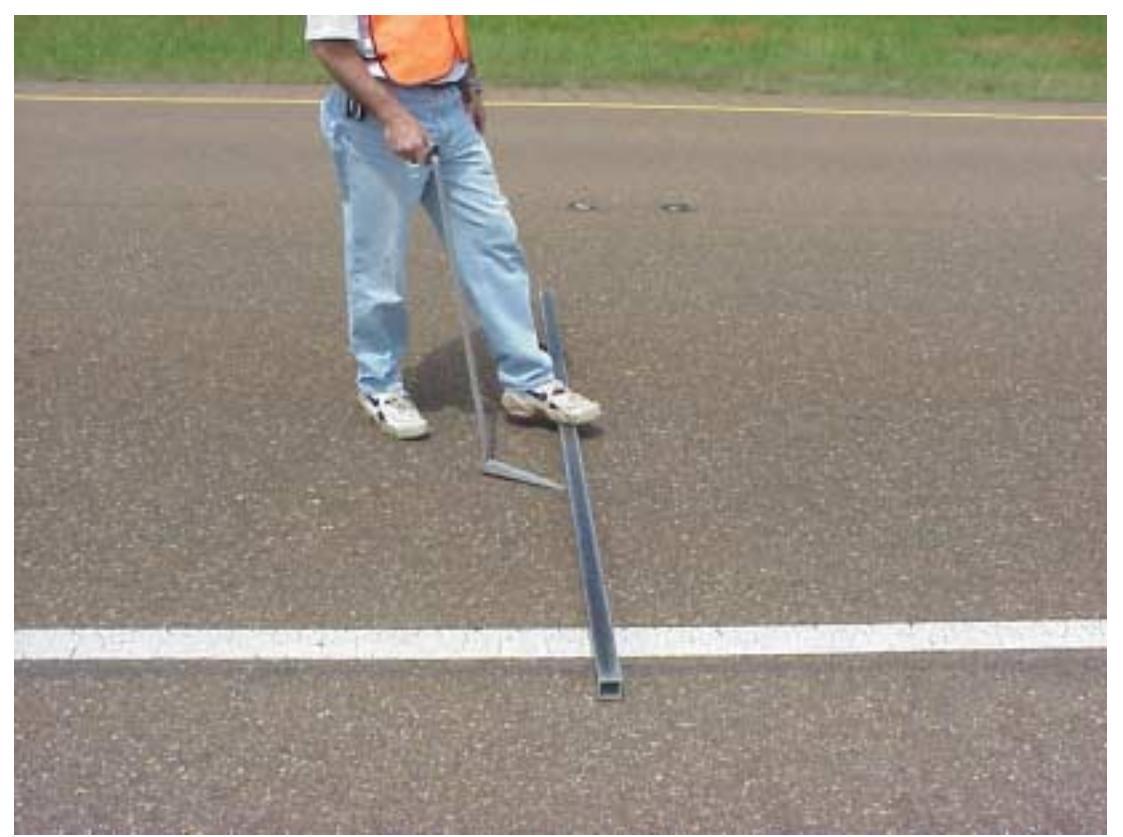
Figure 17 – Manual Rut Measurement

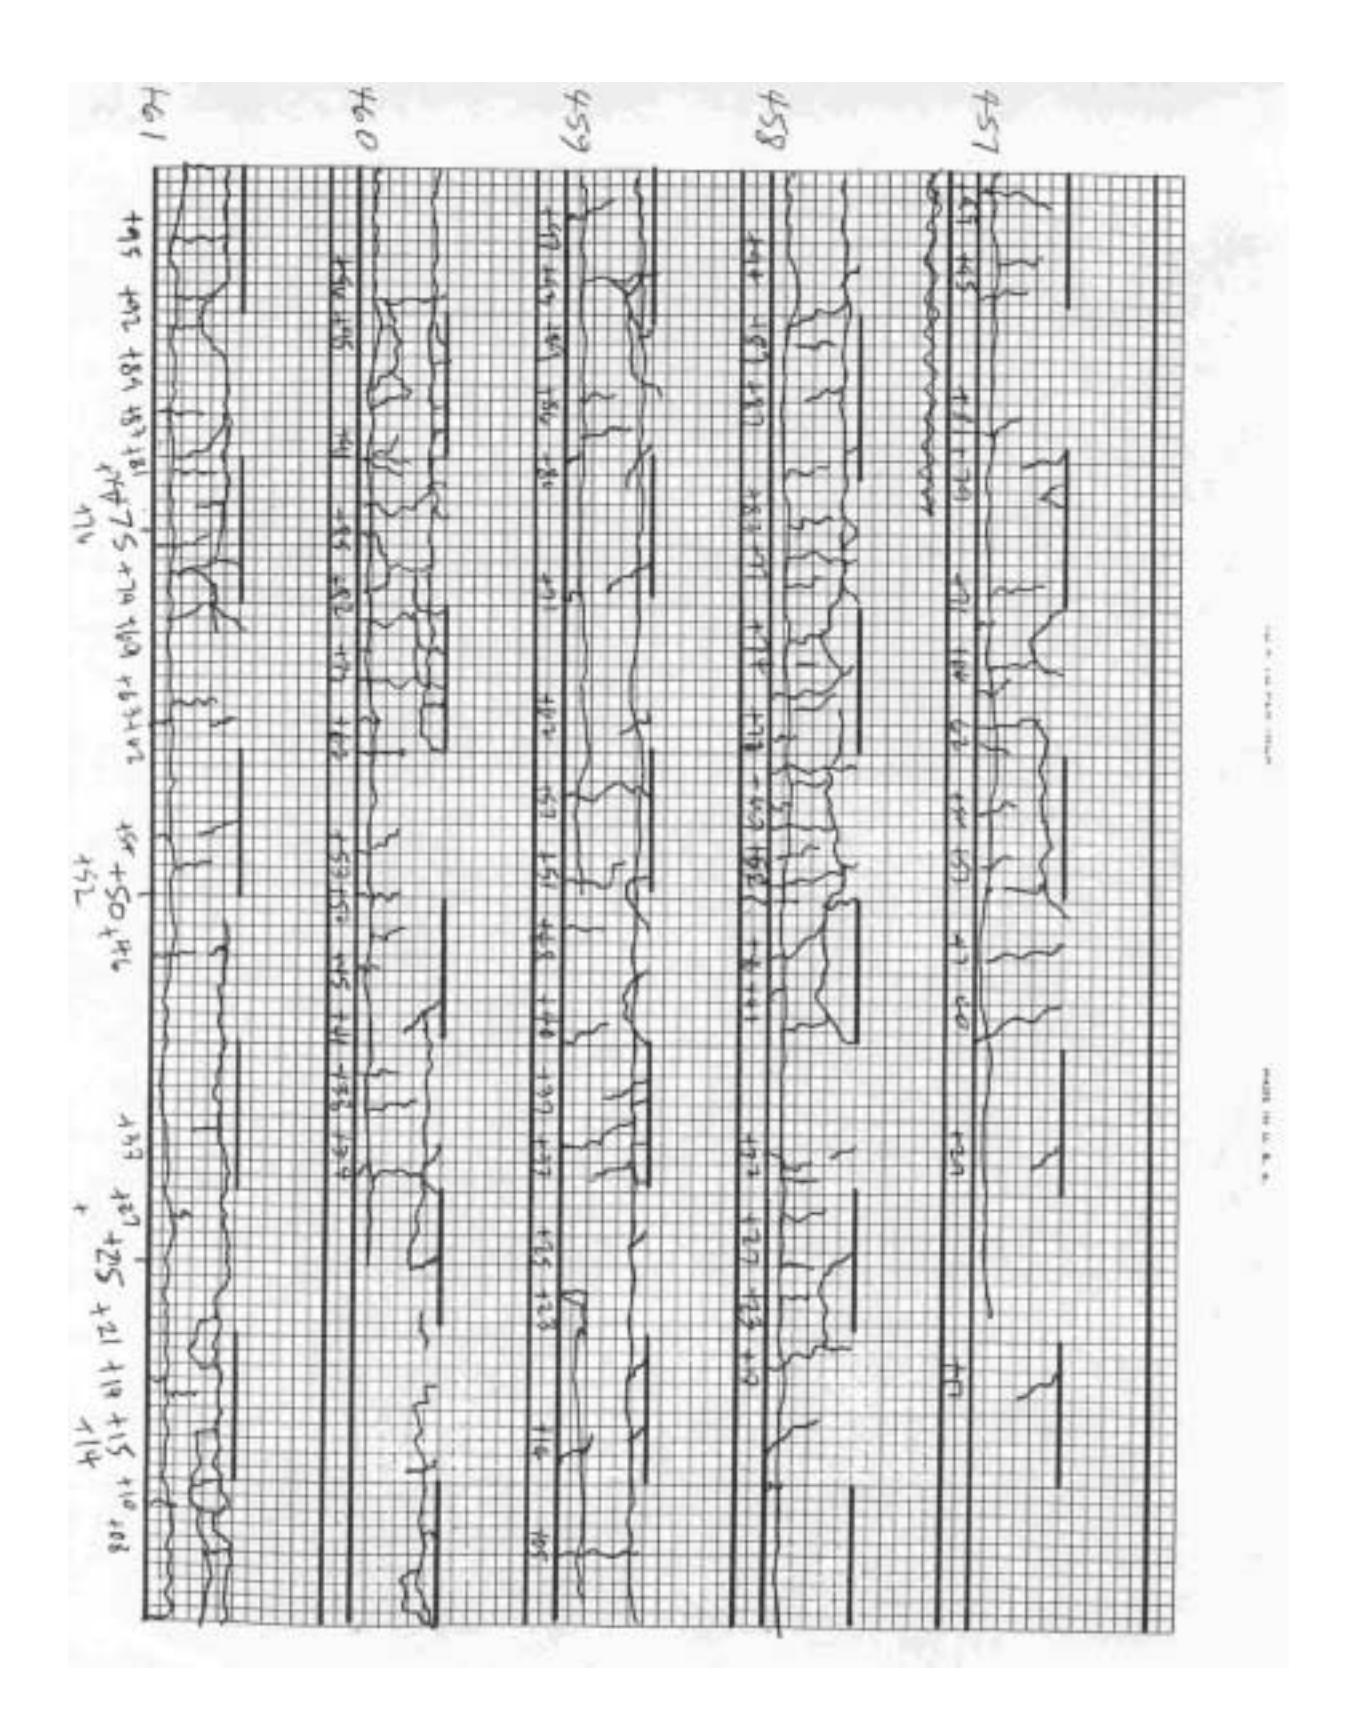
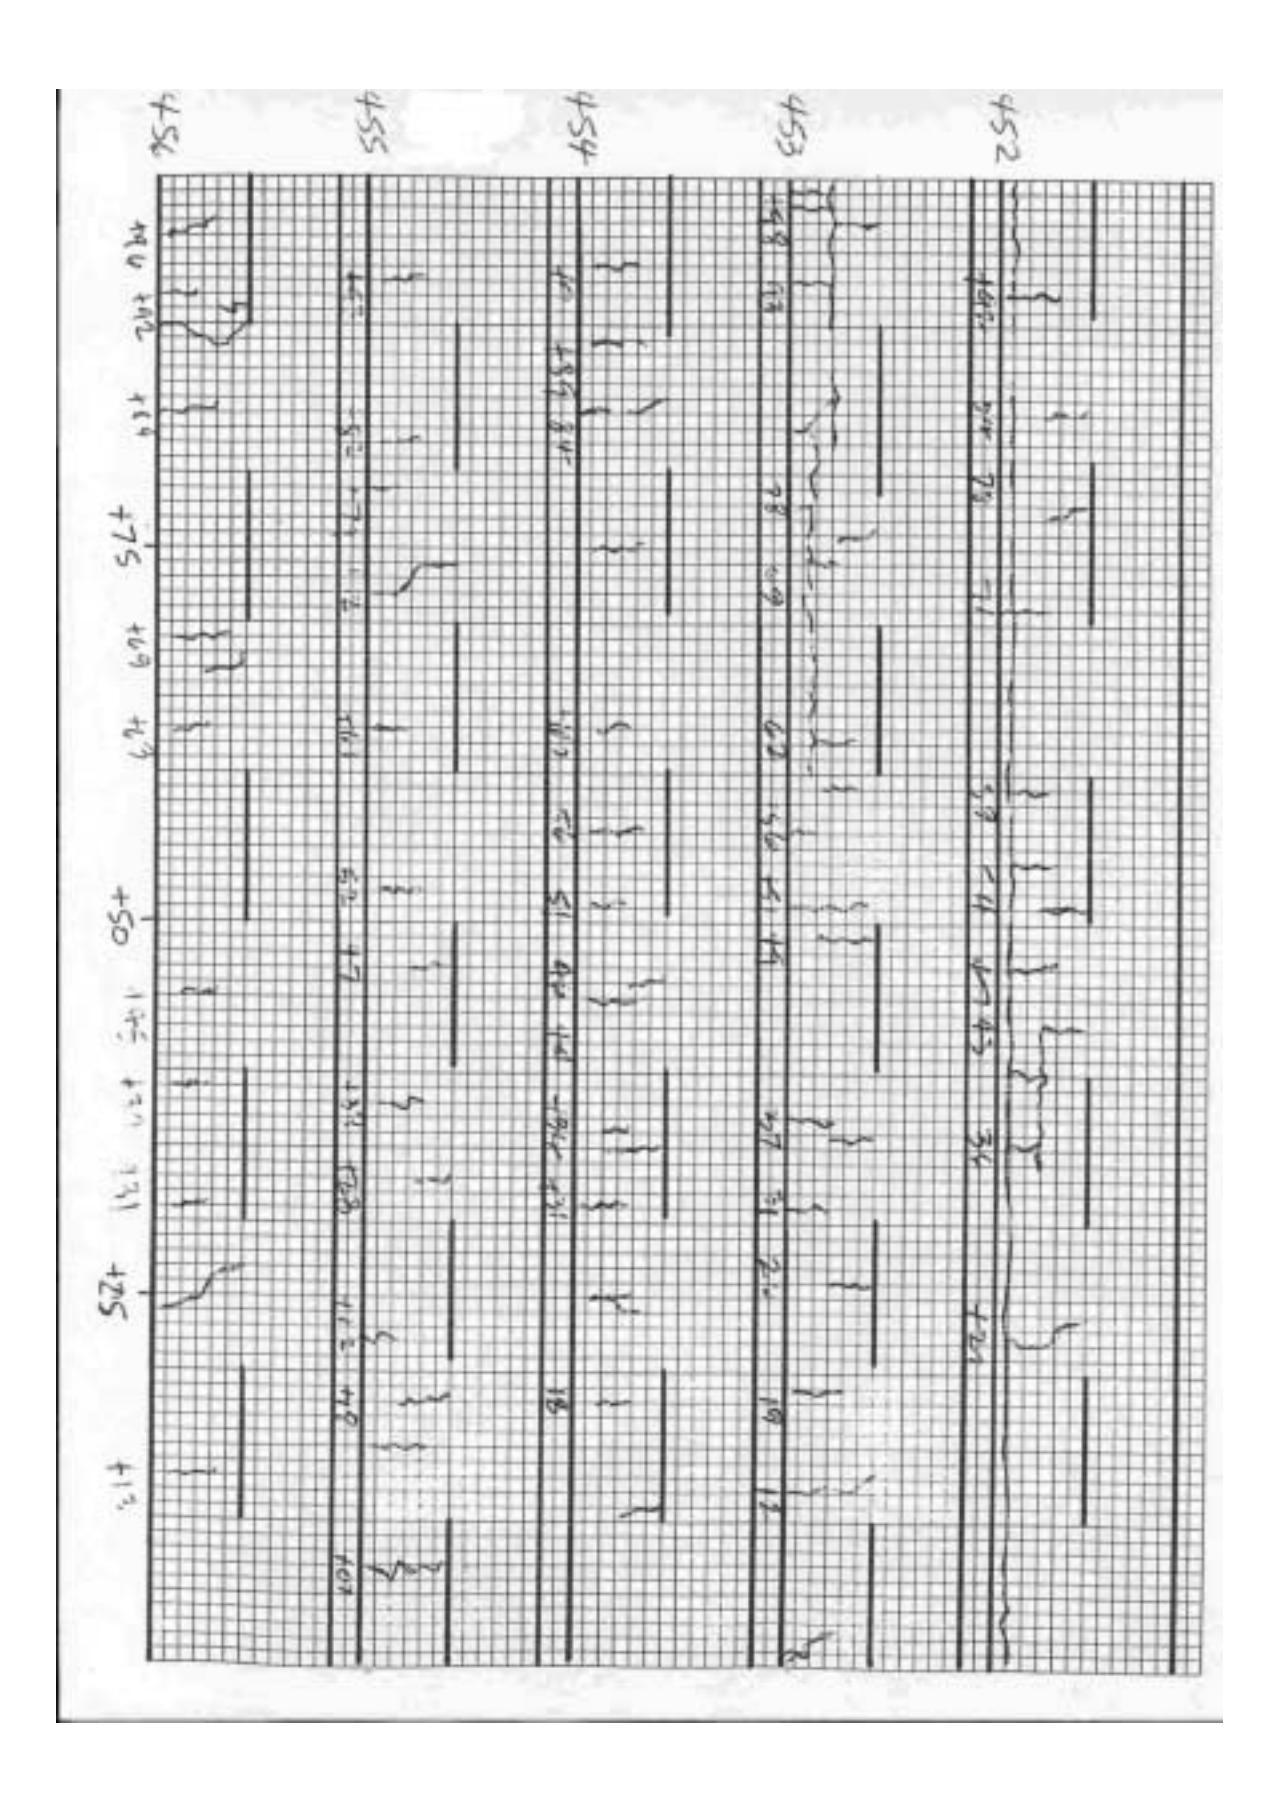
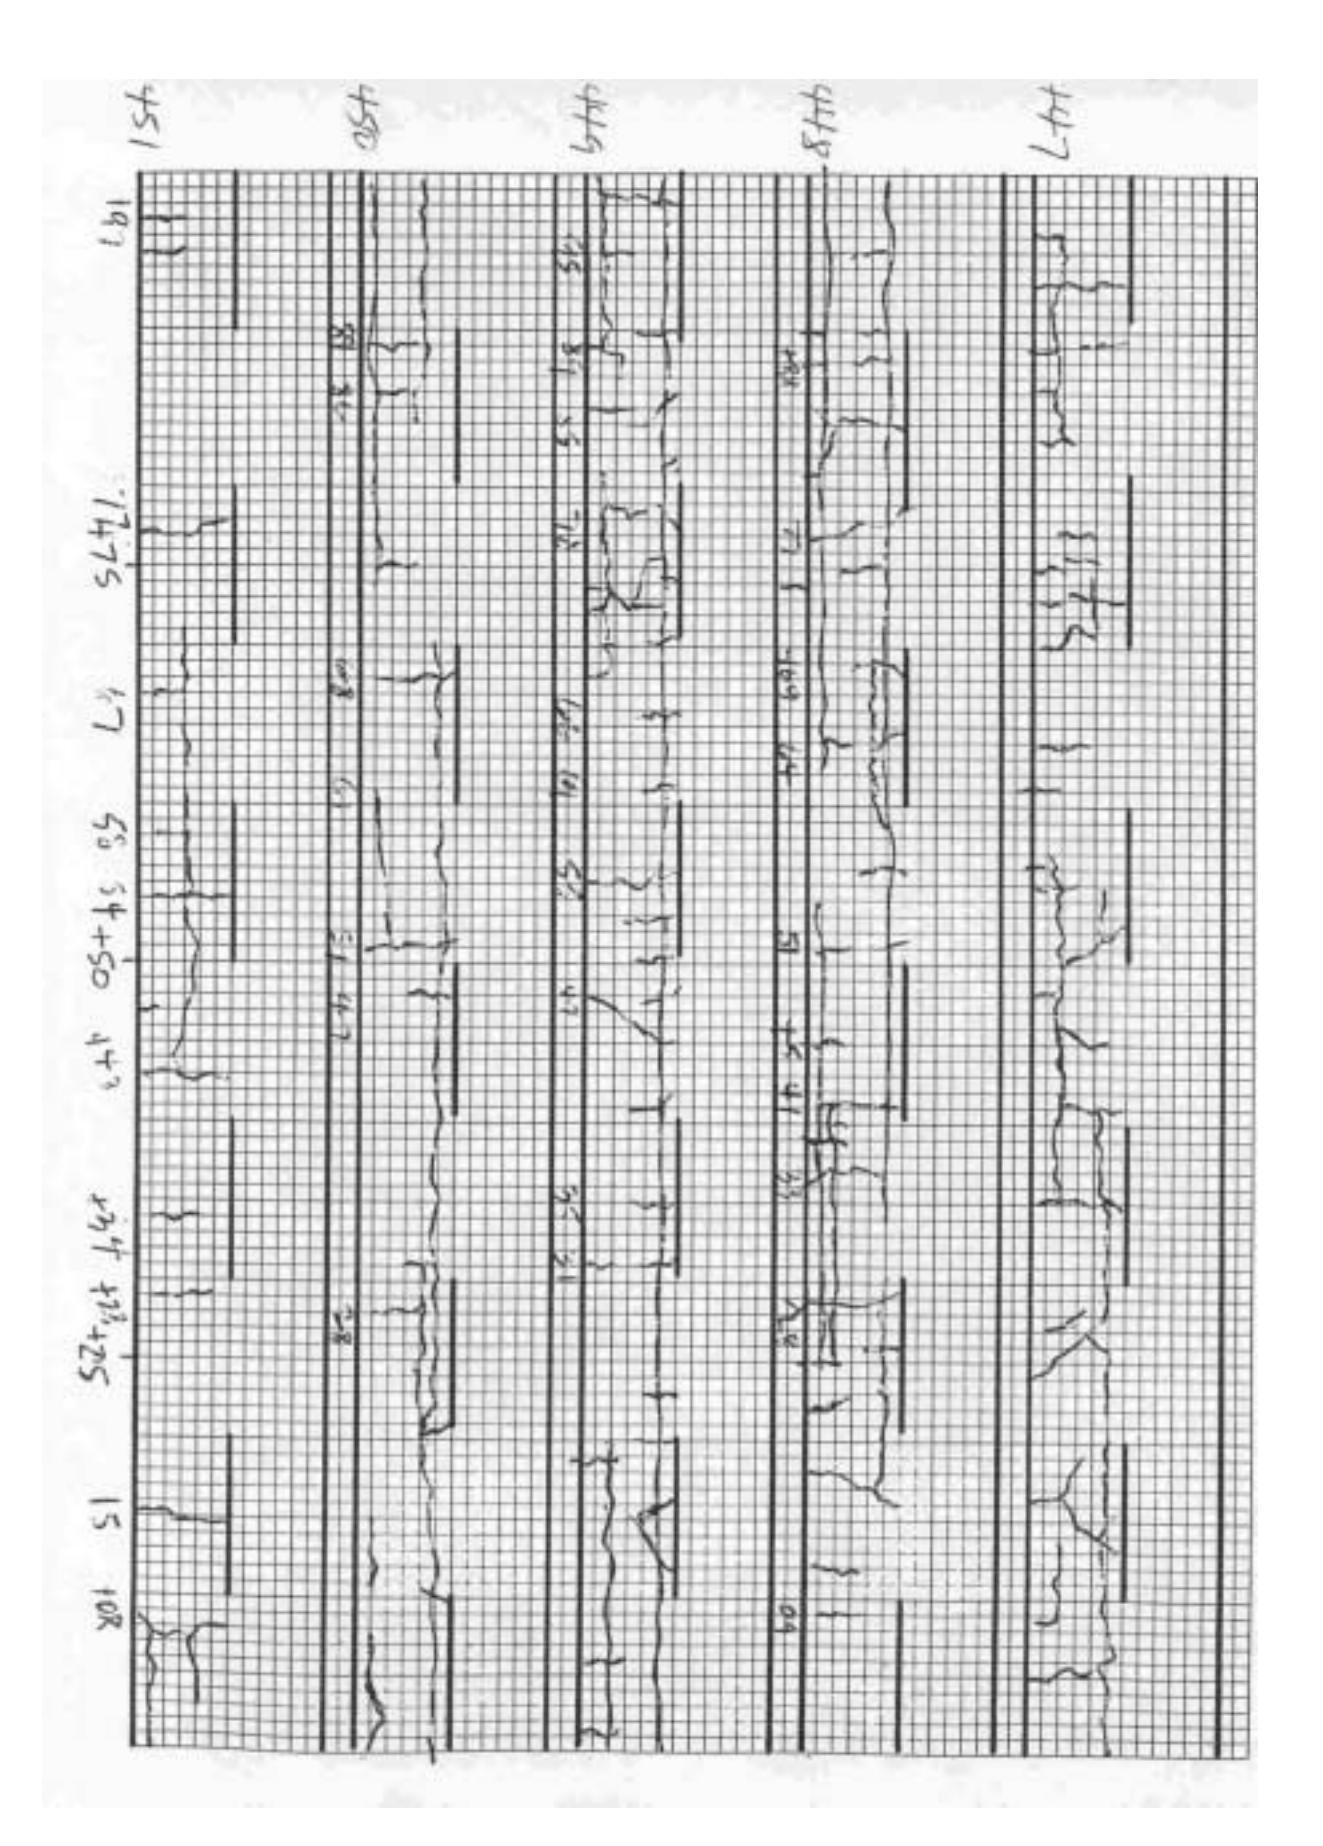
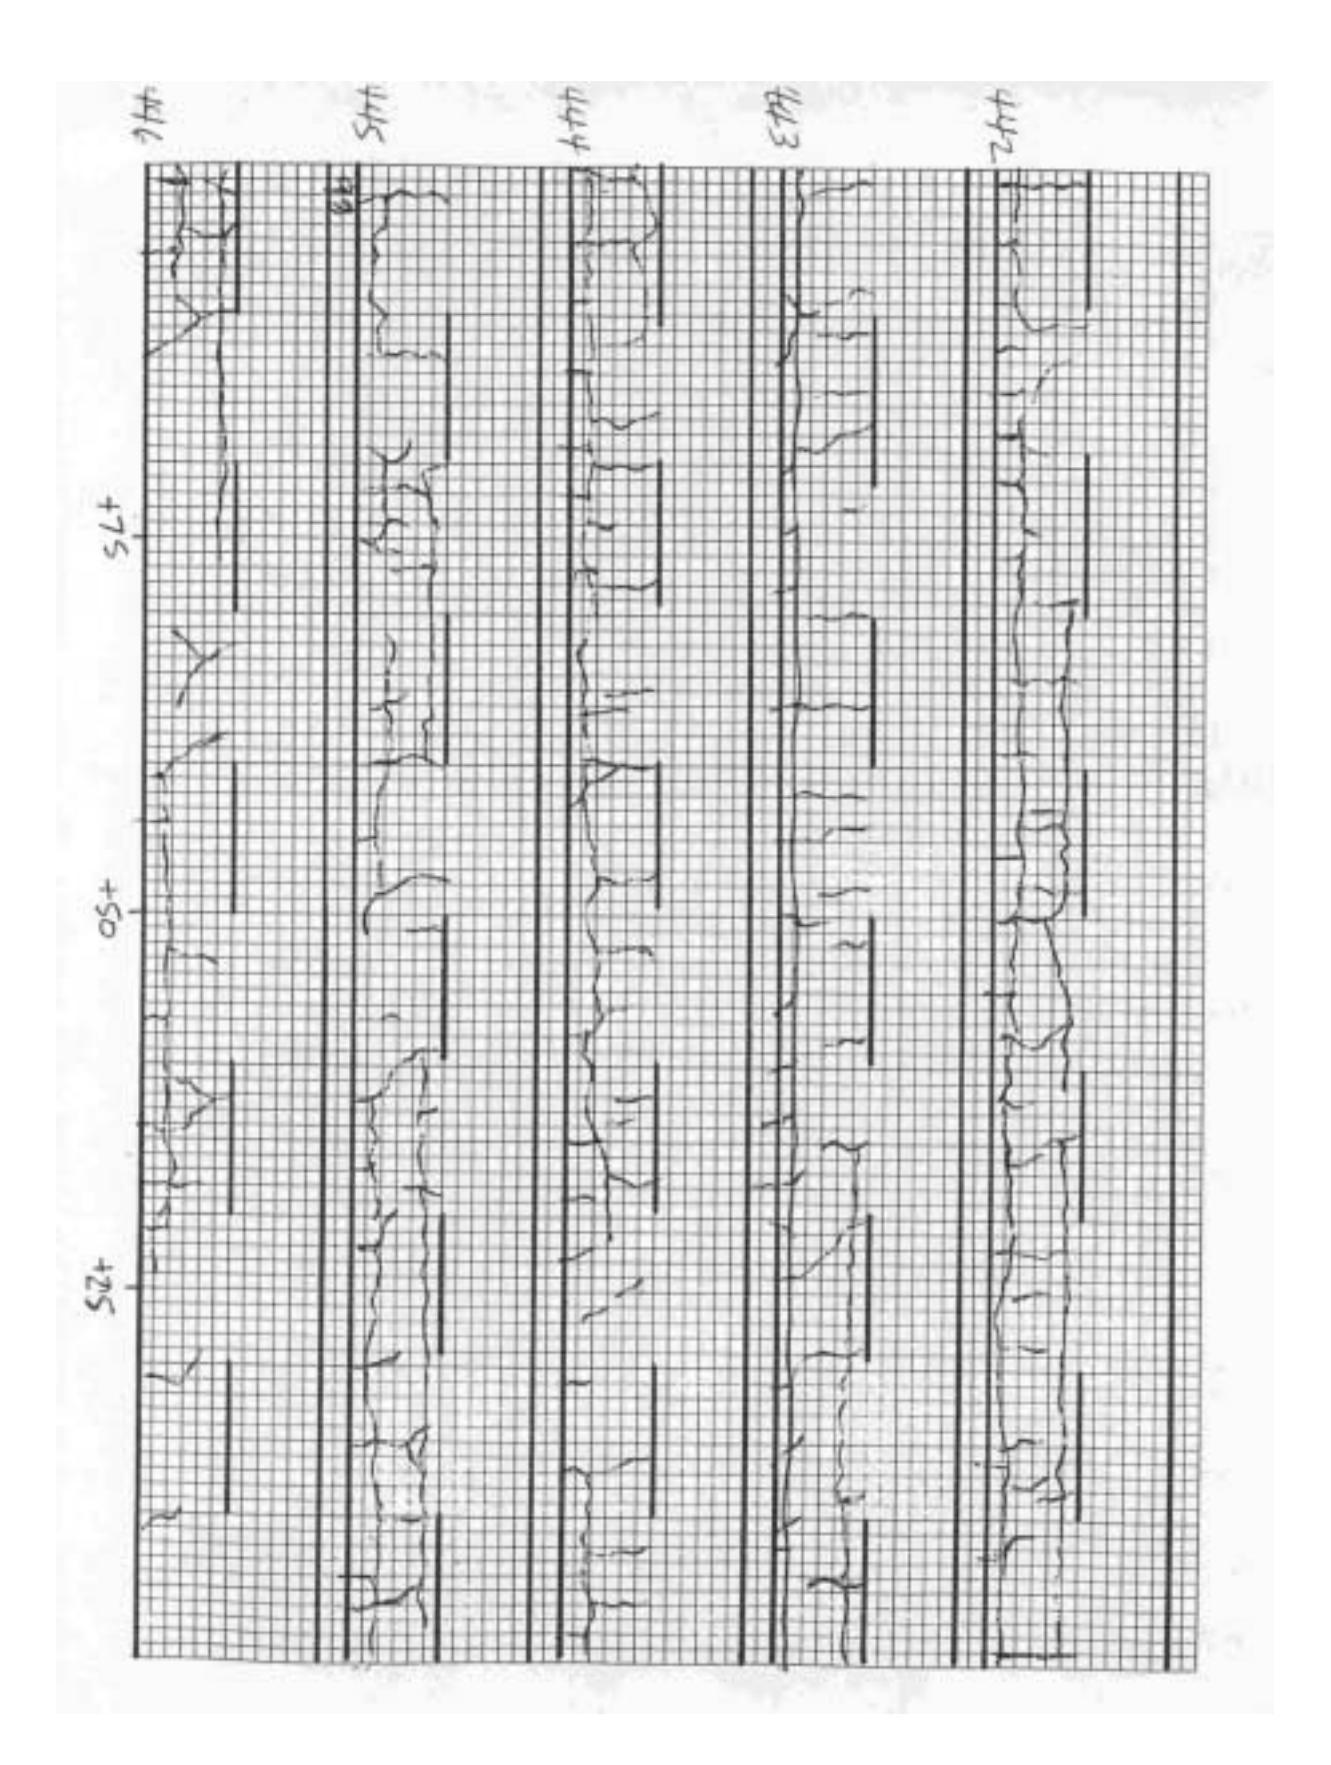
# **CRACK MAPPING FROM U.S. 49 EVALUATION**

Given the performance of the initial E-Krete trial on Interstate 55 near Winona, MS, MDOT was interested in determining if the U.S. 49 test in Madison County would suffer a similar fate. Approximately one year after the application of E-Krete, MDOT surveyed the entire evaluation section for cracking. Appendix D contains the results of that survey.
