# **PHASE II DEVELOPMENT OF A NON- PROPRIETARY, FOUR-CABLE, HIGH TENSION MEDIAN BARRIER**

## **MIDWEST ROADSIDE SAFETY FACILITY**

MwRSF Research Report No. TRP-03-253-12

March 21, 2012

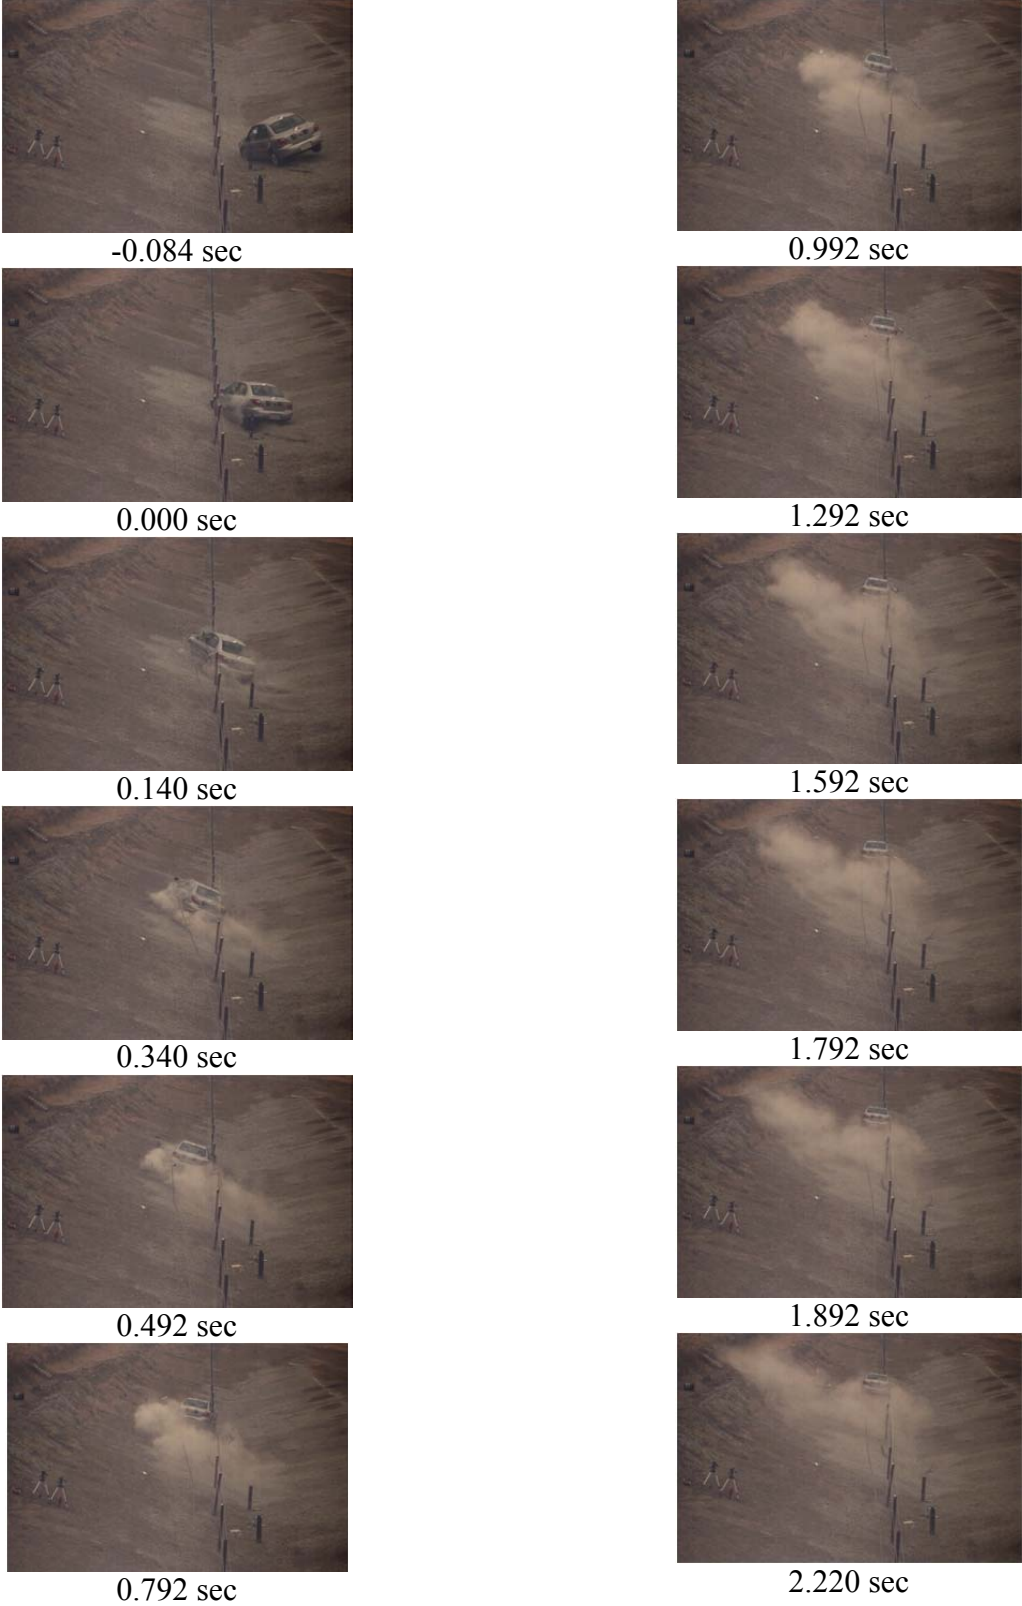
Figure 38. Additional Sequential Photographs, Test No. 4CMB-4

Test no. 4CMB-4 was a repeat of test no. 4CMB-3 with redesigned cable-to-post attachments. The 2,574-lb (1,168-kg) passenger car impacted the four cable median barrier 4 ft (1.2 m) laterally up from the bottom of the ditch on the backslope at a speed of 61.1 mph (98.4 km/h). The passenger car entered the slope at an angle of 25.8 degrees and impacted the barrier at an angle of 25.7 degrees. A summary of the test results and sequential photographs are shown in Figure 36. Additional sequential photographs are shown in Figures 37 through 39.

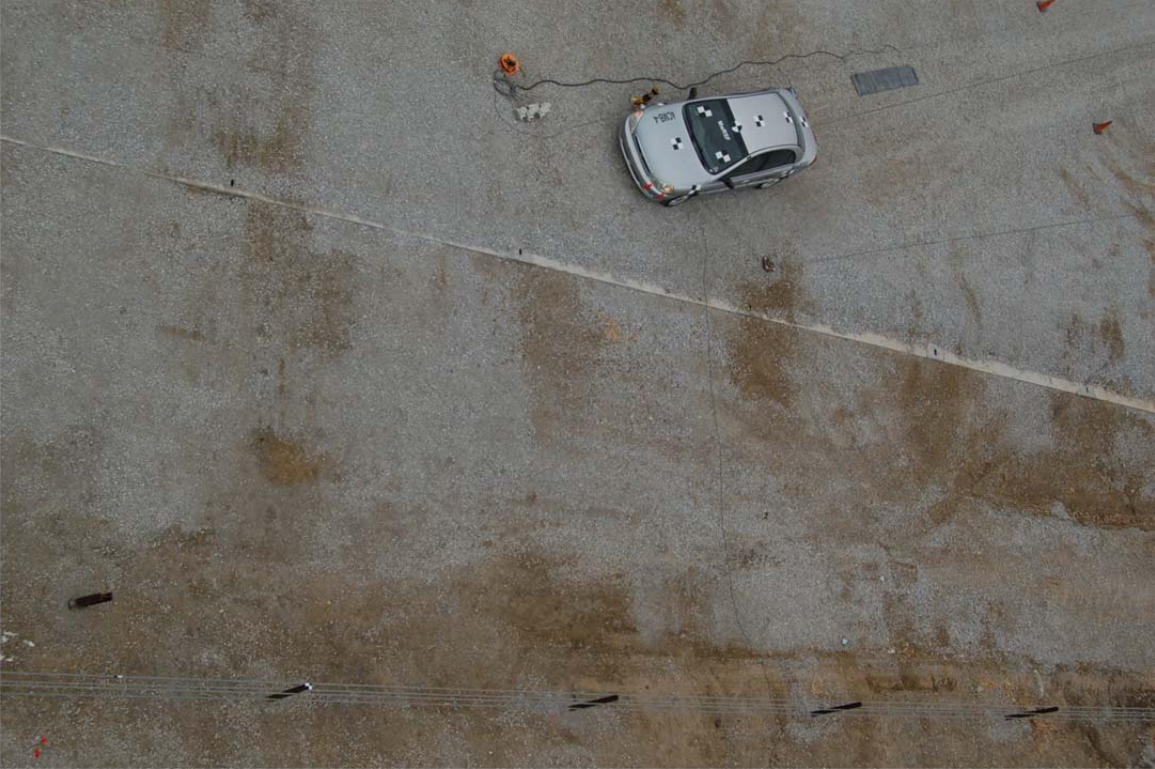
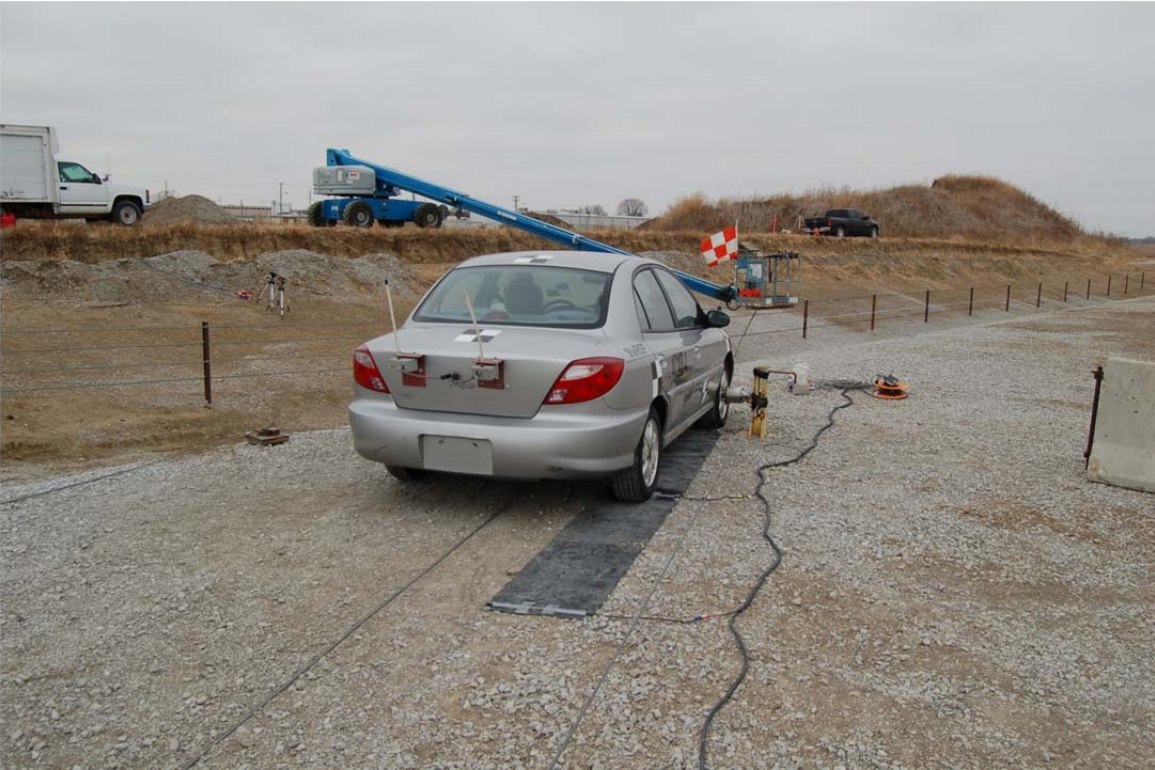
Figure 40. Impact Location, Test No. 4CMB-4

Initial vehicle impact was to occur 5 ft – 4 in. (1.6 m) downstream of post no. 16, as shown in Figure 40, which was selected using an analysis of the vehicle trajectory over the slope to maximize the potential for vehicle underride. The actual point of impact was 5 ft – 4in. (1.6 m) downstream of post no. 16. A sequential description of the impact events is contained in Table 5. The cables were numbered from 1 to 4, from the top to bottom, respectively. The vehicle came to rest parallel to the system captured in the cables 85 ft – 8 in. (26.1 m) downstream and 4 ft – 4 in. (1.3 m) to the left of the initial impact. The vehicle trajectory and final position are shown in Figures 36 and 41.

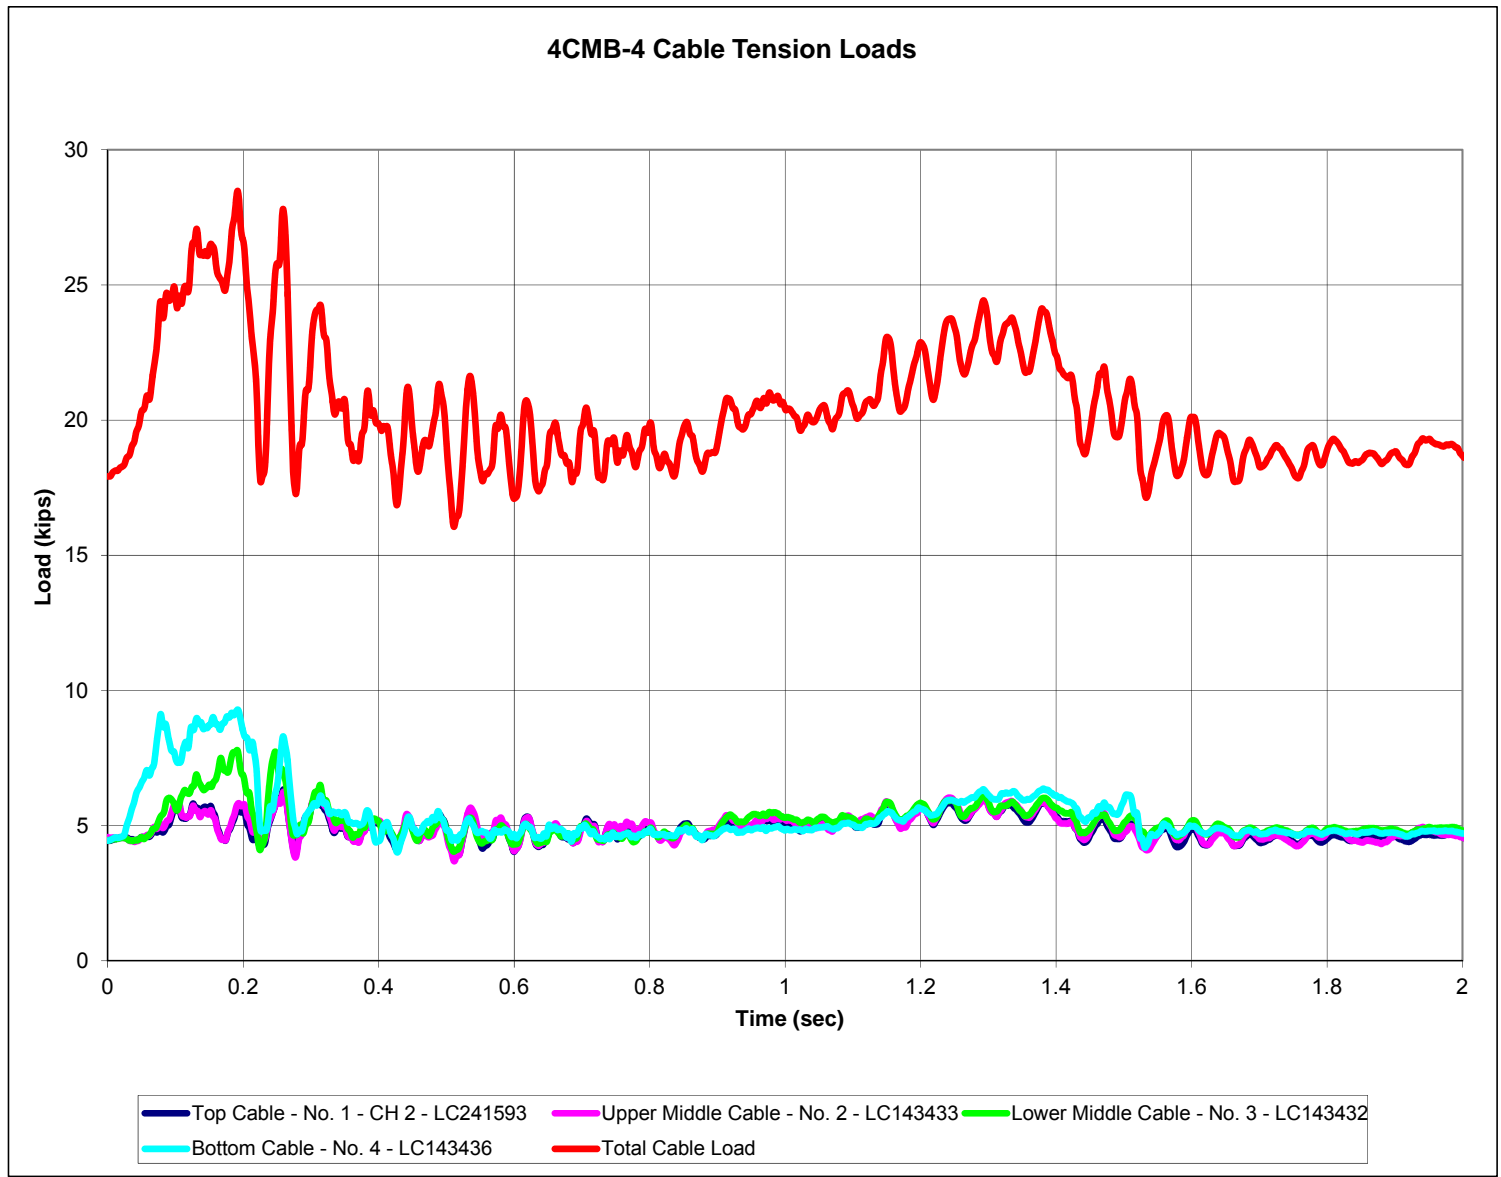
Figure 49. Cable Tension vs. Time, Test No. 4CMB-4

along with the total combined cable load imparted to the upstream end anchor, were determined and are shown graphically in Figure 49.

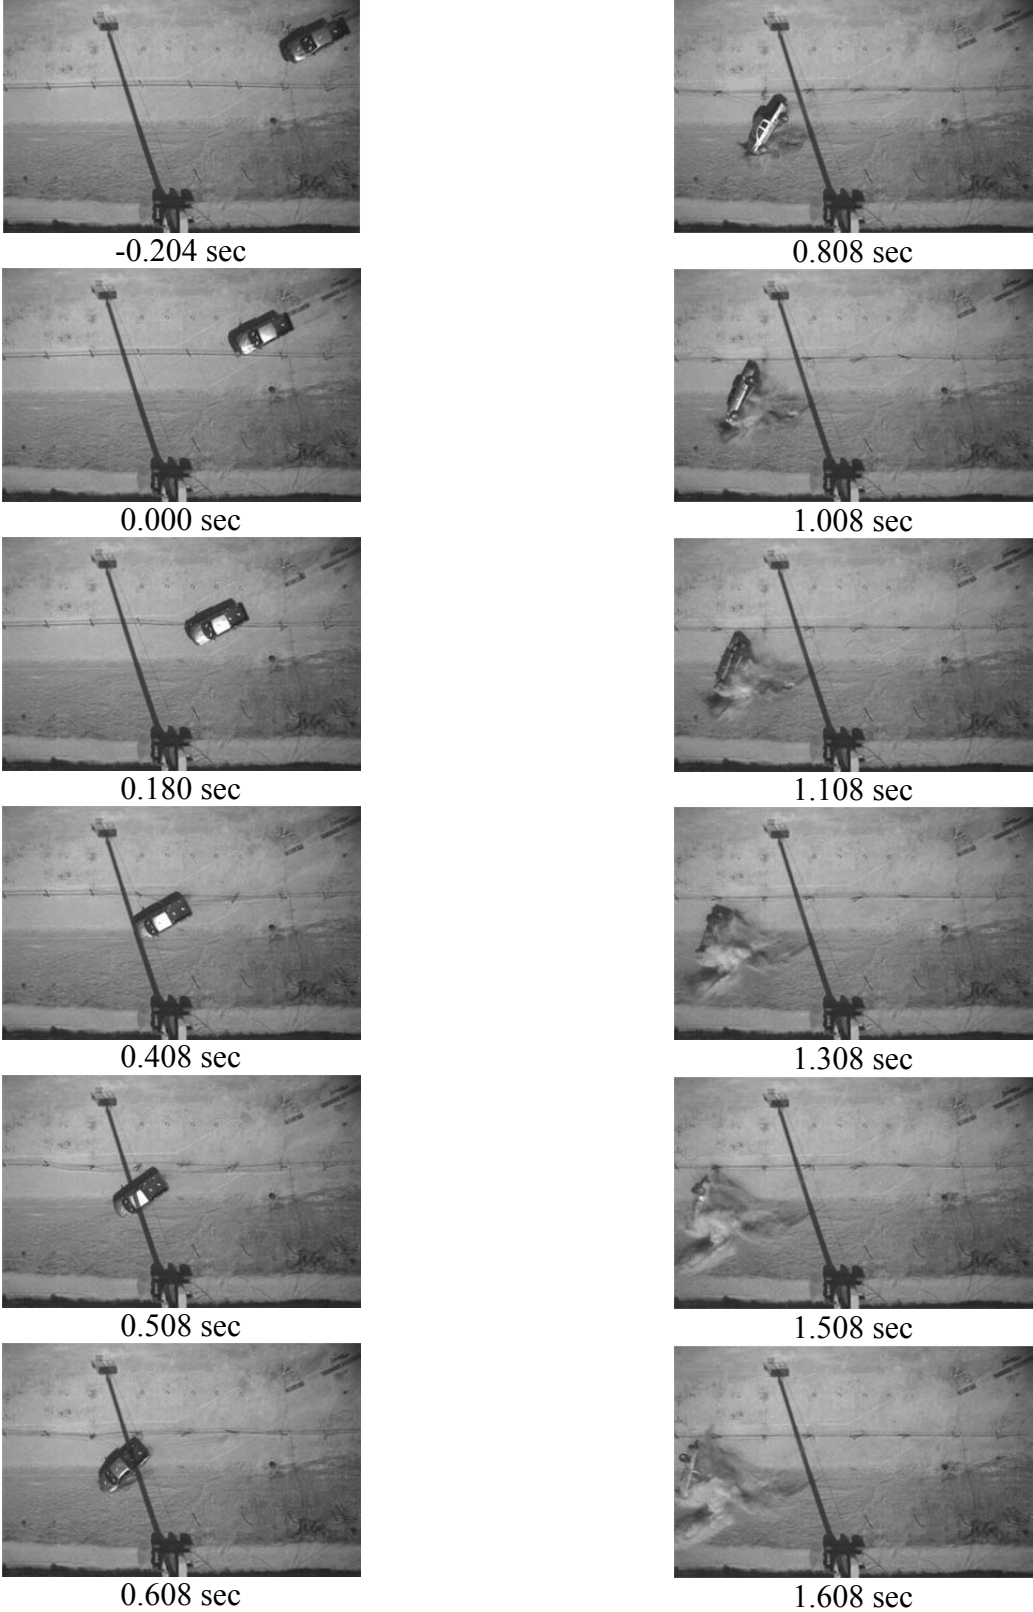
Figure 74. Additional Sequential Photographs, Test No. 4CMB-5

The 5,149-lb (2,336-kg) pickup truck impacted the four cable median barrier 12 ft (3.7 m) laterally down from the slope break point at a speed of 61.8 mph (99.5 km/h). The pickup truck entered the slope at an angle of 26.5 degrees and impacted the barrier at an angle of 27.7 degrees. A summary of the test results and sequential photographs are shown in Figure 73. Additional sequential photographs are shown in Figures 74 through 77.

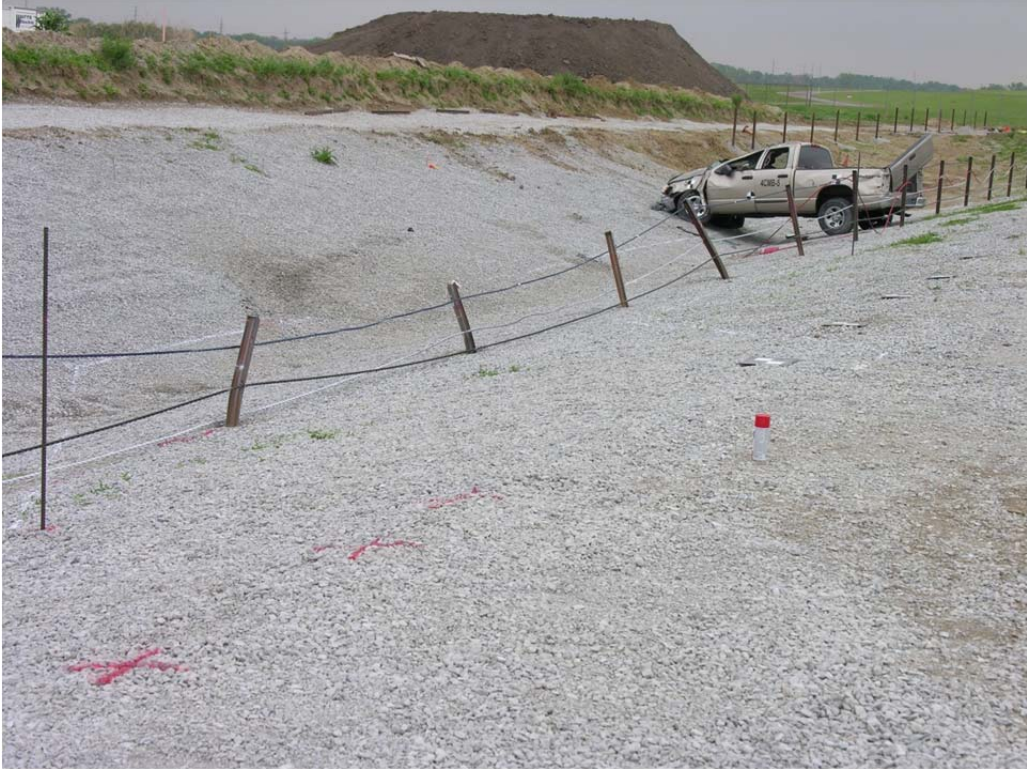
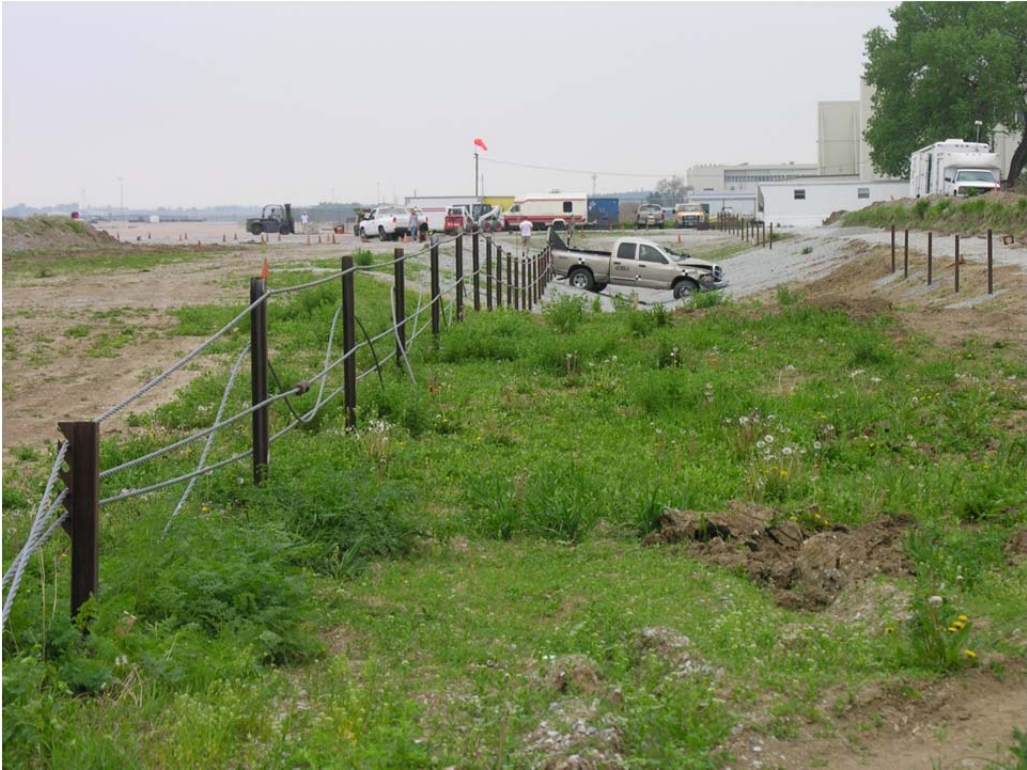
Figure 78. Impact Location, Test No. 4CMB-5

Initial vehicle impact was to occur 1 ft (0.3 m) upstream of post no. 15, as shown in Figure 78, which was selected using an analysis of the vehicle trajectory over the slope which would impact near a post causing the greatest potential to override the post and cables. The actual point of impact was 1 ft (0.3 m) upstream of post no. 15. A sequential description of the impact events is contained in Table 10. The cables were numbered from 1 to 4, from the top to bottom, respectively. The vehicle came to rest behind the barrier, 99 ft – 6 in. (30.3 m) downstream, straddling the bottom of the v-ditch with the rear of the pickup adjacent to the backside of the barrier. The vehicle trajectory and final position are shown in Figures 73 and 79.

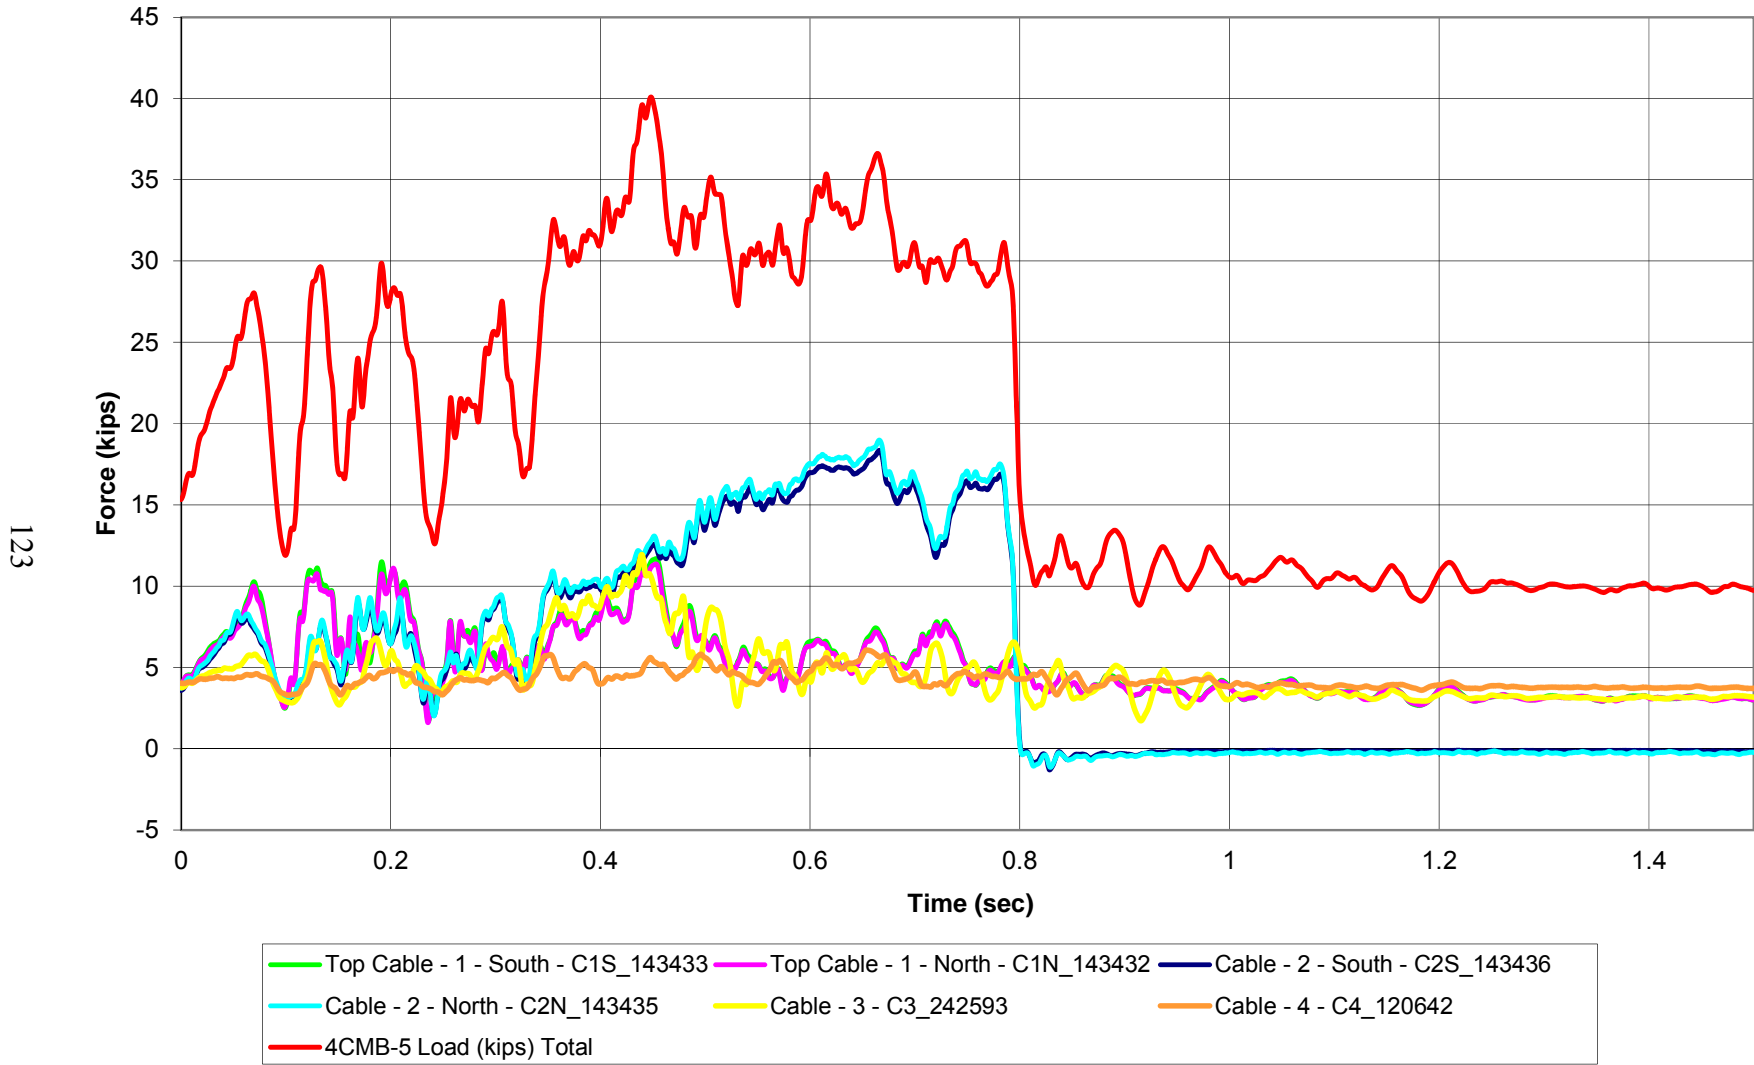
Figure 88. Cable Tension vs. Time, Test No. 4CMB-5

with respect to time. The load cell results are summarized in Table 14. The individual cable loads, along with the total combined cable load imparted to the upstream end anchor, were determined and are shown graphically in Figure 88.
