# HEATWURX PATCHING AT TWO LOCATIONS IN SAN ANTONIO

Project 5-9043-01  
Report 5-9043-01-1  
Project Title: Evaluation of Asphalt Pavement Patching Using Infrared Heat

March 2012  
Published: June 2012

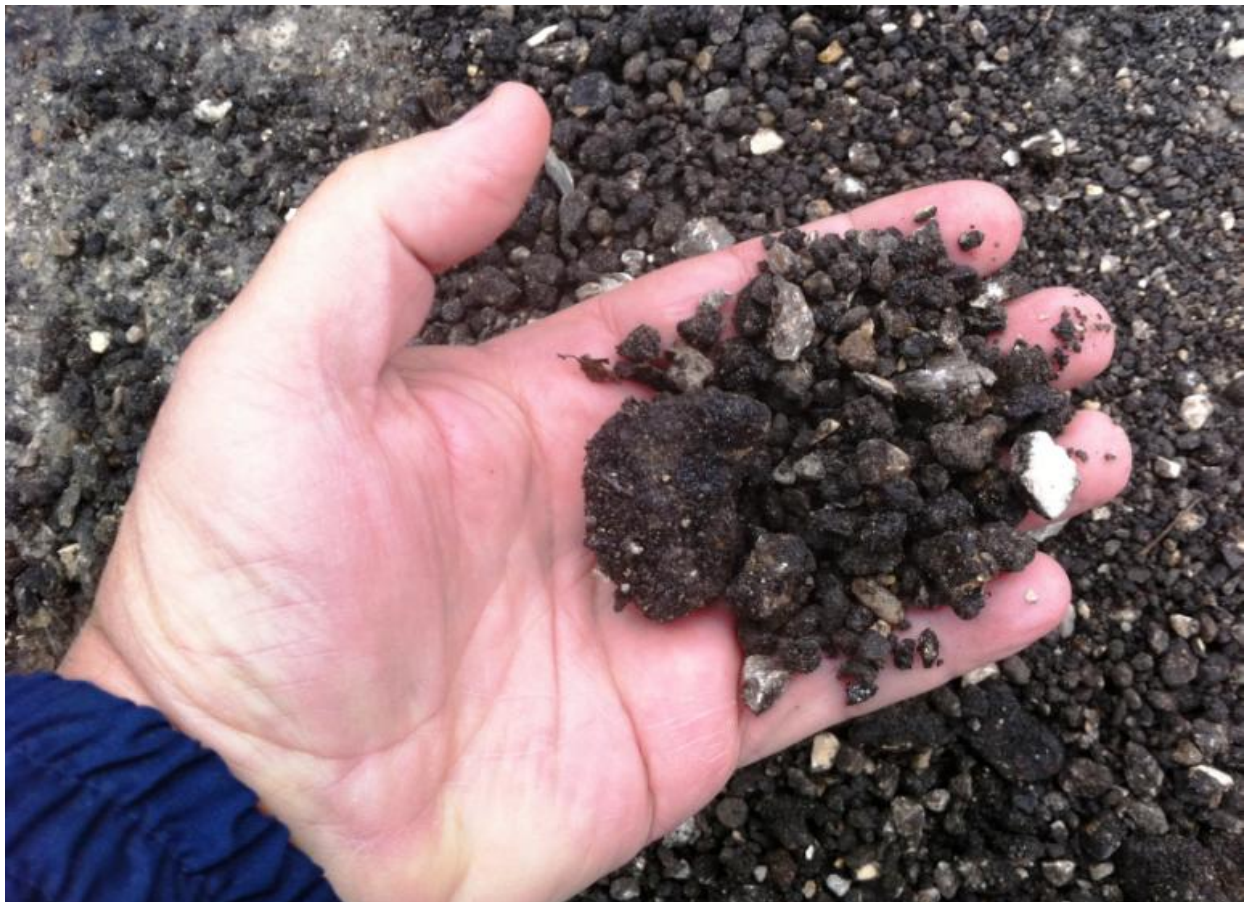
The processor head is lowered to the pavement surface and the scarifying and milling teeth engaged. Two to three passes of the equipment are made, depending on the speed of travel, to break the pavement into small pieces (see Figure 15). Typically, about 90 percent of the processed material would pass a 1-inch sieve.

**Figure 15. Size Distribution after First Milling Pass.**

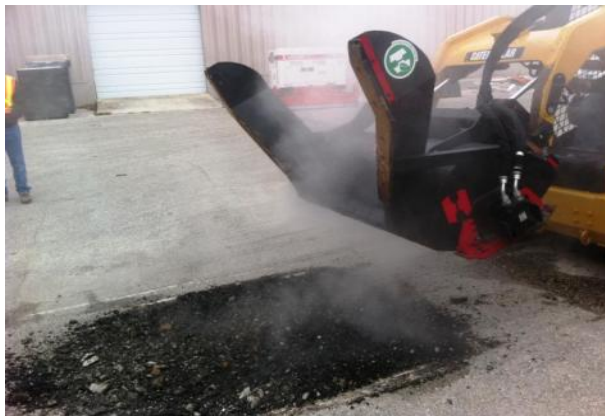
During and immediately after the first milling pass, additional moisture trapped in the pavement is often released (see Figure 16).

**Figure 16. Preparing to Mill and Scarify.**

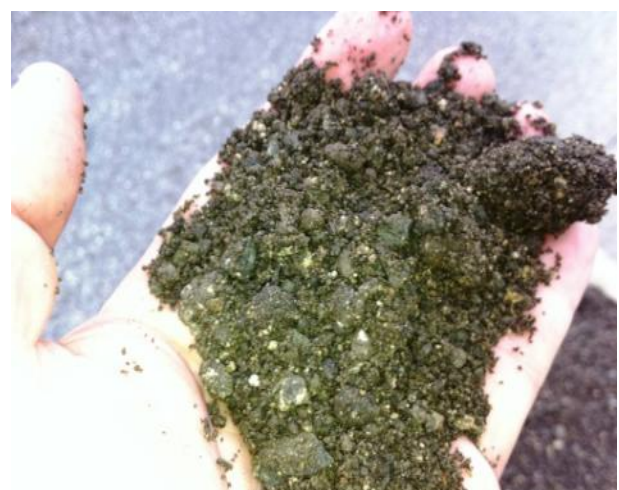
**Figure 19. Size Distribution of Millings.**

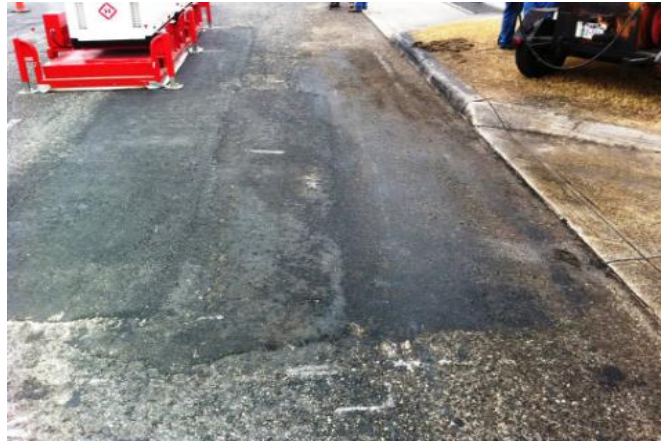
Figures 22 and 23 show completed patches. The surface of the patch in Figure 22 looks dirty because the water in the roller tracked mud onto the patch and not due to the HeatWurx system. The patch in Figure 23 shows how multiple patches can be laid adjacent to previous patches.

**Figure 23. Multiple Patches and Overlap.**

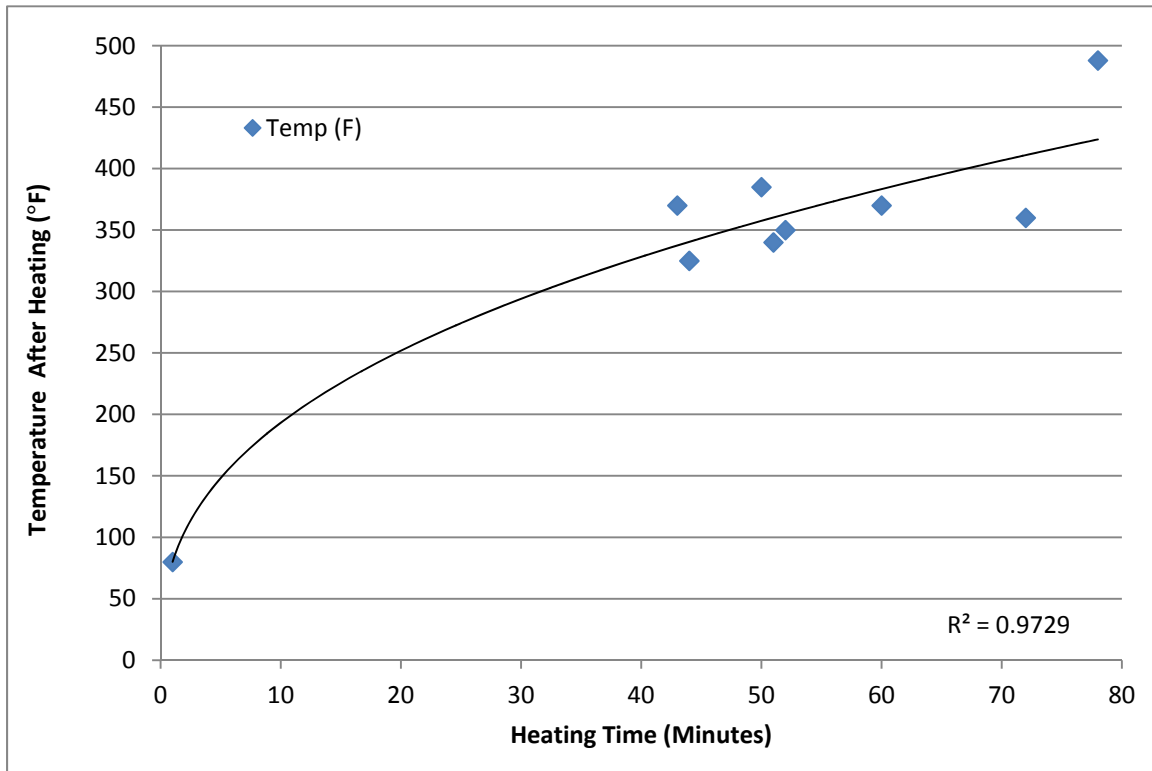
Table 2 lists the times and temperatures for the IH410Fr location. Data taken at the IH10 Frontage road site (IH10Fr) was lost before it could be transferred to the research team. However, the next section shows that infrared camera readings of temperature were available for IH10FR. Figure 33 illustrates the heating time versus pavement temperature curve for the IH410Fr-1 and -2 sites.

**Figure 33. Pavement Temperature versus Heating Time (IH410-1 and -2).**

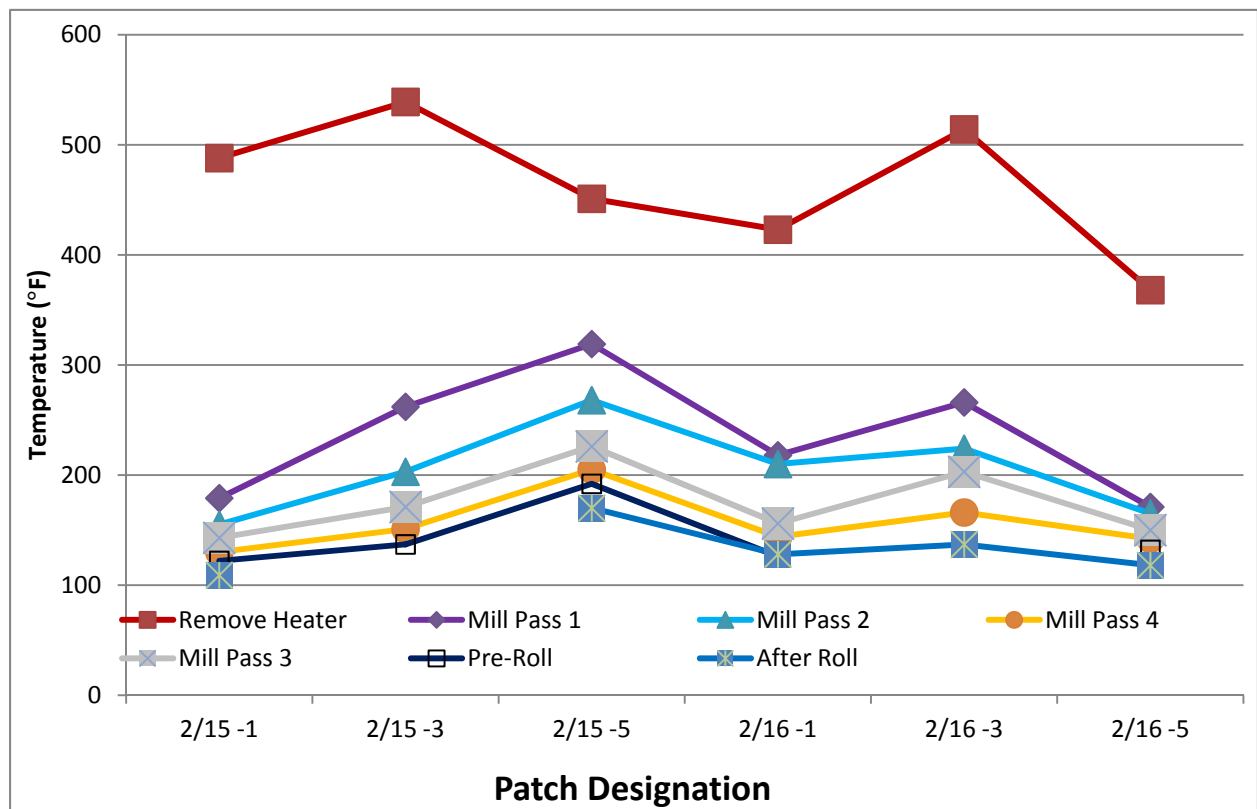
At the IH10Fr site, an infrared camera was available to help document the surface temperatures. Table 3 contains the data documenting the repairs from the site. Figure 34 shows plots of temperatures for the locations where a full set of infrared temperatures was measured. When two patches were placed side by side, there is a temperature for each patch after the removal of the heater. Since the material is mixed together for both patches, the data represents the combination of the two patches. On two occasions, researchers recorded the temperature of

The temperatures after the removal of the heating unit varied from a low of 368°F to a high of 629°F. The lower temperatures for the last two patches were an attempt to see if the work could be done at a lower temperature with less heating time. Table 3 and Figure 34 illustrate the variability in temperature experienced in the HeatWurx process. Unfortunately, the recorded temperatures could not be tied to the performance of the patches, as this site was completely repatched about four months later. This is discussed in the section on performance.

Figure 34. Graph of Temperatures at IH10 Site.

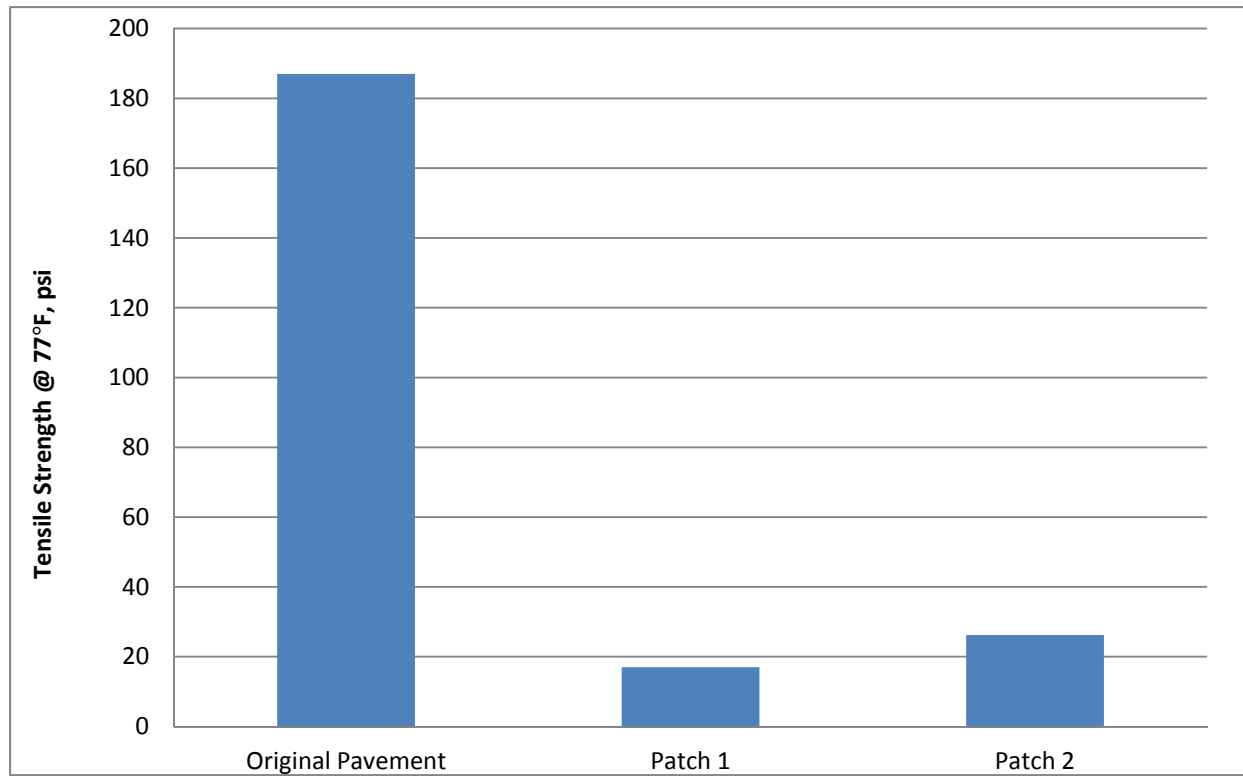
The test results are summarized in Table 4. Figures 66 and 67 give the indirect tensile strength at 77°F and the resilient modulus at 39.2° and 77°F, respectively.

Table 4 shows that the bulk density of the materials in the patches are lower than the bulk density of the original pavement by about 5 to 10 lbs/ft<sup>3</sup>, and that the air voids for the patch material are greater by 0.6 to 3.5 percent. The indirect tensile strength is almost 10 times lower for the patch materials than the original pavement (see Figure 66). The resilient modulus values of the patch materials for both 39.2° and 77°F are lower than the original pavement by about a factor of 5 to 10 (Figure 67). The reasons for the difference between the patching materials in terms of tensile strength and resilient modulus are most likely attributable to two primary factors:

**Figure 66. Indirect Tensile Strength of the Original Pavement and Patches for IH410Fr.**

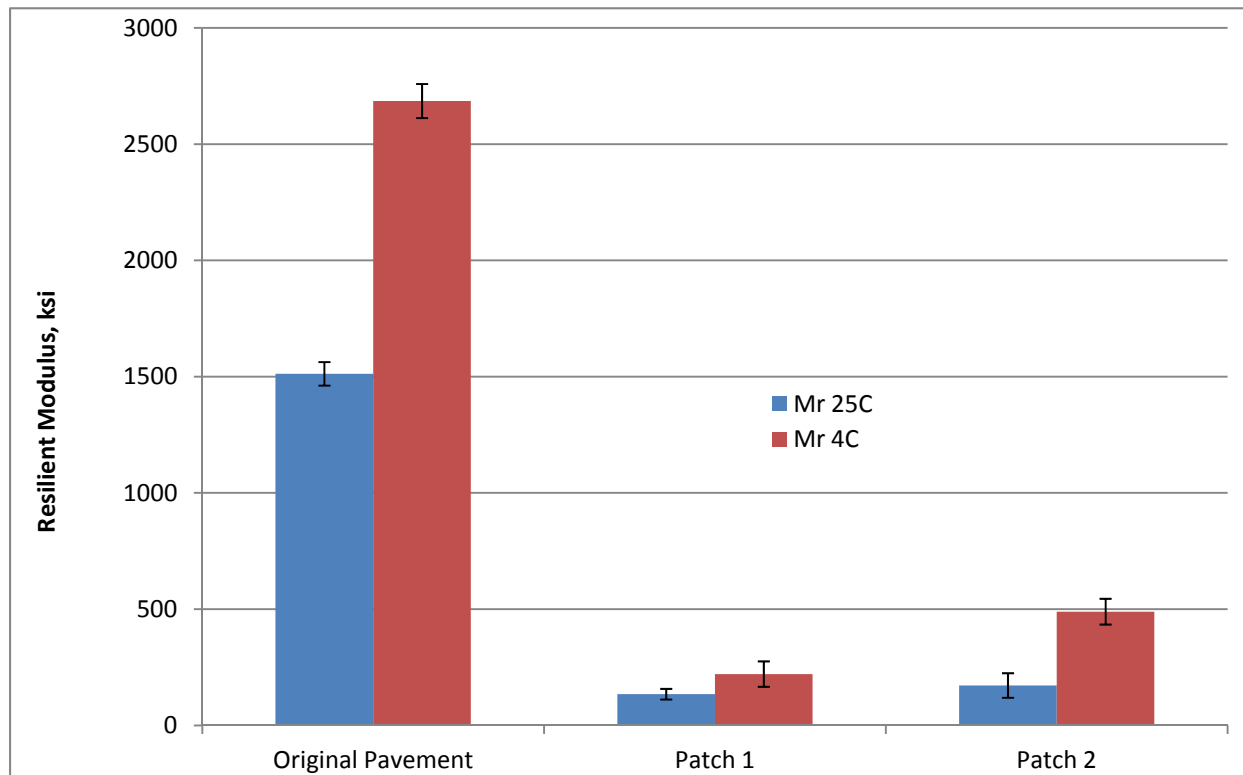
**Figure 67. Resilient Modulus of the Original Pavement and Patches for IH410Fr.**
