FAILURE OF RIPRAP PROTECTION - PHASE II (FINAL REPORT)

Report NM04STR-04

JUNE, 2008

Paola Bandini, Ph.D., P.E.
Associate Professor
Civil Engineering Department
New Mexico State University

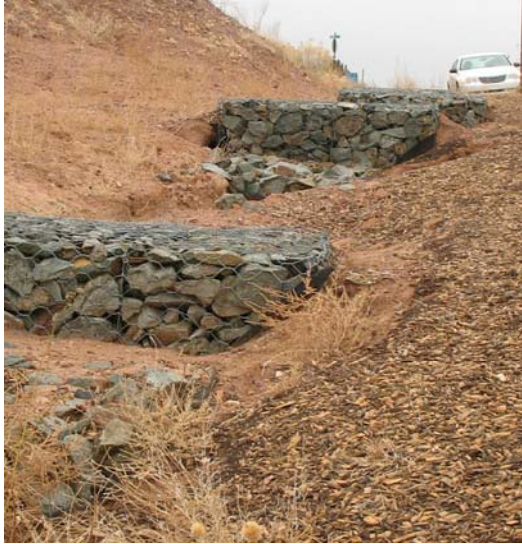
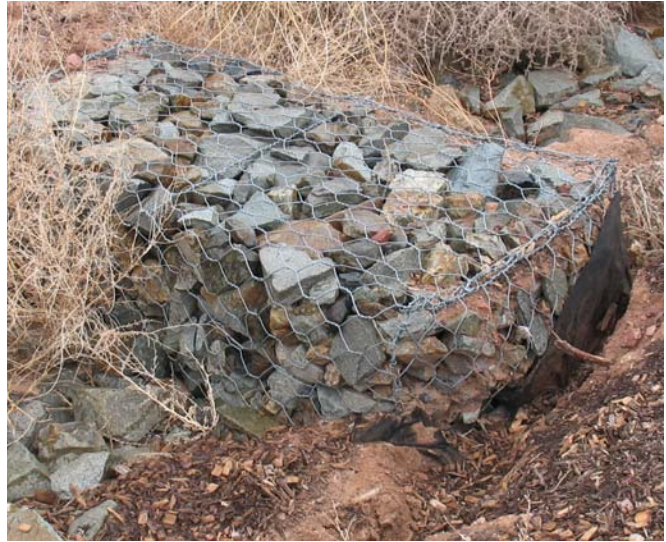
Figure 18. Riprap gabion baskets in highway NM 14, between mileposts 34 and 35.

non-enclosed riprap mats in the front and back (Figures 18a and 19a). Non-woven geotextile is installed underneath and on the sides of the gabion baskets and riprap mats (Figure 18b). The gabion baskets are spaced about 20 ft (6.1 m). A small non-enclosed Class G riprap rundown is placed upslope from the gabions (Figure 19b).
