REPORT APPENDIX

IDENTIFICATION OF CAUSES AND SOLUTION STRATEGIES FOR DECK CRACKING IN JOINTLESS BRIDGES

Appendix to Report No. CEE-RR – 2012/04

Research Report for MDOT under Contract No. 2009-0746/Z1
SPR No. 108522

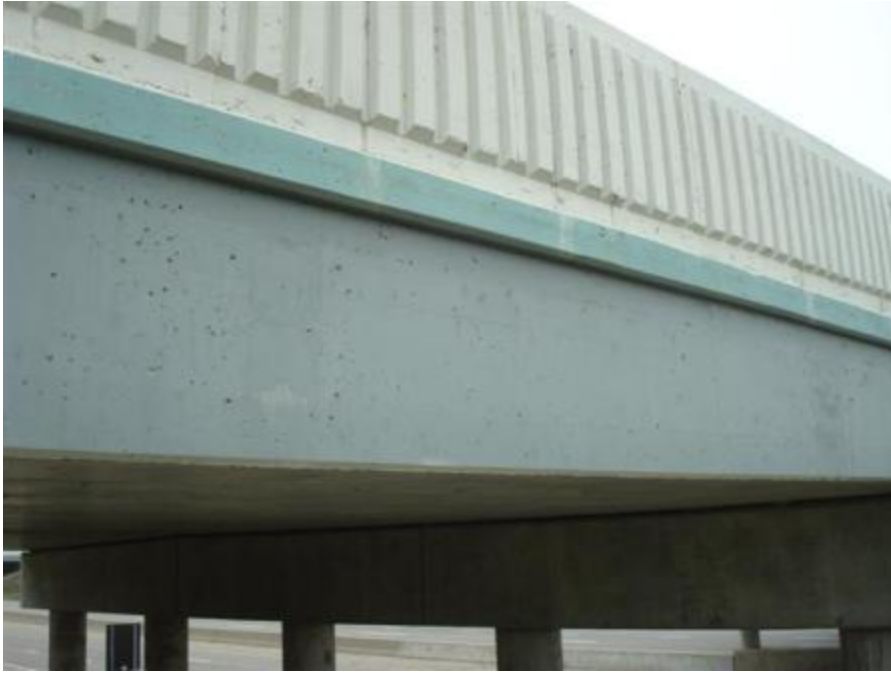
- Side-by-side concrete box beams
- 3-span, continuous deck for live-loading, simply supported beams
- *Mostly longitudinal cracking evident, spaced at the same spacing as the width of the beams (3-4 feet). Transverse cracking only evident at the construction joints, by the piers, and also at the approach slabs. Cracking is not likely due to restrained concrete shrinkage.*

Figure 2. Cracking in deck fascia

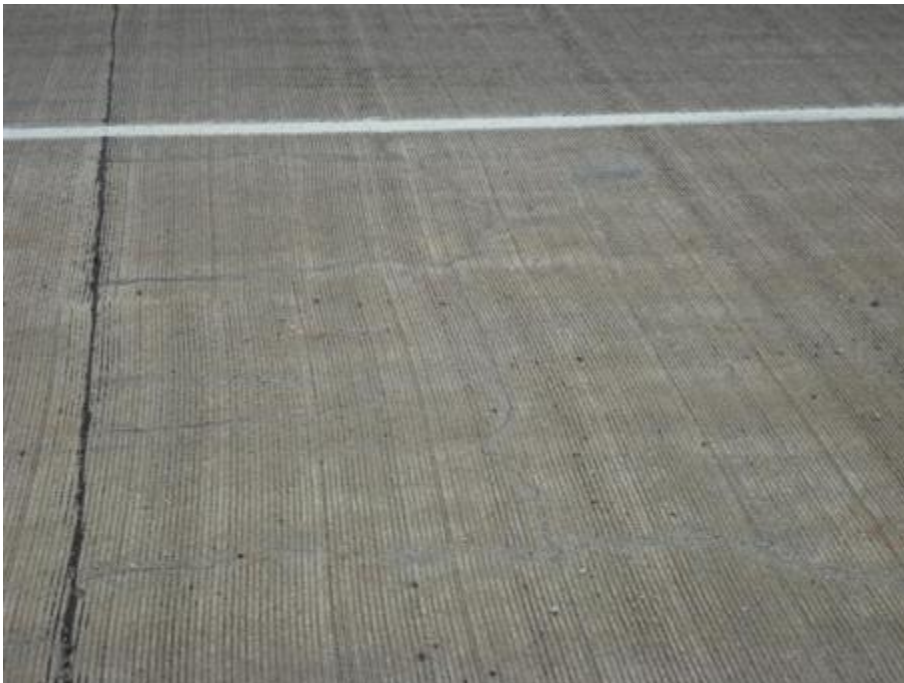
Figure 3. Longitudinal cracks in the deck surface, near the approach slab

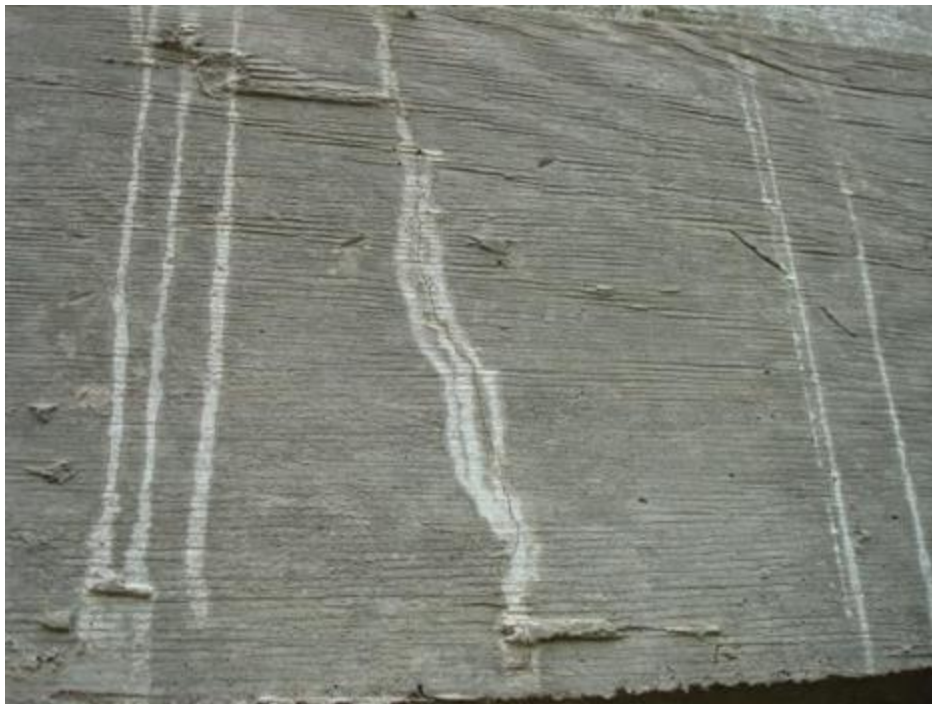
- Spread concrete box beams
- 1-span, continuous deck and fully integral beams at the abutment.
- *There was some transverse cracking in the deck fascia, at the underside of the deck. The barrier walls experienced widespread vertical/transverse cracks. Both transverse and longitudinal cracking was evident in the deck.*

Figure 12. Cracking in deck fascia

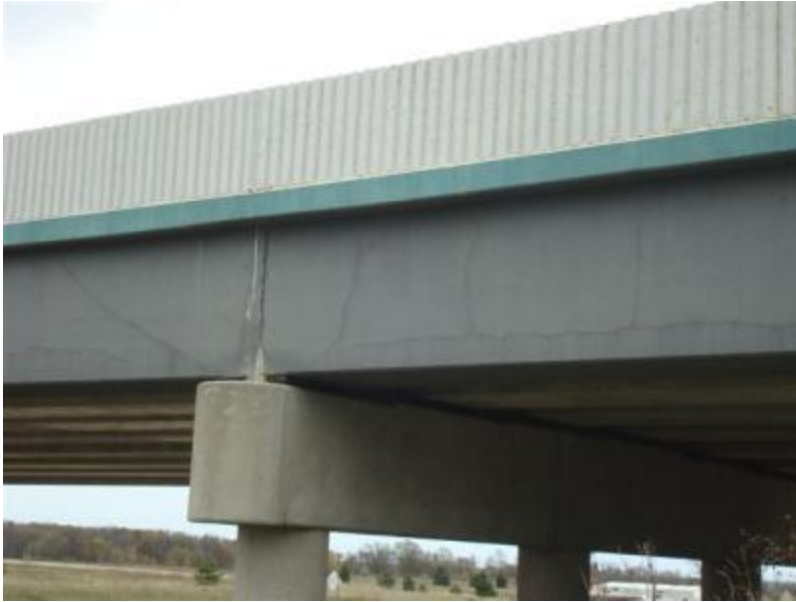
- Spread concrete box beams
- 4-span, continuous deck for live loading, simply supported beams (semi-integral abutment).
- *Some diagonal shear cracking was evident in the beams, near the piers. Transverse cracking was evident throughout the entire deck surface, spaced at every 3' to 4'. The cracking continued over the pier areas. The crack density was much greater in the area over the piers, or in the "middle" deck pour. According to the inspection reports, the cracks were previously sealed. As evident in the inspection, the cracking has continued through the seals.*

Figure 20. Cracking in beams by the pier

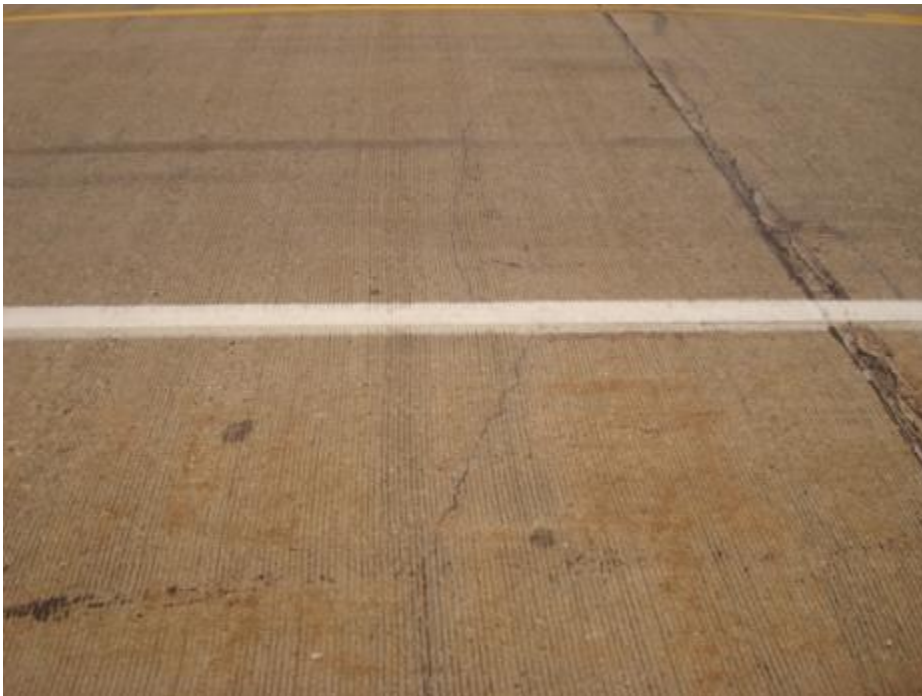
**This bridge shows the most evidence of evenly-spaced transverse cracking, and is likely the best prototype candidate for cracking due to restrained concrete shrinkage.*

Figure 25. Transverse crack near construction joint

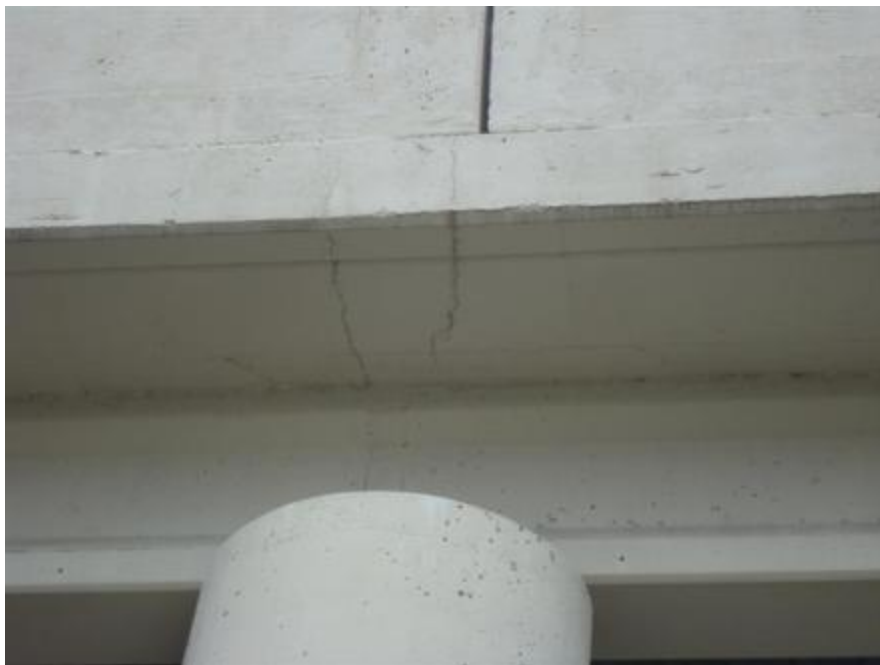
- Concrete I-beams
- 3-span, continuous deck for live-loading, simply supported beams
- *Some fairly widespread transverse/vertical cracking is evident in the concrete barrier walls. Some transverse cracking is evident in the bottom of the deck/deck fascia. The top deck surface did not have many evident signs of cracking. The bridge appears to be new/recently renovated.*

Figure 30. Cracking on underside of deck, by the pier area

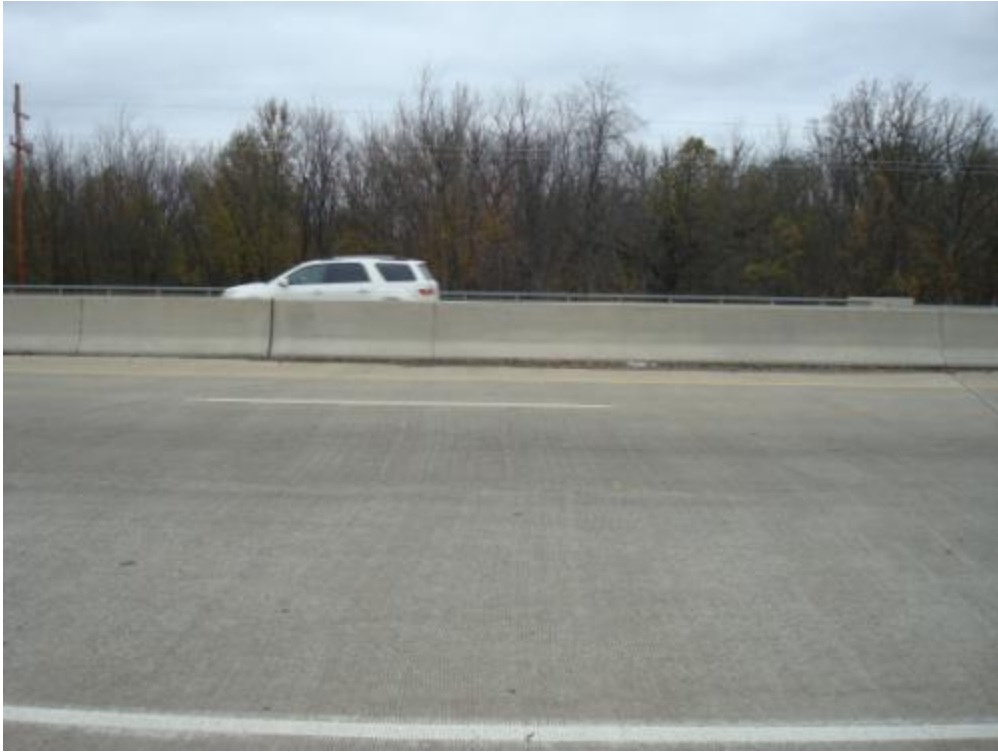
Figure 49. Bridge deck surface (no notable cracks)

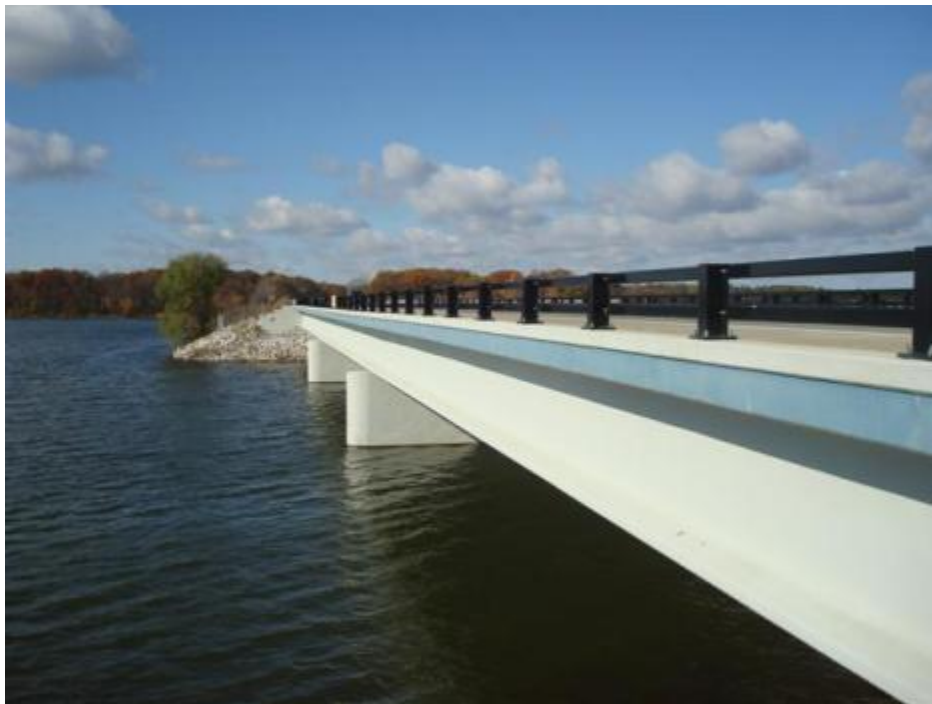
- Spread Concrete I-girders (MI-1800 I-beam)
- 3-span, continuous deck for live-loading, continuous beams
- Removable plywood forms underneath
- *The eastbound side had significant longitudinal cracking throughout, and transverse cracking in the areas of the piers and approach slabs. The westbound side had no significant cracking in the bridge surface, some longitudinal cracking at the east approach.*

Figure 51. Overall Bridge View (Eastbound side)

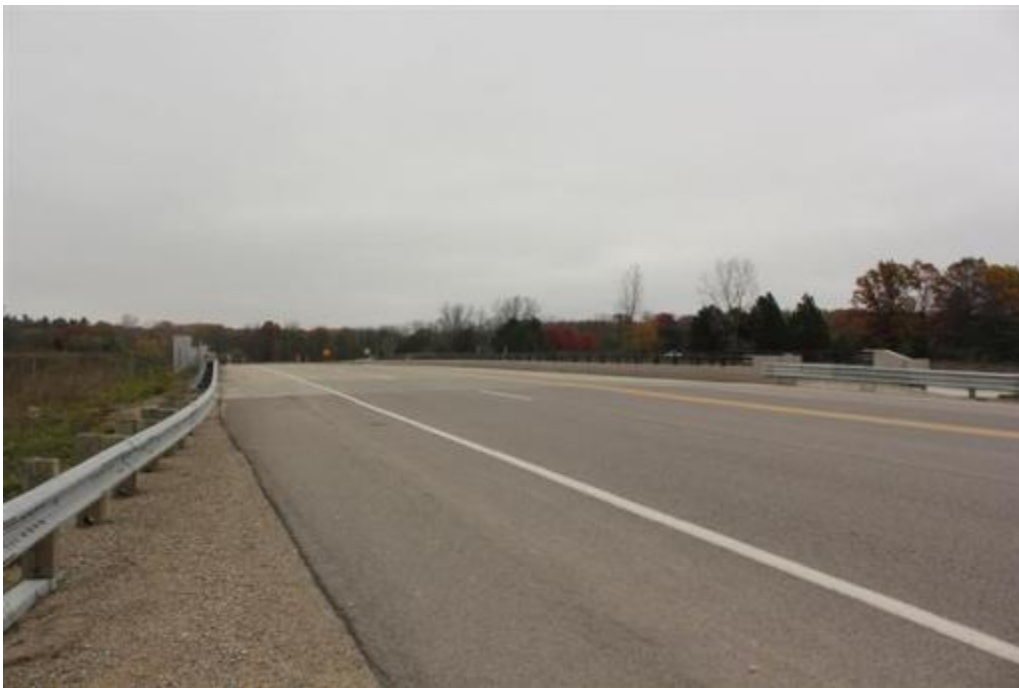
- Steel girders
- 2-span, continuous deck for live loading, fully integral abutments, SIP metal forms underneath
- Sidewalk on west side of the bridge
- *Extensive transverse cracking is evident by construction joints, and close to the pier area. Longitudinal cracking is evident throughout the bridge deck. The barriers and sidewalk have extensive vertical/transverse cracking as well, some of which continued into the bridge deck as transverse cracks. Interestingly, this bridge was recently re-constructed (2009), yet it is experiencing a relatively high amount of cracking*

Figure 61. Bridge overall view

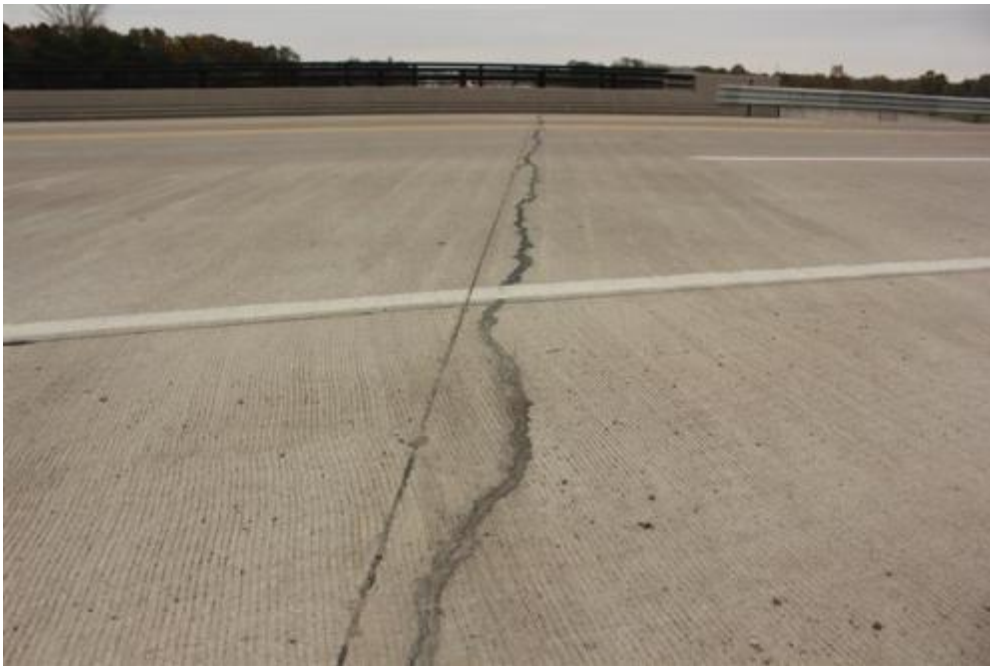
Figure 65. Large transverse crack at the abutment

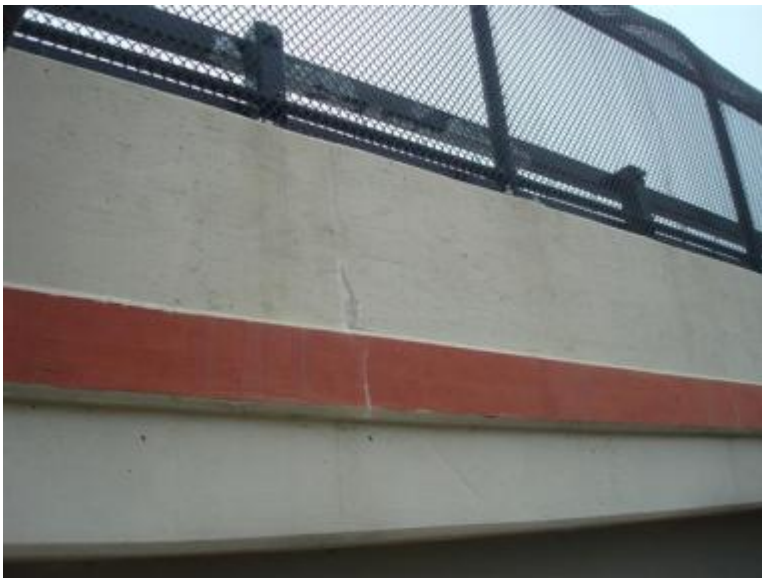
Figure 72. Cracking in outside fascia of deck and barrier

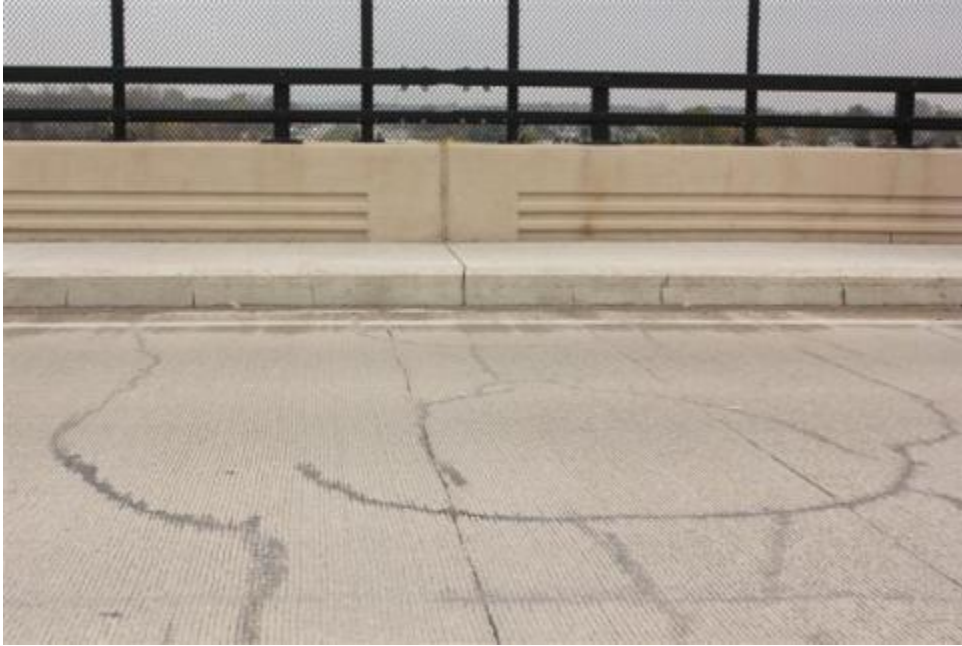
Figure 79. Transverse cracking continuing into the sidewalk

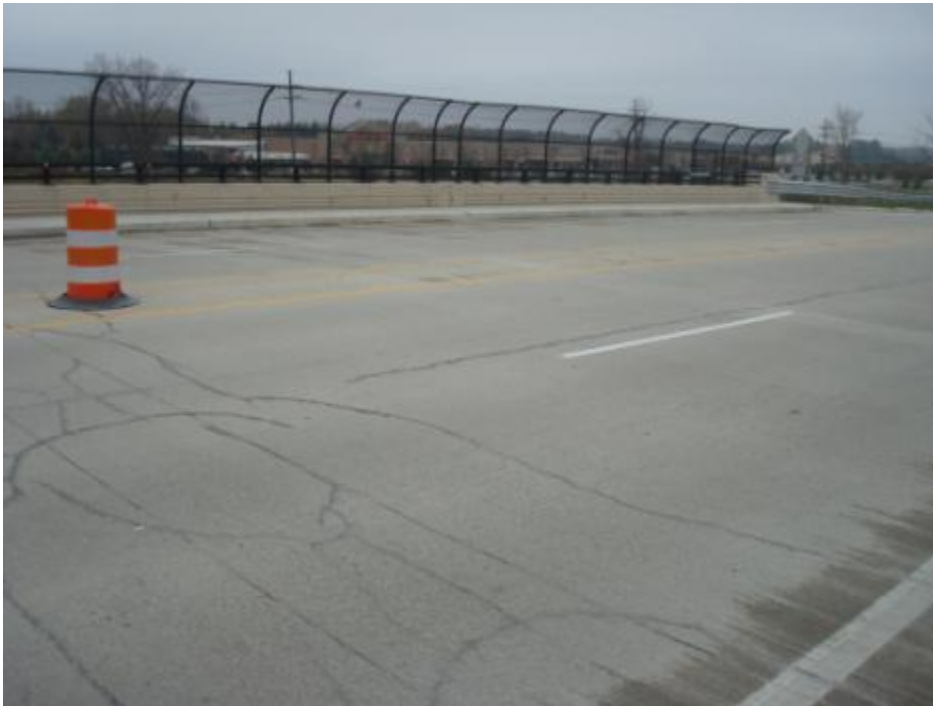
Figure 80. Transverse and longitudinal cracking

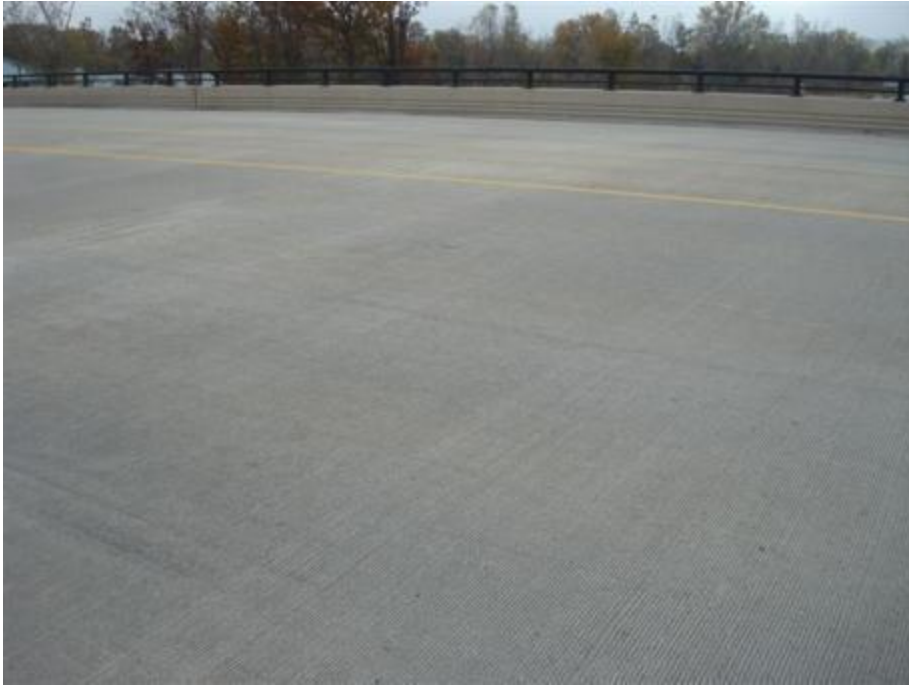
Figure 87. Longitudinal cracking in bridge surface

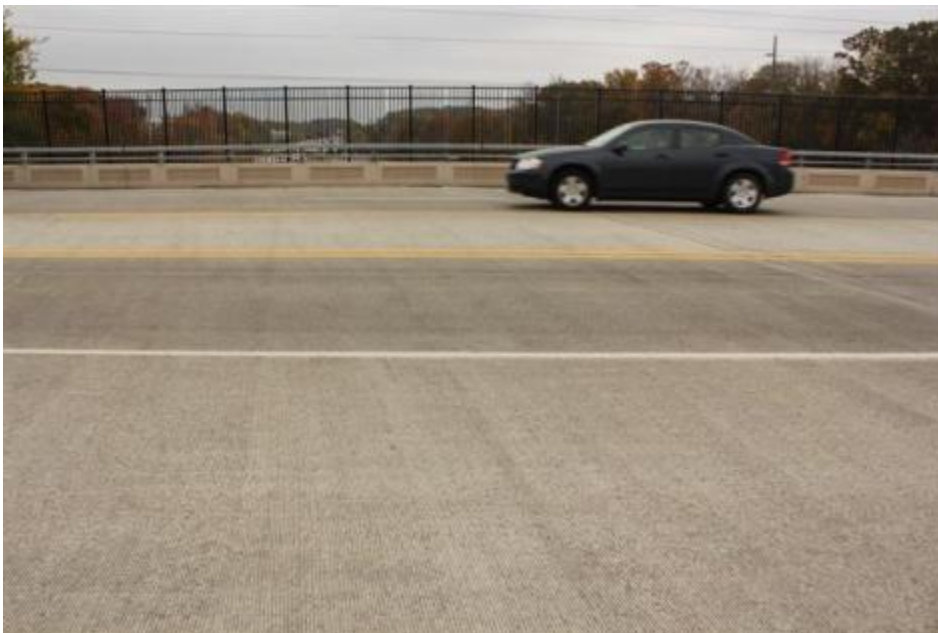
Figure 93. Possible longitudinal crack in the middle (it was not clear in the investigation whether it was a crack or roughed surface)

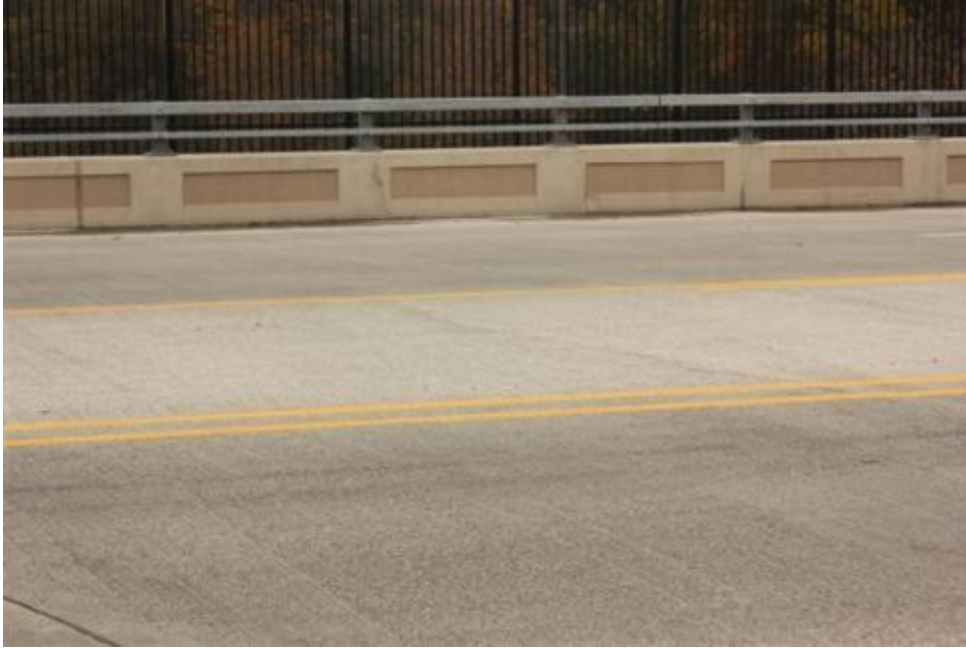
Figure 94. Cracking in barrier wall, potential transverse crack in the middle

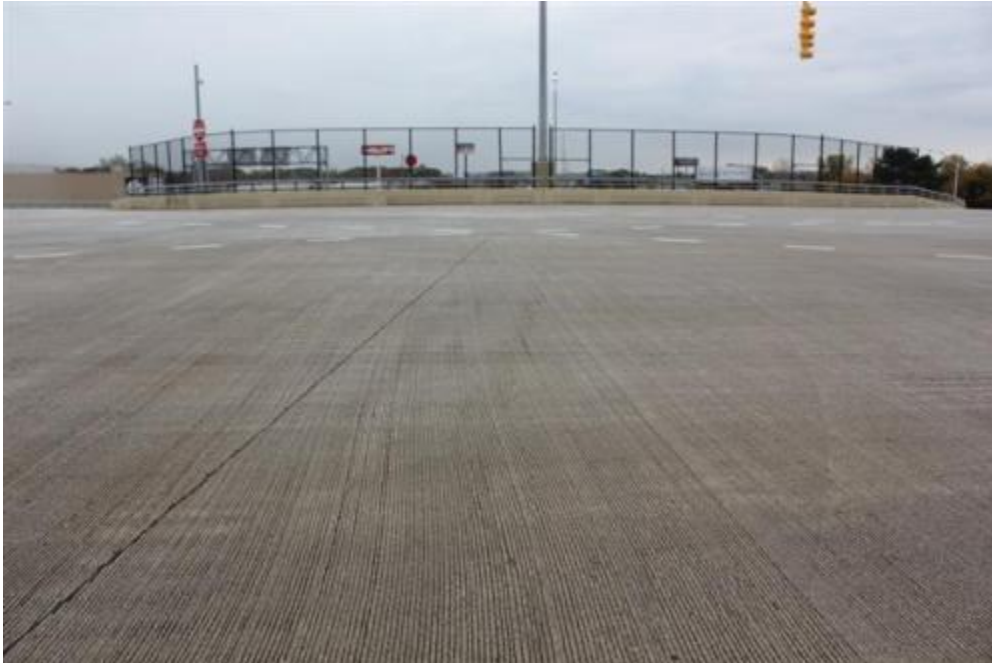
Figure 111. Transverse cracking in pier area

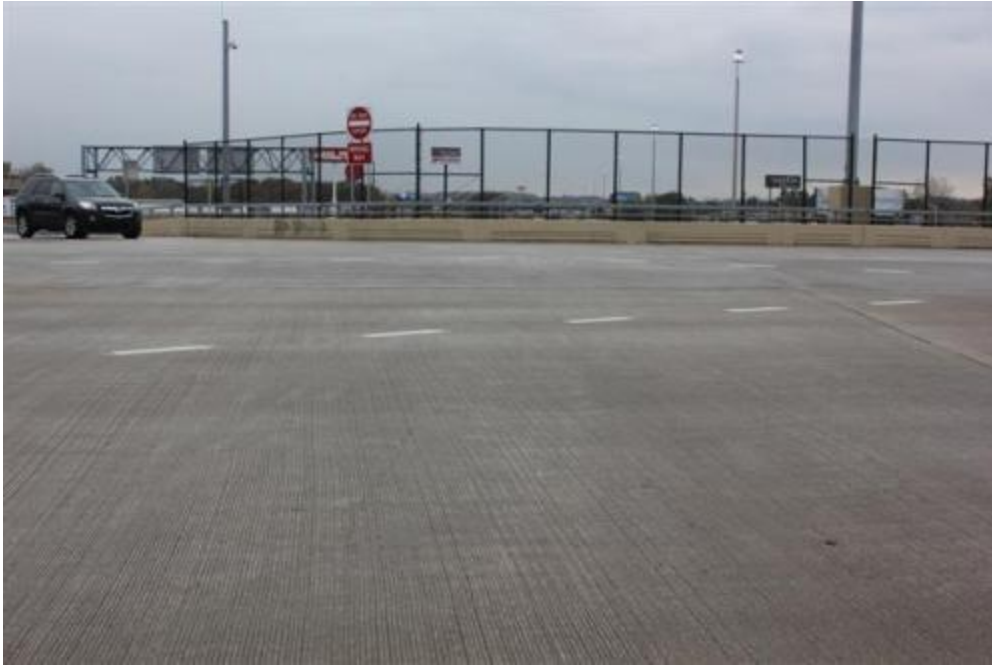
Figure 112. Transverse cracking in-between pier and abutment

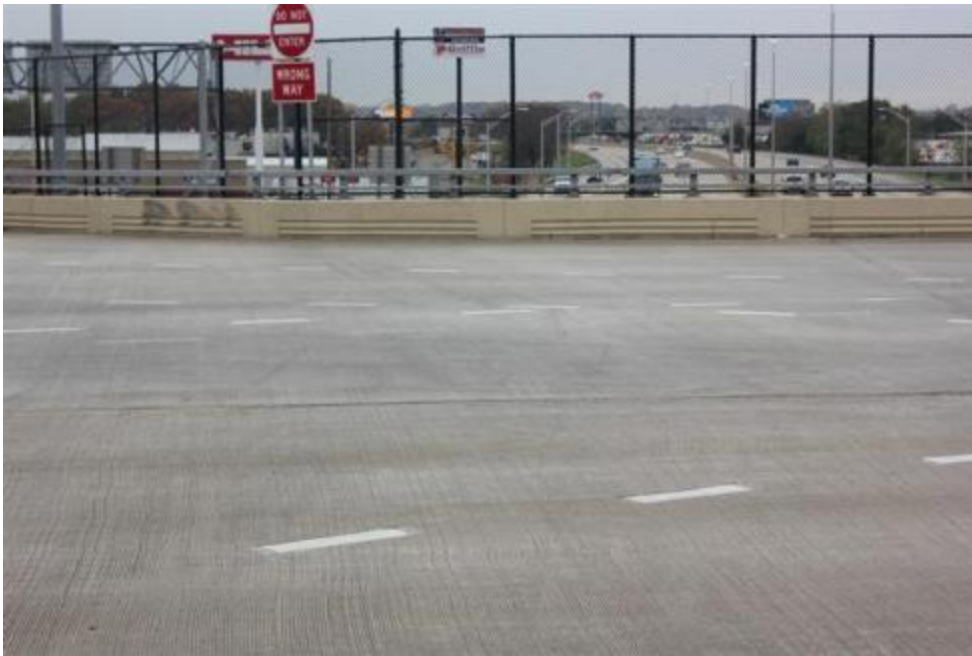
Figure 113. Transverse cracking in bridge deck

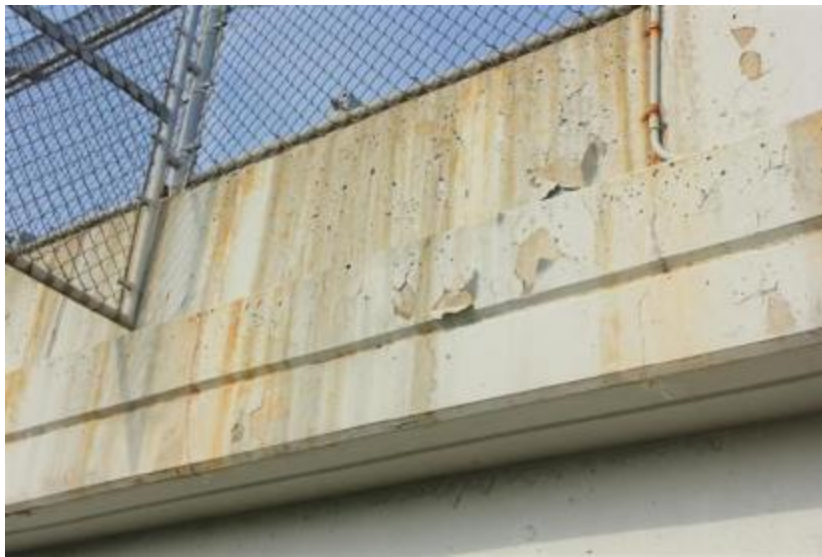
Figure 130. Deteriorated outside/fascia of the bridge
