FINAL REPORT

Corrosion of Spiral Rib Aluminized Pipe

Final Report to Florida Department of Transportation

August 2012

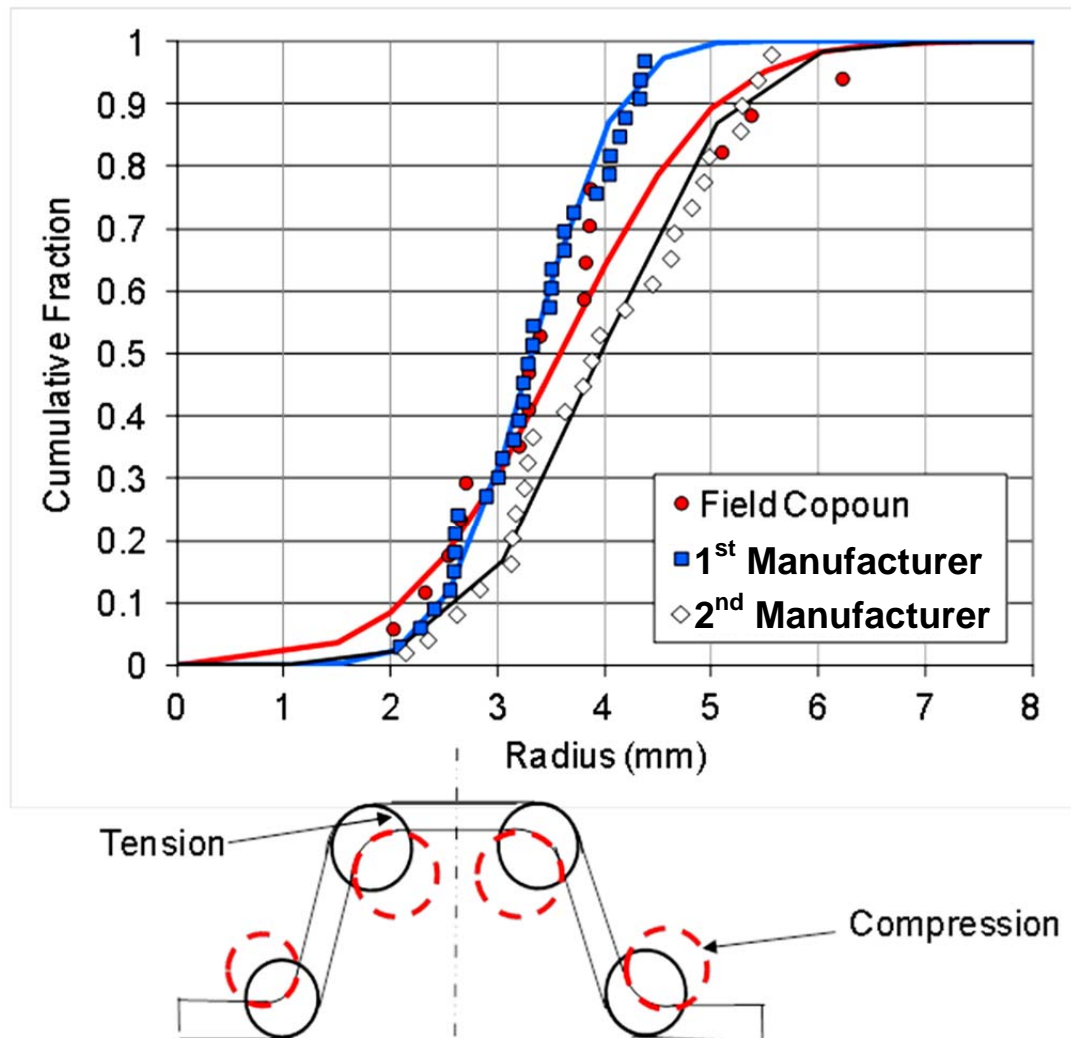
The results in Figure 8 show differences between the average radius of the various cases that are in the order of, or less than the corresponding standard deviations. Moreover, the average radius for the Mode A corrosion case

fell in between those of the samples from the two manufacturers. Overall, the results do not support the hypothesis that the Mode A corrosion was associated with earlier pipe production having experienced unusually severe fabrication forming, at least as measured by the value of the radius of curvature at the bends.

Figure 8 : Comparison of cumulative distributions of rib radius of curvature (mm) between samples from newly produced aluminized steel type 2 pipes made in two different manufacturers and from a pipe once in service for 10 years at the Curlew Rd. site. The schematic shows the position of the circles fit to each bend for each cross-section.

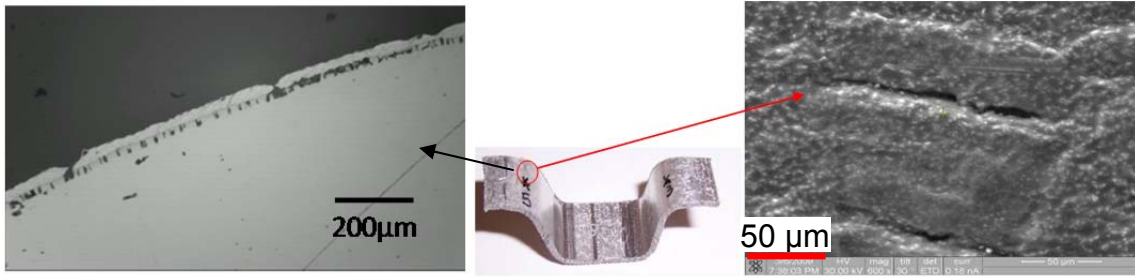
Figure 10 : SEM image of the bend at rib regions of newly produced SRAP (right), Metallographic cross-section of bend region (left)

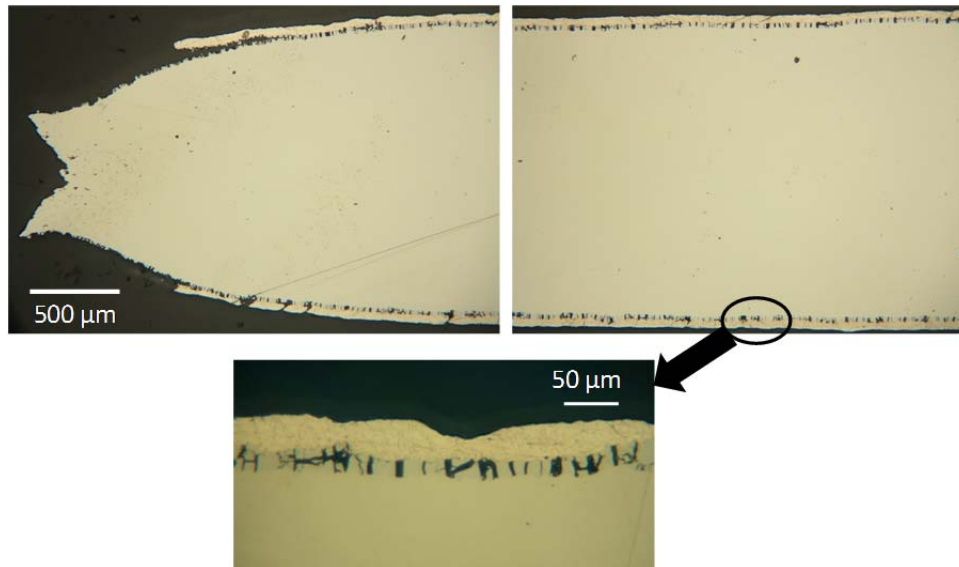
Figure 11, illustrate the tensile specimens and their metallographic cross-section near by the necking zone. While significant amount of breaks occurred in the intermetallic very few outer coating breaks were present. To see direct occurrence of corrosion at regions with coating breaks, parts the tensile specimens were immersed in solution S after the edges were covered with epoxy. As shown in Figure 12 at a very small length near the necking zone the corrosion products in forms of yellow shade are present. The control specimen with no stress shows no sign of corrosion after few days of exposure.

Figure 11: Metallographic cross-section of tensile test at the necking zone (top left) and ~1 cm away from the necking zone (top right)

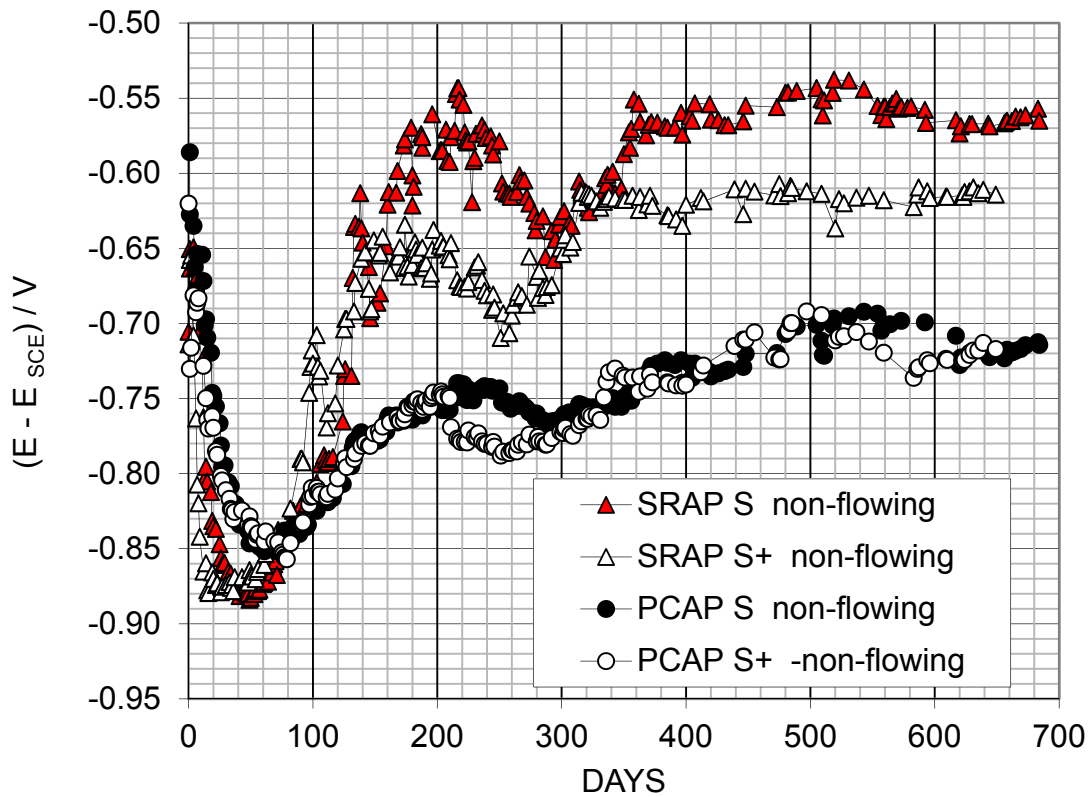
The E_{OC} (Figure 20) is slightly more positive for SRAP in solution S, where aluminum is mostly passive and the system is polarized due to steel substrate exposed at the formed regions.

Figure 20 : E_{OC} of SRAP and PCAP in solution S and S+

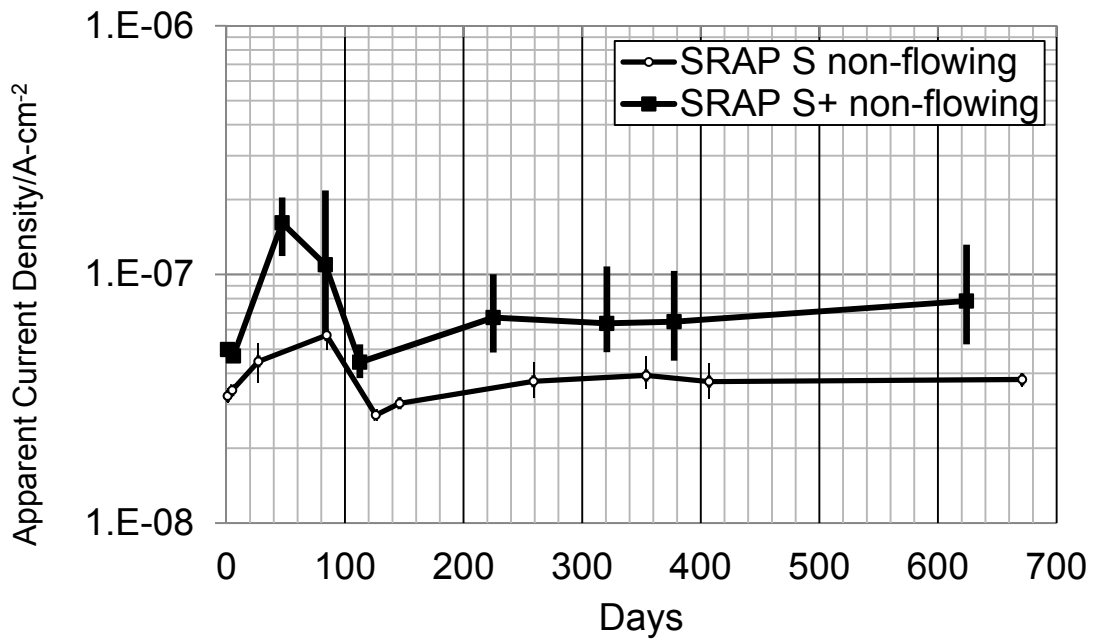
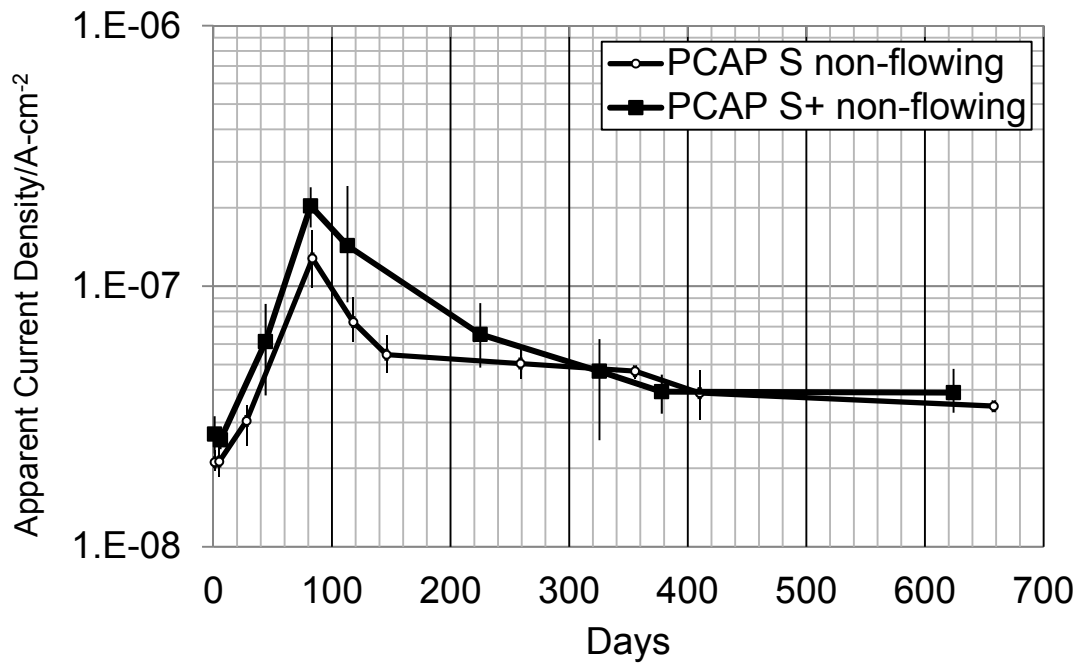
Figure 21 compares the apparent corrosion current density of two categories of pipes (SRAP and PCAP) in solutions S and S+ . While slightly higher corrosion rates took place for SRAP in aggressive solution, no dramatic difference was observed suggesting no inherent deficiency with normal production of these pipes.

Figure 21: Apparent corrosion current density of SRAP (Top) and PCAP (Bottom) in solution S and S+

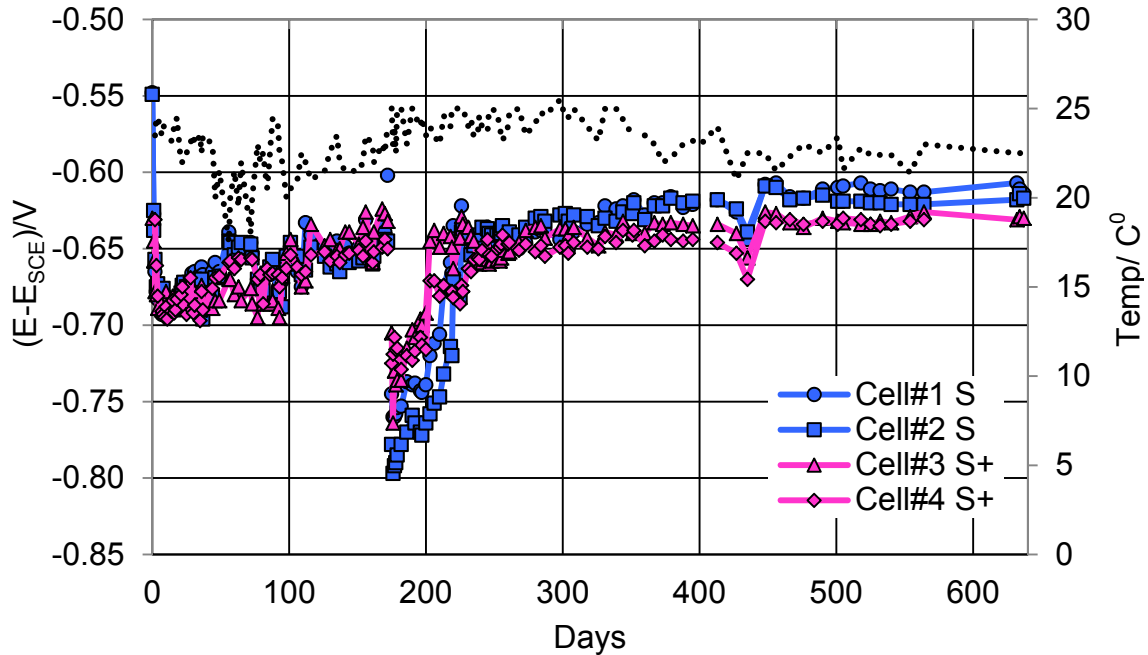
Figure 27 illustrate the E_{OC} evolution of the mixed pot of the system while Figure 28 shows the value of apparent corrosion current density and macrocell current. From the beginning of exposure, the galvanic current flowed between the

connected specimens. As expected, galvanic current measurements confirmed that the corroding steel edge was the cathode. This current gradually increased for the first 200 days as the cathode area increased (more steel corroded). During this period, the lateral discoloration and corrosion propagation of aluminum, initiating from the edges, continued.

At 175 days of exposure, the specimens were extracted for a few hours for surface inspections and were placed back into the cells in fresh solutions (Figure 29). Following the solution replenishment, the galvanic current between the sealed-edge and exposed-edge sections significantly increased for ~30 days; this increase was accompanied with an open circuit potential drop in all cells (Figure 27). It appears that the process of extraction and solution replenishment may have removed some of the iron corrosion product on the edges of exposed-edge specimens; the rust previously may have hindered or slowed down the corrosion rate, and the removal of corrosion products provided fresh sites for corrosion progression. As the corrosion rate of exposed edges increased, aluminum tended to provide higher galvanic protection by sending greater current.

Figure 27: E_{OC} of open cut edge experiments (specimens taken out at 175 days).

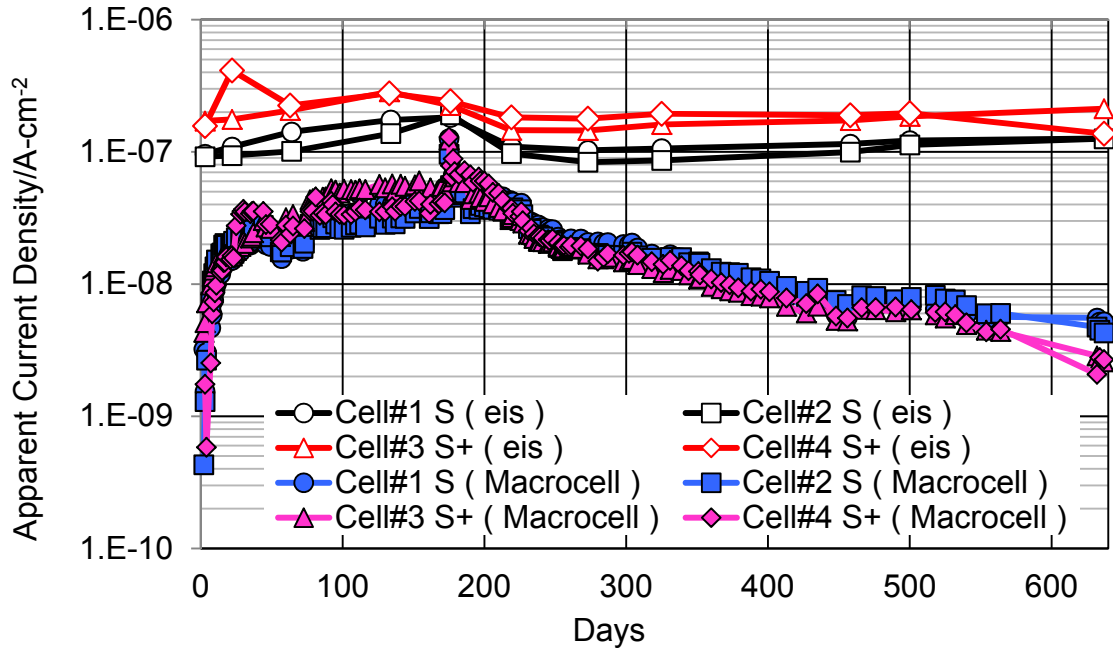
After 200 days of exposure, where much of aluminum areas were discolored, the galvanic current gradually decreased with time to low values. The reduction of galvanic corrosion rate may indicate some surface alteration process that hinders the rate of the anodic reaction on the aluminum surface. In any event, the galvanic protection although present from the beginning of the exposure, was not sufficient to provide full protection of steel at open edges even for such small area fraction of cathode to anode. This occurrence is consistent with the presence of rust at the edges, and the less negative mixed potential values that approaching the typical potential of corroding steel in neutral water (McCafferty, 2010).

Figure 28: Micro cell current vs. apparent corrosion current density obtained from EIS tests.

The corrosion current density measured by EIS tests indicates a low but relatively constant corrosion rate. It should be indicated that for the calculation of this current density, the entire area of the anode (aluminum) was considered. However, if one only considered the narrow discolored areas of aluminum immediately adjacent to corroding steel the corrosion rate would be more than one order of magnitude greater. Determination of nominal corroding area to be used for corrosion current density is a difficult task as this area changes with time. Another complication in interpreting the EIS data is the effect of a corroding cathode (steel) that is not stationary as its area changes by time. These factors need consideration in subsequent investigations.

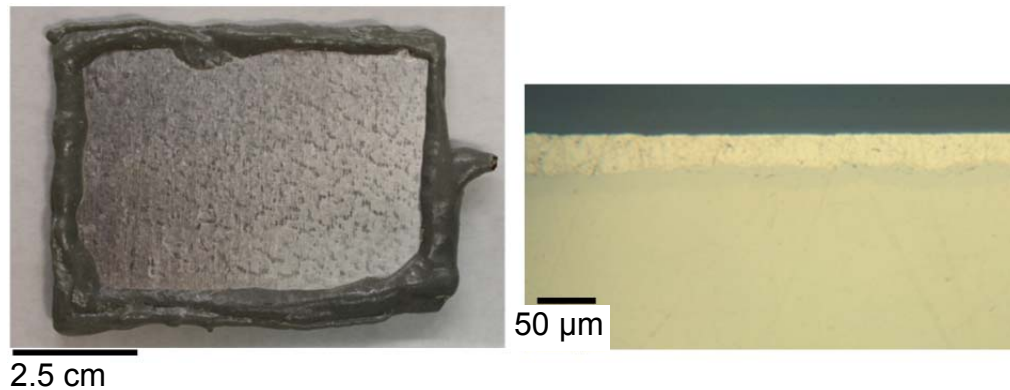
As indicated by pH and conductivity measurements, the near neutral environment in these tests, resulted in extremely low corrosion rates of $< 1 \mu\text{m}/\text{yr}$ for both saturated and moist sand experiments Figure 34. While infrequent pits were observed on the surface of some specimens, in general the extracted specimens show no sign of severe corrosion. A typical metallographic cross-section of the specimen showing negligible wastage is given in Figure 35.

Figure 35: Bright appearance of specimen after exposure 250 days of exposure to water in sand medium (left); metallographic cross-section showing no significant aluminized layer consumption (right).

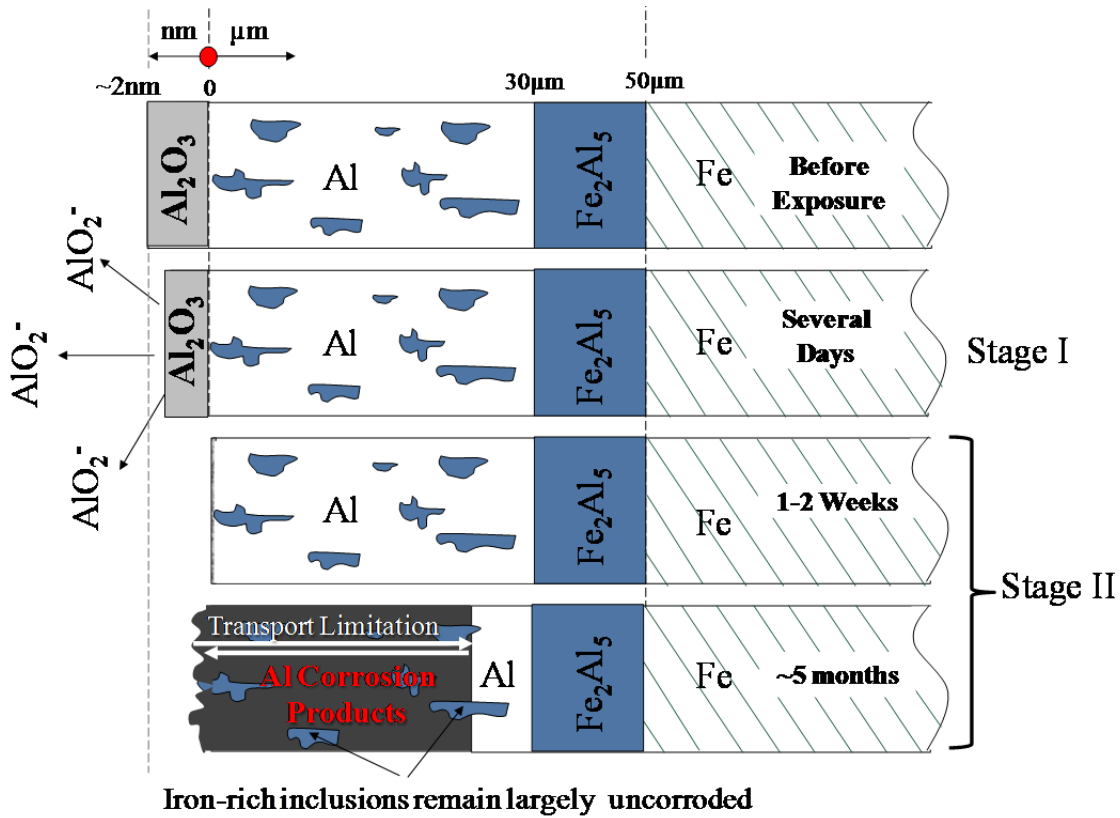
Figure 44: Scenario of corrosion progression under flowing water condition.

During Stage I the passive film on the outer layer of the aluminized coating is consumed by interaction with the high pH generated by dissolution of limestone under near-closed system conditions. After 1-2 weeks the film is completely consumed and active corrosion of the aluminum begins (Stage II) at a high rate. Corrosion products remain in place and transport limitation of one or more of the species responsible for the rate of corrosion ensues in an increasingly thick film. Nevertheless, after several months of exposure a significant fraction of the aluminized coating had been consumed. Aluminate inclusions and the inner aluminized layer are less attacked. Corrosion of the underlying carbon steel, not addressed in the present experiments, is expected to take place at a later date, but the observed attack of the aluminized coating in such short time portends a dramatic reduction in the life expectancy of the pipe

compared to the desired performance. The results thus provide an explanation for the early damage observed in the field.
