EVALUATION OF THE NEW YORK LOW-TENSION THREE-CABLE BARRIER ON CURVED ALIGNMENT

MIDWEST ROADSIDE SAFETY FACILITY

New York State Department of Transportation
50 Wolf Road, 6th Floor
Albany, New York 68502

MwRSF Research Report No. TRP-03-263-12

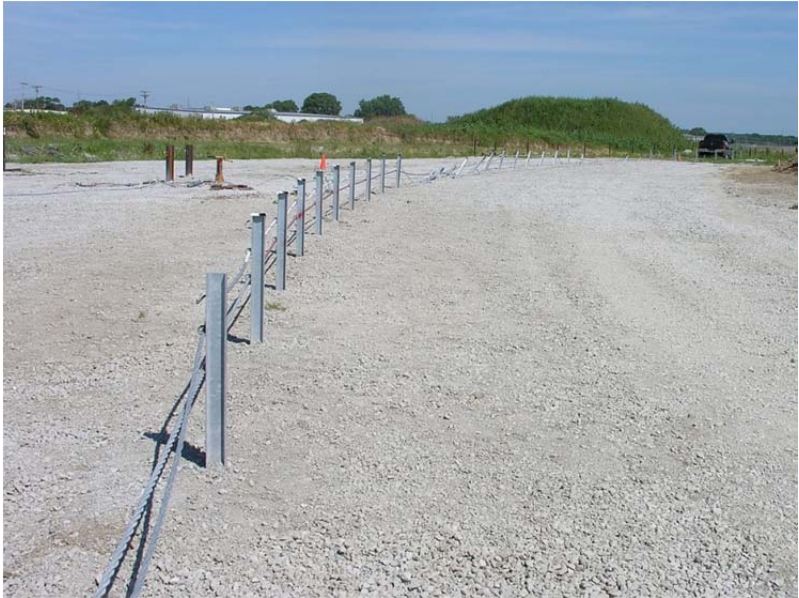
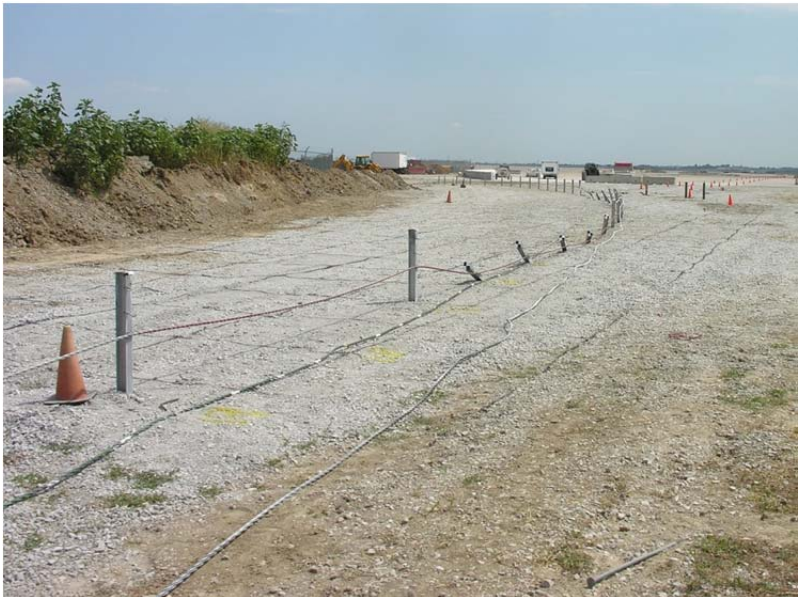
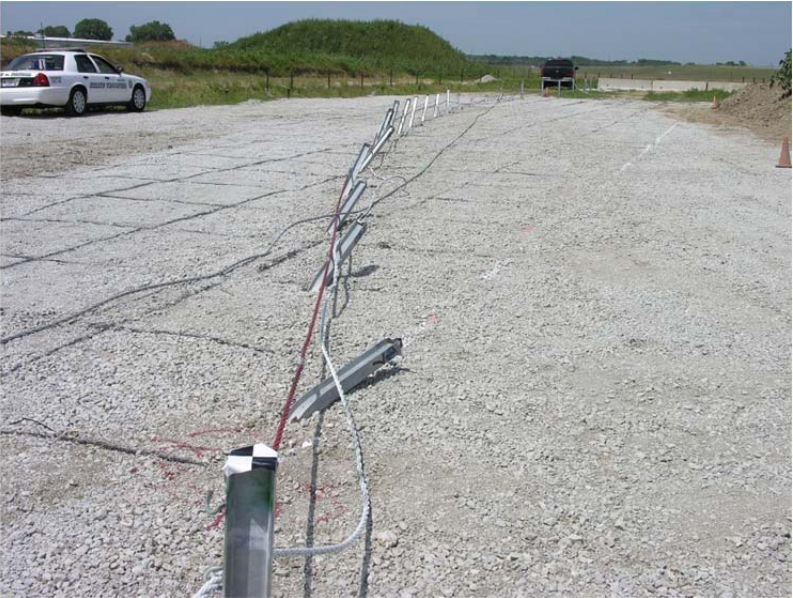
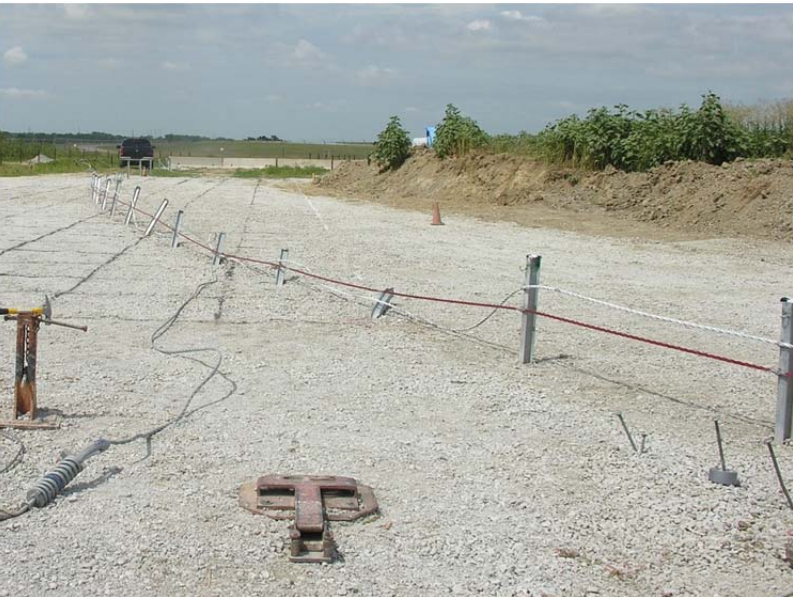
Figure 41. System Damage, Test No. NYCC-1

Damage to the barrier was extensive, as shown in Figures 41 through 55. Barrier damage consisted of bent posts, disengaged cables, weld failures, and anchor rod fractures. The length of vehicle contact along the barrier was approximately 130 ft (39.6 m), which spanned from 2 ft (0.6 m) upstream from post no. 17 through post no. 33.

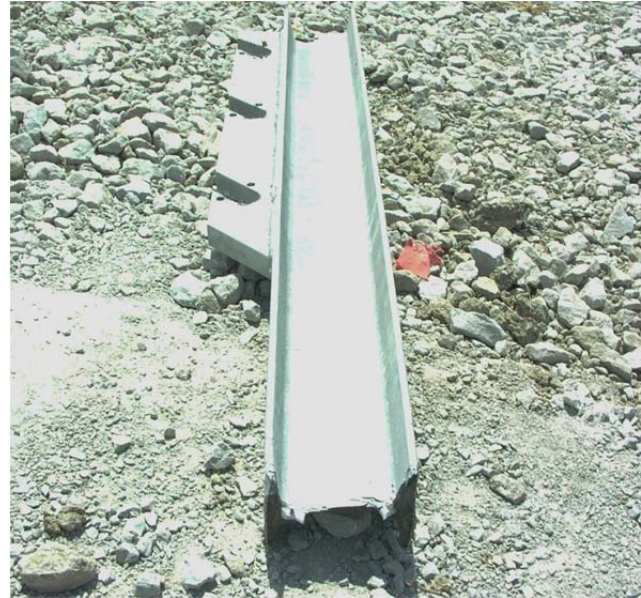
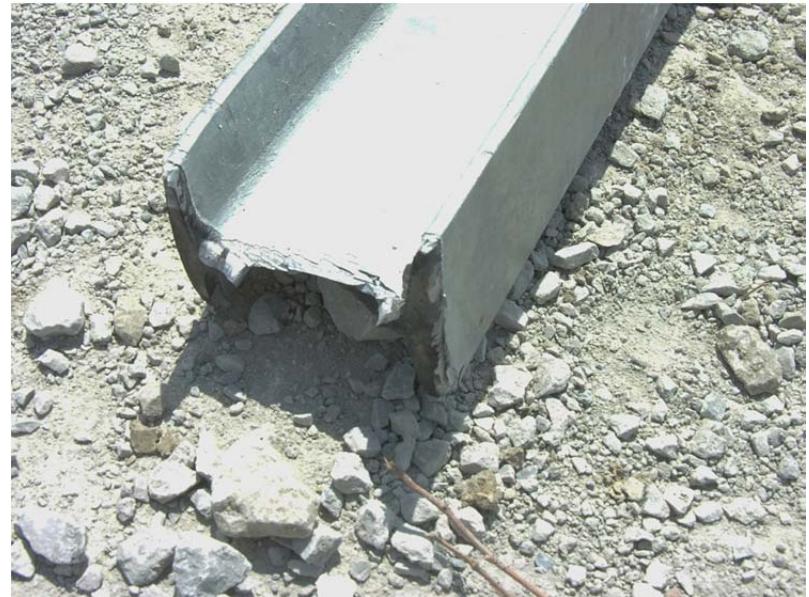
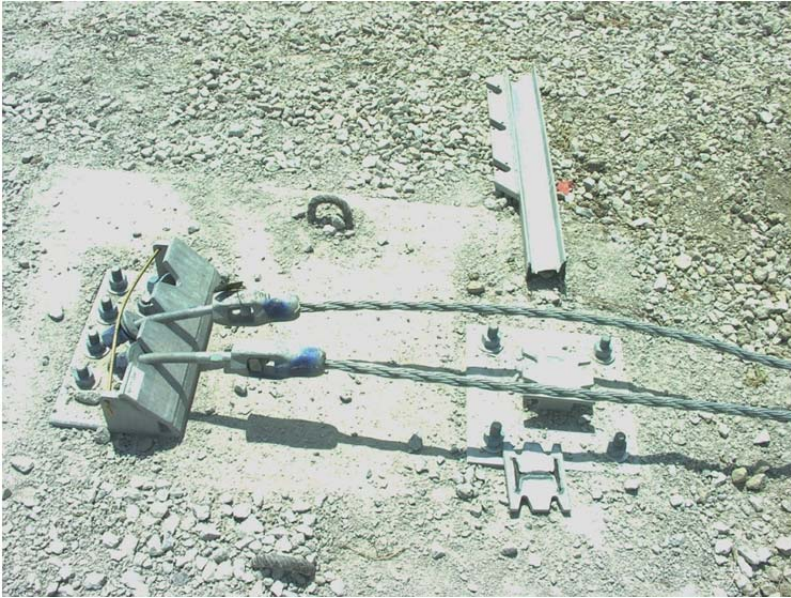
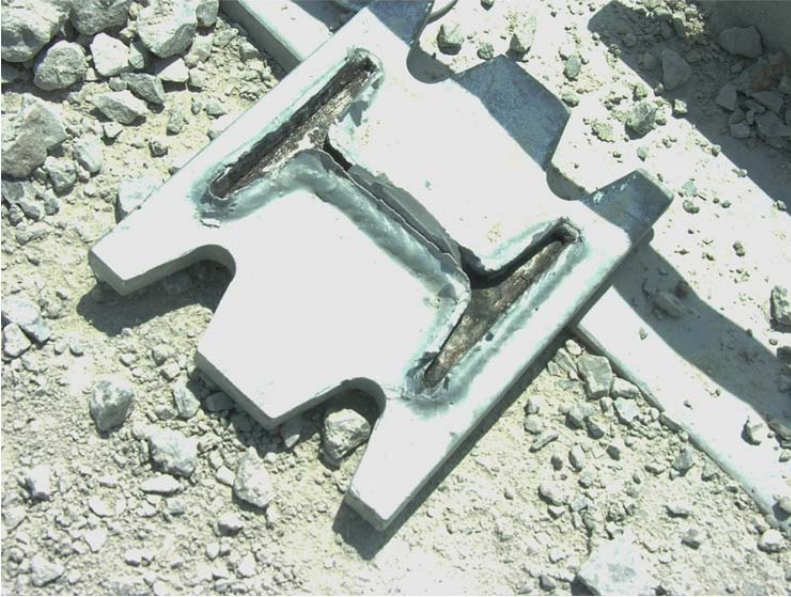
Figure 42. System Damage: Upstream Anchor and Post No. 1, Test No. NYCC-1

The upstream anchorage was moderately and unexpectedly damaged. The weld between post no. 1 and the slip base plate failed, as shown in Figure 42. Both the post and the plate were found adjacent to the slip base stub. All of the cables were disengaged from post no. 1. The top cable anchor rod fractured and the middle cable anchor rod bent, as shown in Figure 43. The upstream end of the top cable came to rest about 10 ft (3 m) in front of post no. 15. The brass keeper rod on the angled anchor plate was also bent.

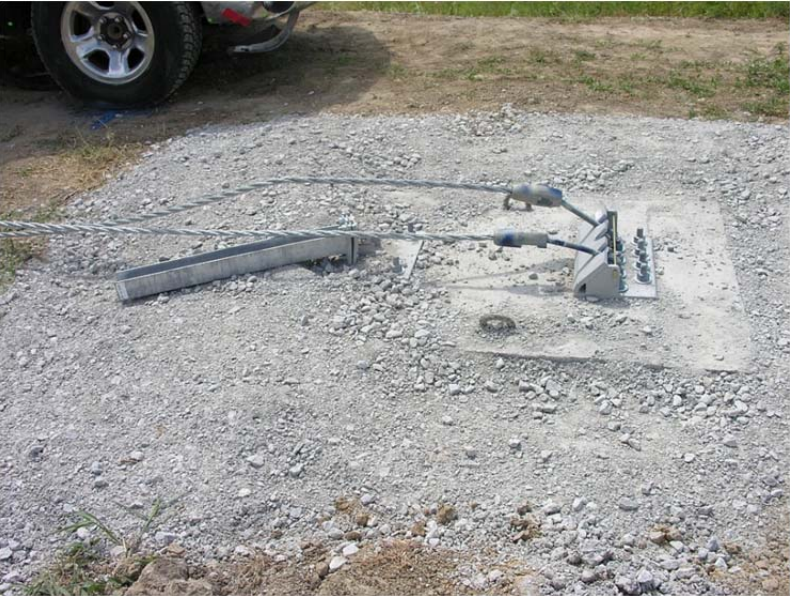
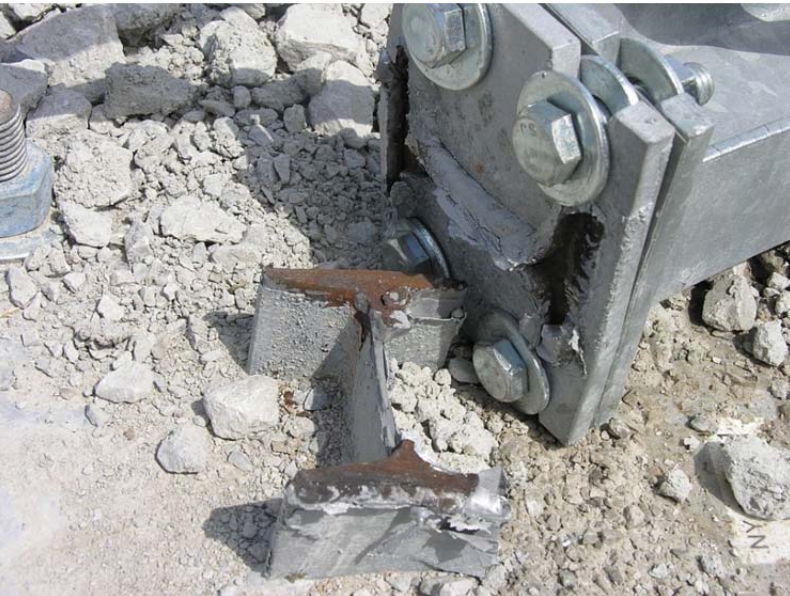
Figure 44. System Damage: Downstream Anchor and Post No. 40, Test No. NYCC-1

The downstream anchorage experienced similar damage. The weld between the bottom slip base plate and the post stub failed, as shown in Figure 44. The post came to rest adjacent to the stub with the slip base completely intact. All three cables were disengaged from the post. The middle cable anchor rod fractured, as shown in Figure 45, due to the cable being snagged on the vehicle. The downstream end of the middle cable came to rest behind the vehicle, about 6 ft (2 m) in front of post no. 38.

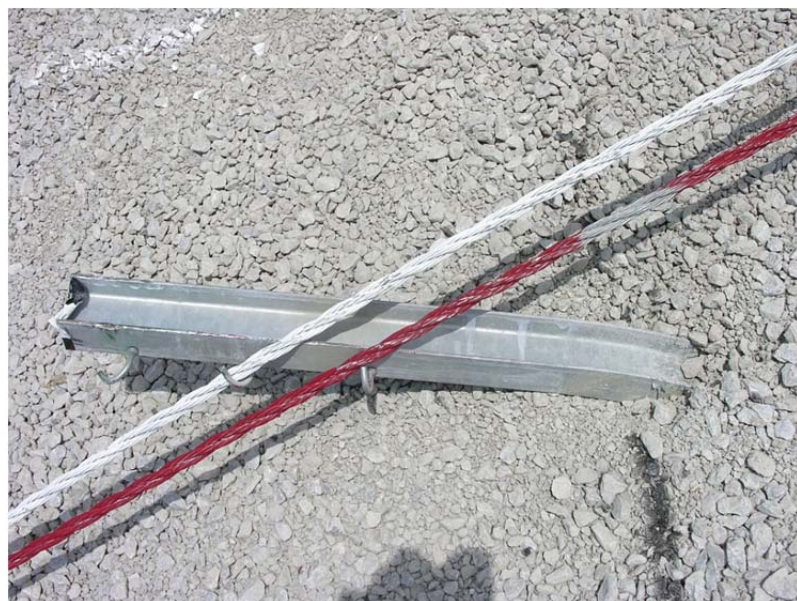
Post No. 18

through 19, 30, and 33. The middle cable between post nos. 17 and 18 frayed. The fray consisted of two broken wire strands, as shown in Figure 46.

Figure 47. System Damage: Post Nos. 17 and 18, Test No. NYCC-1

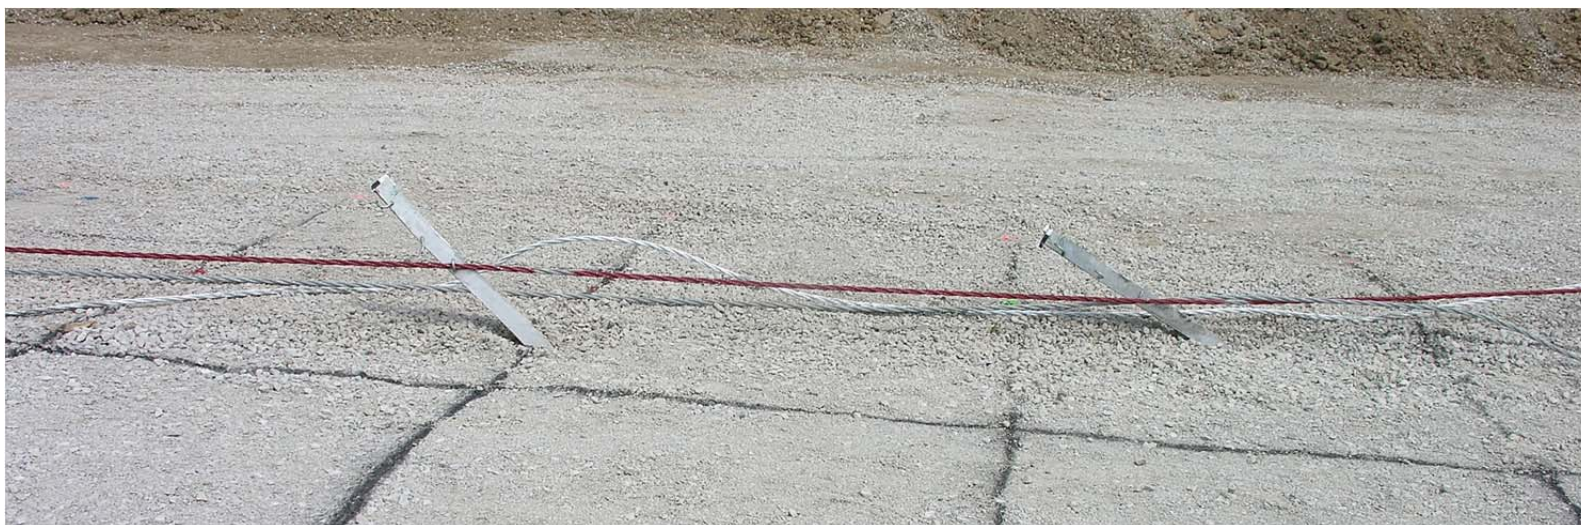
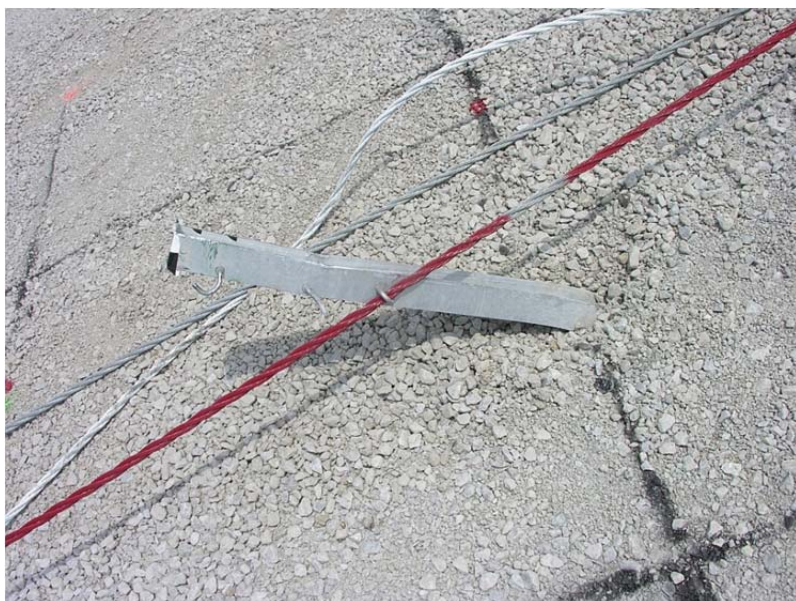
Post No. 20

Figure 48. System Damage: Post Nos. 19 and 20, Test No. NYCC-1

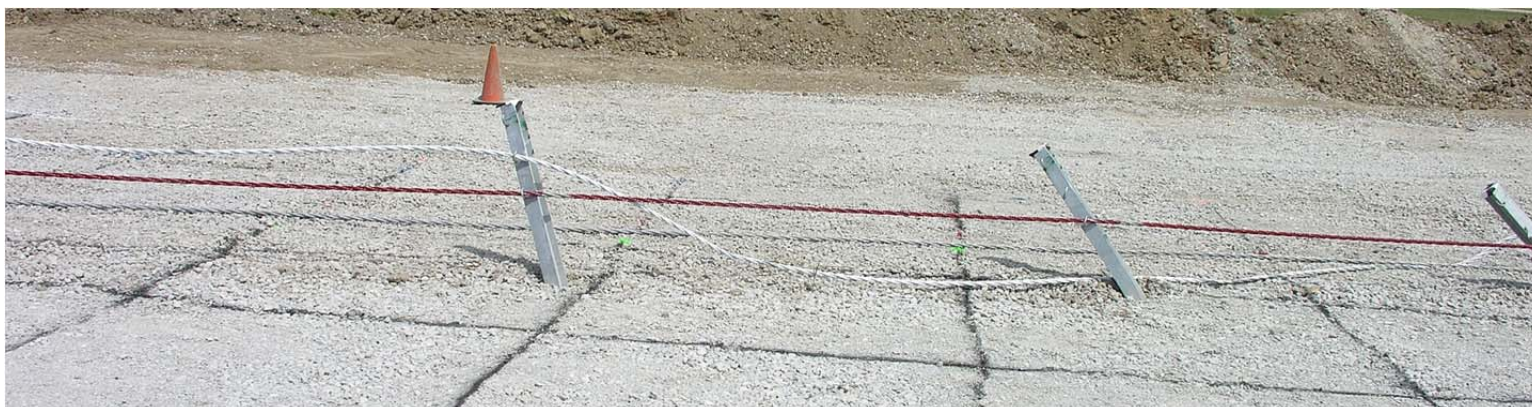
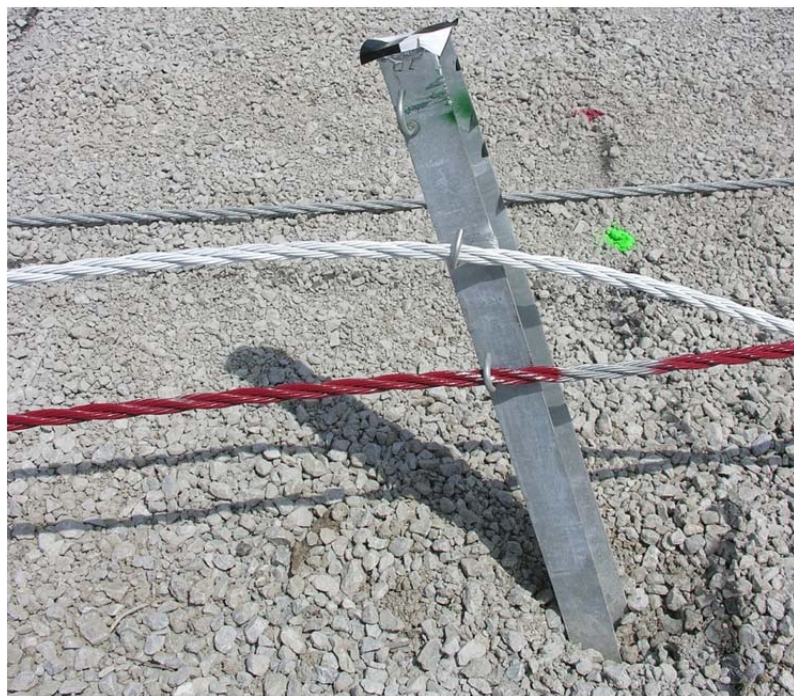
Post No. 22

Figure 49. System Damage: Post Nos. 21 and 22, Test No. NYCC-1

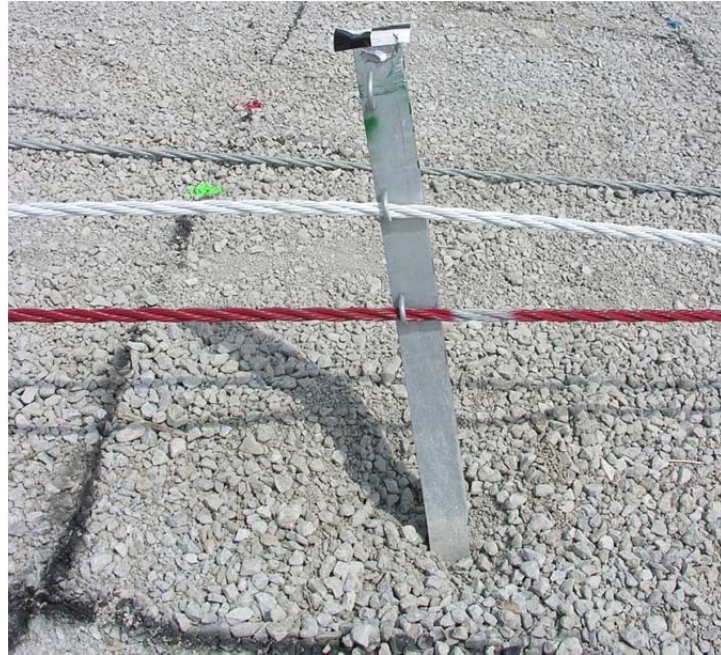
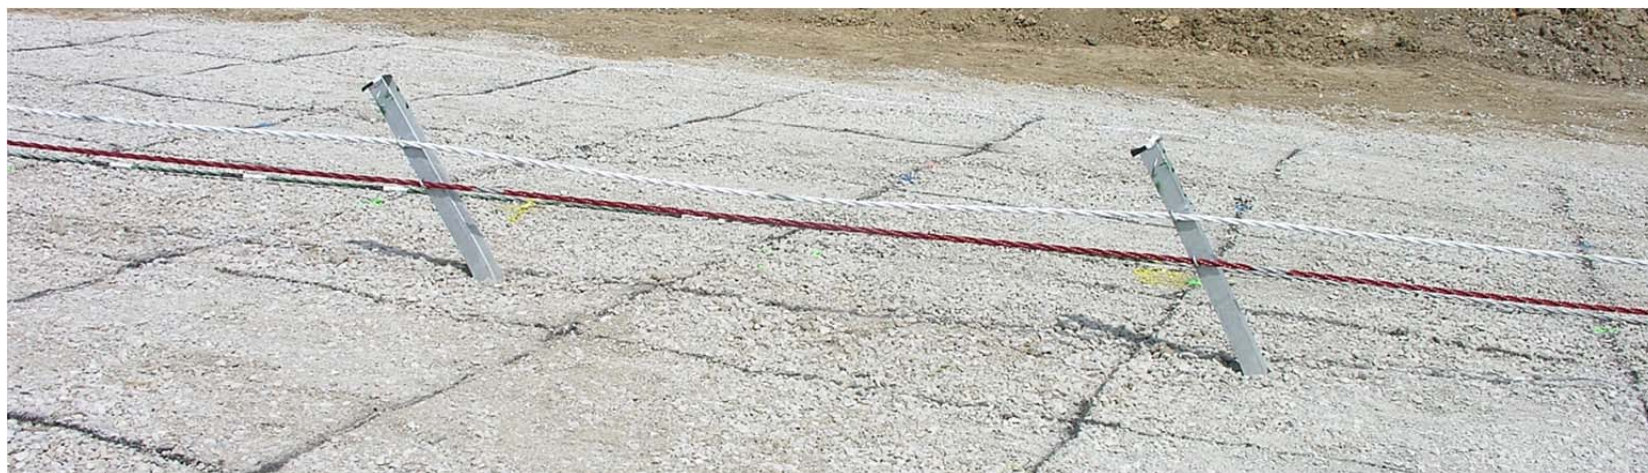
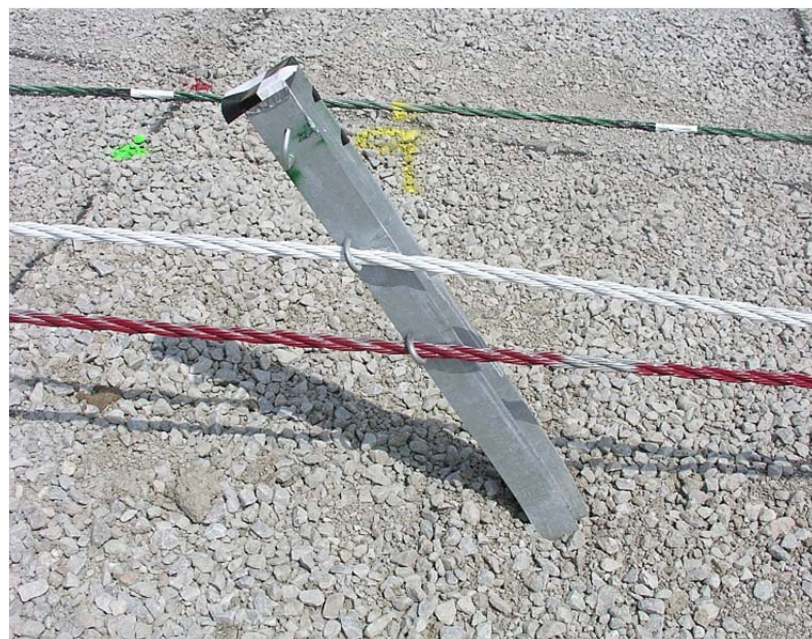
Figure 50. System Damage: Post Nos. 23 and 24, Test No. NYCC-1

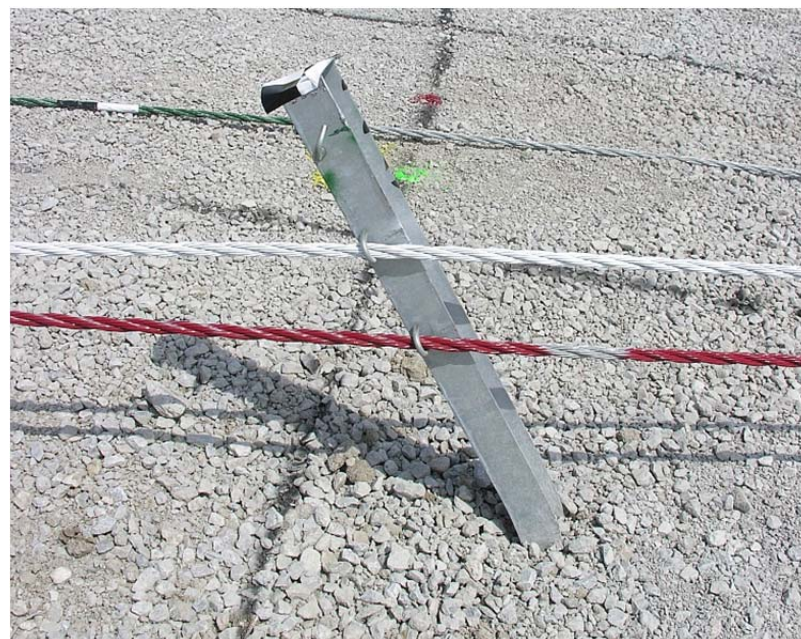
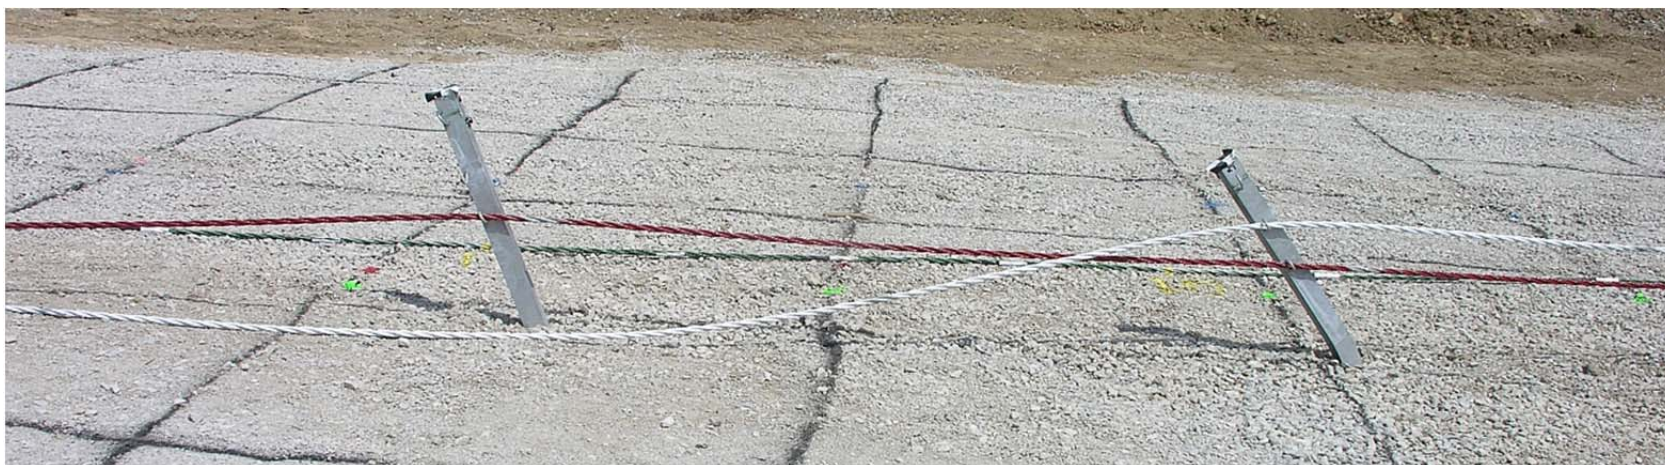
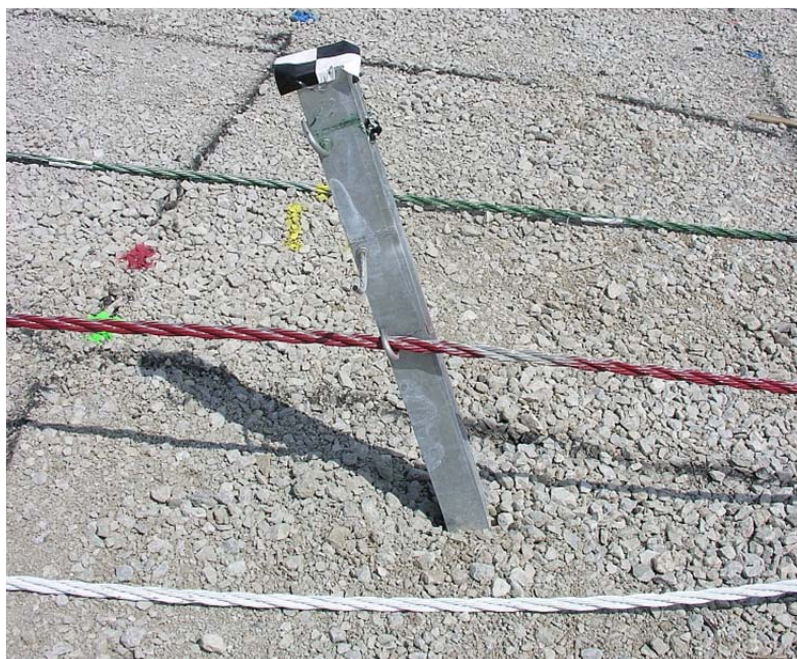
Figure 51. System Damage: Post Nos. 25 and 26, Test No. NYCC-1

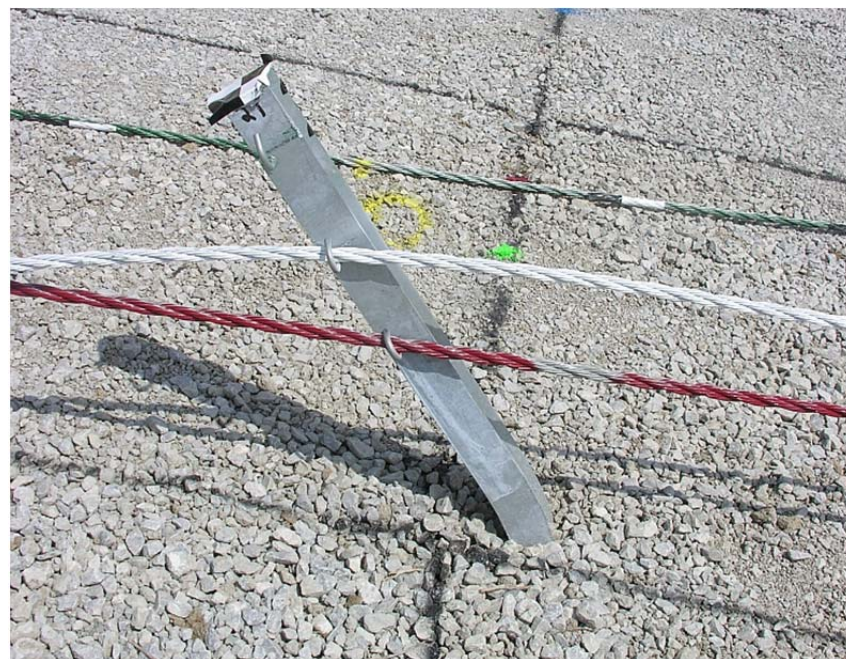
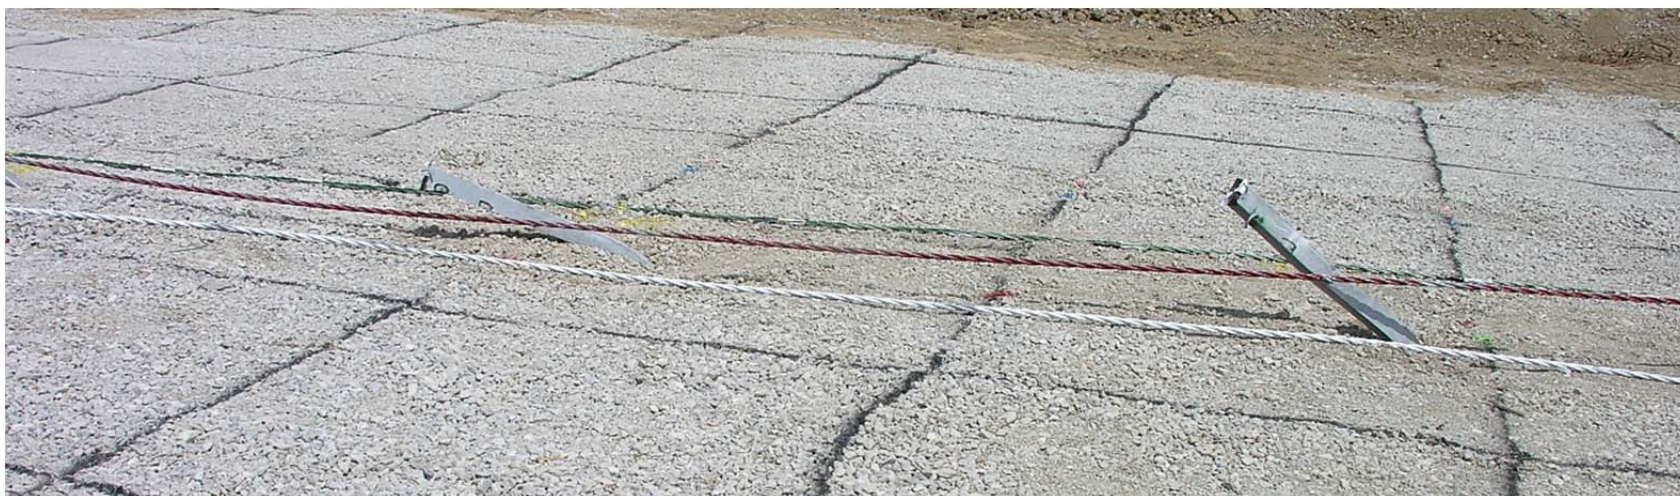
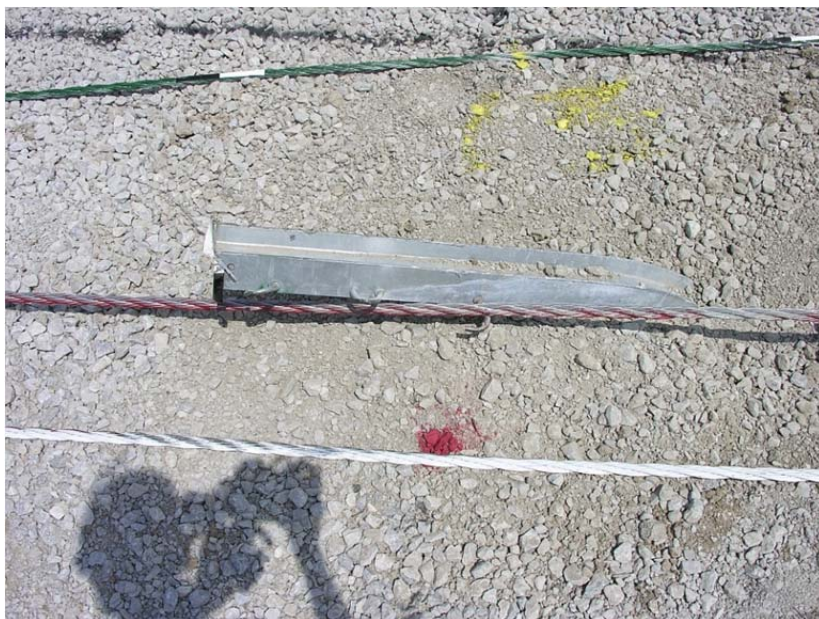
Figure 52. System Damage: Post Nos. 27 and 28, Test No. NYCC-1

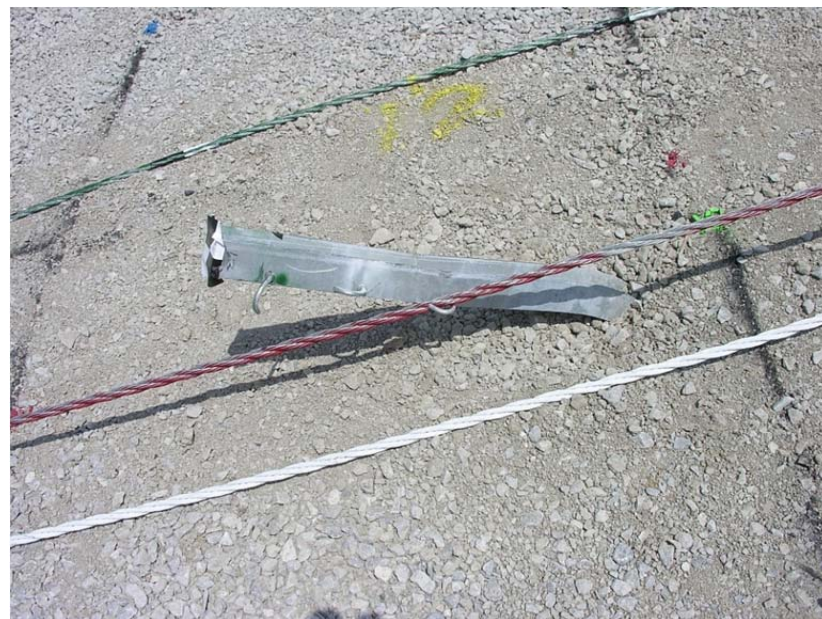
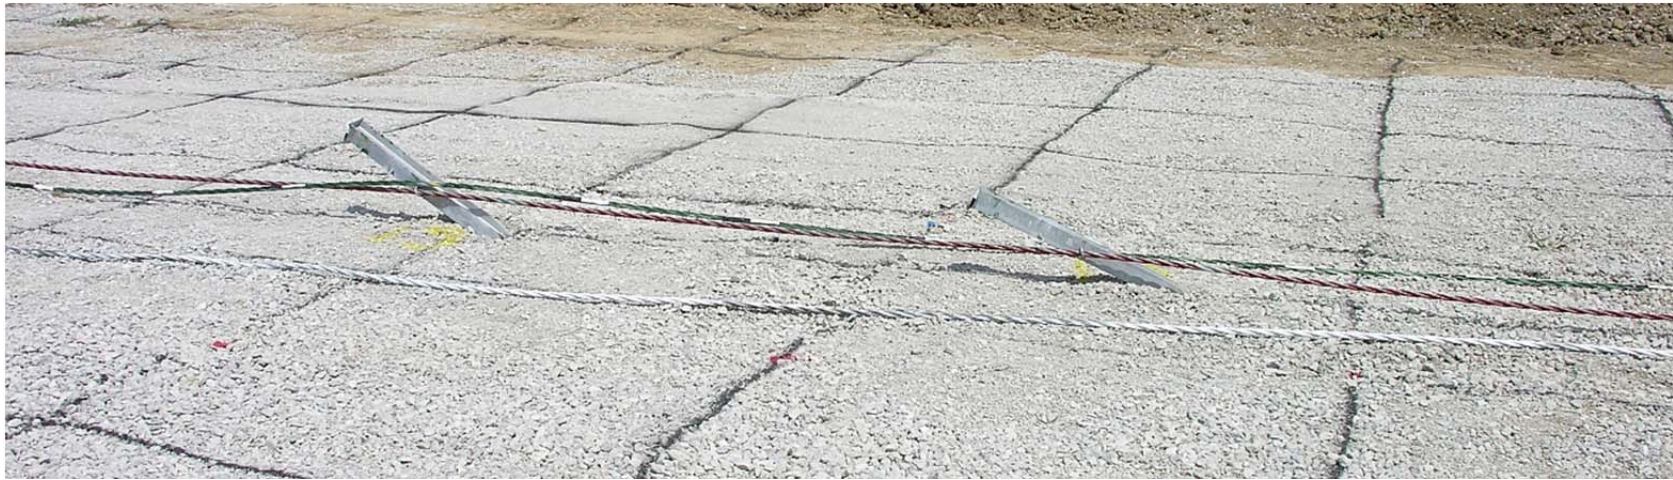
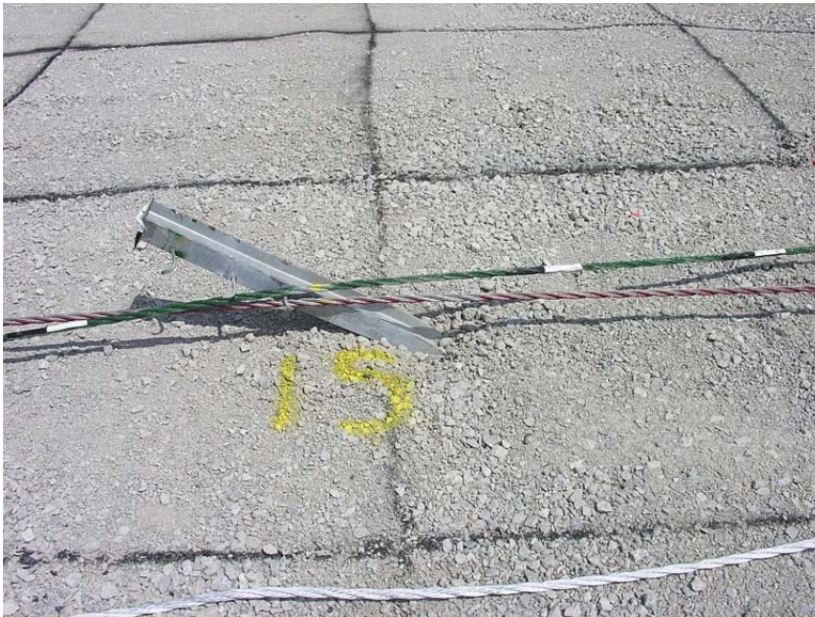
Figure 53. System Damage: Post Nos. 29 and 30, Test No. NYCC-1

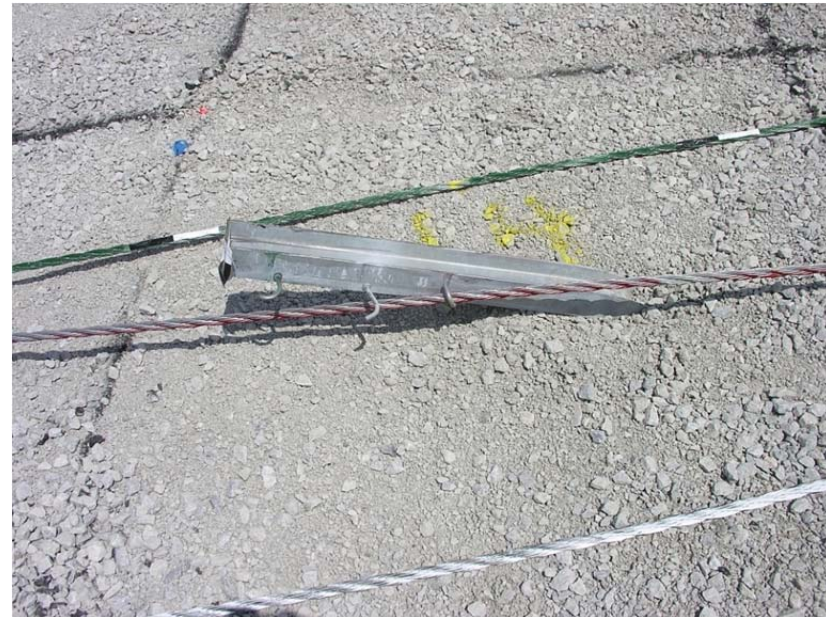
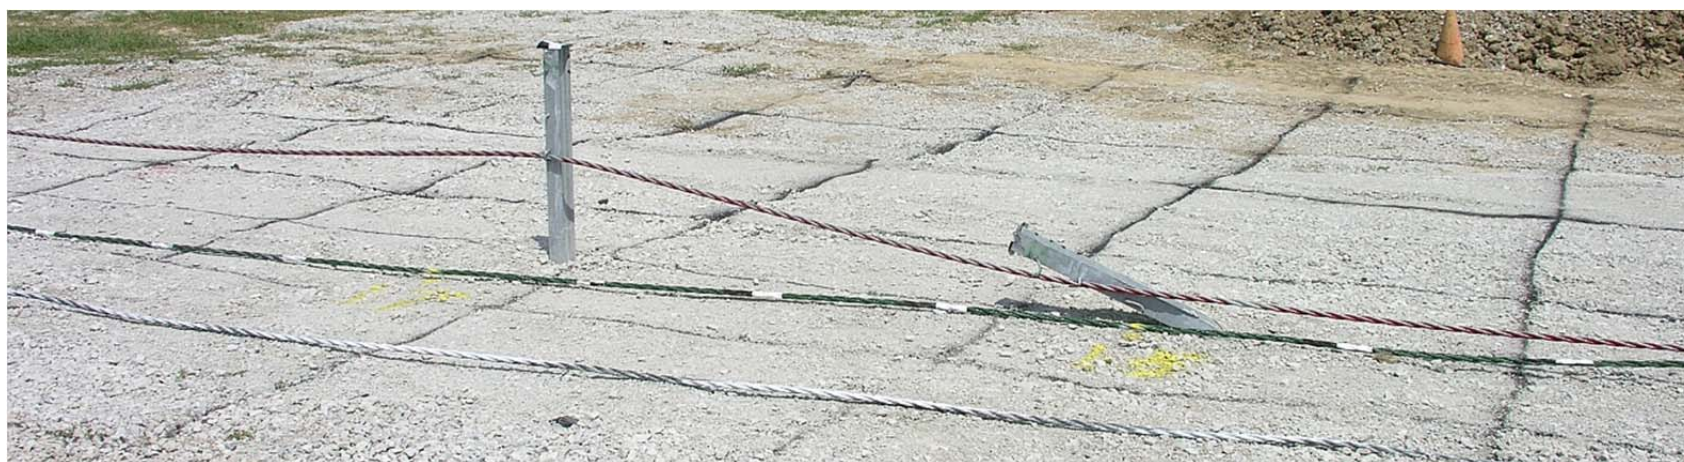
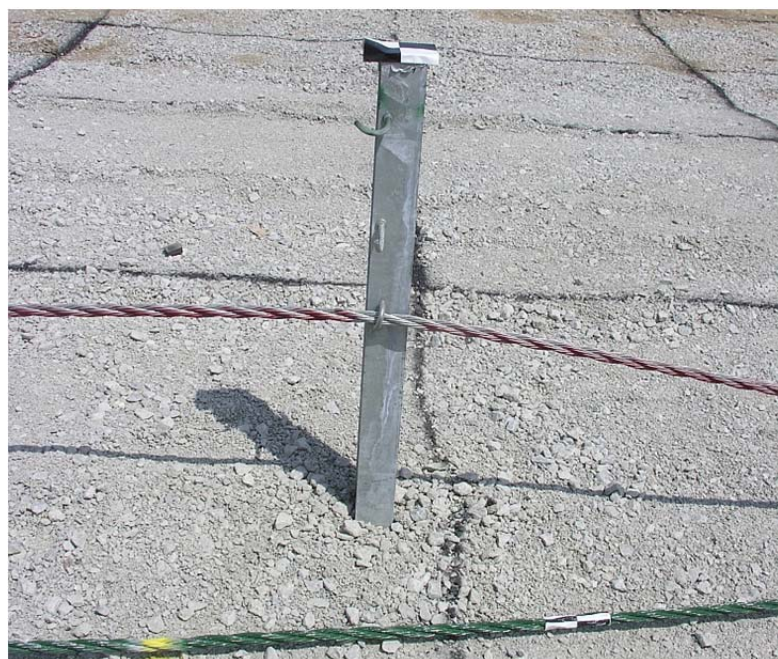
Figure 54. System Damage: Post Nos. 31 and 32, Test No. NYCC-1

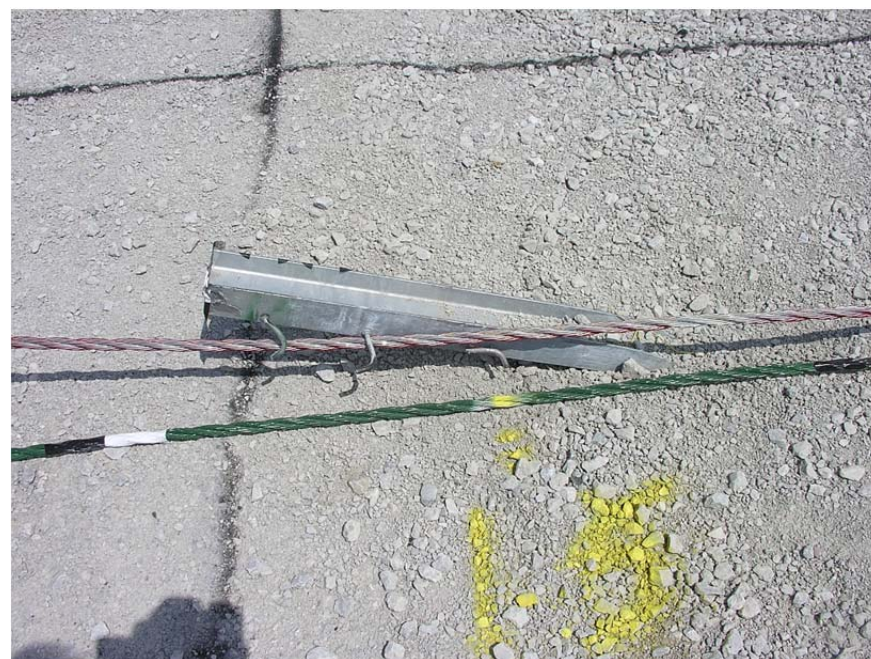
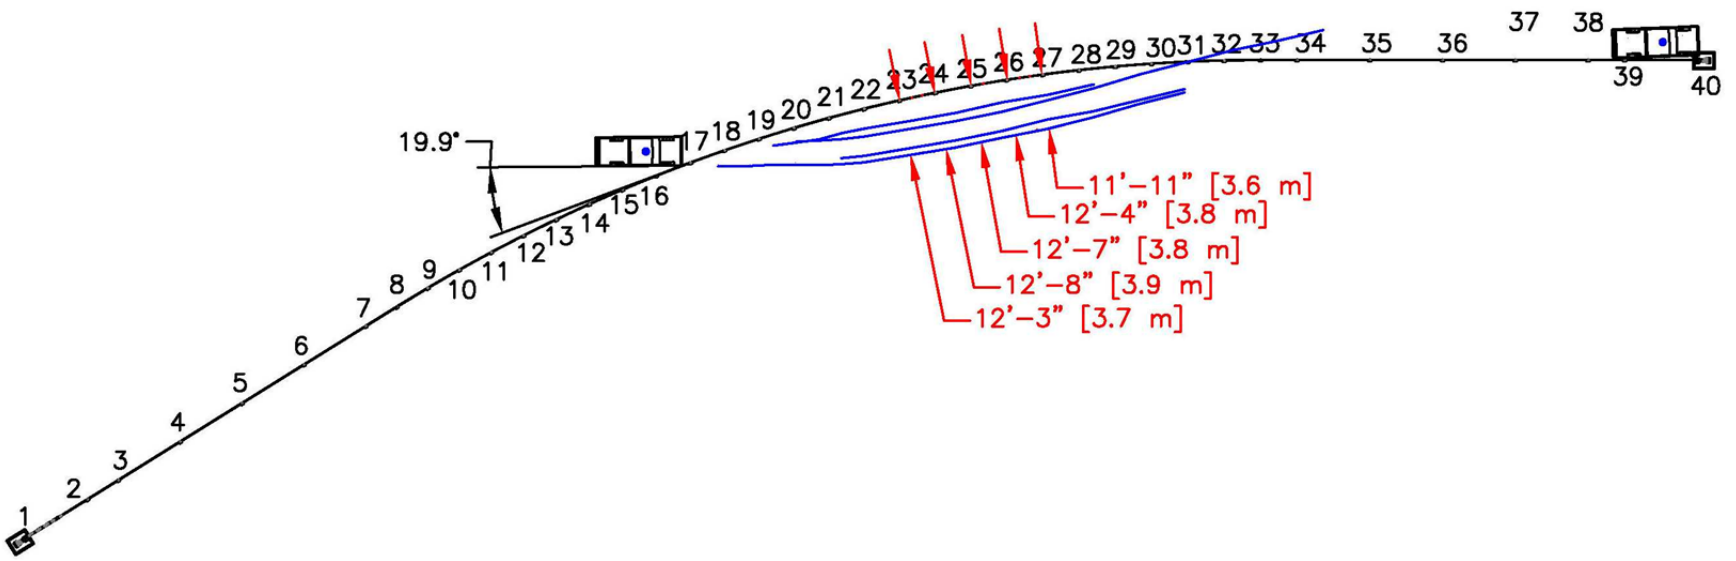
Figure 55. System Damage: Post Nos. 33 and 34, Test No. NYCC-1

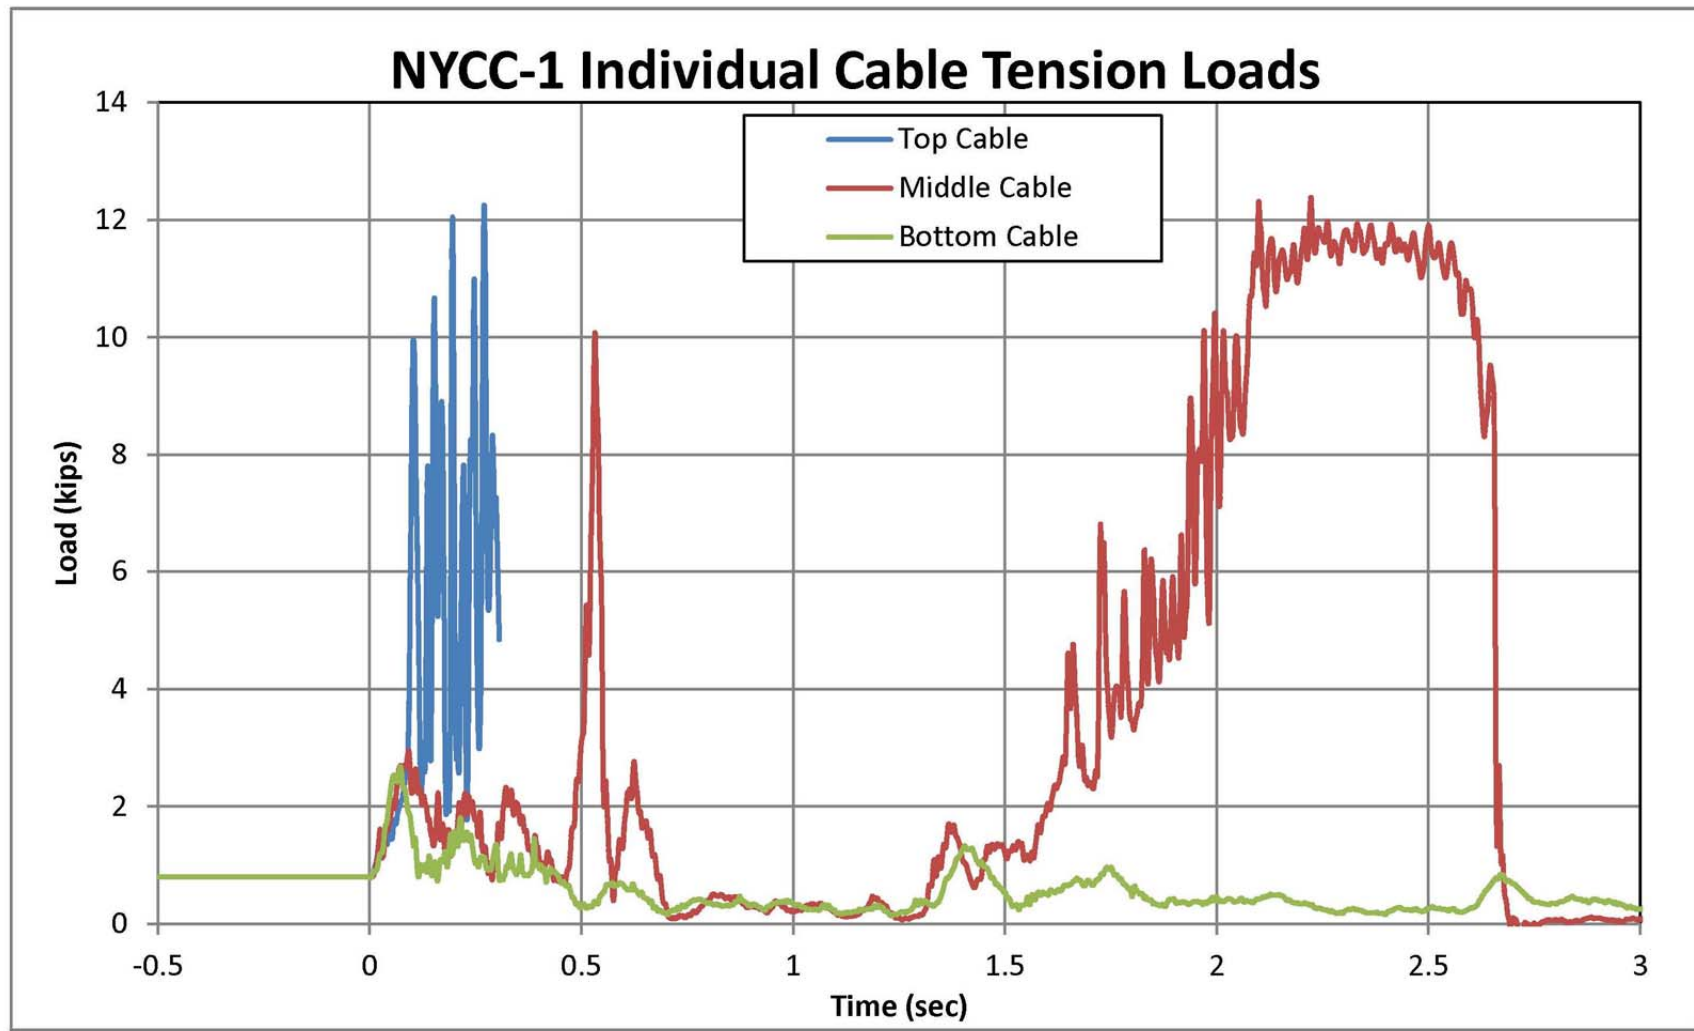
Figure 59. Individual Cable Tension vs. Time, Test No. NYCC-1

As previously discussed, tension load cells were installed in line with the cables at the upstream end of the barrier system in order to monitor the total load transferred to the end anchor system with respect to time. The load cell results are summarized in Table 7. The individual cable loads and the total combined cable load imparted to the upstream end anchor are shown graphically in Figures 59 and 60, respectively. The pre-tension for each cable was 800 lb (3.56 kN), as measured by displacements in the spring compensators near the upstream anchorage. During the test, the top cable anchor rod fractured, and the cable was pulled upstream. Subsequently, the load cell wire severed, and data was no longer recorded for the top cable. Also,

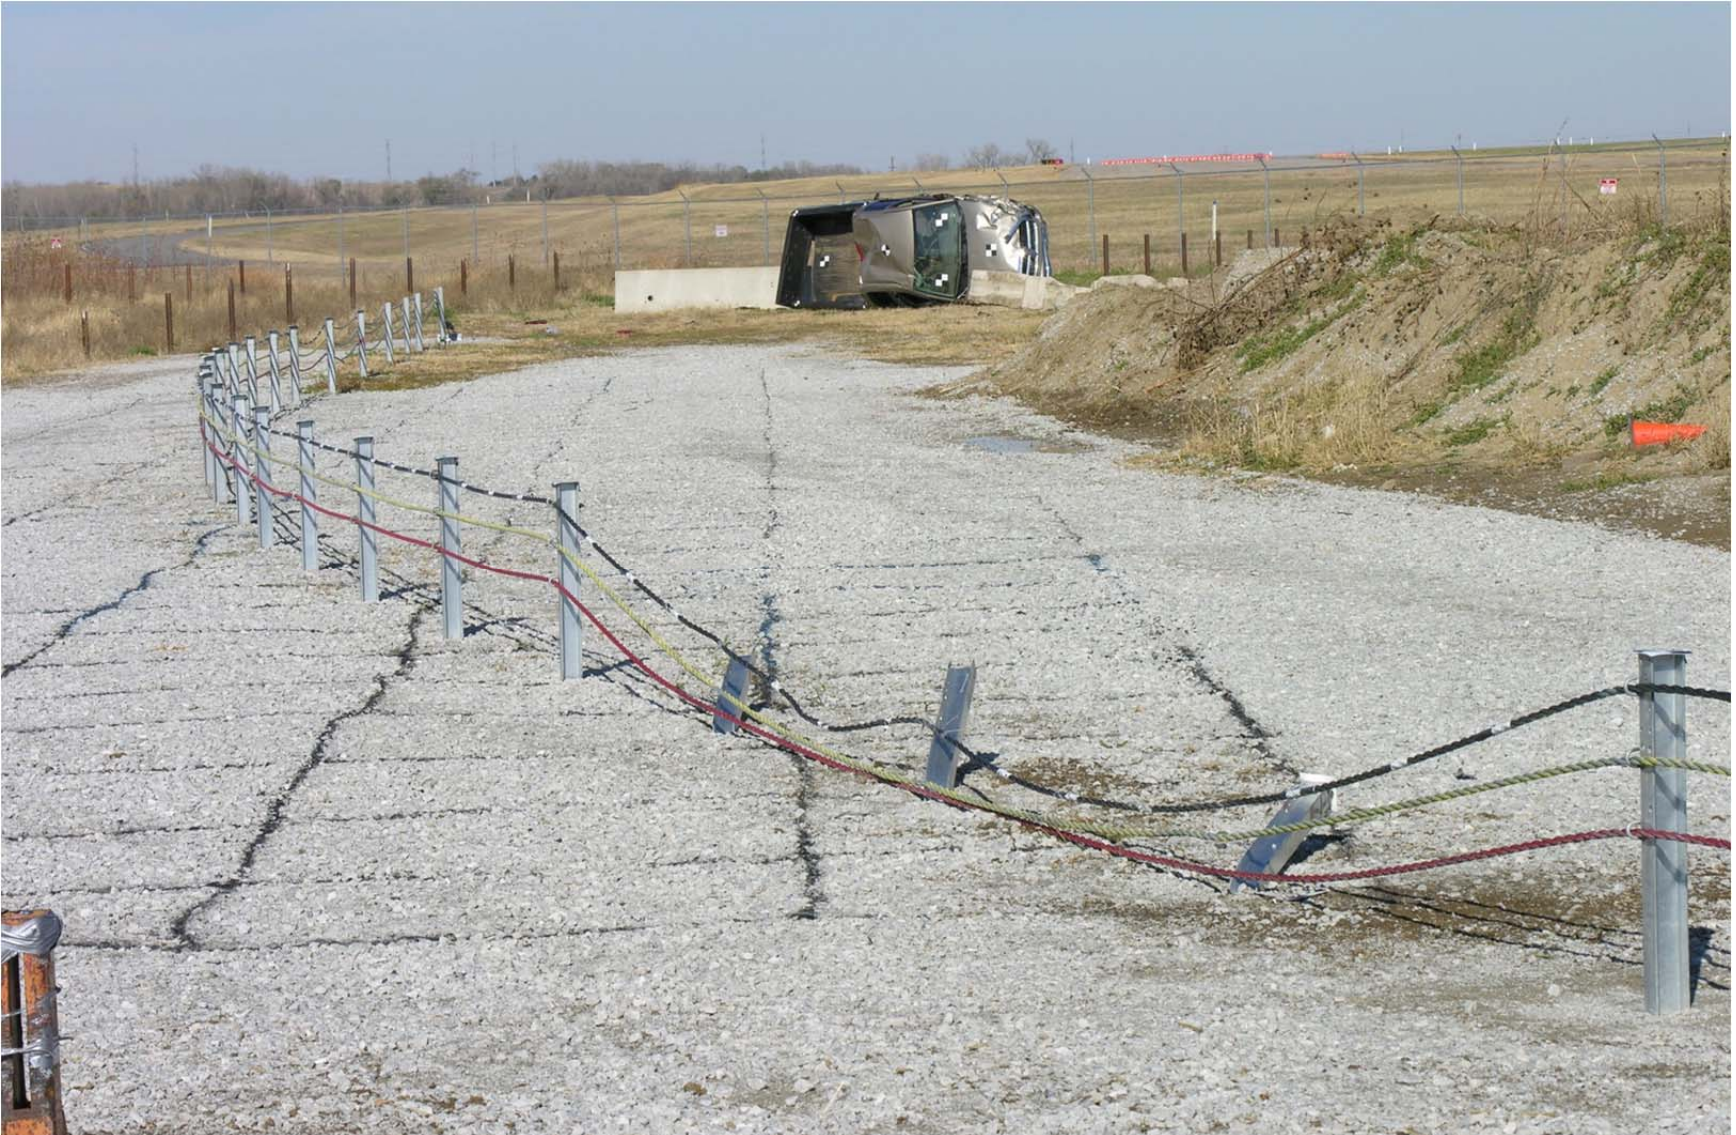
Figure 71. Vehicle Final Position and Trajectory Marks, Test No. NYCC-2

Initial vehicle impact occurred at the targeted impact point 2 ft (0.6 m) upstream of post no. 17, or 70 ft (21.3 m) downstream of post no. 8, as shown in Figure 70, which was selected by NYSDOT personnel. A sequential description of the impact events is contained in Table 9. The vehicle came to rest on its side behind the barrier at a location of 282 ft (86.0 m) downstream of impact and 7 ft (2.1 m) laterally behind a line parallel to the impact point, as shown in Figures 66 and 71.
