EVALUATION OF THE NEW YORK LOW-TENSION THREE-CABLE BARRIER ON CURVED ALIGNMENT

MIDWEST ROADSIDE SAFETY FACILITY

New York State Department of Transportation
50 Wolf Road, 6th Floor
Albany, New York 68502

MwRSF Research Report No. TRP-03-263-12

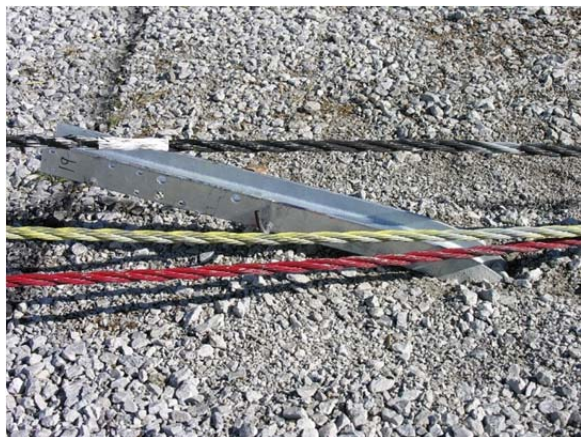
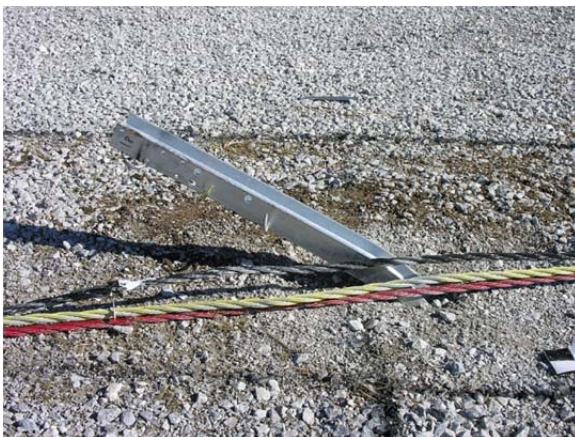
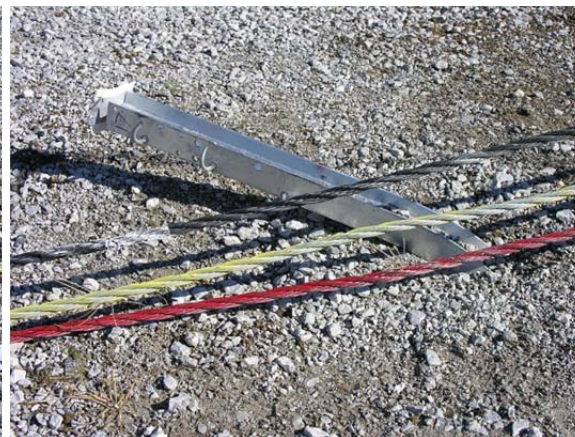
Figure 74. System Damage: Post Nos. 17 through 19, Test No. NYCC-2

Damage to the barrier was minimal, as shown in Figures 71 through 74. Barrier damage consisted of bent posts and disengaged cables. The length of vehicle contact along the barrier was approximately 24 ft (7.32 m), which spanned from 2 ft (0.6 m) upstream from post 17 through 2 ft (0.6 m) upstream from post 20.

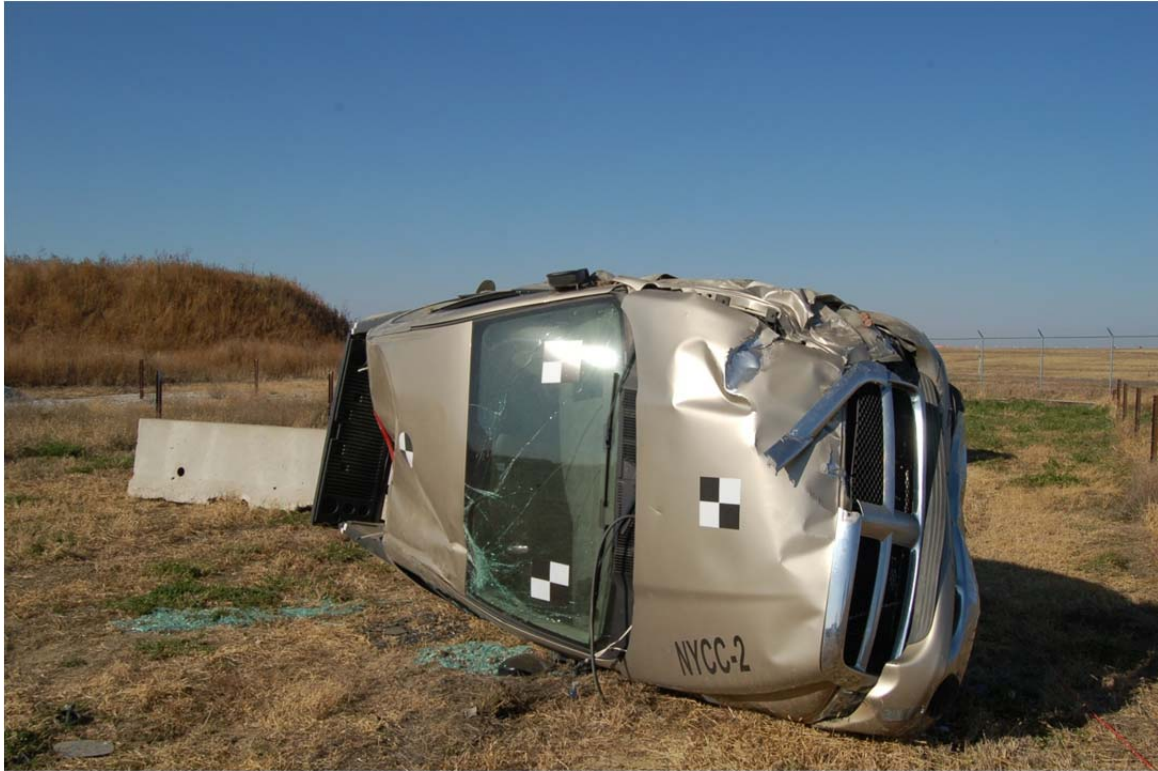
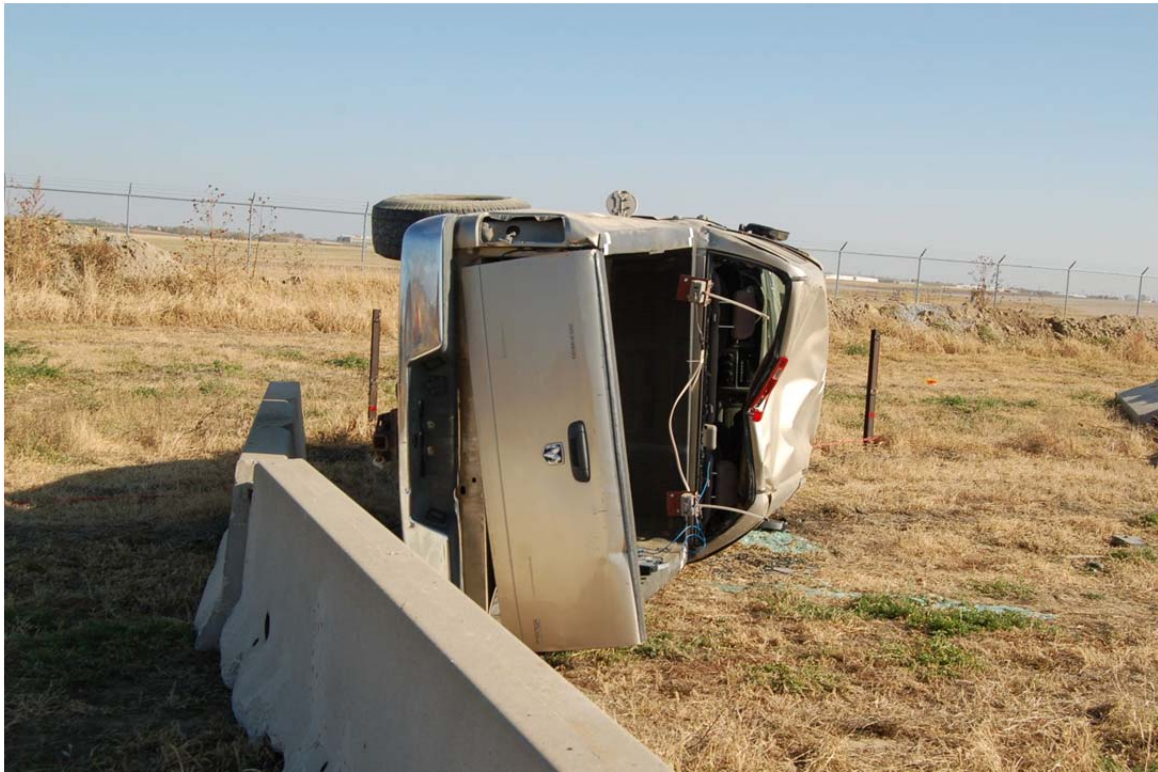
Figure 75. Vehicle Damage, Test No. NYCC-2

The damage to the vehicle was moderate, as shown in Figures 75 through 78. However, only minor vehicle damage resulted from the interaction with the barrier. The damage due to rollover was not attributable to the curved-cable system as the vehicle was stable and tracking before climbing the embankment. The maximum occupant compartment deformations are listed in Table 10 along with the deformation limits established in MASH for various areas of the occupant compartment. Note that the maximum permissible roof crush limits described in

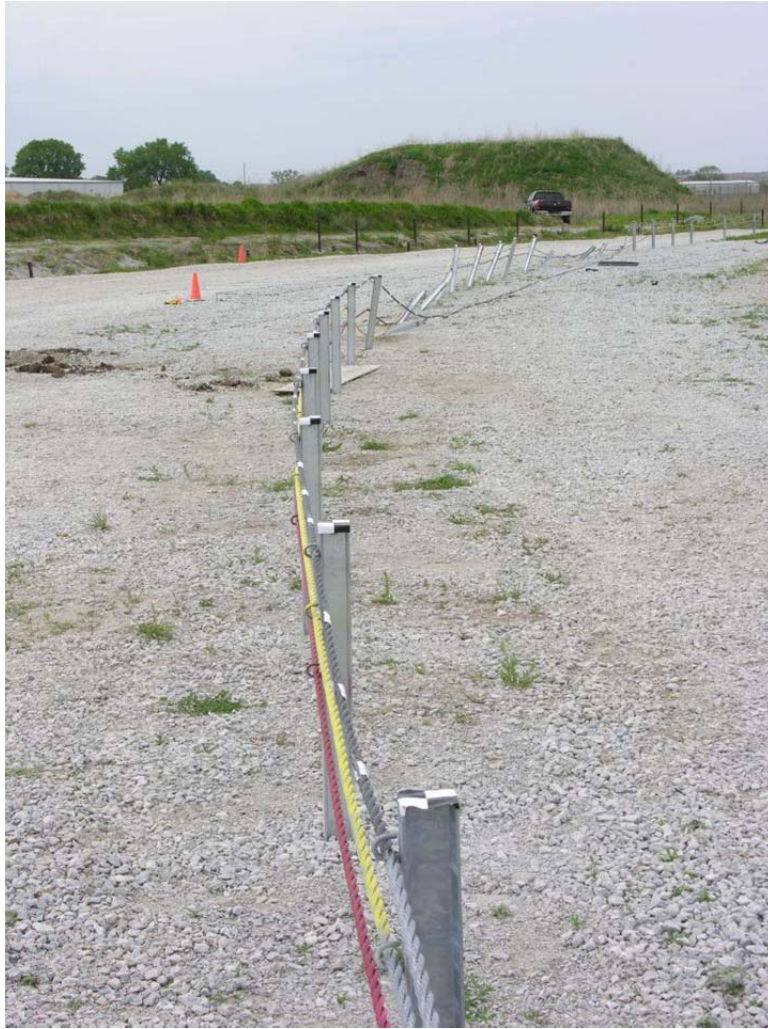
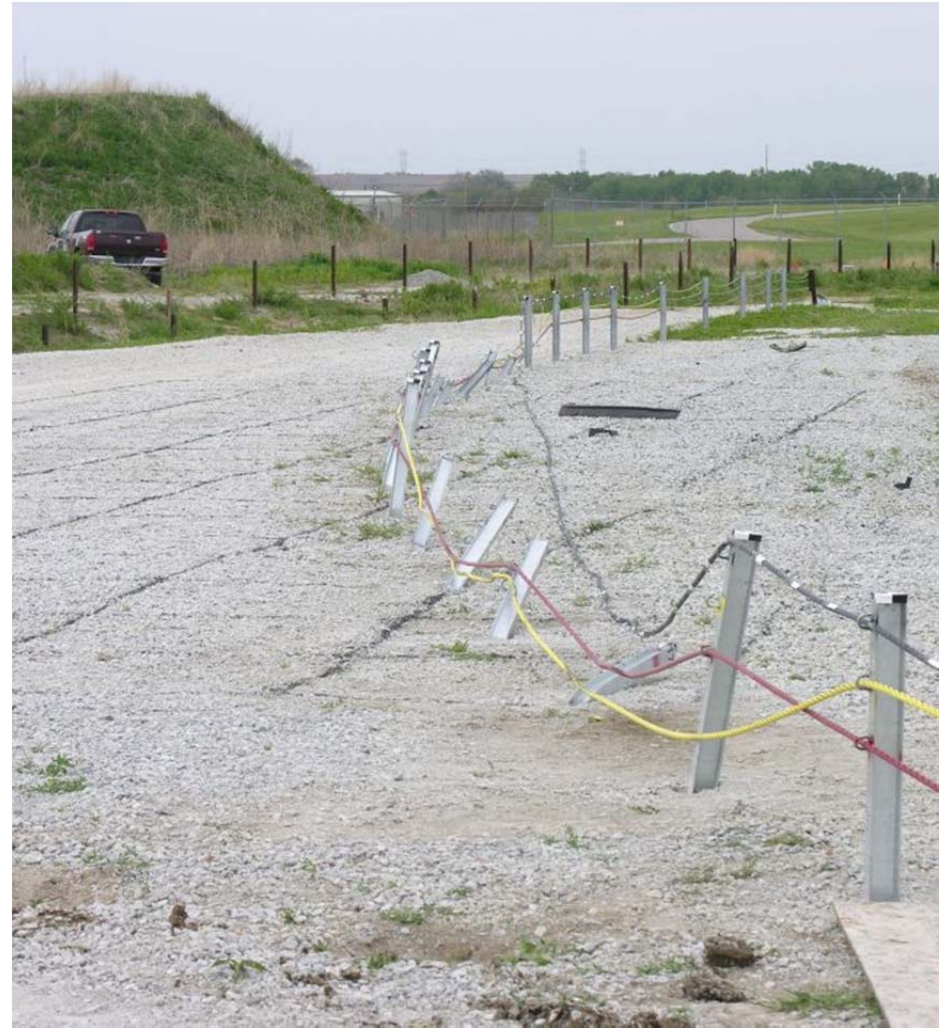
Figure 106. Vehicle Final Position and Trajectory Marks, Test No. NYCC-3

Initial vehicle impact occurred at the targeted impact point 2 ft (0.6 m) upstream of post no. 17, as shown in Figure 105, which was selected by NYSDOT personnel. A sequential description of the impact events is contained in Table 14. The vehicle came to rest 310 ft – 7 in. (94.7 m) downstream of impact and 78 ft – 11 in. (24.0 m) laterally from the original impact point. The vehicle trajectory and final position are shown in Figures 99 and 106.

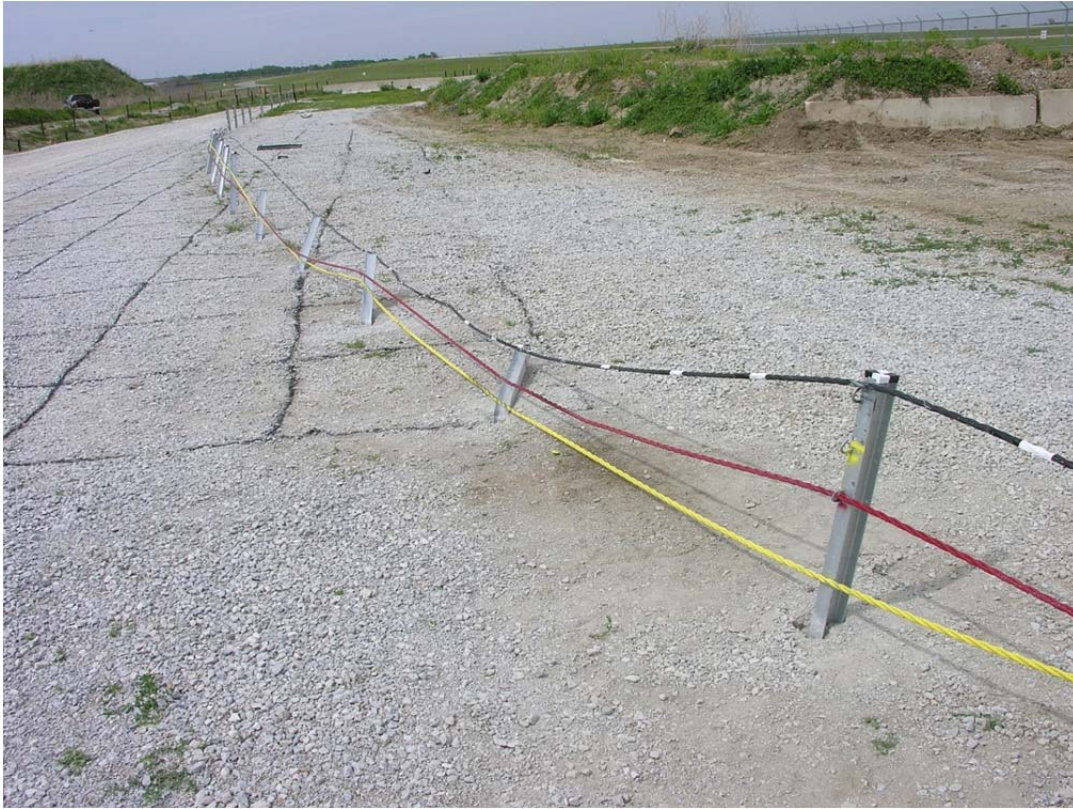
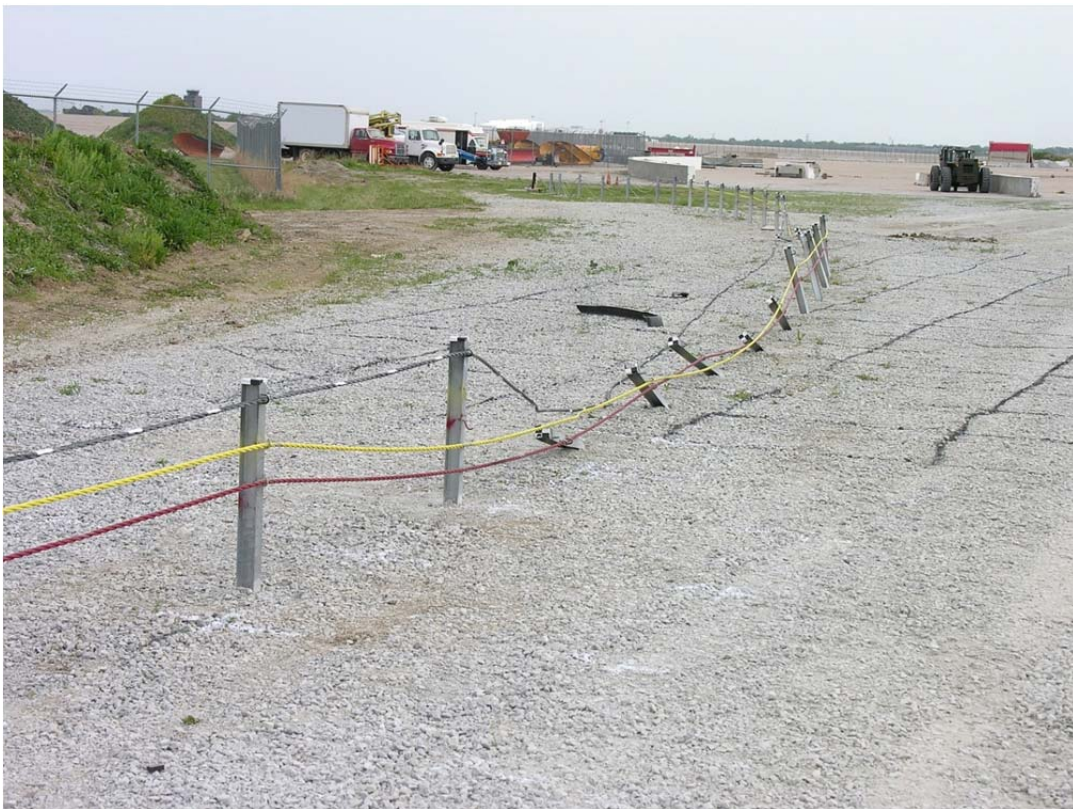
Figure 107. System Damage, Test No. NYCC-3

Damage to the barrier was moderate, as shown in Figures 107 through 116. Barrier damage consisted of bent posts and disengaged cables. The length of vehicle contact along the barrier was approximately 130 ft (39.6 m), which spanned from 2 ft (0.6 m) upstream from post no. 17 through post no. 31.

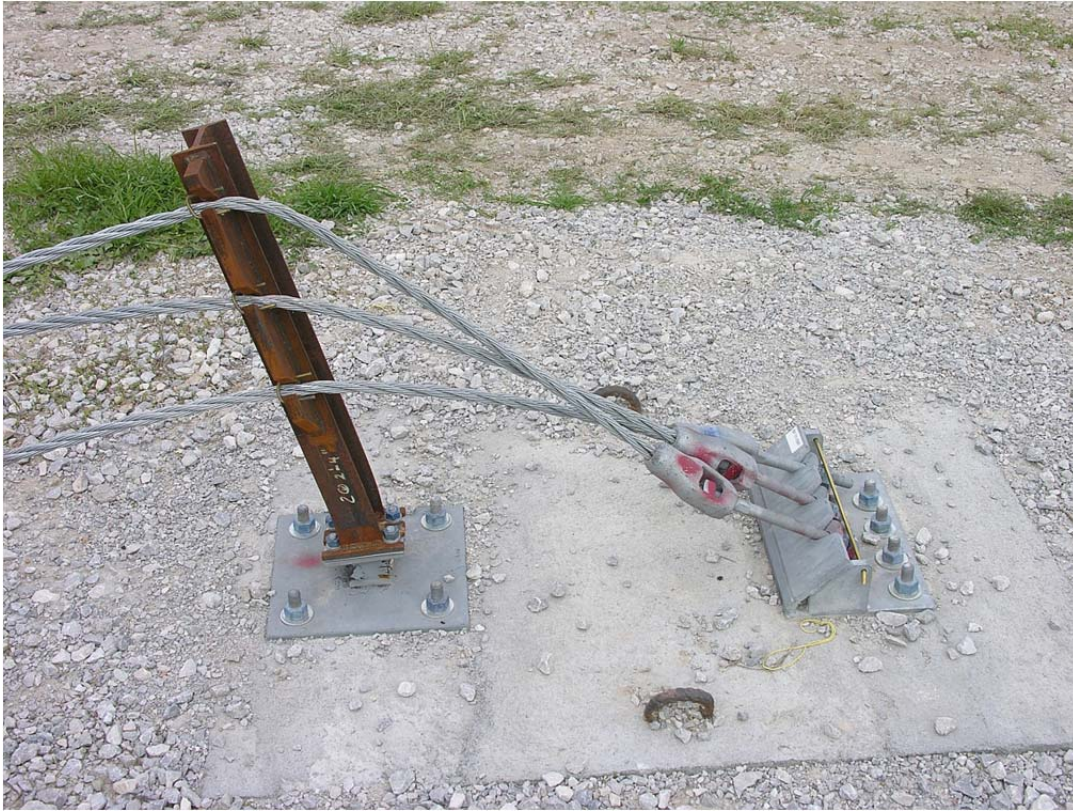
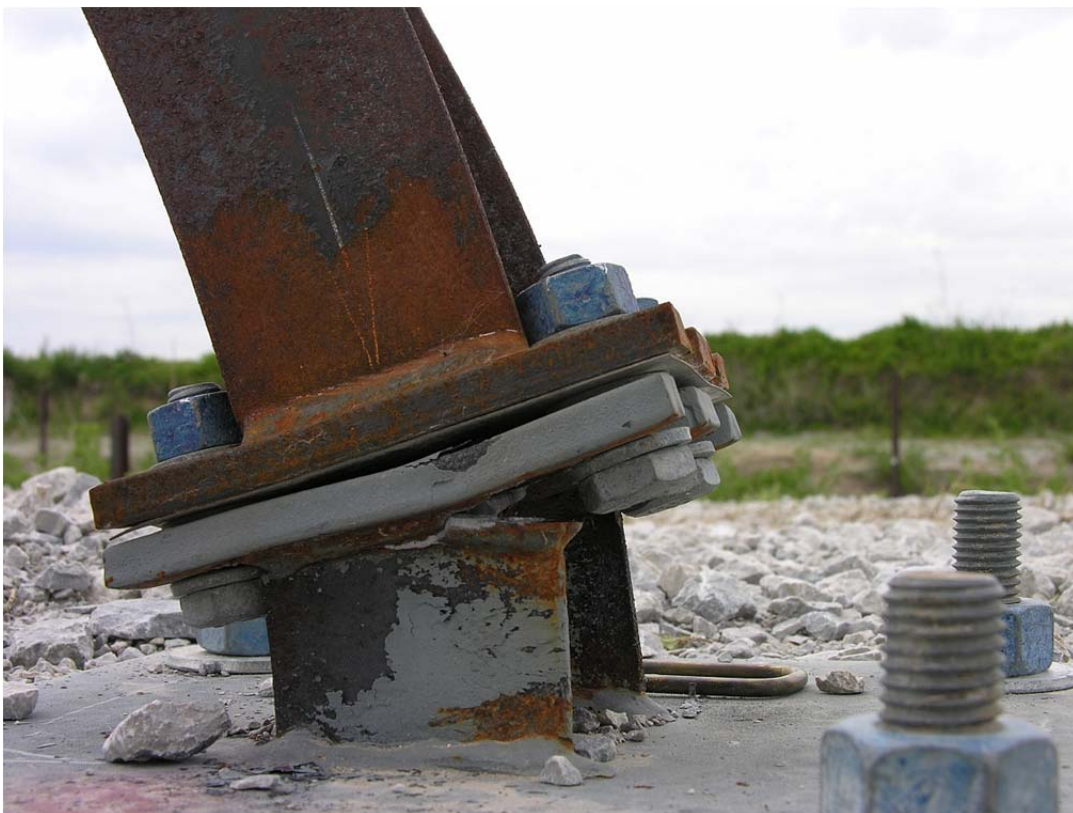
Figure 108. System Damage: Post No. 1, Test No. NYCC-3

Post no. 1 was bent downstream at the slip base. All cables remained engaged with the upstream end anchorage as shown in Figure 108. No damage occurred to the system between post nos. 2 and 15.

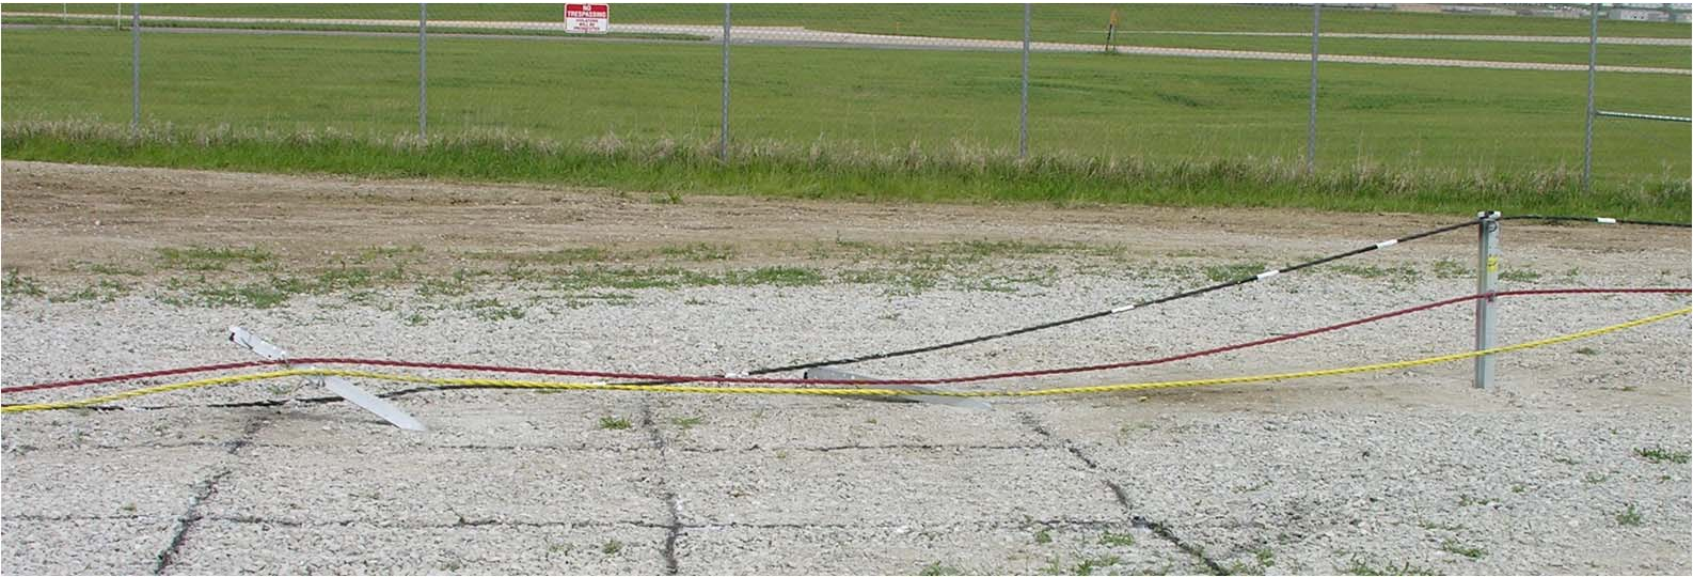
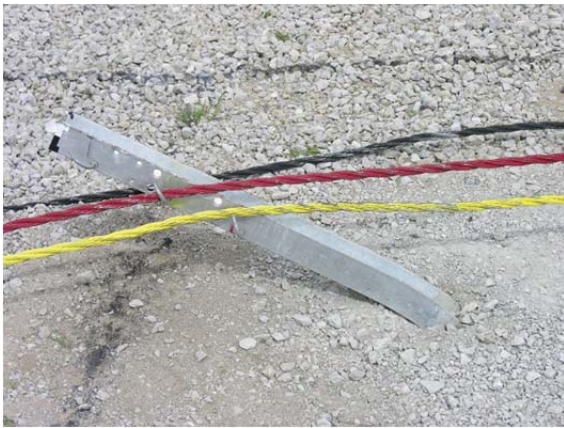
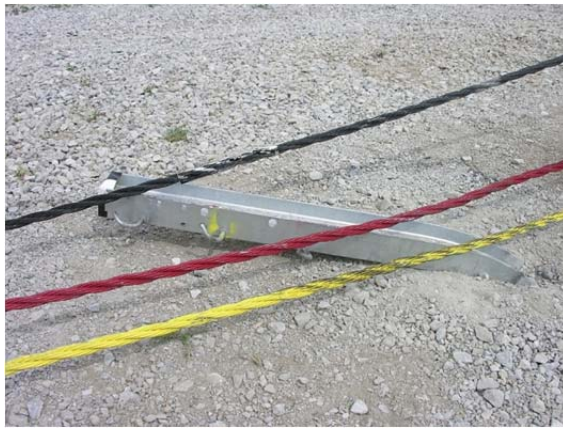
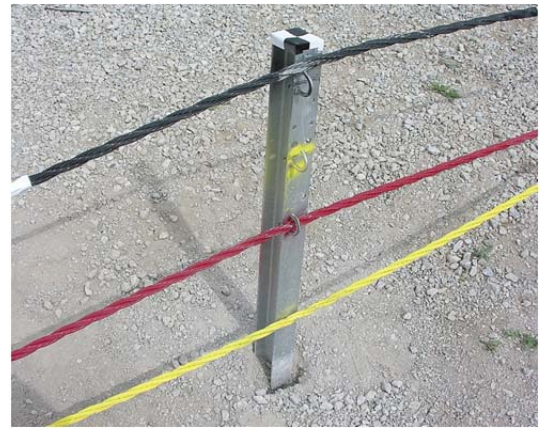
Figure 109. System Damage: Post Nos. 16 through 18, Test No. NYCC-3

Post no. 16 was bent and rotated downstream. Post nos. 17 through 20 were severely bent backward and twisted downstream with contact marks observed on the front flanges. Post nos. 21 through 25 were bent and rotated backward and downstream. Post nos. 26 through 30 were bent and twisted downstream with contact marks on the upstream edges of the flanges. Additionally, post no. 30 had gouges in the front and back flanges. The brass keeper rod for the bottom cable on post no. 40 was disengaged and the post was bent upstream with weld failure under the slip base as shown in Figure 116.

The permanent set of the system was 24 in. (610 mm) which occurred at post no. 17, as measured in the field. The maximum lateral dynamic barrier deflection was 14 ft - 4 in. (3,564 mm) which occurred near post no. 22, as determined from high-speed digital video analysis. The working width of the system was found to be 14 ft – 5 in. (4.4 m) and is shown in Figure 117.

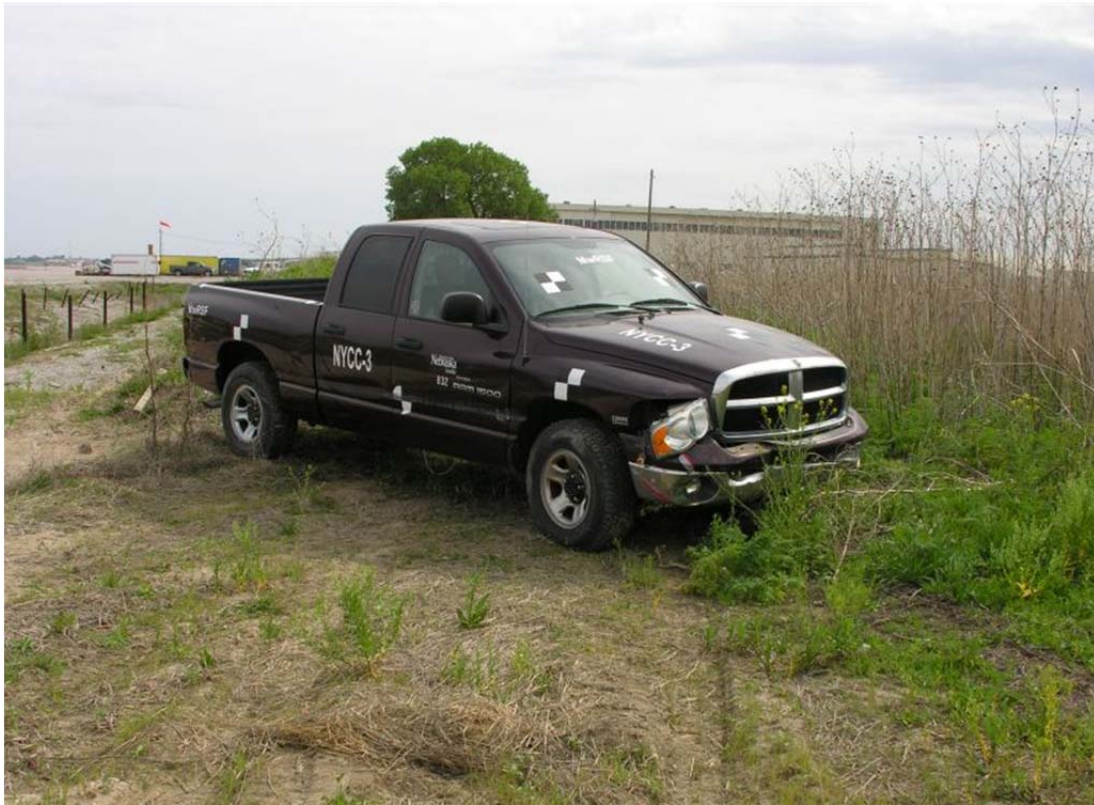
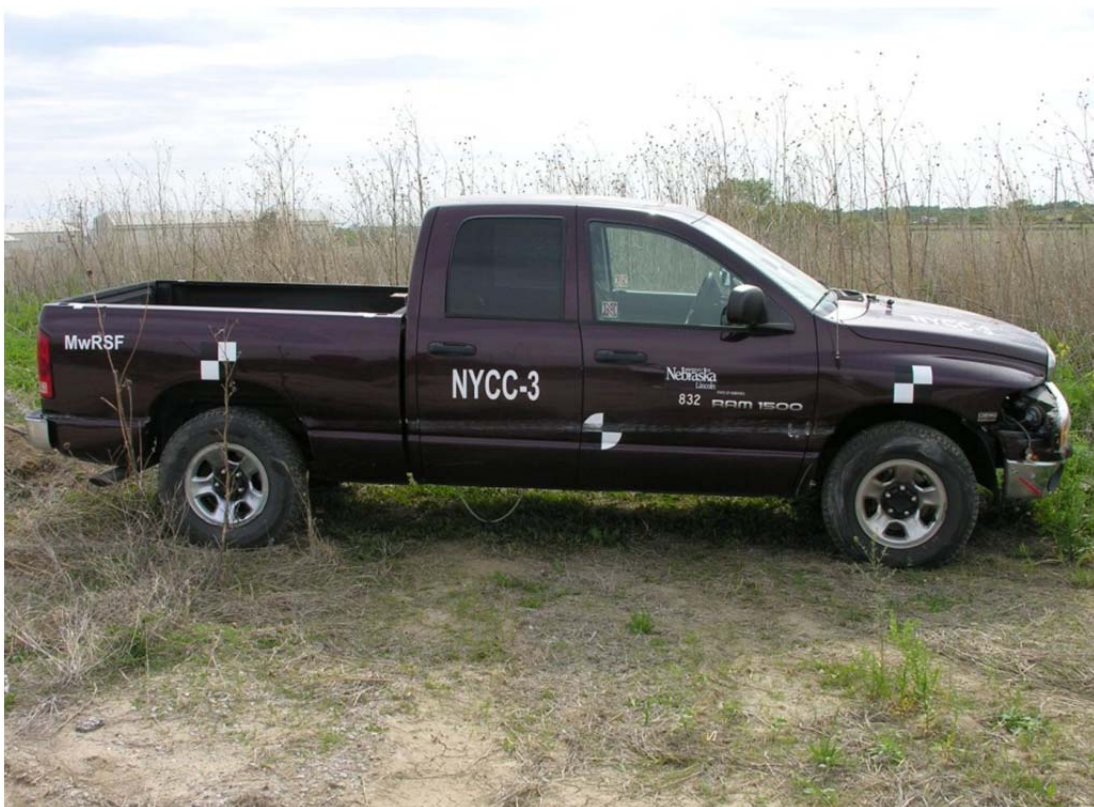
Figure 118. Vehicle Damage, Test No. NYCC-3

The damage to the vehicle was minimal, as shown in Figures 118 and 119. The maximum occupant compartment deformations are listed in Table 15 along with the deformation limits established in MASH for various areas of the occupant compartment. Note that none of the MASH established deformation limits were exceeded. Complete occupant compartment and vehicle deformations and the corresponding locations are provided in Appendix D.

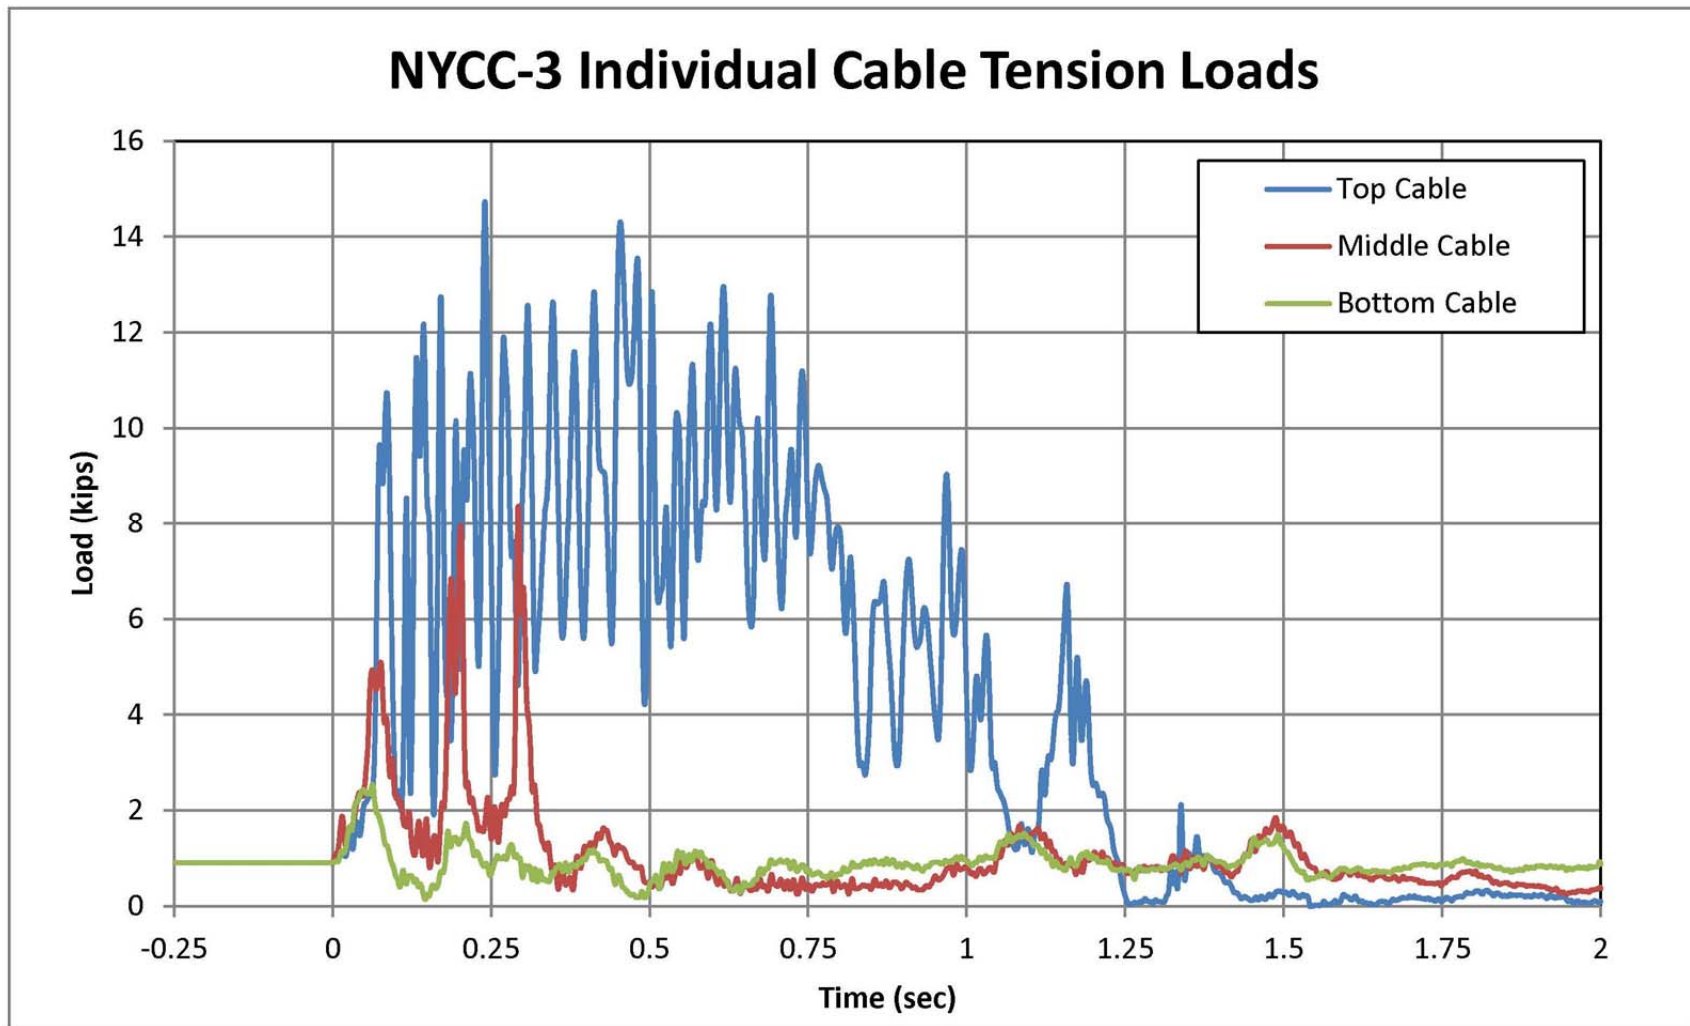
Figure 120. Individual Cable Tension vs. Time, Test No. NYCC-3

As previously discussed, tension load cells were installed in line with the cables at the upstream end of the barrier system in order to monitor the total load transferred to the end anchor system with respect to time. The load cell results are summarized in Table 17. The individual cable loads and the total combined cable load imparted to the upstream end anchor are shown graphically in Figures 120 and 121, respectively. The pre-tension in each cable was 914 lb (4.07 kN) as measured from the displacement in the spring compensators near the upstream anchorage. After the crash test, the tension in the top, middle, and bottom cables was 99.8 lb (0.44 kN), 378 lb (1.68 kN), and 883 lb (3.93 kN), respectively.
