Evaluation of MEMS-based In-place Inclinometers in Cold Regions

Margaret M. Darrow, Ph.D.
David. D. Jensen, E.I.T.

December 2012

INE/AUTC 12.38

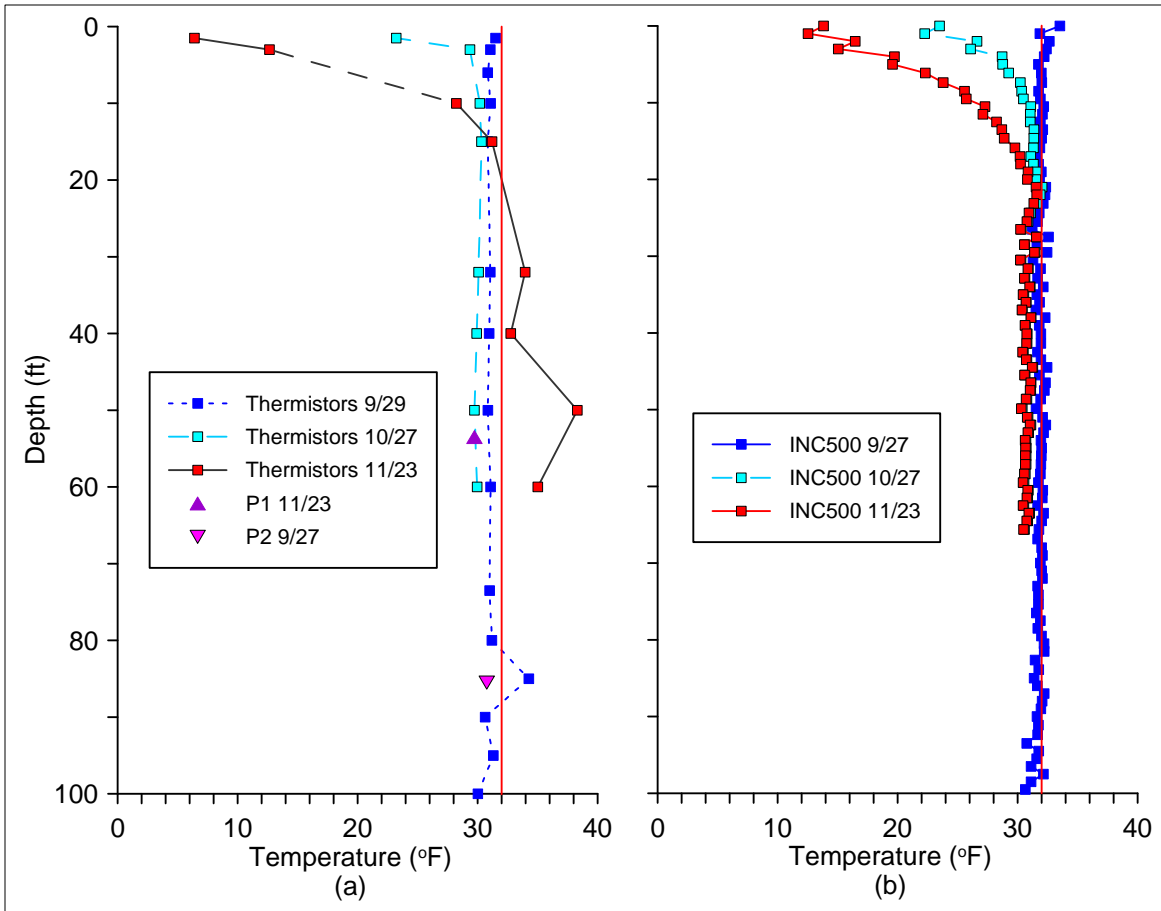
Figure 28. Temperature readings from TH12-9004. (a) Temperature readings from the thermistor string and two VW piezometers attached to the outside of the casing; “P1” and “P2” are readings from the vibrating wire piezometers installed at 53.5 and 85.5 ft bgs, respectively. (b) Temperature readings from the INC500. Nearest pairs of readings were averaged to reduce the scatter. For both plots, the phase-change temperature is indicated by the vertical red line.

remaining thermistors at depth began reporting a steady increase in temperature resulting in above-freezing values, as indicated by the erratic temperature profile from November 23; yet the VW piezometer located at 53.5 ft bgs (i.e., “P1”) measured 29.7°F, matching the previous temperature trend. Figure 28b is a plot of temperatures obtained using the INC500 device installed within TH12-9004. To reduce some of the temperature variability to illustrate data trends better, nearest pairs of readings were averaged together. The INC500 stopped reporting accurate temperatures below 65.5 ft bgs on October 24; however, the data above this depth are sufficient to indicate below freezing temperatures. Thus, the M-IPI data confirmed that the thermistors below 15 ft bgs began to malfunction on November 9, likely the result of glycol entering the cable and affecting the measured resistance.

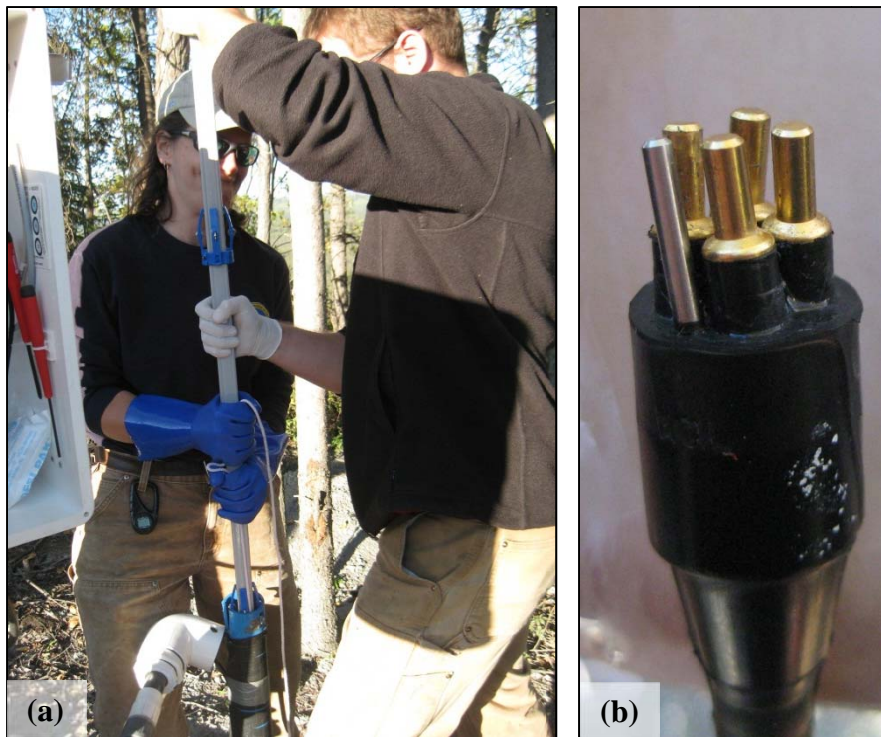
Figure A-21. Retrieving the INC500 in September 2010 to adjust the positioning of the centralizers. (a) Pulling the INC500 from the guide casing. (b) Some of the connectors demonstrated twisting. (Photographs courtesy of S. Huang)

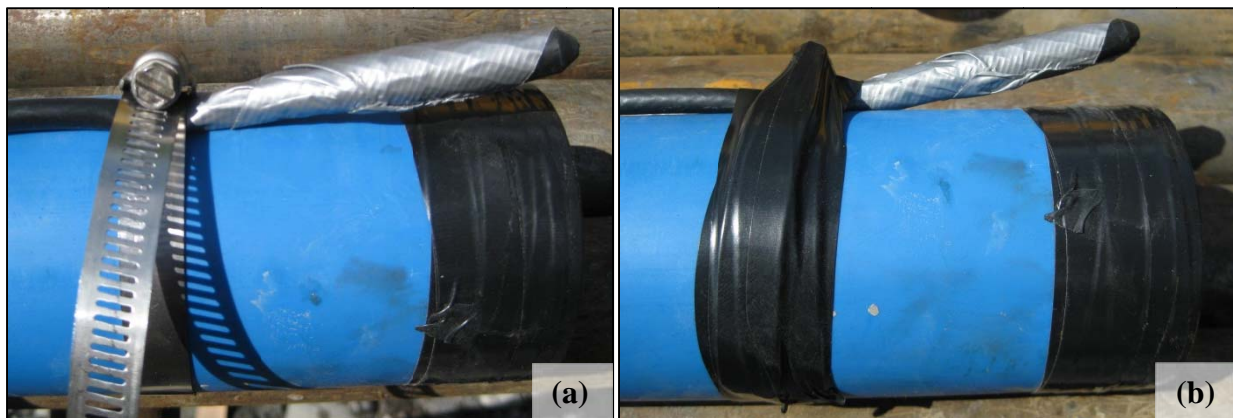
Figure B-2. Configuration of the coaxial (TDR) cable on the outside of the guide casing. Photograph (a) illustrates the crimp into the cable by the hose clamp; (b) the hose clamp was wrapped with tape to prevent snagging on the walls of the boring. (Photographs by M. Darrow, June 2010)

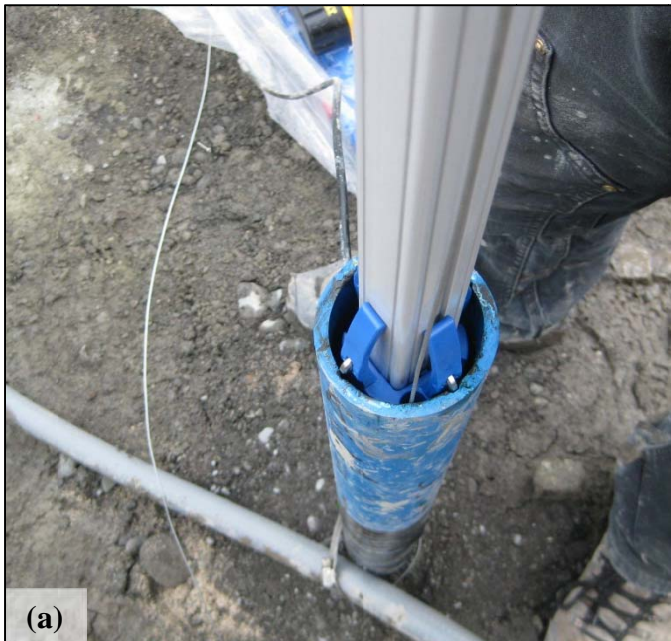
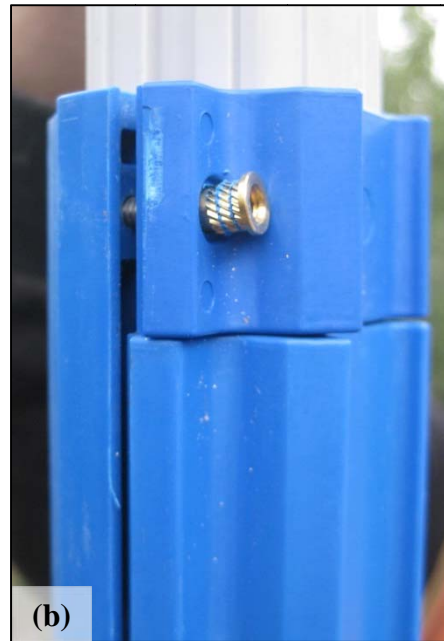
Figure B-4. Installing the INC500 within the guide casing. (a) This photograph shows the arrangement of the centralizers and the wire rope used as a safety line; (b) some of the insets for the machine screw popped out of the plastic housing. (Photographs by M. Darrow, June 2010)

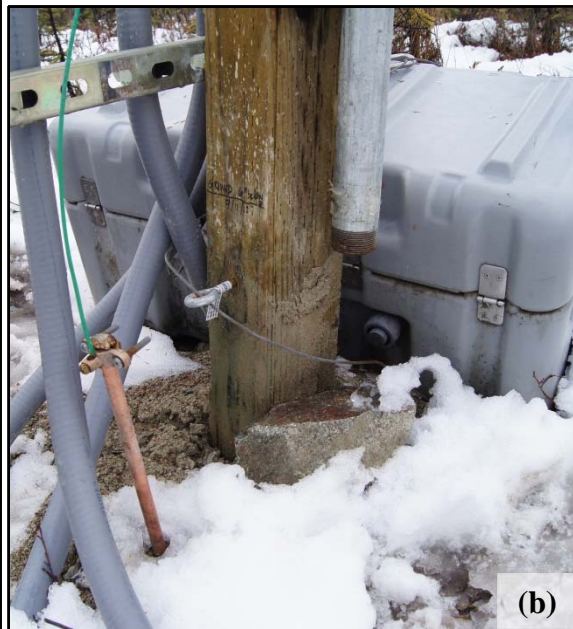
Figure C-28. Changes at the ADAS during the fall of 2012. (a) Post, solar panel support, and grounding rod on July 11, 2012; (b) Settlement of ground surface as of October 6, 2012. (Photographs by M. Darrow and D. Jensen)

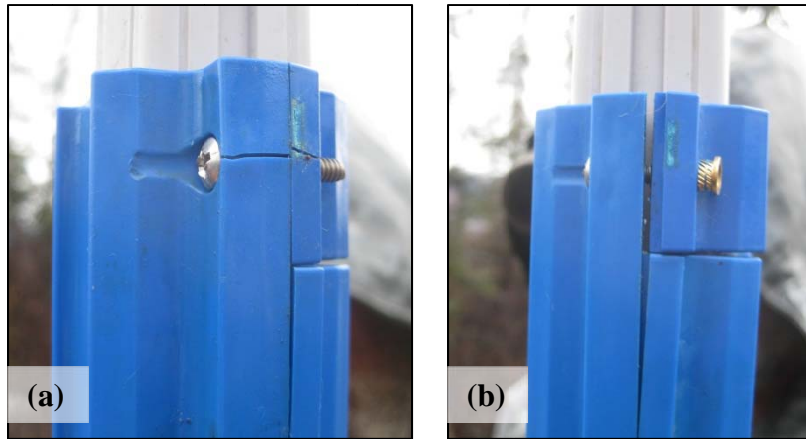
Figure D-5. Examples of coupler damage. (a) Cracked coupler, and (b) threaded insert that popped out of the plastic coupler and would not tighten. (Photographs courtesy of J. Simpson, Sept. 2012)
