1. Report No. FHWA/TX-13/9-1002-12-6		2. Government Accession No.		3. Recipient's Catalog No.	
4. Title and Subtitle <b>MASH Full-Scale Crash Testing of 4-ft Mounting Height, 24"×30" Chevron Sign Installed on 5.5H:1V Slope Ditch</b>				5. Report Date Published: March 2013

***MASH* Full-Scale Crash Testing of 4-ft Mounting Height 24"×30" Chevron  
Sign Installed on 5.5H:1V Slope Ditch**

Report 9-1002-12-6  
Project 9-1002-12  
Project Title: Roadside Safety Device Crash Testing Program

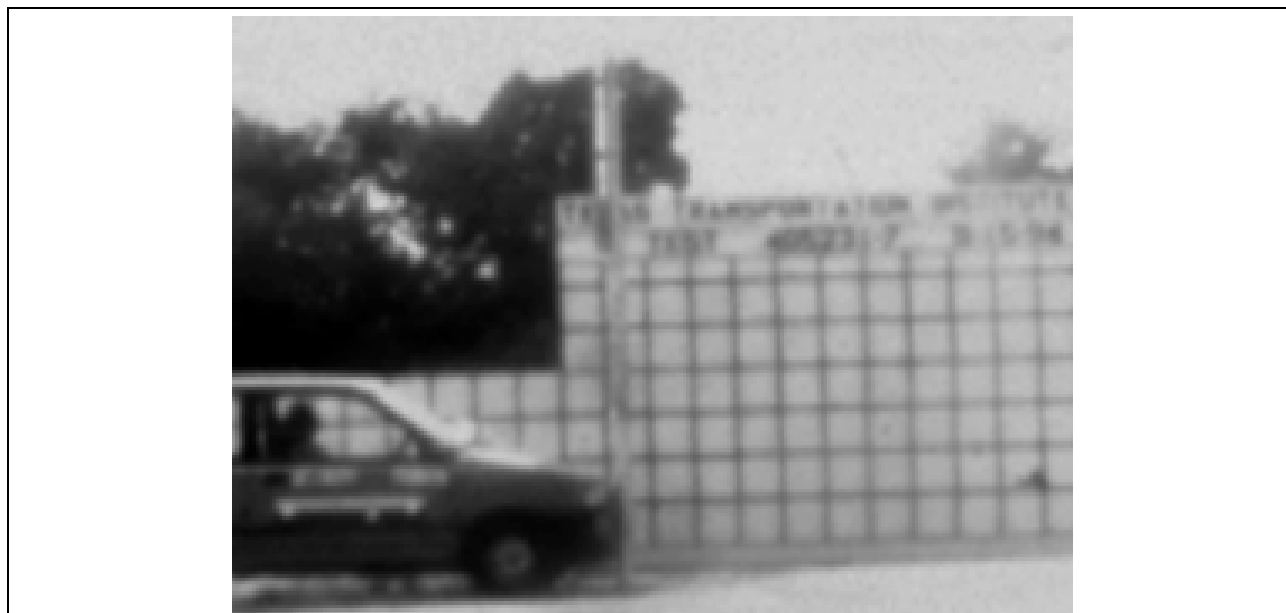
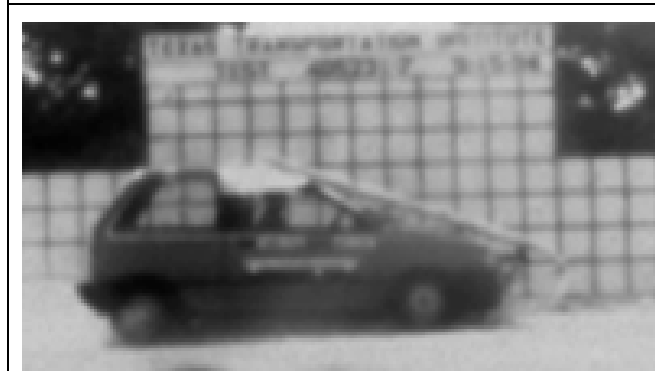
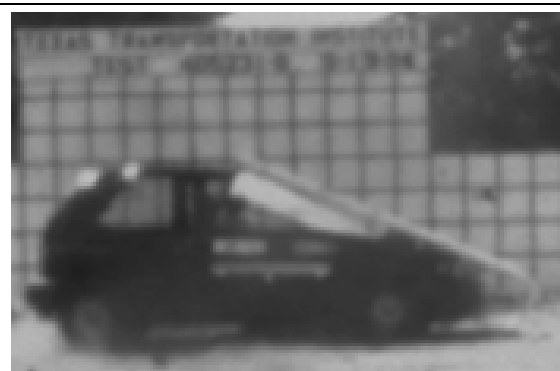
**Figure 1.2. Thin-Walled Aluminum Sign Support Tests Nos. 405231-7 and 405231-9.**

(a) Initial Configuration for Test Nos. 405231-7 and 405231-9

(b) Roof Impact Location Test No. 405231-7

(c) Roof Impact Location Test No. 405231-9

The post-impact behavior of the sign support system has been evaluated for effective post heights of 56 inches and 110 inches above the bumper in projects FHWA/TX-01/1792-2 and 405231-1F, respectively (8, 9). The lower effective height resulted in no secondary post contact and the higher effective height resulted in contact with the vehicle roof. Effective post heights between these two values have not been investigated, and there exists a possibility that an intermediate effective post height could result in the sign support contacting the windshield of the vehicle. Since it is common practice for TxDOT to install chevron signs in ditches at a 4-ft mounting height and a lateral offset between 2 and 8 ft from the pavement edge, and this practice results in effective post heights between those tested, TxDOT research project 0-6363 recommended that this installation practice be evaluated. Under TxDOT project 0-6363, TTI researchers performed vehicle dynamics simulations to determine bumper trajectories for passenger cars entering a ditch with 6H:1V slopes at different speeds (40 and 60 mi/h) and angles (5, 10, and 25 degrees). A 6H:1V slope ditch was chosen in conjunction with TxDOT personnel because it was considered to represent a reasonable and typical design condition in Texas. Lateral offsets between 2 ft and 8 ft from the slope break point were considered based on TxDOT standard practice. The trajectory analyses were performed using a computer program called CarSim® (10).

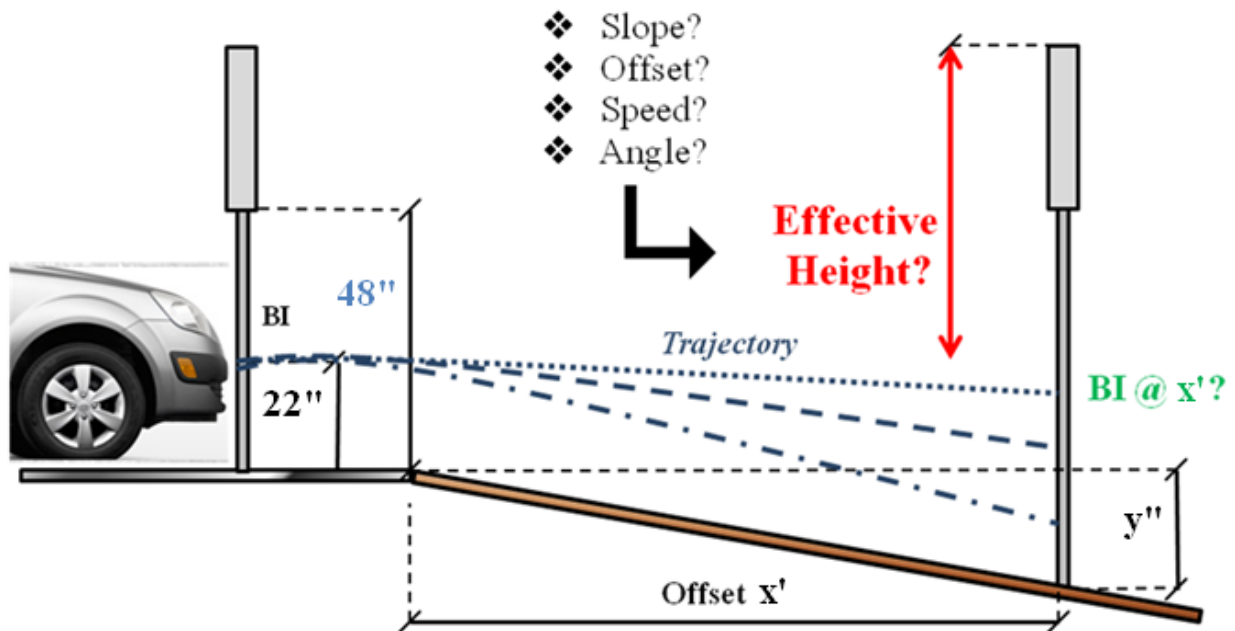
**Figure 1.4. Effective Pole Height Variation for Chevron Installation in Ditch.**

A common TxDOT practice is to install chevron sign systems in roadside ditches. For this type of installation, TxDOT standards specify that the sign mounting height be established from the pavement surface. Once a sign support system is installed on a slope, the local mounting height of the sign (calculated from ground level at the location of installation) will be greater than that for the same system installed on flat, level ground. For a general installation of a sign support system on a slope at an offset distance “x” from the slope break point, the depth “y” of the ditch at the particular installation location contributes to an increase in the length of the support post and local mounting height of the sign (see Figure 1.4).

The bumper trajectory and offset distance of the chevron installation from the slope break point determine the height of bumper contact above the local ground elevation. Consequently, the effective height of the post above the bumper can vary.
