Appendix C–SR-72 Tests

1 Introduction

2 Girder and Deck Design

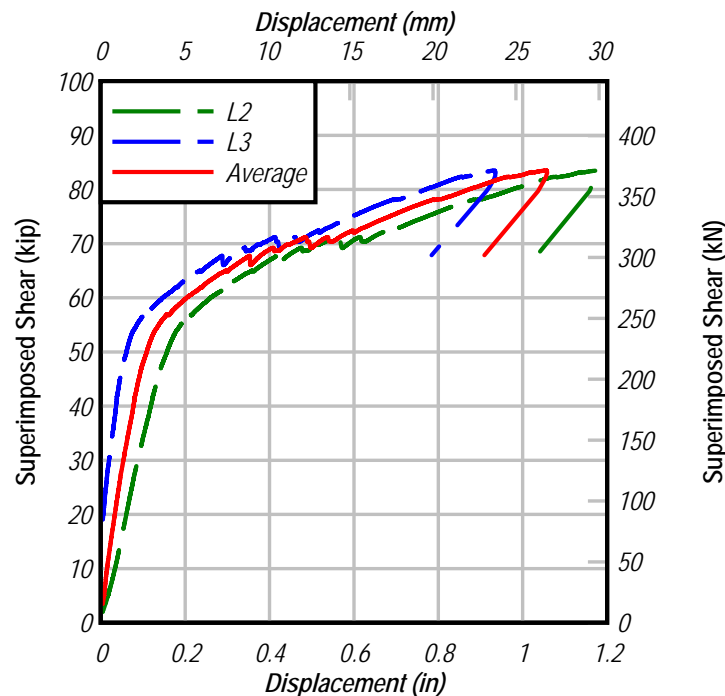
Figure 12–X7 shear vs. vertical displacement

Girder X7 was load tested at an a/d ratio of 3.4. Shear-displacement behavior of X7 is shown in Figure 12. As load was applied the girder displaced vertically and laterally, and rotated about its longitudinal axis. Lateral displacement is presented in Figure 13. The maximum rotation was approximately 0.14 degrees, as determined from LVDTs L2 and L3 which were placed on either side of the load point. The rotation and lateral movement are attribute in-part to the asymmetric cross-section and load location which was not through the section's shear-center. Uneven bearing pad deformation may also have contributed to the rotation. As previously discussed, and as presented in Figure 9, multiple bearing points were placed at the far end of X7 to prevent instabilities due to asymmetry of the cross-section and load.

Referring to Figure 12, the abrupt changes in the shear-displacement curve between 65kip and 70kip correspond to the formation of additional cracks. Cracks formed farther from the load point and at shallower angles as the load increased. Comparing the final crack pattern with the location the transverse reinforcement (Figure 14), it is noted that with only one exception, the cracks did not cross transverse reinforcement. Thus, after cracking the load could not have transferred through truss action, but rather was carried through arch action. Girder X7 supported a maximum superimposed shear of 84kip. At this load a punching shear failure occurred in the slab and curb. Figure 16 is a photo of the curb side of X7 showing the location of the punching failure. The red strap in the picture is from the crane which was lifting the girder as the photo was taken.

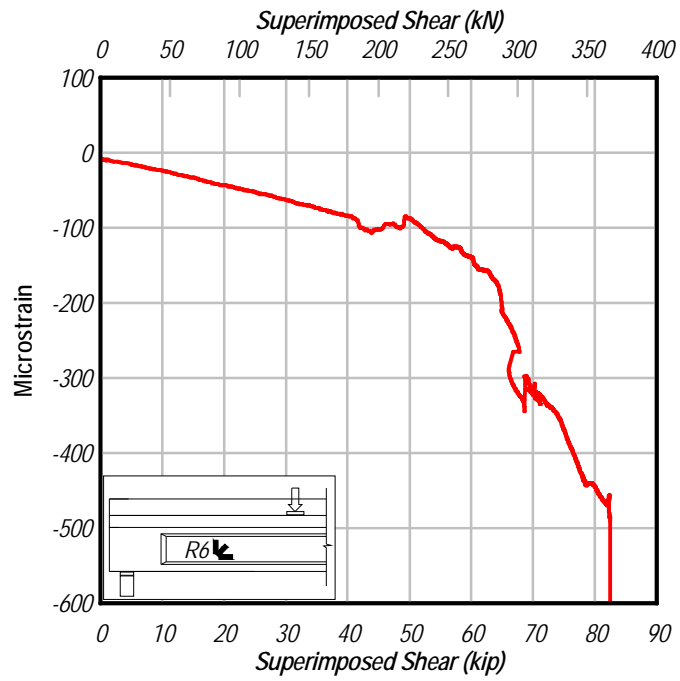
Figure 15–X7 rosette R7

The girder behaved linear-elastically until the formation of cracks. Visible cracking was first observed in the web at a superimposed shear load of approximately 51kip (Figure 14). Although cracks were not visible prior to 51kip, data from rosette R7 indicates that the crack first formed at a shear of 41kip (Figure 15). At 58kip of shear, the initial crack in the web was observed to have joined with a flexural crack in the bottom flange. This load corresponds to the change in slope on the shear-displacement plot; the change in stiffness being attributed to cracking.

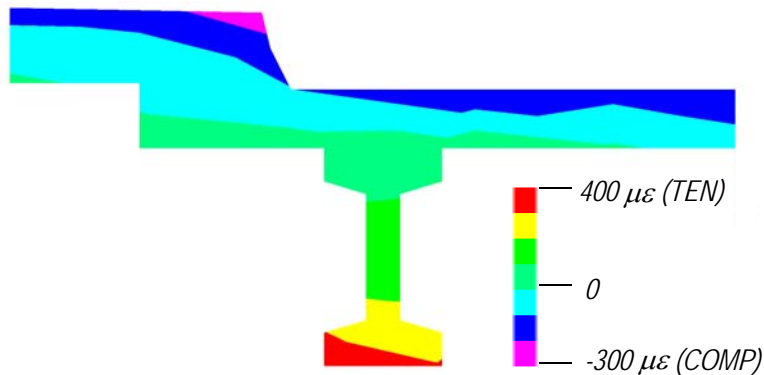
Figure 17–X7 Strain contour at shear of 45 kip at section below load point

Strain gages were placed around the cross-section at three sections along the length of the girder. Data from these gages were combined via linear interpolation to approximate the strain contour of the section during loading. Figure 17 shows the strain contour at the section below the load point at a shear of 45 kip. The maximum compressive strain occurred at the top corner of the curb. Because the section experienced biaxial bending, the strain contours were inclined.

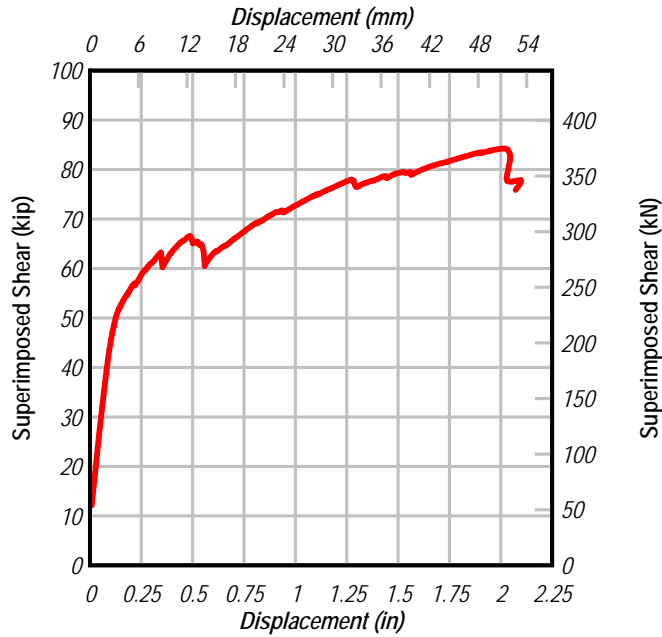
Figure 18–X4 shear vs. displacement

Referring to Figure 18, girder X4 behaved linear-elastically until a superimposed shear of about 45kip. The transition from linear-elastic behavior corresponded to the formation of flexural cracks at the bottom of the girder below the load point (Figure 20). Data from gage S25 (Figure 21) indicate that cracking initiated at a shear of 44kip. Initial cracks were first visually observed at a shear of 56kip.

The abrupt changes in the shear-displacement plot at 62kip and 66kip correspond to the formation of incline cracks in the web. Cracks continued to form farther from the load point and at shallower angles as the load increased. At the final stages of the load test incline cracks had a maximum width of 1 in. As shown in Figure 20 vertical reinforcement was not engaged by the inclined cracks. The relatively large crack widths and absence of engaged vertical reinforcement suggest that the girder supported load by arch-action.

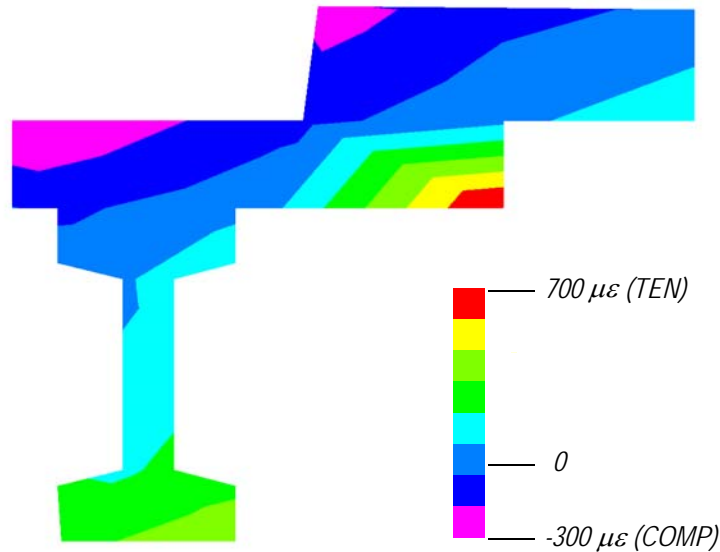
Figure 22–X4 strain field at load location at a superimposed shear of 46 kip

Strain gages were placed around the cross section to evaluate the flexural strain field during load testing. Figure 22 shows the strain field at the section below the load point at a superimposed shear load of 46k. Contours indicate biaxial bending with the neutral axis inclined at approximately 20 degrees from horizontal. The largest compressive strains occurred in the upper corner of the curb and slab. Formation of the initial flexural cracks on the curb side is consistent with the measured strain field which recorded the largest tensile strains at the location of cracking.

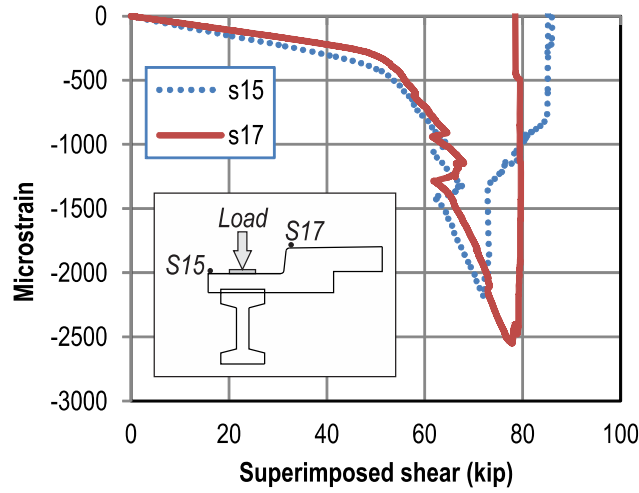
Figure 23–X4 shear vs. compressive strain

Crushing of the compression zone in the slab near gage S15 began at a shear of 71kip. Examining data from S15, the compressive strain reached 2200 microstrain prior to crushing (Figure 23). Crushing is attributed to the superposition of bearing strain from the load point and the flexural strain. The corner of the slab near S15 continued to crush and spall as the shear increased beyond 71kip. The corner of the curb near gage S17 began to crush at a shear of 76 kip. According to gage S17, the strain at the corner of the curb reached 2550 microstrain immediately prior to crushing (Figure 23). Girder X4 supported additional load after the initial crushing at the corners of the slab and curb, reaching a maximum superimposed shear of 84kip. As previously noted, the girder behaved as a tied-arch in the final stages of loading. The failure mode of Girder X4 was flexural compression failure of the concrete. The moment at failure was 95% of the calculated nominal moment capacity. Details of nominal capacity calculations are presented in a later section.

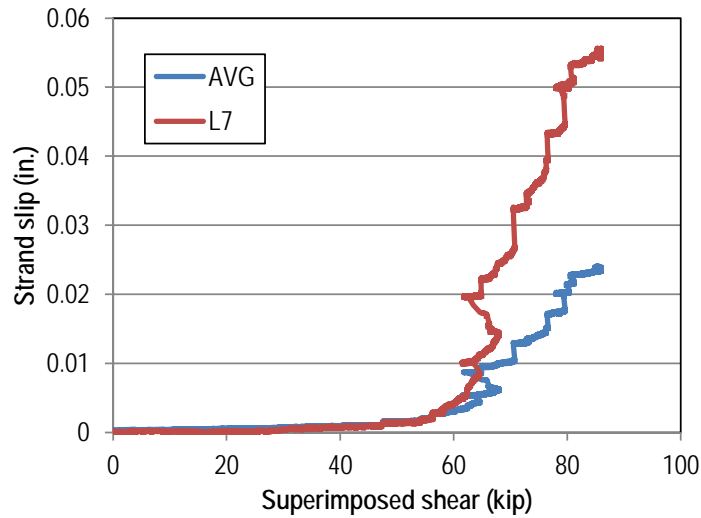
Figure 24–X4 strand slip vs. shear

Girder X4 was the only test in which the strands exhibited significant slip (Figure 24). The strand monitored by LVDT L7 was located the curb side in the bottom row. This strand was in the region of highest tension in the bottom flange (Figure 22). Slipping of the strands in X4

contributed to the rotation about the load point and crushing of the compression zone. Because X4 failed in flexural the strands in this girder likely supported higher loads than in other girders, making slip more likely. Slip was also augmented by the asymmetric bending as demonstrated by the slip L7.

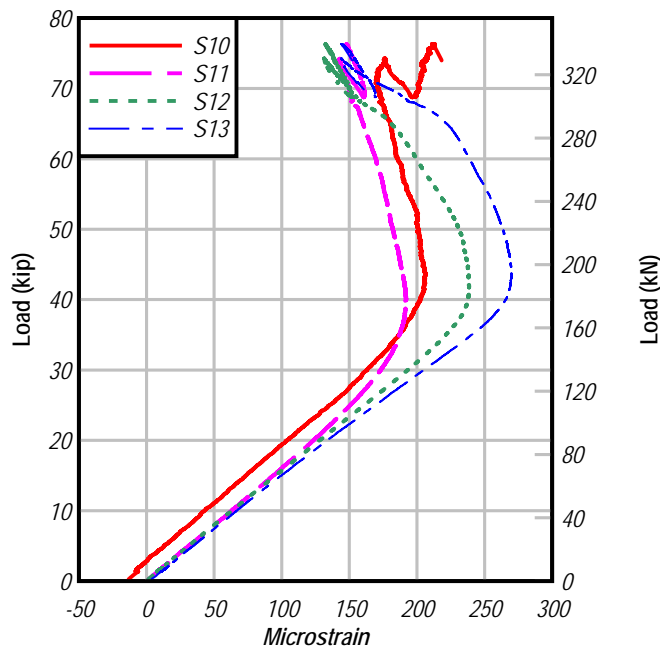
Figure 26–I2A load vs. decompression strain (crack opening)

Girder I2A was loaded to failure after the initial cracks were marked and strain gages were installed. Figure 26 shows applied load vs. strain data from each strain gage placed adjacent to the flexural cracks. Theoretically, as load is increased, the cracks should open when the tension due to bending equals the precompression from the effective prestress force. This behavior is indicated by a bilinear shape in the load-strain plots shown in Figure 26. At a load of 40kip (22kip shear) the load-strain relationship became nonlinear due to reopening of the flexural cracks. Knowing this load at which the cracks reopened (i.e. precompression force was overcome), the effective prestress force in the girder was calculated using flexural theory. Specified initial prestress force, effective prestress force and total losses are shown in Table 2. Note that calculation of the experimental prestress force utilized flexural stiffness properties derived from the experimental load-displacement data.

An effective prestress force of 112kips was calculated from the experimental data. Assuming an initial prestress force of 210kip as per the construction drawings, the experimental data indicate a 47% loss in prestress force. This value of prestress loss is unusually high suggesting that the initial prestress force may have been less than specified. This would not be unreasonable considering other inconsistencies between the girders and plans, such as placement of vertical reinforcement. It is not known if the experimentally evaluated prestress force from I2A was representative of all test girders.

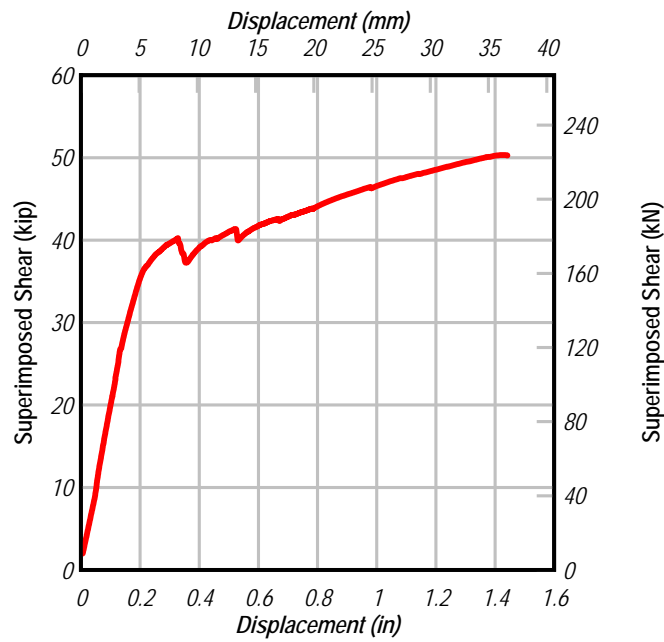
Figure 27-I2A shear vs. displacement

After evaluating I2A for effective prestress, the specimen was loaded to ultimate load. Load was applied at an a/d ratio of 4.5. Shear-displacement data from the ultimate load test is presented in Figure 27. Contrary to X4 and X7, girder I2A did not rotate about its long axis during loading. Flexural cracks reopened at a load 40 kip, corresponding to 22 kip superimposed shear. According to the shear-displacement plot, significant deviation from linear-elastic behavior did not occur until the shear reached 36k. Softening of the girder corresponded to the propagation of flexural cracks. The abrupt changes in the shear-displaced data at shear forces near 40 kip were due to the formation of inclined cracks in the web. As the load increased, additional cracks formed farther from the load point and at shallower angles. Cracking in the web between the load point and the near support was particularly severe, as noted by the shaded area in Figure 28 and shown in Figure 29.

Failure was precipitated by the formation of tensile cracks in the top of the arch between the near support and load point. After the cracks formed, the arch became unstable, buckled upward (Figure 29) and lost load carrying capacity. Failure occurred at a superimposed shear of 51 kip. This behavior was captured by gage S1 (Figure 31) located on top of the girder. After inclined cracks formed in the web, the compressive strains on top of the slab at gage S1 decreased suddenly. As testing continued strain reported by S1 became tensile. This tensile action at the top of I2A resulted in cracking and instability of the compression load path. This type of failure has also been reported by Kostovos (1987).

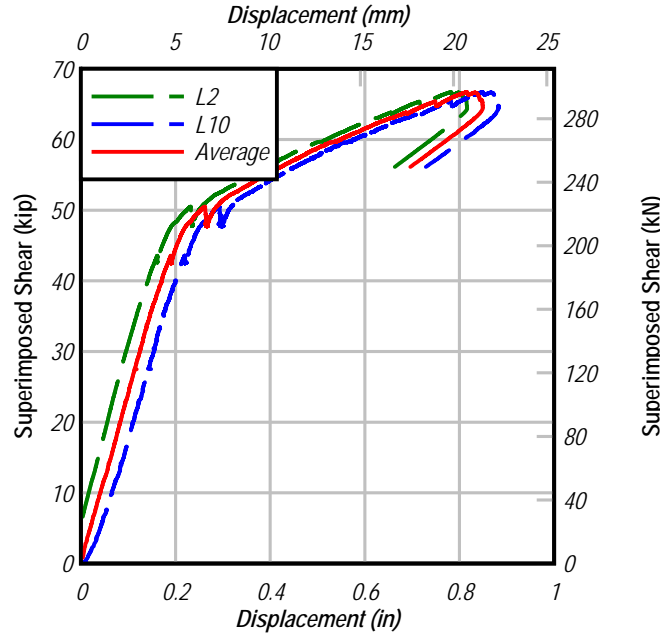
Figure 32–I2B superimposed shear vs. displacement

Girder I2B was loaded at an a/d ratio of 3.3. Figure 32 shows the superimposed shear vs. load point displacement. I2B rotated 0.22 degrees about its long axis as the shear increased from 0kip to 5kip. The girder maintained this rotated orientation for the remainder of the test. Girder I2B behaved linear-elastically until the shear reached about 43kip, at which point flexural cracks formed below the load point (Figure 33). After formation of the initial cracks, load was held constant and the cracks were marked. After loading was resumed, inclined cracks formed in the web and additional flexural cracks formed in the bottom flange. Loading was stopped again to mark the cracks at 50kip of shear. The abrupt change in the shear-deflection plot at 50kip was due to relaxation of the load while cracks were being marked. Loading was again resumed, and additional shallower cracks formed farther from the load point towards the far support. One of these cracks formed at the peak load of 67kip. The load supported by the girder dropped after the formation of the crack at 67kip, and the load was held to mark cracks for the final time. After loading resumed, the inclined cracks near the far support continued to open and propagate,

The limiting factor on ultimate strength of I2B was capacity of the web near the far support to withstand the formation and propagation of inclined cracks. Additional displacement beyond peak displacement would have resulted in failure of the truss and/or arch mechanisms; however it is unlikely that additional displacement would have accompanied load in excess of the previous peak. It is concluded that the girder strength was controlled by the web capacity, and it is presumed that the displacement capacity would have been controlled by failure of the arching action.

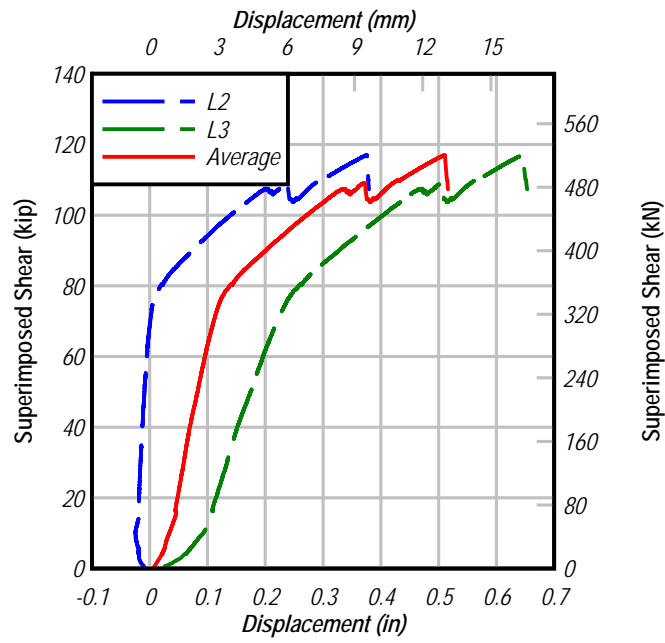
Figure 34-I4 shear vs. displacement

Girder I4 was loaded at an a/d ratio of 2.1. Figure 34 shows the superimposed shear vs. load point displacement. I4 began rotating about its long axis as soon as load was applied. The angle of rotation increased with increasing load, reaching a maximum of 0.57 degrees just before failure.

As the load was increased additional cracks formed in the web on the far support side. The cracks formed farther from the load point and at shallower angles at higher loads. The abrupt changes in the shear-displacement plot near 112 kip and 118 kip correspond with formation of inclined cracks towards the far support. During the final stages of loading cracks in the web were wide approximately 0.5in wide. As shear could not transfer across the cracks, and as the cracks did not engage transverse reinforcement, it is believed that the end of the girder towards the far support behaved as a tied arch during the final stages of loading. The peak superimposed shear supported by girder I4 was 118k.

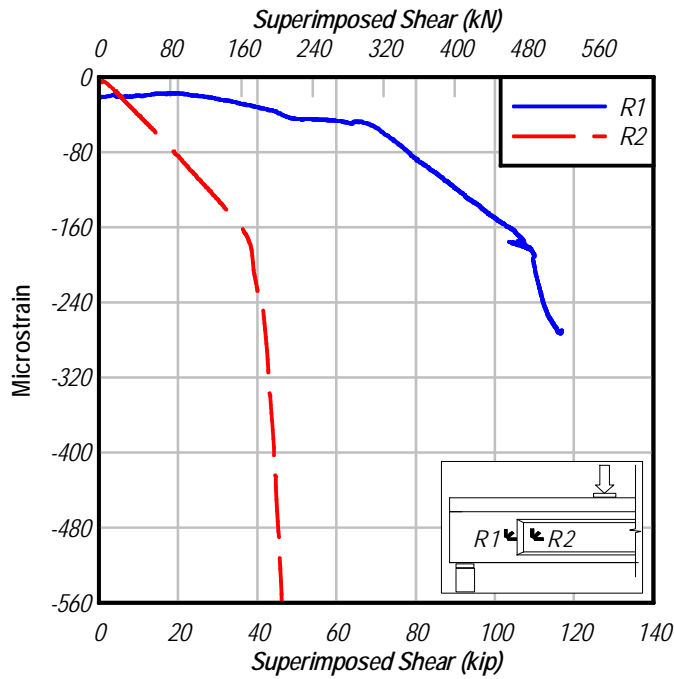
Figure 35-I4 principal strain vs. shear

The first crack formed at a shear of 38 kip as reported by rosette R2 on the web (Figure 35). The initial crack was an incline crack in the web (Figure 36), and appears to have had little effect on the girder stiffness as measured by the shear-displacement relationship. Stiffness of the girder changed at a shear of 75 kip. This is the same load at which the inclined crack near gage R2 was first visually observed.

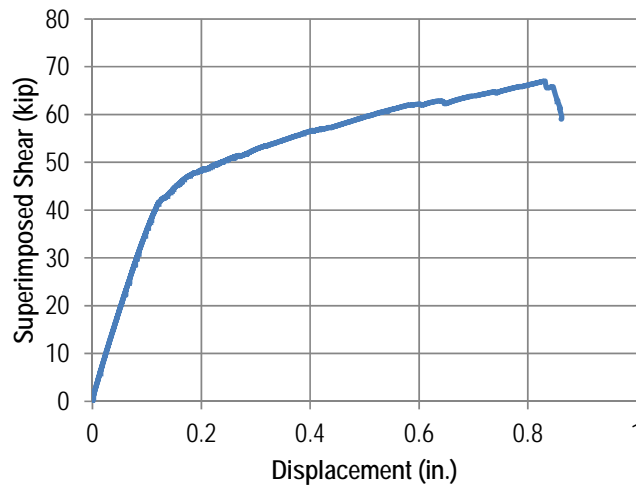
Figure 37-I6 shear vs. displacement.

Girder I6 was loaded at an a/d ratio of 3.5. Figure 37 shows the superimposed-shear versus load-point displacement. The girder behaved linear elastically until the first crack formed at a shear of 43kip. Load at cracking was determined by data from gage S29 (Figure 38). The initial crack was a flexural crack below the load point (Figure 39). Inclined cracks formed in the web toward the near support at a shear of 48kip. Shallower cracks formed farther from the load point as the load was increased. The load test was terminated after a sudden drop in load caused by the formation of an incline crack at the far end of the girder. The maximum superimposed shear was 68kip. Girder I6 did not rotate as load was applied.

The limiting factor on girder strength was capacity of the web on the far support side to withstand the formation and propagation of inclined cracks. Additional displacement beyond the tested peak would likely have resulted in failure of the truss and/or arch mechanisms, however it is unlikely the additional displacement would have resulted in that the loads in excess of the observed peak. Girder strength was controlled by the web capacity and it is presumed that displacement capacity would have been controlled by failure of the arch and/or truss mechanisms.

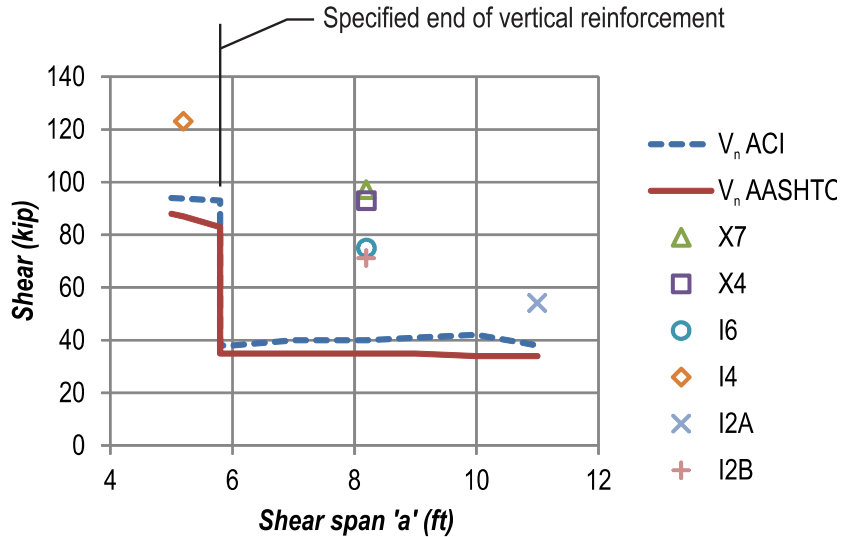
Figure 40–Experimental and theoretical shear capacities.

Based on the girders for which concrete compressive strength and effective prestress were tested, it is assumed that the specified properties are unconservative relative to the physical properties. Thus the approach used for shear calculations resulted in nominal capacities larger than the capacities calculated using the available tested properties. This effect of the approach is inconsequential considering that the experimental capacities were significantly higher than the nominal capacities as shown in Figure 40 and Table 3.

Figure 40 shows the code calculated nominal capacities plotted against the shear span length (a). The discontinuity at $a = 5.7$ occurs due to the specified termination of transverse reinforcement at that location. Point data on the figure represent the experiment shear capacity of the test girders. The experimental capacity of the girders was taken as the maximum superimposed shear plus the dead load shear. In each case, the experimental capacities of the girders were greater than the theoretical capacities predicted by ACI and AASHTO codes. Also note that the exterior girders exhibited 30% greater shear capacity than the interior girders tested at the same shear span.

Data from Figure 40 are tabulated in Table 3. The average experimental shear capacities were 1.96 and 2.10 times larger than the capacity of the standard girder predicted by ACI and AASHTO, respectively. The average experimental-to-nominal capacity ratio for the exterior girders was 2.56 (ACI) and 2.71 (AASHTO), compared to 1.66 (ACI) and 1.79 (AASHTO) for the interior girders. This increased capacity of the exterior girders is attributed to the shear capacity of the curb. As the test girders tended to behave as tied-arches prior to failure, the presence of the curb contributed to the strength of the arch and thus to the shear capacity of the girder.

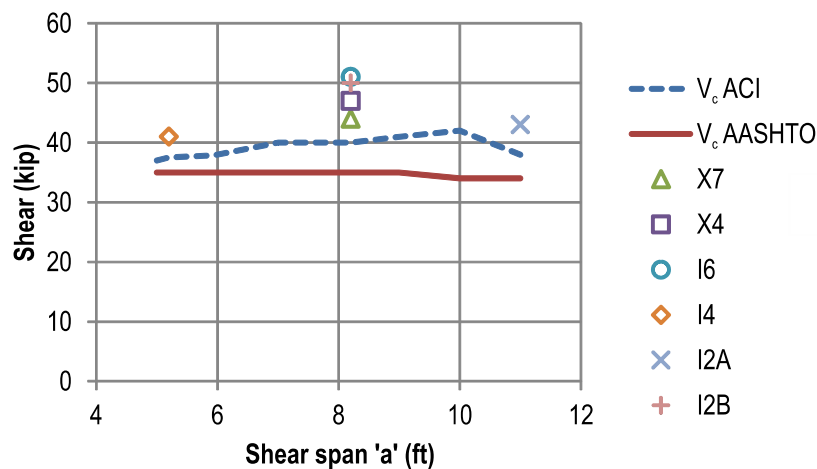
Figure 41–Shear at initial cracking and theoretical concrete contribution.

Experimental loads at the initiation of cracking provide another means of comparison with the theoretically calculated capacities. This comparison is useful for evaluating service behavior and cracking for similar in service girders. Figure 41 shows the theoretical concrete contribution as calculated by the ACI and AASHTO provisions. The theoretical concrete contribution represents the nominal strength of the standard section without shear reinforcement. The point data on this figure mark the total (dead plus superimposed) shear load of the first inclined cracking in the web. Load at first web cracking was determined from the strain gage data. Cracking load indicated by the strain gages was lower than the load at which cracking was visually observed. Data from Figure 41 are tabulated in Table 5. The average ratio of the experimental shear at cracking to the concrete contribution was 1.17 and 1.32 for the ACI and AASHTO procedures, respectively.
