# **Long Term Monitoring of Mechanical Properties of FRP Repair Materials**

Rebecca A. Atadero, Assistant Professor  
Douglas G. Allen, Graduate Research Assistant  
Oscar R. Mata, Graduate Research Assistant  
Department of Civil & Environmental Engineering  
Colorado State University  
Fort Collins, CO

Mountain-Plains Consortium  
and  
Colorado Department of Transportation  
DTD Applied Research and Innovation Branch  
Denver, CO

June 2013

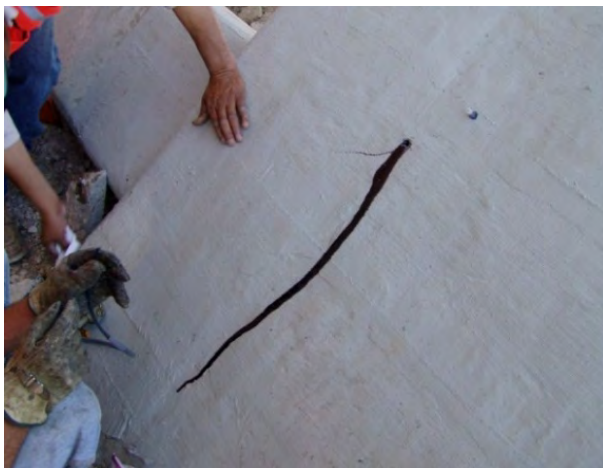
In addition, the contractor, accompanied by the engineer and manufacturer's representative, was required to examine all surfaces 24 hours after application of FRP sheets and initial resin cure to check for voids, delaminations, and air bubbles. The inspection was accomplished by visual observation and acoustic tapping tests to locate voids or defects. Areas of voids or delaminations can be detected due to the different sound emitted when tapped or when a solid object is slid over the area. Minor areas of voids of less than 38.7 cm<sup>2</sup> (6 in<sup>2</sup>) were injected with resin to fill the void and provide a bond between the FRP and the substrate. Voids larger than 38.7 cm<sup>2</sup> (6 in<sup>2</sup>) were repaired by removing and re-applying the required number of layers of CFRP. A void that had been injected with resin directly following the CFRP application can be seen below in Figure 2.12. There was no documentation of this procedure or any information regarding the areas repaired or filled with resin, but it is assumed that this process was satisfactory.

**Figure 2.12** Void injected with resin during 2003 renovation (Mohseni, CDOT)

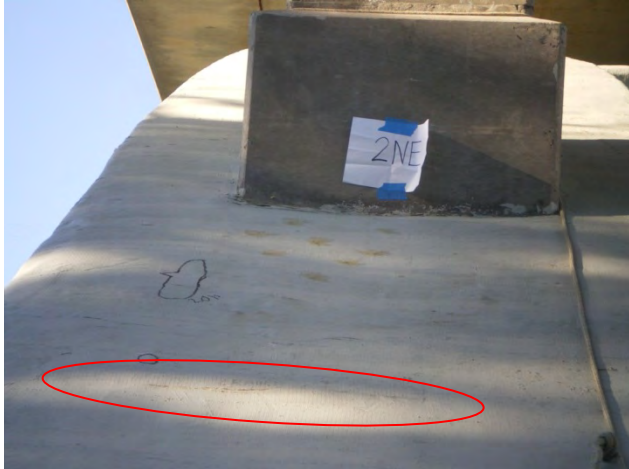
Markings made with a permanent marker on the bridge from the 2007 bridge inspection were barely visible at the time of the 2011 field assessment. Depending on the exposure from moisture and sun, markings on the bridge can exist for only a relatively short time with respect to the life span of the bridge. Below are three photographs of the areas identified from June 2007, two of which were barely visible at the time of the July 2011 visit. There were no markings found on the east arch from the inspections in 2005 and 2009. In addition to the three voids, three cracks in the CFRP were also identified in 2007, one of which can be seen below.

**Figure 2.16** Crack identified in 2007

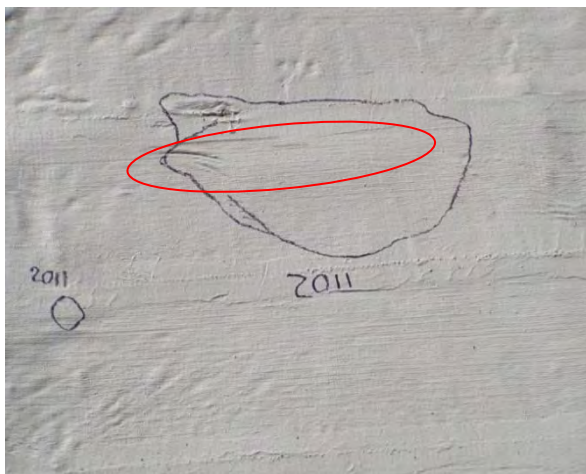
The images above are of two voids found in the first bay on the north end of the east arch. The area of the larger void was one of two areas eventually removed from the arch and is referred to as the “smaller” patch removed from the arch. Note the horizontal or transverse cracks enclosed in the red oval near the top of the void in Figure 3.2.

**Figure 3.2** Two identified voids during the 2011 inspection, visible cracks in CFRP

All three voids identified during the biannual inspection in 2007 had grown in size, and all voids found in the 2011 field assessment that were not previously identified presumably developed in the time between the 2007 bridge inspection and the 2011 field assessment. It was not possible to determine whether the

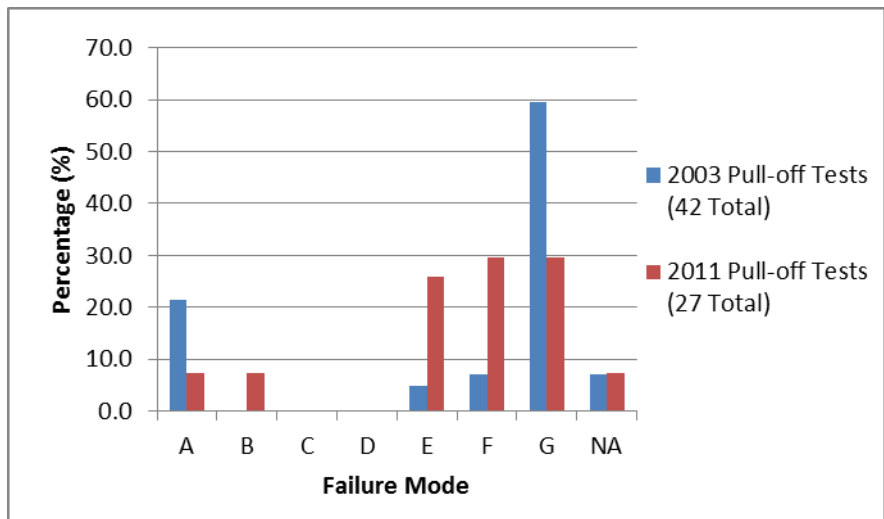
**Figure 3.16** Failure Modes of Pull-off Tests from 2003 and 2011

The number of failure modes E, F, and G are roughly equal in number with only approximately 7% of the specimens failing in each of the A, B, and NA failure modes for the tests conducted in 2011. From Figure 3.16, it is apparent that the high percentage of failure mode G from 2003 significantly decreased to the evenly distributed modes E, F, and G of the 2011 test results. Mode B was a failure mode that did not occur in 2003, but did in 2011 twice out of 27 tests. An increase in percentage of failure modes B, E, and F indicates that other interfaces, other than within the substrate, are weaker and controlling. Failure Mode B is, according to ASTM D7522, “an indication of poor through-thickness properties of the FRP. Such failures may be due to incomplete wet-out of the fibers or plies comprising the laminate. Such failures may also result from environmental degradation of the FRP material itself.” The term “wet-out” is referring to the quality of the CFRP composite material and whether the fibers were fully saturated in epoxy during the wet lay-up process. Failure Mode E is an indication of poor adhesion properties and Failure Mode F is a commonly observed mixed failure mode that is believed to initially fail in the cohesion in the substrate, followed by propagation to the adhesive interface. Different substrates at the location of the pull-off tests of 2003 and 2011 could have influenced both the failure mode and results of the pull-off tests. It is reasonable to consider that the tensile strength of concrete could have improved marginally since 2003 due to continued curing, especially if the substrate was shotcrete rather than the original concrete. However, even in the case of shotcrete as the substrate, this improvement or increase in strength would be fairly marginal. Comparing bond strengths of the 2003 and 2011 tests of only failure mode G tests would be a reasonable evaluation of this possible strength gain of the substrate if the testing

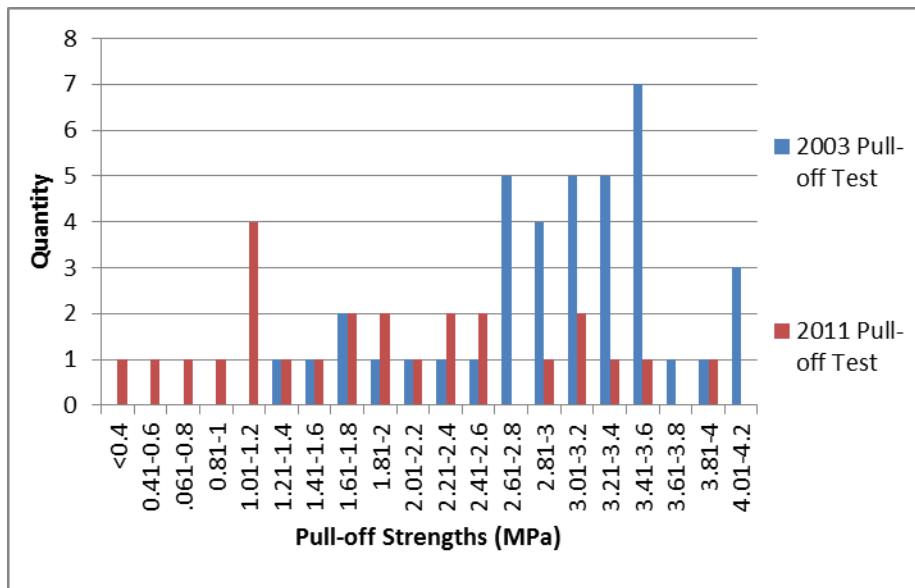
Of the 27 pull-off tests conducted in 2011, nine tests, two of which were failure mode G, failed to meet the 200 psi minimum requirement of CDOT’s construction specifications (Revision of Section 602). Six of the nine tests that had strengths less than 200 psi had failure mode E. This failure mode is a failure at the interface between the CFRP and the substrate. A relatively thick layer of resin was used to smooth the surface of the substrate at the time of the CFRP repair. The thick “filler” resin varied in thickness and in color. These pull-off tests with low values all appeared to have very similar failure modes and strengths as well as appearance of the failure plane. Only one of the 42 tests conducted in 2003 failed to exceed 200 psi. Below are two figures displaying the distribution of pull-off strengths and probability density functions based on a normal distribution of pull-off strengths.

**Figure 3.17** Histogram of Pull-off test strength

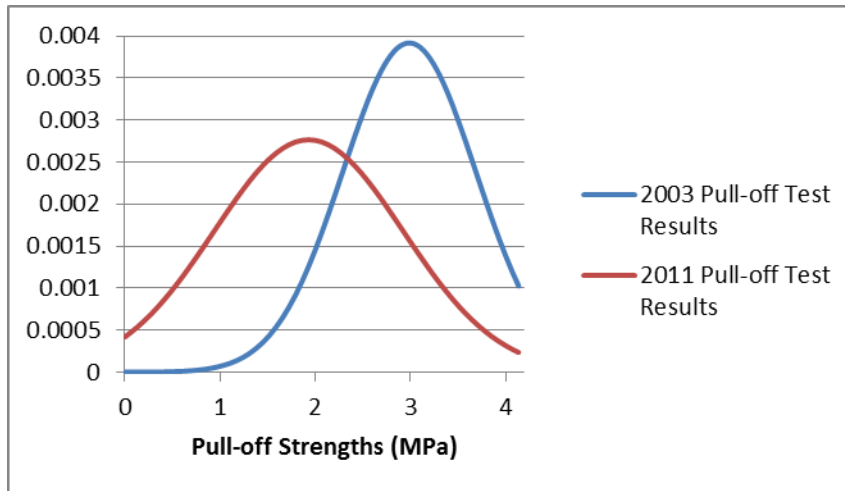
**Figure 3.18** PDF of Pull-off test results

The lower, wider, curve of the 2011 PDF in Figure 3.18 gives evidence that the standard deviation increased from 2003 to 2011. The data were fit with a normal distribution for the creation of the PDF and statistical analysis. In addition, from 2003 to 2011, the mean lowered, shifting to the left. If the influence of the testing procedure could be disregarded, the larger variance of the 2011 results would likely represent the varying conditions in which the CFRP was exposed. The decrease in the mean from 2.98 to 1.93 from 2003 to 2011 gives indication of an overall decrease in the bond strength of the CFRP to the concrete. This indicates a possible durability concern for long-term applications.

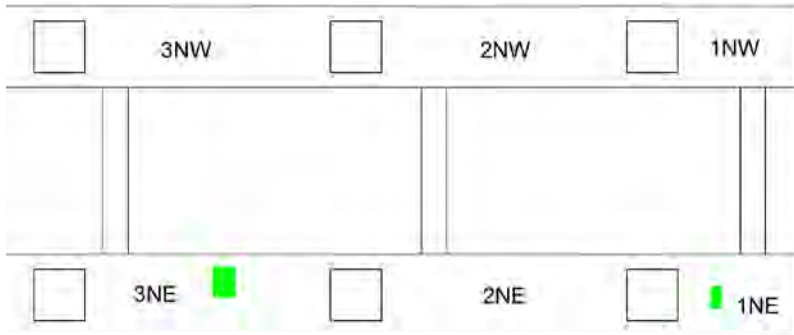
**Figure 3.19** Areas removed are highlighted in green

The smaller of the two voids, approximately 28 cm x 51 cm (11" x 20") in size, was removed from the extrados of the first bay on the north end of the east arch. This void had a previously identified crack running in the transverse direction on the arch. A right-angle grinder mounted with 11.4 cm (4 ½") masonry cutting wheel was used to cut through the CFRP layer in a rectangular shape enclosing the area of the void. Once the CFRP was removed, it was reasoned that this area of CFRP was at one time bonded to the substrate, because the crack previously seen in the surface of the CFRP was also present in the substrate. It was likely that the concrete cracked due to service loads or shrinkage. It is possible the crack was present before the CFRP was applied and the crack opened more causing the CFRP to crack. According to CDOT's construction specifications, cracks in the substrate larger than 1.5 mm (0.06 in) in width were to be pressure injected with epoxy resin prior to the application of the CFRP. When the concrete cracked or the crack widened due to internal tension, the same strain was imposed on the CFRP to cause cracking there as well. A local bond would have been necessary to impose the same strain to the CFRP. Once the CFRP became cracked, water and moisture were able to penetrate the CFRP layer and subsequent freeze/thaw cycles not only opened the crack more, but debonding of the CFRP from the substrate also occurred. The debonded area increased over time due to freeze/thaw cycles and temperature fluctuations. The unidirectional CFRP fabric was more susceptible to cracks in the transverse direction because the carbon fibers were aligned in this same direction and no, or very few, fibers had to rupture. The ultimate tensile strength 90 degrees to the primary fibers of Tyfo® SCH-41, according to Fyfe, is approximately 4.6% of the ultimate tensile strength in the direction of the primary fibers.

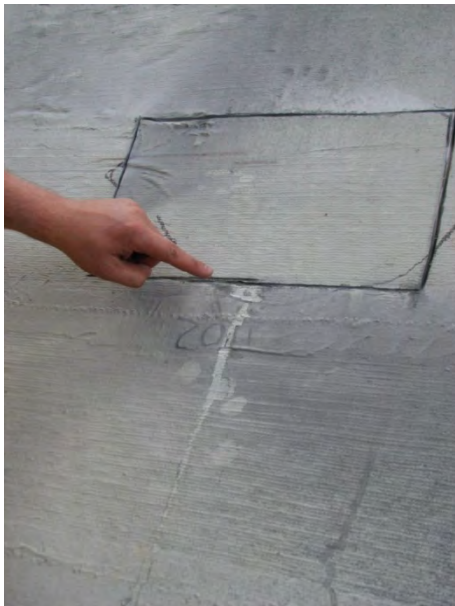
Upon cutting the lower edge of the CFRP rectangle, water exited the cut at the bottom of the void, revealing standing water at the interface between the CFRP and substrate. Photographs of the void and the removal of the CFRP layer are shown in Figures 3.20, 3.21, and 3.22.

**Figure 3.21** Water exiting the void area directly after the lower cut through the CFRP was completed

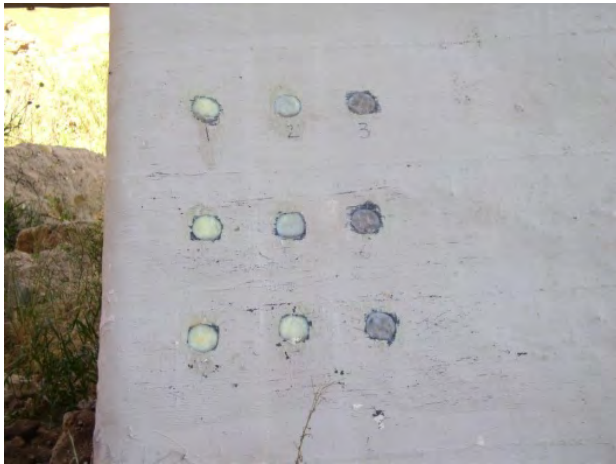
**Figure 3.24** Epoxy filled holes following the pull-off tests

Due to the pull-off tests, a total of 27 – 57.15 mm (2 ¼”) diameter holes of varying depths, depending on the failure mode, were created on the arch. These areas were filled with epoxy to replace the cross-sectional area. Initially, the same epoxy used to adhere the aluminum pucks to the CFRP was used to fill the holes created from the pull-off tests. Due to the inclined angle, this epoxy, which is less viscous before curing, would slump and run down slope on the locations near the base of the arches. This was undesirable and a more viscous epoxy, 3000 psi Loctite epoxy gel, was used to fill the holes created from the pull-off tests. These filled holes of varying depths can be seen below.

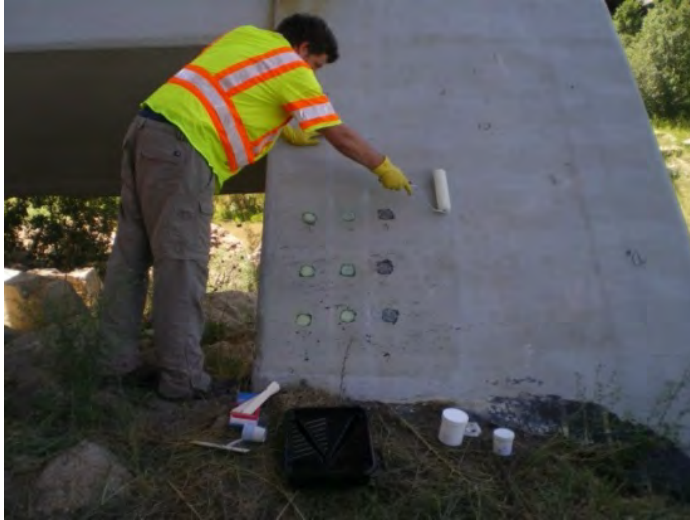
**Figure 3.25** Applying a primer coat to the areas for repair

Once the holes were filled with epoxy, the three areas of pull-off tests and the two areas of removed CFRP (debonded regions) were prepared for a repair process. First these areas were washed using a non-toxic, biodegradable, soap and water, then they were cleaned with 70% isopropyl alcohol to remove any remaining soap film. CFRP patches must overlap a minimum of 6”; therefore, primer was applied to the affected areas of the arches plus a minimum of 6” in each direction. The primer used for the repair was a two part epoxy made by HJ3, STRONGHOLD Primer Epoxy (STR-BW-200A). The mix ratio was two parts of the PC-200 Primer Resin, Part “A,” to one part of the PC-200 Primer Hardener, Part “B.” Once the two-part epoxy was well mixed, the primer was distributed to the repair areas using 9” rollers, as seen in Figure 3.25.

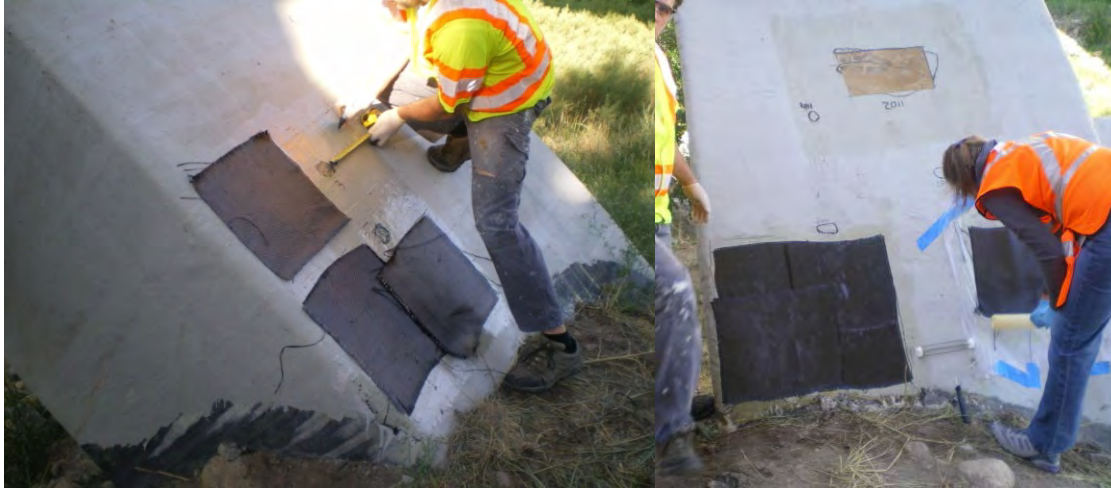
**Figure 3.26** Allocating fabric for repair and applying the second layer of CFRP to the area of pull-off tests on the east arch

The CFRP fabric was saturated by applying a well-mixed two-part epoxy, two parts of HJ3 SRS-400-A Resin, and one part HJ3 SRS-400-B Hardener, to both sides of the fabric. The two-part epoxy was also applied to the repair areas identical to that of the primer. The saturated fabric was then placed on the arch and the use of hand pressure and rollers eliminated air bubbles and pockets between the fabric and the substrate. Unidirectional CFRP fabric was used to repair the area where the patches were removed. Proper alignment of the fiber direction in the transverse direction was necessary to repair the transverse wraps. The pull-off tests were conducted closer to the edge of the arches, damaging both transverse and longitudinal sections. Therefore, biaxial patches were used to repair these areas. This process is represented in the photographs below. Following the CFRP repair, 24 hours was allowed for curing before the areas were painted.

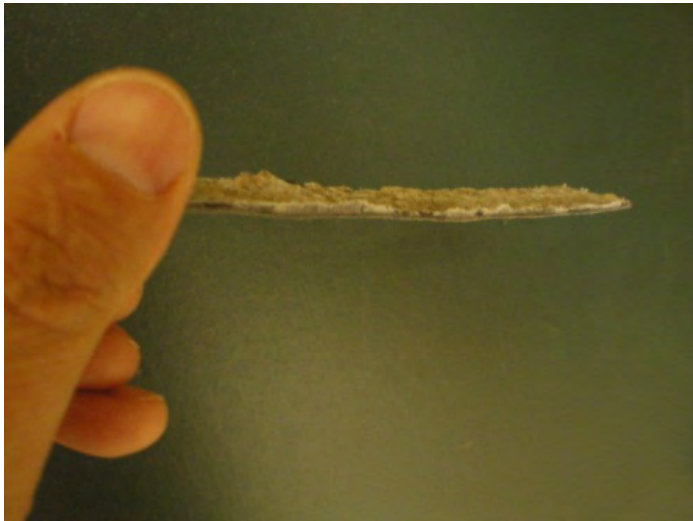
The thickness of the CFRP strips varied significantly due to the rough contour of the adhered side of the CFRP. As previously discussed in sections 3.2.4 and 3.2.5, a thick filler resin was applied to smooth the surface of the substrate prior to adhering the CFRP fabric to the arches. A photograph of the rough texture is shown in Figure 4.1.

**Figure 4.1** The rough contour of a tensile test strip of CFRP

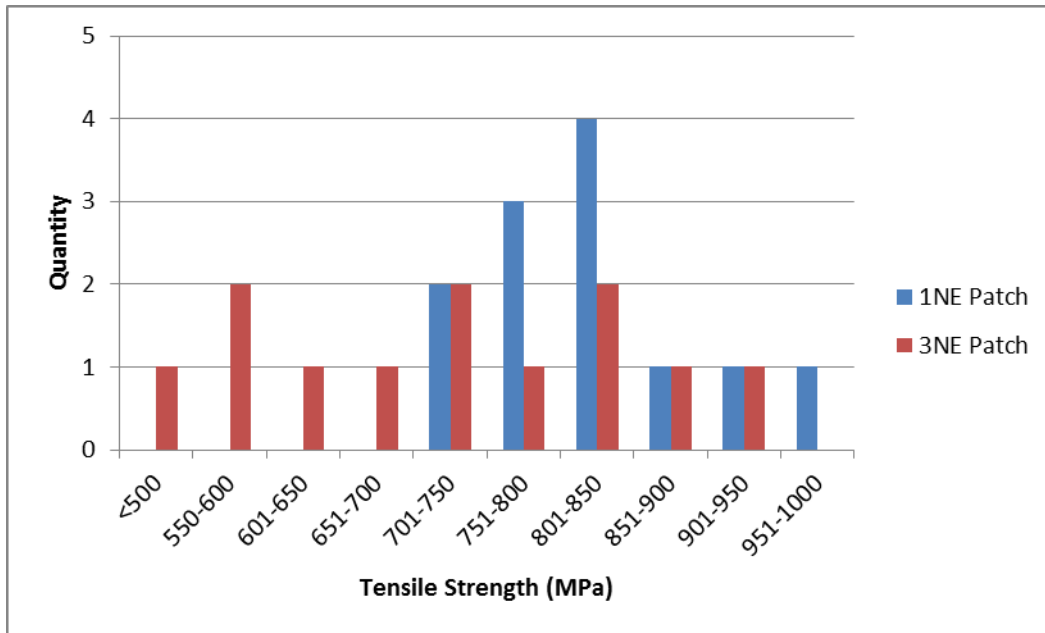
**Figure 4.4** Distribution of tensile strength results

In summary, the tensile strengths were significantly lower than the values reported by the manufacturer, Fyfe, and required by CDOT. It is difficult to determine whether these values are due to poor workmanship during the 2003 repair or degradation. Initial values at the time of repair would help make this differentiation if the samples tested in 2003 were representative of the material on the bridge. No results from such tension tests were recovered for comparison. The modulus of elasticity values were reasonably close to reported values considering the sample size. The rupture strain, similar to the tensile strength, had values lower than acceptable design values according to CDOT’s construction specifications (Revision of Section 602).

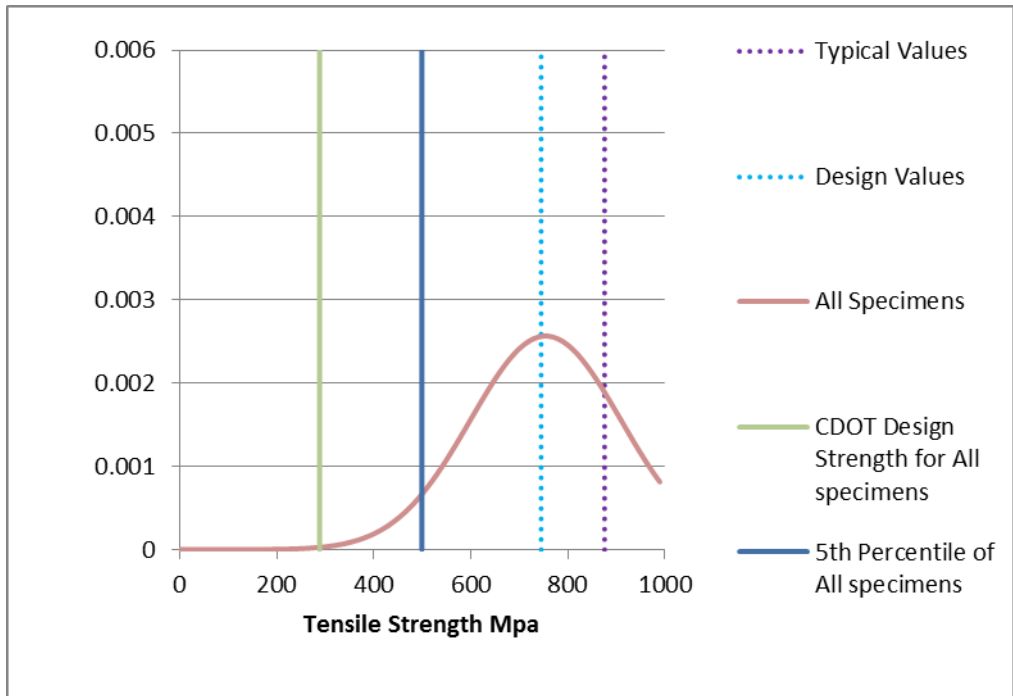
**Figure 4.7** Probability density function of all tensile tests

Looking at the location of these values in Figure 4.7, there is a very concerning discrepancy between the values of tensile strength provided by the manufacturer and the values generated from the tensile tests. The values of modulus of elasticity are fairly representative of the values provided by the manufacturer. By assuming the stress versus strain response of the CFRP was linear until failure, the rupture strain was found by dividing the ultimate tensile strength by the modulus of elasticity, which was the chord modulus of 0.0043 strain or less. CDOT’s construction specifications (Revision of Section 602) required a minimum rupture strain of 0.006 cm/cm. The rupture strain of the material at the time of repair was identified in the CDOT report as being 0.012 cm/cm for both the typical and design value.

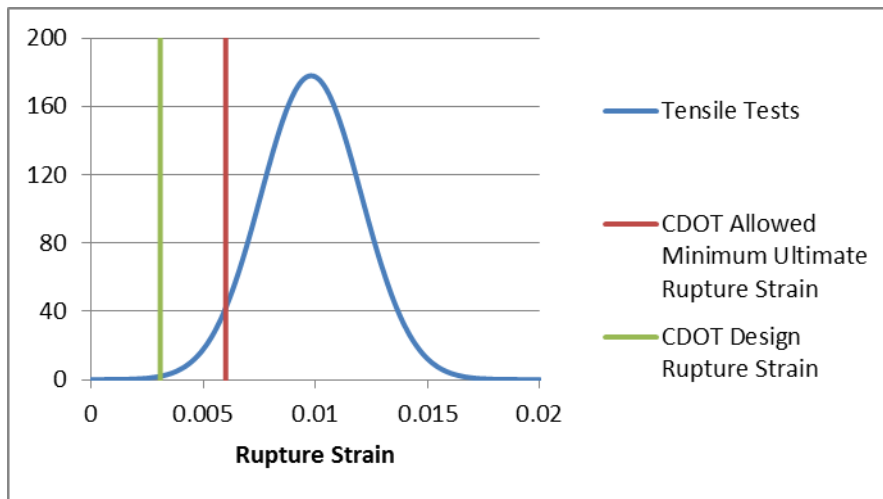
**Figure 4.10** Probability density function of the rupture strain of all tensile tests

The 5<sup>th</sup> percentile value in the table above would satisfy the minimum rupture strain requirement of CDOT’s construction specifications (Revision of Section 602), but the “CDOT Design rupture strain” calculated per CDOT’s construction specifications (Revision of Section 602) is not adequate. A visual representation of this can be found in the probability density function in Figure 4.10.

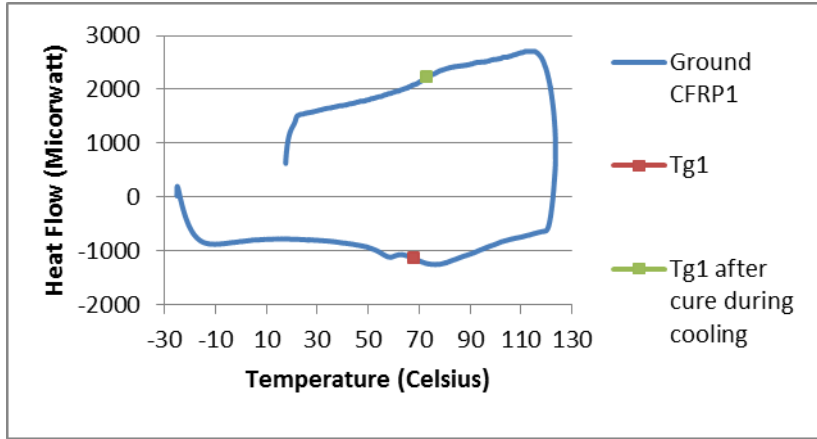
**Figure 4.14** Ground CFRP specimen

During heating, the glass transition temperature,  $T_g$ , was  $67.95^{\circ}\text{C}$ , while during the cooling process, the  $T_g$  was  $73.19^{\circ}\text{C}$ . This increase in  $T_g$  is due to the curing process caused by the heating up to  $130^{\circ}\text{C}$ . The glass transition temperature of the CFRP composite was expected to be between  $60^{\circ}\text{C}$  and  $82^{\circ}\text{C}$ , as quoted by the manufacturer as being the design value and typical test value, respectively. The highest temperature of the composite’s thermal history was probably not much greater than  $40^{\circ}\text{C}$ , which explains the additional curing and the upwards shift in the  $T_g$  during the heating process up to  $130^{\circ}\text{C}$ .

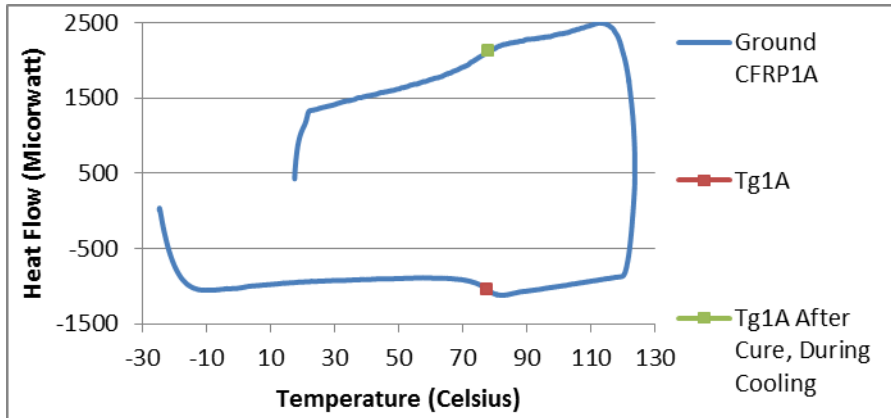
**Figure 4.15** Ground CFRP1A

The erratic or irreversible behavior does not exist in the classic behavior of the DSC curve in the plot above. The behavior during heating and cooling are reversible and look identical. Subtracting the Ground CFRP1A curve from the Ground CFRP1 curve would yield an area that represents irreversible behavior.

The two glass transition temperatures were found to be 77.38°C and 78.02°C for the heating and cooling processes, respectively. The second time the specimen was heated to 130°C the  $T_g$  increased by a much smaller amount due to the post-curing that occurred during the first test. The closer a specimen gets to being fully cured, the smaller the influence additional heat will have on  $T_g$ . Additionally, there is a relatively small shift in the  $T_g$  that is due to the different processes of heating and cooling that should be considered when comparing the  $T_{gs}$  found during the heating and cooling processes. During the heating the  $T_g$  is shifted to the right and during the cooling the  $T_g$  is shifted to the left; the glass transition temperature should be taken as the average of the two values found during the heating and cooling processes if no significant curing occurred during the heating process. A plot of the heat-cool-reheat-cool process is in the figure below.

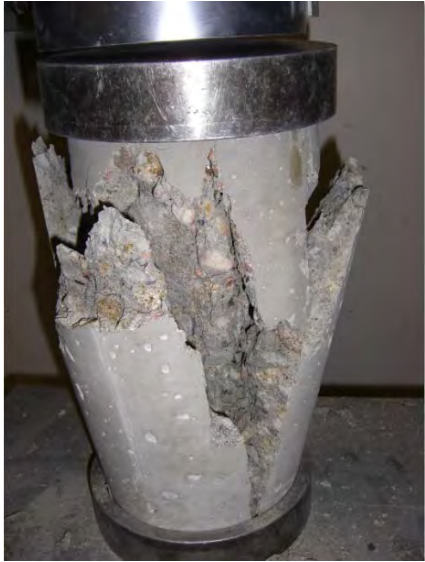
**Figure 6.17** Characteristic failure for compression tests

A total of four cylinders were tested in compression during Stage 0. Cylinders were of the standard size of 6 in x 12 in (15.2 cm x 30.4 cm). A high average strength of 6.26 ksi (43.16 MPa) was seen in this group. Table 6.5 shows the individual and average values for compressive load and compressive strength. Figure 6.17 shows the characteristic failure corresponding to the four specimens.

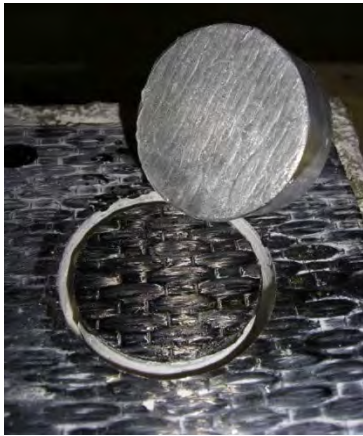
**Figure 6.18** Pull-off Mode A failure

A total of six pull-off tests were conducted for stage zero. Block #1, equivalent to test labels 1, 2, and 3, showed results of 374 psi (2.58 MPa), 442 psi (3.05 MPa), and 391 psi (2.70 MPa), respectively. Out of the three pull-off tests planned on Block #1, test 1 showed an adhesive failure between the dolly and the CFRP, labeled as failure Mode A by ASTM D7522/D7522M (2009), not an acceptable failure for statistical validation. Figure 6.18 below illustrates the adhesive failure mode from test 1.

The persistence of the adhesive failure modes was attributed to two main reasons. Twisting of the dolly during adhesion could have caused minor air voids in the dolly-CFRP interface, which decreased the suitability of the bond. The second possibility for adhesive failure could be the curing time of the Devcon epoxy. For all previous tests, the epoxy was allowed to cure for 24 hours, and failure Mode A was still showing. Therefore, tests 9 and 10 on block #2 were allowed to cure for five days to ensure that the epoxy was fully cured. For these last two tests, the dollies were not twisted, they were slowly placed on the surface as uniform pressure was applied for 30-90 seconds to avoid slippage. As a result, tests 9 and 10 showed strengths of 433 psi (2.98 MPa) and 439 psi (3.03 MPa), respectively, with acceptable Mode F failures. Figures 6.20 and 6.21 illustrate the strengths and failure modes of all the pull-off tests performed during stage zero. The notations on Figures 6.20 and 6.21 represent the test number, the ASTM D7522/D7522M failure mode letter, and the strength in psi. These results are also summarized in Table 6.6.

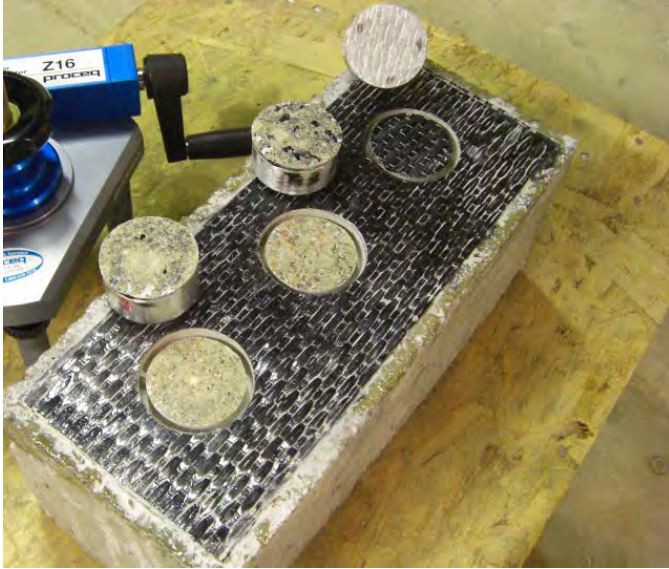
**Figure 6.19** Pull-off tests 1, 2, and 3 failure modes

As illustrated in Figure 6.19, the dollies from tests 2 and 3 show mostly concrete failure but with some black spots in which the CFRP did not adhere to the concrete during the reinforcement process. In the case of block #2, equivalent to tests 4, 5, and 6, all three showed a Mode A failure, with strengths of 444 psi (3.06 MPa), 270 psi (1.86 MPa), and 266 psi (1.83 MPa).

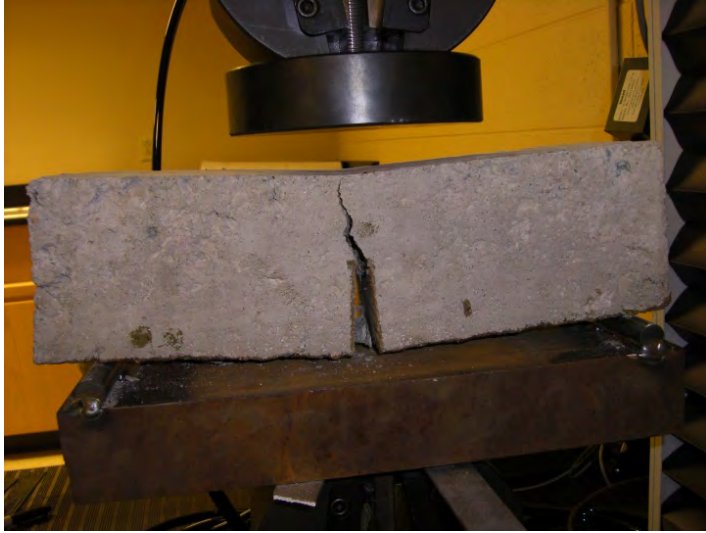
**Figure 6.22** Beam following crack failure

Stage 0 contained three small beams to be tested under three-point flexure. Due to an error with the testing machine, one specimen was prematurely damaged so the remaining two were used as the control specimens. As previously mentioned, a United Testing Machine Model SFM- 300 kN was used and the parameters recorded were time, force, and deflection as measured by the crosshead position. Figure 6.22 shows failure of one of the beams and how a single flexural crack was developed at the top of the saw cut, as desired.

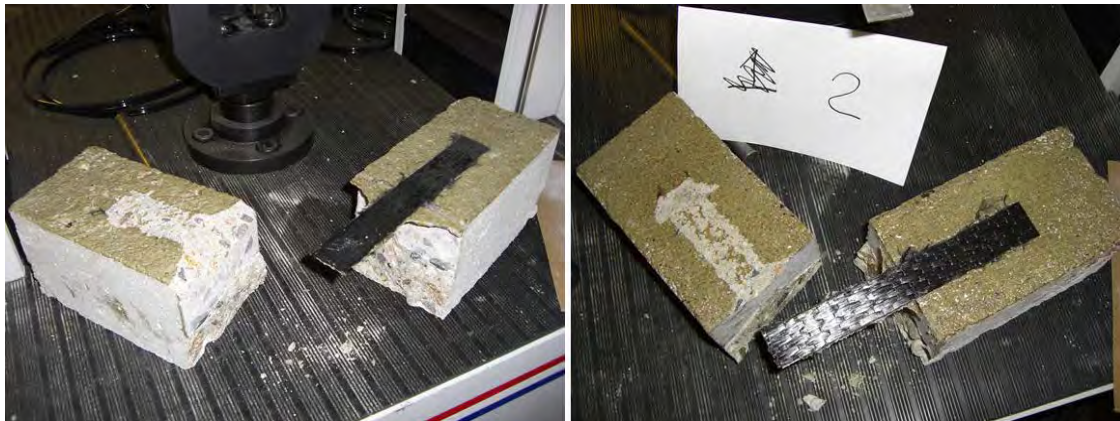
**Figure 6.23** Beam 1 (left) and Beam 2 (right) following testing

Both beams from this stage showed a fairly similar failure behavior, in which one side of the beam debonded before the other. However, the peak force witnessed on Beam 1 was considerably higher, 0.563 kips (2.50 kN) greater than for Beam 2. The larger force resisted by Beam 1 also resulted in a displacement of 0.029 in (0.74 mm) greater than for Beam 2. One possible reason for Beam 2 having a lower peak force is a weaker CFRP-concrete bond coming from the CFRP application. The darker spots on the failure surface for Beam 2 show that the CFRP did not completely adhere to the concrete substrate during application. Beam 1 contained little to no adhesive layer on top of the concrete surface after failure, which indicates that the CFRP was fully bonded to the concrete. Figure 6.23 shows the failure surfaces for both specimens, and it is noticeable how Beam 2 contained a significantly higher amount of adhesive on the concrete.

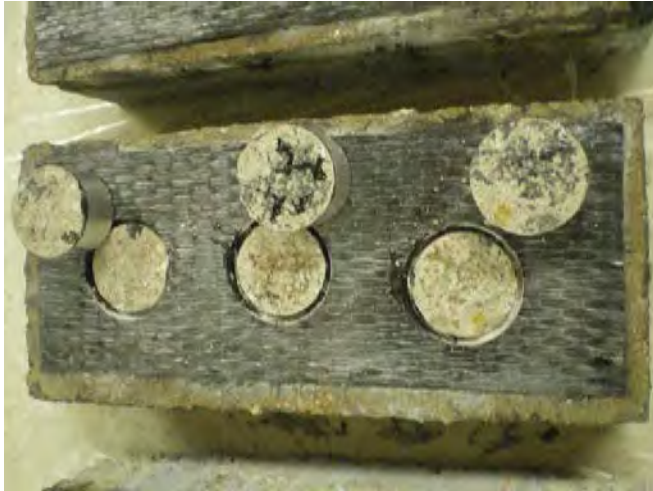
**Figure 6.25** Mode F failures (ASTM D7522) during Stage 1 testing

The most common failure was identified by Mode F, as labeled by ASTM D7522. Thirty-three of the 45 dollies tested showed this type of failure, in which a partial adhesive failure of the FRP-concrete interface, combined with a partial concrete failure, is seen. Figure 6.25 shows a typical failure Mode F encountered during testing. The figure illustrates how the CFRP did not fully adhere to the concrete, and it is noticeable by the black spots of CFRP that are still visible, especially on the middle dolly.

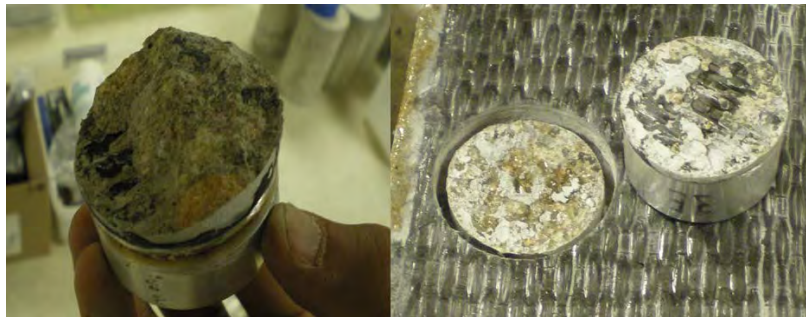
**Figure 6.26** Test 35 (left) vs. Test 38 (right)

This particular pull-off was characterized as an ideal concrete failure, Mode G in ASTM D7522. It is believed that the reasons for the extremely large discrepancies among the specimens that underwent the

exact same conditioning is due to the large aggregate present on test 35, as well as the presence of moisture within the concrete-FRP interface on test 38. This moisture was noticed because of the lighter color of the concrete, as well as a softer and more clayey feel to the touch. Notice in Figure 6.26 the large aggregate on Test 35, as well as the lighter color and thinner layer of concrete on test 38.

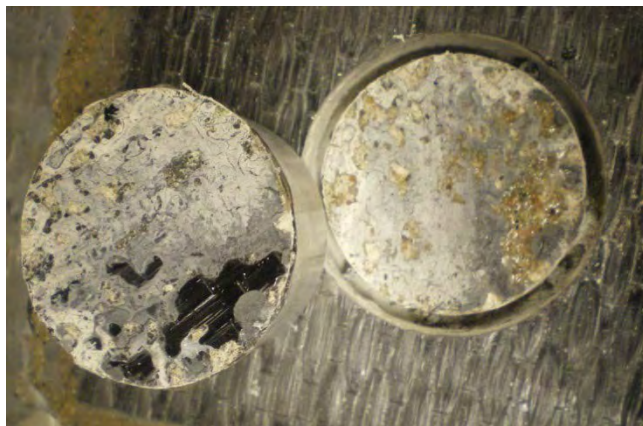
**Figure 6.27** Presence of moisture at CFRP-concrete interface

The second special case encountered during testing has some relation to test 38 above: the presence of moisture in the CFRP-concrete interface on Blocks #4, #9, and #13. This moisture was not present at the time of fabrication of specimens. Therefore, the deicing solution that these blocks were exposed to actually infiltrated into the bond either through the FRP or the concrete. This moisture was noticed in the specimens with different tonalities of gray in the concrete, as well as a softer, more clayey feel to the touch. It was determined that such moisture did decrease strength considerably. In the case of block #4 corresponding to wet-dry cycles, dollies #10, #11, and #12 showed moisture and did result in the ones with weaker strengths out of the whole group. In addition, dolly #16 from the non-chloride based deicer group showed a strength of 271 psi (1.868 MPa) lower than the remaining dollies in that group, and it was the only pull-off that exhibited levels of moisture within that group.

The same moisture level – strength relationship was witnessed in dollies #25, #26, and #27 (Block 9) within the non-chloride based deicer group, as well as dollies #33 from Block 11, and dollies #37 and #38 from Block 13. With these patterns identified, one can draw the conclusion that the presence of moisture does in fact reduce the pull-off strength. However, reasons why some dollies within the same group may or may not have exhibited moisture are unknown. A characteristic example of a dolly showing signs of moisture is illustrated in Figure 6.27.

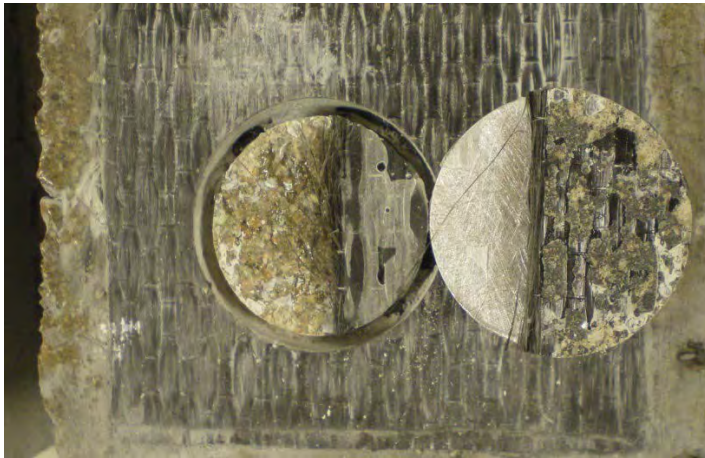
**Figure 6.28** Combined Mode A and Mode F Failure

The last special case consisted of having a mixed failure mode between Mode A and Mode F. In this special case, the CFRP fibers may not have been fully saturated during application, causing separation of

the bundles. Figure 6.28 shows how half of the dolly completely detached from the concrete at an adhesive level on the dolly-FRP interface, whereas, the second half was seen as an adhesive failure on the concrete-FRP interface.

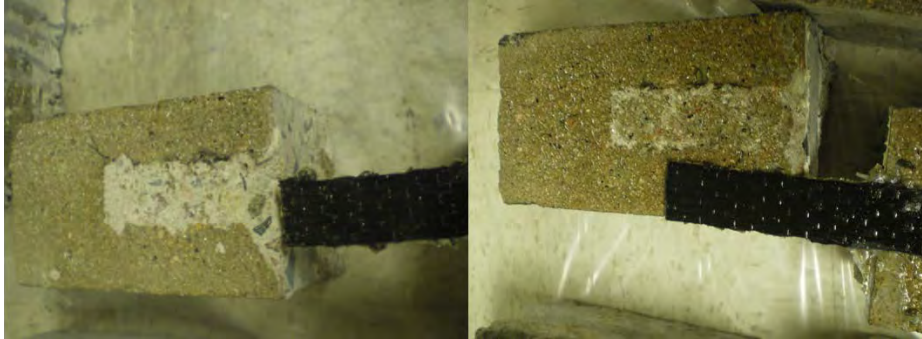
**Figure 6.29** Beam #1 (left) vs. Beam #8 (right) failure

Two control specimens were kept at dry conditions and room temperature. From the 13 beams tested, these two possessed the highest peak load values at 4.242 kip (18.87 kN) and 3.843 kips (17.09 kN). The absolute lowest load experienced on the beams was identified on Beam #8, corresponding to immersion in non-chloride based deicer. Figure 6.29 below clearly demonstrates the major differences in the bond

between one of the control specimens (Beam #1) and Beam #8. The larger area of darker spots on the concrete surface where the CFRP failed was found noticeable. The dark spots correspond to the cured epoxy adhesive that did not fully bond with the CFRP strip. Although it is possible that the non-chloride deicer may have contributed to degradation of the bond, the other potential cause for this behavior is improper adhesion of the CFRP onto the concrete during preparation.

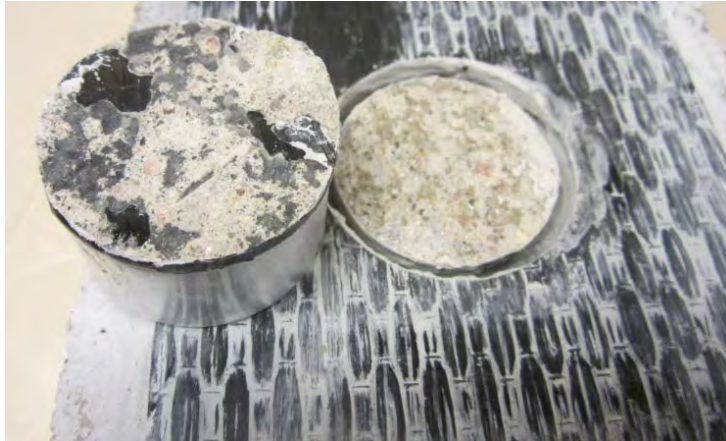
**Figure 6.30** Representative Mode F failure for Stage 2

Once again, the most common failure type corresponds to Mode F. Thirty-two of the 45 pull-off tests resulted in this failure mode, equivalent to 71% of the total. Figure 6.30 shows a representative failure for these 32 dollies. The black spots on the dolly correspond to sections where the CFRP did not fully adhere to the concrete, followed by partial concrete detachment within the same dolly.

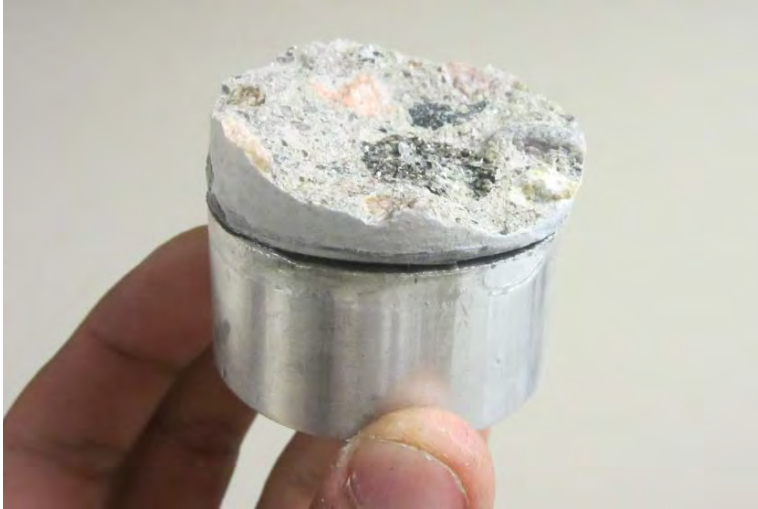
**Figure 6.31** Mode G Failure in Dolly #20

Four blocks were exposed to a non-chloride based deicer, equivalent to a total of 12 pull-off tests. Two of these blocks were reinforced with two layers of CFRP, and the remaining two blocks with three layers of CFRP. Failure modes varied from Mode A in three pull-offs, Mode F in eight dollies, and the last one corresponded to an ideal Mode G failure. Figure 6.31 shows the Mode G failure that was witnessed on dolly #20 from this stage, corresponding to one of the blocks reinforced with two layers of CFRP.

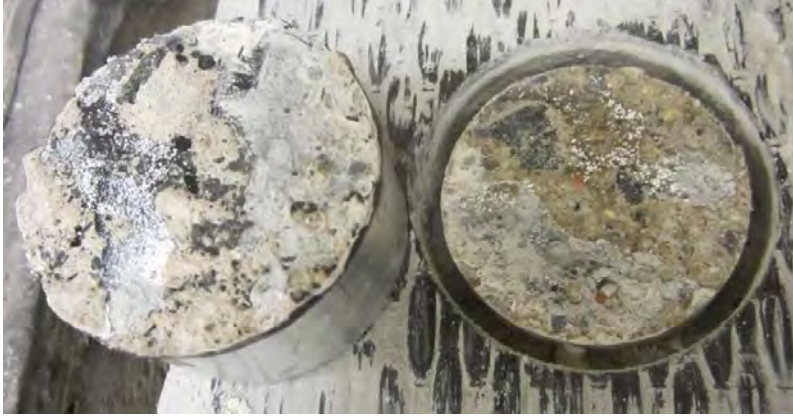
**Figure 6.32** Presence of moisture on Dollies

In this stage, the presence of moisture in some of the dollies was also witnessed. Two of the dollies within the water exposure group, three within the wet-dry cycle group, three within the non-chloride based deicer group, and nine within the chloride-based deicer group, were the specimens that showed moisture between the concrete and FRP. Once again, the different tonalities of gray as well as a softer more clayey feel to the touch helped identify which dollies showed levels of moisture. The amount of moisture ranged from very small spots around the edges to larger areas within the dolly. Figure 6.32 shows a characteristic image of the presence of moisture in the specimens. As far as moisture – strength relationship in the water group, no logical pattern was found. In fact, dollies #8 and #9 resulted in the highest bond strength in the group, even though these were the ones that showed some moisture within the group. However, dollies #25, #26, and #27 did turn out to be weakest ones within the non-chloride based deicer group. For the chloride-based deicer group, the moisture-strength relationship makes sense in the double-layer reinforcement ones, where dollies #28, #29, #32, and #33 showed the lowest strengths as opposed to the drier ones. These patterns, however, are difficult to interpret, as the moisture was not present within individual blocks, but rather within individual dollies.

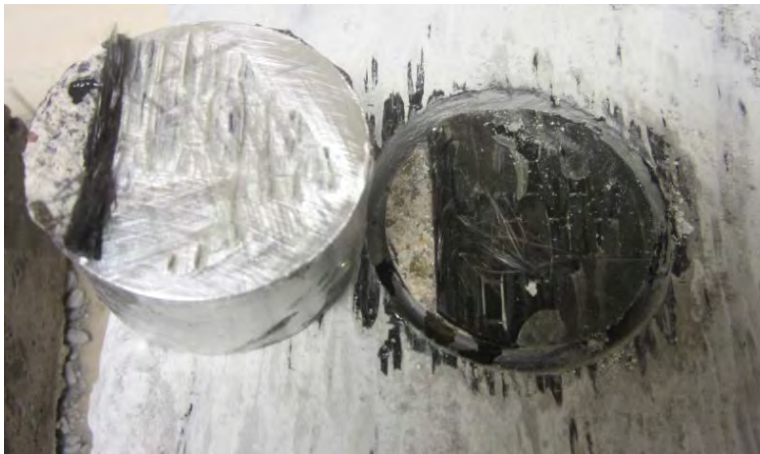
**Figure 6.33** Combined Mode A and Mode F failure in Dolly #42

Finally, the special case in which a combined Mode A and Mode G failure was witnessed in dolly #31 from Stage 1, was also seen in Stage 2 in dolly #42. Figure 6.33 shows dolly #42 with this particular failure. The cause may have been once again due to improper adhesion of the fabric, causing separation of the bundles, or due to a weak pattern of concrete on one side.

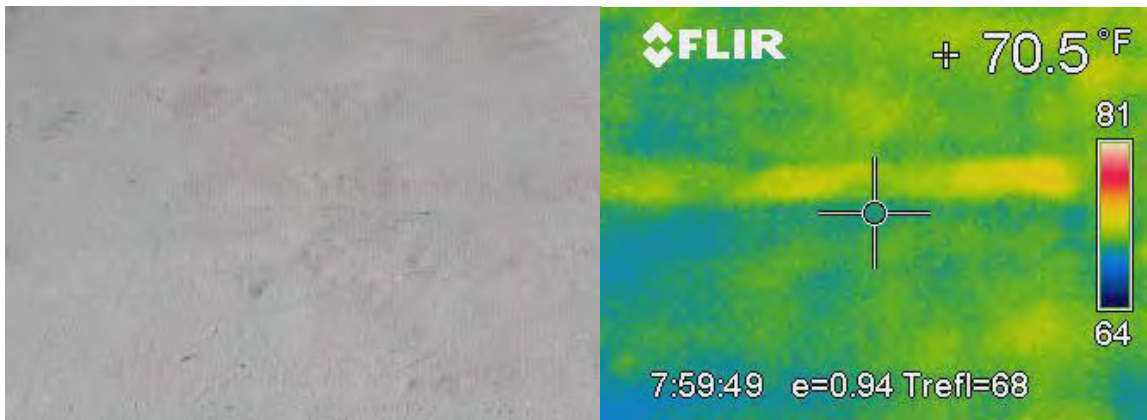
**Figure A12.** Photograph and thermal image of a seam in the CFRP sheets, no void present

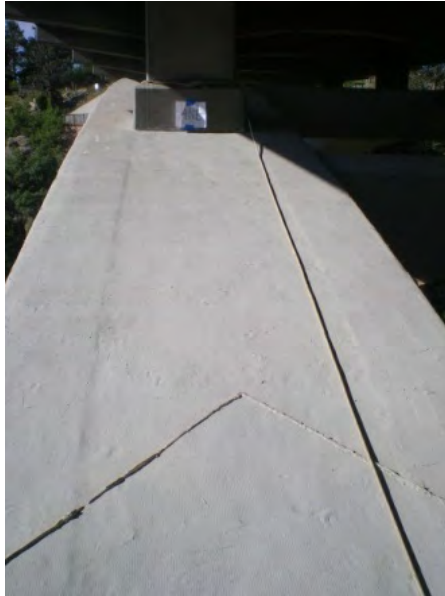
## **Bay 4NE: 1 Void**

**Figure A13.** Bay 4NE, V-shaped silicone bead water diverter

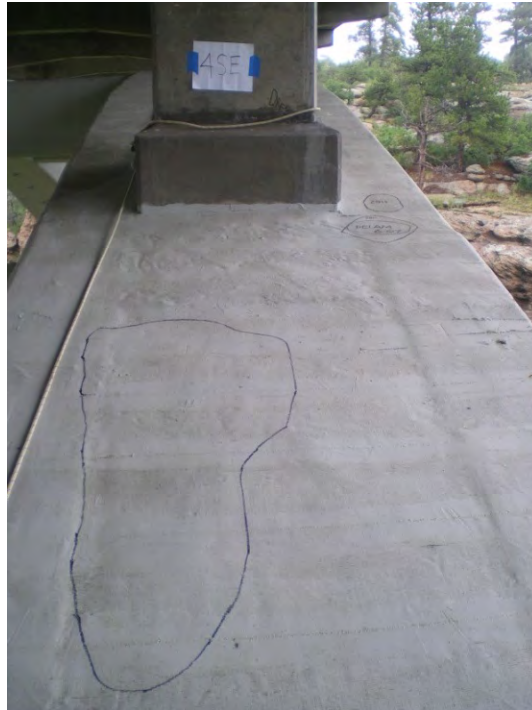
**Figure A16.** Bay 4SE

**Bay 4SE: 3 Voids, 1 Was Identified in 2007**

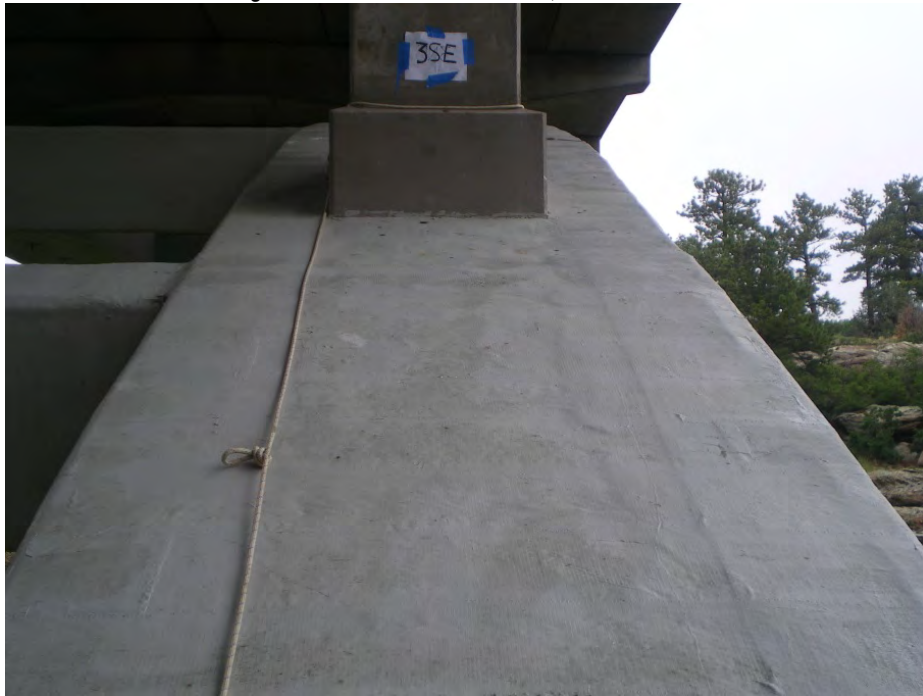
**Figure A18.** Bay 3SE

### **Bay 3SE: 2 Voids, 1 Crack**

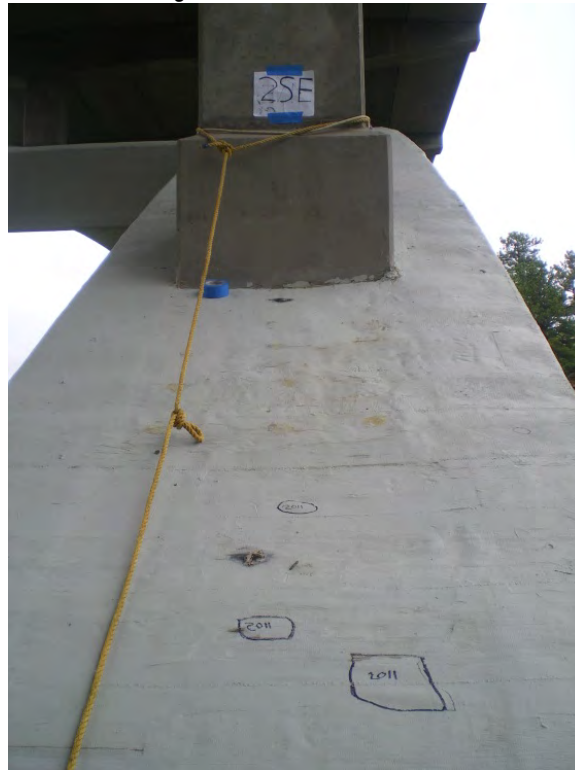
**Figure A20.** Bay 2SE

### **Bay 2SE: 3 Voids**

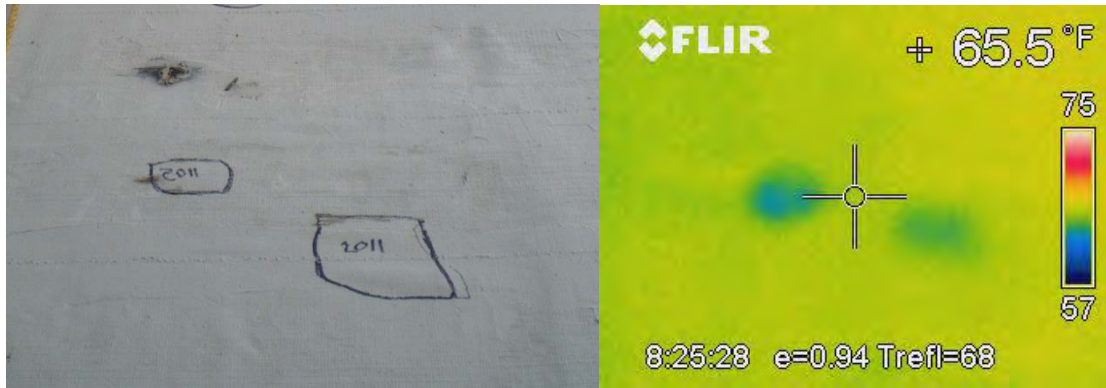
**Figure A21.** Photograph and thermal image of two voids

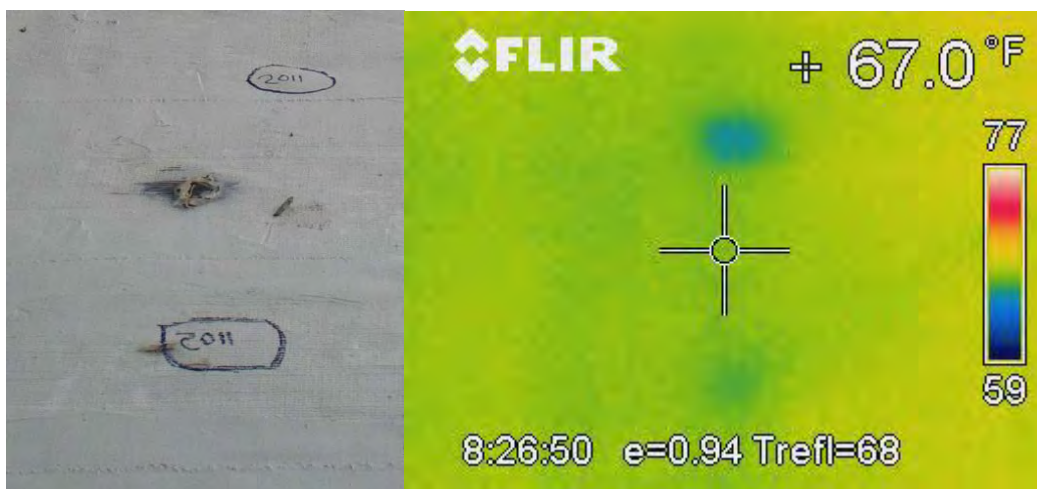
**Figure A22.** Photograph and thermal image of two voids, the black color in the photograph is left over strain gauges from the work done by Colorado University of Boulder
