# **Long Term Monitoring of Mechanical Properties of FRP Repair Materials**

Rebecca A. Atadero, Assistant Professor  
Douglas G. Allen, Graduate Research Assistant  
Oscar R. Mata, Graduate Research Assistant  
Department of Civil & Environmental Engineering  
Colorado State University  
Fort Collins, CO

Mountain-Plains Consortium  
and  
Colorado Department of Transportation  
DTD Applied Research and Innovation Branch  
Denver, CO

June 2013

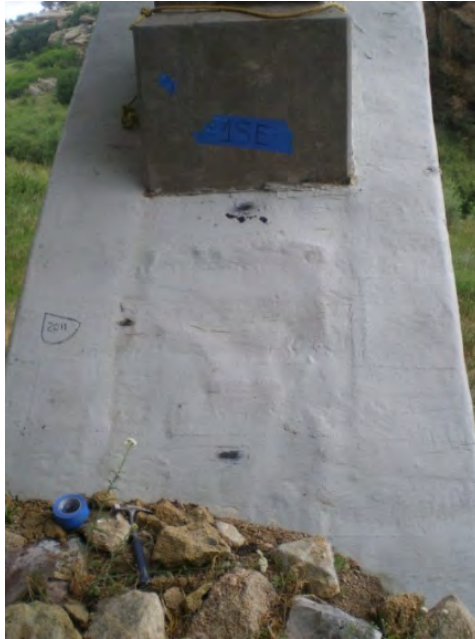
Figure A23. Bay 1SE, 1 void

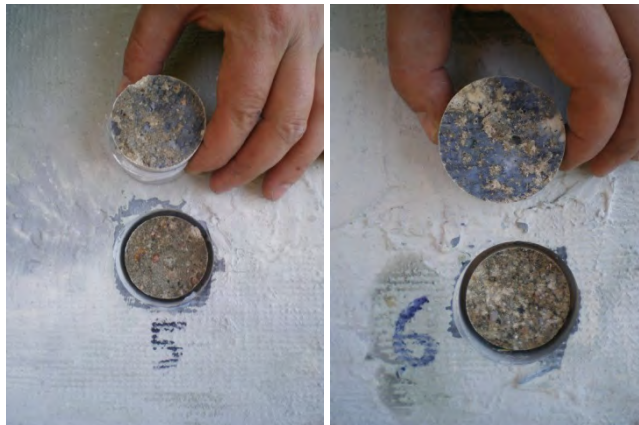
**Figures B4 and B5.** Test No.5, note puck slid off of center while epoxy was setting, and Test No. 6

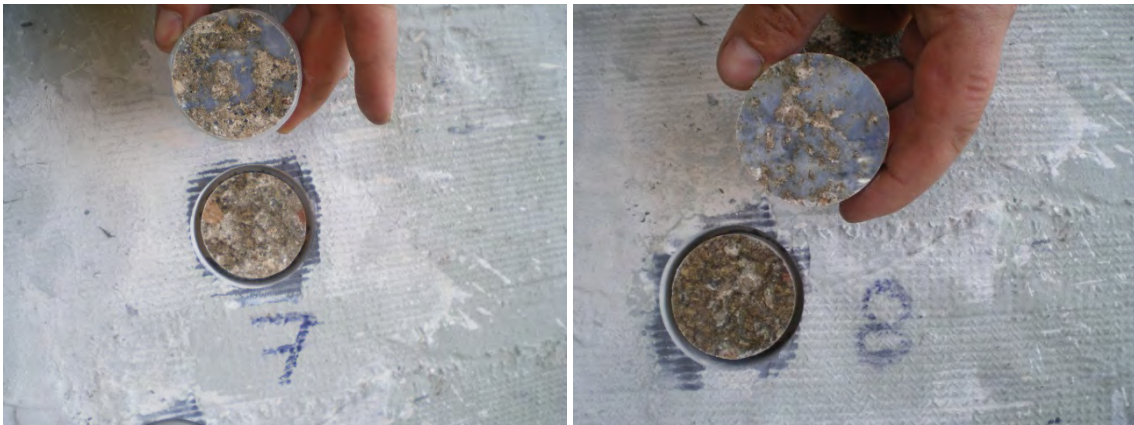
**Figures B6 and B7.** Test No.7 and Test No.8, weak bond strength

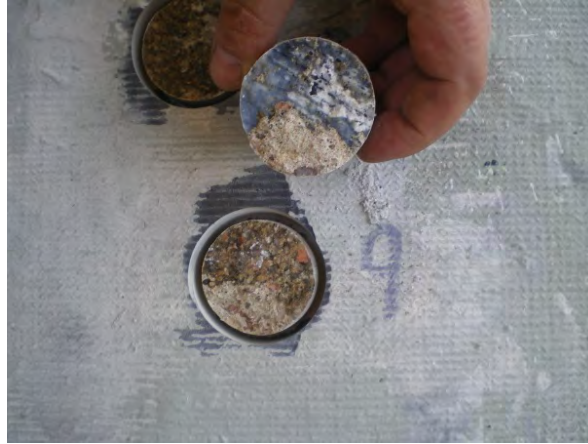
**Figure B8.** Test No.9, weak bond strength

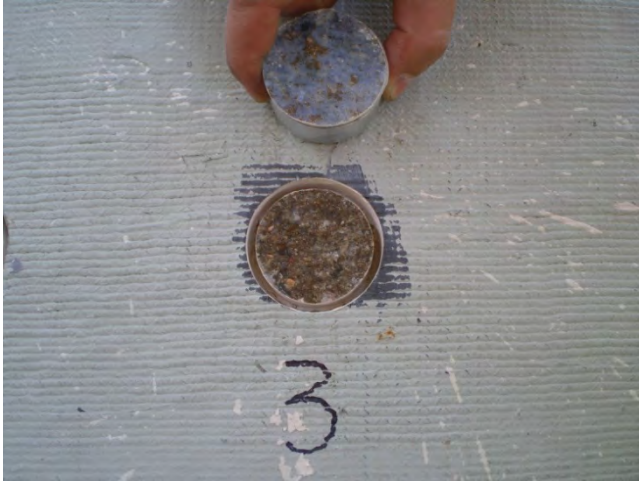
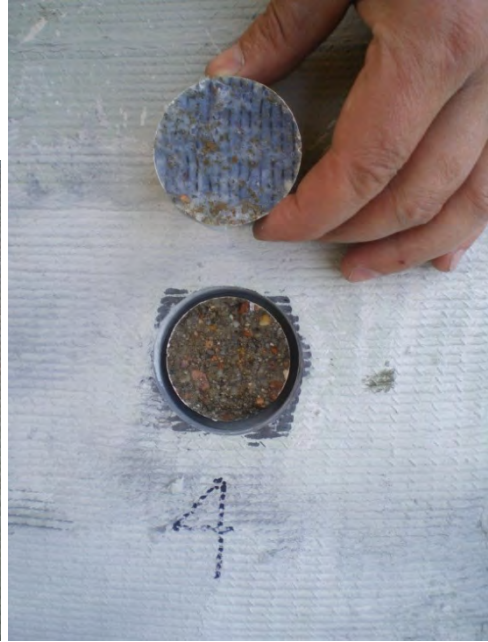
**Figures B10 and B11.** Test No.12, weak bond strength, and Test No.13, weak bond strength

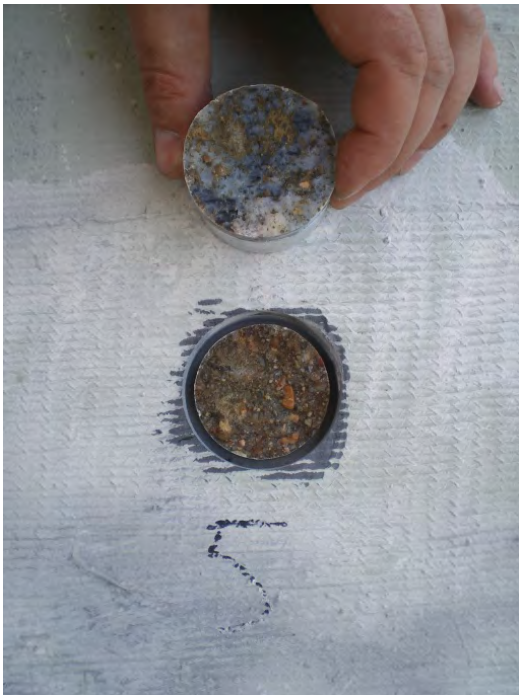
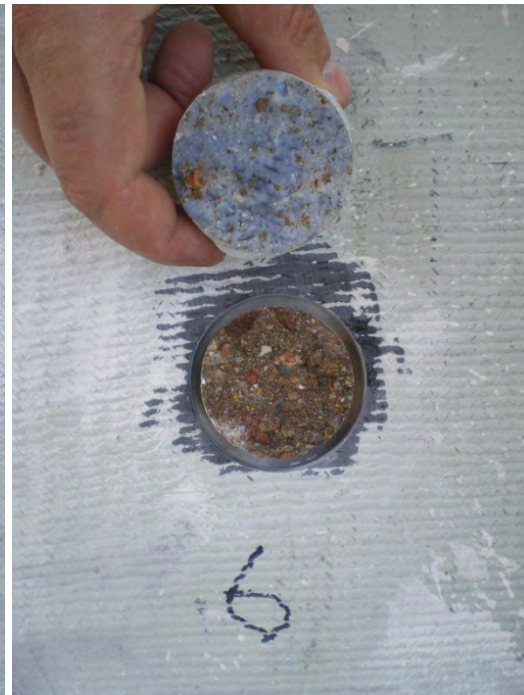
**Figures B12 and B13.** Test No.14, weak bond strength, and Test No.15, weak bond strength  
Test No.16 Not available, puck had faulty threads

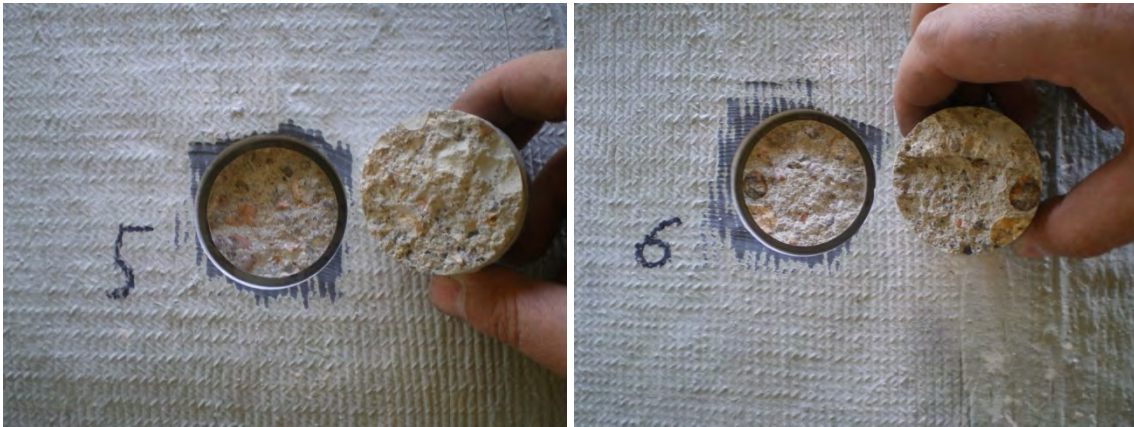
**Figures B20 and B21.** Test No.23, weak bond strength (poorly mixed concrete?), and Test No.24

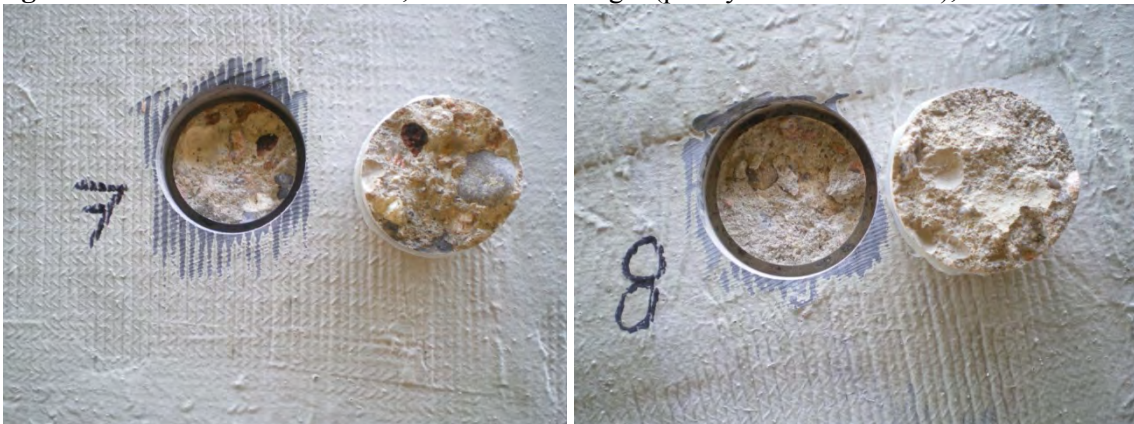
**Figures B22 and B23.** Test No.25 and Test No.26, note very weak bond strength (poorly mixed concrete?)
